Analysis of Tram Traffic-Induced Vibration Influence on Earthquake Damaged Buildings

Ivo Haladin ^{1,*}, Marijan Bogut ² and Stjepan Lakušić ¹¹ Faculty of Civil Engineering, University of Zagreb, 10000 Zagreb, Croatia; stjepan.lakusic@grad.unizg.hr² Končar—Electrical Engineering Institute Inc., 10000 Zagreb, Croatia; bogut@koncar-institut.hr

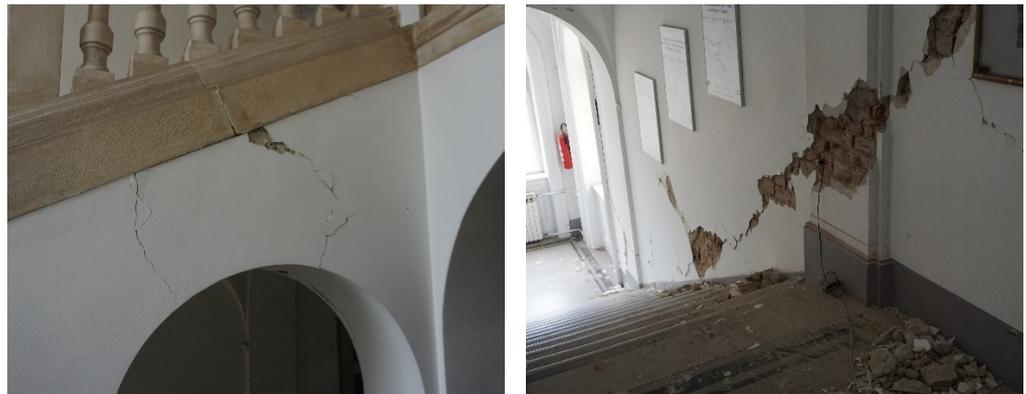
As a result of the M5.5 earthquake that hit Zagreb, the building suffered considerable damage at the level of the central staircase, partition walls, and load-bearing walls on higher floors of the building, Figure 4. The south wing was marked as temporarily unusable (PN2) according to the rapid post-earthquake assessment described in [27], while the east and west wings were marked as usable (U2) with minor damage. The building is also situated in the immediate vicinity of the tram track passing through Mihanovićeve street. The centreline of the closer track is situated only 5 m away from the facade of the building. Since the south wing, closest to the track, was completely evacuated after the earthquake, with the permission of HŽI, it served as an optimum location for performing an initial investigation of the influence of tram vibrations on the earthquake-damaged building.

Figure 4. Damage to the central staircase in the HŽI head-office building.

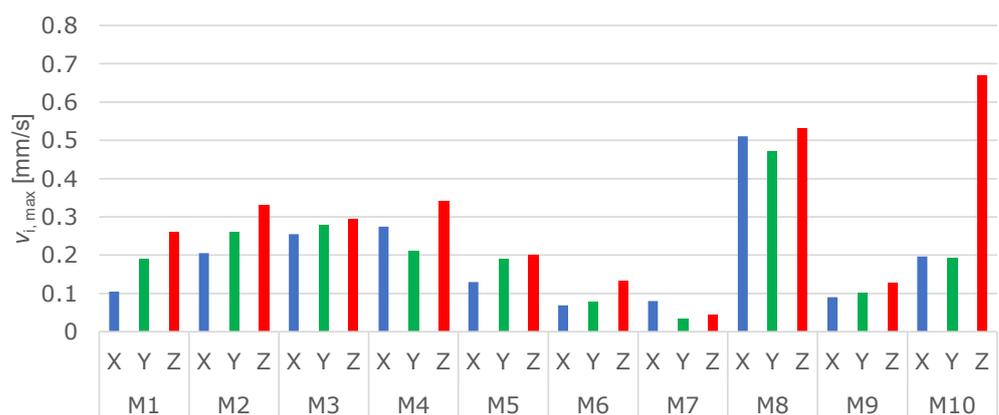
Figure 10. Peak vibration velocities measured in the building at ten measurement positions for the second pass-by of the reference tram.

The vibrations generated at the distant south track (pass-bys 1 and 3) reached 5-to-10-times lower peak values compared to vibrations generated at the north track (pass-bys 2 and 4), which was to be expected due to energy loss with the distance from the source to the receiver. Therefore, pass-bys on track closer to the building façade are further investigated. If the central position of the south façade is observed, vibrations tend to increase with the floor of the building, being the smallest at the basement level (M5) and increasing from the

ground floor to the third floor (M1 to M4). On the third floor, a drop in horizontal vibration level was observed, which is probably due to the stiffer reinforced concrete structure compared to the rest of the building. It is also visible that peak velocities drop with the distance from the track (M1 → M6 → M7) on the same floor. The analysis shows that the highest vibration levels are at the south-east wing connection (M8, ground floor, and M10, third floor of the building). From vibration trends of the passing tram (Figure 9), a distinct peak in the 12th second is visible at the left side of the bogie (PLZ). This peak occurs in a broad spectrum, with the maximum at around 30 Hz. At this position, the tram changes direction (drives in an S curve), which also leads to the deteriorated track geometry when compared to other positions on the building. Additionally, the accelerometer position at the crossing of the south and east bearing walls ensures vibration transfer through the structure.

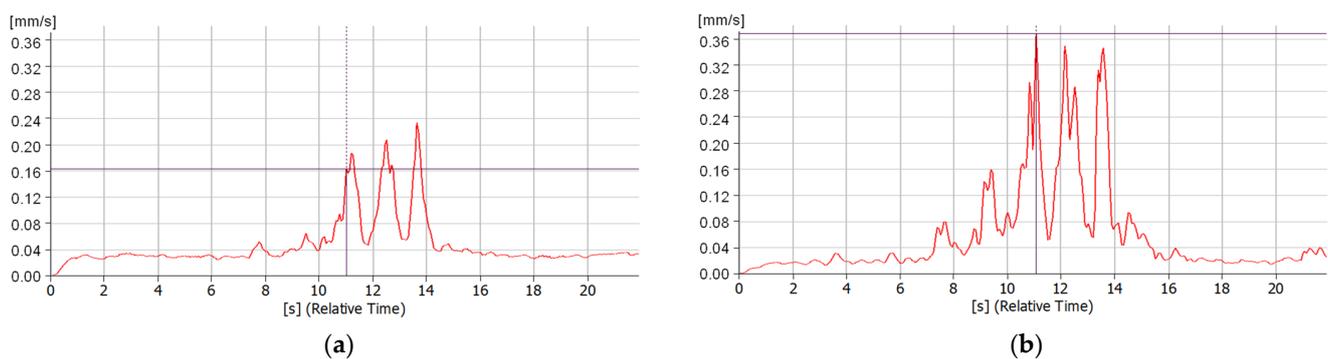
Second pass-by of the reference tram, Figure 11, induced maximum vibrations in terms of PPV when compared to any other observed pass of all trams, and it was therefore used to evaluate the level of long-term vibration exposure. Table 1 gives an overview of available thresholds for assessing the impact of vibrations on structures. According to a standard currently in place in Croatia [19], the long-term vibration exposure of sensitive structures should not exceed 2.5 mm/s of PPV calculated according to Equation (2). The maximum level was recorded in Z direction $-v_{z, \max} = 0.68$ mm/s, well below the allowable limit. If the Swiss standard [18] is considered, PPV calculated according to Equation (1) is 0.724 mm/s, which is also below the recommended value of 1.5 mm/s for vibration-sensitive buildings exposed to long-term vibrations. Therefore, damage occurrence due to tram vibrations has a very low probability.

Figure 11. Vertical (Z) vibration velocity trends at (a) M8 and (b) M10 for the second pass-by of the reference tram.

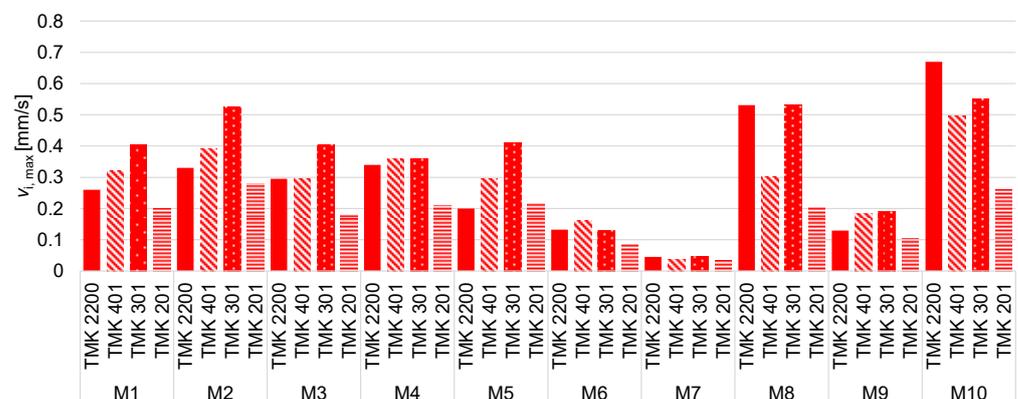
Figure 12. Peak vibration velocities in Z direction according to tram type.

By comparing four pass-bys, the highest vibration amplitudes can be observed in the vertical (Z) direction. Additionally, for all pass-bys, maximum levels were measured at location M10. For each of the tram types, vibrations at M8 are similar in amplitude for all directions. As to the south-central axis (M1–M5), the highest vibrations were induced by TMK 301 tram. Overall maximum vibration levels were induced by TMK 2200 at M10.

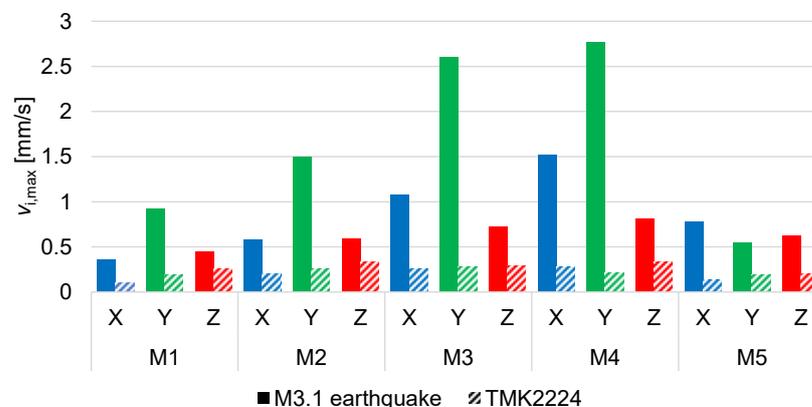
If the 3.1 (ML) response is analysed in terms of PPV according to [19], a direct comparison to the acquired tram response can be made. The results presented for M1 to M5 clearly indicate how even small-intensity earthquake-triggered vibrations are considered harmful for historic masonry structures, Figure 16, while maximum tram vibrations trigger a much smaller response.

Figure 16. Comparison of peak vibration velocities generated by M3.1 earthquake and pass-by of TMK2224 vehicle.
