Post-Earthquake Assessment of a Historical Masonry Building after the Zagreb Earthquake—Case Study

Ivan Hafner, Damir Lazarević, Tomislav Kišiček * and Mislav Stepinac

Faculty of Civil Engineering, University of Zagreb, 10000 Zagreb, Croatia; ivan.hafner@grad.unizg.hr (I.H.); damir.lazarevic@grad.unizg.hr (D.L.); mislav.stepinac@grad.unizg.hr (M.S.)

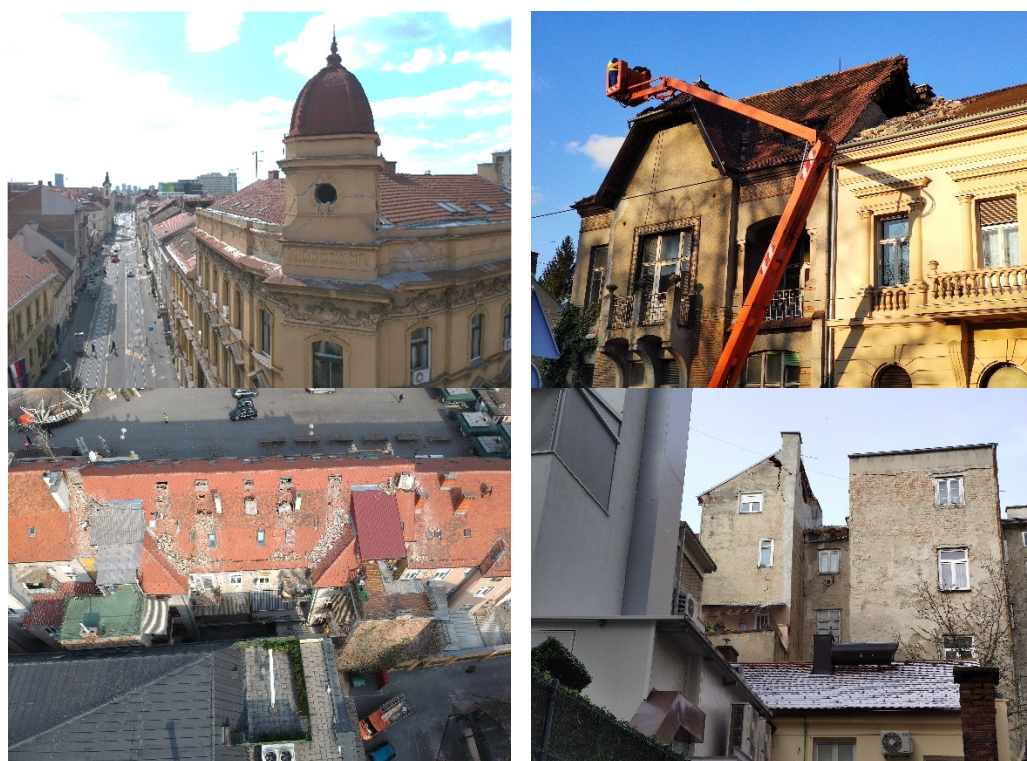
Figure 2. Typical damage of buildings in the city center of Zagreb (photo credit: Mislav Stepinac).

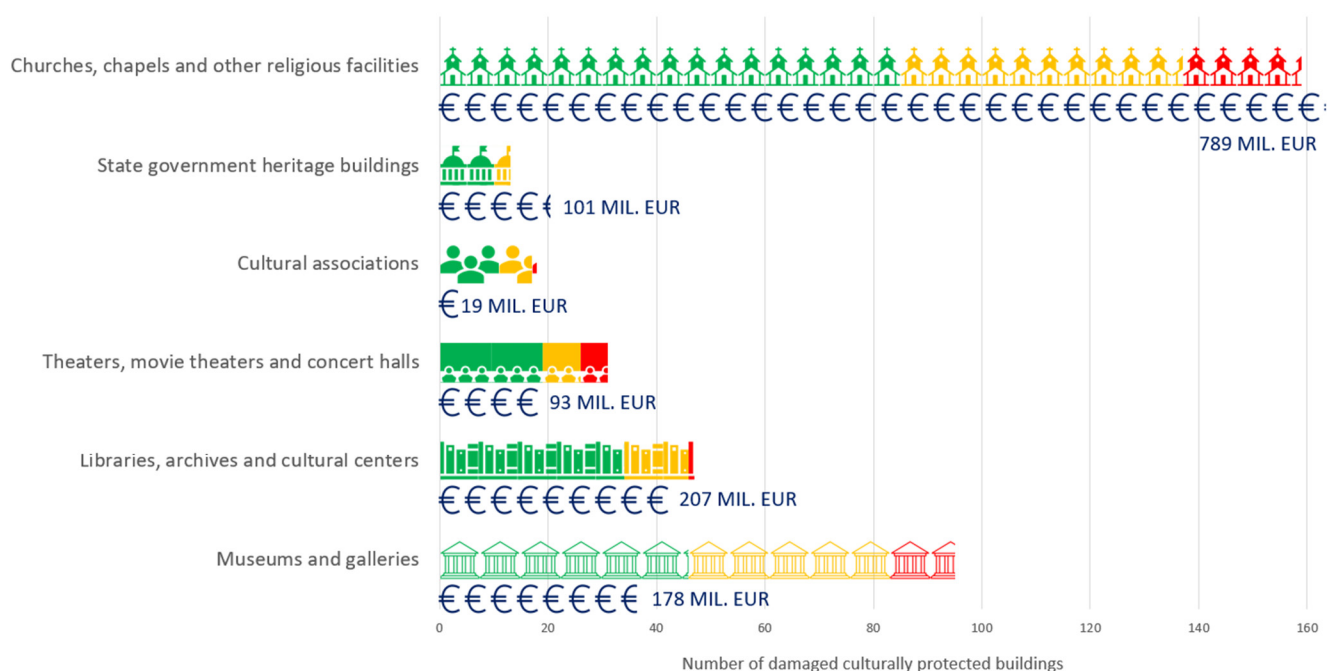
Figure 3. Damage to the heritage buildings after the Zagreb earthquake in 2020.

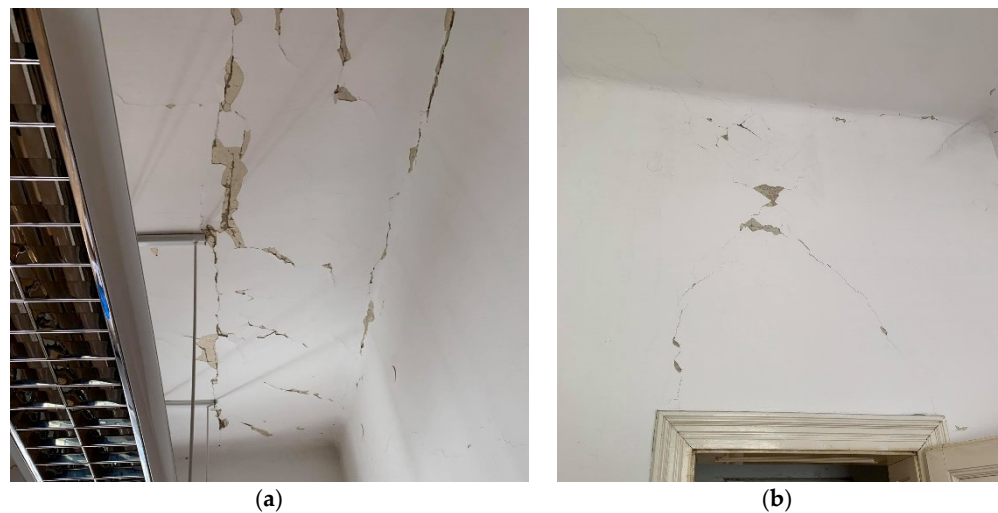
- Different crack patterns on the ceilings and above the openings (Figure 7a,b)
- Longitudinal cracks in joints between the walls and ceilings
- Diagonal X-pattern cracks on parapet walls between the openings on the façade (Figure 8)
- Cracks on load-bearing walls and cracks on walls where previous interventions were made, such as bricked-up doors (Figure 9a,b)
- Smaller cracks in the staircase of the building

Figure 7. Cracks in the ceiling (a) and above the openings (b) on the 2nd floor.

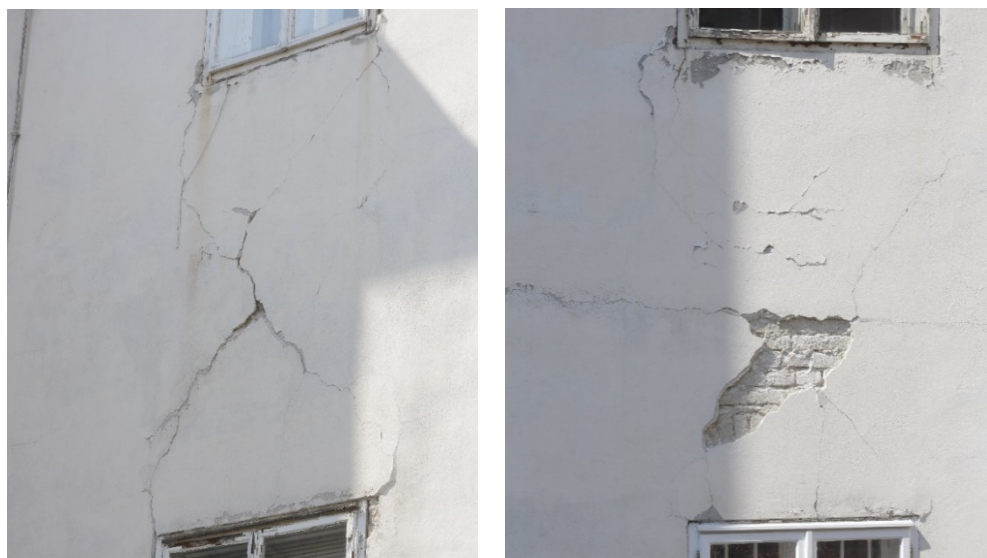
Figure 8. Diagonal X-pattern cracks on parapet walls between the first and second floor.

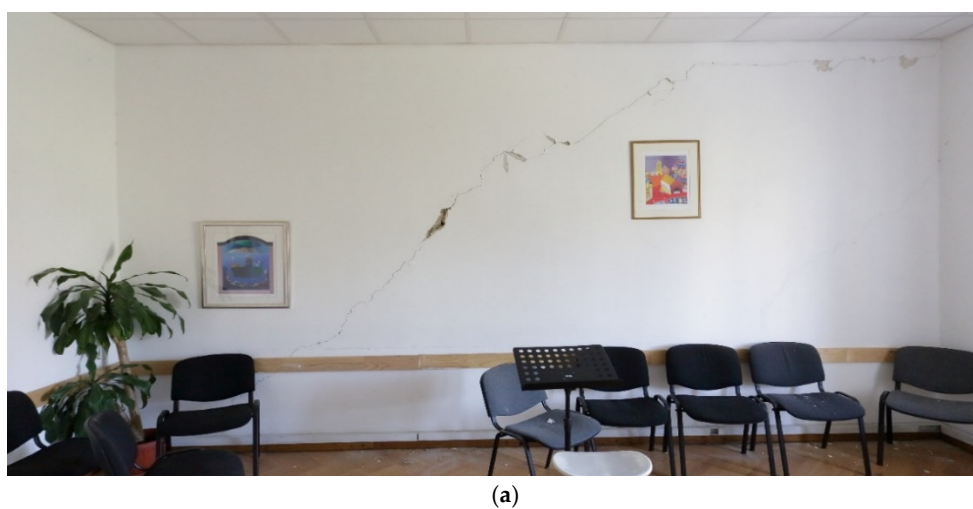
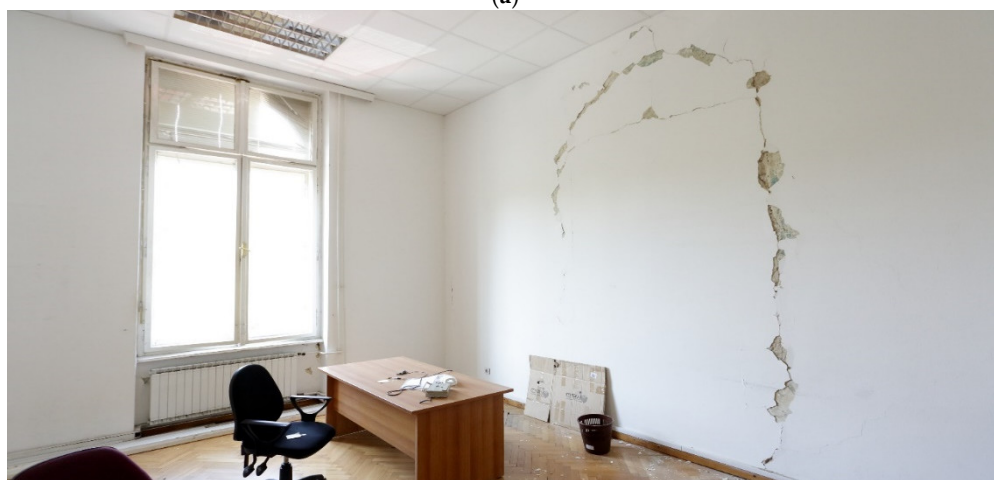
Figure 9. Cracks on load-bearing walls (a) and cracks on walls where previous interventions were made such as bricked-up doors and above the openings (b) on the 3rd floor.

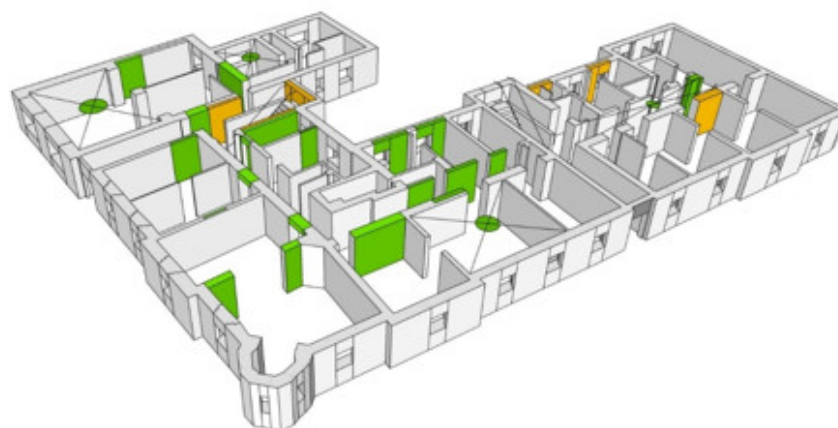
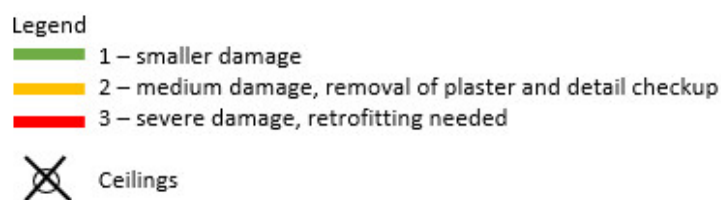
Figure 10. Damage scheme for the 1st floor of the building.

- The basement: no damage was found that could be linked to the earthquake.
- 1st floor/ground floor: different types of damage were revealed. As it can be seen in Figure 10, no severe damage was found on the ground floor. The majority of the damage is visible in the form of light cracks or local decay of plaster on the wall coverings, vaults and ceilings. Moreover, minor diagonal and X-pattern cracks are visible in the walls over the doors and parapets between the windows on the façade. A few more damaged parts of the building's ground floor include the Eastern staircase and the load-bearing walls in the South–North direction located in the most Southern part of the building (Figure 10). Again, the damage is mostly visible in the form of

diagonal cracks. In this particular case the removal of plaster was needed with a more detailed inspection to be conducted.

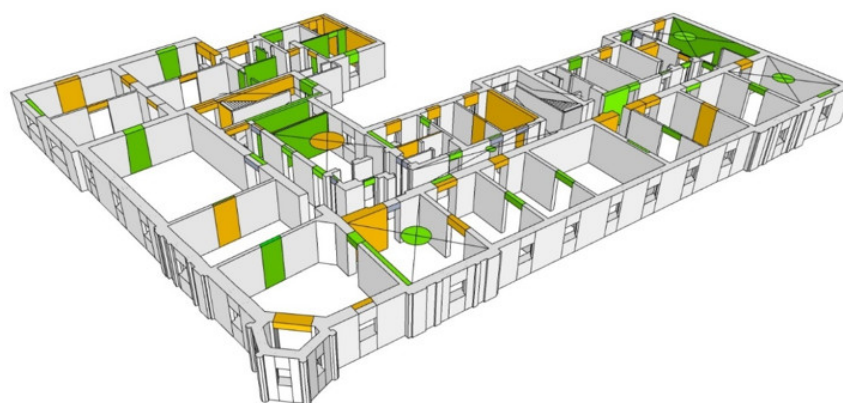
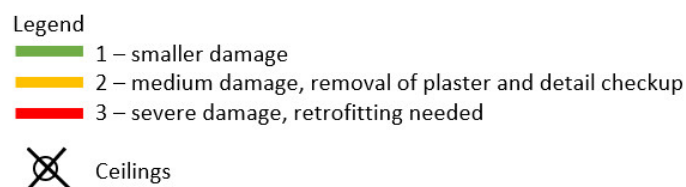
Figure 11. Damage scheme for the 2nd floor of the building.

- 2nd floor: more damage was detected than on the first floor, as can be concluded from Figure 11. The damage pattern is quite similar, with most of the damage being cracks and plaster decay. More severe damage was detected in wooden ceilings and load-bearing walls. Most of the cracks are diagonal or in an X-pattern, with some being longitudinal across the wall. These longitudinal cracks are typical for locations where there is a difference in the materials used or where electrical wiring is placed. Another type of cracking is found on the second floor. In the locations where, throughout the years, openings or doors were closed, excessive damage may be found (Figure 11). These types of cracks appear due to the differences in material used for the construction of the wall and the material used for bricking up a door or an opening in the same wall. This type of damage is very typical in old masonry buildings. Most of the damaged parts of the second floor need to be inspected with more detail.

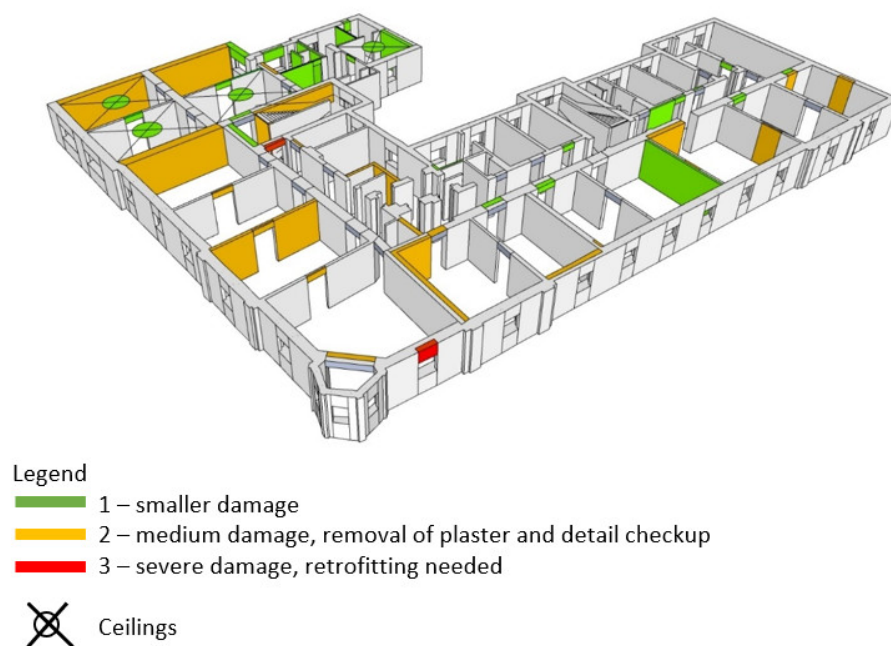
Figure 12. Damage scheme for the 3rd floor of the building.

- 3rd floor: first signs of severe damage may be found. As shown in Figure 12, the red color indicates that retrofitting methods must be used. In particular, a load-bearing wall at the North-Western corner of the building and a wall in the Eastern part of the building were severely damaged. Besides that, on the third floor, the diagonal and X-pattern cracks are in some cases quite wider than on the first and second floors. Furthermore, the cracks extend throughout the length of the wall, which means that the entire wall has fulfilled its purpose when it comes to its shear strength. A detailed inspection is needed for the vast majority of the damage found on the third floor.

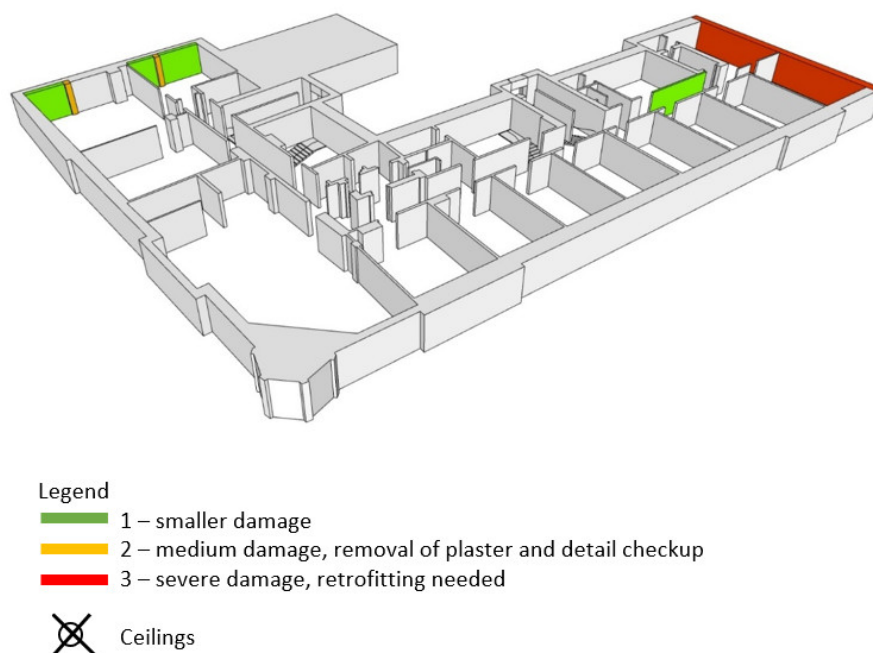
Figure 13. Damage scheme for the attic of the building.

- Finally, in the attic, no specific damage was found except the Southern gable wall, which practically needs to be rebuilt and is a danger to any bystander in the street. A more detailed assessment is needed in the Western gable wall (Figure 13).

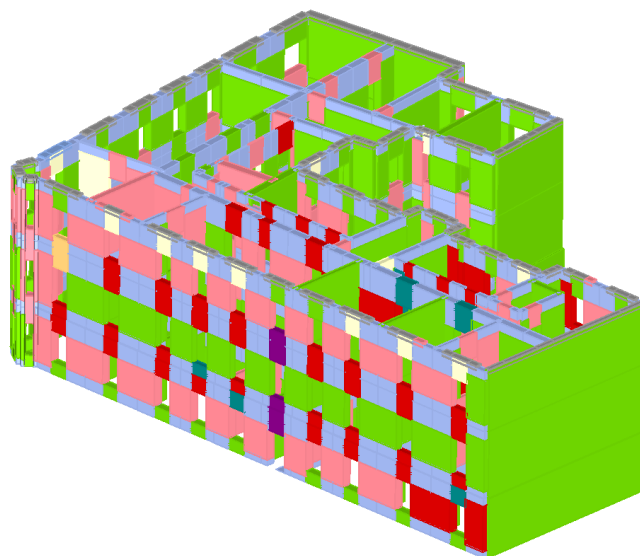
In Figures 19 and 20, the damaged state of the building at the last step of the pushover analysis is shown. In Figure 19, the damaged state of the building is shown for the x-direction. Most of the damage is bending damage and failure (red and pink color), with a couple of walls and spandrels being damaged in shear (beige color). A lot of tension failure may be seen as well (blue color). In Figure 20, a similar situation may be observed. However, in the y-direction, most of the building is damaged but failure has not yet occurred in any shape or form.

Figure 19. Damage at maximum displacement capacity for pushover in the x-direction.

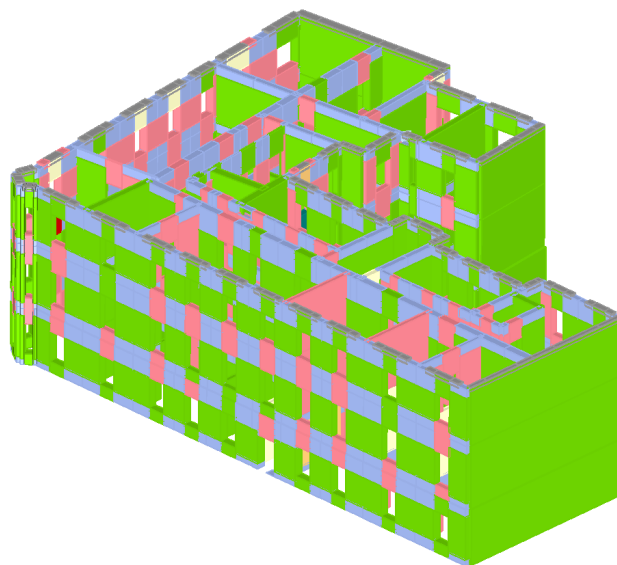
Figure 20. Damage at maximum displacement capacity for pushover in the y-direction.

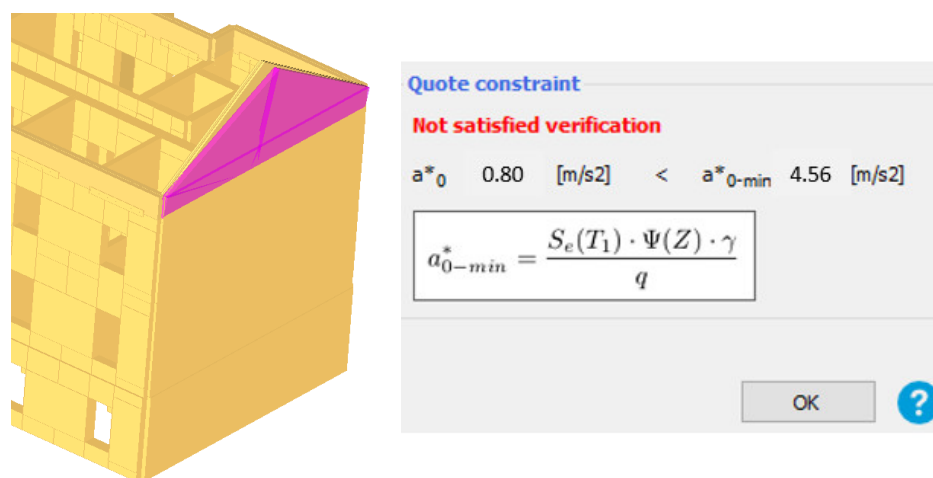
In Figure 22 the first mechanism LM1 is the most common type of a local mechanism. After the Zagreb earthquake, most of the damage was detected in the form of damaged chimneys and out-of-plane failure of gable walls. As it may be seen from the quote constraint verification, this mechanism does not satisfy the analysis. In Figure 23, local mechanism LM2 shows the wall of the 2nd floor that is divided into two parts. This mechanism does not satisfy the quote constraint verification as well. In Figure 24, local mechanism LM3 shows two walls of the 2nd and 3rd floor that show an out-of-plane failure. The verification is not satisfied again.

Figure 22. Local mechanism LM1 (Southern gable wall).

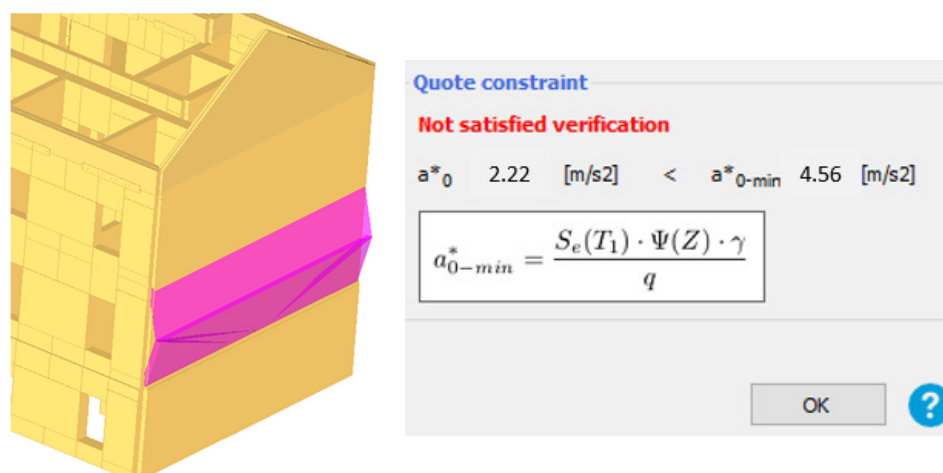
Figure 23. Local mechanism LM2 (Southern wall of the 2nd floor).

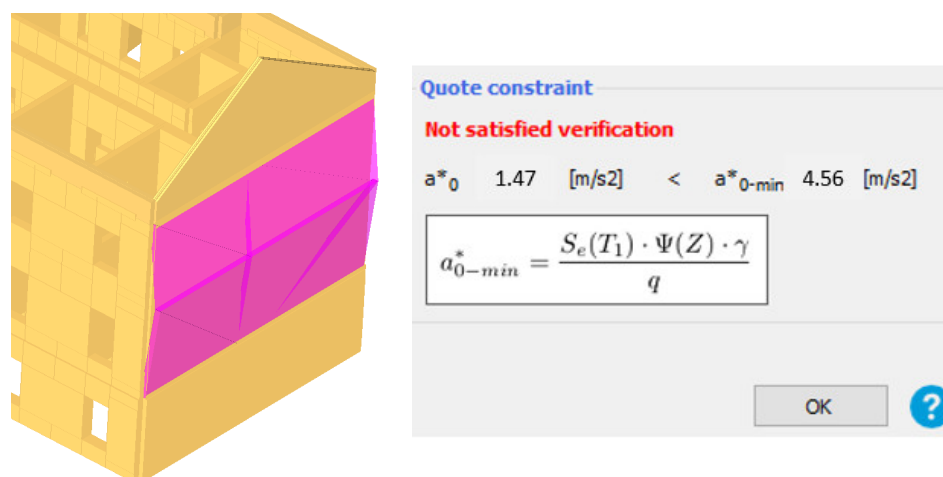
Figure 24. Local mechanism LM3 (Southern walls of the 2nd and 3rd floor).

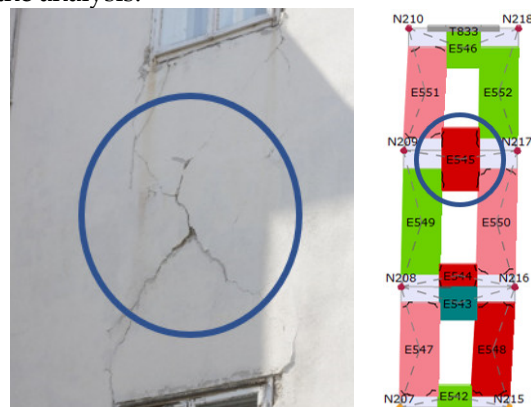
The results obtained via the aforementioned analyses are compared to the real-life damage, as seen in Figures 25–27. Understandably, the results of the numerical analysis vary from the ones obtained in the post-earthquake assessment. However, as seen from the figures below, the damage detected in-situ is similar to the damage obtained from the software. This is perhaps the greatest value of the non-linear static pushover analysis because damage patterns may be obtained for every macro-element in every single step of the analysis.

Figure 25. Comparison of the damaged spandrel (Eastern façade).

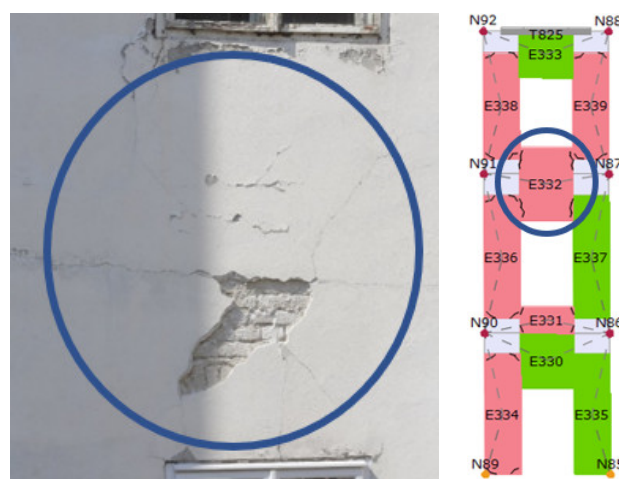
Figure 26. Comparison of the damaged spandrel (Southern façade).

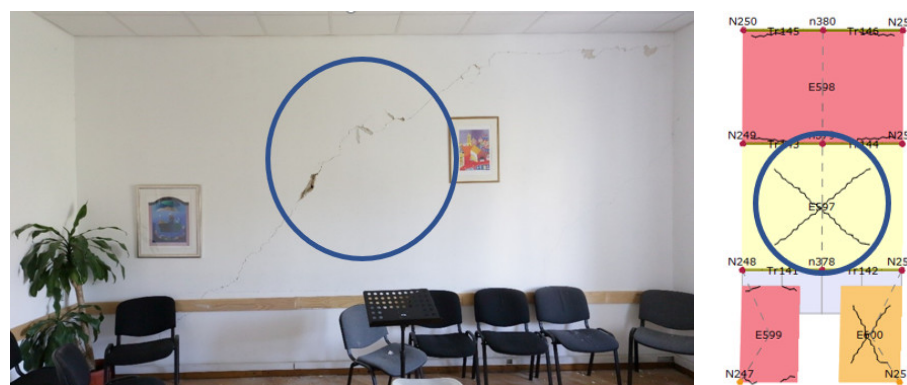
Figure 27. Comparison of the damaged bearing wall in the y direction.
