# Enhanced Documentation and Evaluation of Grouting Process, through the Fusion of Non-Destructive Testing and Evaluation Information—The Case Study of the Katholikon of the Monastery of Panagia Varnakova

**Abstract:** The restoration of historic buildings and structures involves a wide range of scientific and technical fields. The grouting process is among an array of rehabilitation and preservation interventions and aims to homogenize the structure after the implementation of strengthening measures. The process can provide important information regarding the state of preservation of the examined structure and correlate the progress of the process with the pathology of the monument. To achieve this, the analysis of typical raw grouting data is progressively fused with additional information from the diagnostic studies, non-destructive testing, geospatial information, and from the calculation and analysis of grouting indices. The restoration project of the Katholikon of the Monastery of Panagia Varnakova in Fokida, Greece was selected as the case study, due to its large scale and the severe earthquake damage it has sustained, which has necessitated comprehensive strengthening inte

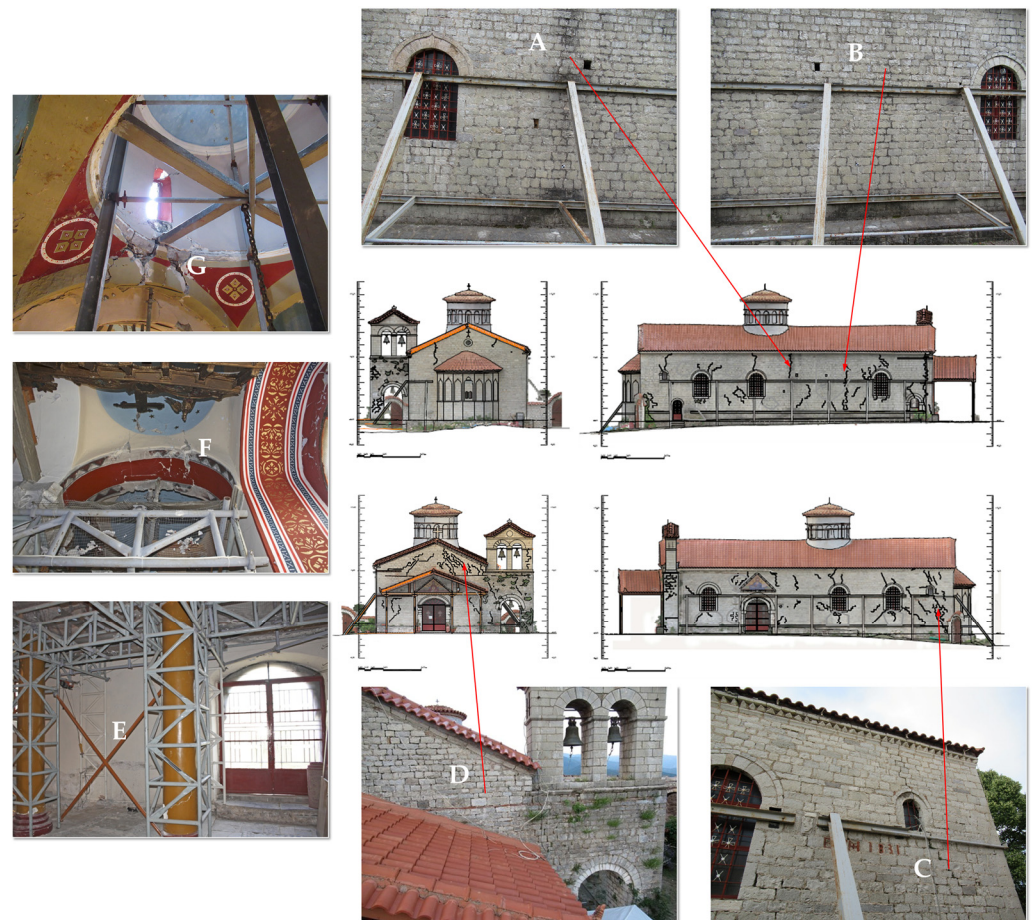
As mentioned above, the Katholikon has sustained extensive structural damage due to recent earthquakes, as evidenced macroscopically by exterior and interior cracks and failures. The pathology is described in detail in [58], whereas its non-destructive evaluation with ground-penetrating radar is presented in [60]. Figure 2 presents typical cracks and

failures prior to the initiation of the restoration works. Figure 2A indicates an exterior structural crack observed on the north side of the Katholikon, which corresponds to the pair of structural cracks created by the northward thrust of the main dome during the earthquakes (mode along the N–S direction) as validated by the finite element modeling and assessment of the dynamic behavior of the Katholikon under simulated earthquakes [58,60]. Figure 2B indicates the crack located at the north side at the junction of the exo-narthex and the main church. Figure 2C indicates the cluster of structural cracks created at the east end of the south side of the Katholikon, as the result of the dynamic loading during the earthquakes along the E–W direction [58,60]. Figure 2D indicates a typical cluster of cracks created in the west side and the bell tower. Figure 2E indicates typical horizontal cracks observed at the interior of the main church (south aisle in this case), whereas Figure 2F,G indicate typical failures of the arches supporting the domes. Figure 2G, in particular, corresponds to the south arch supporting the main dome, and it is interesting to note that no pair of exterior structural cracks is observed in the corresponding positions on the south side of the Katholikon, as compared to Figure 2A. This indicates that the failure at the south arch relieved much of the earthquake loadings and did not influence the south wall accordingly, during the movement of the main dome along the N–S direction. In addition, many other cracks originate at the openings (doors and windows) of the Katholikon.

**Figure 2.** The pathology of the Katholikon (adapted from [58]). Typical damage/cracks (A–G); see description in main text.

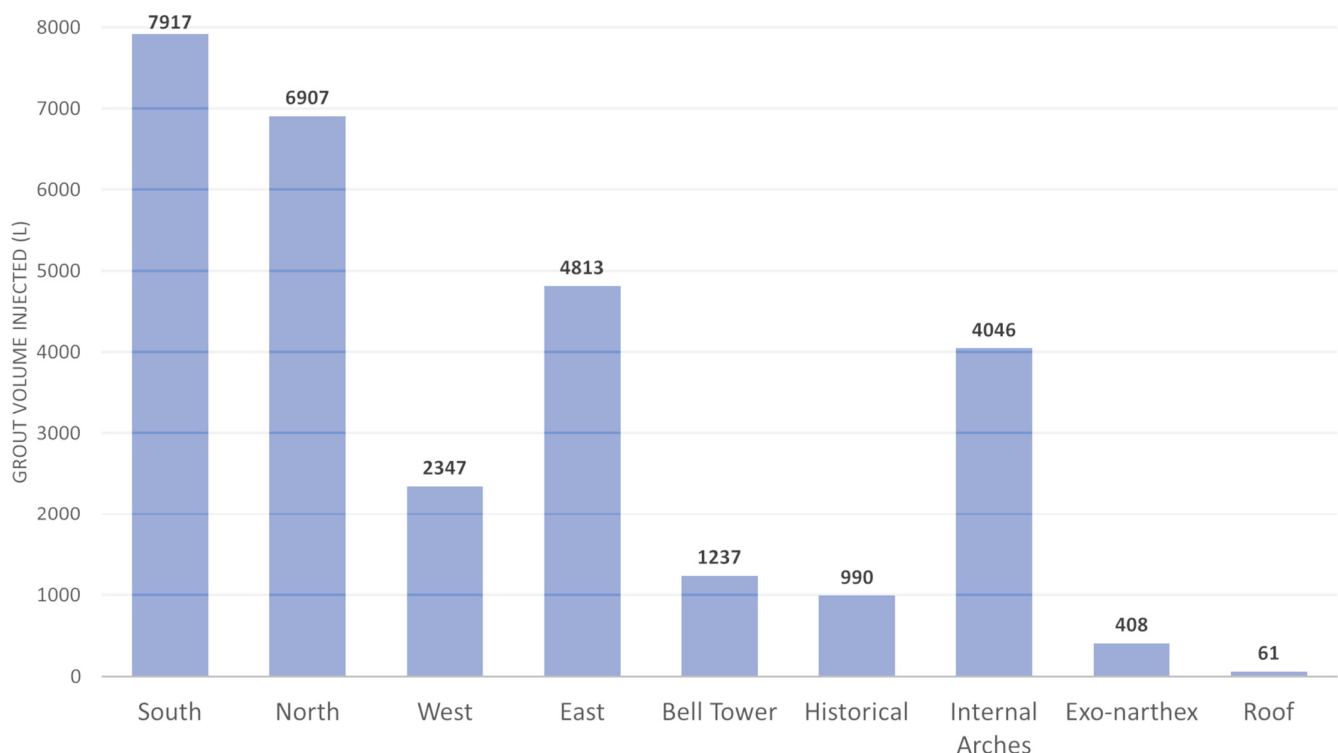
Approximately >2500 tubes functioned as entry tubes, and >1000 tubes ended up as output tubes. The total volume of grout injected was 28.73 m<sup>3</sup> (see Figure 5). The grouted masonry was approximately 309 m<sup>3</sup> and 747 m<sup>2</sup>, i.e., demonstrated an average grout “consumption” of 93 L/m<sup>3</sup> or 38.5 L/m<sup>2</sup>. The value of 93 L/m<sup>3</sup> corresponds to 9.3% of the masonry volume, a rather large percentage, indicating the severe state of damage of the Katholikon, although this includes significant grout consumption that apparently was diverted to the Katholikon foundations (see comments below).

**Figure 5.** Volume of grout injected per area of the Katholikon.

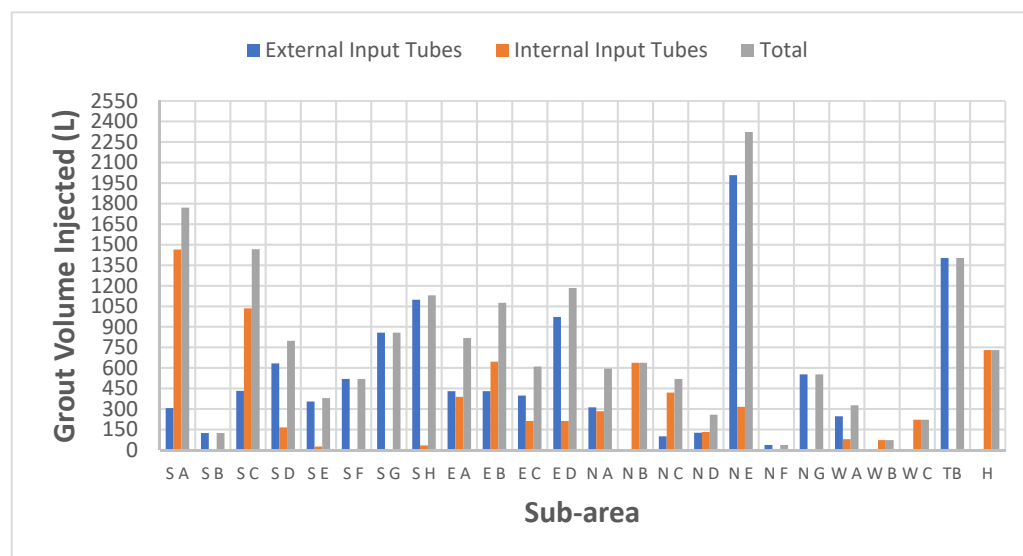
Figure 6 presents the grout volume injected per sub-area of the Katholikon. Significant variations can be observed, but these should be examined considering the size of each sub-area, its pathology, its apparent interconnectivity with adjacent sub-areas, and the overall grouting sequence.

Worth noting is the large amount of grout injected in sub-area NE. However, this specific sub-area is the largest sized and contains some structural cracks that are attributed to the thrust of the dome towards the north direction (during earthquake—see discussion in previous section) and the presence of a transverse wall (initially the west façade of the original church) and the corresponding cracks on the north masonry [58,60].

Another interesting observation regards the grouting behavior of the south side of the Katholikon. Sub-areas SA, SB, and SC, which correspond to the south parts of the exo-narthex, demonstrate increased amounts of grout injected from the interior tubes, instead from the exterior, which is the opposite situation for the rest of the south side (SD to SH). In comparison, the corresponding north part of the exo-narthex (sub-areas NF, NG) demonstrates a much lower grout volume injection, exclusively from exterior tubes. Even so, an analysis based solely on the total grout volume per sub-area can be misleading; 85% of the total grout volume of sub-area SA corresponds to one interior tube (PS109) which reached 70 exit points, predominantly over the west masonry of the Katholikon. Instead, the analysis should take into account the findings from the Finite Element Modelling (FEM) and dynamic behavior of the building [60] and the observed pathology (Figure 2).

**Figure 6.** Volume of grout injected per sub-area of the Katholikon.

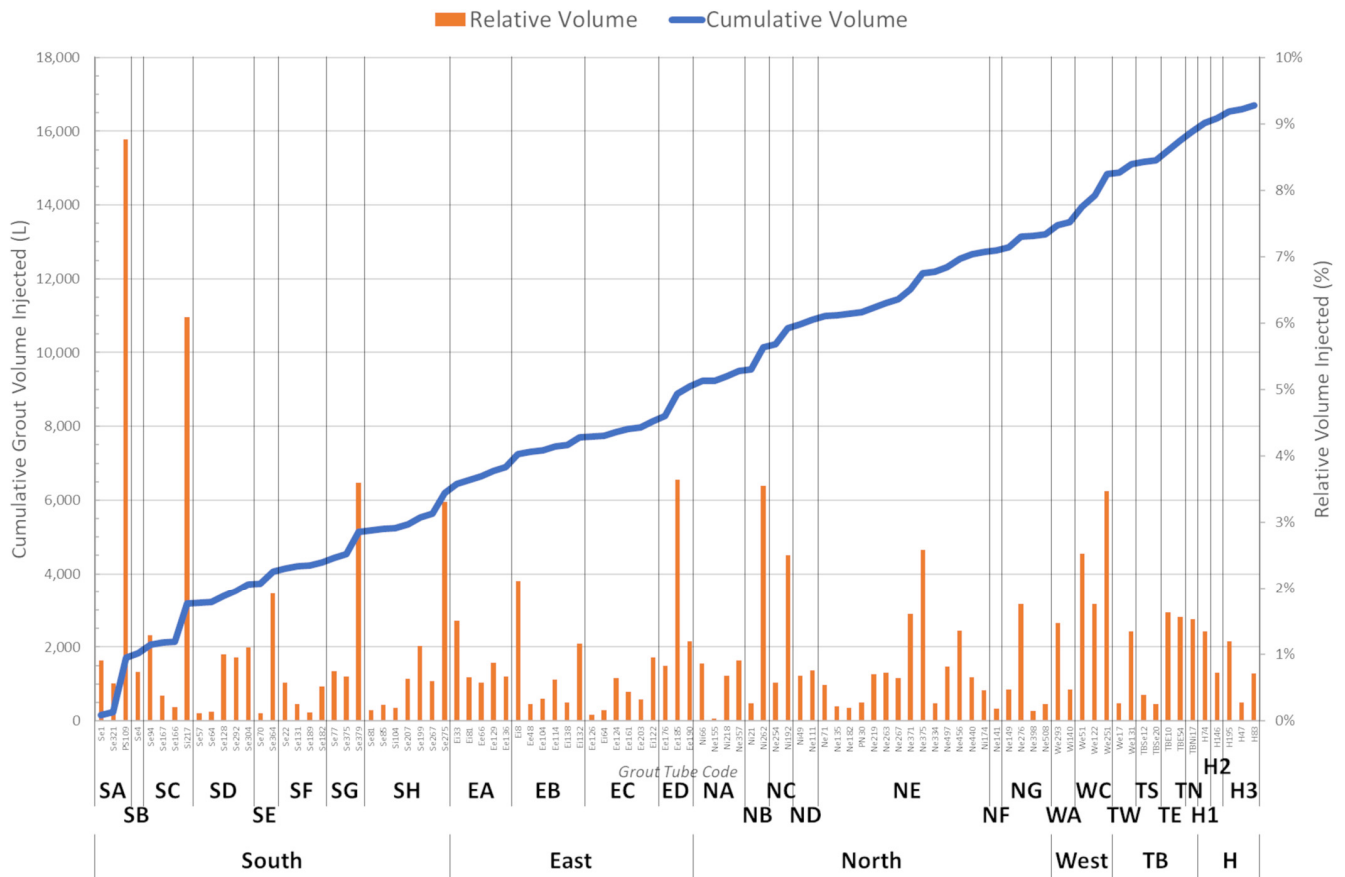
Two very prominent “steps” regard tubes in the south part of the exo-narthex (SA, SB, and SC). Tube PS109 is located at the interior corner between sub-areas SA and WC, at a height level of 4 m (Figure 8). It required a grout volume of 1464 lt, reaching 70 exit

**Figure 7.** Cumulative volume of injected grout and relative volume of grout injected in each tube throughout the timeline of grout injection for each sub-area. Sub-area codes are shown in Figure 4.

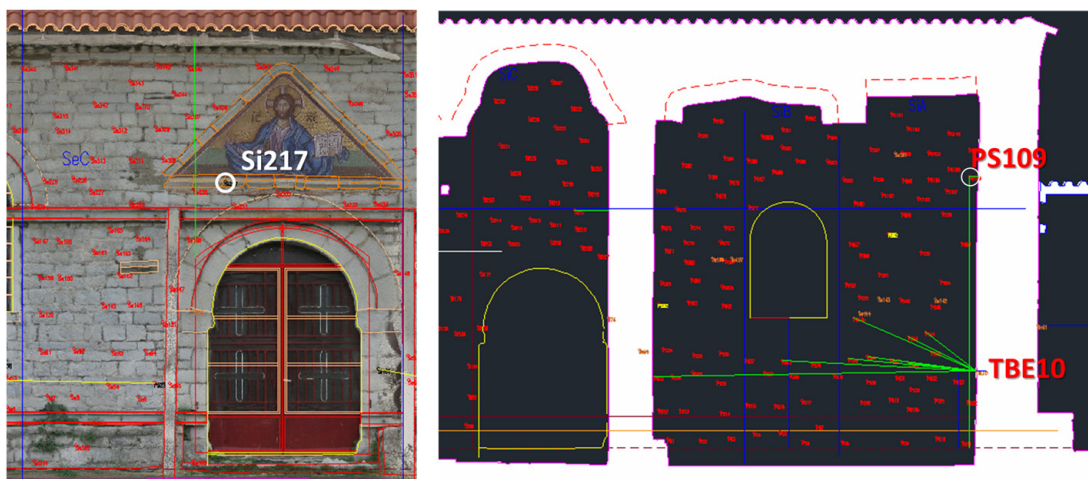
points, almost all in the west façade. Tube Si217 is located at the interior, above the south main entrance, at a height level of 3.5 m (Figure 8). Hence, it is located in the south aisle. Nonetheless, most of the 36 exit points were observed at the exterior or interior of the south side of the exo-narthex, while a few were over the byzantine masonry (H). None, however, were observed towards the adjacent SD sub-area. These observations support the scenario of leaf-detachment, as discussed above, and highlight the influence and damage imposed by the transverse historical masonry (H) in this junction area of the building.

**Figure 8.** Location of entry tubes PS109 and Si217 which exhibited the highest grout volume injection.

Regarding entry tubes PS109 and Si217, it is worth noting that although they demonstrate a very high volume of grout injected and number of exit points, their grouting indices do not show analogous deviations from the mean values of the remaining tubes in this area. For example, PS109 and Se321 show similar values for all three indices, despite being located at comparable positions at the interior and the exterior of sub-area SA, respectively. This indicates that the morphology and cluster of internal cracks and voids filled through these entry tubes is not dissimilar to that achieved from the remaining entry tubes in this area; PS109 only happens to provide access to a continuous cluster of internal voids. The utilization of grouting indices highlights this behavior, which would otherwise be characterized as atypical.

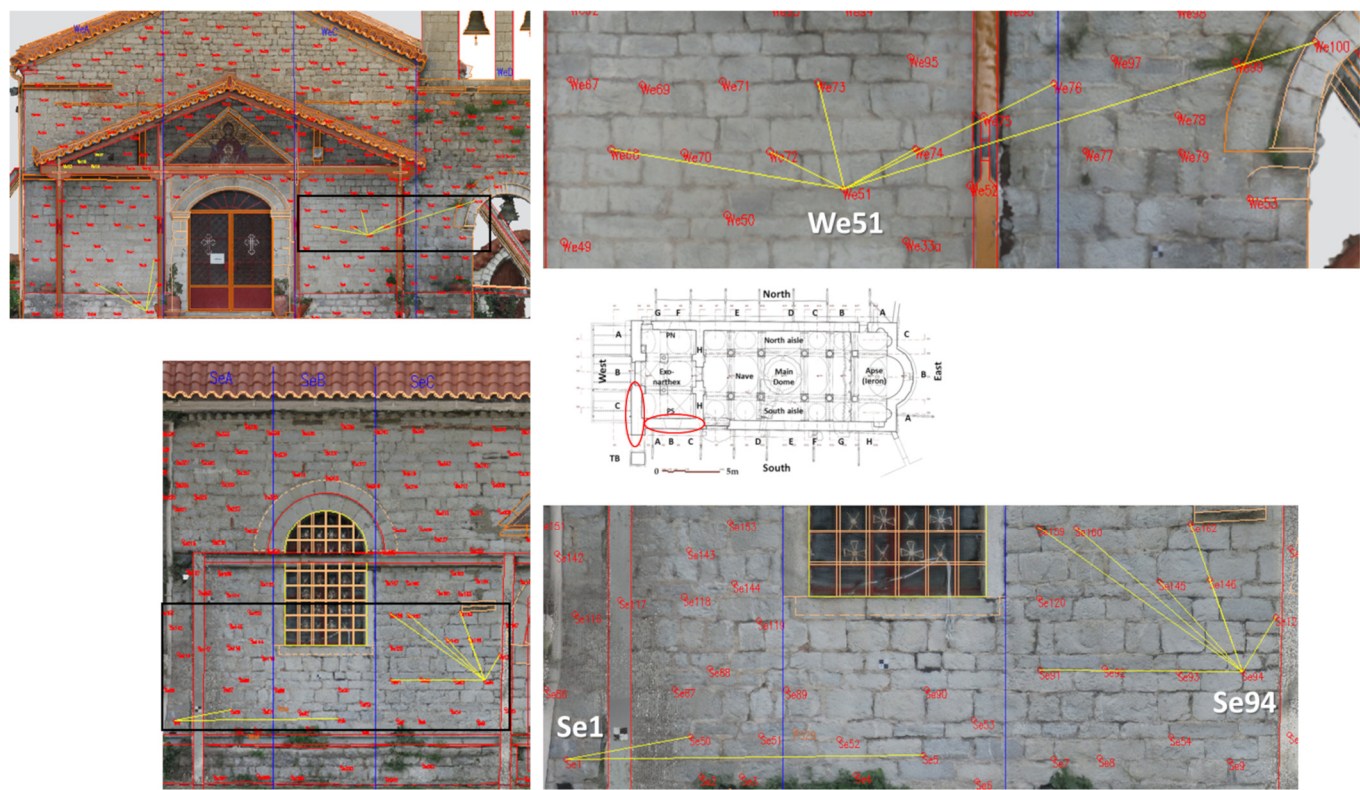
The values of grout indices for sub-area WC underline the difficulties encountered in assessing this information. For example, worth noting is the significant difference for index  $I^{VVL}$  calculated for We51 (10.22) and Se1 (26.35) which are both located in the corner area. It could be argued that the low value of  $I^{VVL}$  for We51 is the result of too many exit points, their vector length potentially double-counted due to their relative vicinity. This situation has been identified in [55]. However, the value of  $I^{VNX}$  for We51 is almost half of that for Se1, despite the latter demonstrating 6.5 times less exit tubes than We51. In addition, index  $I^{VLN}$  has comparable values for these two tubes (note: mathematically, only two of these indices are independent). In conjunction with the observed pathology in the two respective sub-areas, the above assessment indicates relatively larger voids for the case of tube Se1, as compared to the many smaller but highly dispersed and interconnected voids for the case of tube We51. Worth noting is that tubes We51 and Se94 demonstrated similar values for

all three indices, potentially corresponding to a similar pathology, with many smaller but highly dispersed and interconnected voids.

**Figure 9.** Location and (exterior) exit points of tubes We51, Se1, and Se94.

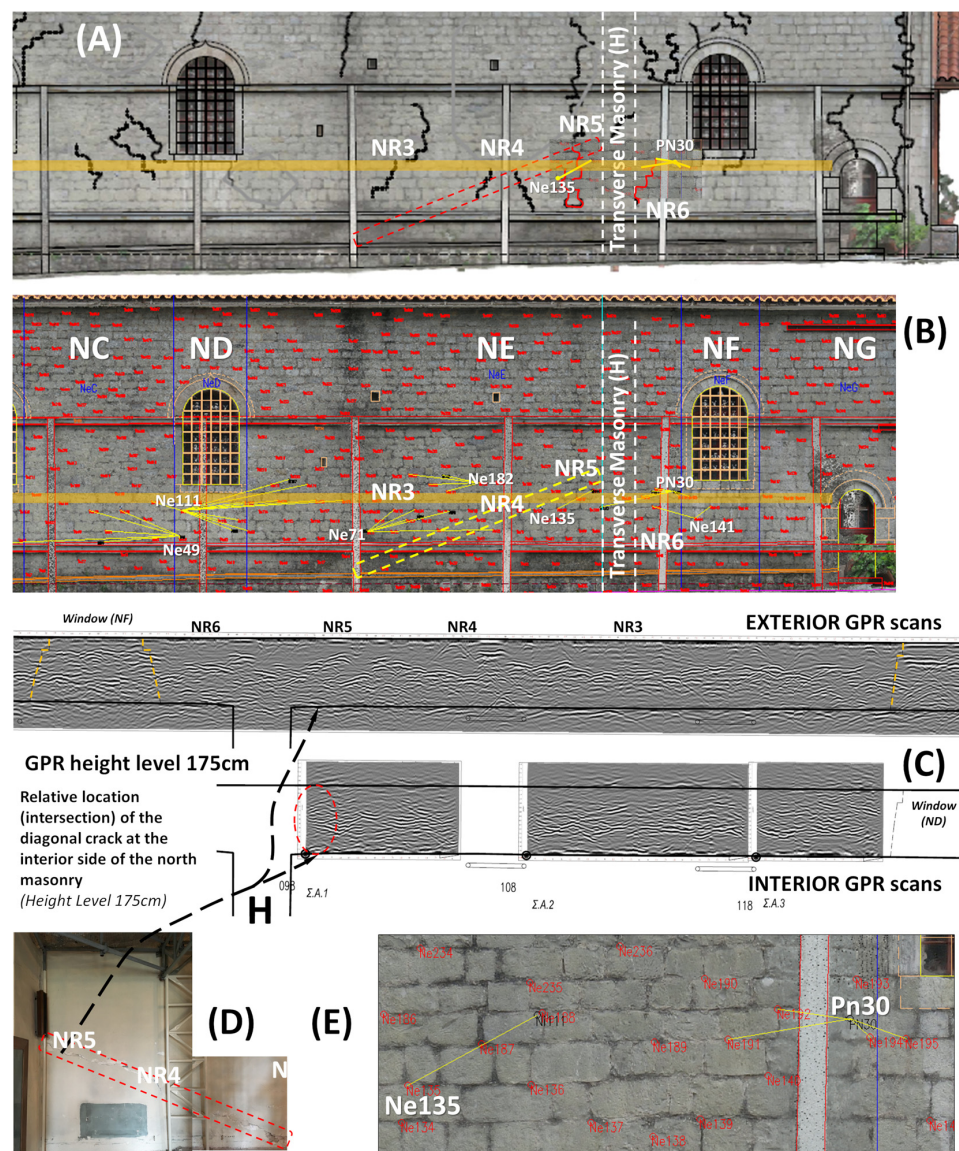
Figure 10 shows the position of these two tubes in relation to the aforementioned junction of the masonries, the observed exterior pathology, and the macroscopic large diagonal crack at the interior. GPR analysis [58,60] (Figure 10E) has indicated that an interior large diagonal macroscopic crack is not extending to the exterior through the three layers of the masonry (interior stone layer; filler layer; exterior stone layer), neither through the junction towards the north part of the exo-narthex. These findings are supported by the pattern of these two tubes.

**Figure 10.** (A) The pathology of the north façade in relation to the junction of the transverse historical masonry and sub-area NE. NR3–NR6 correspond to cluster of macroscopic exterior cracking in the joints of the stone layer; (B) 2D orthophoto created from the 3D model of the Katholikon with location and (exterior) exit points of entry tubes Ne135 and Pn30, as well as entry tubes Ne49, Ne111, Ne71, Ne182, and Ne141; (C) overlay of exterior and interior GPR scans over the plan of the Katholikon at sub-area NE in the vicinity of the junction with the historical wall, H (adapted from [58]); (D) an overview of the interior diagonal macroscopic crack; (E) close-up of the 2D orthophoto for entry tubes Ne135 and Pn30.

Specifically, for both entry tubes, no exit tubes (thus, probably no paths too) are observed that pass through the transverse wall, neither over the transverse historical masonry. The orientation of the vector for tube Ne135 appears to follow closely the orientation of the interior macroscopic crack. It should be reminded that the insertion depth of the tubes (50 cm) effectively injects the grout closer to the opposite stone layer from where the grout is injected. The sole observed exit point for tube Ne135 was at the interior. Two-thirds of the total grout volume corresponded to this exit point, the remainder corresponding to no exit point observed. These remarks agree adequately with the GPR findings and observed pathology. The grout injected from Ne135, close to the interface between the interior stone layer and the filler layer, occupied all available interconnected

voids within. Once it reached the interface between the exterior stone layer and the filler layer, along the general direction of the large crack, it exited from a tube inserted close to this interface, i.e., a tube installed from the interior. Moreover, the grout's apparent paths appear to have stopped prior to intersecting the junction of the masonries. Although similar total grout volumes are observed for Ne135 and PN30, the very values calculated for the grout indices suggest much different crack cluster patterns. This is to some degree expected, since tube Ne135 is located at the main church, whereas PN30 is located at the exo-narthex. These parts influence the overall dynamic behavior of the Katholikon in a different way, and this is expressed in their pathology [58,60].

Noteworthy is the rather limited dispersion of exit points for these two entry tubes, as well as for the nearby entry tube Ne141 (Figure 10B), as compared to tubes located further to the west, Ne182, Ne71, Ne111, and Ne49 (Figure 10B). This is reflected in the values of  $I^{VVL}$  which tend to decrease as the dispersion—expressed by  $N^{XT}$  and  $TVL$ —is increased (Table A1). In conjunction with the observed pathology (Figure 10A) at the lower zone of the junction area, it can be theorized that internal cracking was not as severe as in the case of the upper zone. For example, entry tubes Ne317 and Ne375, located higher, required a total of 700 lt of grout and demonstrated 63 exit points (Table A1). The previous discussion for the corresponding south region (sub-area SC, south entrance) and the influence of the transverse wall (H) agrees well with the above.

The GPR analysis indicates that the macroscopic diagonal crack at the interior (Figure 10D) does not appear to expand through the three layers [58,60]. The values of the grouting indices for entry tubes Ne71, Ne182, and Ne135, the grout volume required (Table A1), and their dispersion pattern ( $N^{XT}$ ,  $TVL$ , Figure 10B) are supported by the findings from GPR analysis, at this lower zone of the north masonry. The fusion of such multimodal data indicates rather limited internal cracking (and voids) at this lower zone, in the vicinity of the masonry junction.

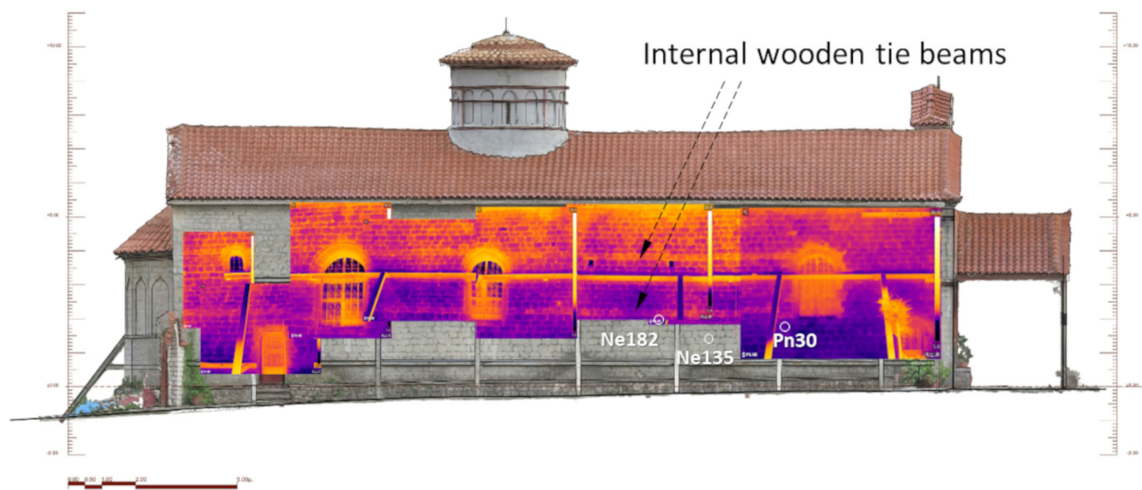
An interesting observation regards the dispersion patterns for Ne182, Ne135, and PN30, which do not appear to reach higher exit points. The IRT survey of the north façade (Figure 11) indicated two parallel stone block zones of different thermohygic behavior. These correspond to internal wooden tie beam elements or void spaces where the wood has deteriorated. Actually, as can be seen in Figure 11, the three entry tubes examined are located below the lower wooden tie beam element. Almost half of the grout volume injected from entry tube PN30 corresponded to filling such a void, as verified during the grouting works.

**Figure 11.** IR thermographs overlaid on the orthophoto of the north façade. Two parallel internal wooden tie beams are discerned, behind the exterior stone layer.

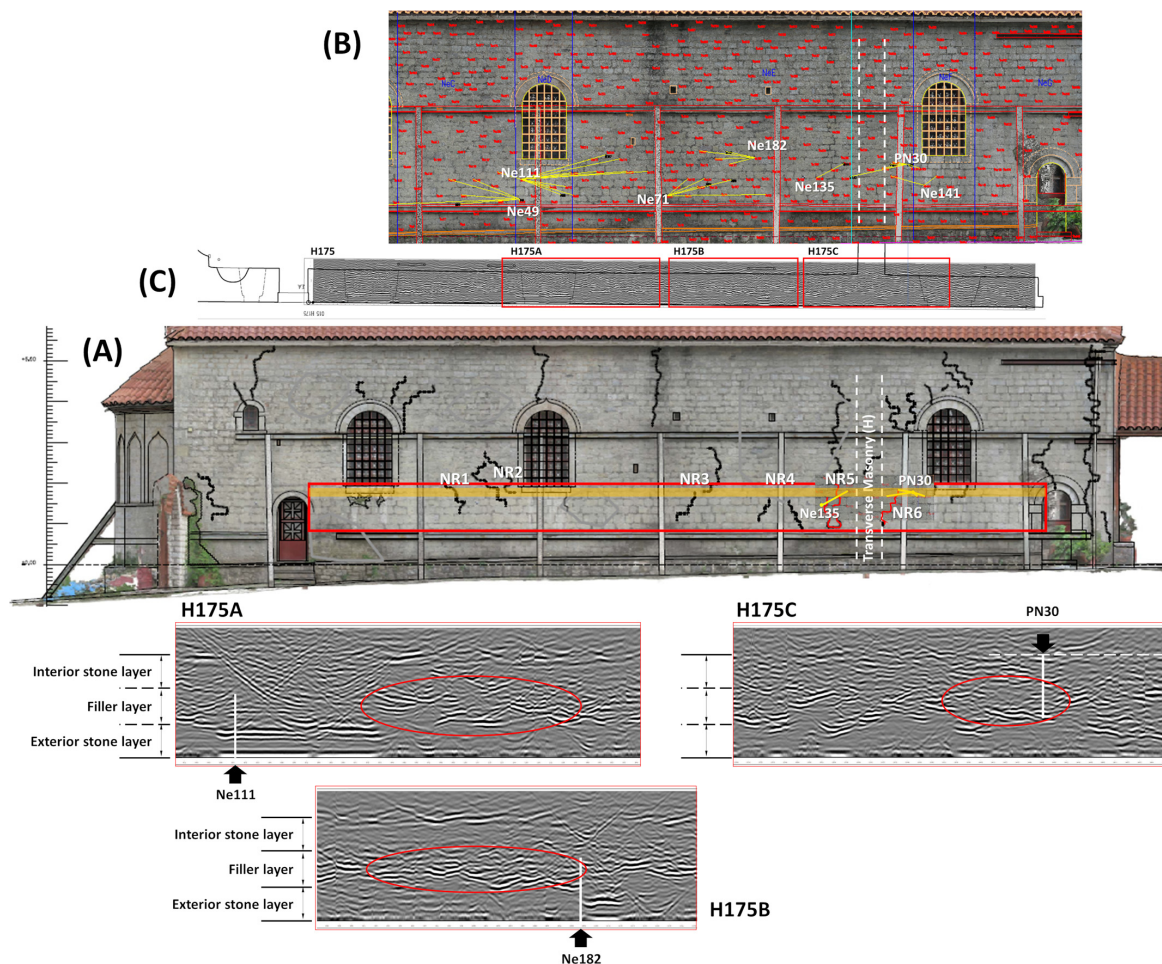
An analogous GPR survey over the north façade provided indications for the type and location of the internal voids filled with grout during the restoration works. Figure 12A depicts the position of GPR scan H175 (Figure 12C) over the north façade, prior to the initiation of restoration works. This scan runs below the aforementioned wooden tie beam element. Figure 12B depicts the (exterior) exit points of entry tubes Ne111, Ne182, and PN30 along the path of the scan. H175, H175B, and H175C are close-ups of this large scan, over which the location of the three entry tubes is indicated. The red outlines indicate the potential voids and internal structure that was filled with grout. The findings correlate adequately with the observed dispersion of exit points, the grout volumes injected, and the pathology of the masonry.

**Figure 12.** (A) Orange color indicates the position of GPR scan H175 over the north façade. (B) 2D orthophoto created from the 3D model of the Katholikon with location and (exterior) exit points of entry tubes Ne111, Ne182, and PN30 along the path of GPR scan H175; (C) GPR scan H175 overlaid on the plan of the north masonry; the corresponding positions of specific entry tubes is indicated on closeup of parts of the scan (bottom).
