# Seismic Response of a Damaged Multi-Story RC Building During the 6 February 2023 Kahramanmaraş Earthquakes

The aim of this study is to investigate the structural damage of a newly constructed 13-story building in Malatya province after the Kahramanmaraş earthquake. For this purpose, firstly, the structural features of the examined building are given in detail. The earthquake damage that occurred in the building was marked on the structural plan. Important parameters such as the results of the concrete sample taken from the building are given within the scope of the study. Then, a nonlinear analysis of the reinforced concrete building was performed using the finite element method. The factors that are effective in damaging the reinforced concrete building have been evaluated. Additionally, within the scope of the study, the effects of the Kahramanmaraş earthquakes on the examined building were evaluated.

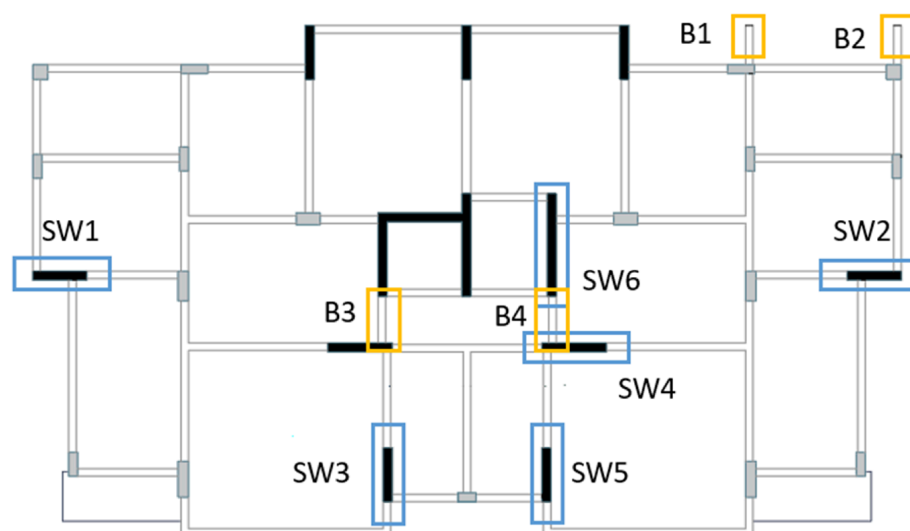
The investigated building has severe damage to load-bearing elements. Figure 8 shows the ground floor plan and damage locations of the building. Crushing of the concrete cover and buckling of reinforcement were observed at the end zones of the six shear walls, as shown in Figure 9. Pounding occurred between the examined building and the adjacent building. Therefore, B1 and B2 beams have been damaged due to the pounding effect (Figure 10). The beam dimensions in the structural plan were designed as 25/60. However, the dimensions of beams B3 and B4 were taken as 25/45. Crushing of the concrete was observed in these beams located between the shear walls. In addition to these damages, shear cracks with widths less than 3 mm were observed in many load-bearing elements and connection zones. Furthermore, damage was noted in the building's infill walls.

**Figure 8.** Locations of observed damage marked on the ground floor plan.

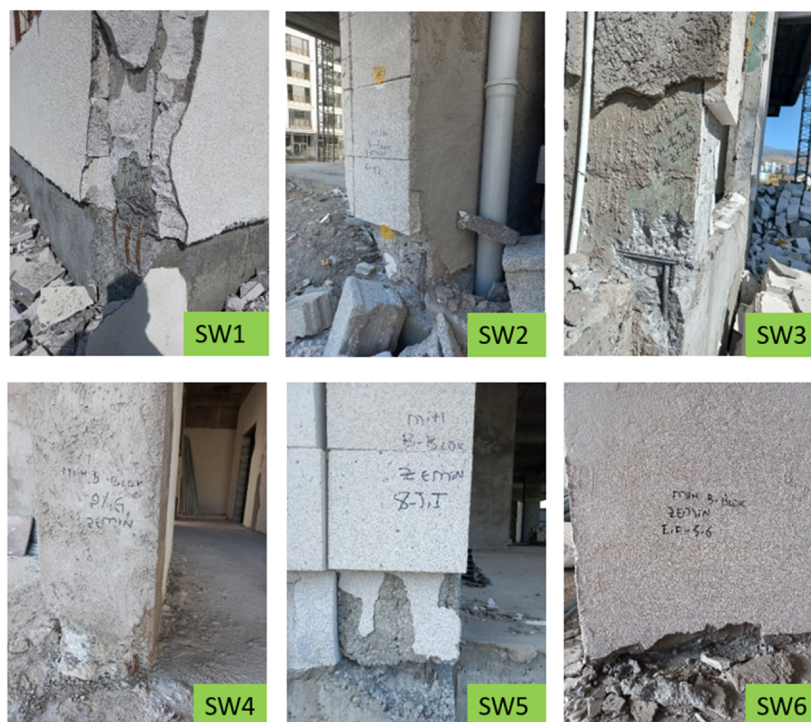
**Figure 9.** Structural damage to the shear walls on the ground floor.

- The ground story height of the investigated building is 4.5 m, while all other stories were designed to be 3 m high. Furthermore, the infill walls on the upper stories were largely removed from the ground story. These two factors created a soft and weak story effect in the building. This is consistent with the fact that the damage to the vertical load-bearing elements occurred only on the ground story.

- Reinforcement buckling occurring at the end regions of the ground story shear walls indicates that more attention should be paid to the distance of transverse reinforcement in these regions.

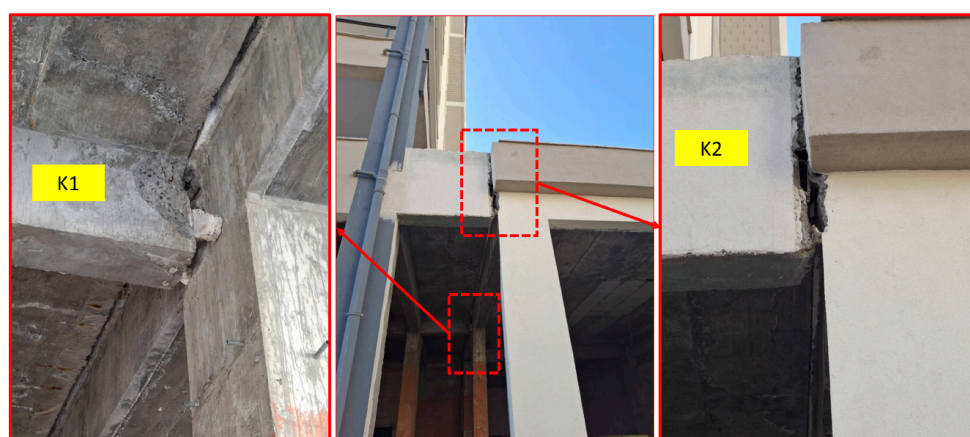
**Figure 10.** Observed damage due to the pounding effect.

- There is insufficient seismic gap distance between the 13-story investigated RC building and the adjacent 2-story RC building. Although a collision occurred at floor level between these two buildings, only two beams sustained damage. The same floor level prevented further damage from pounding.

- Beams connecting the vertical load-bearing elements must have sufficient strength. Especially, beams connected to shear walls are subjected to greater loads. In the 13-story building, all beams were designed to be 60 cm high, while the two beams connecting the U-shaped elevator shear wall were designed to be 45 cm high. This caused significant damage to these two beams, even on the upper stories.

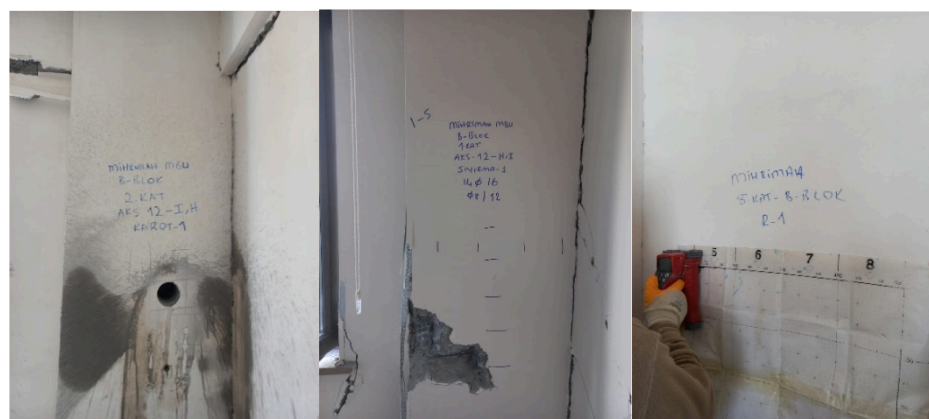
Core samples were taken to determine the concrete strength of the investigated building (Figure 11). Compressive strengths of the cylindrical samples are given separately for each story in Table 3. The building's design concrete compressive strength was specified as 30 MPa. Examination of core samples revealed that the concrete quality was consistent with the design. Also, removal of concrete cover and X-ray analyses were carried out on the columns to check the reinforcement in the load-bearing elements. As a result of the examinations, it was determined that the spacing of the transverse reinforcement in the confinement regions ranged between 10 and 14 cm.

Figure 11. Experimental study in the investigated building.

- To obtain the compressive strength of the concrete, core samples were taken and subjected to a compressive strength test. The results of the experimental test are compatible with the values considered in the design of the building. The vertical structural elements were investigated on site by removing concrete cover and X-ray analyses to obtain the reinforcement details.
