# Wooden Beam Ceiling from the 13th Century—Condition Assessment and Its Conservation Challenge

This article thoroughly documents the focus, long-term monitoring, and survey of the condition of a unique early Gothic wooden ceiling from the 13th century in Zvíkov Castle in the Czech Republic. Through long-term monitoring of climatic parameters, wood moisture, and the movement of ceiling beams, this paper described how wood constantly works, that is, swells and shrinks during a single annual cycle. At the interface of the ceiling beams and the masonry, the ambient temperature ranged from 2.75 °C to 31.75 °C, and the relative humidity of the air from 38 to 93%. The condition of the walled-in beam ends was assessed by resistance drilling and endoscopy. Out of a total of 16 beam ends, 7 ends are completely degraded by brown rot fungus. The condition of the ceiling structure is not good, even in the case of the boards covering the ceiling. Here, the sapwood parts are additionally damaged by the beetle *Anobium punctatum* which, in combination with rot, has broken down the wood into crumbling matter. High static load due to a massive embankment 35–50 cm thick, two layers of fired paving,

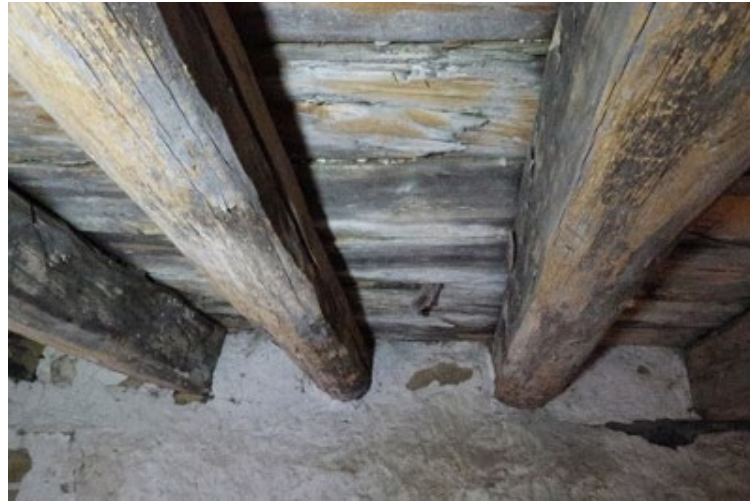
**Figure 4.** Ceiling beams worked in various ways.

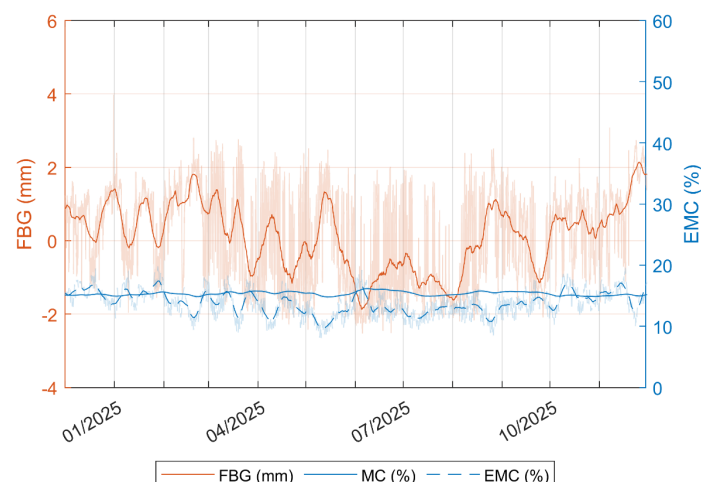
**Figure 11.** Results of wood moisture content (MC) measurements, equilibrium moisture content of wood (EMC), and movement of ceiling beams (FBG), in the period from 1 December 2024 to 30 November 2025, measured for the southern end of ceiling beam no. 1.

Measurements of movements have shown that the ceiling beams continuously “work” depending on changes in temperature and relative humidity. As humidity increases, the wood swells and the beams move downwards; when drying, they shrink and return back. These cyclical volumetric changes (movements in the range of 2–4 mm) contribute to the mechanical stress of already weakened elements, to which a number of sources refer [25–27].

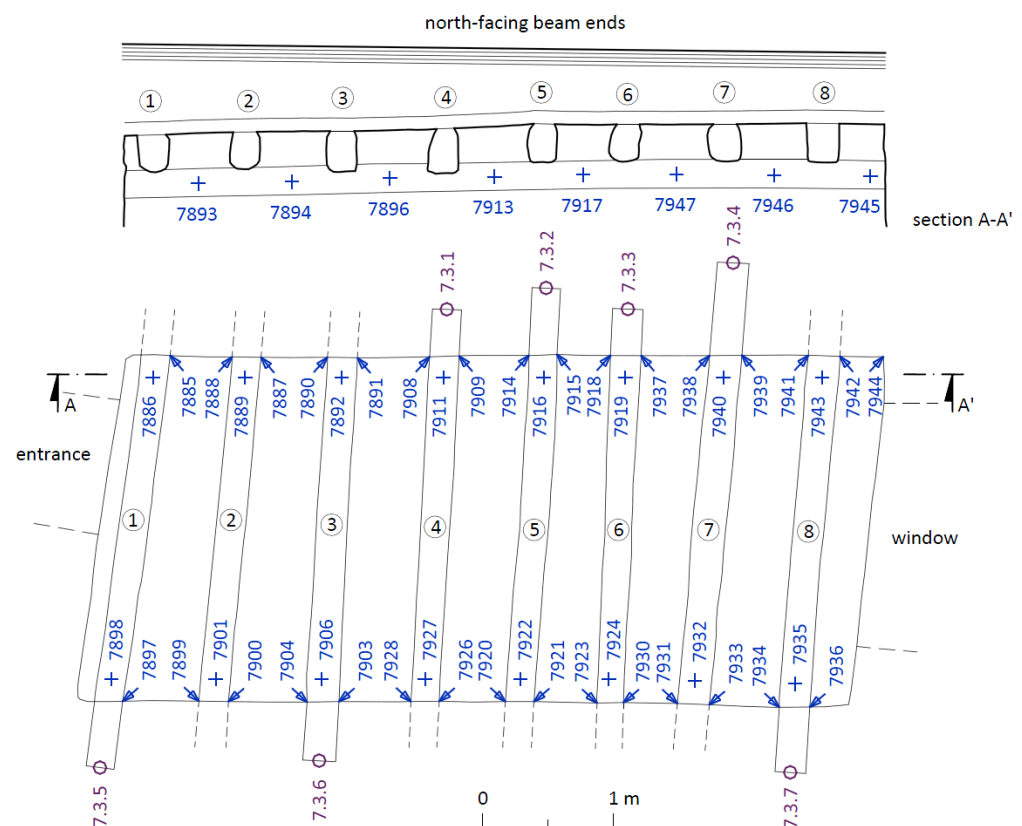
**Figure 12.** Designation of places where the resistance characteristic (RM) was measured using a Resistograph drill, and the endoscopy for inspection anchoring depths (circles).

**Table 1.** Results of the assessment of the condition of the ends of ceiling beams, evaluated according to the resistance characteristic (RM) obtained from measurements using a Resistograph drill—upper part with southern ends, bottom part with northern ends of beams.

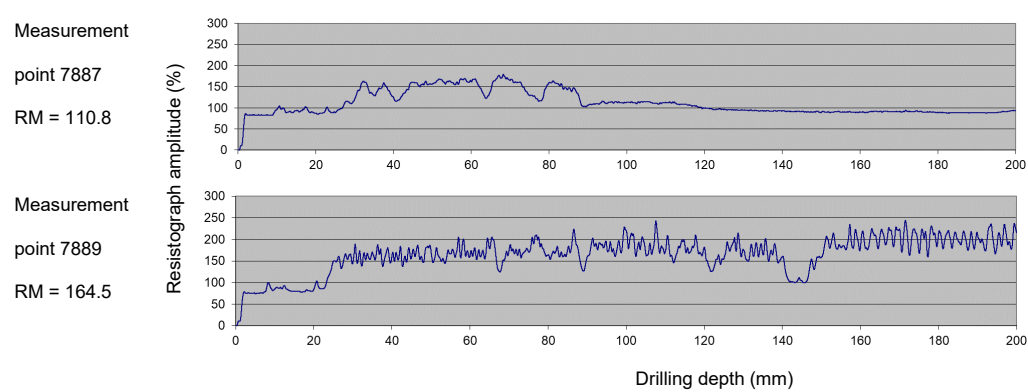
The output of the Resistograph measurement is a graphical record (density profile, dendrogram) corresponding to the energy consumed to maintain a constant drilling speed (y-axis) [13]. The x-axis represents the width of the beam. Peaks in the graphical record correspond to higher energy, indicating higher resistance and density, while lower points are associated with lower energy, lower resistance and density. The numbering of individual drills and their placement is schematically illustrated (Figure 12), and the RM results (resistance characteristics) calculated from the area under the curve and drilling depth are entered into the evaluation table for individual elements; see Table 1. An example of graphical records from individual measurement points using a drill is shown in Figure 13. When assessing the degree of damage, the authors use in their practice a scale from 1 to 4, where (1) means minimal infestation and (4) maximum infestation: (1) Slightly damaged element: well-dried structural elements, endoscopy drill smooth with clearly visible wood grain, without color changes or signs of biotic attack. (2) Moderately damaged element: well-dried structural elements, endoscopy drill smooth with clearly visible wood grain. In surface areas, there may be small signs of biotic damage—occasional bore tunnels of wood-eating insect larvae, spots with changed color due to decay. (3) Severely damaged element: Wood showing signs of biological attack, bore for endoscopy with splintered walls, traces of tunneling—presence of dust and debris from their filling, holes in the bore walls. Signs of wood-decay fungi—color change, cubical disintegration of the wood. Damage does not exceed 30% of the element's cross-section. (4) Total destruction of the element: Wood severely damaged by wood-boring insects and rot; the element crumbles into dust and small skeletons, and in the case of rot into cubes of varying sizes. The color of the wood is dark. Remaining wood has limited material properties. Damage exceeds 30% of the element's cross-section.

**Figure 13.** Example of measurement results from resistance drilling into the northern end of ceiling beam no. 2.

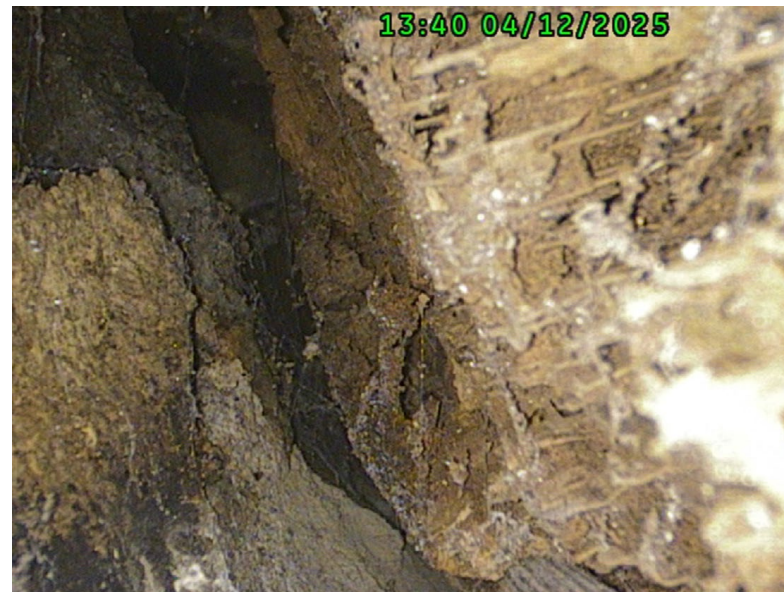
**Figure 14.** Example of endoscopy measurement results of the beam no. 7 northern end denoted as position 7.3.4 in Figure 12.

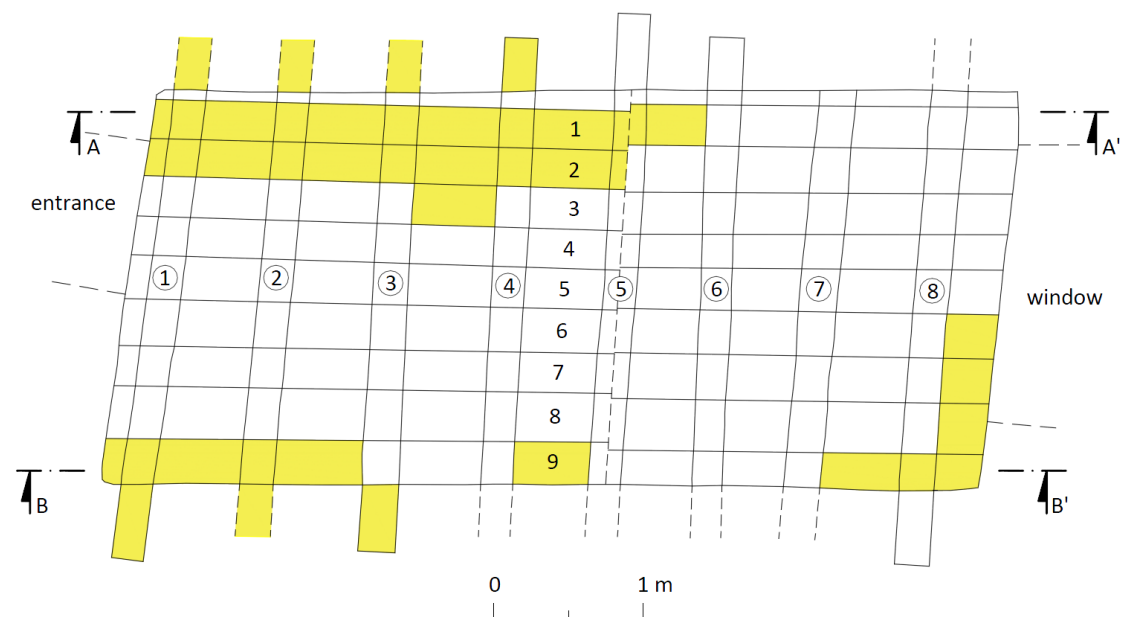
Therefore, for classification, all available in situ test results are combined, in this case including the extent of biological attack, micro-drilling results, and endoscopy results where available, e.g., Figure 14. The extent of biological attack is objectively assessed by the density of exit holes, with up to 25 holes per dm<sup>2</sup> considered grade 2, 25–50 holes for grade 3, and more than 50 holes for grade 4. Micro-drilling results are used to support and adjust the above assessment, since the RM value is relative and depends on the type of wood and its moisture. Available measurement results on oak structures show a typical RM = 181.2 average value as the boundary between healthy and damaged wood [14]. The classification is not standardized and is used mainly as a guide for determining urgency and priorities of conservation actions. Measurements on walled-up sleepers showed that they are mostly in a condition comparable to the ceiling beams, (see Appendix B), with the northern sleeper being less damaged than the southern one, which is in a critical condition in the western part. The worst results were obtained on the decking boards, which are in places completely destroyed. The extent of serious damage is summarized in Figure 15.

**Figure 15.** Overview of critical degradation—elements most affected by biotic damage are marked in yellow.

The most damaged parts are the ends of the ceiling beams, (especially the northern ends of beams no. 1–4 and the southern ends of beams no. 1–3), where significant deformations have occurred, while the beams in the span usually do not show overall sagging. This is due to the short span of 2.6 m. The serviceability limit criteria related to deflection

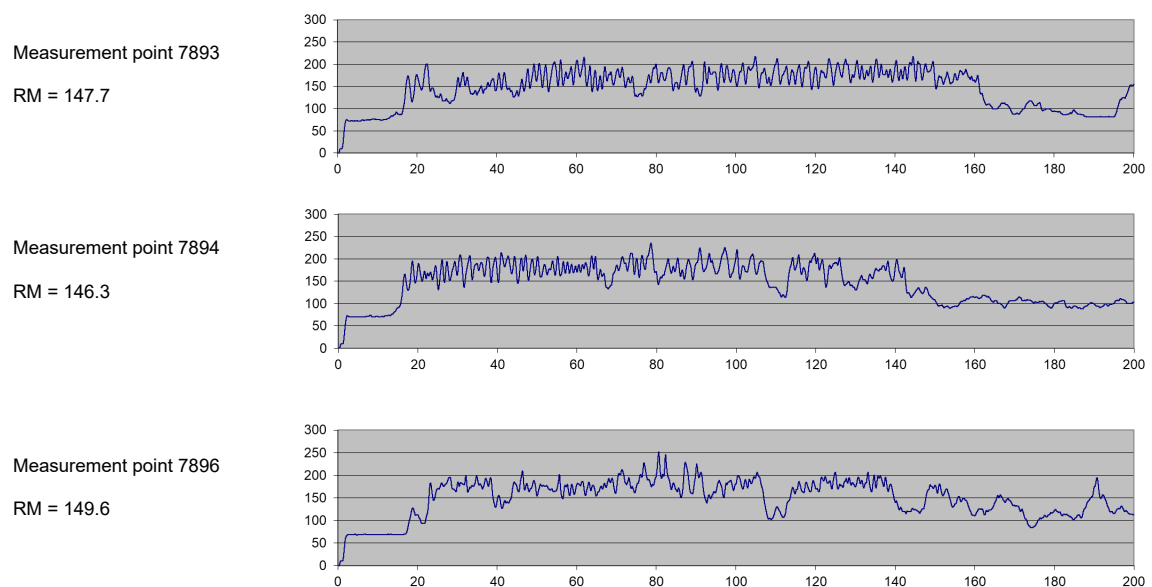
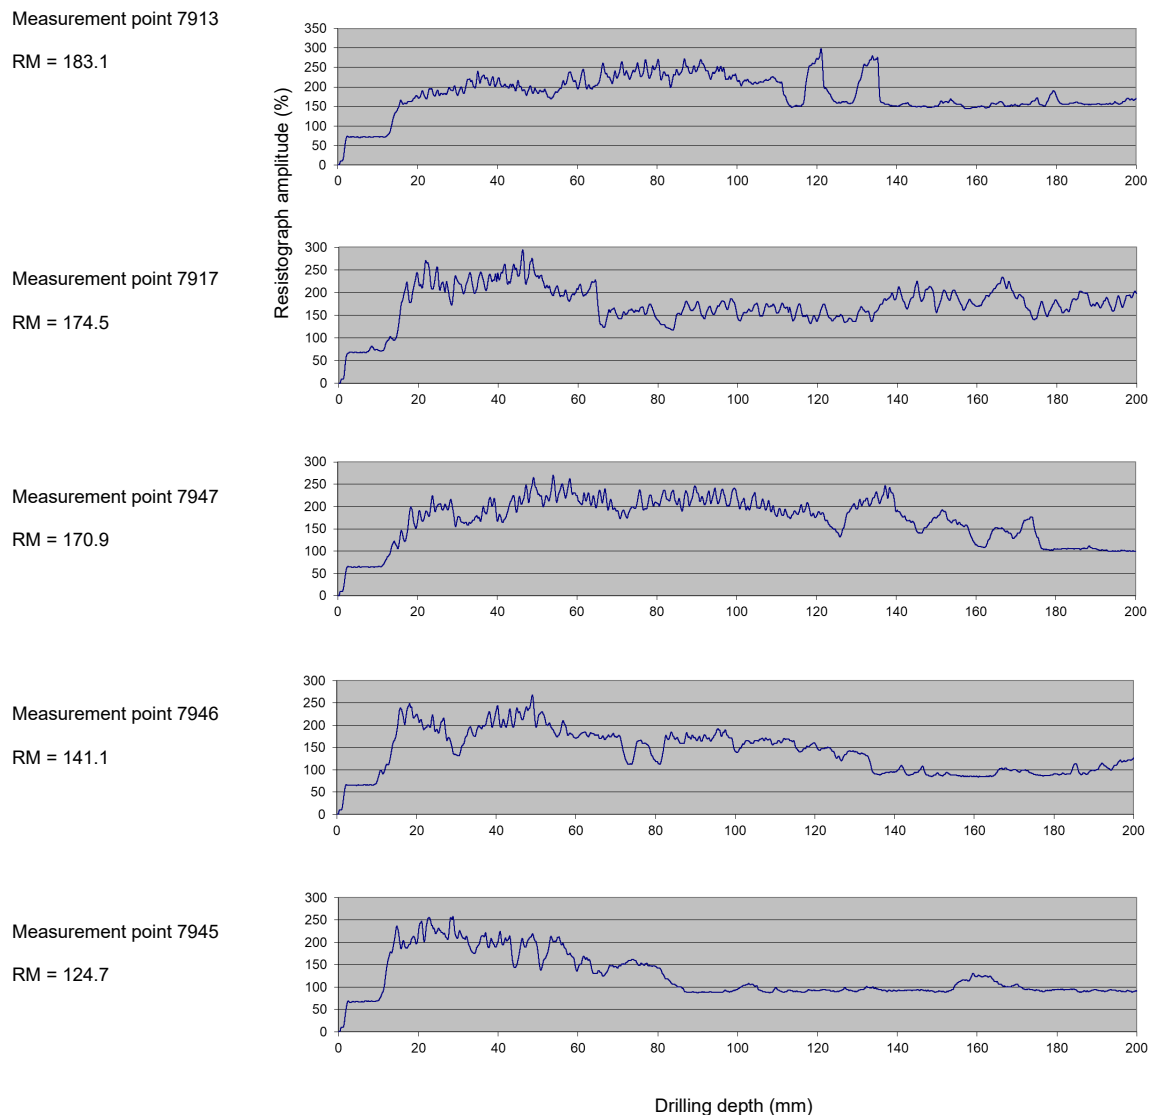
**Figure A2.** Resistance drilling measurements on the northern sleeper.
