# Evolution of Galvanized Steel Pipe Corrosion in Hot Water Supply Systems

Valentin Chukhin, Nikolay Makisha \*

Research and Education Centre “Water Supply and Wastewater Treatment”, Moscow State University of Civil Engineering, 26, Yaroslaskoye Highway, Moscow 129337, Russia

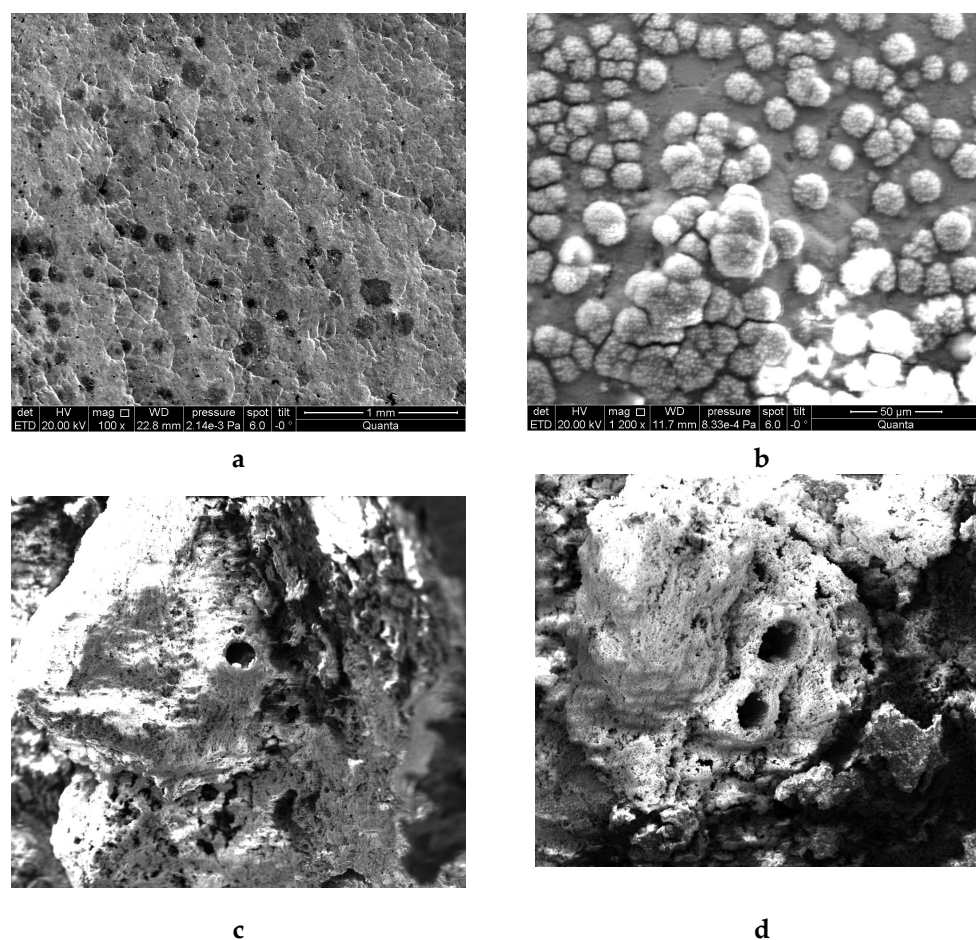
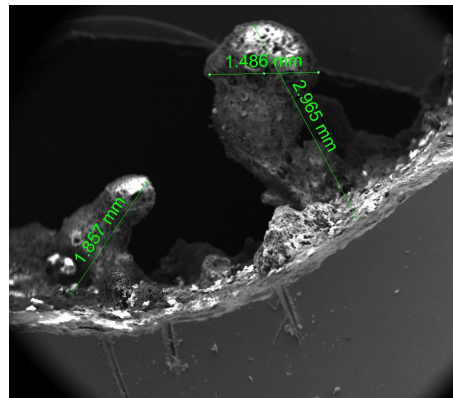
**Figure 1.** Microphotographs of the progressive degradation of zinc coating of galvanized steel pipes in HWSS: (a) inner surface of a new pipe DN 20; (b) inner surface of a pipe after 25 h in hot water at a temperature of 50 °C; (c,d) the formation of a tubercle after 70 days of bench experiment (pipe DN 15) [12]; (e) the same after 224 days of bench experiment [13].

Figure 1 shows that corrosion of the zinc coating develops unevenly and has an ulcerative character with the formation of anode and cathode areas. Similarly to uncoated steel pipes, tubercles on the pipe surface consist mostly of oxides and zinc carbonate. This makes corrosion running intensive, with hydrogen depolarization and the release of hydrogen (see round holes on the surface of the scale, Figure 1c,d).

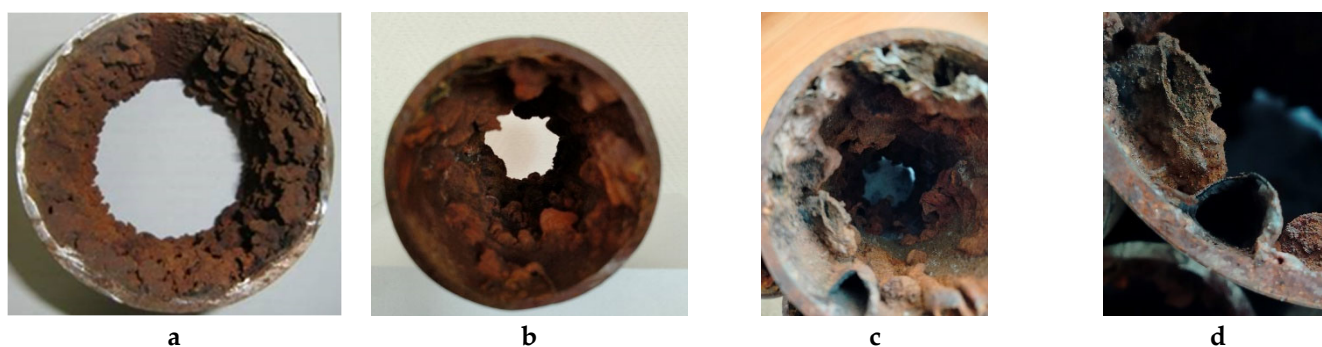
**Figure 2.** Samples of steel galvanized pipes: (a) DN100; (b–d) DN80.

The pipes were taken out from the HWSSs of residential buildings after 3–5 years of operation due to the appearance of fistulas. The structure of the majority of tubercles included a dense layer, a core (filled with either an amorphous sediment (Figure 2a,b) or a solution of salts (Figure 2c,d)), and a corroding base. The tubercles were friable and could be easily removed mechanically; the dense layer is less rigid and has a thickness of approximately 0.5 mm.

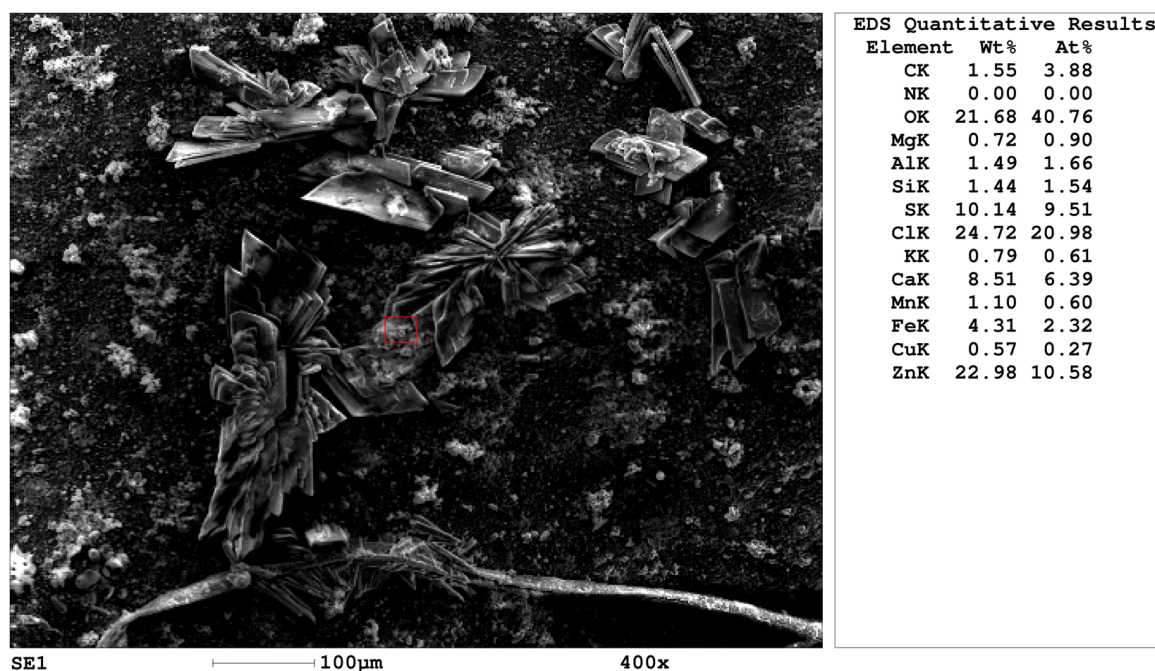
The microphotograph of the sediment and the quantitative results of the spectral analysis are shown in Figure 3. These data demonstrate that the main components of the solution were chlorides, sulfates, zinc, and calcium. The contribution of the other elements is estimated at 0.5–1.5%. The ratio of Cl/SO<sub>4</sub> anions was 2.44. The dense layer in non-galvanized pipes exhibits higher selectivity for chloride transfer compared to sulfates (Table 2), which is clearly related to the crystal structure of the dense layer.

**Figure 3.** Microphotograph of the scale and results of spectral analysis (of the area inside the red square).

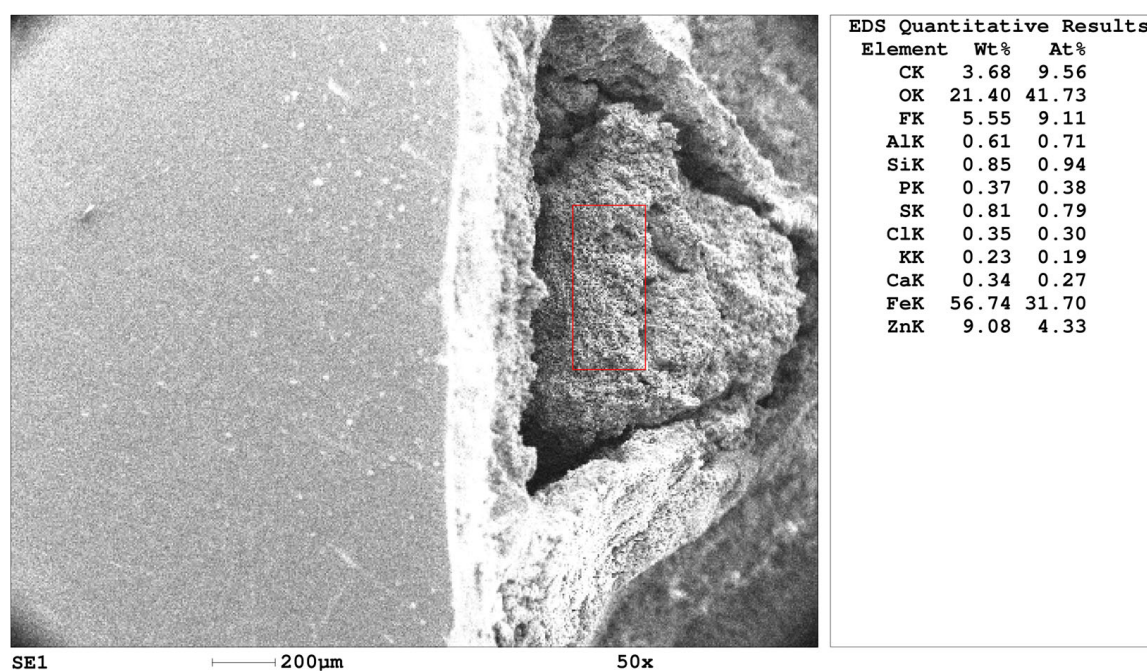
Figure 5 clearly shows a dense layer and a loose core, whose main components are iron, zinc, and oxygen (cations); sulfates and chlorides act as anions. The content of sulfates exceeds the content of chlorides, which indicates the different nature of the permeability of the dense layer to anions depending on the sample under study (see Table 2). The dense layer is firmly bound to the pipe wall, while the core has a loose structure and shrinks when drying. Figure 5 also shows that, despite to the dimensions of the tubercle, the pipe wall has minor damage. At the same time, there are no signs of the transition to more destructive corrosion with the formation of fistulas.

**Figure 5.** Microphotograph and spectral analysis (of the area inside the red square) of the scale composition in a tubercle in a galvanized pipe (DN15) extracted from the HWSS.

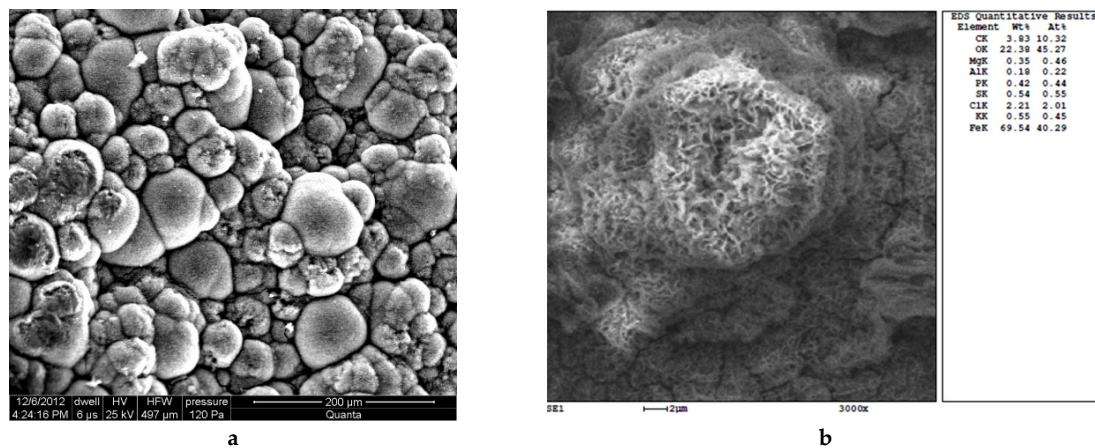
Figure 6a confirms that pitting corrosion develops along grain boundaries or in the presence of intermetallic inclusions [34]. At the same time, the shape of some crystallites differs from hemispherical and becomes closer to tubular. Figure 6b shows a fragment of the pitting that has an oblong shape with a decreasing diameter. According to the chemical composition, chlorides represent most of the anions.

**Figure 6.** A microphotograph of the base of the tubercle (copying the metal surface at the time of pipe removal (a)). The sediment was extracted from an uncoated steel pipe (DN 900). Micrography and spectral analysis of the growing pitting (b).

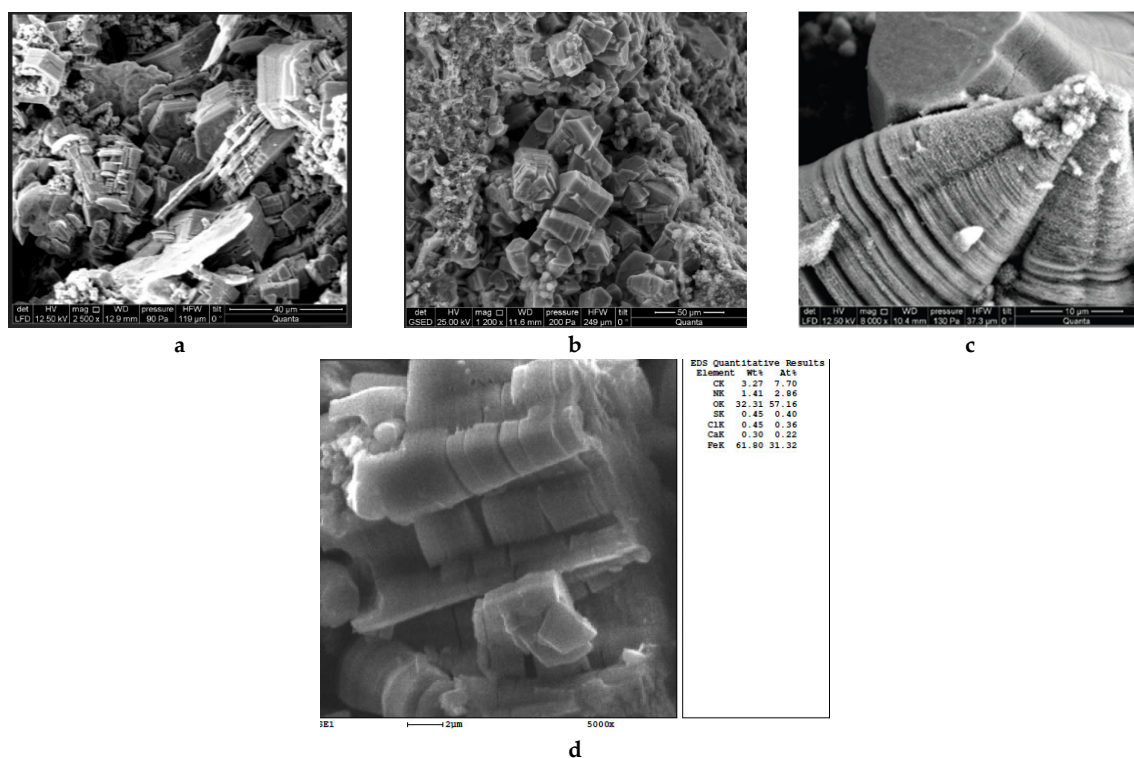
**Figure 7.** Microphotographs of crystalline replicas formed in the cavities of the pitting: (a–d)—uncoated steel pipes; (c)—galvanized pipe from the HWSS.

Figure 7 shows crystal structures with a variety of shapes, including a conical shape that copies the shape of the recess in the metal. The random location of single crystals indicates their mutual movement inside the tubercles during the corrosion.

Another difference is the shape of the crystal structures formed in the pitting. In uncoated steel pipes, pits have a cylindrical or hexagonal shape, constant or slightly tapering in length (Figure 7a,b), which meets the conditions of their formation at an almost constant density of the corrosive current. In galvanized steel pipes, the pitting replicas have a conical shape (Figure 7c), which corresponds to an initially high current density that decreases over time at a high rate. These differences are also related to the temperature conditions in which corrosion deposits formed in the pipes in question. In the case of uncoated pipes, scale was removed from the outdoor cold water supply system, and corrosion occurred over a long period, while the galvanized pipe removed from the HWSS underwent accelerated corrosion.

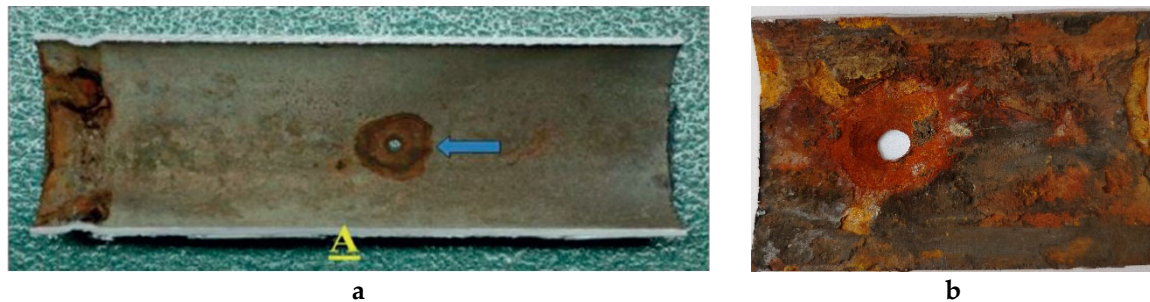
Figure 8 shows typical photographs of cross-cutting damage to the pipe wall in the form of fistulas formed due to corrosion of galvanized steel [34] and non-galvanized steel pipes. The tubercles with intense internal corrosion were directly above the fistulas.

**Figure 8.** (a) Through-wall damage in the lower part of the NPS3 galvanized steel pipe (with an outer diameter of 3.5 inches) in the dry pipe system [35]; (b) uncoated steel pipe (DN150) from the heating system.
