# Failure Causes Analysis of Circumferential Cracking on Gathering Pipeline in M Oil and Gas Field

Xuehui Zhao <sup>1,2,\*</sup>, Zicheng Zhang <sup>3</sup>, Zhiwu He <sup>4</sup>, Yan Han <sup>1,2</sup> and Juntao Yuan <sup>1,2</sup>

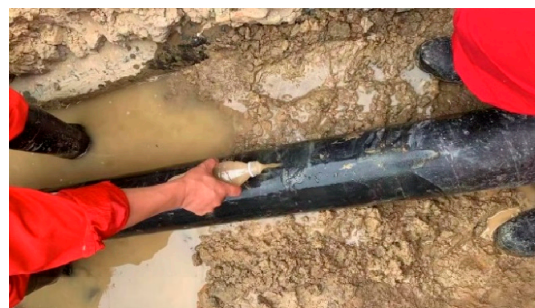
The gathering pipeline failed due to corrosion cracking after 2 years of operation. The pipeline, identified as an L360N seamless pipe with dimensions of  $\Phi 168 \text{ mm} \times 6.3 \text{ mm}$ , was used for transporting shale gas (wet gas) containing a small amount of CO<sub>2</sub> and suspected H<sub>2</sub>S gas. The two ends of the pipeline were welded. The service temperature was about  $30^\circ\text{C} \pm 2^\circ\text{C}$ , and the operating pressure was 2.1 MPa. Failure analysis was conducted on a 600 mm pipe sample received from an oil and gas field (see Figure 1). The gathering pipeline, treated with a corrosion inhibitor and bactericide for antiseptic purposes, was put into operation in April 2021 but experienced cracking and failure in late June 2023.

**Figure 1.** Photo of the pipeline failure site.

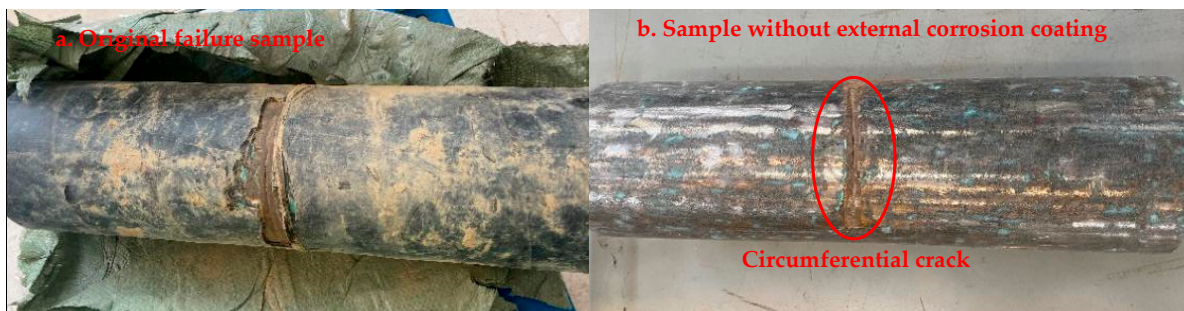
The extracted failure sample from the site is illustrated in Figure 2. The external wall of the failed tube was coated with a black 3PE anti-corrosion layer, which has detached at the cracked section of the tube body, exposing a rust-colored area (Figure 2a). The crack was circumferential and can be observed to encompass approximately one third of the pipeline's circumference (as indicated by the red circle in Figure 2b). Additionally, it was observed that the length of the main crack penetrating the wall thickness comprised two thirds of the total crack length.

**Figure 2.** Macroscopic morphology of the outer wall of the failure sample.

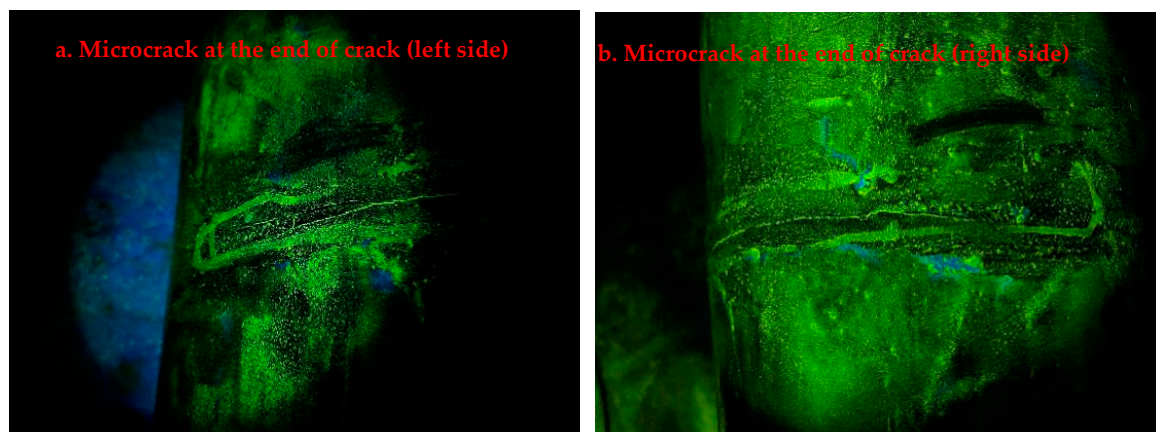
Non-destructive testing was performed on the failed tube body after removing the outer corrosion layer, in accordance with ASTM E709-21 [12]. The test results are shown in Figure 3, revealing that the crack extends along the circumferential direction to both ends with microcrack branching lines at each end. The results indicated that no additional cracks or instances of cracking were detected on the outer wall of the failed tube, apart from the circumferential cracking and crack propagation zone.

**Figure 3.** Non-destructive testing appearance of the outer wall.

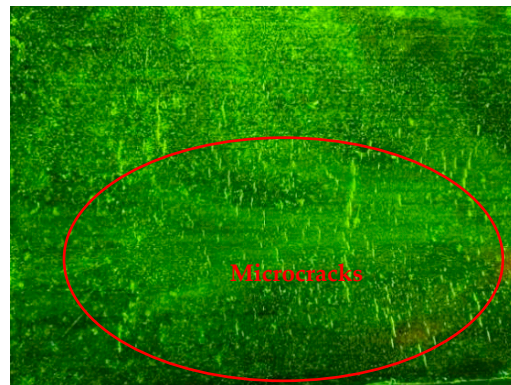
The failed tube was dissected to observe the inner wall morphology, as depicted in Figure 4. Fluorescent magnetic particle detection was employed to observe the inner wall, revealing an absence of microcracks at the three, six, and nine o'clock positions along the pipeline circumference. However, circumferential microcracks were clearly evident at the top section of the pipeline, as illustrated in Figure 4 (see inside the red circle). The distribution pattern indicates that microcracks are predominantly concentrated in the area between the eleven o'clock and one o'clock positions in a clockwise direction. So, the existence of microcracks indicates that the pipeline cracking is inevitable. As long as the stress of the pipeline exceeds a certain critical value, the cracking failure will inevitably occur in an acidic environment.

**Figure 4.** Magnetic particle test results on the top of the inner wall.

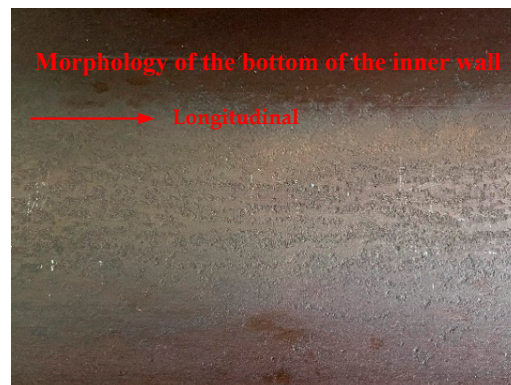
In addition, the morphology of the inner wall illustrates that there were traces of fluid medium deposition at the bottom of the pipe at six o'clock, and small pitted corrosions were observed in the localized deposition area at the bottom (Figure 5). The surfaces on both sides of the inner wall of the tube appear flat, with no apparent signs of corrosion.

**Figure 5.** Macroscopic corrosion morphology of the inner wall.

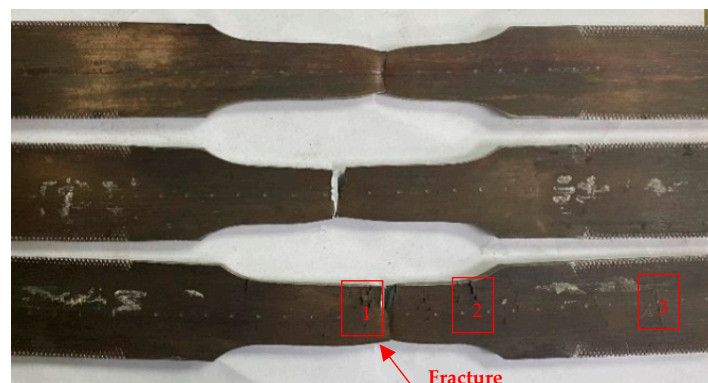
The test was carried out using UTM5305 material testing machine (Sansi equipment Co., LTD, China). According to ASTM A370-22 [13], the mechanical properties of the failed tube were tested by sampling the uncracked area. The test results are shown in Table 1. Figure 6 illustrates the macro-morphology of the stretched sample. It was evident that one of the three parallel samples (sampling at the top of the tube) exhibits noticeable original microcracks near the fracture (See the red box 1 in Figure 6). During the tensile test, these original microcracks were pulled apart. At the same time, microcracks were also found in other areas of the inner wall of this sample (see the red boxes 2 and 3 in Figure 6). The sample ultimately fractured at a microcrack and has less pronounced necking compared with the other two samples.

**Figure 6.** Fracture morphology of the tensile test.

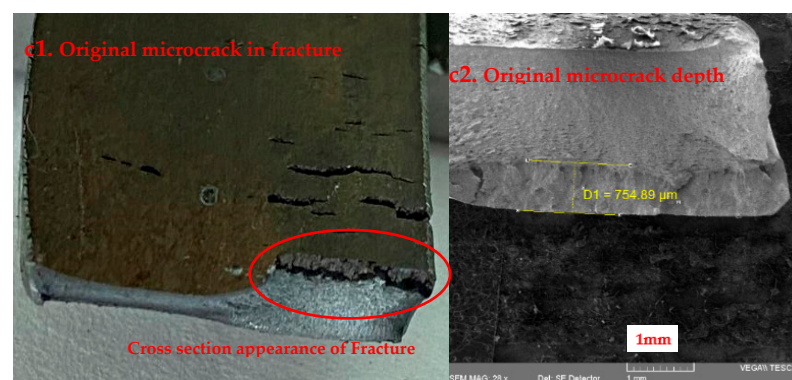
By observing the macro-morphology of the original microcrack in the fracture (see Figure 7c1), it can be seen that the original crack has a certain depth and appears dark brown (see red circle). Scanning electron microscopy was used to observe the cross section and measure the original microcrack. It can be seen that the depth of the original microcrack was 0.755 mm, and the microscopic morphology of the cross section of the fracture is shown in Figure 7c2.

**Figure 7.** Fracture morphology of the tensile fracture sample.

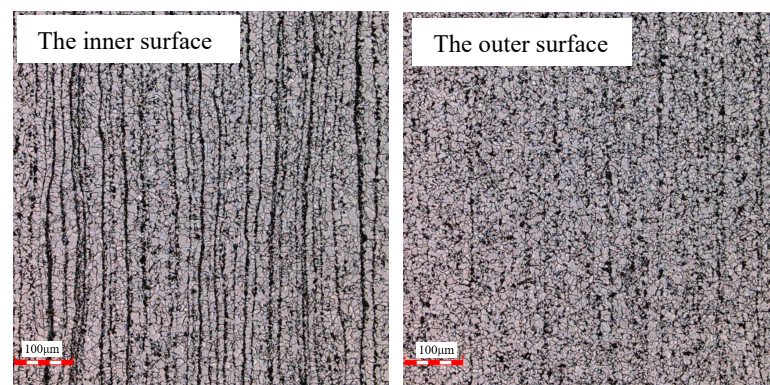
Metallographic samples were extracted from the top (microcrack area) and the bottom two areas of the pipe, respectively. The metallographic structure consisted mainly of pearlite + ferrite. Additionally, compared with the micro-metallographic structure between the inner and the outer surface of the samples at the top and bottom of the pipeline (refer to Figures 8 and 9), it was observed that the microstructure of both the inner and outer surface of the samples was similar. Meanwhile, there were evident segregation phenomena in the metallographic microstructure, and the segregation of the inner surface was relatively obvious. The grain size and non-metallic inclusion of the sample are detailed in Table 4. The results indicate that there was no significant difference in grain size and impurity content between the top and bottom of the pipe, which was not the primary factor influencing the material properties [16].

**Figure 8.** Inner and outer surface metallographic structures of the sample at the top of the tube.

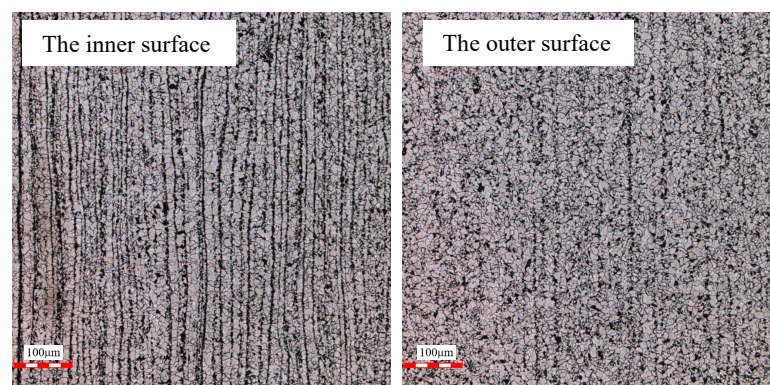
**Figure 9.** Inner and outer surface metallographic structures of the sample at the bottom of the tube.

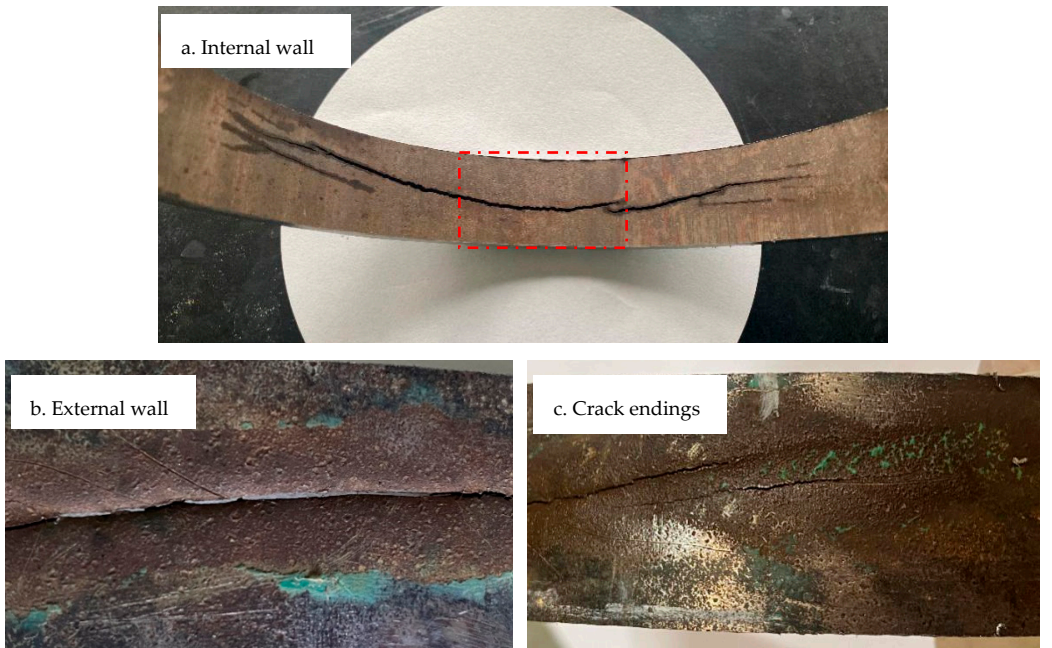
The internal wall morphology of the crack in the failed pipe was observed, as depicted in Figure 10a. It is evident that the main crack was circumferential and extends to both ends, and the dendritic microcracks presented near the ends of the main crack. Figure 10b shows the external wall topography corresponding to the main crack, and it can be seen that the crack penetrated the wall thickness of the pipe, while Figure 10c shows the macroscopic morphology of the end of the main fracture. It is apparent that the cracks also penetrated the wall thickness at this point.

Figure 10. Macrocrack appearance in the failure tube.

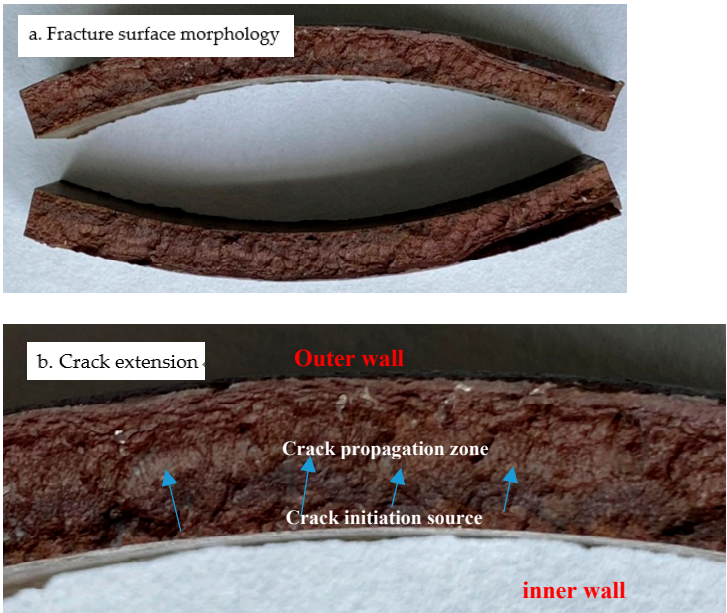
Figure 11 shows the fracture morphology of the main crack in the middle region, which corresponds to the red box area in Figure 10a. The fracture has lost its metallic luster and the surface was covered with dark brown corrosion products. Figure 11b shows the locally enlarged topography of the fracture. It can be inferred from the characteristics of the fracture initiation zone and crack propagation zone that the fracture originated from the internal surface and has multi-source fracture characteristics.

Figure 11. Fracture morphology of the circumferential main crack.

The macroscopic morphology analysis of the fracture revealed that the fracture initiated on the inner wall of the pipe and extended along the wall thickness to the outer wall until fracture, resulting in a multi-source brittle fracture morphology. The circumferential fracture exhibited more dendritic bifurcation at its end, and the crack propagation displayed obvious inter-granular and trans-granular brittle characteristics, which were consistent with stress corrosion cracking [19,20]. The initial depth of the microcrack at the top of the pipeline was 0.755 mm, and the micro-morphology of the crack surface exhibited quasi-cleavage with accompanying secondary cracks, indicating a brittle fracture [21,22].

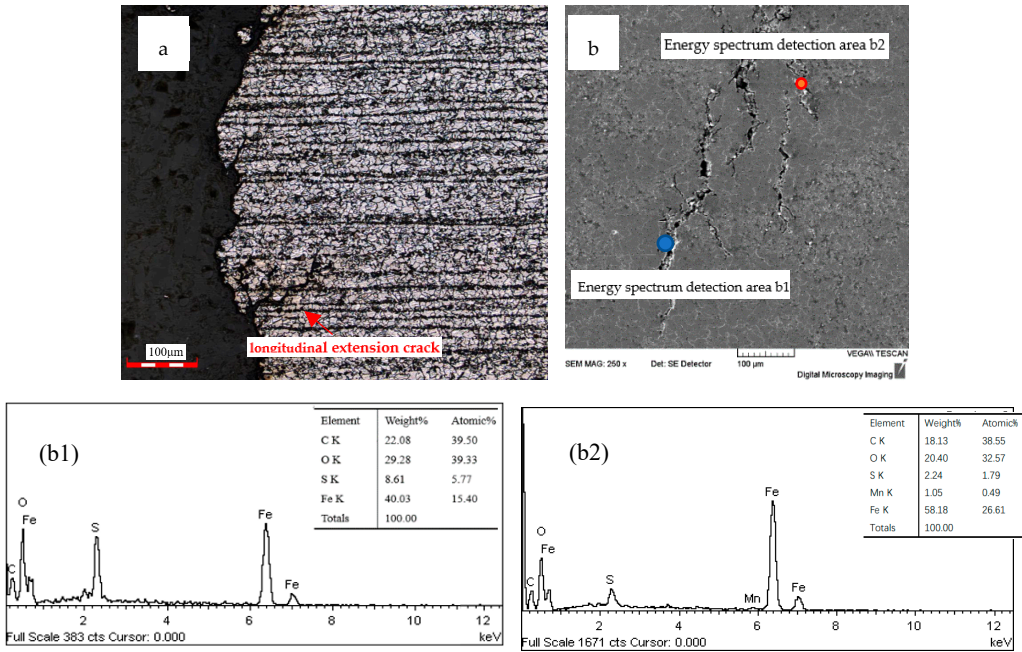
The longitudinal sample containing a cross section was intercepted in the central area of Figure 10a, and the metallographic structure near the fracture was observed, as shown in Figure 12a. Upon examination of the section, it was evident that there was a crack of longitudinal extension, with no abnormal tissue present around it. In Figure 12b, the metallographic structure of the cross section at the crack revealed dendritic expansion characteristics. Meanwhile, the energy spectrum analysis of products from various locations within the crack gap revealed a significant presence of sulfur (Figure 12(b1,b2)). The atomic percentage concentration of sulfur was measured as high as 5.77%, indicating the presence of  $H_2S$  in the service medium environment.

Figure 12. Metallographic structure and EDS analysis near the fracture. (a) Metallographic structure of longitudinal sections; (b) morphology of crack growth; (b1) Energy spectrum analysis of products in the blue circle region; (b2) Energy spectrum analysis of products in the red ring region.

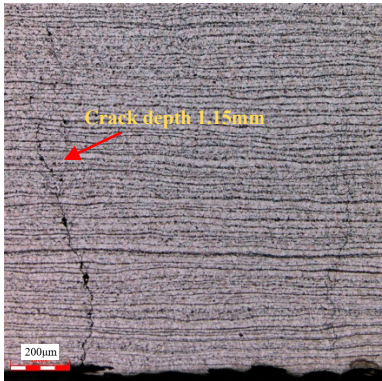
At the same time, the cross section of the sample in the inner wall microcrack area was examined, as depicted in Figure 13, revealing distinct characteristics of inter-granular and trans-granular crack propagation. The depth of the cracks was measured from the inner surface along the wall thickness direction, with some cracks extending up to 1.15 mm.

**Figure 13.** Crack observation on the inner surface of the sample at the top of the pipeline.

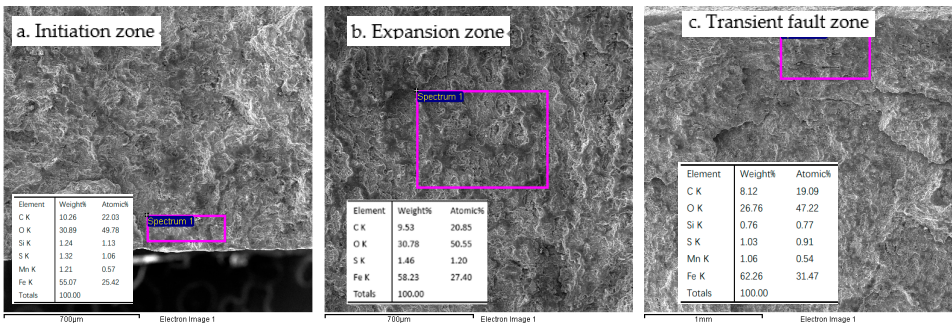
Scanning electron microscopy was utilized to observe the microscopic corrosion morphology of the fracture surface, while EDS was employed for energy spectrum analysis of the corrosion products on the surface of the cracking source region, crack propagation region, and transient fault region, as depicted in Figure 14a–c. It was evident that the primary elements present were C, O, S, and Fe. Among these elements, S was detected from the initiation zone to the transient fault zone with a sulfur atom content ranging from 0.91% to 1.2%. This indicates that  $H_2S$  reacts with the matrix surface along the direction of crack propagation after crack formation.

**Figure 14.** Fracture surface corrosion morphology and energy spectrum analysis.

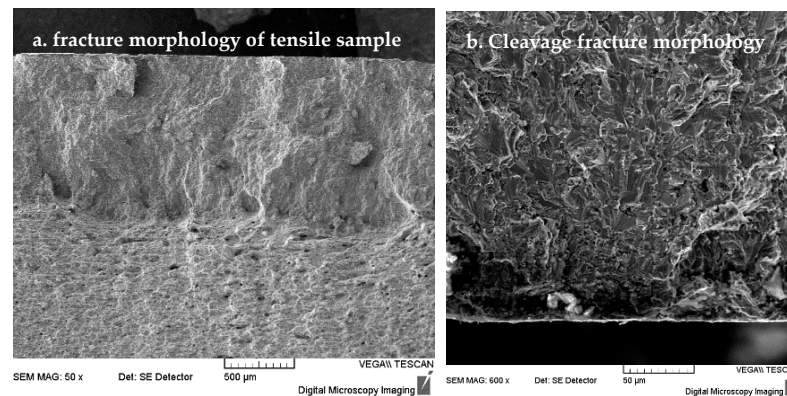
The fracture morphology of the mechanical samples at the microcrack were observed (as shown in Figure 15a). It can be seen that the surface of the original microcrack on the cross section was dark brown because of corrosion. By observing the crack initiation source region of the microcrack, it can be seen that the radial quasi-cleavage fracture characteristics were obvious, accompanied by secondary cracks (as shown in Figure 15b).

**Figure 15.** Cleavage fracture morphology of the tensile sample at the microcrack surface.

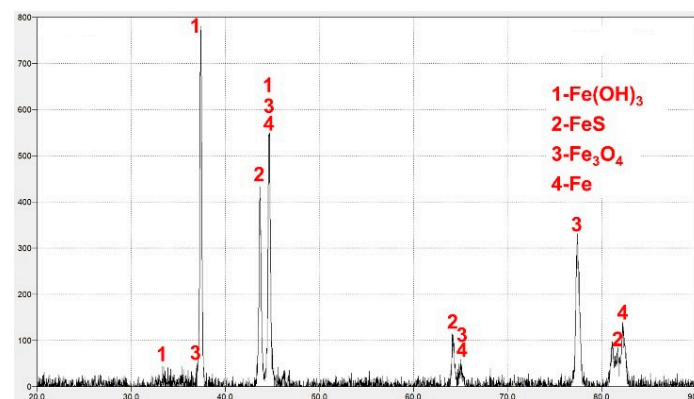
The corrosion products were sampled from the cracked surface of the microcrack for XRD phase analysis. The results indicated that the corrosion products mainly consisted of a mixture of FeS, Fe<sub>3</sub>O<sub>4</sub>, and Fe(OH)<sub>3</sub> (refer to Figure 16). When H<sub>2</sub>S dissolves in water, its ionization occurs as follows:

**Figure 16.** XRD analysis of the corrosion products on the fracture surface.
