Preliminary Observations on Historical Castle Trakošćan (Croatia) Performance under Recent $ML \geq 5.5$ Earthquakes

Abstract: Trakošćan Castle, built on a rocky peak in the late 13th century, is a cultural heritage site protected as a historical entity by the Republic of Croatia. The Castle is constructed as a highly irregular masonry structure with timber or shallow masonry arches, vaults or dome floors. It was substantially renewed, upgraded and partially retrofitted from the 16th century until the year 2000. The M5.5 (VIII EMS) and M6.2 (VIII-IX EMS) earthquakes, which struck the city of Zagreb on 22 March 2020 and the Pokupsko-Petrinja area on 29 December 2020, strongly shook the Castle's structure. Earthquake damage was observed and assessed by visual inspection accompanied by ambient vibration measurements. The slight cracks that appeared on masonry arches were found to be critically positioned, and can likely lead to the arches' collapse if their spreading is not prevented. Ambient vibration measurements, which were compared to pre-earthquake ones, revealed the decrease in the fundamental frequencies of the Castle's central tower unit and the second floor, thus possibly in

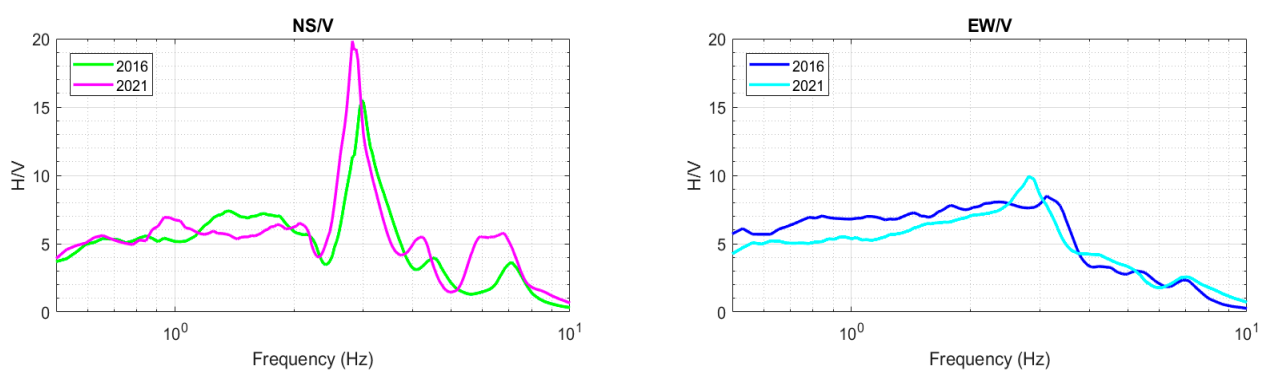
Figure 6. Comparison between ambient noise measurements carried out in 2016 and 2021 on the top of the Castle's tower.

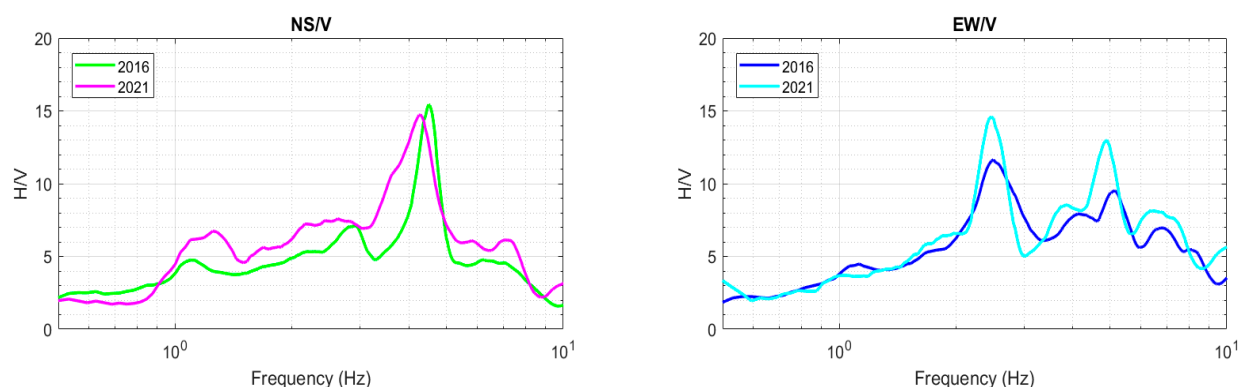
Figure 7. Comparison between ambient noise measurements carried out in 2016 and 2021 on the Castle's 2nd floor, position 1.

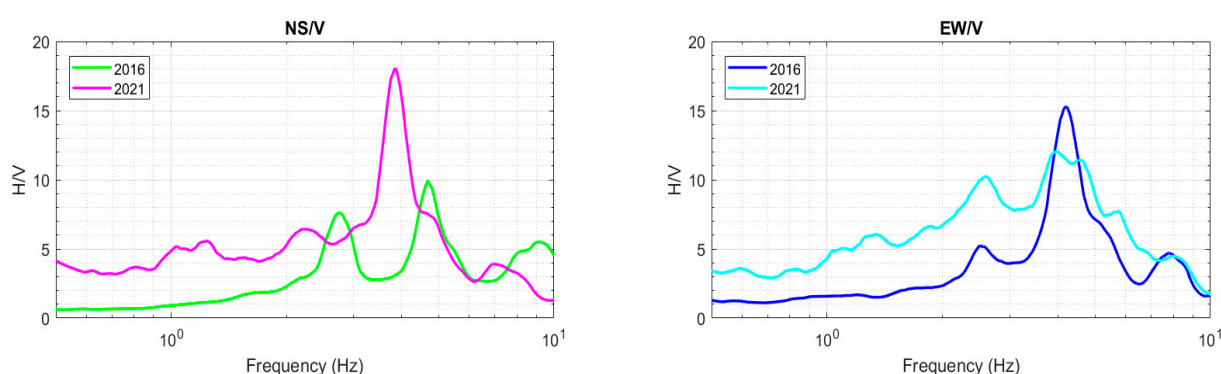
Figure 8. Comparison between ambient noise measurements carried out in 2016 and 2021 on the Castle's 2nd floor, position 2.

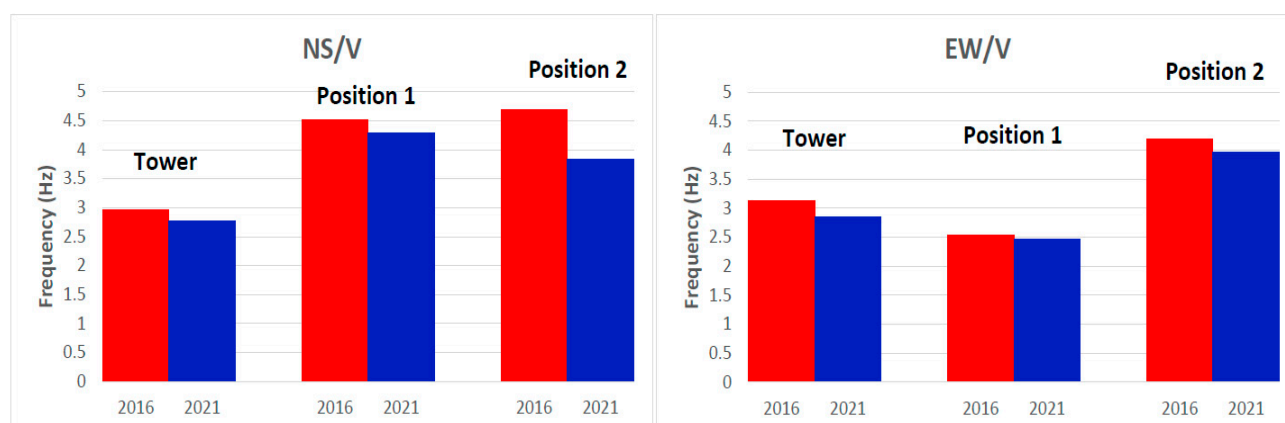
Bar charts in Figure 9 show that the change in fundamental frequency for the tower and 2nd floor (position 1) is not so significant as the change at the other location on the 2nd floor (position 2) for the average N/V component, where visible cracks were observed. Concerning the latter, the Zagreb M5.5 earthquake induced slight cracks that were spread after the Petrinja M6.2 earthquake. Therefore, the decrease in frequency may potentially suggest the loss of structural stiffness as a consequence of the earthquake damage assessed by visual inspection, accompanied by ambient vibration measurements.

Figure 9. Bar charts showing change in fundamental frequency on the Castle's tower, and 2nd floor positions 1 and 2.

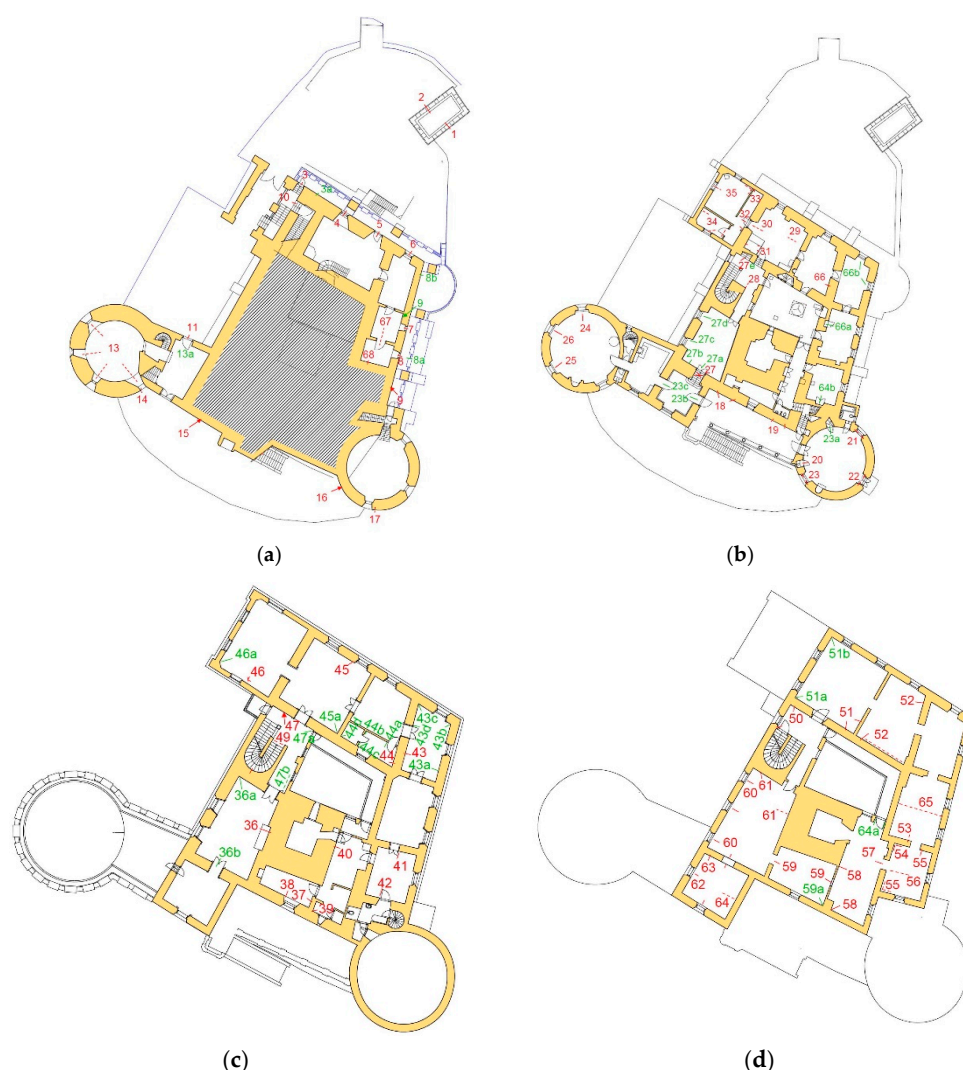
As shown in Figures 10 and 11, cracking was generally initiated in the vicinity of opening corners or wall ends, and spread throughout the building. The cracks in walls were mostly bound by fine oblique shear cracks. Based on the cracking type, distribution and characteristics (width, length, indentation, direction and location), damage to the building shown in Figures 10 and 11 belongs to the class of minor damage (Grade 1: Negligible to slight damage) in compliance with the EMS-98 scale [25]. Therefore, the observed damage does not pose a threat to the load-bearing capacity and usability of the building (see Figures 12–15 for examples).

The damage marked as 12 (see Figures 10 and 11) is a hairline tensile crack < 1 mm wide, formed at the apex of a shallow arch spanning 4.35 m, extending to adjacent arches, from which the arch assumes the corresponding part of the load. Although the crack does not indicate substantial to heavy damage according to the EMS-98 scale, due to the location of its occurrence (arch vertex), proper crack control measures should be taken. The damage marked as 52 (see Figures 10 and 11) is a crack < 3 mm wide, and represents slight damage to the part of the 2nd floor wall perpendicular to the outer wall on which the roof structure rests, and is also further weakened by the presence of chimneys. In the observed portion of the wall, the vertically continuous chimneys are placed within the wall. However, the gross wall thickness was kept the same as in the remaining portion of the wall. Therefore, due to the reduction in the net thickness of the wall, the chimneys represent the intrinsic lack of structural integrity of the particular wall or building itself. Figures 13 and 14 show the

Figure 10. Map of crack positions observed during the in situ visual inspection: (a) Basement; (b) Ground floor; (c) First floor; (d) Second floor (note: red colored marks designate the damage after the Zagreb M5.5 2020 earthquake and green colored marks designate damage after the Petrinja M6.2 2020 earthquake).

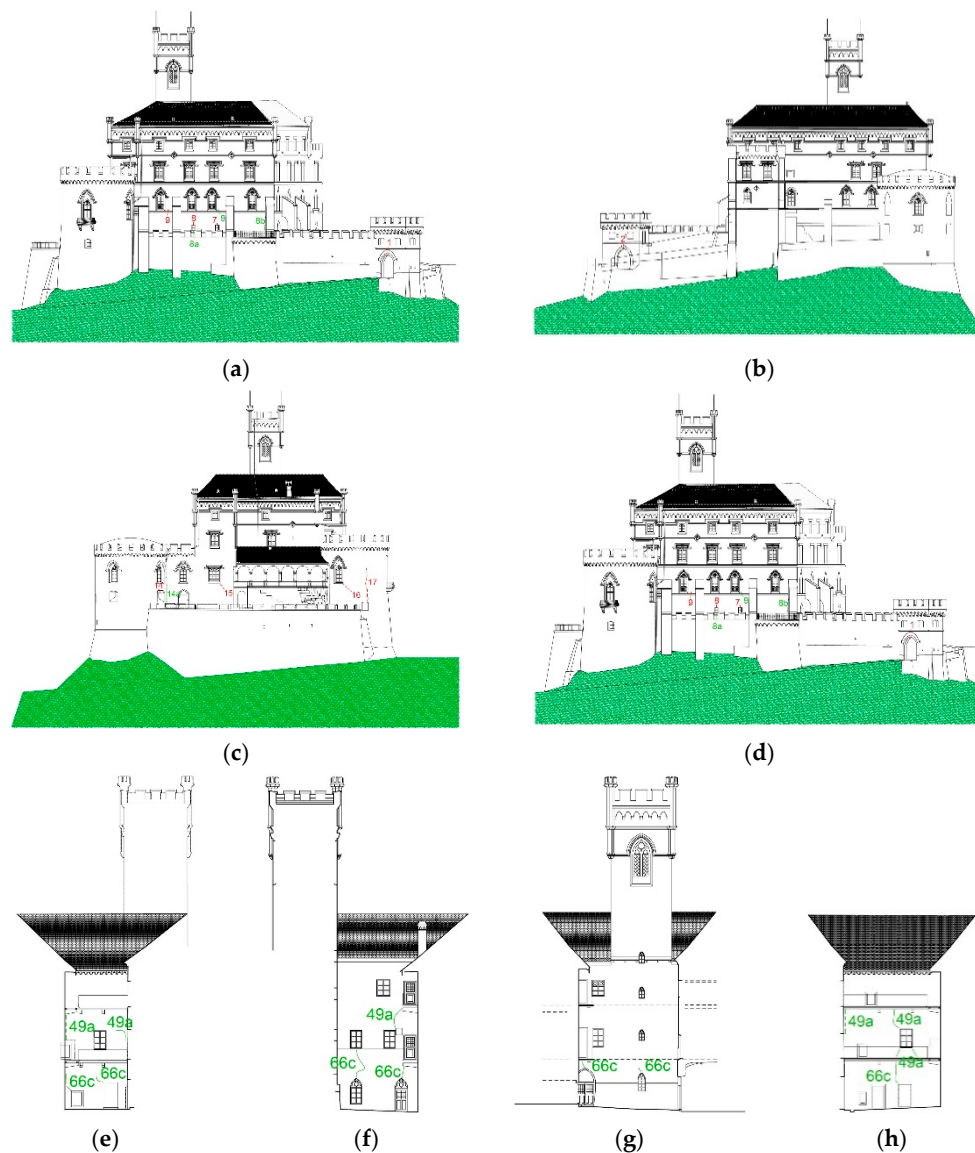
Figure 11. Map of crack positions observed during the in situ visual inspection: (a) East façade; (b) West façade; (c) South façade; (d) North façade; (e) Inner east façade; (f) Inner west façade; (g) Inner south façade; (h) Inner north façade.

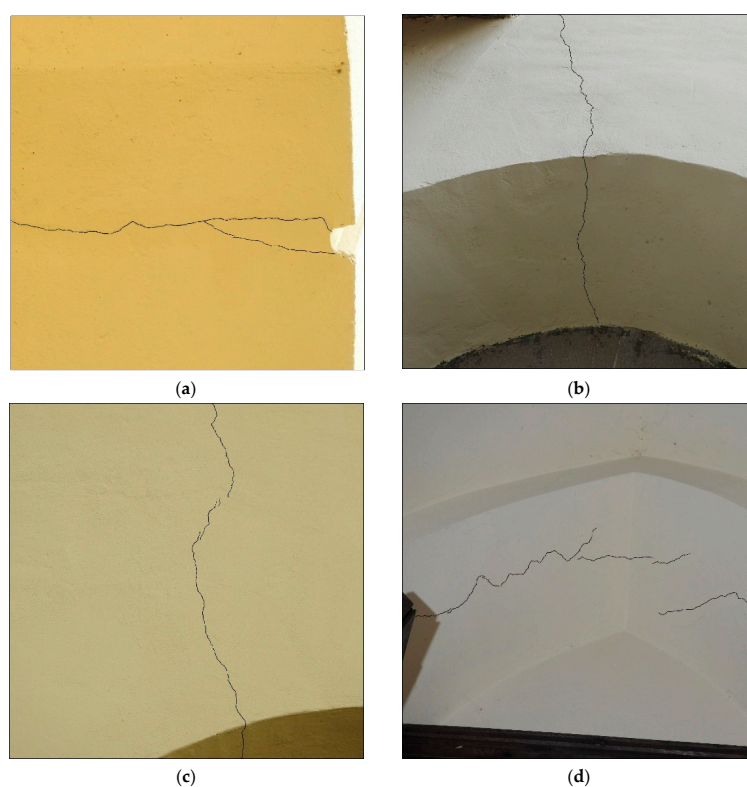
Figure 12. Examples of damage on arches and vaults marked on map of cracks: (a) Crack on arch over entrance (ID 2 in Figure 10a); (b) Crack on lintel arch (ID 4 in Figure 10a); (c) Crack stretching across arch and façade wall above it (ID 14 in Figure 10a); (d) Cracking of pointed arch over window (ID 21 in Figure 10b).

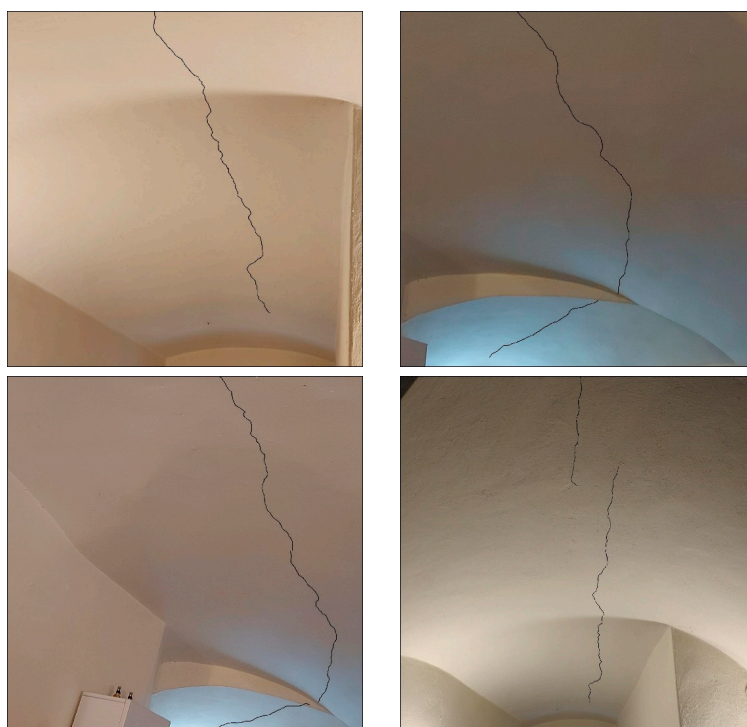
typical damage observed on vaults and arches in the form of sparsely distributed hairline cracks, with length ranging from 2 to 6 m, and in some cases even over 10 m. The majority of cracks are positioned perpendicular across vaults and arches and from there propagate to openings close to them (see Figure 12b,c). Longitudinal cracks on arches and vaults have been observed above openings in the east tower at floor level (cracks IDs 21, 22 and 23 in the damage distribution map in Figure 12d). An interesting spatial crack pattern (Figure 13) has been observed on the ceiling vault of the ground floor (ID 13), where cracks are spread from openings (windows) upwards to the center of the vault. The cracks observed on a vault shown in Figure 10a (crack ID 13) imply the decomposition of the vault load-bearing structural system to an individual arch system, which represents the new equilibrium of the structure. Above the nearby outer wall, retrofitting measures were carried out with reinforced concrete horizontal confining elements (Figure 15). However, these measures were inadequate, since there is an interruption of the confining element that makes it ineffective. For this reason, it is necessary to further monitor the development of this crack.

Figure 13. Damage observed on ceiling vault of the west tower at ground floor (damage ID on all four images is 13 in Figure 10a).
