Risk Assessment in Landslide-Prone Terrain within a Complex Geological Setting at Kadugannawa, Sri Lanka: Implications for Highway Maintenance

Sunera Mahinsa Pitawala ¹, Harindu Wimalakeerthi ¹ and Thomas Heinze ^{2,*}

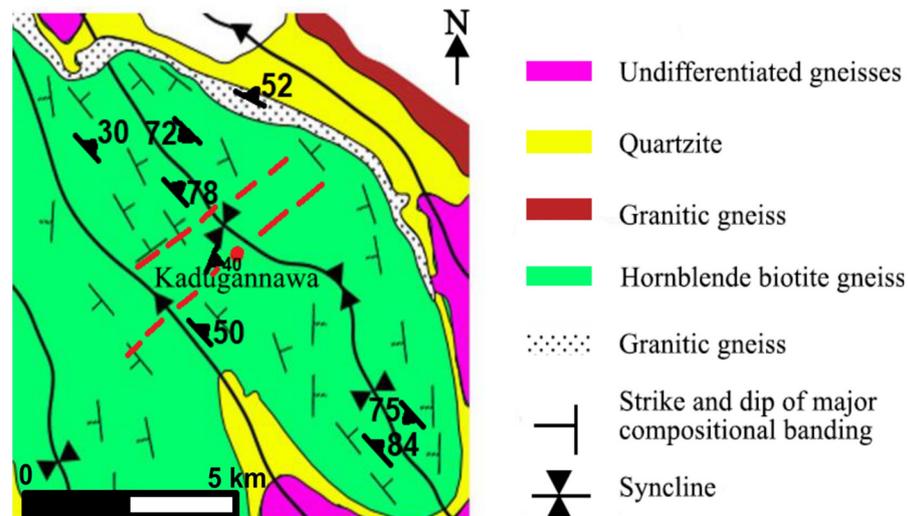
Figure 2. Map showing the major structural setting of the study area and its surroundings based on data from [53] and the present study. The red lines marked in the map are possible lineaments according to the aerial photographs and satellite images.

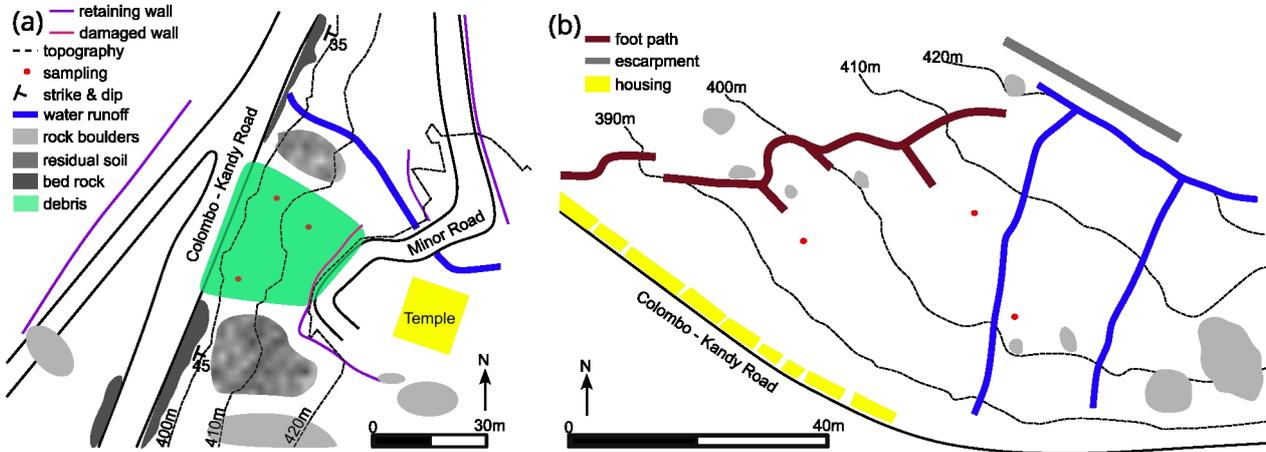
Figure 3. Geomorphological mapping of study site 1 (a) and site 2 (b). The water runoff originates from springs at higher slopes. Both landslides reached the Colombo–Kandy road, with rock boulders present at site 2 while residual soil was visible along both sides of the debris at site 1.

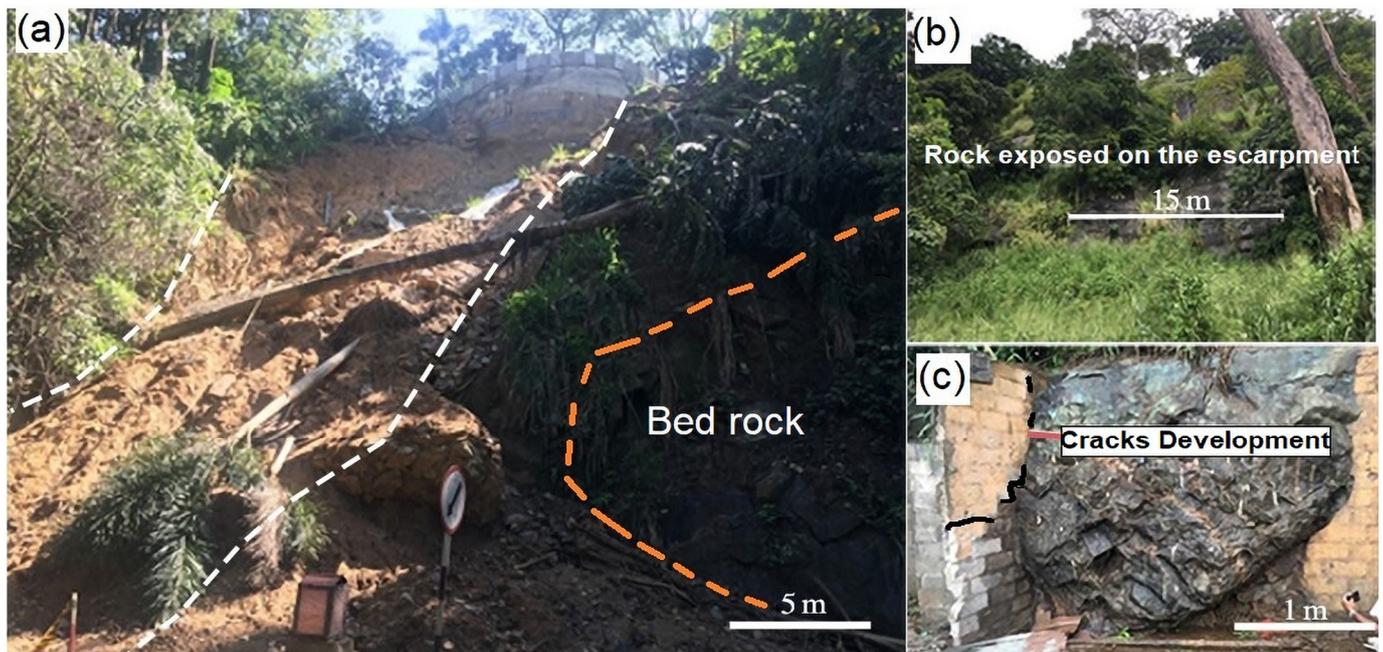
Figure 4. Photographs of (a) the failure area at site 1, revealing a soil mass devoid of rock boulders with large trees in the surroundings; (b) the scarp slope in the crown area of landslides at site 2; and (c) a boulder surrounded by boutique construction (site 2).

The presence of residual soil formed on hornblende biotite gneiss distinguishes the slope failure area at site 1 from that at site 2. This gneiss has a dip angle of around 60° and slopes northeastward. In the crown area and closer to the right flank of the slope failure, small man-made ponds and natural perennial and semi-perennial drainage networks are prevalent. Large boulders, several square meters in size, occur obliquely to the strike of the bedrock and are ubiquitous in the southern and top areas of the slope (Figure 3a). Because they are oriented in different directions, this indicates that the slope has been formed by one or more large-scale landslides that occurred a long time ago. Furthermore, residual soil and bedrock exposures are present on the southern side of the failure area (Figure 3a). The failure area has an irregular shape, with a length of 35–45 m and a width of 35–40 m, and extends from an elevation of 420 m down to 395 m. The mass movement occurred on the oblique to the dipping angle of the basement rock, and the residual soil moved as a single mass until it reached the weathered bedrock. The thickness of soil in the crown area of the slide is higher, up to 15 m, and a steep main scarp has developed (Figure 4a). This can be identified as a translational landslide.

Site 2 spans a polygon-shaped area of up to 120 m wide at the foot and 40 m wide at the top that is roughly 60 m long. It is characterized by very steep (35°–55°) to extremely steep (up to 70°) slopes with numerous bedrock exposures (Figure 4b). Two large rock scarps are present in the area that have not been subjected to slope failure and formed due to regional geological conditions because the slope is located on a limb of a synform. The top of the slide is situated above the road, while the toe lies at the cut bank of the road. The crown of the landslide is on the upper parts of the hills, close to the rock exposures of the escarpment. The upper part of the area is covered in soil with sparse vegetation. The hummocky to relatively smooth top surfaces, the presence of narrow steep slopes and boulders of varying sizes (Figure 3b), and the diversity of the vegetation, ranging from small bushes to large trees, all indicate that the slope had been subjected to mass movement at various stages over the past hundred years. The basement rock mainly consists of charnockitic gneiss with small bands of hornblende biotite gneiss. The mountain escarpment is made up of rocks with a high joint and fracture density, as well as a thin layer of soil and colluvium. The construction of paths and small buildings, primarily along the toe area of the failures, has an anthropogenic influence on the slope (Figure 3b). Similar to site 1, natural streams on the surface are common, and there are also seepages and springs on the slope. The land failures predominantly occurred along the planes of joints and faults. Both rockfalls and small-scale rotational slides occurred along the slope. Unplanned construction along the roadside and the diversion of water in the upper region of the slope resulted in significant rainwater infiltration. The heavy and prolonged rainfall, as described in Section 2, coupled with the accumulation of groundwater throughout the month on the slopes of the escarpments, generated strong destabilizing forces on the loose materials. The excess pore-water pressure within the soil reduced the shear strength, causing boulders (with a size ranging from 5 m to less than 1 m) to be transported within the moving debris.

Surficial features at site 2 can be classified into three zones: (i) the crown area, which contains less disturbed soil masses, rock boulders, and basement rock exposures; (ii) the main body, which includes several minor scarps and cracks, as well as highly disturbed colluvial soil with boulders; and (iii) the toe area, which contains disturbed geologic materials and small-scale mud flows. The crown of the slide is closer to the scarp slope of the basement rocks, while the toe is on the road. Field observations within the study period noted that, during the rainy season, the development of cracks between the rock masses and soil is common due to the seeping of water through the fractures in the basement rocks or the boundary between the rock masses and soil, indicating the instability of the slope. Human activity in the middle of the slope and toe areas is quite high, involving the diversion of natural water flow paths and the cutting of slopes for construction. The slope of the adjacent area is partly eroded due to its height and consists of rock boulders ranging from 0.5 to 7 m. On colluvial and residual soils, weathered rock boulders are common at relatively shallow depths. The formation of colluvium deposits may be attributed to climatic fluctuations and rock falls [55,56]. Additionally, duricrusts ranging from a few millimeters to several centimeters may form due to the frequent seepage of groundwater [57]. Intensively weathered colluvial soil has been mixed up with residual weathering profiles. Houses and small boutiques have been constructed on colluvial soil formations (Figure 4c).

The most likely slip surface at site 1 is residual clayey soil and weathered rock associated with hydrophilic secondary minerals. The presence of water in the soil decreases the residual soil profile's shear strength. Therefore, managing surface water infiltration into the soil is crucial. This is in accordance with the methods proposed by Bracko et al. (2022) [14] to reduce the water net infiltration in soils of low permeability. Further, it is necessary to utilize ground improvement methods to increase the strength and stability of weak soil [71,72]. This can involve several methods, such as chemical methods, stabilization through geotextile and fabrics, and mechanical stabilization to improve the soil's engineering properties. Reinforced soil structures or soil nailing are the most appropriate

The high load of unstable soil in site 2 in the upper slopes, the flow of water into the surface of the slopes, groundwater influence in the upper slope and the perched water table, and the underlying colluvium material, which causes soil softening, are the main reasons for instability in the site. As long-term measures, introducing a new surface drainage system to divert the rainfall water, strengthening the affected area by adding soil nails, constructing a new retaining wall next to the main road to support the load [75–77], and the implementation of regulations for the construction and diversion of any water paths are required. In addition, to improve the stability of the risk area marked at site 2, it is necessary to lower the groundwater level using long drains (pipes) connected to fractured basement rock to remove water. Gravity-type retaining walls must be built at the toes of sites to prevent the lateral movement of soil masses and soil erosion.

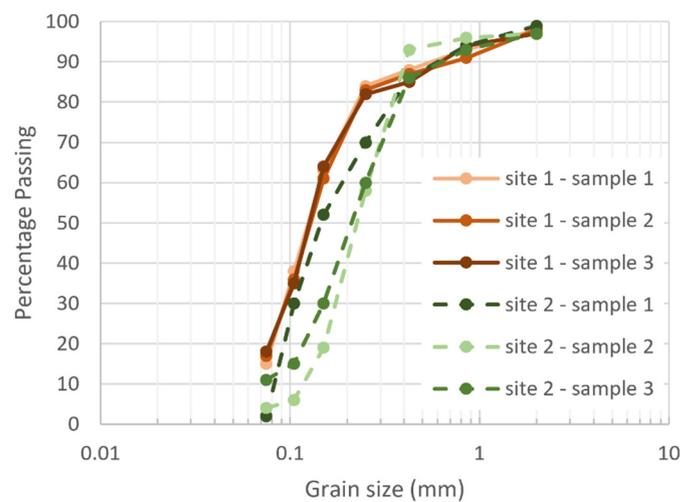
Figure 5. Particle size distribution curves of three soil samples taken at each site at the locations marked in Figure 3.

The sampling locations of soil for laboratory analyses are shown in Figure 3 and the results of the sieve analysis for two sites are presented in Figure 5. The sieve analysis of the soil revealed that the clay fraction of the soils at site 1 is generally higher than 10% and has a fine texture. Therefore, the shrink–swell properties of the soil are high, indicating that the soils exhibit extreme expansion potential, making them susceptible to landslides [58]. The grain size distribution of overburdened soils shows that they have a similar texture, implying that they derived from similar types of chemical weathering. The variable textures of the soils at site 2 indicate that they may have been formed after undergoing several physicochemical processes. Further, the presence of colluvium in the soil has also contributed to the formation of the soil, as well as the basement rock. This is because colluvium has a higher infiltration capacity compared to the residual soil found at site 1. Therefore, overland flow is reduced and infiltration increases, resulting in the formation of clay-rich soils. Further, the content of cobbles and pebbles is considerably higher in some areas of the soil in the site.

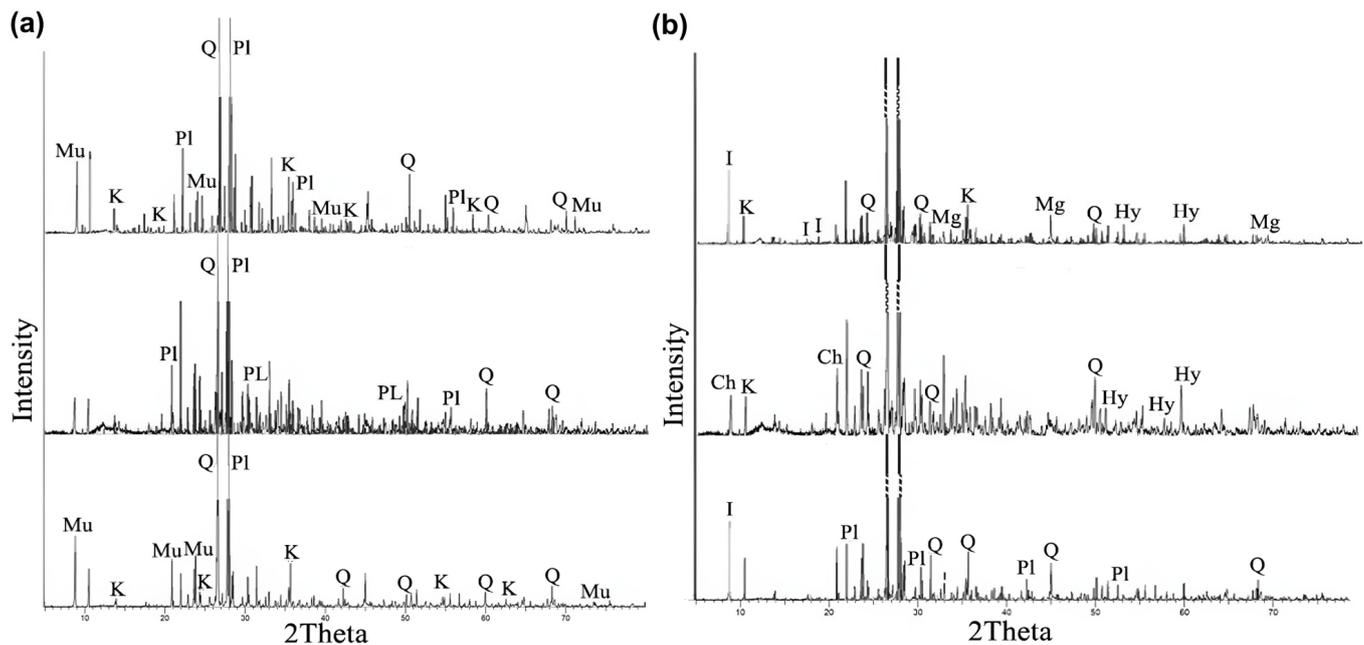
The prominent clay mineralogical composition of the soil in the studied sites is illustrated in Figure 6. The fine fraction of the weathering profile of soils at site 1 contains kaolinite and muscovite, in addition to quartz. Experimental results revealed that the octahedral surface of kaolinite is hydrophilic. Montmorillonite, illite, and mica show a range of wettability: montmorillonite wets strongly, illite wets strongly to weakly, and mica wets completely [59]. This implies that kaolinite and muscovite mica at site 1 have a high water-bearing capacity due to their negative charges. Due to their plate-like morphology, clay minerals associated with water can increase the lubrication property of soils, which may induce slope instability [60,61]. Muscovite mica acts as such a lubricant since it has perfect cleavage, high flexibility, and high elasticity [62]. Although kaolinite has low cation exchange capacity and limited swelling and shrinking properties, hydrophilic kaolinite has high lubrication properties due to its plate morphology [61]. Slipping zones that exhibit a lubricating effect between landslide masses and bedrock may function as impervious boundaries, effectively segregating landslide masses from the surrounding environment [63]. This agrees with our field observation, reported above, that the exposed slide surface was covered by mica- and feldspar-rich layers. Therefore, both muscovite and kaolinite in the fine-fraction-rich soil at site 1 resulted in slope failure. Triaxial and direct shear tests from the shear zone of the Watawala Earthslide (Sri Lanka) revealed a significant loss of strength in the involved clay-rich soils due to this lubrication effect [64]. Also, in the slope failure in Kahagolla, the role of weak, clay-rich soil layers has been highlighted [65]

In contrast, site 2 is low in such clays, with them forming less than 5% of the gravitational fraction in the sieving analysis. Therefore, the contribution of clay to the mass movement in the area is low.

Figure 6. Mineralogical composition of the fine fraction of the soil ((a)—site 1; (b)—site 2). Ch—chlorite; Hy—hypersthene; I—illite; K—kaolinite; Mg—magnetite; Mu—muscovite; P—plagioclase; Q—quartz. The scale does not account for intensity, given the exceptionally high intensity of certain peaks.

constructions for the site [73,74]. Our study results show that, at site 1, the clay-rich soil layers including the minerals muscovite and kaolinite act as potential failure planes due to their lubricating effect. Mitigation measures either need to improve water drainage at these layers through drainage systems or stabilize these layers mechanically, potentially also through respective land use and cultivation with deep-reaching roots. Clay-rich layers can be identified using geoelectrical methods during field investigations [44].

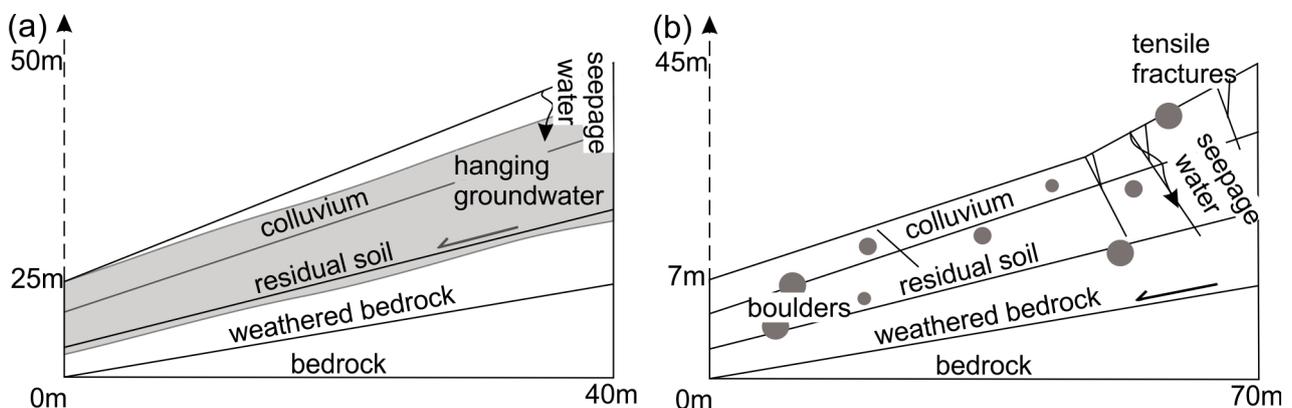
Due to their differences in lithology, soil texture, and hydrogeological conditions, both sites show different failure modes and mechanisms. The studied event at site 1 is a translational debris flow. The failure plane developed along the clay-rich layer of weathered bedrock below the residual soil due to the lubrication effect of the mica and kaolinite minerals, which caused a significant drop in cohesive and shear resistance due to the percolating water during the prolonged rainfall in November 2021. The increasing pore water pressure due to the limited infiltration capacity of the weathered bedrock further reduced the normal stress and subsequently caused slope failure (Figure 7a).

Tensile crack opening around the crown and upper part of the slope at site 2 indicates that tensile failure initiated a landslide, which then transitioned into rotational debris flow with minor rockfall. The high fracture density due to the regional geology of an anticline allows water to quickly infiltrate deeper layers while also providing cohesionless planes

(Figure 7b). The presence of boulders of varying sizes within the residual soil further reduces the cohesiveness of the soil along the soil–boulder interfaces, which also provide preferential fluid pathways.

Figure 7. Conceptual model of the failure mechanisms at site 1 (a) and site 2 (b). Slope failure is caused by a lubrication effect in combination with increasing pore pressure due to water infiltrating the boundary between residual soil and weathered bedrock. At site 2, the tensile cracks allow for fast water migration towards the weathered bedrock, where the increased pore pressure along the cohesionless cracks and boulder–soil interfaces reduce the normal load to initiate failure.
