## Article

# Post-Fire Inspection, Material Testing, Repair, and Field Load Testing of a Full-Scale Concrete Box Girder Bridge: Delta Bridge Case Study

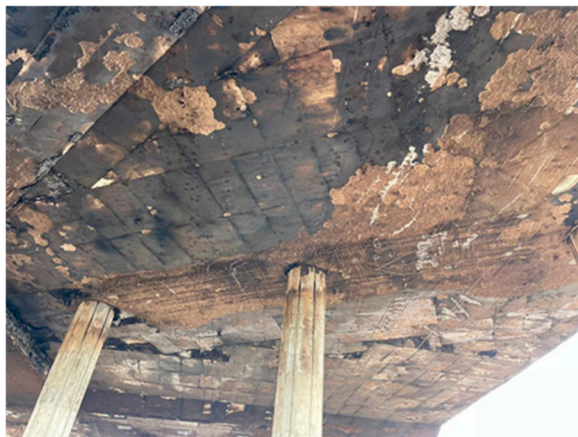
(a) Span 8

As shown in Figure 3, the incident caused varying degrees of damage to the bridge's bottom slabs, webs, columns, and bearings. The black rectangular areas in Figure 3a correspond to charring and soot marks caused by the combustion of plywood formwork that was directly in contact with the concrete surface. No intact plywood residues remained after the fire, only combustion-induced surface marks. The following day, at 10:00 a.m., engineers from Saad International Consulting performed a detailed on-site inspection. Their preliminary evaluation concluded that the bridge sustained moderate fire damage but remained standing. Nevertheless, there was concern that the residual structural capacity and serviceability of the affected spans may have been compromised, prompting further material testing and field load evaluation.

**Figure 3.** Post-fire condition of the Delta Bridge, showing severe charring, concrete spalling, discoloration, and exposure of columns and soffit surfaces beneath the box girder spans.

The inspection documented concrete spalling, loss of cover, cracking patterns, and discoloration. The most severe damage was concentrated in spans 8 and 9, as illustrated in Figure 3a,b. Fire-induced effects on these spans included extensive surface charring, localized spalling of the soffit concrete, and soot deposition. In contrast, the footings at piers 8, 9, and 10 exhibited only minor surface damage, characterized by map cracking, light pink discoloration, and soot deposits on the front walls. Importantly, no concrete

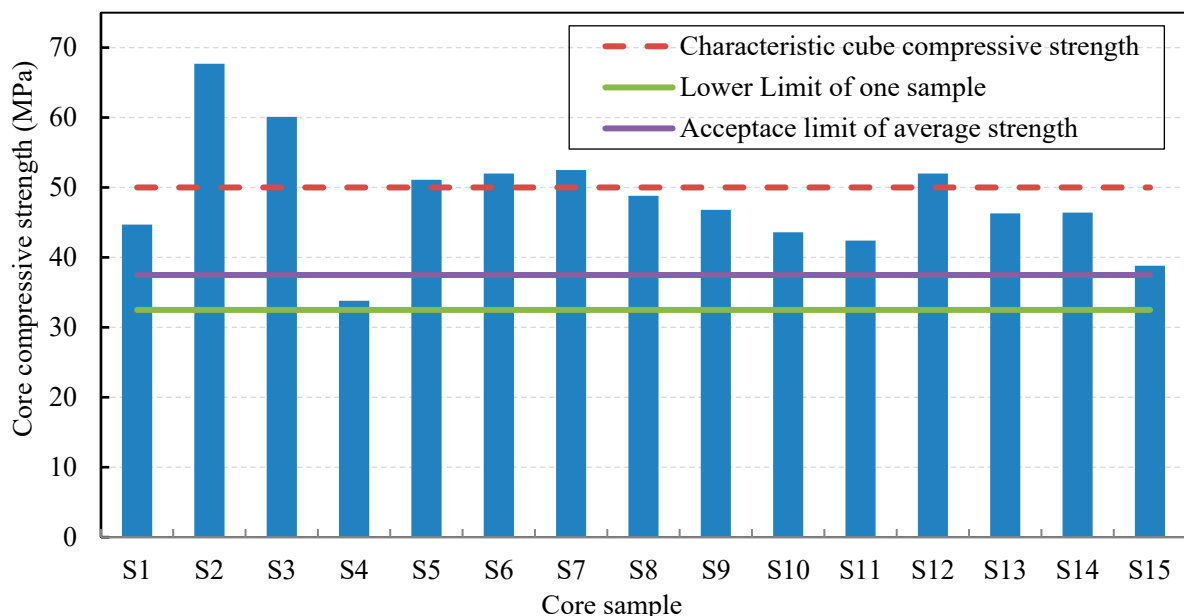
**Figure 5.** The post-fire compressive strength results of the bottom slab cores.

Although the standard deviation of the slab core strength results is relatively high ( $\approx 8.23$  MPa), this does not indicate different concrete production batches. The bottom slab concrete was originally cast using the same concrete mix design and production process during construction, as confirmed by the recorded in situ construction strength data.

The observed variability in post-fire core strength is primarily attributed to the non-uniform thermal exposure during the fire event, including variations in flame contact, temperature gradients through the slab thickness, and localized cooling effects during fire suppression. Such variability is commonly reported in post-fire concrete assessments and reflects heterogeneous thermal damage rather than differences in original concrete quality.

Based on the results in Figure 5 and Table 3, the post-fire compressive strength of the bottom slab satisfies the acceptance criteria. The average compressive strength of the lower slab after fire exposure showed a reduction of approximately 8.5% compared to the original in situ concrete strength recorded during construction. Nevertheless, the measured value of 48.50 MPa still exceeds the minimum required average strength of 37.50 MPa specified by ECP 203 [37] by 29.24%. Furthermore, all individual core strengths are greater than the minimum required value of 32.50 MPa. These findings confirm that the residual concrete strength of the bottom slab remains structurally adequate after the fire exposure.

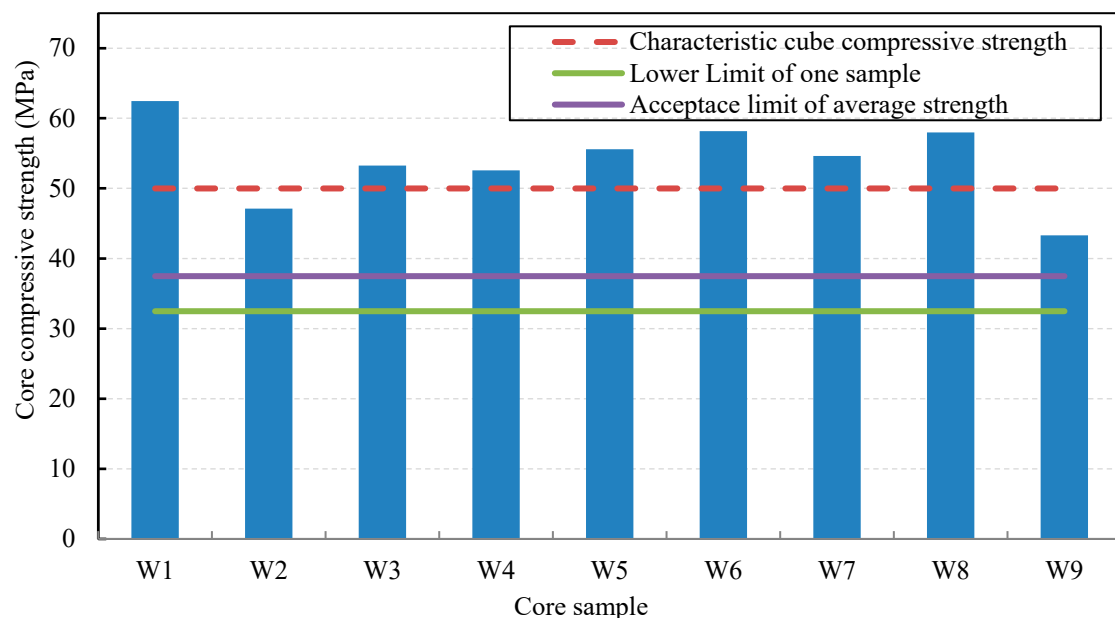
**Figure 6.** The post-fire compressive strength results of the web cores.

Figure 6 presents the post-fire compressive strength results of the web cores. Sample W1 exhibited the highest strength at 62.50 MPa, representing a 24.9% increase relative to the Characteristic cube compressive strength of the concrete web. This was followed in descending order by samples W6, W8, W7, W5, W3, and W4. Conversely, samples W2 and W9 recorded the lowest strengths at 47.10 MPa and 43.30 MPa, respectively. The average compressive strength of all cores extracted from the webs of the fire-exposed spans showed a reduction of approximately 7.9% compared to the original in situ concrete strength recorded during construction. Nevertheless, the measured average value of 53.90 MPa still exceeds the minimum requirement specified by the Egyptian Code (ECP 203) [37]. Moreover, Table 3 and Figure 6 confirm that every individual sample meets the minimum acceptance criterion for a single core. These results collectively indicate that the post-fire compressive strength of the webs satisfies the acceptance requirements stipulated in ECP 203 [37].

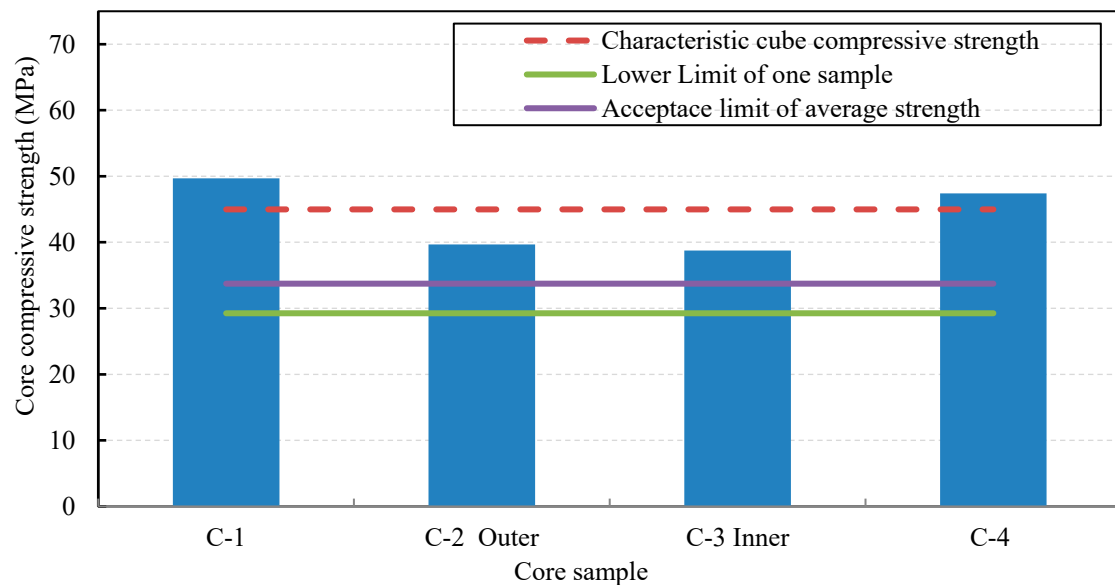
**Figure 7.** the compressive strength results of core samples extracted from the post-fire columns.

Figure 7 presents the compressive strength results of core samples extracted from the post-fire columns. It is evident that the compressive strengths of samples C1 and C4 increased by 10.40% and 5.40%, respectively, relative to the column Characteristic cube compressive strength of 45 MPa. Conversely, the compressive strengths of the C-2 Outer and C-3 Inner samples decreased by 11.80% and 13.90%, respectively. The average compressive strength of the cores extracted from the fire-exposed columns was 43.88 MPa. This value represents a reduction of approximately 10.8% compared to the original in situ concrete strength recorded during construction. However, it still exceeds the minimum required strength specified by ECP 203 [37] by approximately 30%. Despite these reductions, all tested samples satisfy the minimum acceptance criteria stipulated by ECP 203 [37], confirming that the concrete in the columns of the two fire-exposed spans remains structurally acceptable.

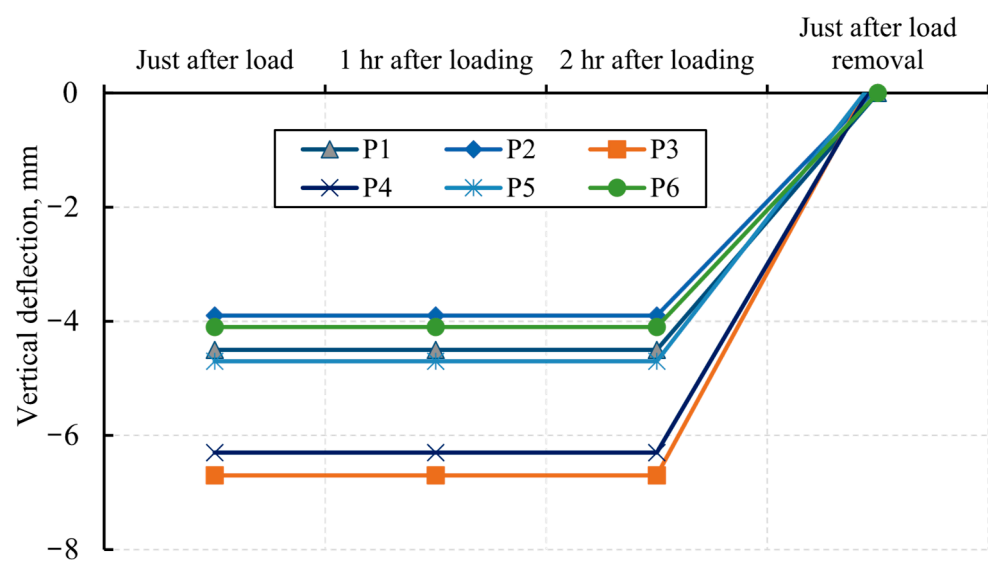
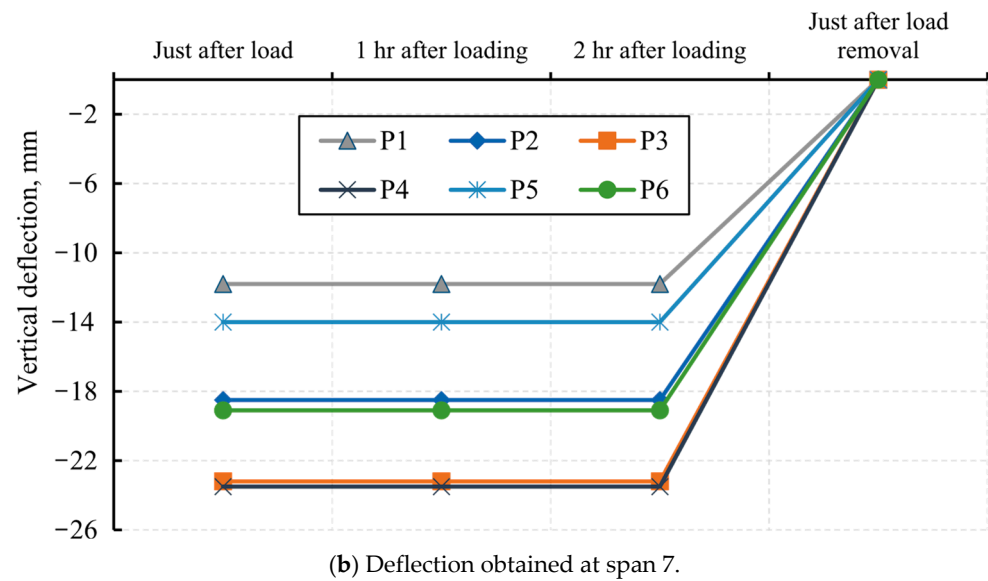
**Figure 12.** Experimental deflection during the loading test.

The experimental deflection responses of the post-fire spans during the static loading tests are presented in Figure 12. As shown in Figure 12a,b, the vertical deflections of the loaded spans remained nearly constant under the different loading stages. For instance, the deflection measured at point P1 for spans 8 and 9 was consistently 4.50 mm immediately after loading, one hour after loading, and two hours after loading, indicating minimal time-dependent deformation. Upon load removal, the deflection values approached zero, demonstrating good elastic recovery. At mid-span, the maximum recorded deflections were 6.70 mm at point P3 and 6.30 mm at point P4. The measured deflections at other points were nearly constant across loading stages, with values of 4.50 mm at P1, 3.90 mm at P2, 4.70 mm at P5, and 4.10 mm at P6.

Figure 12b illustrates the deflection profile of composite steel span 7. Similar to spans 8 and 9, the vertical deflection response remained stable across all loading stages. The maximum deflection occurred at mid-span point P4 (23.50 mm), followed by P3 (23.20 mm), P6 (19.10 mm), P2 (18.50 mm), P5 (14.00 mm), and P1, which exhibited the lowest deflection of 11.80 mm. It is evident that the deflections of span 7 are significantly larger than those of spans 8 and 9. This difference is attributed to the structural and geometric characteristics of the spans: span 7 has a considerably longer length (81.88 m) compared to spans 8 and 9 (19.30 m each) and is constructed using steel girders, whereas spans 8 and 9 consist of precast concrete beams.

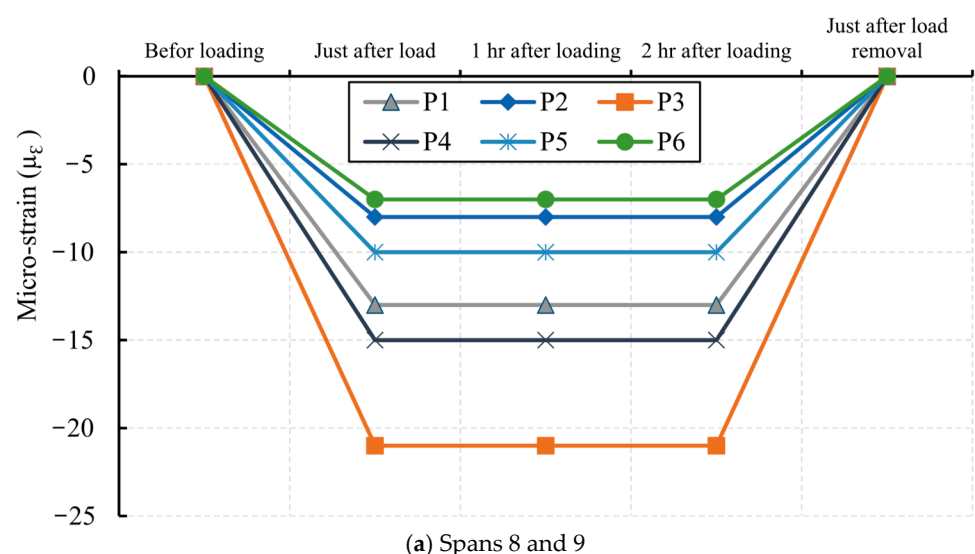
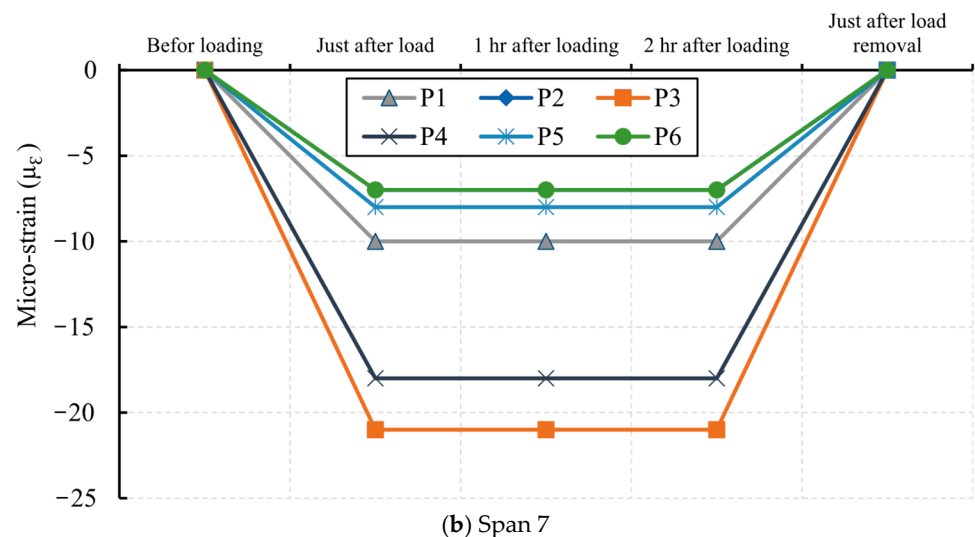
**Figure 13.** Micro-strain measurements of the steel reinforcement.

Figure 13 presents the micro-strain measurements of the steel reinforcement in the post-fire top slab during the static loading tests. As illustrated, the micro-strain values at all slab measurement points remained nearly constant throughout the different loading stages (immediately after loading, one hour after loading, and two hours after loading). In contrast, the micro-strain values were close to zero prior to loading and immediately after load removal, indicating full elastic recovery.

Among the measured points, P3—located at mid-span—recorded the highest micro-strain of 21  $\mu\epsilon$ , followed by P4 with 15  $\mu\epsilon$ . The remaining points exhibited micro-strain values of 13  $\mu\epsilon$  at P1, 10  $\mu\epsilon$  at P5, 8  $\mu\epsilon$  at P2, and 7  $\mu\epsilon$  at P6. A similar micro-strain distribution trend was observed for span 7, confirming the consistency of the structural response across the tested spans.

The measured deflections and micro-strain values remained nearly constant over the 2-h sustained loading period, indicating negligible time-dependent deformation. Furthermore, the nearly full recovery after unloading confirms that the structural response was predominantly elastic under the applied service load.
