# Effect of Wave Process of Plastic Deformation at Forging on the Fatigue Fracture Mechanism of Titanium Compressor Disks of Gas Turbine Engine

Andrey A. Shanyavskiy <sup>1,2,\*</sup>, Alexey P. Soldatenkov <sup>1</sup> and Alexandr D. Nikitin <sup>2</sup>

**Citation:** Shanyavskiy, A.A.; Soldatenkov, A.P.; Nikitin, A.D. Effect of Wave Process of Plastic Deformation at Forging on the Fatigue Fracture Mechanism of Titanium Compressor Disks of Gas Turbine Engine. *Materials* **2021**, *14*, 1851. <https://doi.org/10.3390/ma14081851>

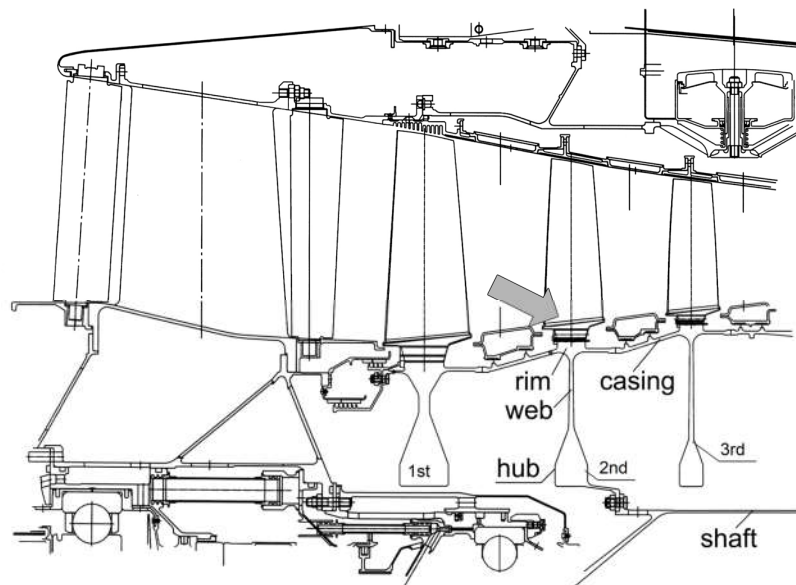
During the operation of the An-124 aircraft with the number RA-82043, a surge of the GTE of the power plant No. 4 occurred in the climb regime, with a fire alarm and automatic activation of the first stage of the fire extinguishing system. Subsequently, the engine No. 4 was automatically shut down. The aircraft landed safely at the departure airport. Inspection on the ground of the failed engine established its non-localized fracture due to the release of fragments of the titanium second-stage disk of the IPC (Figure 2).

**Figure 2.** Fragment of the scheme of the GTE intermediate-pressure compressor. The arrow indicates the location of the initial fracture of the second-stage disk.

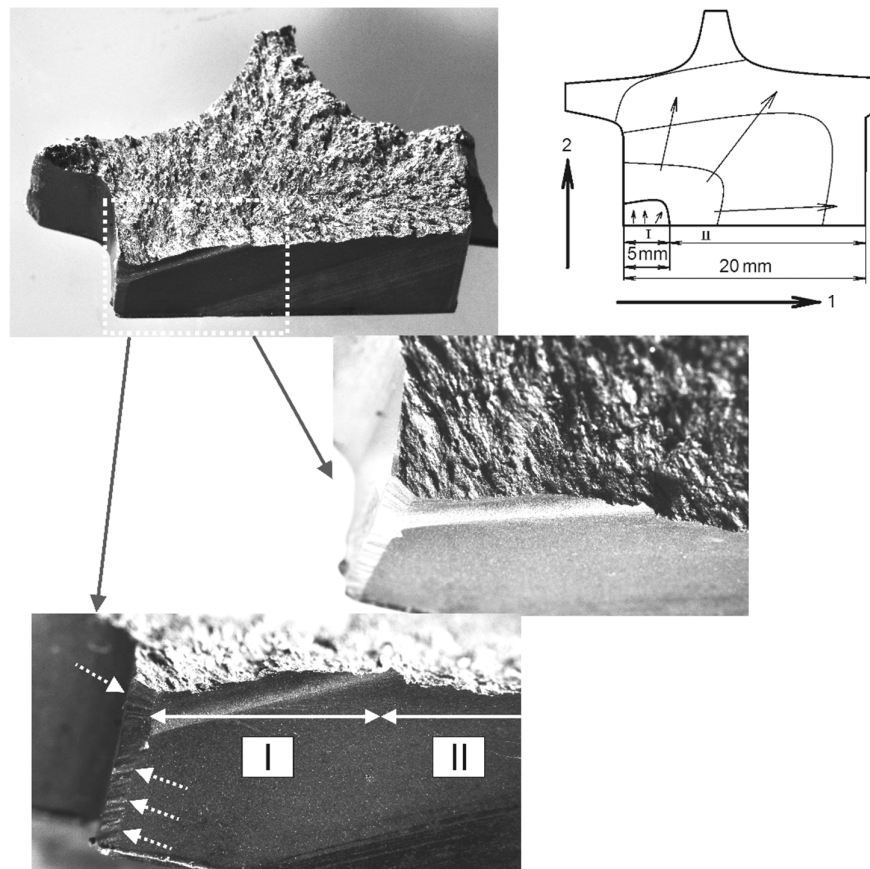
Based on the disk fracture surface analyses, it was established that the main fracture occurred in the radial direction from the rim part toward the disk hub (Figure 10). The initial zone of crack initiation and growth within about 5 mm from the lateral surface of the rim (zone I in Figure 10) is located along the slot for the blade. The fracture surface boundaries are oriented according to the scores from machining the surface along the radius transition of the bottom of the slot for the dovetail blade to the lateral surface of the inter-slot volume. Therefore, in the crack initiation zone along the slot for the blade along the radius transition, a combination of radial and tangential loads took place. Analysis of the crack initiation zone shape, its location, and changes in the path of fracture development at the subsequent stage shows that the crack initiation in the disk is generally due to the local stress concentration in the shape of the radius transition of the slot for the blade, and not to the total stress intensity of the disk.

It is established by the analysis of the fracture surface relief in the region I that the fracture has a multi-origin fatigue nature with the formation of a meso-tunnels' cascade (Figure 11). In the fracture surface origins, a predominantly faceted pattern was observed. Between them, the blocks of fatigue striations were formed during the fracture of the bridges between the meso-tunnels. The uniformity of the fatigue striation formation has such a manner that within their block, the spacing remains almost the same. However, in some regions of the fracture surface (Figure 11b) within one meso-tunnel, there was a sharp change in the block of fatigue striation spacing of the same size to a block with a wider spacing. This reflects the specifics of the changing stress state of the material in the bridges between the meso-tunnels.

**Figure 10.** Initial fracture zone of the second-stage disk and its schematic representation indicating the orientation of the fracture surface formation from the region of the slot for the blade along the radius transition with the origin of the fatigue crack (indicated by a rectangle) in the disk. Dashed arrows indicate a region with high roughness along the boundary of the transition of the bottom of the slot for the blade to the rim surface. Roman numerals designate successively formed different zones of the fracture surface.

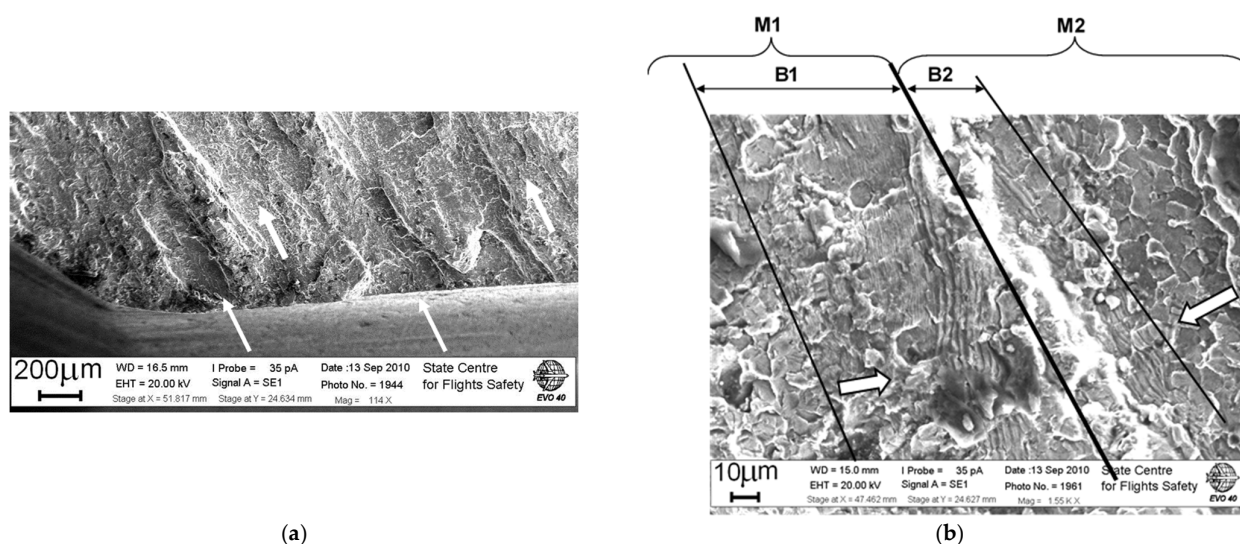
The observed nature of crack propagation with the formation of two types of fracture surface relief is typical for a material with a pronounced filament texture when the crack growth process is initially realized as a result of crack extension by the mechanism of a facet formation. Then, the bridges between the previously formed fracture surface regions are connected with the formation of fatigue striations (see, for example, Figure 4). In case of fracture from multiple origins, the duration of crack propagation in the direction 1 (see scheme in Figure 10) should be evaluated only starting from a distance of about 5 mm, when the crack emerged from the radius transition of the slot bottom under the blade (region II in Figure 10). This approach is based on the observation that on fracture surface region I in the direction 1, fatigue striations are formed toward each other (Figure 11b).

**Figure 11.** (a) Features on the zone I (see Figure 10) of fracture surface in the bridge between the initial meso-tunnels and (b) two meso-tunnels M1 and M2 with a faceted pattern. Blocks of fatigue striations formed simultaneously to meet each other are designated by B1 and B2, and the directions of fracture development are shown by hollow arrows.

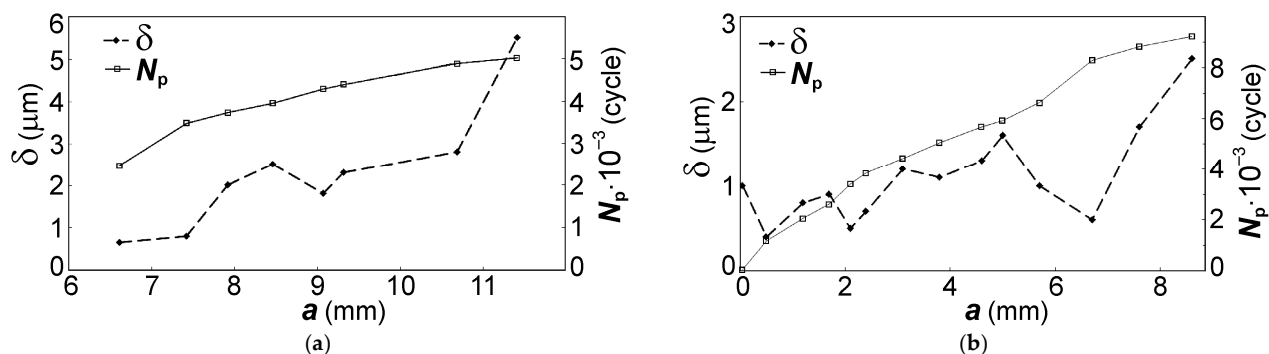
Therefore, in the direction 1, the regularity of fatigue striation formation was analyzed with the recalculation of the established number of unit cycles into the number of flight cycles on the length range of 5–20 mm. For example, the method of determining the crack growth duration by the fatigue striation spacing is shown in [14]. The fatigue striation spacing was measured, the number of loading cycles for the rim part of the disk during the fatigue crack propagation was calculated, and the results are shown in Figure 12. The increase in the fatigue striation spacing along the crack length was established to be insignificant. Stable formation of areas with fatigue striations occurred in the crack length range of 5–11 mm. Then, along the considered direction, an accelerated, repeated-static fracture of the disk was realized with the formation of areas with the faceted patterns and dimples. The crack growth duration resulted from measurements of the fatigue striation spacing at a length of 5–11.5 mm is about 5000 cycles and an additional 1900 cycles at a length of 11.5–20 mm according to the approximation of the spacing dependence on the length obtained at the interval of 5–11.5 mm.

**Figure 12.** Dependences of fatigue striation spacing  $\delta$  and the number of cycles for the crack propagation  $N_p$  on the crack length  $a$  in the rim of the disk for direction (a) 1 and (b) 2.

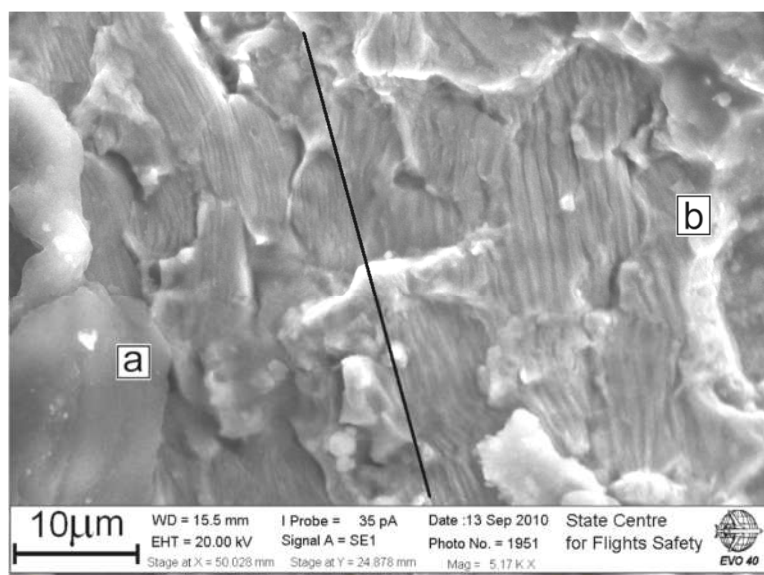
The validity of considering several loading cycles of the disk, causing the crack propagation during flight, is confirmed by the results of fractographic studies, presented, for example, in Figure 14. Within the fracture surface region length of about 40  $\mu\text{m}$ , there are two blocks of fatigue striations “a” and “b” with an average spacing of 0.36 and 1.2  $\mu\text{m}$ , respectively. In some fracture zones, pronounced blocks of fatigue striations formed without changing their spacing within sequences of striations belonging to one block (8–14 striations) were observed. These sequences can be a result of material fracture during the implementation of transient loading modes, as follows from the scheme of engine operating conditions for a typical flight (see Figure 13).

**Figure 14.** Fracture surface with two blocks “a” and “b” of fatigue striations with similar average spacing in each block, but differing by more than three times for the blocks “a” and “b”.

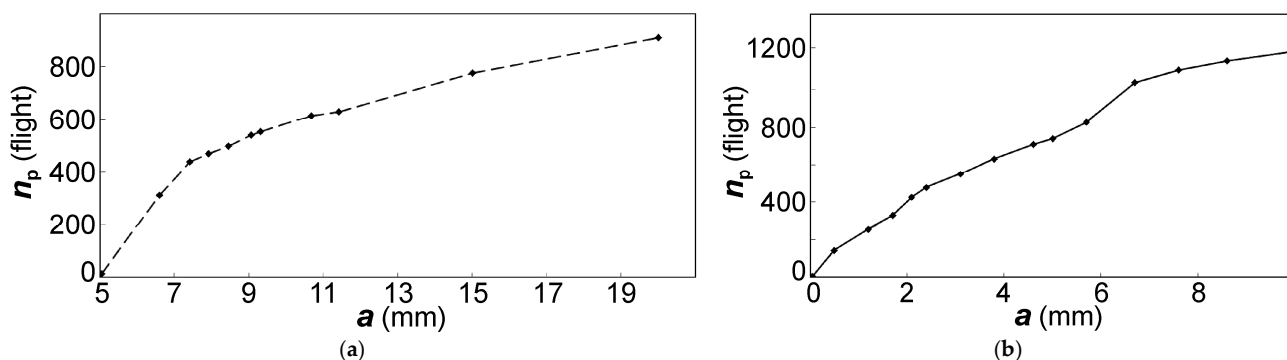
The performed recalculation and the described regularities of disk fracture allowed obtaining the following results (Figure 15): (1) the crack growth duration along the direction 2 was about 1200 flight cycles; (2) the fracture durations in the directions 2 and 1 correspond to each other; and (3) within the range of first 5 mm along the surface of the slot for the blade,  $n_p$  of about 340 flight cycles should be considered (i.e.,  $n_p = (9600 - 6900)/8$ ). The dependencies shown in Figure 15 allow determining the frequency of disk inspections, starting with the crack length determined by the resolution of the inspection tool and the accessibility of the zone where the crack can be detected.

**Figure 15.** Dependences of the fatigue crack propagation duration in terms of flights  $n_p$  on the crack length  $a$  in the second-stage disk of the intermediate-pressure compressor (IPC) for directions (a) 1 and (b) 2 (shown in Figure 10).
