Metallographic Testing of 19th Century Steel in an Operating Water Tower

Eugeniusz Hotała ¹, Rajmund Ignatowicz ^{1,*} and Maciej B. Lachowicz ^{2,3}
¹ Department of Building Structures, Faculty of Civil Engineering, Wrocław University of Science and Technology, Na Grobli 15, 50-421 Wrocław, Poland; eugeniusz.hotala@pwr.edu.pl

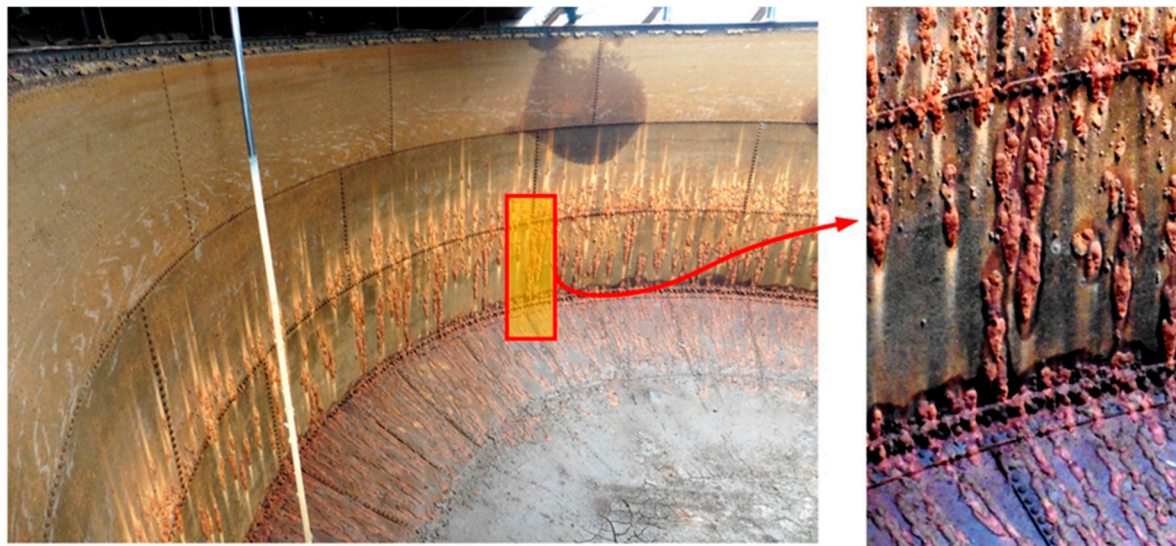
Figure 2. View of a fragment of the interior of the steel tank in the tower.

During renovation of the pressure tower roof (Figure 1), the steel tank was emptied (Figure 2) and the corrosion wear of the metal sheets was tested from the inside, as these were clearly visible. From the external side of the tank, the corrosion process was not so intense (Figure 4) given 135 years of operation.

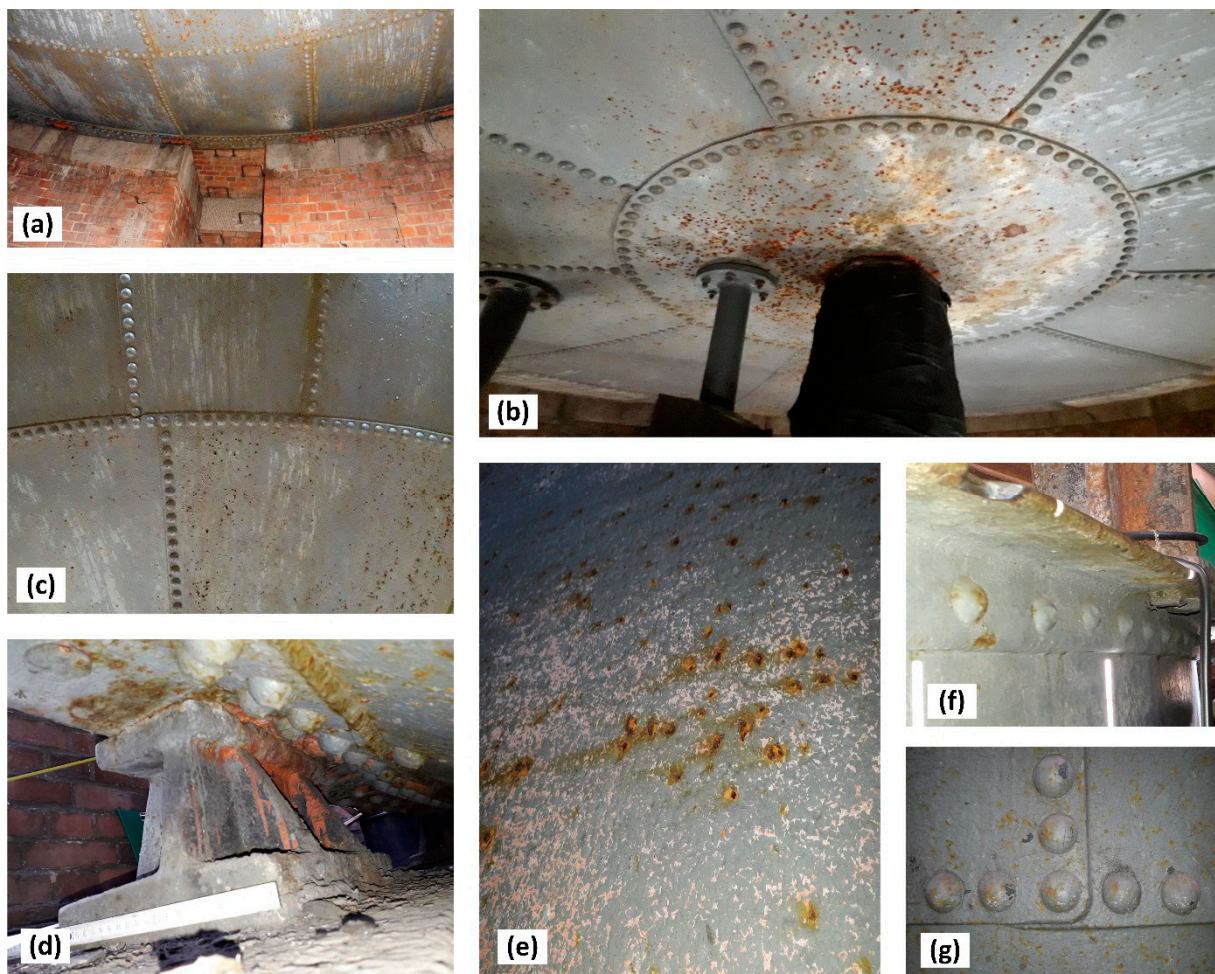
Figure 4. Condition of the outside surface of the sheet steel of the tank: (a–c) the tank bottom, (d) tank support, (e–g) tank wall.

The corrosion was found to be electrochemical in character and evenly distributed, but with local pitting corrosion up to a depth of 1.0–1.5 mm. The highest corrosion losses in the steel sheet of the cylindrical sides of the tank did not exceed 2.5 mm, whereas in the steel sheets of the spherical bottom they did not exceed 1.0 mm, taking into account also localised corrosion pits. The bottom of the tank was almost always covered with a layer of water, as the tank was very rarely emptied completely, hence the corrosion rate of the bottom steel was almost always low. The steel sheets of the tank shell were exposed to atmospheric corrosion on a daily basis. This was because when the water level in the tank fell during the day, so the shell remained covered with a thin layer of water, which together with the substances dissolved in it formed an electrolyte. Every night the tank was filled completely with water.

Features of atmospheric corrosion of the tank bottom and tank shell were found on the external side of the riveted tank (Figure 4). Localised flaking of the anticorrosive paint coating and localised corrosion pits are visible, but their intensity is not high.

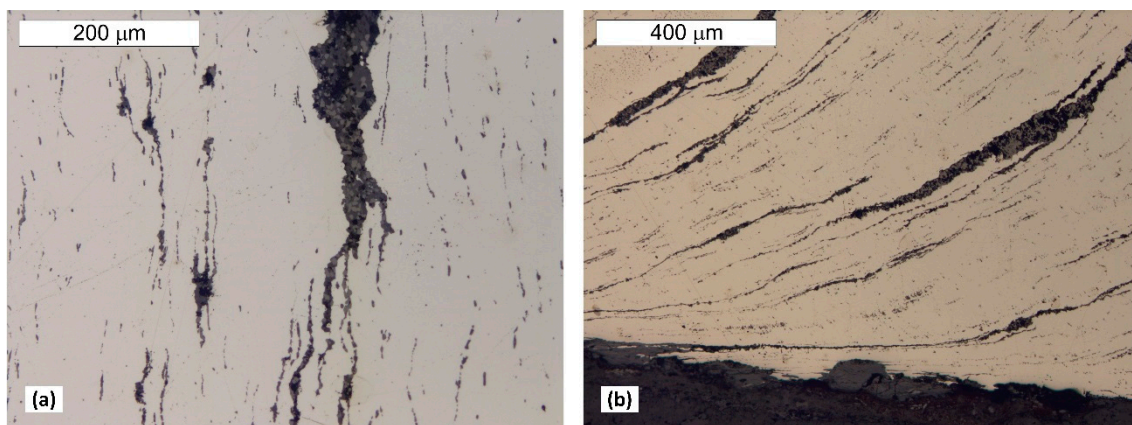
Figure 7. Longitudinal cross-section (a) and lateral (b) samples P1 taken from the tank wall. Numerous banded impurities and heterogeneity indicating their complex structure. Light microscope, non-etched state.

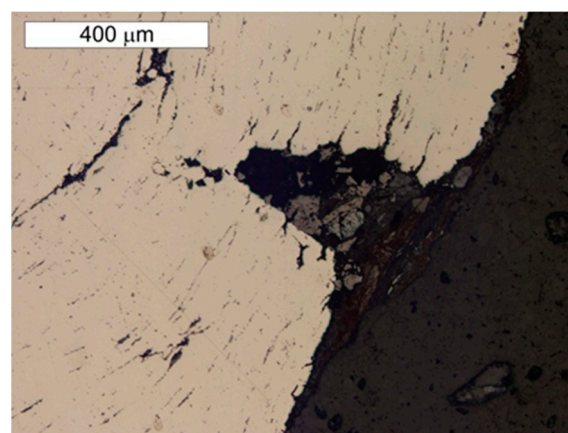
Material tests were carried out after long-term exposure. Samples for testing were taken in locations indicated in Figure 6. Microscope analysis indicated the presence of significant amounts of slag impurities in the material microstructure of the angle section tested (different in size and morphology), which is a characteristic feature of old weldable steels (Figures 7 and 8). The chemical composition of the steel is conducive to the formation of precipitations composed mainly of phosphorus and sulphur. However, oxide inclusions are also common in these materials [7]. Slag inclusions are distributed in bands, longitudinally to the direction of metal forming. The transversal cross-section provided a visible orientation of the microstructure in the direction of plastic deformation, resulting most probably from the shaping of the tank shell edges. A corrosion products layer is visible on the surface. They locally penetrate deep into the material of the tank wall (Figure 8).

The microstructure present in the material will favour the formation of surface delamination caused by the corrosion processes. Such delamination was also observed by Panasyuk et al. [5] in the microscope image.

Figure 8. Transversal cross section of sample P1 taken from the tank wall. Numerous banded slag impurities are visible. A layer of corrosion products is visible on the surface, penetrating into the wall material interior at specific locations. Light microscope, non-etched state.

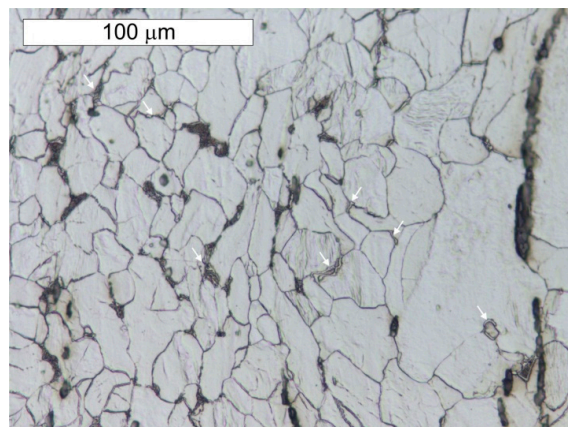
Figure 9. Longitudinal section of sample P1 taken from the tank wall. Tertiary cementite and degenerated perlite formed as a result of material degradation are marked with arrows. Light microscope, etched state.

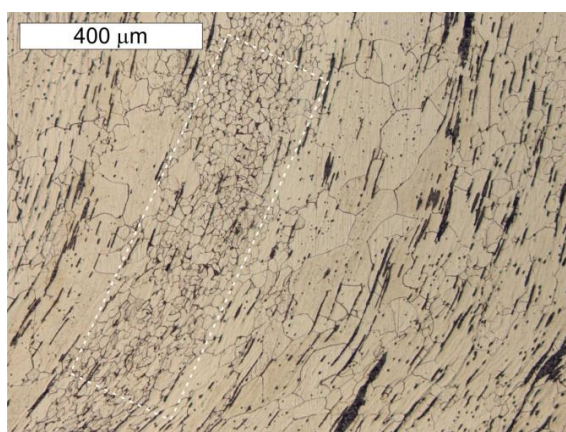
Figure 10. Cross section of sample P1 taken from the tank wall. Numerous bands of slag impurities are visible. The ferritic microstructure predominates with heterogeneous grain with localized areas of ferritic-perlite microstructure (frame). Light microscope, etched state.

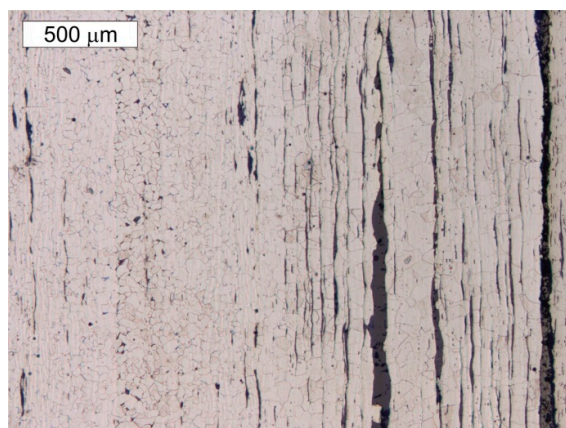
Figure 11. Longitudinal cross-section of the P2 sample taken from the angled section of the tank band. Ferritic microstructure with few perlite grains. Numerous bands of slag impurities are visible. Light microscope, etched state.

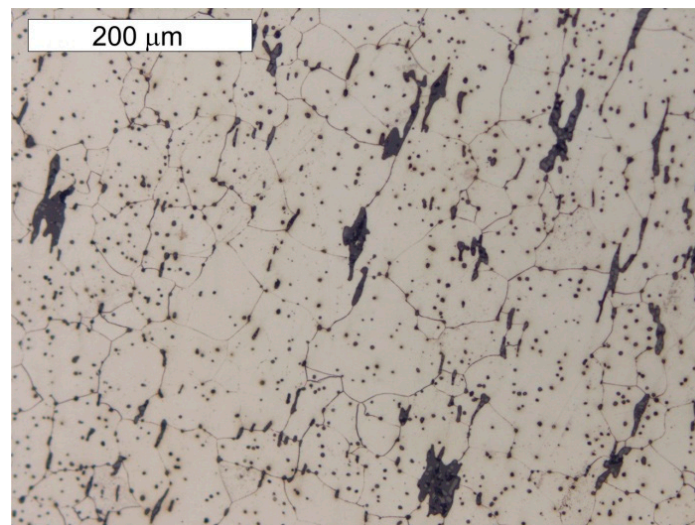
Figure 12. Lateral cross-section of sample P2 taken from the angle section of the tank band. High degree of slag impurities is visible in the area of the ferritic microstructure. Light microscope, etched state.

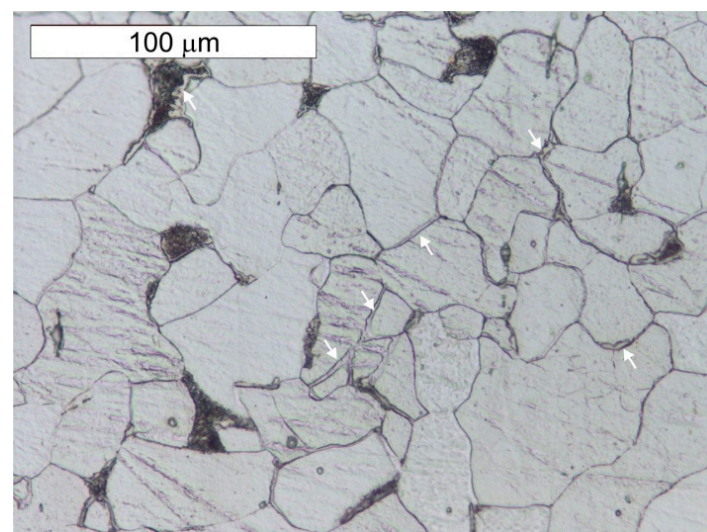
195.1 ± 14.8 HV1 and 132.9 ± 4.4 HV1, respectively. Similarly to in the case of the P1 sample, numerous precipitations of tertiary cementite were observed at the grain boundaries of ferrite and degenerated perlite, which are associated with the long-term degenerative processes occurring in these types of steel (Figure 13).

Figure 13. Longitudinal cross-section of the P2 sample taken from the angle section of the tank band. Tertiary cementite and degenerated perlite formed as a result of material degradation are marked with arrows. Light microscope, etched state.

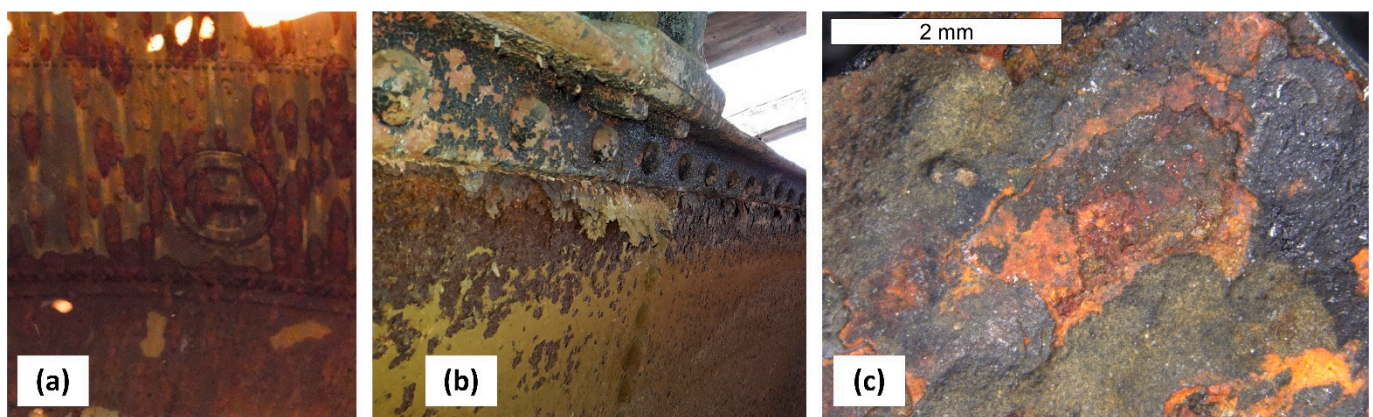
Microbiologically Influenced Corrosion (MIC) may occur in water tanks, the course and effects of which are described in various papers, among others [18,19]. Aside from a significant amount of oxygen associated with the formation of iron oxides and high lead content, the EDS microanalyses of the corrosion products inside the tank also detected small amounts (1–3%) of zinc (Zn), calcium (Ca), silicon (Si) and aluminium (Al). A similar origin related to anticorrosion protection as in the case of lead can be attributed to zinc and aluminium observed in the EDS spectrum. No significant sulphur content was found in these products. This suggests that the corrosion is unlikely to be caused by biofilm induced by sulphate-reducing bacteria (SRB) (Figure 14).

Figure 14. Corrosion products taken from the tank wall: (a) tank walls at the inspection deck, (b) top edge of tank wall, (c) corrosion area in the stereoscopic image.

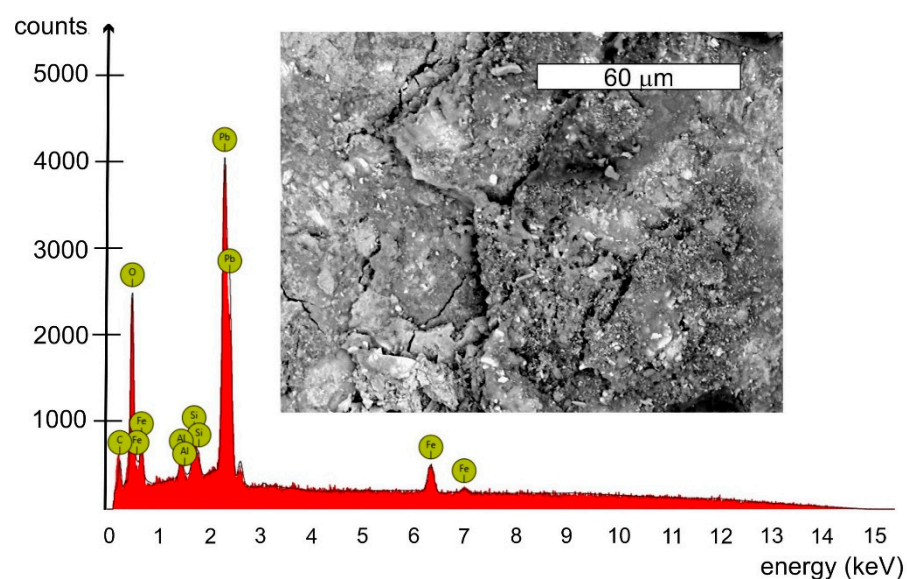
Figure 15. Example of EDS spectrum obtained for the area shown in the microscope image.

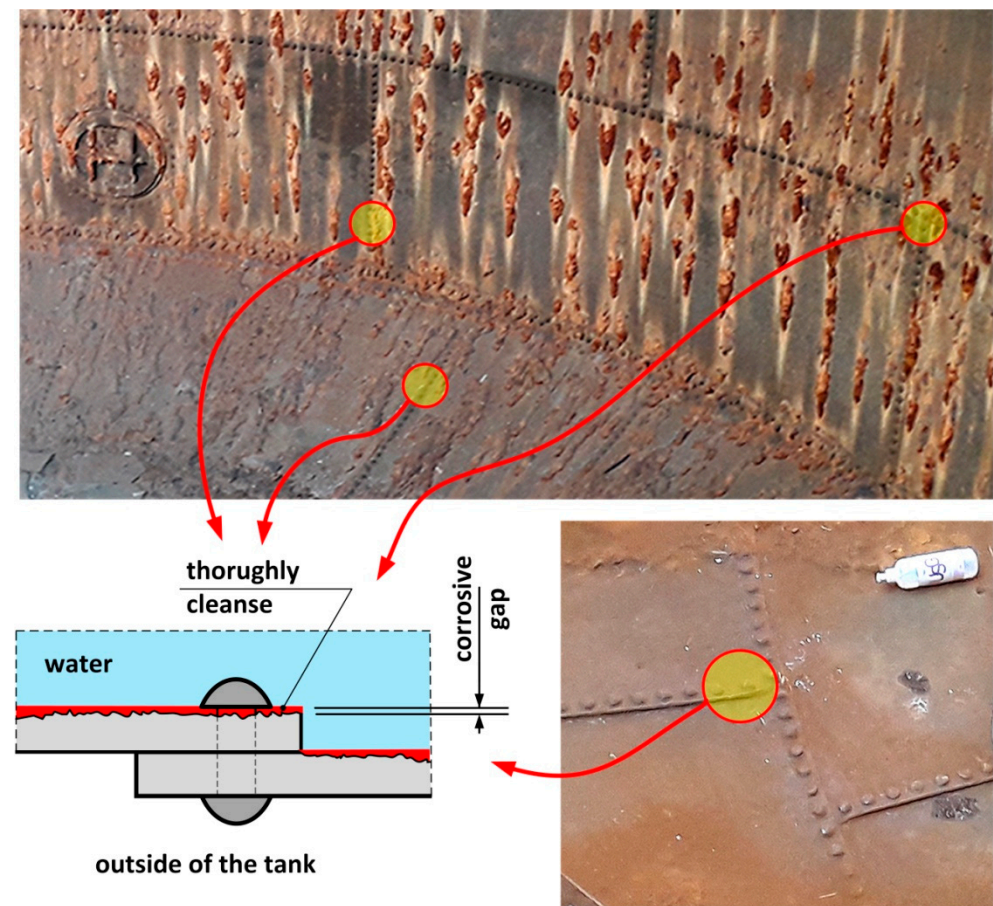
Figure 16. Possible case of corrosion of sheets beneath the rivets.
