Assessment of Destructive Impact of Different Factors on Concrete Structures Durability

Janusz R. Krentowski

Assessment of Destructive Impact of Different Factors on Concrete Structures Durability. *Materials* **2022**, *15*, 225. <https://doi.org/10.3390/ma15010225>

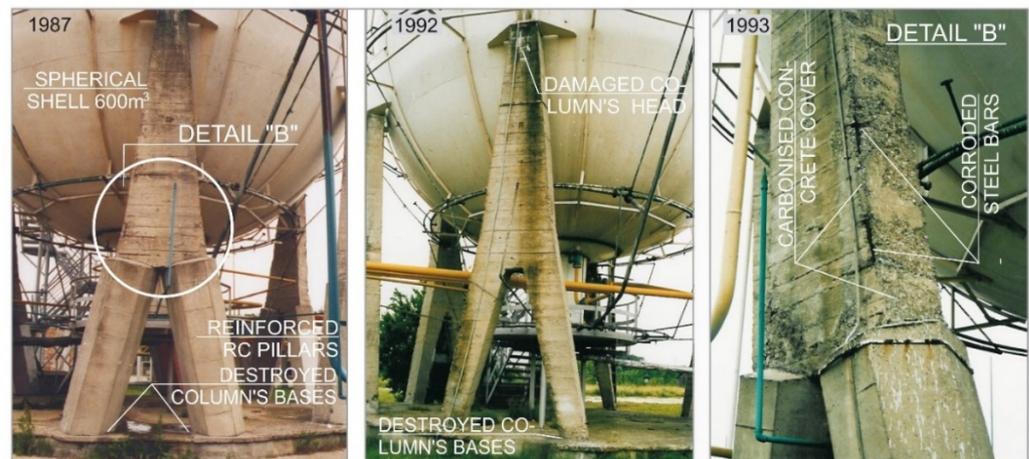
During the operation of the carbonized elements, the corrosion products increased in volume and generated tensile stresses and, consequently, concrete scratches and loosening of the cover fragments. The damage, which facilitated the access of aggressive factors from the environment, intensified the corrosion processes, while the corrosion losses reduced the load-bearing capacity of reinforced-concrete elements (Figure 2).

Figure 2. Structural faults of support structures of tanks with a capacity of 600 m³.

Degraded supporting structures posed a threat to the safety of the tanks. The inclination of the supporting structure of the tank with a capacity of 600 m³ at an angle of 6° was the main reason for the weakening of the lower zones of the columns. Incorrectly implemented support zones for the tanks on the column heads did not ensure the correct transfer of the acting loads to the supporting elements.

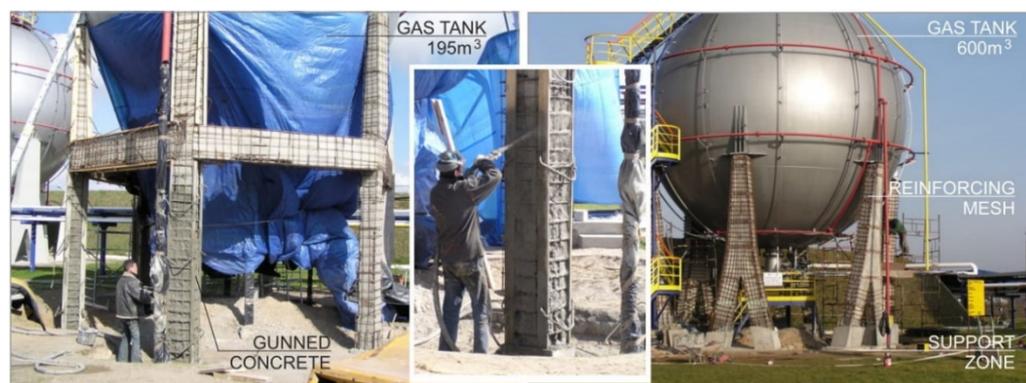
Figure 3. Details of the implemented tank-reinforcement structure.

As a result, the existing carbonated concrete substances and exposed reinforcement bars were secured and monolithized (Figure 3). After the shotcrete was made, a monolithic, rigid reinforced-concrete structure was obtained, which also took over bending moments resulting from the leaning of the columns [24]. The final stage of the strengthening works was to protect the connection zones of the support brackets of the steel spherical tanks and the surface of the column heads against mutual displacement in the event of exceptional loads.

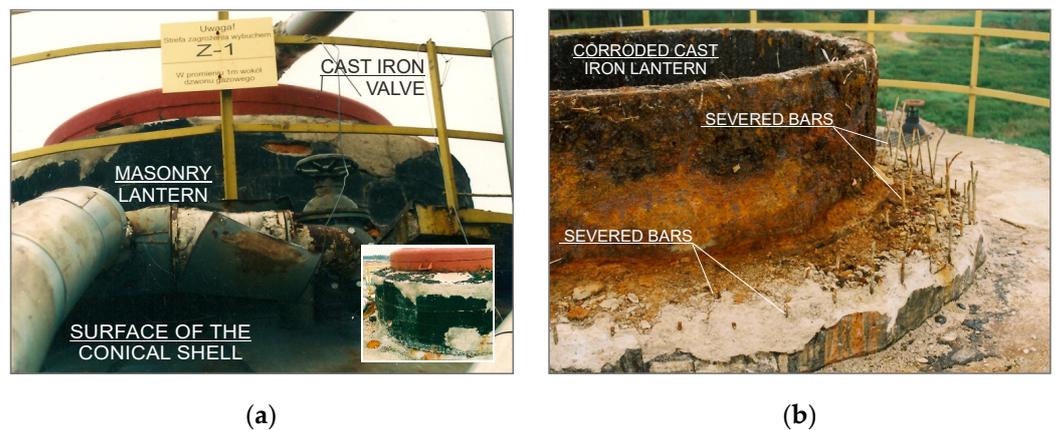
The durability of the fermentation chambers is reduced by natural destruction processes. Damage caused by a reduction in the strength parameters of the materials used, short-term exposure to exceptional loads, or an unsignaled change in the static pattern of the structure of the building is significant. Natural wear and tear of materials operated for over 30 years in an aggressive environment, uncontrolled and unidentified at the stage of periodic tests, as well as improperly conducted verification of current material parameters, may generate errors in the assessment of the stage of structural damage, e.g., in terms of the impact of exceptional loads. The above-mentioned factors were the most common causes of the analyzed disasters. The state of the threat was usually intensified by the fact that sewage treatment plants are implemented in the form of a battery of several fermentation chambers cooperating with each other.

Figure 4. Degraded zones of fermentation chamber roofing shell: (a) before explosion; (b) after explosion.

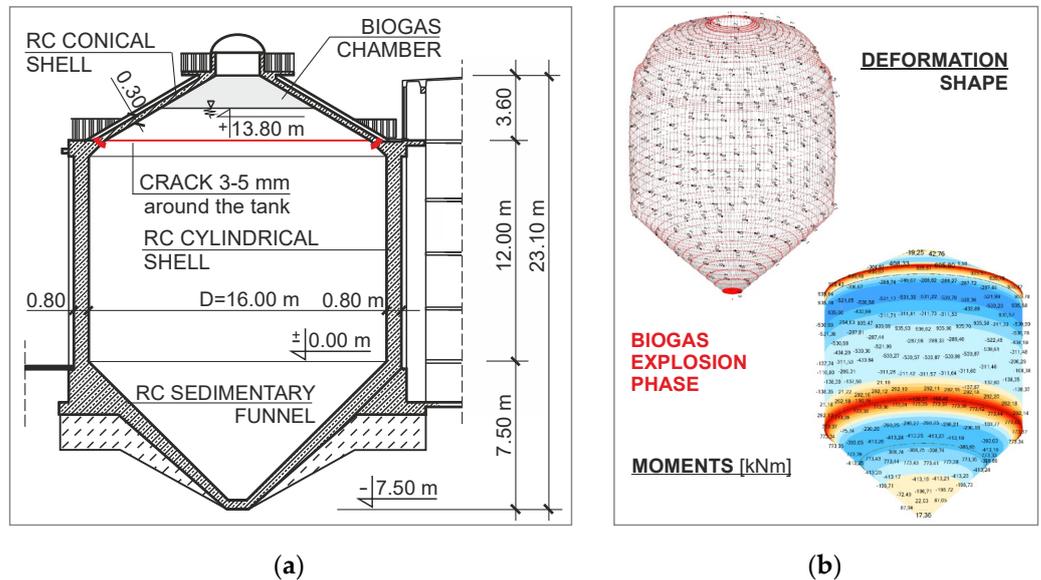
Figure 5. Digestive sewage tank: (a) cross section; (b) shape deformation and bending moments resulting from the explosion.

The results of numerical calculations verifying the post-disaster stage, which took into account the change in the static scheme, made it possible to determine the actual state of stresses and deformations in the concrete structure. The exceeding of both the ultimate and serviceability limit conditions justified the occurrence of cracks in the monolithic wall structure and the tank cover.

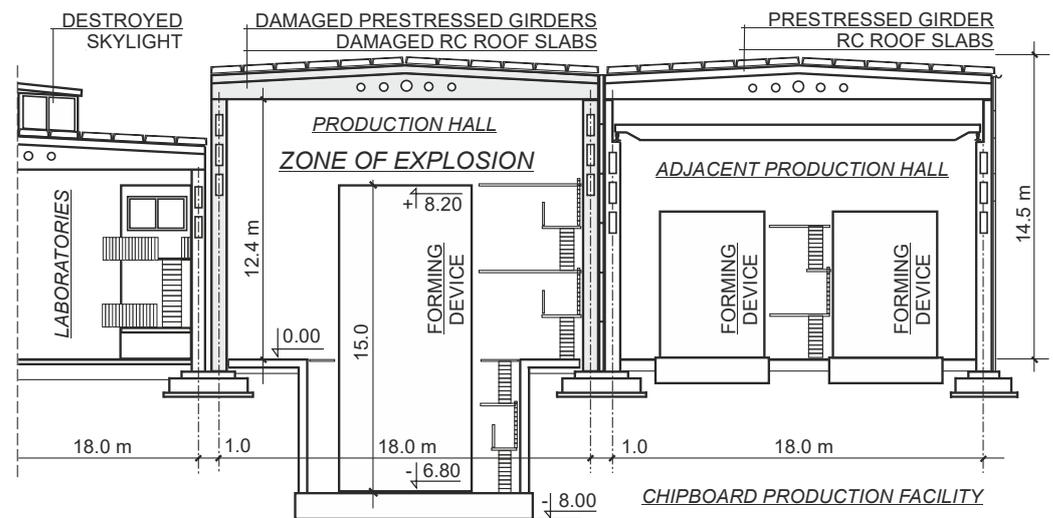
The explosion of technological devices used in wood processing initiated a construction disaster of a prefabricated hall with a reinforced-concrete structure (Figure 6). The facility, consisting of several buildings, was commissioned in the 1980s. As a result of the shock wave, high fire temperature, and then cooling and thermal shock resulting from the extinguishing action, concrete in the structural elements lost its elastic properties. This could have led to the spread of the disaster and the total collapse of the hall. The greatest threat was the loss of adhesion of the prestressing tendons to the concrete, the weakened strength of which could not be classified [30,31]. As a result of the propagation of the shock wave pressure after the explosion, there was damage to brick walls made of autoclaved aerated concrete (AAC) blocks in rooms located in adjacent aisles, separated from each other by fire barriers [32].

Figure 6. Cross-section of the damaged production hall.

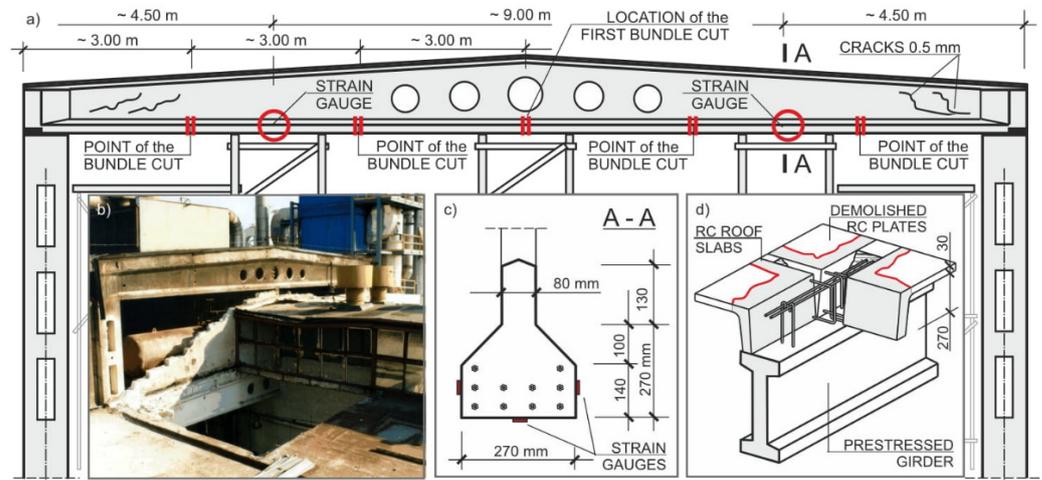
After the analysis of all the collected information, it was found that two more explosions occurred in the production hall. The first was caused by the spontaneous combustion of a mixture of wood dust and air supplied to the technological machine with a sharp increase in pressure inside it. The accelerator of the reaction was vapor of formaldehyde resin, which was used in the production of the plates. The self-ignition flame ignited the wood dust accumulated in the hall and triggered a secondary explosion that damaged the structure of the prefabricated reinforced-concrete walls and roof of the building.

Figure 7. Production hall of wooden chipboards: (a) cross section; (b) degradation after explosion; (c) strain gauges' locations, (d) RC plate demolition.

As a result of the tests and calculations carried out, it was found that the implementation of the reinforcements taking over the weight of the damaged prestressed girders was not effective. The girders were qualified for dismantling (Figure 7). The works commenced with the dismantling of the damaged and deformed roof plates. The layers of concrete overlay and the upper surfaces of the roof plates were opened and removed, the reinforcement meshes were cut out, and the previously supported ribs of the plates were dismantled. Subsequently, the prestressing strands in the chords of the lower girders were cut. The supported and stabilized girders were disassembled in batches, breaking up the concrete from the central zone towards the supports. Due to the hazardous condition of the structure of the facility, the disassembly of prestressed elements was carried out under the constant supervision of authorized technical personnel. Ongoing geodetic "monitoring" of the deformation state of the building's elements was also carried out. At the same time, during the process of cutting the tensioning tendons, a control process was carried out with the use of a set of strain gauges. Their indications after cutting the fibers were

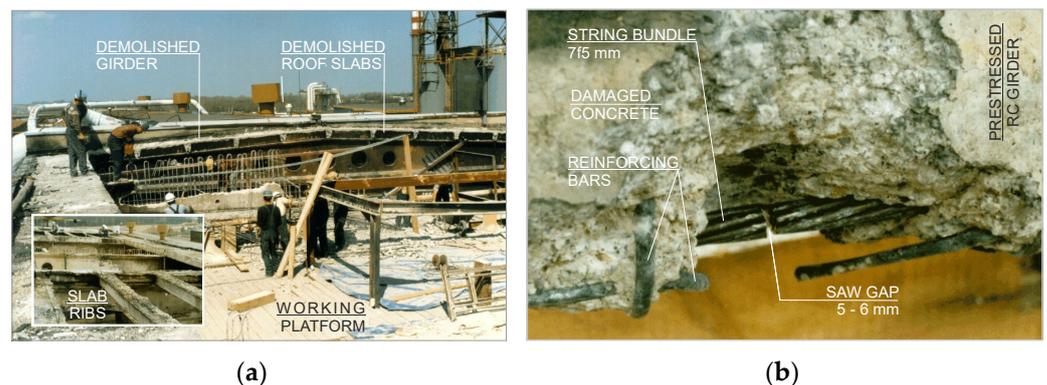
Figure 8. Demolition works of prestressed girders: (a) view of the working platform; (b) string cutting.

stable, which confirmed the fact that the tendons had sufficient adhesion to the cover layer, despite a drastic decrease in the concrete strength of the prestressed girders. The conducted demolition works are shown in Figure 8.

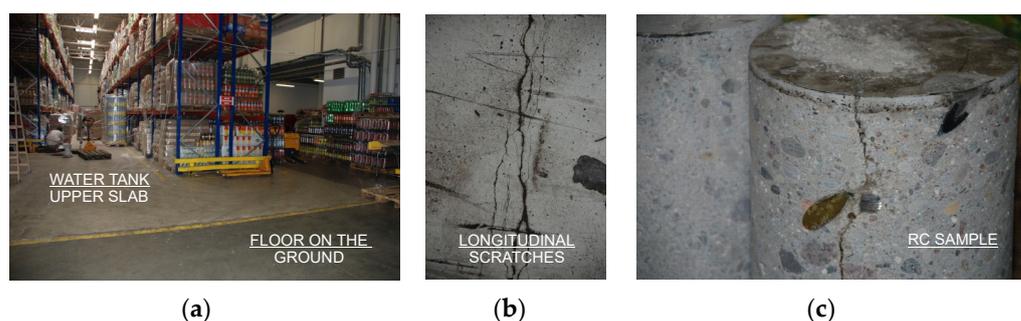
As a result of the visual tests, the presence of irregular scratches of the floor, located along the direction of the main reinforcement of the slab, was confirmed. Cracks with a width of 0.5–2.5 mm were located at intervals of 1.2–2.0 m (Figure 9). The concentration of defects occurred along the central longitudinal wall and in other communication spaces that were exposed to the load, with the presence of goods trolleys varying over time. Detailed research confirmed the hypothesis of the occurrence of scratches and cracks also on the lower surface of the tank plate.

Figure 9. Shopping center warehouse: (a) slab-loading racks; (b) cracking of the top plate; (c) RC samples.

It was found that the flaws in the design of the distribution bars of the tank top plate reinforcement stimulated the failure condition of the structure loaded with the environmental temperature load through roof skylights, which was not taken into account at the design stage. The slab's cross-section was classified as concrete, as the used reinforcement bars had a cross-section area smaller than required by the standards. The load-bearing capacity of the unreinforced-concrete element turned out to be insufficient, which resulted in the destruction of the concrete structure due to bending moments and the formation of cracks in the slab along a direction parallel to the direction of the main reinforcement.

On the basis of the tests and identification of the deformation process, it was found that the upper plate did not lose its elastic properties despite significant damage. The consequence of the research work was the development of the concept of the reinforcing structure, and then the commencement of the reinforcement implementation after emptying two of the four compartments of the tank at the same time. Thanks to this technology, the facility still had a water reserve in case of fire. During the works, the commercial facility was in operation. The reinforced-concrete monolithic structure was made of C35/45 concrete, in the form of a four-span beam, supported in nests, profiled in the extreme gable walls of the tank and on square-section columns. The girders were connected with the upper plate of the tank with an individually designed structure of round spindles, reducing the mutual displacement of the separate plate strips.
