# Failure Analysis of a C-276 Alloy Pipe in a Controlled Decomposition Reactor

**Abstract:** Failure analysis was carried out on a ruptured C-276 pipe heated externally at 1050 °C, which had been used for a few months in a controlled decomposition reactor (CDR) system. To catch the decomposed perfluorinated compounds (PFCs, e.g., CF<sub>4</sub>, SF<sub>6</sub>, NF<sub>3</sub>, C<sub>3</sub>F<sub>8</sub> and C<sub>4</sub>F<sub>8</sub>) present in the exhaust gas, the C-276 reactor was periodically purged with water mist, which caused a temperature gradient from the external to the inner surface of the pipe. The precipitation of large amounts of intermetallic compounds along the grain boundaries were found to be corroded preferentially. The internal surface of the used pipe was covered with many fine cracks. The corrosion and cracking of grain boundary precipitates accounted for the short service life of the C-276 pipe. Compositional measurements by electron probe micro-analyzer (EPMA) and phase identification by electron backscatter diffraction (EBSD) confirmed the presence of  $\delta$  and  $\mu$  phases in the ruptured pipe. The coarse intergranular precipitates were the  $\delt

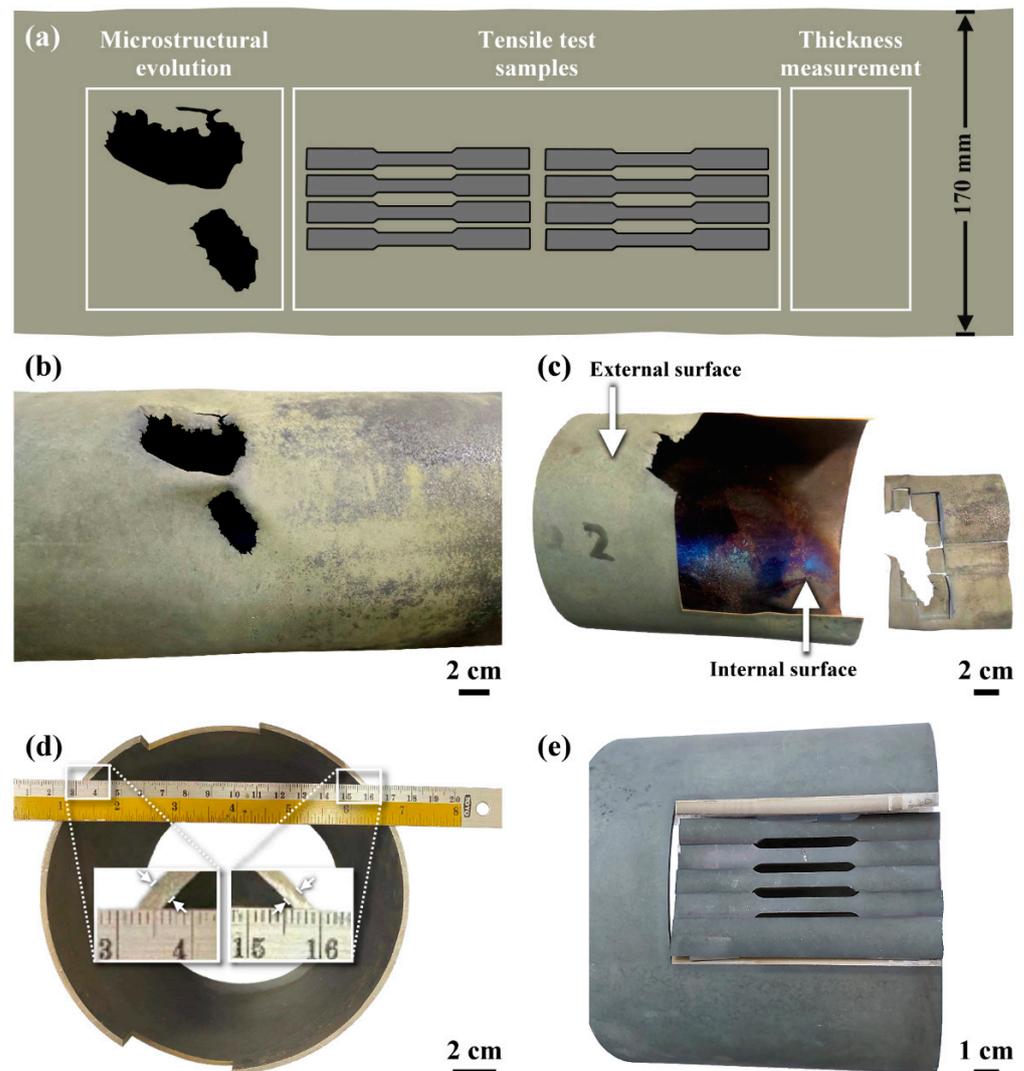
Figure 1 shows the schematic diagram of the investigated samples cut from the ruptured C-276 pipe and the macro-view of various samples. The C-276 pipe had failed in a much shorter time than the expected service life. As mentioned previously, the C-276 pipe was constructed by plasma-arc welding of the rolled plate in the keyhole mode. The fusion zone and heat-affected zone are known to be the weak sites of the C-276 weld [14–16]. To prevent the premature failure of the pipe, the weld metal was installed on the low temperature side of the CDR system. By contrast, the C-276 pipe without the weld seam was located on the high temperature side, which was heated by an external heater to a constant 1050 °C. The inlet exhaust gas containing  $\text{NF}_3$ ,  $\text{NH}_3$ ,  $\text{SiH}_4$ ,  $\text{SiO}_2$  was decomposed in the pipe at elevated temperature and pressure lower than atmospheric pressure. To catch the decomposed harmful species, the pipe was purged periodically with water mist, which caused a temperature gradient from the external to the inner surface of the pipe. It was expected that  $\text{HNO}_3$  and  $\text{HF}$  would be the reaction products of the decomposed exhausted gas. Thus, the inner side of the pipe would be corroded severely by the reaction products of the decomposed exhausted gas.

**Figure 1.** (a) Schematic diagram showing the investigated samples cut from the ruptured pipe, (b) the macro-appearance of the ruptured C-276 pipe with the caved-in holes on the pipe, (c) the samples sectioned by wire-cutting for microstructural examination, (d) the uneven thickness of the ruptured pipe, (e) the tensile samples cut from the failed pipe.

As shown in Figure 1b,c, the macro-appearance of the ruptured C-276 pipe showed that the pipe caved in and cracked because the reactor was operating under low pressure relative to the external atmosphere. The color of the external and internal surfaces of the ruptured pipe was dark green and dark gray, respectively. The colors of the products formed on the external and inner surfaces of the ruptured pipe could also be used to identify the specific species on the surfaces. It was observed that the edges of the holes of the C-276 pipe had been etched to less than 0.5 mm thickness. Moreover, many fine cracks around the hole extended into the surrounding substrate. It was noticed that the inner side of the C-276 pipe was etched much more obviously than the outer side of the pipe. The uneven temperature distribution around the pipe also led to a non-uniform reduction in thickness (Figure 1d). Besides, the external surface being heated to 1050 °C and water mist sprayed into the pipe contributed to high temperature oxidation of the pipe, particularly that of the external surface. Under such circumstances, the C-276 pipe was experiencing very harsh conditions.

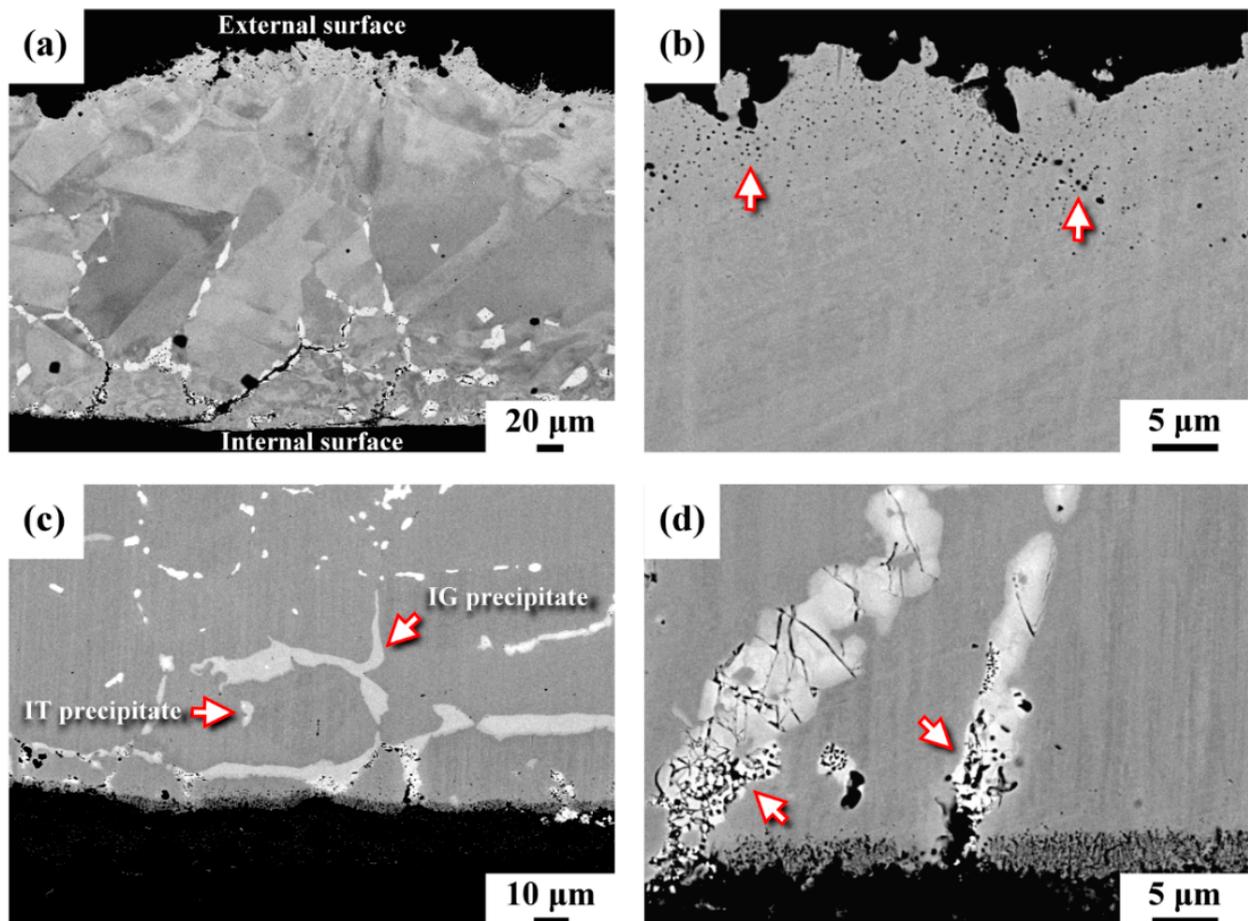
Figure 2 presents the microstructures of the ruptured pipe in cross-sectional view. It was noticed that the thickness of the pipe near the rupture had been thinned to less than 300 µm, as shown in Figure 2a. The external surface in the irregular profile was covered by thin scales. At higher magnification, many fine pinholes, indicated by the arrows, were found just beneath the outer surface (Figure 2b). Surface scales cracked and detached from the outer surface of the pipe during service. Moreover, no precipitates were found in the region near the external surface of the pipe, as shown in Figure 2a,b. In contrast, numerous

precipitates in the back scattered electron (BSE) image were observed on the inner side of the pipe (Figure 2c). Overall, the intergranular (IG) precipitates were much coarser and greater in amount than the intragranular (IT) precipitates. It was noticed that two kinds of precipitates in gray and bright images were present in the investigated samples (Figure 2c). The results also indicated that the IG precipitates were corroded preferentially (as indicated by the arrow in Figure 2d), resulting in the formation of fine pores within the coarse precipitates. The temperature gradient between the outer and inner regions of the pipe inevitably induced thermal stress, which was responsible for severe cracking of the IG precipitates (Figure 2d). Moreover, the reaction products of decomposed perfluorinated compounds and oxidizing environment in the pipe led to an extensive, severe corrosion attack of the matrix, which resulted in forming an etched porous layer on the inner surface of the pipe (Figure 2d). It was deduced that thermal stress assisted the cracking of the grain boundary precipitates. Furthermore, the coalescence of micro-pores into micro-cracks and the linkage of micro-cracks resulted in the fast crack growth along the grain boundaries of the pipe. Furthermore, the combination of thermal stress and the corrosion attack caused spalling of the corroded segments, which was responsible for the rapid thinning in the wall of the C-276 pipe.

**Figure 2.** The microstructures of the samples cut from the ruptured pipe in the cross-sectional view: (a) the thinned sample beside the rupture, (b) the microstructure around the external surface, (c) the microstructure around the inner surface, (d) the etched inner surface and the cracking of coarse precipitates.

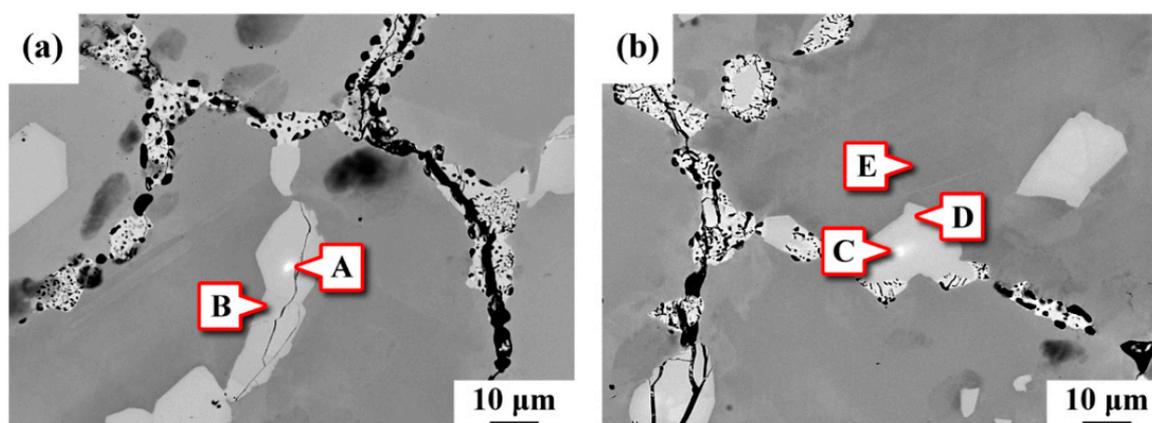
Figure 3 shows the SEM morphologies of the precipitates present in the C-276 pipe in BSE images and the corresponding chemical compositions determined by EPMA at the specific sites are listed in Table 2. The main elements (in wt.%) of the substrate were

16.2 Cr, 15.7 Mo, 3.2 W, 6.7 Fe and the balance Ni. The results indicated that the IT and IG precipitates were all rich in Mo (sites A–D). It was noted that two kinds of precipitates distinguished by the brightness in the BSE images were present in the samples. Some bright spots (sites A and C) were embedded in the coarse precipitates (gray). As listed in Table 2, it was obvious that the bright fine particles were highly enriched in Mo and W but lean in Cr, relative to the substrate. Compared with the W-rich precipitates, the coarse precipitates were rich in Cr (sites B and D). It was deduced that at least two different kinds of precipitates were present in the ruptured pipe. Overall, the C and O contents in the detected precipitates were very low. It was obvious that the IT and IG precipitates were not alloy carbides. It was also deduced that the precipitates in the ruptured pipe were most likely intermetallic compounds. The accumulation of Cr, Mo and W in the precipitates dispersed intergranularly and intragranularly might have contributed to the formation of an alloy-deficient zone adjacent to the precipitates. The chemical compositions of site E near the precipitates contained an obviously low amount of Mo and W, which implied the diffusion of Mo and W to the precipitates.

**Figure 3.** The SEM-BSE photos showing the precipitates in the C-276 pipe and the corresponding chemical compositions determined by EPMA at the specific sites are listed in Table 2: (a) the intragranular and (b) the intergranular precipitates.

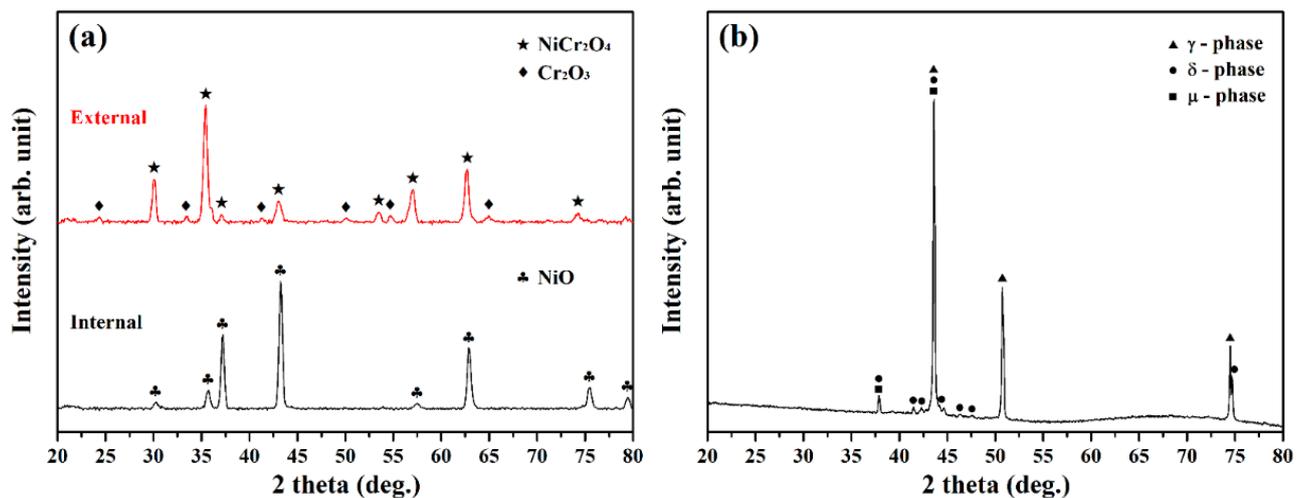
The XRD patterns of the external and inner coverings and the ruptured pipe are displayed in Figure 5. As shown in Figure 5a, the surface covering consisted of  $\text{NiCr}_2\text{O}_4$  mixed with  $\text{Cr}_2\text{O}_3$ , which was consistent with EPMA measurements (site F and G in Figure 4a,b). As shown in Figure 4c, the reactive products on the inner surface of the pipe were composed of two kinds of oxides. The chemical composition of site I in Figure 4c, which was enriched in Ni and O was related to NiO (Figure 5a). Based on the chemical analysis of site J in Figure 4c, it seemed that a Mo-Cr oxide layer had formed beneath the Ni oxide layer. Grinding and polishing were employed to form a flat area, and the XRD spectrum of the substrate of the inner pipe is shown in Figure 5b, revealing that two kinds of precipitates ( $\delta$  and  $\mu$  phases) were present in the  $\gamma$  matrix.

**Figure 5.** XRD patterns of the (a) external and internal surfaces and (b) substrate of the ruptured C-276 pipe.

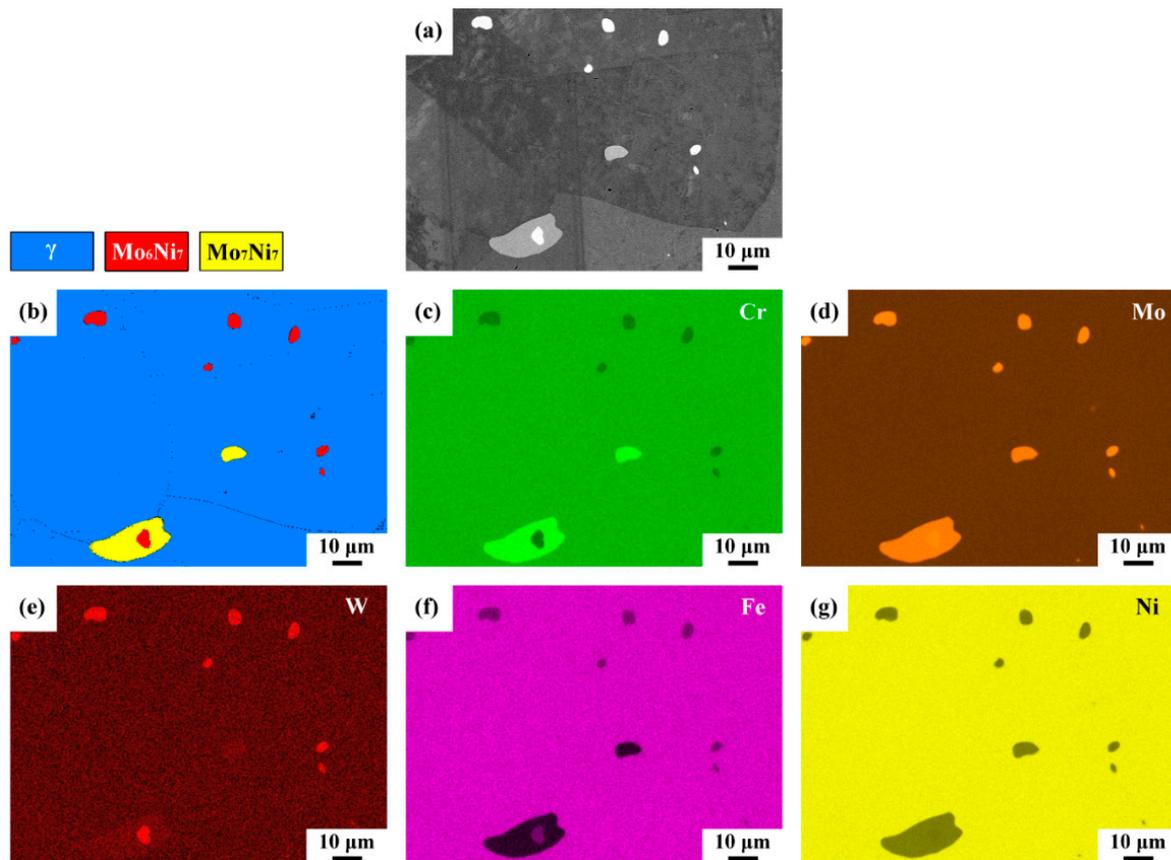
After metallographic preparations, the morphologies of the precipitates in the ruptured pipe were inspected by SEM in BSE mode, as shown in Figure 6a. Moreover, the precipitates in the sample were identified by EBSD phase map (Figure 6b). The distributions of the alloy elements in the examined sample were determined by energy-dispersive X-ray spectroscopy (EDS). Compositional maps (Figure 6c–g) were applied to confirm the EBSD analysis. The SEM-BSE image displays a few fine bright particles dispersed in the  $\gamma$  matrix and bright precipitates embedded in a large gray precipitate at the grain boundary (Figure 6a). The EBSD map confirmed that the fine particles were  $\text{Mo}_6\text{Ni}_7$  ( $\mu$ ) and the large precipitate was  $\text{Mo}_7\text{Ni}_7$  ( $\delta$ ) in the  $\gamma$  matrix (Figure 6b). As listed in Table 2, the  $\mu$  and  $\delta$  phases had similar Mo contents, but the  $\mu$  phase was rich in W and lean in Cr relative to the  $\delta$  phase. The compositional maps showed the differences in alloy concentrations in the  $\mu$ ,  $\delta$  and  $\gamma$  matrix. These maps allowed the elemental distributions to be distinguished but lacked the accuracy of specific site measurement by EPMA. Overall, the maps demonstrated that the precipitates were lean in Fe (Figure 6f) and Ni (Figure 6g) relative to the substrate but enriched in Mo (Figure 6d). Therefore, the EDS mappings and EPMA analysis listed in Table 2 were consistent; the W tended to segregate to the  $\mu$  phase (Figure 6e) but the  $\delta$  contained a higher Cr concentration (Figure 6c).

**Figure 6.** (a) SEM-BSE image and (b) EBSD phase map of the examined sample; (c–g) the compositional maps determined by EDS.

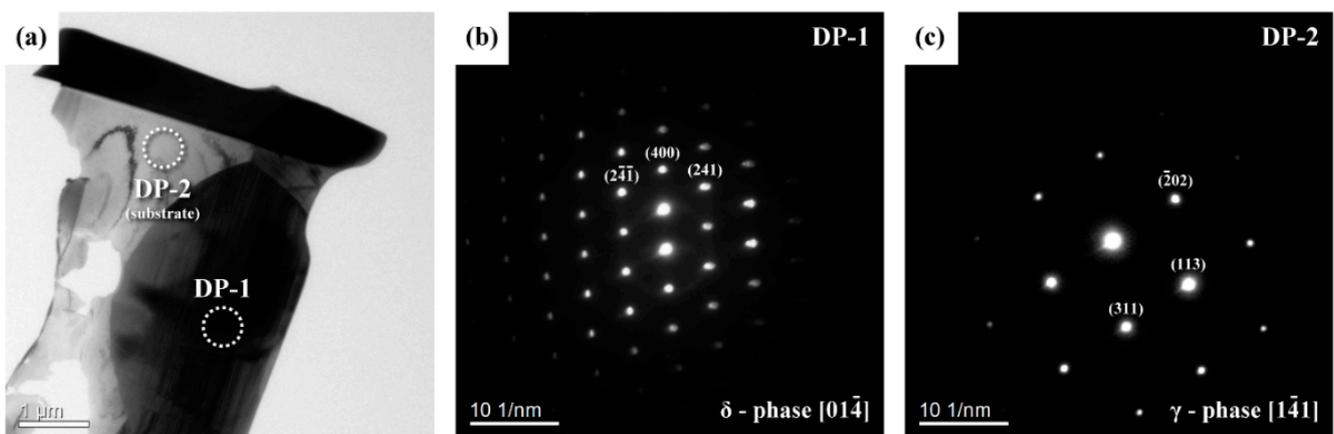
A bright field (BF) TEM micrograph and the selected area diffraction patterns (SADP) of the coarse precipitates at the grain boundaries, which were cut by FIB from the C-276 sample, are shown in Figure 7. SADP (Figure 7b) was used to identify the crystal structure of the precipitate. As reported in prior studies [17–19], the  $\delta$  phase has an orthorhombic structure, and its lattice constants are  $a = b = 0.9108$  nm,  $c = 0.8852$  nm. The calculated lattice constants of the inspected precipitate were  $a = 0.9128$  nm,  $b = 0.9134$  nm, and  $c = 0.8836$  nm, which were very close to the data disclosed in the open literature. Thus, the investigated coarse precipitate in the  $\gamma$  matrix was likely the  $\text{Mo}_3(\text{Mo}_{0.8}\text{Ni}_{0.2})_5\text{Ni}_6$  [19] or  $\text{Mo}_7\text{Ni}_7$  ( $\delta$ ) phase.

**Figure 7.** (a) Bright field TEM image of the FIB sample and the SADP of the (b)  $\delta$ -phase and (c) substrate.

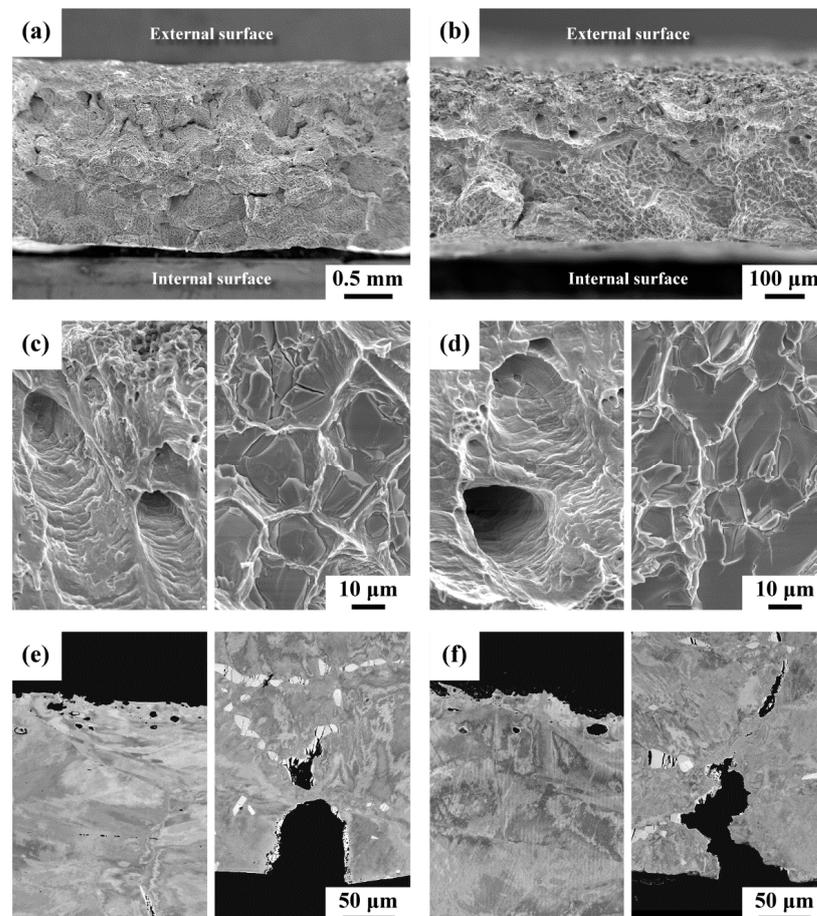
SEM micrographs of typical fracture morphology and microstructure around the outer and inner surfaces of the tensile samples are shown in Figure 8. Despite the thickness of tensile samples, the macro-appearance of the fractured sample displayed secondary crack growth along the coarse grain boundaries (Figure 8a,b). The occurrence of intergranular fractures around the inner surface of the pipe should be associated with numerous precipitates at the grain boundaries. In contrast, many fine pores were very likely found around the outer surface of the fractured pipe. Examining the surface features of the two fractured samples in Figure 8a,b at higher magnifications, tear-shear ruptures with deep holes were seen in the region around the outer surface (left-hand image in Figure 8c,d), which could be attributed to the porous structure around the external surface. Brittle flat facets were observed in the region around the inner surface (right-hand image in Figure 8c,d), which were associated with the separation along the grain boundary precipitates. To correlate the tensile fracture feature with the microstructure around the outer and inner surfaces of the pipe, a few samples were cut from the fractured tensile samples and subjected to metallographic preparations. The microstructure adjacent to the tensile fractured zone of the tested samples is shown in Figure 8e,f. Despite the original sample thickness, fine pores without any precipitates were observed in the outer surface zone (left-hand image in Figure 8e,f). Moreover, crack growth along the grain boundary and cracking of the coarse precipitates were observed in the inner surface region (right-hand image in Figure 8e,f). The higher extent of the etched layer and crack-extension zone in the thinner samples caused a higher degree of degradation in tensile properties than those of the thicker ones.

**Figure 8.** SEM micrographs showing the tensile fracture morphology and microstructure of the (a,c,e) thick sample and (b,d,f) thin sample: (a,b) the macro-fracture appearance; (c,d) the micro-fracture feature; (e,f) the microstructure around the tensile fracture zone. The left-hand image in (c–f) photos from around the outer surface and right-hand image in (c–f) photos from around the inner surface.
