Visual Exploration of the Spatiotemporal Evolution Law of Overburden Failure and Mining-Induced Fractures: A Case Study of the Wangjialing Coal Mine in China

In this article, the borehole television approach is applied on the working face 20105 of the Wangjialing Mine in China to visually detect (1) mining-induced fractures in overburden strata; (2) movement failure of coal seam-overburden stratum-ground surfaces; (3) temporal and spatial evolution of mining-induced fractures, exfoliation, and caving of overburden strata.

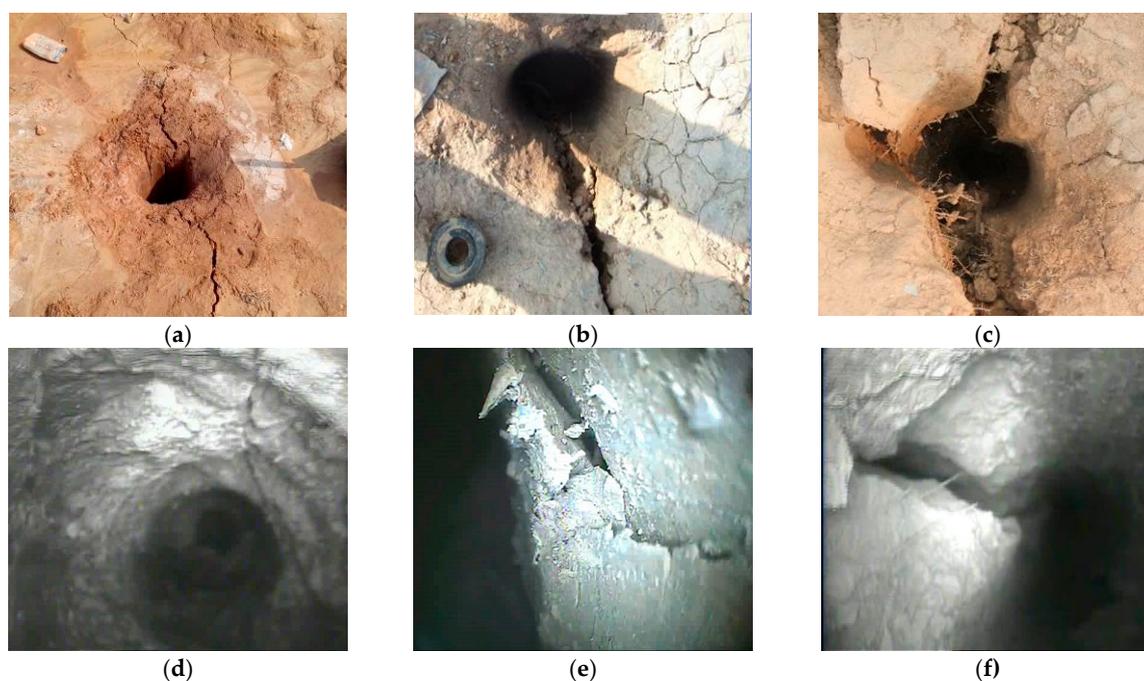
When the working face was 96.7 m away from borehole #1, cracks (Figure 6a) first appeared in the area around borehole #1 and its size increased as the working face moved forward. As a result, the borehole opening was divided in half (Figure 6b). Then, deformation and cracks were observed in the epipedon (Figure 6d), and vertical fractures in the mudstone beneath the epipedon appeared.

When the working face was 29.2 m away from the borehole, the borehole opening deformed and the epipedon deformation was exacerbated with exfoliation of the borehole wall (Figure 6e,f). Meanwhile, vertical fractures appeared on 63–79 m deep bedrocks. Then, the borehole opening deformation (Figure 6c) was exacerbated. The quantity and size of vertical fractures on the bedrocks continuously increased, while horizontal fractures were observed. However, no obvious fractures appeared on bedrocks under 80 m deep.

Figure 6. Observations in borehole #1: (a) crack at the borehole opening; (b) crack propagation; (c) borehole opening deformation; (d) fractures in the loess layer; (e) fracture propagation; (f) exfoliation.

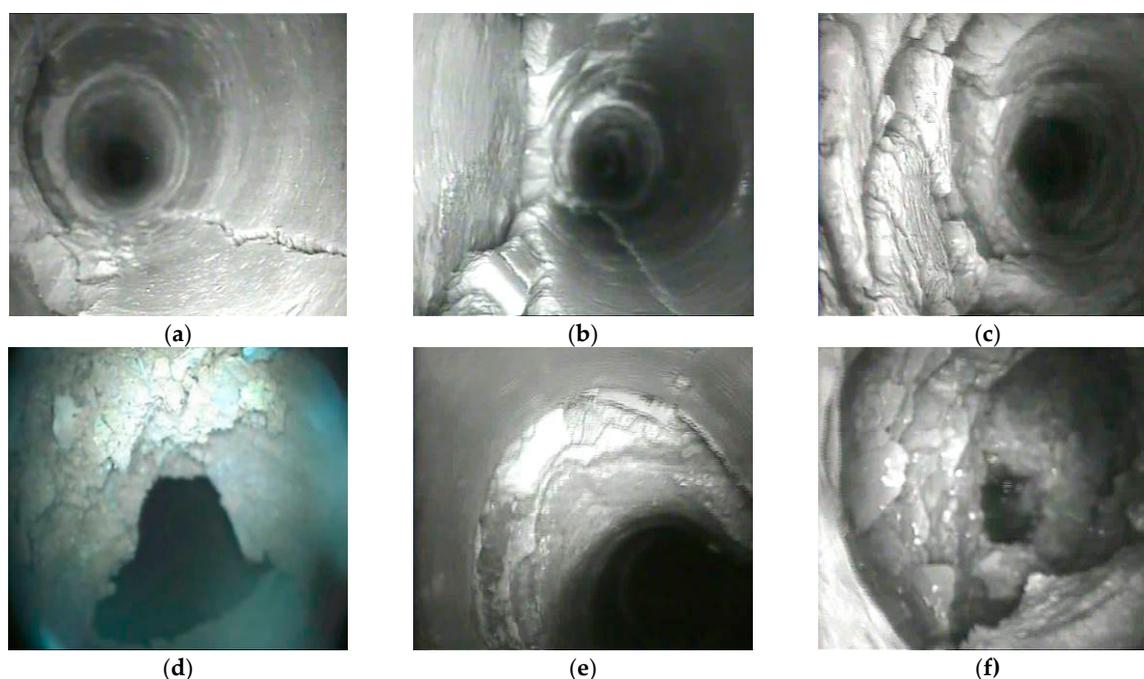
When the working face was 11.9 m away from the borehole, the borehole opening was divided into two parts, with a height difference of 12 cm. Fractures (Figure 7a) were observed in mudstone at depths of 282.3–285.7 m. Shortly after the working face passed the borehole, the loess layer subsided severely above goaf, and the height difference increased to 30 cm. The influence of mining to the fracture propagation in the borehole was significantly increased and the propagation rate of fractures was obviously faster than before.

When the working face was 13.2 m past the borehole, caving of the immediate roof and strata at a depth of 282 m (Figure 7d) was observed. When the working face was 26.5 m past the borehole, failure of the main roof (the first sub key stratum) was observed and the caving height reached 21.6 m. Dislocations (Figure 7e), accompanied by propagation of vertical fractures and irregular fractures (Figure 7b), were observed on strata at depths of 242–261 m, and a bed separation between the second sub key stratum and the sandstone beneath it was observed. And fractures propagated

and severe damages of borehole wall (Figure 7c,f) appeared. When the working face was 42.4 m past the borehole, the second sub key stratum failed. Bed separation, dislocation, and vertical fracture propagation of the stratum above the second sub key stratum were observed. The height of the caving zone increased to 78 m.

Figure 7. Observations in borehole #1: (a) vertical fracture; (b) irregular fracture; (c) damages of borehole wall; (d) strata caving; (e) dislocations; (f) severe damages of borehole wall.

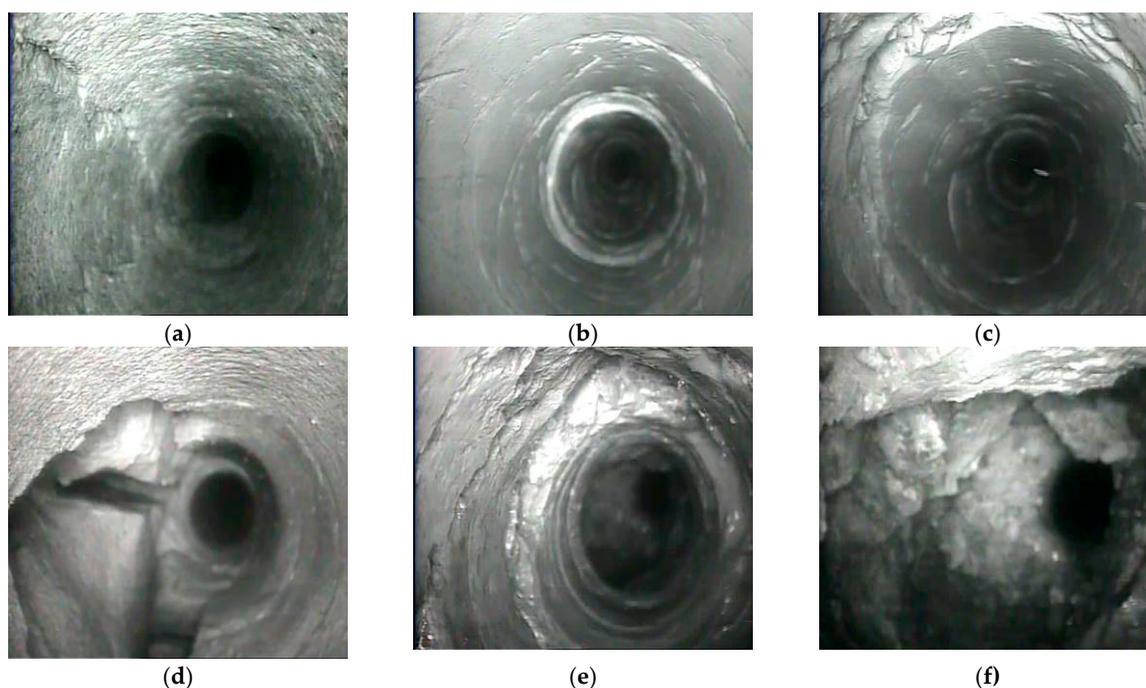
Owing to the delay in movement of the overburden strata, borehole #1' was drilled three months after the working face reached borehole #1. A 50 m seamless steel pipe was inserted to mitigate the influences of severe damages in the loess layer. Discontinuous vertical fractures and partial damages appeared on 60–90 m deep bedrocks, indicating that the tensile strength of the bedrocks was not strong enough to prevent breakage. Most parts of the drill core on 90–160 m deep was undisturbed. Circular fractures were observed on the borehole wall at a depth of 170 m (Figure 8c); the fracture density increased with depth. The results indicated that the fractured zone of Panel #20105 propagated to the fine stone layer at a depth of 173.4 m and a maximum height of 120 m. Drill sticking, accompanied by fractured rock core and wall failure (Figure 8d), was observed in the fine sandstone layer (depth varied from 185.46 m to 200.66 m). Severe dislocations (Figure 8e) were observed in strata at depths between 210 and 220 m. Severe drill sticking and considerable consumption of drilling fluid forced the drilling process to end at a depth of 231 m. The observation results obtained from borehole #1' are shown in Figure 8.

Figure 8. Observations in borehole #1: (a) burial depth of 50–100 m; (b) burial depth of 100–170 m; (c) burial depth of 170–200 m; (d) burial depth of 200–210 m; (e) burial depth of 210–220 m; (f) s burial depth of 220–230 m.

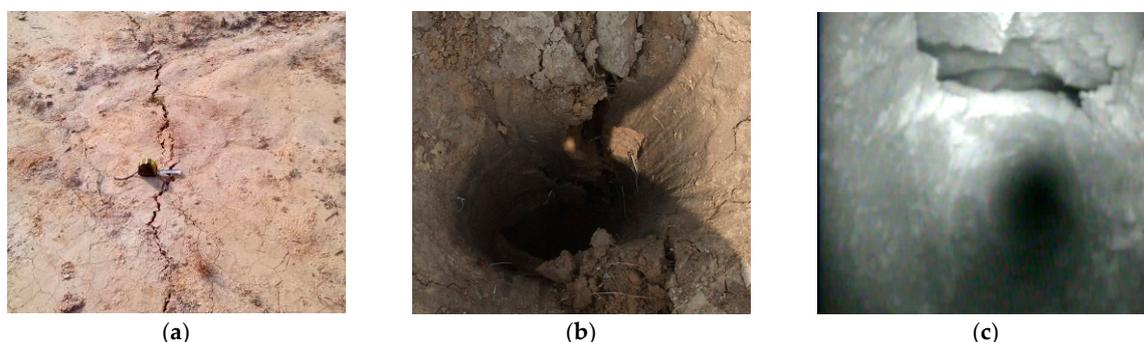
When the working face was 87.5 m away from borehole #2, cracks (Figure 9a) first appeared in the area around borehole #2 and its size and quantity increased as the working face moved forward. Then the epipedon deformation was observed (Figure 9b). Whereafter slight damage appeared near the interface between epipedon and rock. Vertical fractures (width = 1–2 mm) and horizontal fractures appeared at depths of 50–60 m. With the working face advancing, the epipedon deformation was exacerbated with exfoliation of the borehole wall (Figure 9c), and the size of fractures on the bedrocks continuously increased.

Figure 9. Observations in borehole #2: (a) crack near the borehole opening; (b) epipedon deformation; (c) exfoliation of the borehole wall.

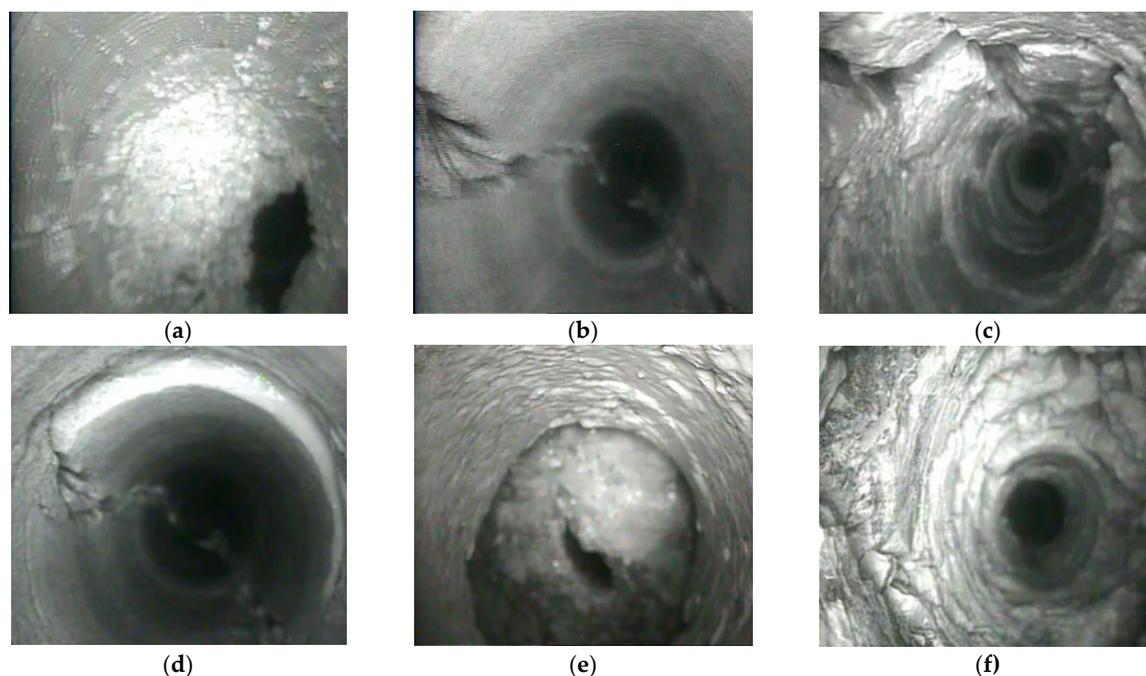
When the working face was 19.0 m away from the borehole, the loess layer subsided above goaf. However, no obvious mining-induced cracks were observed ahead of the working face, indicating that the strength of the main roof was only strong enough to prevent cracking until the longwall face was right under it. After the breakage of the immediate roof and the main roof, the

caving height reached 25.5 m (Figure 10a). Propagation of vertical fractures (Figure 10b) and irregular fractures (Figure 10c) accompanied by dislocations (Figure 10d) were observed, and a bed separation (Figure 10e) between the second sub key stratum and the medium sandstone beneath it was observed. As the working face moved forward, fractures propagated and severe damages of borehole wall (Figure 10f) were observed. When the working face was 56.9 m past the borehole, the second sub key stratum failed. Bed separation, dislocation, and vertical fracture propagation of the stratum above the second sub key stratum were observed. The height of the caving zone increased to 82 m.

Figure 10. Observations in borehole #1: (a) strata caving; (b) vertical fracture; (c) irregular fracture; (d) dislocations ; (e) bed separation; (f) damages of borehole wall.

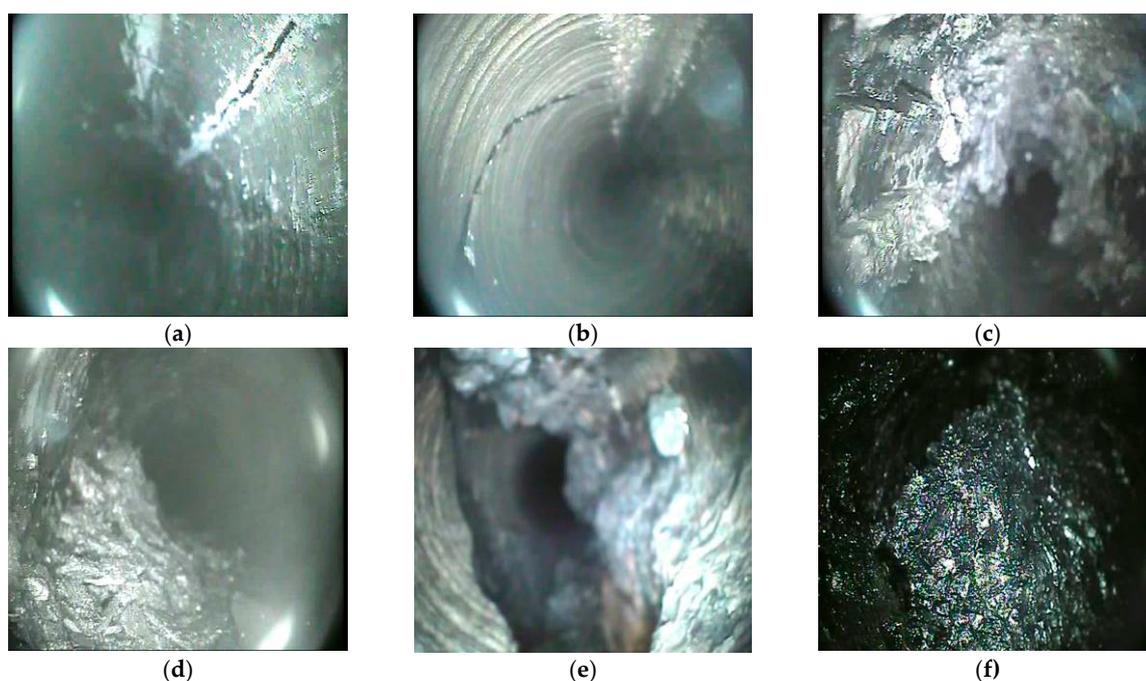
When the working face was 43.5 m away from the borehole opening, axial fractures (length = 3–4 cm, width = 1 mm) first appeared in borehole #3. As the working face moved forward, both density (Figure 11a) and average size of axial fractures increased and local breakage of the coal wall were observed (Figure 11c). When the working face was 19 m away from the borehole opening, the fractures increased up to 20 cm and the height increased to 15–18 m. After that, fracture propagation was significantly accelerated and the maximum fracture exceeded 50 cm. Irregular fractures were observed (Figure 11b), significant wall breakage were observed, and quantity and size of crushed coal in the borehole increased (Figure 11d). Half of the cross section of the borehole

was occupied by crushed coal, indicating that the working face had significant effects from mining activities. Additionally, the fractured zone spread to 20–22 m.

When the working face was 11.1 m away from the borehole opening, severe coal wall damages and considerable crushed coal were observed. The observation borehole was significantly damaged, resulting in severe deformations (Figure 11e). The camera was stuck at the location 1.9 m behind the working face and 14.5 m above the channel roof. Dislocations caused by the roof caving into the goaf were observed on the borehole. The height of the caved zone was 15–18 m. During the six-day idling period, the borehole #3 was blocked by crushed coal (Figure 11f) that was located 20.9 m from the opening.

Figure 11. Observations in borehole #3: (a) axial fractures; (b) irregular fractures; (c) wall breakage; (d) crushed coal; (e) deformations; (f) blocked by crushed coal.

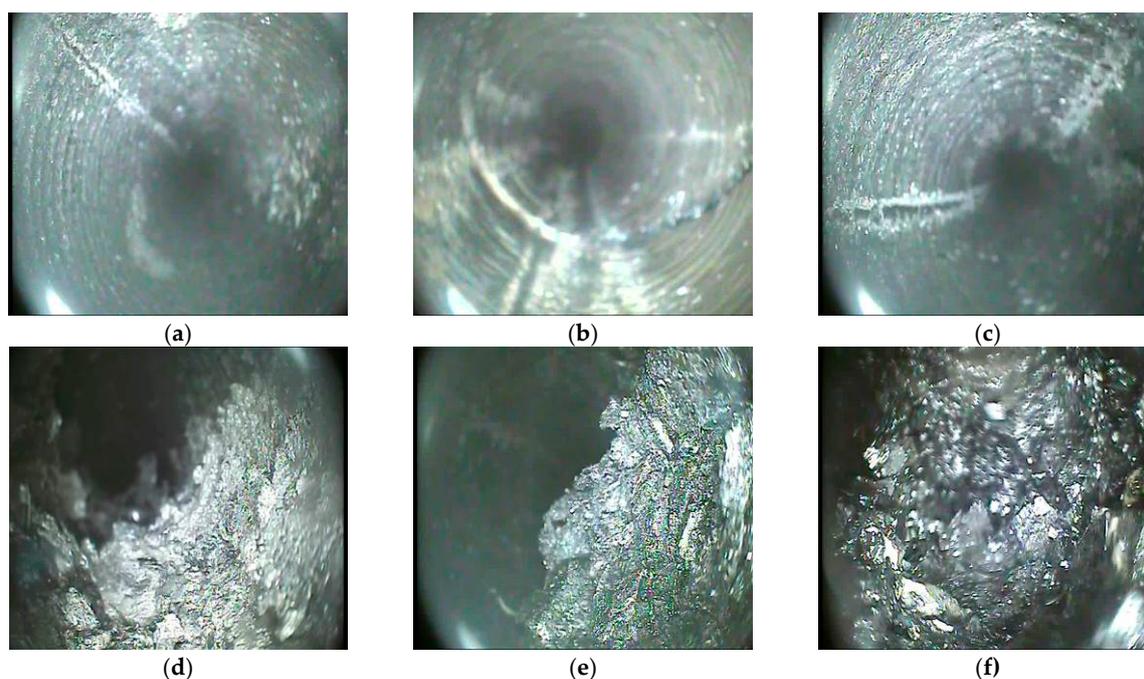
When the working face was 19 m away from the borehole opening, axial fractures were observed in the borehole #4 (Figure 12a). During the four-day idling period, the density of axial fractures increased, while damages of the coal wall were not affected. The propagation of fractures during this period can be attributed to the fact that propagations of mining-induced fractures were slightly behind the roof caving. The height of the water-conducting fracture was 17–19 m.

With the working face advancing, the density of axial fractures increased and the maximum length reached 35 cm. Irregular fractures were observed (Figure 12b) and damages of the coal wall (Figure 10d) were exacerbated. The fractured zone propagated upwards and the height was 20–23 m. Then one axial fractures reached 60 cm in length. Deep fractures propagated along the internal wall (Figure 12c). Observations in the six-day idling period revealed severe damages of the coal wall and considerable crushed coal in the borehole. Deformations of the borehole were observed at a depth of 58.5 m. This location was 7.2 m behind the working face and 29.3 m above the roadway roof. It can be concluded that the borehole was significantly affected by mining activities. The height of the fractured zone reached 25–27 m. When the working face was 5.6 m away from the borehole opening, breakage of the coal wall was exacerbated and the borehole was blocked by crushed coal at a depth of 13.5 m (Figure 12f).

Figure 12. Observations in borehole #4: (a) axial fractures; (b) irregular fractures; (c) fracture propagation; (d) wall breakage; (e) crushed coal; (f) blocked by crushed coal.

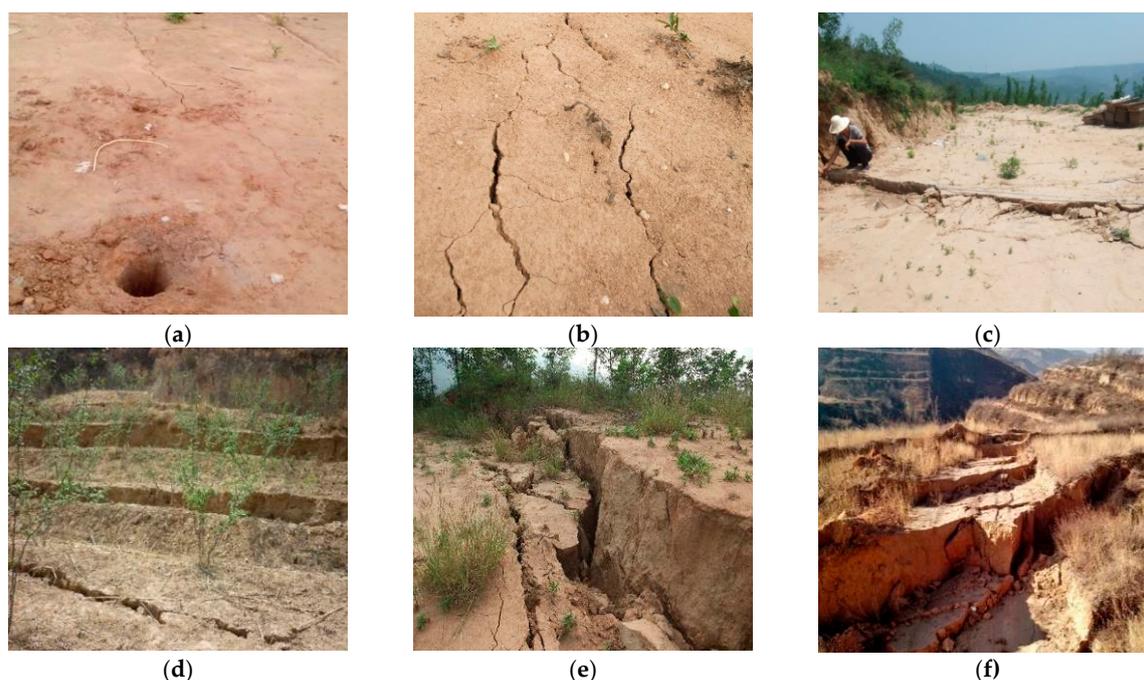
When the working face was 96.7 m away from the surface borehole, fractures that are parallel to the working face inclination were first observed in the vicinity of the borehole. The advance affecting range of mining was approximately 100 m, and the movable basin area significantly exceeded the mining area. Based on the advance affecting range and mining depth, it is deduced that the advance affecting angle was 71° . As the working face moved forward, the quantity and size of cracks increased further.

When the working face was 29.2 m ahead of the surface borehole, step subsidence appeared in the vicinity of the borehole. The ground surface subsided gradually and continuously. After the mining process, severe damages to the ground surface and step subsidence (maximum subsidence = 4.2 m) were observed, and surface cracks were distributed all over the goaf. The inter-fracture and inter-step distances varied from 1.0 to 6.2 m. The process of the surface subsidence around boreholes was shown in Figure 14.

Figure 14. Surface subsidence around boreholes: (a) cracks; (b) quantity of cracks increased; (c) surface subsidence; (d) step subsidence; (e) subsidence increased; (f) final subsidence.
