The Memorial Chapel (Formerly Holy Trinity Church) in the Tempio Evangelico Valdese (Florence): Surveys and Characterization of Decorative Plasters for a Conservative Recovery

Abstract: This study focuses on the Memorial Chapel, a historical site located inside the *Tempio Evangelico Valdese* in Florence. In 1843, the first Anglican church in Florence, known as Holy Trinity Church, was built by D. Giraldi. Around 1892, G. F. Bodley began the reconstruction of a new building of neo-Gothic style at the same site, which was completed in 1904. This new church had a space dedicated to memory called Memorial Chapel. In 1967, the monumental complex was acquired by the Waldensians, now known as the *Tempio Evangelico Valdese*. This interdisciplinary investigation aimed to study the most damaged painted walls of the chapel. For this purpose, samples of decorative plaster mortars were collected from various points, after carrying out a digital mapping of the degraded areas. Mineralogical, petrographic, optical, chemical, and microchemical analyses were performed. This study made it possible to highlight the composition and the characteristics of the different layers of the plaster mortars,

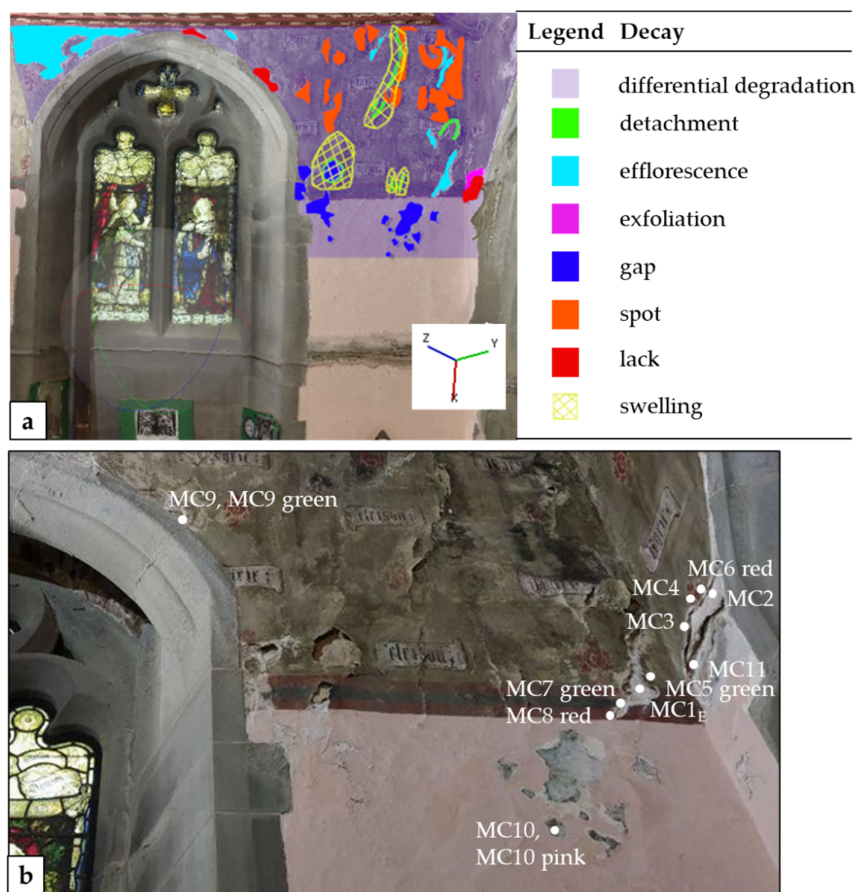
The Memorial Chapel exhibits a high degree of degradation, particularly evident in the left corner of the wall facing south-southeast (Figure 2). Prior to the restoration of the exterior facades (2010–2013), this area suffered significant damage due to both the partial breakage of the adjacent window and fractures in the wall, which facilitated the infiltration of rainwater, leading to moisture exchanges with the external environment. A digital reconstruction of the macroscopic different forms of decay of the plaster mortars on the aforementioned wall was obtained using Agisoft Metashape Professional (Version 1.8.4) and Gimp software (Version 2.10.34) [16–18]. Agisoft Metashape, a photogrammetry software, processes digital images and generates 3D digital environments. Additionally, this software provides detailed documentation and the flat reproduction of walls. Gimp software, an image editor, was employed for a graphical representation of degradation-related information. This software enables the highlighting of degradation areas through synthesized graphics and relevant iconography.

Figure 2. Digital reconstruction of the degraded areas of the chapel’s plaster mortars, which allowed a graphic rendering, representing the walls [19] (a). Plaster mortars, painted layers, and efflorescence sampled on the south and southeast walls of the chapel (b). For the ID sample, see Table 1.

The different forms of degradation were delineated and mapped with distinct colors, shown in Figure 2a, accompanied by a legend and description of the decay phenomena [19]. This graphical documentation facilitated the distinction among the different layers consti-

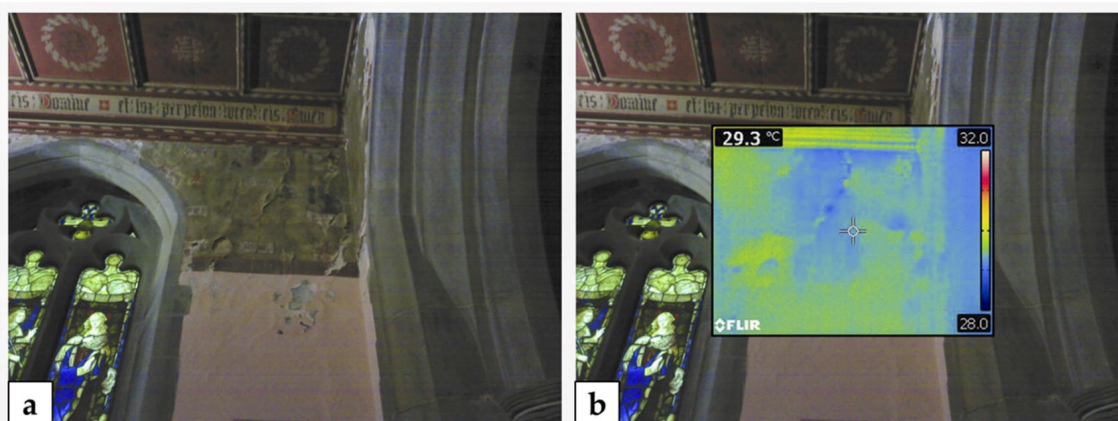
To better understand the degradation phenomena, a thermal imaging camera (Teledyne FLIR E50bx Building Inspection Thermal Camera with 240 × 180 Resolution; Thousand Oaks, CA, USA) was employed to assess the thermal condition of the area (Figure 3a). The measurements were performed during the summer of 2022, with the external temperature ranging between 34 and 38 °C. Figure 3b shows that the average temperature on the wall was 29.3 °C. It was observed that many colder areas (depicted in blue) correspond to regions most affected by detachments and swellings. The crack responsible for the intense degradation in the corner has been properly restored. As a result, both the interior and exterior walls of the chapel now exhibit a similar and constant temperature.

Figure 3. Image of the degraded wall (a), and distribution of the temperature revealed by the thermal camera (b).

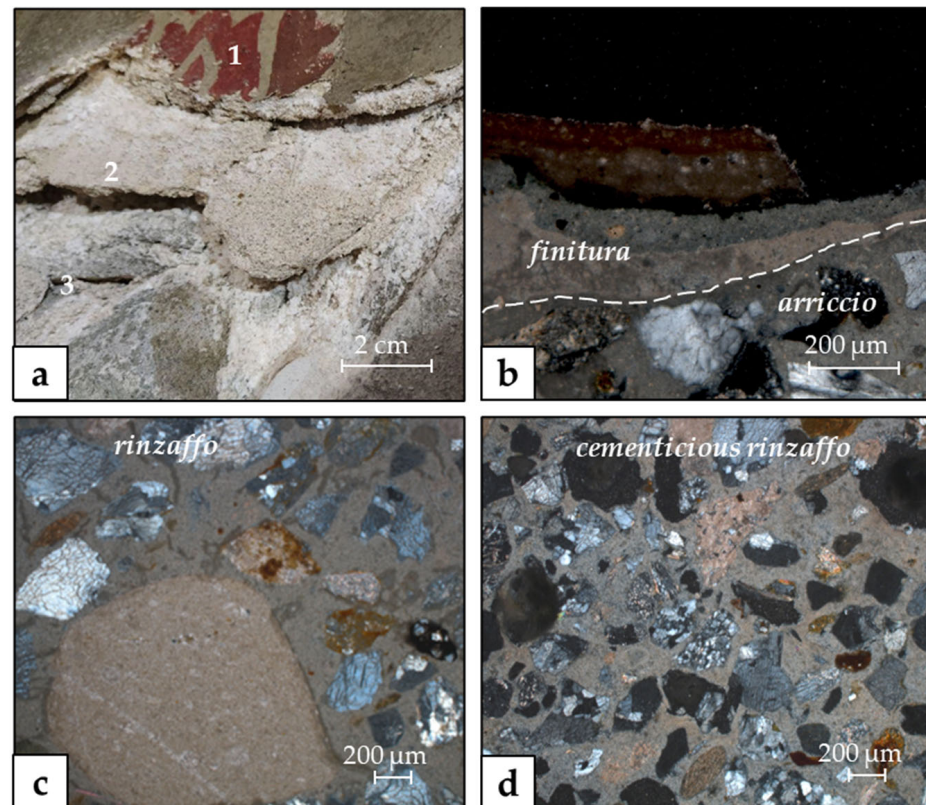
The samples of *finitura* (MC5, MC6, MC7, MC8, MC9, MC10) show a typical fine superficial layer constituted by lime whitewashing added with distinct colors (Figure 4b, sample MC9). The samples MC2, MC3, MC4, MC9, and MC10, with both *arriccio* and *rinza*ffo layers, show no differences between them or between the two layers, except for the variation in the grain size of the aggregate, which is larger in the *rinza*ffo layer. Both layers consist of a binder made of an air-hardening calcic lime, with Havana color, displaying an anisotropic appearance and a micritic texture, with small dark inclusions. These latter are characteristics of natural hydraulic lime, often dispersed in a micritic binder, in low amounts. They are referable to non-completely crystallized compounds of non-hydrated calcium/aluminum silicate, due to the presence of the clay components in low quantity in the limestone. The aggregate has heterogeneous dimensions in the range of 200–600 μm in the *arriccio* and 700–1000 μm in the *rinza*ffo layer (Figure 4b and 4c, respectively, samples MC9 and MC2). The aggregate particles are sub-rounded and sub-angular in shape, well

Figure 4. Macro image of the three layers of the plaster mortars on the wall: 1: *finitura*, 2: *arriccio*, 3: *rinzafo* (a). Microscope images in cross-polarized light (PLM) (b–d): sample MC9 showing the two layers of the plaster mortar: *finitura*—lime whitewashing with different painting colors is visible, and *arriccio*—binder made of air-hardening calcic lime (b); sample MC2: *rinzafo* with a typical Havana color of the binder and a remnant of Alberese Limestone are visible (c); sample MC11: cementitious *rinzafo*, hydraulic binder of grey color with rounded porosity is highlighted (d).

The sample MC11 (*rinzafo*) differs from the others. It shows a hydraulic binder of grey color, an anisotropic appearance, and a micro-sparitic texture. Within the binder, abundant small dark inclusions, constituted by non-hydrated relicts of calcium/aluminum silicate (i.e., belite), medium-high relief, shaded contours, and sub-idiomorphic habitus are observed [32,35,36]. The aggregate has a sub-angular and sub-rounded shape with dimensions in the range of 200–600 μm , well distributed. The composition of the aggregate comprises fragments of quartz crystals, feldspars, and micas, along with fragments of sandstones, quartzites, pelites, and limestones. The macro-porosity is sub-rounded and not high, with no cracks present. The binder/aggregate ratio (L/A) is approximately 1/3 (Figure 4d, sample MC11).

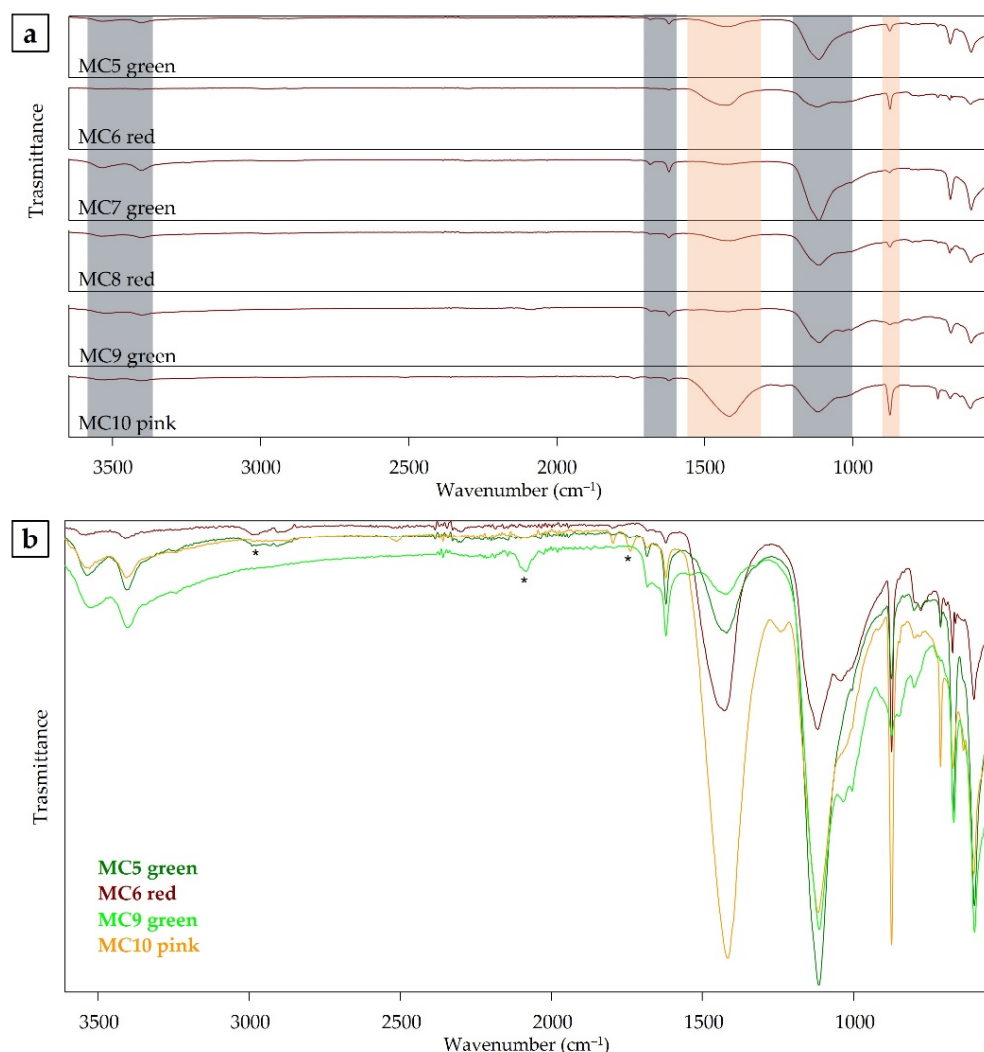
The spectral band assignments show that the samples consist of gypsum, calcite, and silicates (highlighted in Figure 5a, in grey, red, and yellow, respectively), consistent with the XRPD analysis. Additionally, characteristic peaks of organic compounds can also be observed (Figure 5b). Comparing the spectra, MC5 green and MC7 green exhibit similarities, displaying weak bands around $3000\text{--}2800\text{ cm}^{-1}$ (assigned to ν (CH_2 , CH_3 , CH)) and at 1736 cm^{-1} (assigned to ν ($\text{C}=\text{O}$)), which are attributed to organic compounds (highlighted with asterisks in Figure 5b). These bands are not visible in sample MC9 green, which shows a peak at 2083 cm^{-1} , possibly related to the stretching vibration of the $\text{C}\equiv\text{N}$ bond (highlighted with an asterisk in Figure 5b), which is typical of cyanide groups in organic and inorganic compounds and may be indicative of ultramarine blue [37]. Comparing the spectra of MC6 red and MC8 red, they are similar and show weak bands around $3000\text{--}2800\text{ cm}^{-1}$. The spectrum of sample MC10 pink is indicative of predominant

calcite, with gypsum. The peak at 1736 cm^{-1} and the shoulder at 1240 cm^{-1} (highlighted with asterisks in Figure 5b) are possibly related to the stretching vibration of the C-N bond. However, further analysis is required to confirm this interpretation.

Figure 5. Detail of the ATR-FTIR spectra of colored surface samples (range of interest $3600\text{--}500\text{ cm}^{-1}$) with attribution: grey—gypsum; red—calcite (a); ATR spectrum with highlighted bands. The FTIR spectra of four representative samples show the presence of organic compounds, which are highlighted with an asterisk (b).

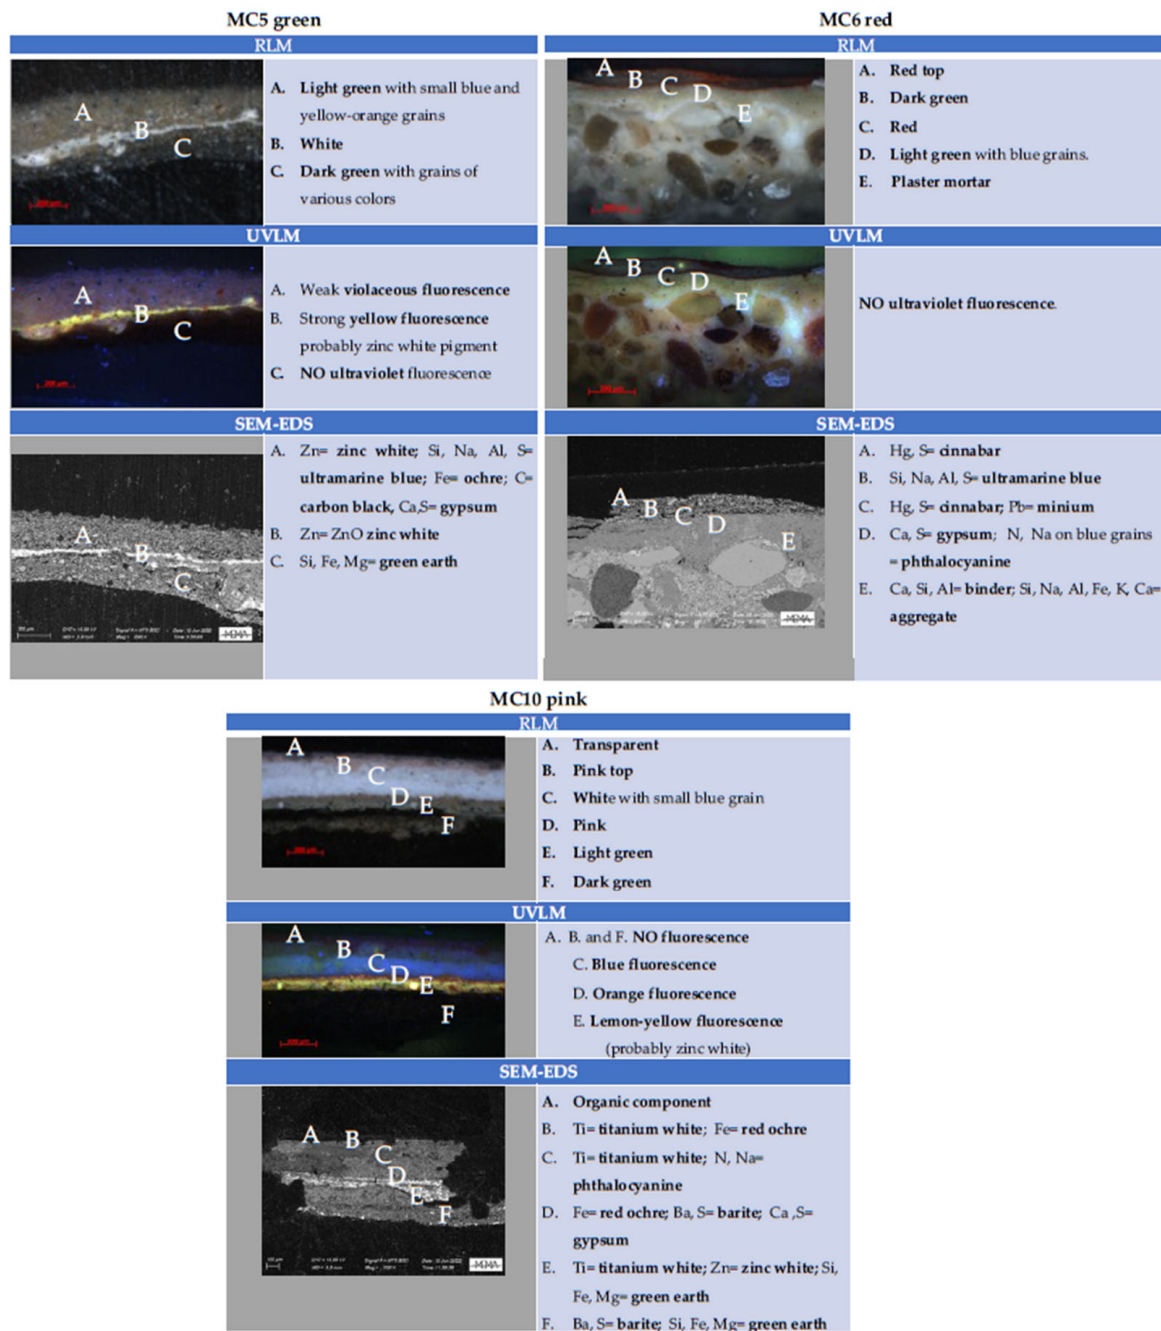
Figure 6. The image shows the microscopical data obtained on three painted samples (MC5 green, MC6 red, MC10 pink) with different surface colors. For each sample, the different stratigraphy of the color layers was highlighted through the optical microscope observation: RLM, UVLM, and analysis: SEM-EDS.

Sample MC5 green presents, in reflected light, three different layers, arranged from the surface downwards: a light green layer containing blue and yellow-orange grains, followed by a white layer, and underneath, a dark green layer with grains of various colors. Microscopic observations under UV light again confirmed the different stratigraphy: the top layer with weak violaceous fluorescence, the middle layer with strong yellow fluorescence, and the bottom layer showed no ultraviolet fluorescence. SEM-EDS analysis allowed us to identify the chemical composition of each layer. The first green layer contains Zn, likely due to zinc white (zinc oxide), Si, Na, Al, and S, attributed to ultramarine blue pigment ($\text{Na}_{8-10}\text{Al}_6\text{Si}_6\text{O}_{24}\text{S}_{2-4}$), responsible also for the blue grains, Fe from ochre (Fe_2O_3), C from

Sample MC6 red shows, in reflected light, four layers that appear from top to bottom: red, dark green, red, and light green with blue grains. Microscopic observations in UV do not show any fluorescence. SEM-EDS analysis highlights the chemical composition of each layer: Hg and S, probably from cinnabar (HgS) are found in the top layer; Si, Na, Al, and S, attributed to ultramarine blue pigment, are found in the second layer; the third layer contains Hg (likely from cinnabar) and Pb, indicative of minium (Pb_3O_4); in the bottom layer, Ca and S from gypsum and N and Na on blue grains, possibly attributed to phthalocyanine ($C_{40}H_{23}N_7O_{13}S_4 \cdot 4Na$), are present (Figure S3).

Sample MC10 pink shows six overlapping layers in reflected light: transparent, pink, white (with small blue grains), pink, light green, and dark green. The first, second, and last layers do not exhibit fluorescence under UV light, while the third layer shows blue fluorescence, the fourth layer shows orange fluorescence, and the fifth layer displays lemon-yellow fluorescence. SEM-EDS analysis shows in the top layer an organic component. The second layer contains Ti, indicative of titanium white (TiO_2), and Fe, of red ochre (Fe_2O_3). The third layer still shows Ti for titanium white and N and Na, possibly due to the presence of phthalocyanine. The fourth layer contains Fe for red ochre, Ba and S, likely for barite, and Ca and S, for gypsum. In the bottom layer are present Ti from titanium white, Zn from zinc white, and Si, Fe, and Mg, attributed to the presence of green earth pigment (Figure S4).
