Earthquake Hazard Knowledge, Preparedness, and Risk Reduction in the Bangladeshi Readymade Garment Industry

Edris Alam ^{1,2}

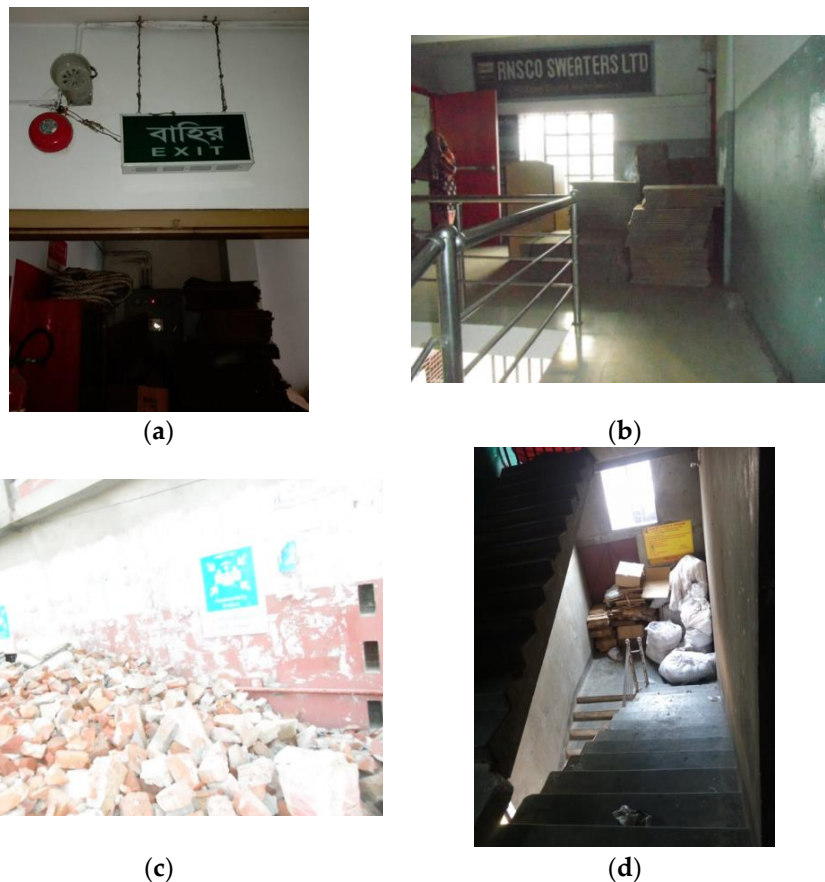
It was noted that of the 20 factories inspected, one factory owner had never practiced evacuation at the workplace. Some factory management claimed they have high levels of preparedness to mitigate fire and earthquake hazards. Key informant discussions with senior executives and owners of the factories deemed compliant by compliance agencies suggest the structural design of the buildings and overall preparation have a zero-tolerance approach to hazards. Seven workers suggest that they could not understand the research question about evacuation because they had not received evacuation training in the workplace. The remaining 139 workers provided responses about evacuation challenges at their workplace (Table 3). These include: (i) the provision of the main entrance and exit on the ground floor is not wide enough for the mobility of workers; (ii) a narrow exit gate; (iii) passages, aisles, corridors, stairways being obstructed by packages; (iv) no fire door installed; (v) no exit sign; (vi) blocked exit gate, etc. (Figure 2).

Figure 2. Evacuation problems in RMG industries. (a) Exit gate is blocked by boxes and other items; (b) stairways are partially blocked by hardboard; (c) brick items placed at an assembly point; (d) stairways are blocked by boxes and garbage items.
