# Metro System Inundation in Zhengzhou, Henan Province, China

**Abstract:** In this study, we investigated the flooding accident that occurred on Metro Line 5 in the capital city of Zhengzhou, Henan Province, China. On 20 July 2021, owing to an extreme rainstorm, serious inundation occurred in the Wulongkou parking lot of Zhengzhou Metro Line 5 and its surrounding area. Flooding forced a train to stop during operation, resulting in 14 deaths. Based on our preliminary investigation and analysis of this accident, we designed three main control measures to reduce the occurrence of similar accidents and mitigate the impact of similar accidents in the future, given the increasing number of extreme storm weather events in recent years: (1) to conduct subway flood risk assessments and to establish an early warning system, involving real-time monitoring of meteorological information during subway operation and construction; (2) to improve subway flood control emergency plans and to establish a response mechanism for subway flooding; and (3) to strengthen safety awareness training to ensure the orderly evacuation of people after accidents.

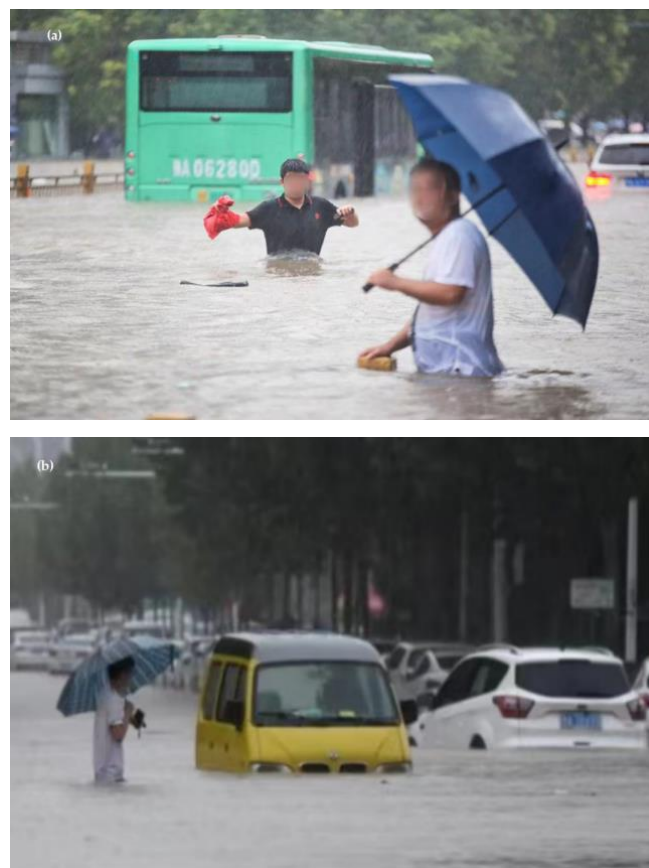
**Figure 1.** Damage caused to Zhengzhou City by a rainstorm on 20 July 2021: (a) pedestrians and vehicles during flooding [6]; (b) on July 20, pedestrians wading through an area with ponding in Zhengzhou [7].

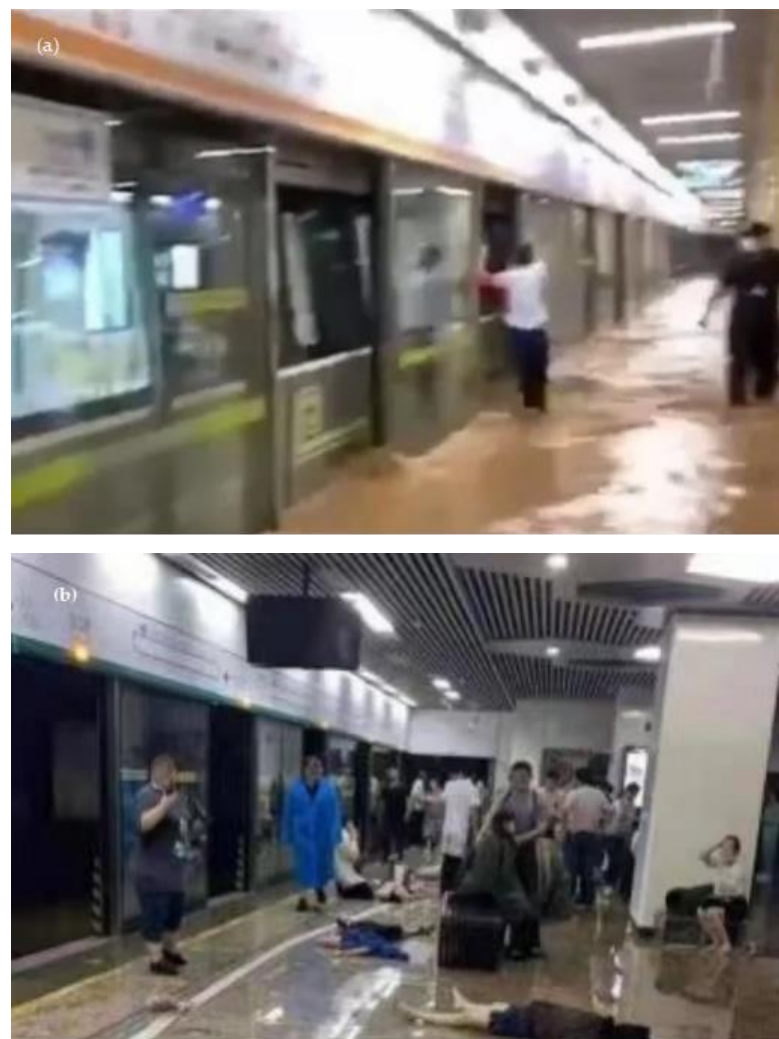
**Figure 2.** Zhengzhou Metro Line 5 was flooded: (a) flooded subway station [8]; (b) passengers trapped in the subway [9].

At approximately 17:00, a train passing along Zhengzhou Metro Line 5 was affected by the rainstorm, necessitating an emergency stop after Huanghe Road station while passengers were on board the train. When the train left Beach Temple Station and was about 200 m away from Shakou Road Station, the train needed another emergency stop. Around 18:00, the water level due to the rainfall exceeded the height of a retaining wall in the tunnel, causing rainwater backflow. When the rainwater entered the mainline section, the train started again and tried to reverse, and the pouring rainwater began to flow into the interior of the carriage. The train was forced to stop in the section between the Shakou Road and Haitansi Stations [18]. The conductor urgently asked passengers to leave the front of the train. After trying to open the front and door of the first carriage, a small number of passengers left by an emergency escape walkway only 50 cm wide and escaped the dangerous area through entrance C of Shakou Road Station one hour later. Most passengers returned to the carriage for rescue because of heavy water flow [19].

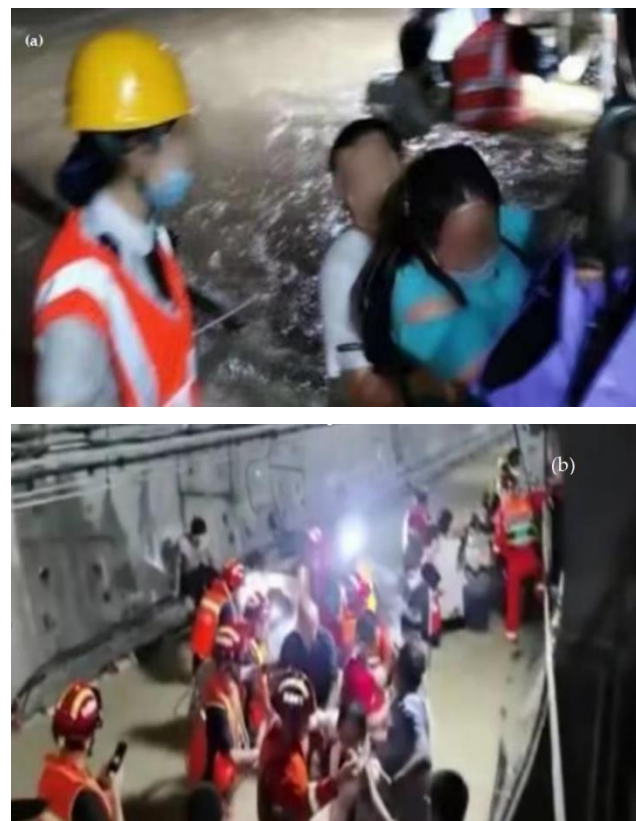
**Figure 6.** Firefighters rescue the trapped people: (a) using safety ropes to guide trapped victims [21]; (b) rescuing the passengers from the main subway line [22].
