# Online Diagnostics as a First Step in the Safe Use of Damaged Photovoltaic Modules

## Abstract

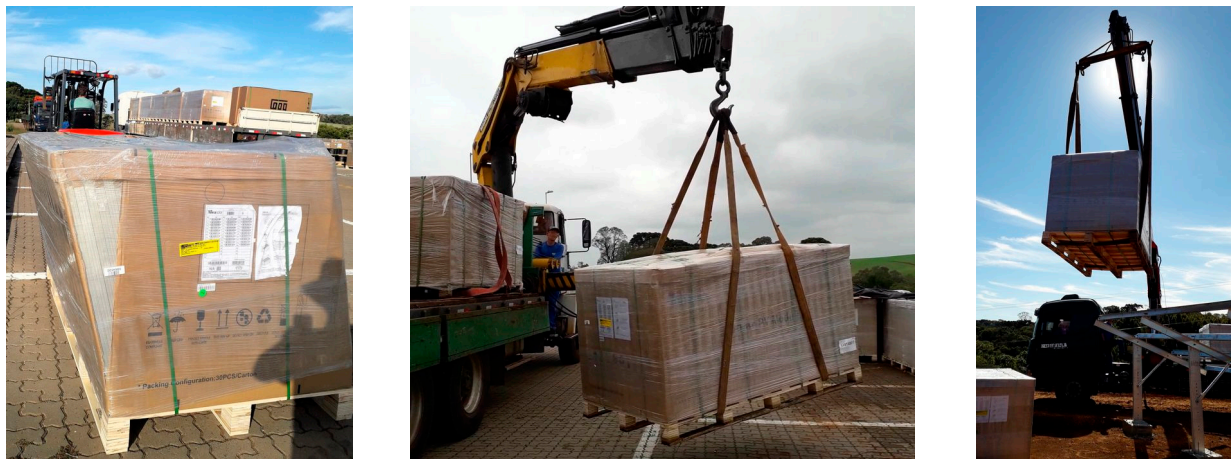
Figure 1 illustrates the logistical challenges associated with transporting new PV modules in Brazil, highlighting the actual work practices of transport and delivery companies. The road infrastructure is in a state of disrepair, and the modules were transported over long distances. The transportation of the materials without glass breakage from the seaport to the laboratory car park at the Federal University of Fronteira Sul Campus, Erechim, approximately 500 km, represents a significant challenge. The lifting was conducted without the use of a lifting rocker. The deformation of the packaging resulted in damage to the aluminum structure of the modules, which was likely a contributing factor for the observed glass breakage. Finally, unloading the PVs onto the ground entailed a risk of collision and tilting of the storage unit.

**Figure 1.** The module box was transported by truck from the seaport to the installation site. The packaging sustained damage because of the load being placed on the lorry platform. The subsequent image depicts the operation without the utilization of a lifting rocker. The subsequent stage of the process involved the transfer of the modules from the storage site to the plant.

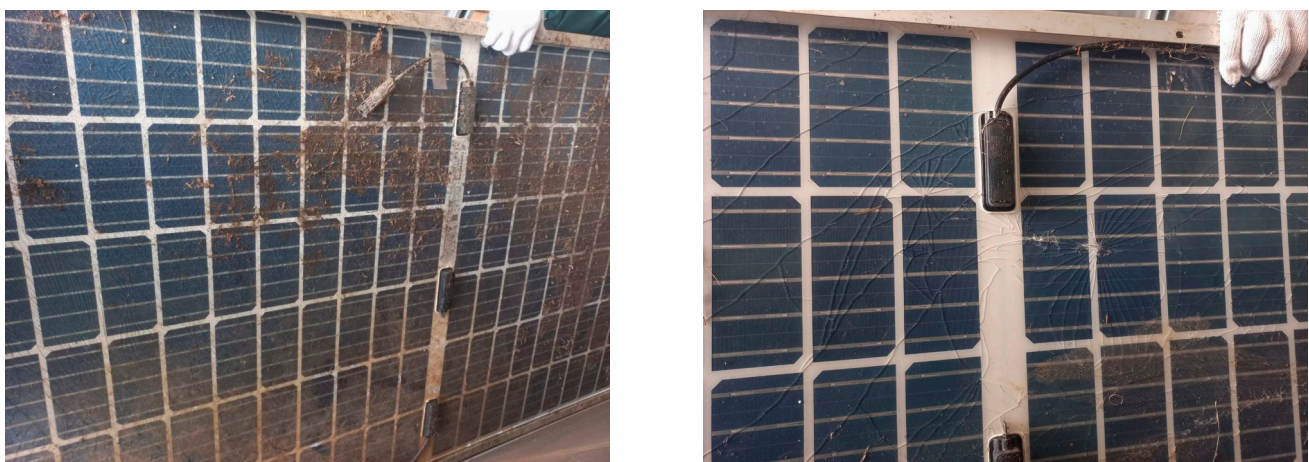
Figure 2 shows the representative condition of the PV modules that were stored following their disposal at the PV plants’ installation sites. All modules originated from the same project and were of a similar model. After checking all modules, the undamaged ones were installed in plants with a combined capacity of 3.45 MWp and 1.4 MWp, comprising over 12,700 modules.

**Figure 2.** Status of the photovoltaic modules stored after being disposed of at the photovoltaic plant installation site.

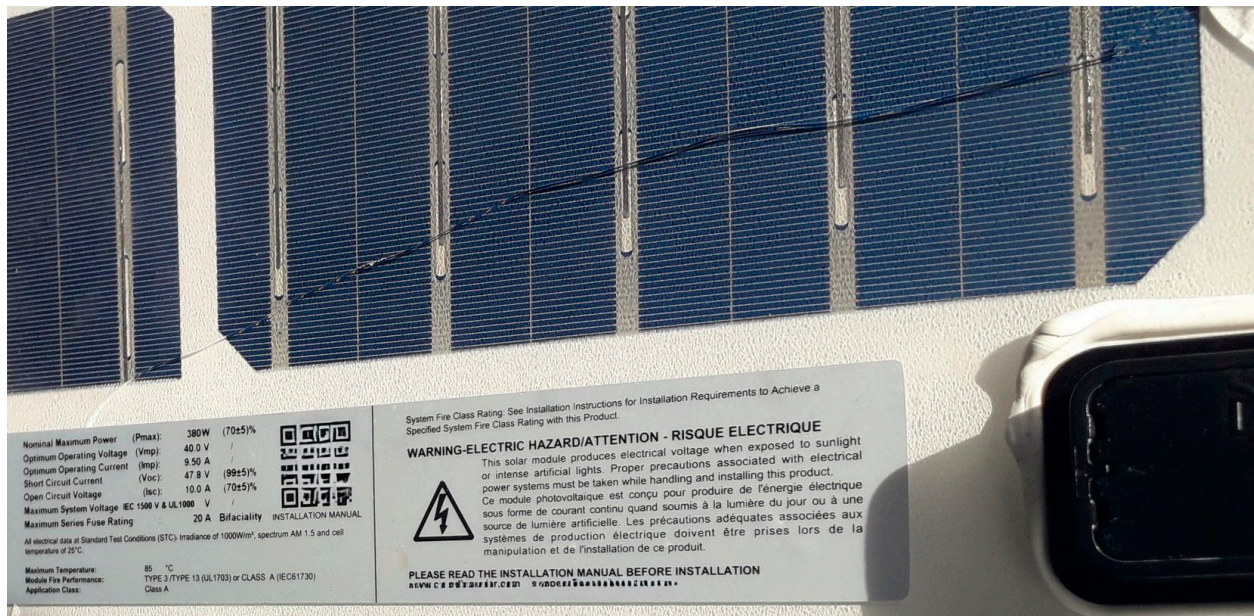
illustrates an example of the visible damage to one of the modules received in the initial shipment following its cleaning. The image was captured after transportation over 400 km, from the PV plant where the modules were stored to the Federal University of the Southern Frontier Campus in Erechim, Brazil. Consequently, for every 70 modules delivered to the site or installed, at least one was found to be damaged (representing 1.45 percent of the total number of modules).

**Figure 3.** Damage visible to the naked eye after cleaning the 16 modules received in the first loading/transport. The WARNING-ELECTRIC HAZARD stands out.

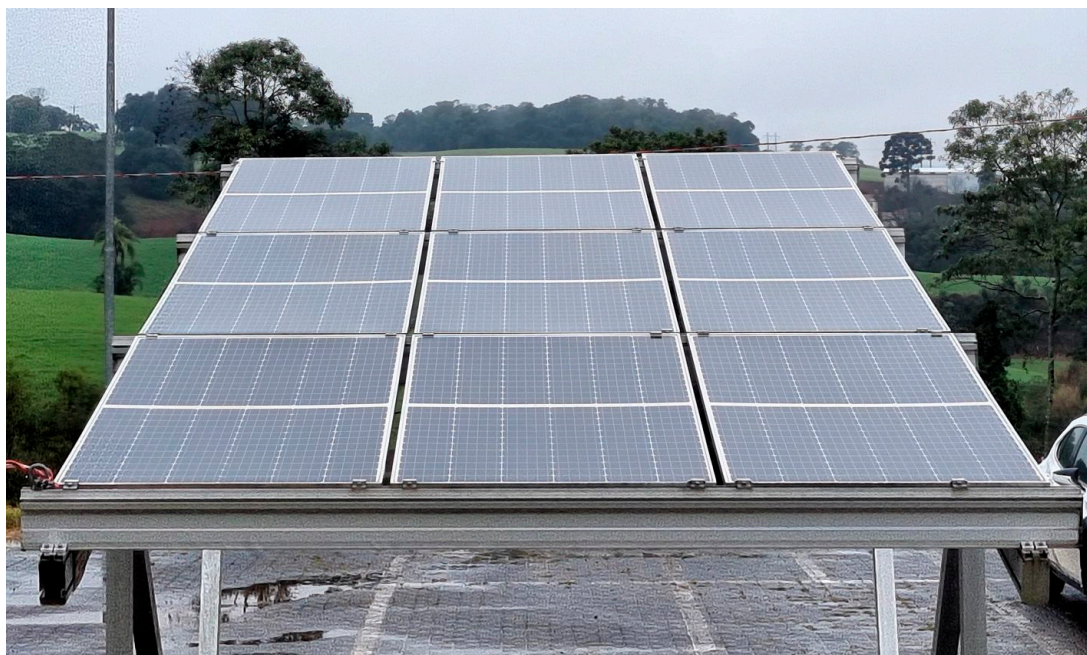
**Figure 4.** Nine bifacial modules installed in a carport structure. All the modules show some kind of damage to the front and/or rear glass. Image was taken on a day with high humidity, which served as a test for the electrical insulation. It is located in a car park of the laboratories at the Federal University of the Southern Frontier Campus Erechim/Brazil.

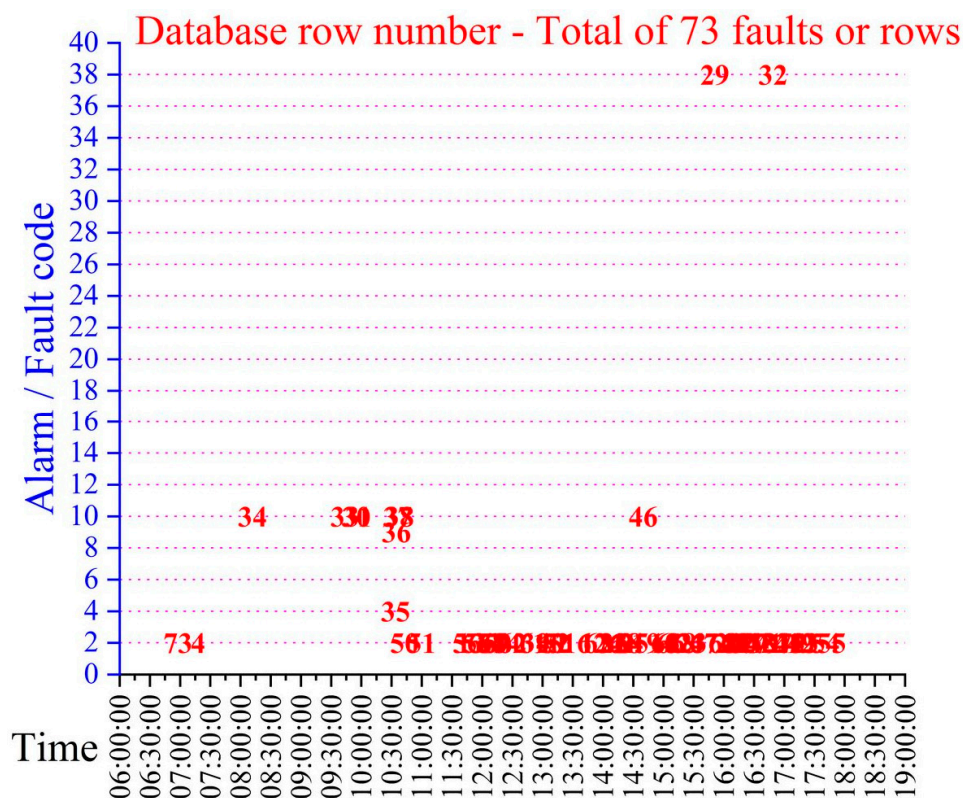
Figure 9 exhibits the alarms and faults documented by the iSolarCloud software and Sungrow's SG3.0RS-S inverter during the interval in which the tests were conducted (1 May 2024–15 August 2024). This is an embedded system within the inverter. Advanced users have restricted access to electronics and some functions of the source code. These are reports that must be interpreted technically.

**Figure 9.** Faults reported by the iSolarCloud software and Sungrow SG3.0RS-S inverter during the period in which the tests were carried out (1 May 2024–15 August 2024). Fault code  $\times$  24 h a day, plot type scatter, custom construction, row number numerics. Total of 73 faults, in time sequence, from past to present: 62 faults, code 2 = grid overvoltage; 7 faults, code 10 = grid outage; 1 fault, code 4 = grid undervoltage; 1 fault, code 9 = grid underfrequency; 2 faults, code 38 = system malfunction.

On the test days, no alarms were issued, except for on 13 June 2024 at 15:18 (15:14:32 to 15:18:42), which was characterized by a mains overvoltage. Figure 9 illustrates that most of the faults were associated with code 2, which is linked to the alarm triggered by mains overvoltage. The data indicate that most faults occurred during the afternoon shift, between 1 p.m. and 6 p.m.

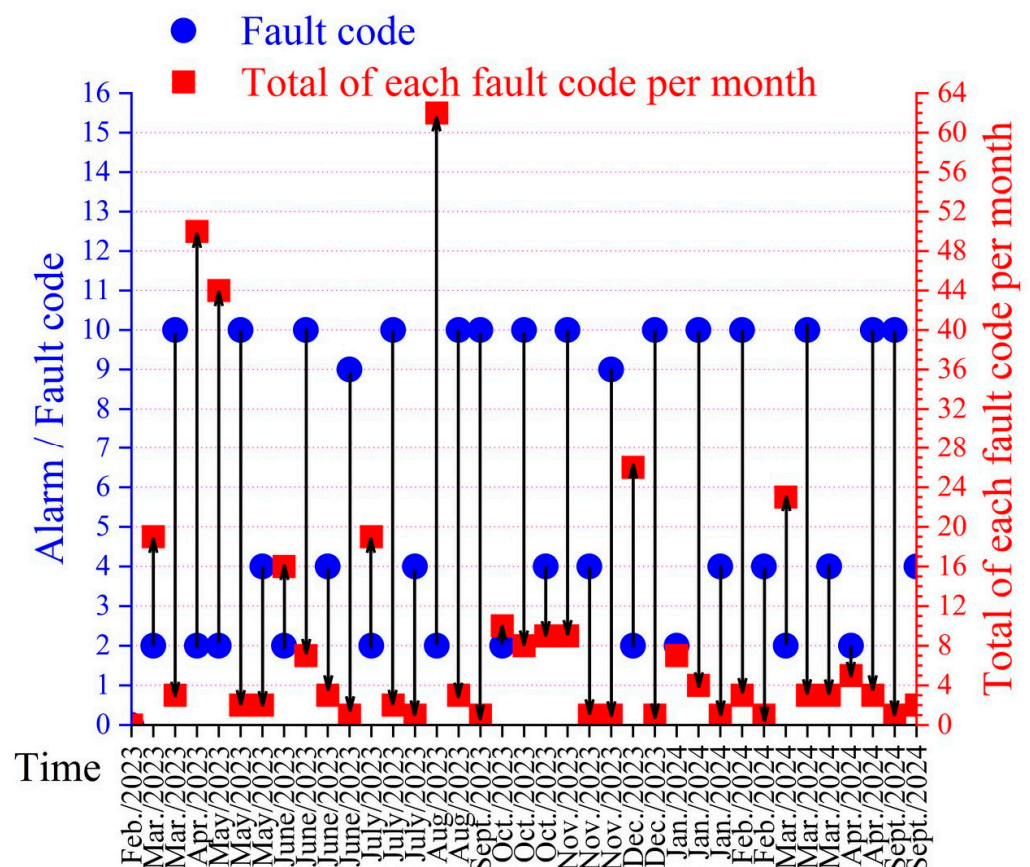
Figure 10 demonstrates the occurrence of alarms and faults between the dates of 10 February 2023 and 30 September 2024, during which the SG5K-D inverter was connected to the photovoltaic plant and the grid. The alarms indicate that the quality of the energy supplied by the electricity distributor was substandard. No issues were identified in the photovoltaic system. The categories of events (overvoltage, voltage drop, undervoltage, and underfrequency) originated from the grid, with no malfunction detected on the PV side. In Brazil, the ANEEL and ABNT standards NBR 16149:2013 [41] regulate the connection interface between PV systems, related to voltage and frequency operation bands, as well as reconnection conditions. Please refer to the Supplementary Materials.

**Figure 10.** Alarms and faults that appeared in the period 10 February 2023–30 September 2024 using the SG5K-D inverter. Total of 356 faults, in time sequence, from past to present: 281 faults, code 2 = grid overvoltage; 50 faults, code 10 = grid drop; 23 faults, code 4 = grid undervoltage; 2 faults, code 9 = grid underfrequency.

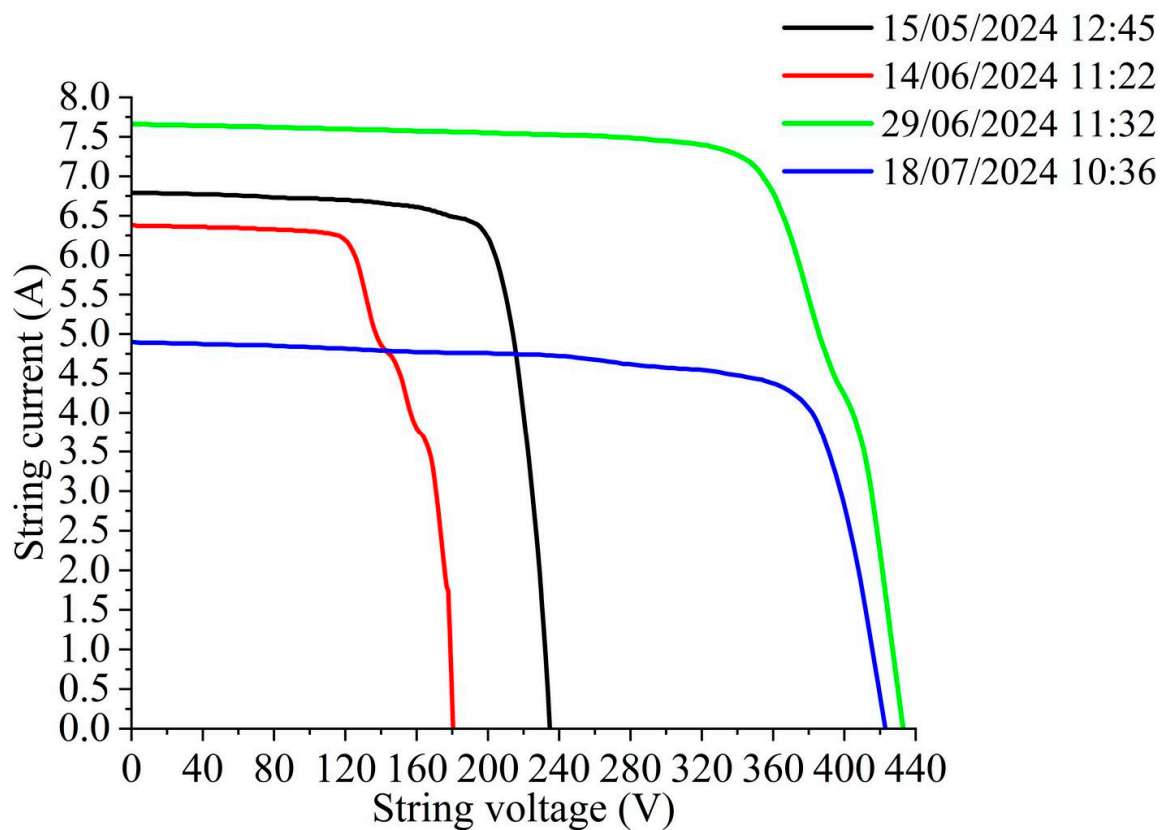
Figure 14 shows the dynamic behavior of the I-V curves, which exhibited a certain degree of deviation. The discrepancy observed in the blue curve (18 July 2024 10:36) can be attributed to ‘current variation’ resulting from the irradiation of 618 W/m<sup>2</sup> (original data,  $I_{sc} = 4.896$  A) at that specific point in time. An increase in irradiation to 688 W/m<sup>2</sup> (original data,  $I_{sc} = 7.661$  A) would not be sufficient to elicit a 2.765 A increase in  $I_{sc}$  in the green-colored curve (29 June 2024 11:32).

**Figure 14.** Dynamic behavior of the I-V curves that showed some kind of deviation, which could be considered a fault.

Therefore, the expected increase is  $\Delta I_{sc}(\text{expected}) = 5.451 - 4.896 = 0.555$  A but the measured increase is  $\Delta I_{sc}(\text{observed}) = 7.661 - 4.896 = 2.765$  A. Comparing the ratios, the irradiance increased by 11.3% ( $688/618 = 1.113$ ), but  $I_{sc}$  increased by 56.5% ( $7.661/4.896 = 1.565$ ), which is not near-linear. For an additional check, PVSyst (version 8.0.13) simulations for the same type of cell (CS3U-380MB-AG) return  $I_{sc} \approx 6.3$  A for  $618 \text{ W/m}^2$  and  $I_{sc} \approx 7.0$  A for  $688 \text{ W/m}^2$ , with an increase of  $\Delta I_{sc} \approx 0.7$  A, again significantly lower than the measured  $\Delta I_{sc}$ . Considering the uncertainty of the irradiance sensors (nominal 5% of full scale) and the possibility of short transients while performing the IV scan, the measured data still show a significant discrepancy and likely involve additional parameters such as irradiance variation during the scan, intermittent shading, mismatch, or measurement artifacts.

In the case of the scans conducted on 14 June 2024 at 11:22 and 29 June 2024 at 11:32, the diagnostic report indicated a string current mismatch and provided repair advice, suggesting possible cracked glass and a cell problem. In the current study, the solar module already had a glass crack, and the I-V curve scan is known to be sensitive to boundary conditions such as the level and stability of the irradiance applied during the scan period. Therefore, the scan is repeated, and if the issue persists, additional tests may be conducted to determine the cause.

It is recommended that the following steps be taken to repair the issue: 1. Check whether there are PV modules in the string that are shaded or where the front glass has cracked. 2. Check whether there are PV modules inside the string with different power ratings or models. 3. Perform infrared image testing to check whether there are hot spot PV modules and also check whether the PV module back plate has burn spots. 4. Perform I-V and electroluminescence (EL) testing again on the PV module to check whether it has low short-circuit current or power or whether the PV module cell has a crack. 5. During the I-V scanning, the shade of clouds covering the string will cause differences in irradiation, and this fault may be reported. It appears that warnings 1 and 4 were the underlying cause of the failure.
