# Fires in Urban Passenger Transport Vehicles Engine—Case Study

The Municipalized Urban Transport Services of Coimbra (SMTUC), a public transportation company that recently celebrated its centennial anniversary, has consistently provided its users with improved transportation conditions (air-conditioned, less polluting buses, equipped with access ramps for citizens with reduced mobility, etc.), aiming to provide greater convenience and comfort to its passengers.

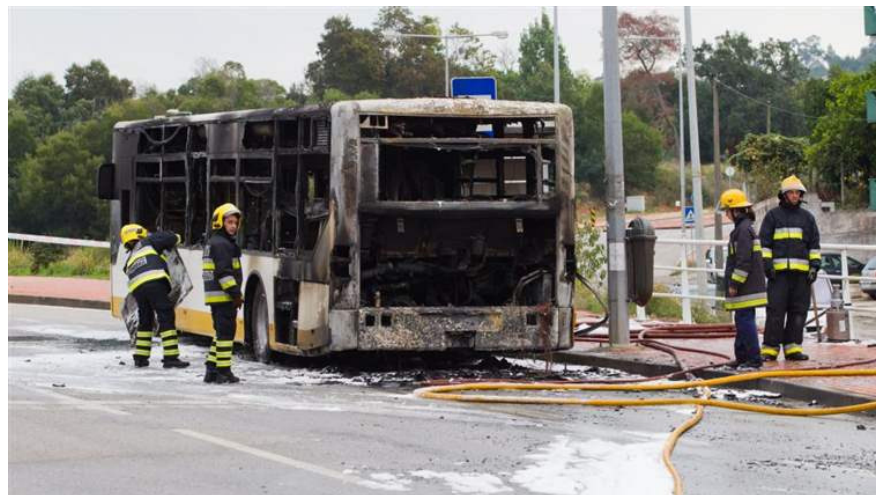
Even considering the high calorific power developed by the combustion in the engine compartment, the ease with which the fire spread to the passenger compartment and the degree of destruction of the plastic material of the seats and decorative or functional elements of the vehicle's interior is striking (Figure 1).

**Figure 1.** Exterior view of the engine compartment of the bus.

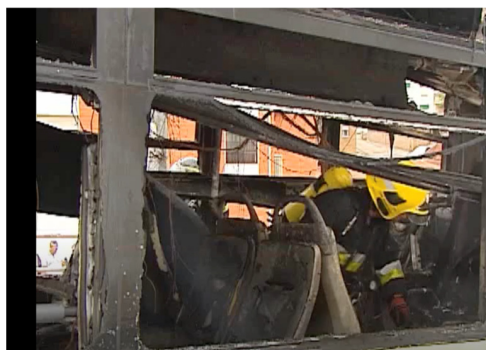
Coimbra Fire Brigade, whose station is less than 400 metres from the scene of the accident—on the opposite road—intervened a few minutes after the fire started but could do nothing to save the vehicle, which was rendered unusable (Figure 2).

**Figure 2.** Photos of the damaged vehicle.

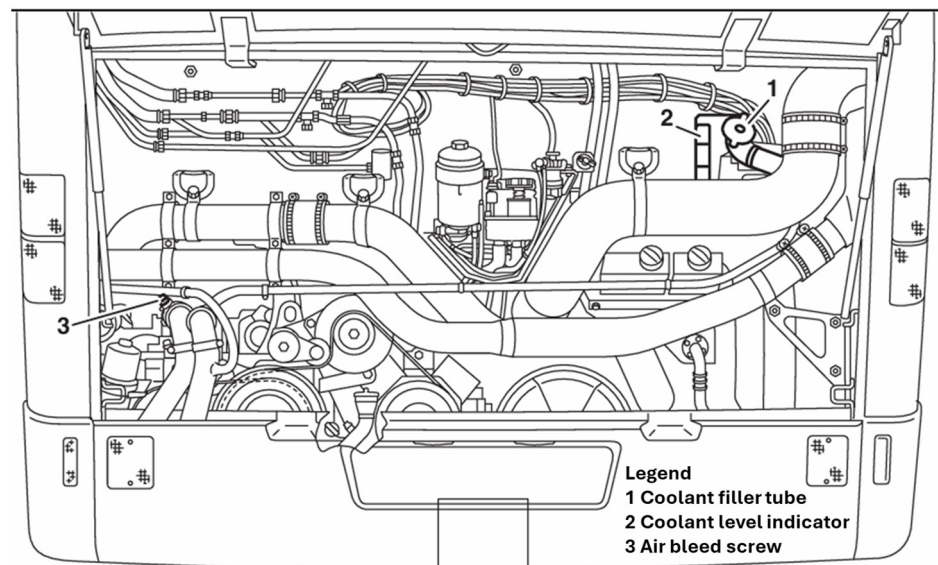
On the basis of the driver’s testimony and the observation made by the investigation team, we are inclined to believe at this stage that the fire was caused by the bursting of a flexible hydraulic engine oil supply pipe that drives the front cooling fan for the intercooler air exchangers, the engine cooling water and also the hydraulic system oil (Figure 5).

The bursting of this hose is consistent with the popping noise heard by the driver, given the high pressure at which the oil circulates in these pipes. It is also consistent with the driver's testimony that the oil came out "in gulps", fuelling the combustion of the liquid that was spilt on the ground at the rear of the vehicle. According to the bus manufacturer, the maximum working pressure of the oil in the hydraulic circuit that incorporates these pipes is 210 bar. The pressure and flow rate in these pipes depends on the speed at which the hydraulic fan motor works. The speed of the fan is adjusted according to the atmospheric conditions in which the bus operates so that the temperature of the engine coolant at the outlet of its radiator is in the 83–89 °C range and the temperature of the charge air coming from the engine's turbocharger at the outlet of the intercooler is in the 45–65 °C range. The maximum working speed of the fan is 2100 rev/min. According to the bus manufacturer, the capacity of the hydraulic circuit that drives the fan is 11 litres of oil.

Therefore, we suggest replacing these pipes after certain periods of use, in accordance with the manufacturer's recommendations, or more demanding ones if the risk of this type of accident warrants it. It should be noted that the use of these vehicles in the high temperatures experienced in Portugal—compared to the countries of origin of these vehicles—may force to reduce preventive maintenance periods or even the replacement of critical components.

50,000 km to 25,000 km; it is recommended to replace the oil pipe during inspection after 100,000 km.

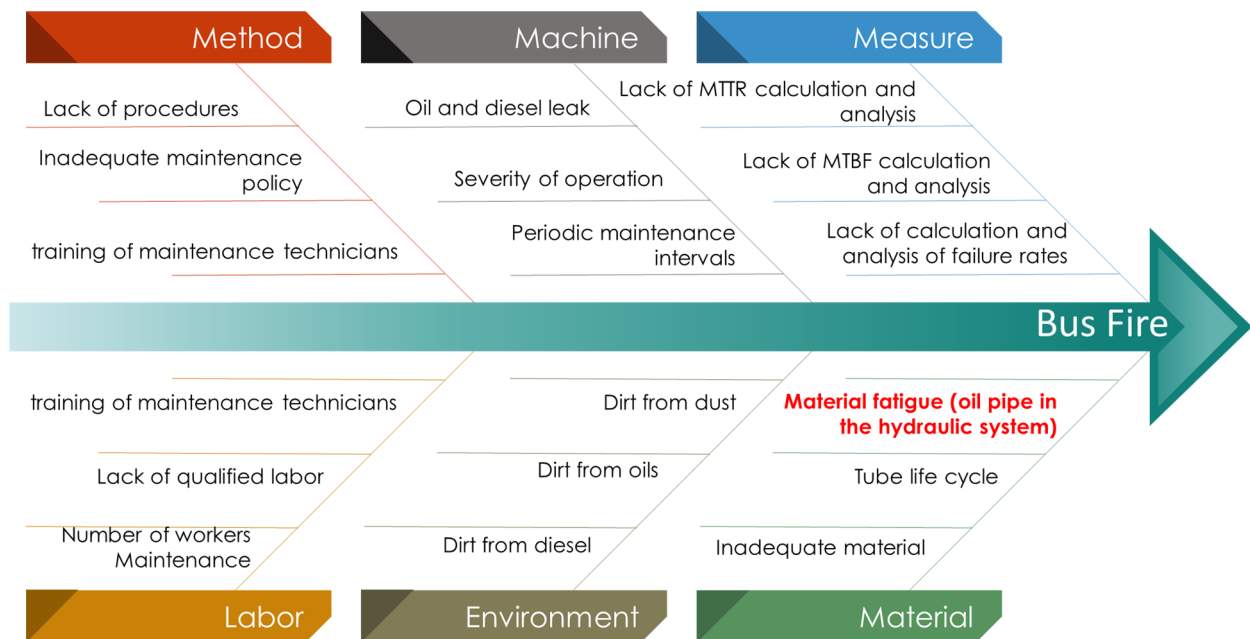
The diagram resulting from this analysis (Figure 6) clearly shows the possible root causes associated with the failure mode, serving as support for defining more effective corrective, preventive, and on-condition preventive actions.

After identifying the cause of the failure using the Ishikawa diagram, namely a ruptured hydraulic system oil pipe, we studied the hydraulic system oil ignition next.

**Figure 6.** Failure Modes—Ishikawa Diagram.

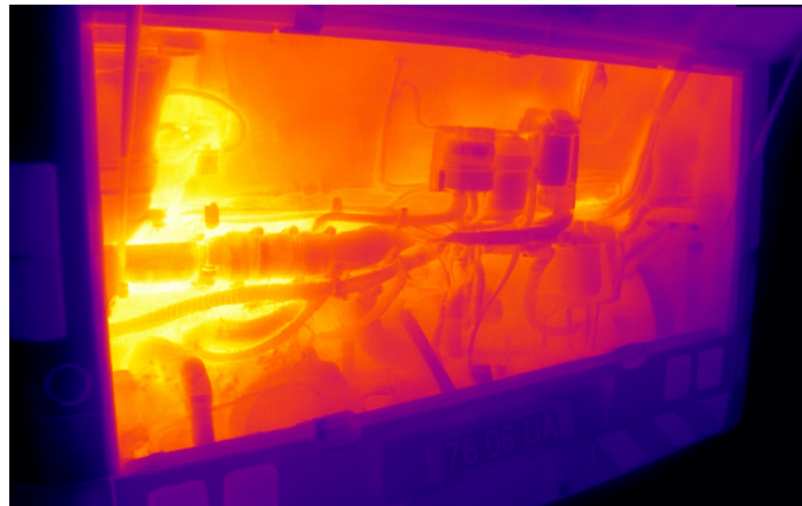
Several tests were carried out with the vehicle’s engine running, reproducing and simulating the actual operating conditions of the engine at the time of the accident. We found that the surfaces in the engine compartment with temperatures above the ignition value (value  $\geq 500$  °C) are the exhaust collector, the exhaust pipe next to the exhaust manifold (exhaust collector) and the turbocharger turbine body. The components that, due to their position, are most likely to be hit by oil droplets from the burst hydraulic pipe are the exhaust manifold and the exhaust pipe next to the exhaust manifold, as shown in Figure 10.

**Figure 10.** Thermal image of the engine compartment.
