# Research on Failure Modes and Causes of 100-m-High Core Wall Rockfill Dams

**Keywords:** core wall rockfill dam; failure modes; dam crest cracking; seepage; long-term deformation; wetting properties

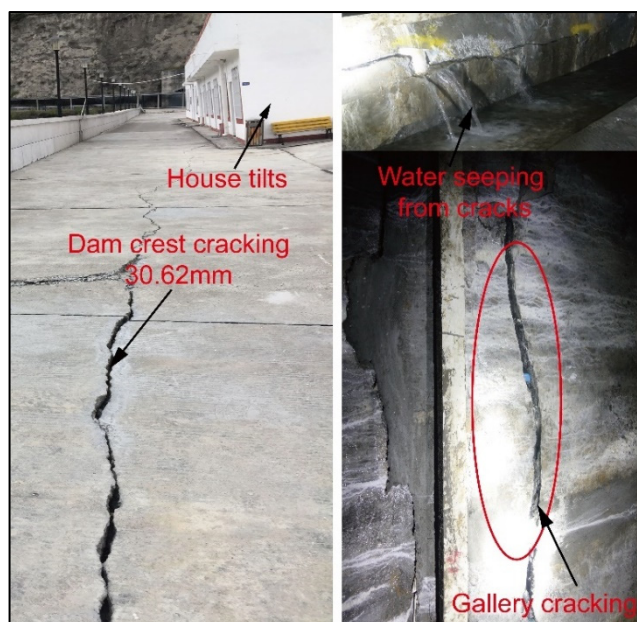
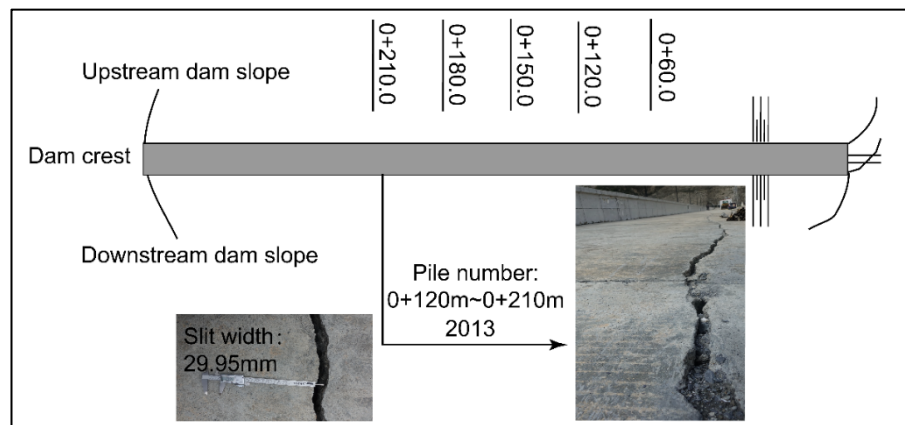
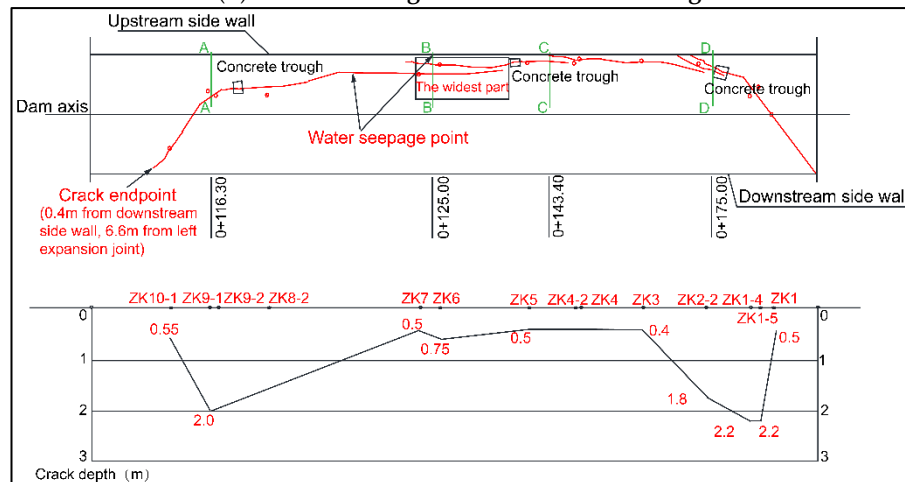
Figure 6. Dam failure schematic.

As shown in Figure 6, three typical failures have emerged since the commencement of dam operations: dam crest cracking, gallery cracking, and high-level water seepage in the dam body.

Deformations and seepage have increased significantly since the second phase of water impoundment began in September 2012. By early October 2013, when the reservoir reached the elevation of EL2536 m, nearing its normal water storage level, extensive longitudinal cracks were observed on the downstream side of the dam crest, and water seepage appeared in the observation room on the uppermost floor of the downstream horse trail.

On 12 May 2008, a strong earthquake with a magnitude of 8 struck Wenchuan County in Sichuan Province, China, with the dam situated a mere 55 km away. During the inspection for earthquake damage on 6 August, cracks were detected in the bottom plate of the riverbed gallery at the elevation of EL2410.5 m of the dam. Subsequent design scrutiny concluded that these cracks had inflicted structural damage upon the gallery.

(a) Fault site.

(b) Schematic diagram of dam crest cracking.

(c) Schematic diagram of the distribution and depth of gallery cracks.

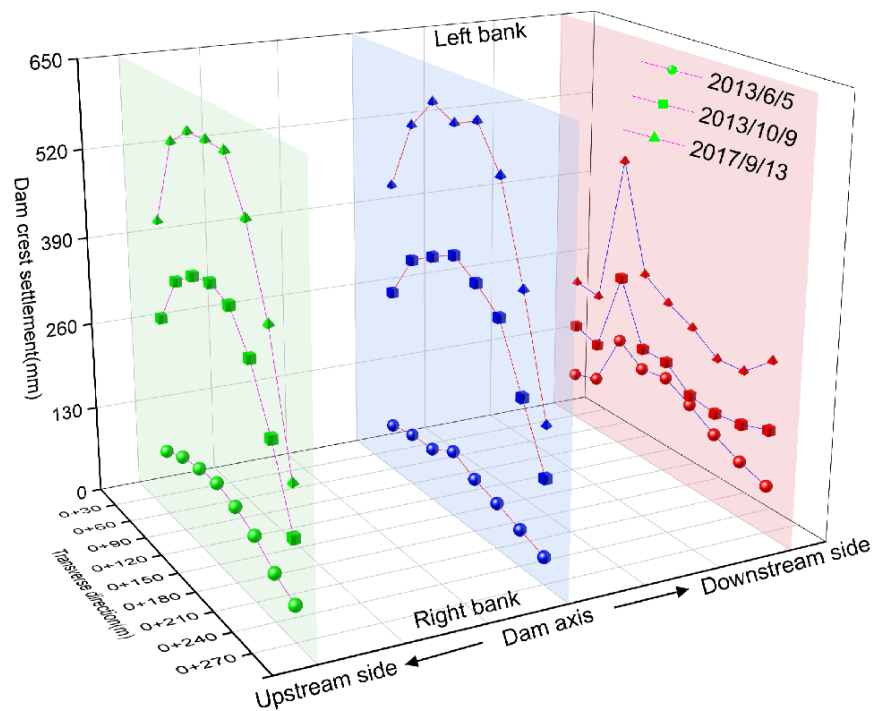
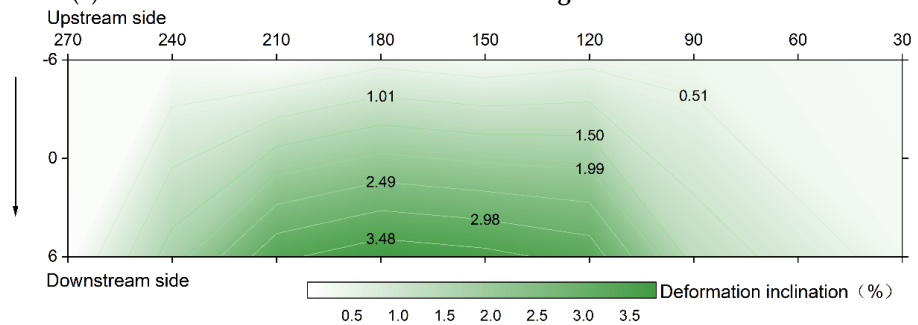
Figure 9. Uneven deformation of the dam crest.

The monitoring data indicate that dam crest cracking is related to the uneven deformation of the dam. Figure 9a shows the coaxial spatial displacement of a typical dam section over time. The settlement deformation of the dam crest decreases from upstream to downstream along the river, with a significant difference, reaching a maximum of 347.95 mm between adjacent measurement points. The dam gradually increases in the axial direction from both banks towards the riverbed, with the left and right banks showing relatively symmetrical distributions. There is a noticeable uneven deformation between the dam's upstream and downstream crests, which increases over time. Figure 9b shows the inclination distribution of subsidence deformation along the river as cracks emerged. It is observed that the inclination of settlement deformation along the river on the downstream side of the dam crest is larger in the riverbed bar section, with pile numbers 0 + 120 m to 0 + 210 m. This inclination decreases from the riverbed bar section towards both banks and gradually increases from upstream to downstream. When cracks were detected on October 2013, they corresponded to uneven riverside settlement deformation inclinations ranging from 3.29% to 3.79% in the range between 0 + 120 m and 0 + 210 m.

(a) Settlement deformation distribution along the dam’s axial direction.

(b) Contour map of downriver settlement deformation inclination on 8 October 2013.

To address uneven deformation, the design will incorporate strict design criteria and improve dam construction materials, such as core wall soil mixed with gravel to enhance compressive strength. However, in practice, it is crucial to strictly control construction quality, optimize the quarry mining program, and rigorously manage the grading of rockfill materials and dam filling construction quality to prevent uneven settlement caused by inconsistent filling.

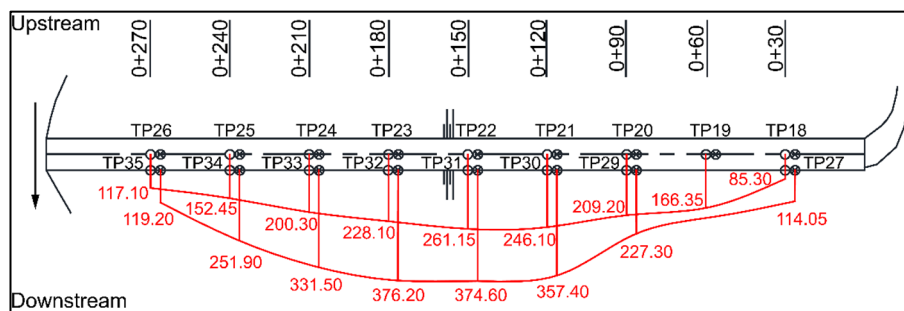
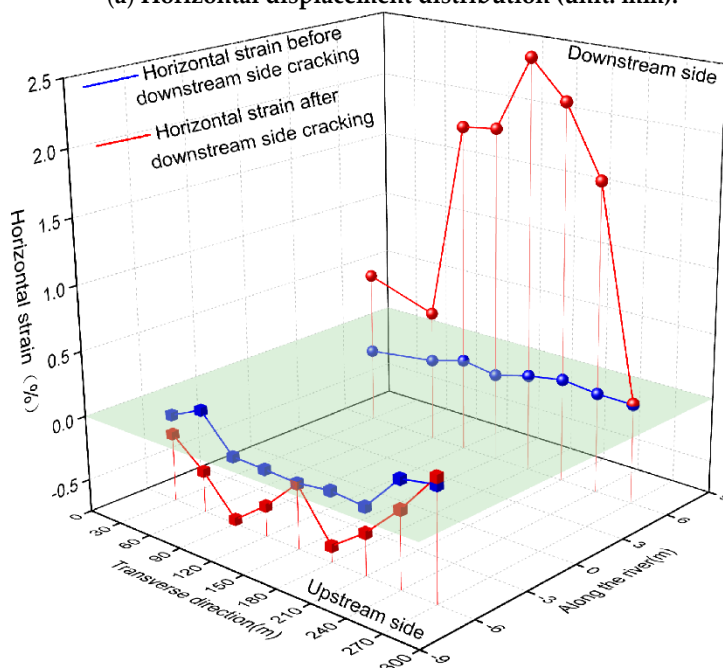
Figure 10. Deformation characteristics of horizontal displacement of the dam crest along the river on 8 October 2013.

Figure 10a shows the deformation characteristics of the horizontal displacement of the dam crest in the downstream direction for each dam section during cracking. It is evident that the overall manifestation of horizontal displacement of the dam crest along the river takes the form of an arc deformation downstream. Within the same cross-section, the downstream exhibits greater displacement along the river than the dam axis, with the maximum deformation difference occurring at the riverbed and gradually decreasing towards both banks. Figure 10b shows the calculated horizontal strain distribution along the river. The areas with high tensile stress are primarily located within the range of 0 + 120 m to 0 + 210 m, corresponding to the downstream longitudinal cracks, which is generally consistent with the spatial distribution of the cracks.

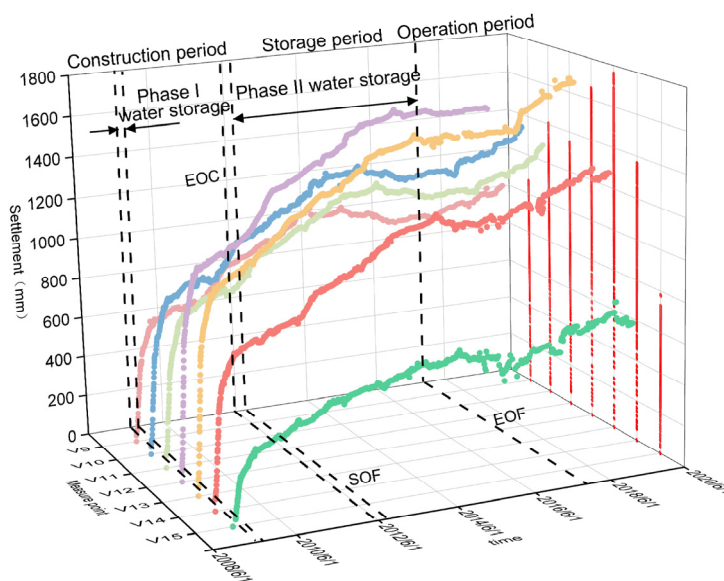
Figure 11 shows the internal settlement changes for the typical section EL2460 m. It is clear that uneven deformation within the dam’s low elevation began during the construction period and continued during the initial storage period. During the first phase of water impoundment, the deformation difference between adjacent measuring points ranged from 30 mm to 367 mm, gradually increasing over time. By the time the dam crest cracked in 2013, the deformation difference between adjacent measuring points had reached a maximum of 574.2 mm.

Figure 11. The 0 + 150 section 2460 m elevation water pipe settlement meter measuring point time-line (EOC, construction completed; SOF, water storage begins; EOF, water storage completed).

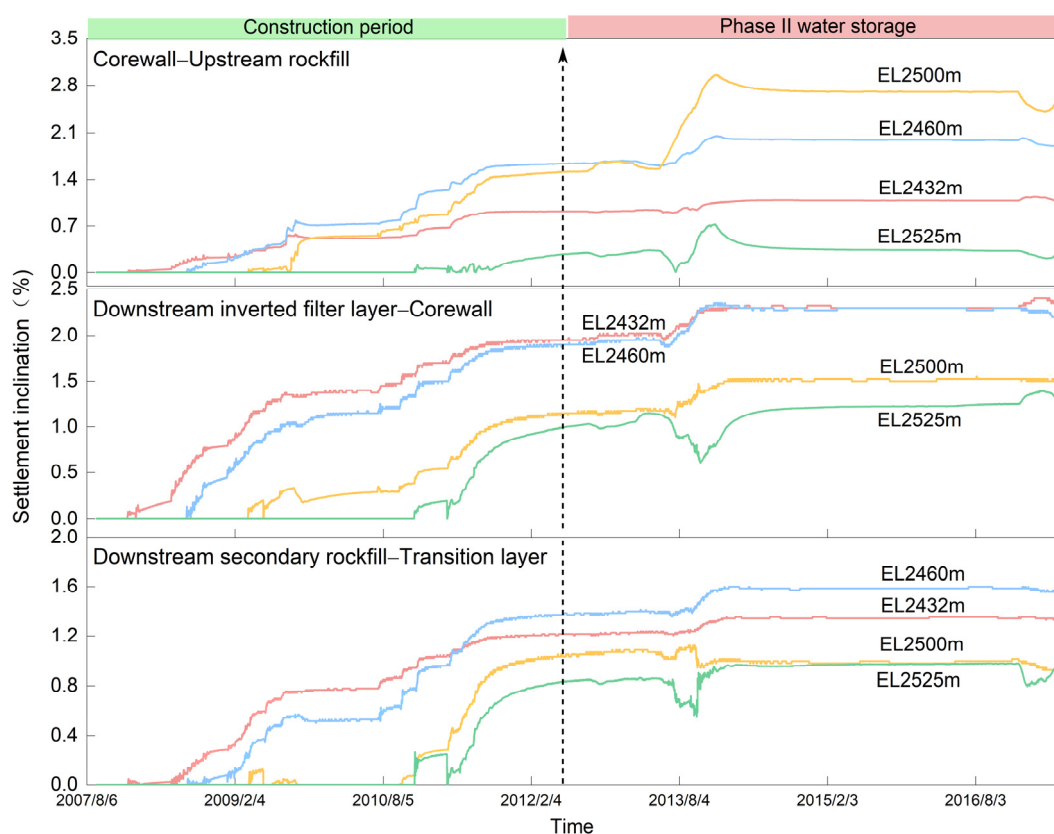
**Figure 12.** The development process of the dam internal deformation inclination obtained from numerical simulation.

A comprehensive analysis is conducted in connection with the finite element simulation of the deformation inclination calculation results for dam internal parts (Figure 12). The deformation inclination of uneven settlement between the downstream rockfill and the core wall primarily occurs during the construction phase. Due to the steep bank slope, the dam will undergo large shear deformation along that direction, forming a strong shear zone at the base of the adjacent rockfill and core wall. Within a certain width along the dam slope, the finite element calculation yields a deformation inclination value more than 1.6%, and the measured value exceeds 1.82%. The large modulus difference between the dam shell rockfill material and the core wall causes large uneven settlement along the river, leading to more severe miscut deformation. The deformation inclination is larger in the downstream contact area between the dam shell rockfill material and the core wall, with a finite element maximum of around 3%.

This is currently the main issue with rockfill dams. Since the shear zone or miscut deformation occurs within the high compressive stress-bearing interior of the dam, and because the rockfill is a bulk material, internal cracks will not form. However, if it is transmitted to the dam crest as the uneven settlement increases, transverse cracking deformation caused by uneven deformation of the left and right banks or longitudinal cracking deformation caused by uneven deformation of the upstream and downstream banks will develop. At the same time, the combined effect of tensile stress and shear caused by uneven horizontal deformation upstream and downstream will further exacerbate the development of cracks.

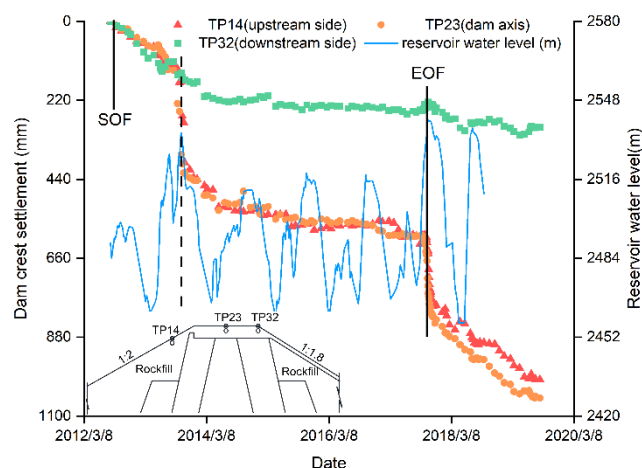
Figure 14 depicts a line graph of the historical settlement deformation process at the typical section 0 + 180 m. The figure shows that the dam experienced two deformation surges on 8 October 2013 and 17 October 2017. The initial abrupt change coincided with the discovery of cracks on the dam crest, and the following stage demonstrated further crack development. On both occasions, the stage of increasing water storage to high levels was reached, with the first instance occurring when the water storage level reached 2534 m and the second when it reached 2540 m. It is evident that the cracking and deformation of the dam crest are correlated with the water level.

**Figure 14.** Settlement duration process line on the dam crest of section 0 + 180 m (SOF, water storage begins; EOF, water storage completed).

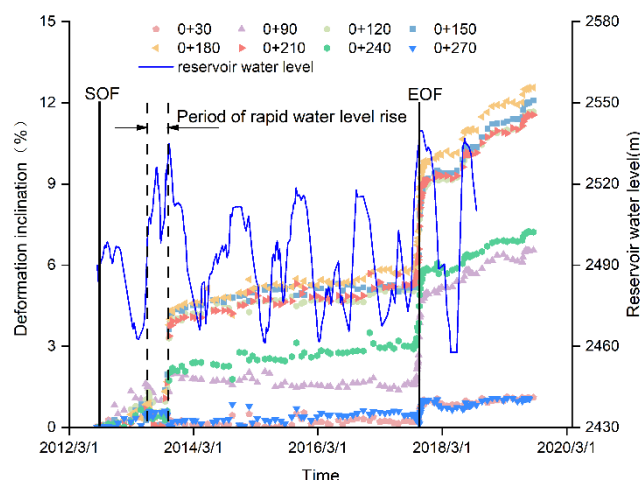
From the inclination time course curves of different sections at the dam crest (Figure 15), it can be seen that the first immersion and rapid rise to high water levels significantly impacted the uneven settlement of the soil. Before the water level was raised, the deformation rate ranged from 0.05 to 1.21 mm/d. However, the first impoundment caused an increase in the deformation rate, ranging from 1.74 to 10.05 mm/d. The deformation inclination of the downriver settlement in each section increased over time, surging particularly in 2013 during the period of rapid water level rise, with the inclination increasing from 0.34% to 3.79%. Following this, the inclination changes became more gradual, with minimal influence from water level fluctuations between storage cycles. However, a surge phenomenon still occurs when the water level rises rapidly to high levels. This behavior is consistent with the wetting of the rockfill materials. After being wetted by water, the particles in the upstream rockfill material will be rearranged as they transition from their natural state to a saturated state. At the same time, the internal friction angle and cohesion decrease, leading to large collapse and settlement after the initial immersion in reservoir water. In contrast, the downstream rockfill is not directly affected by reservoir water and is less susceptible to wetting.

Figure 15. Downriver settlement deformation inclination of each section of the dam over time.

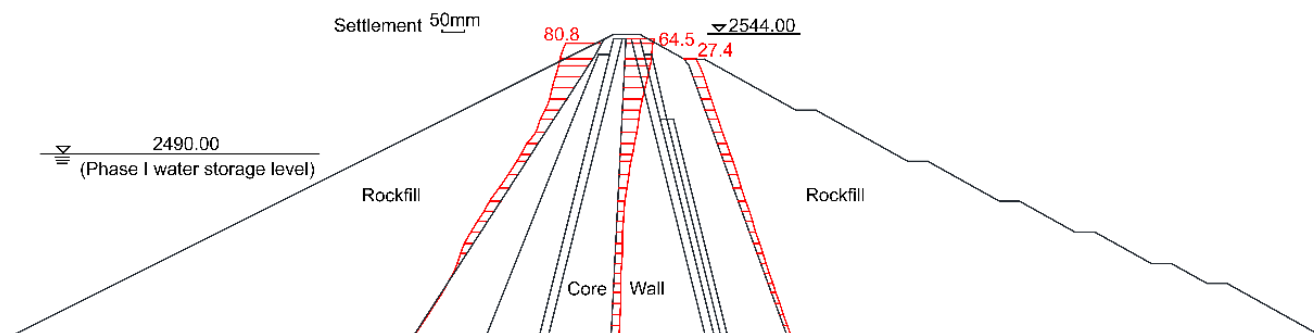
This is further confirmed by the distribution of vertical displacement increment in the 0 + 150 m section during this period compared to the completion period in the numerical calculation results (Figure 16). The overall settlement increment rises with the elevation, and the settlement changes in the upstream rockfill and core wall areas are similar, while the settlement increment in the downstream rockfill is the smallest. The numerical calculation results were analyzed using the deformation inclination method, as shown in Table 5. During the first storage period, the overall increase in deformation inclination along the river settlement was small. Except for a 0.25% increase near the upstream face, all remaining increments were below 0.2%. The greatest deformation inclination increment was 0.46% during the rapid rise in water level in 2013. This indicates that the uneven settlement of the dam during the initial storage period is more sensitive to high storage levels, resulting in more severe wetting deformation. The uneven settlement in different subintervals of the dam increases, resulting in failures such as dam crest cracking and dam seepage due to uneven deformation.

Rockfill is a noncohesive material. When saturation reaches a certain point, it has little effect on the magnitude of wetting deformation. As a result, it is widely assumed that wetting has a greater impact on rockfill dam deformation during the initial storage period and then gradually weakens. The phenomenon of a sharp increase in deformation inclination when the water level reaches a certain elevation during dam operation remains a contentious issue. Some scholars believe this is due to the continued deterioration of the rockfill mass under the dry-wet cycle and repeated stress. To control the uneven deformation caused by the dam's wetting characteristics during the initial storage period, it is recommended to manage the water storage rate, allow a sufficient settlement period, and then proceed with the construction of the dam crest structure once the settlement is stable to prevent the dam crest cracking.

Figure 16. Settlement displacement increment when cracks occur compared to completion.

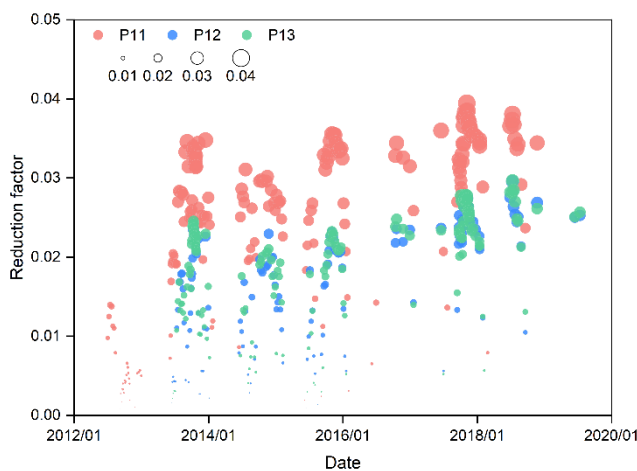
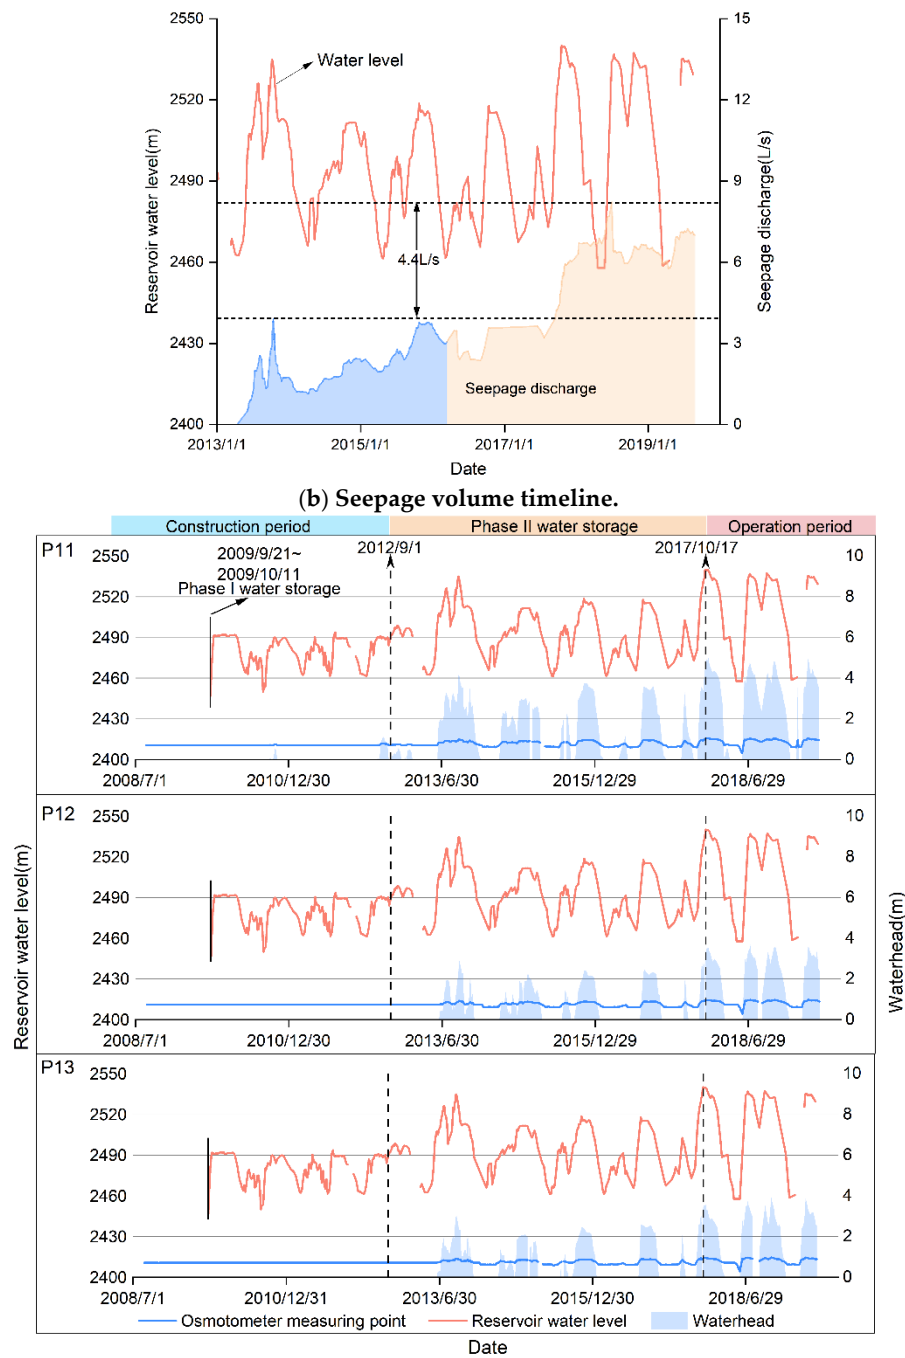
(c) Dam seepage pressure measurement timeline.  
**Figure 17.** Seepage changes in the dam.

Figure 17 depicts the changes in seepage pressure and volume in the rockfill area downstream of the dam over time. Prior to the second phase of water impoundment, the seepage pressure values at each measurement point remained relatively stable. Except for a 0.4-m water head at P11, no significant water head was observed at the other measurement points. The measured seepage pressure was positively correlated with the reservoir water level, especially following a rapid increase in 2013. After impounding water to an elevation of 2536 m, the water head at each measurement point in the downstream rockfill area increased from 2.91 m to 4.20 m over the pre-impoundment levels. According to the dam operation records, the minimum value of the seepage manometer after impoundment is primarily controlled by the water level, which occurs when the water level is low. The maximum value is observed when the reservoir is first impounded to its normal water level, and the maximum seepage manometer value remains relatively constant during subsequent normal high impoundment periods. No obvious anomalies were detected in the measured data. However, in 2017, when the water level rose to a high level, high-level seepage was observed in the uppermost observation room on the downstream horse trail.

The analysis revealed that the seepage manometer functions in a point monitoring mode, potentially missing seepage occurrences in the uppermost downstream range of the horse trail. Consequently, the use of new means that can satisfy surface and body monitoring should be the direction of monitoring development. At the same time, the seepage pressure head at the bottom of the downstream rockfill area is strongly related to changes in the reservoir water level, and the seepage volume at the water collection well doubled, with only a 4-m increase in the maximum water level. This is inconsistent with the general seepage rules of core wall rockfill dams and could be attributed to abnormal high-level seepage. The cause of high-level seepage is currently being investigated and analyzed. To prevent high-level seepage potentially caused by local damage to the core wall from dam crest cracking, the project has implemented grouting treatment on the core wall.

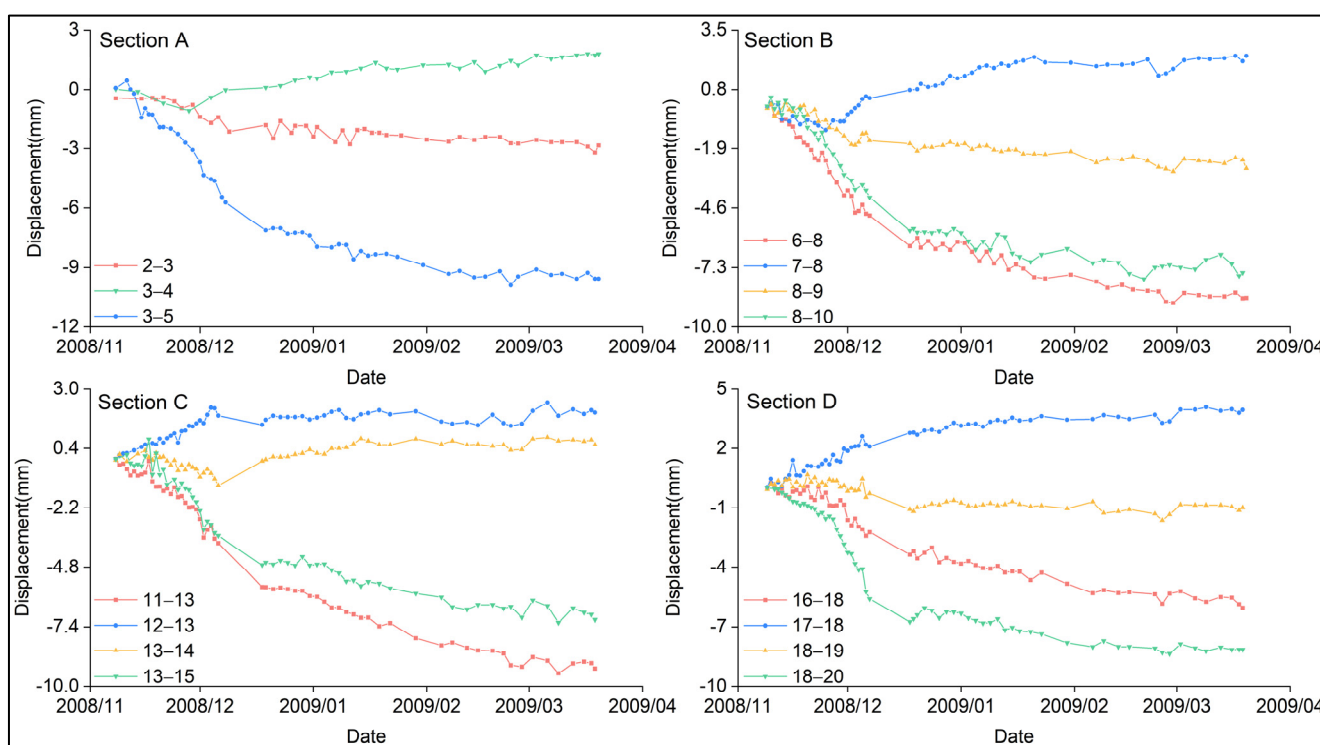
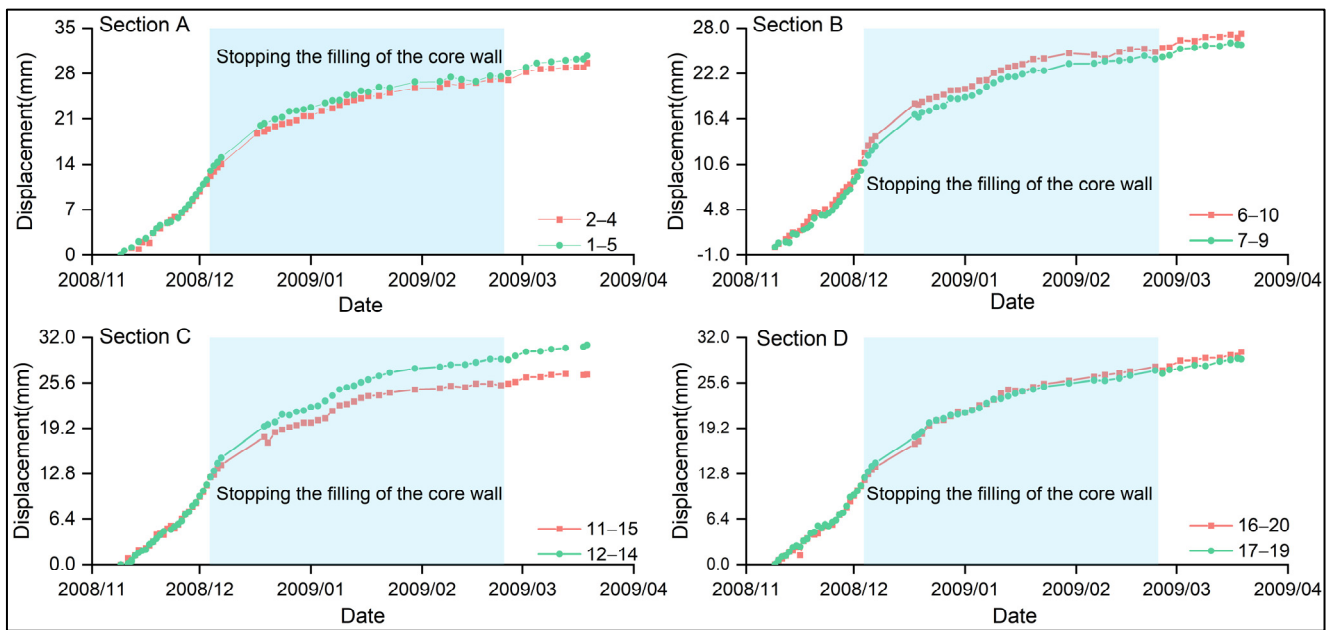
Figure 18. Temporary convergence observations.

Following the Wenchuan Earthquake in 2008, several cracks measuring 10 mm wide and 80 m long appeared in the observation gallery of the dam. Prior to the gallery reinforcement construction, monitoring results during the temporary convergence observation period from 8 November 2008 to 19 March 2009 (Figure 18) revealed that the distances between the top arch point of the four monitoring sections and the measuring points on the upstream and downstream sidewalls decreased, with generally negative changes. The cumulative value was around -8 to -10 mm. Notably, the top arch of the gallery exhibited significant deformation in the free space direction. The cumulative displacement increment between the same elevation measuring points on the upstream and downstream side walls was about 28.00 mm. The upstream and downstream sidewalls of the gallery

showed obvious deformation in these directions, with the displacement change rate increasing as the core wall was filled. After the core wall filling stopped for a while, the deformation rate gradually slowed. Combined with the gallery structure analysis, the seepage prevention for the dam foundation covering layer was addressed by constructing a 1.20-m-thick concrete anti-seepage wall in the bedrock, reaching a maximum depth of 103 m. The gravel core wall forms the upper portion of the anti-seepage wall, which is topped by a grouting gallery. The gallery clearance size is 3.50 × 4.00 m, with sidewalls and a top arch thickness of 1.0 m and bottom plate thickness of 3.65 m (Figure 19). Therefore, the core wall exerts pressure on the upper part of the grouting gallery, while the anti-seepage wall supports the lower part, forming a complex stress structure. The earthquake, as an external force, diminished the overall performance of the core wall rockfill dam. The varying deformation of different materials caused significant deformation on both the upstream and downstream sides of the gallery floor, resulting in high tensile stress and leading to cracking in the gallery floor.
