**Abstract:** The present paper addresses the litho-dynamic and morpho-dynamic processes in the coastal zone of Babie Doły (KM 93.6–93.9), Poland. As a background, the history of coastal engineering measures in this area is described. The impact of post-war structures on the seashore is analysed on the basis of historical maps, supported by results of the sediment transport modelling. Shore regression is caused by the so-called downstream erosion behind the headland with remains of rock palisade structures. The possible consequences for the seashore resulting from the removal of the analysed revetment are discussed. The paper also presents recommendations to the relevant authorities for the future.

Citation: Szmytkiewicz, P.; Ostrowski, R.; Cerkowniak, G.R. Impact of the Revetment on the Seashore in the Region of Babie Doły (KM 93.6–93.9), Poland. *Appl. Sci.* 2022, 12, 668. https://doi.org/ 10.3390/app12020668

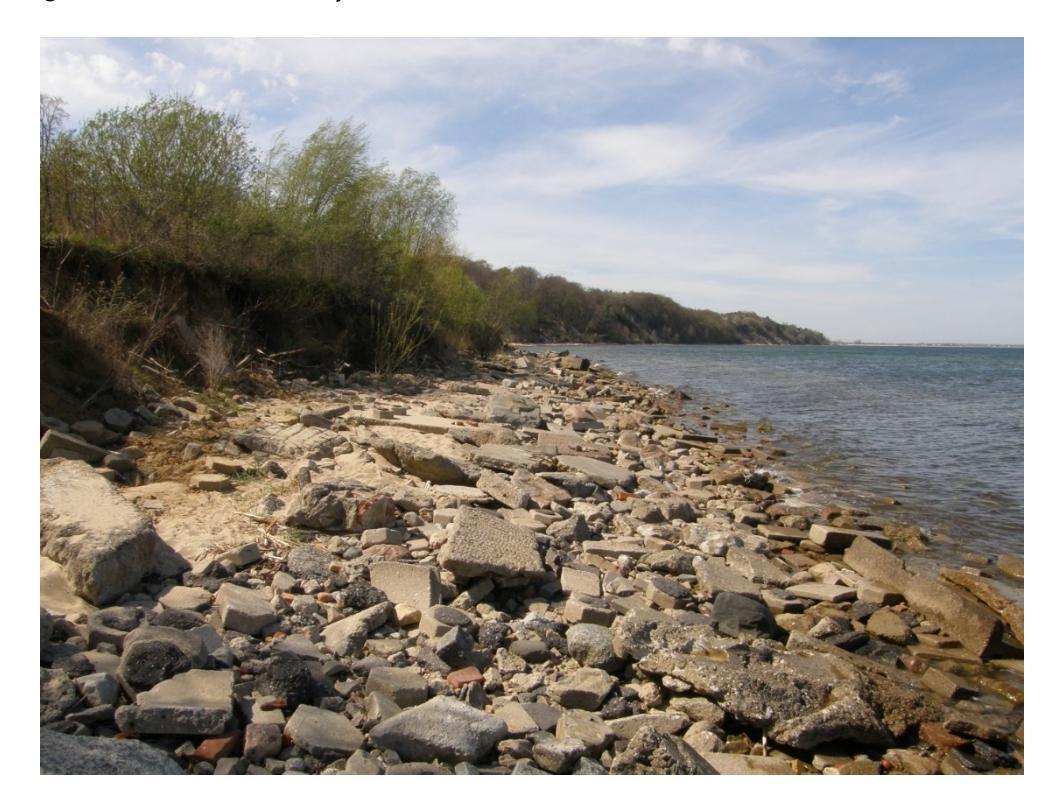
Figure 2. Revetment on the seashore in the region of Babie Doły (KM 93.6–93.9).

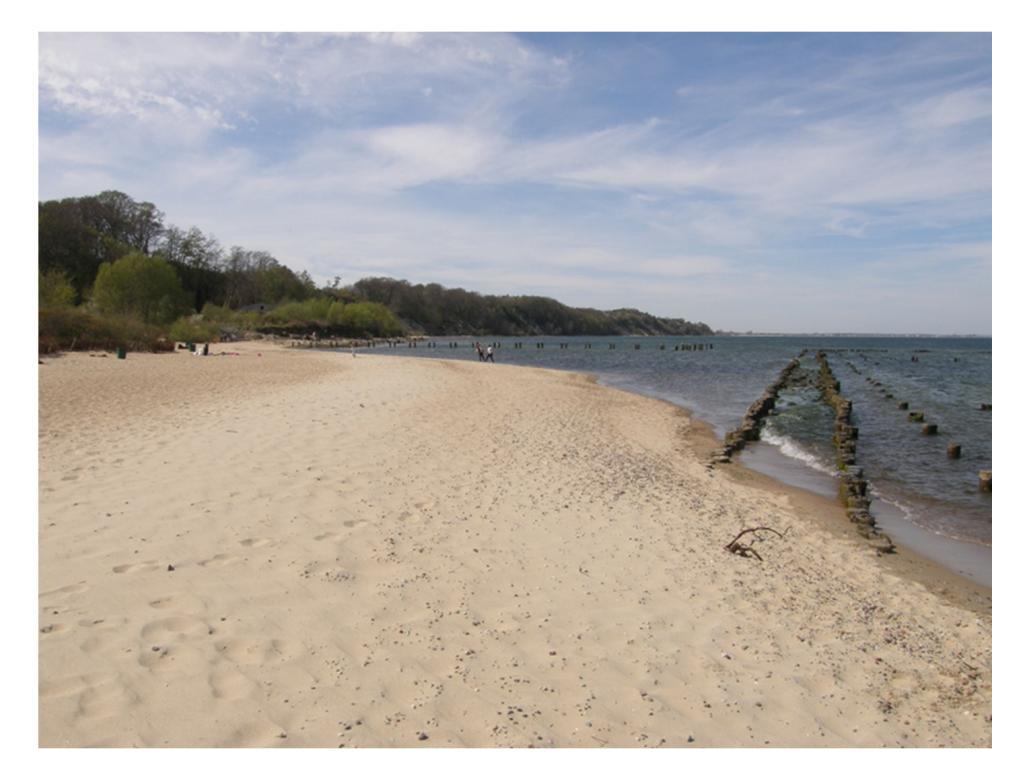
**Figure 4.** Seashore near KM 93.4–93.5; view to the north; sea state: 501 cm; 13.00 UTC, 10 May 2021 (photo by R. Ostrowski).

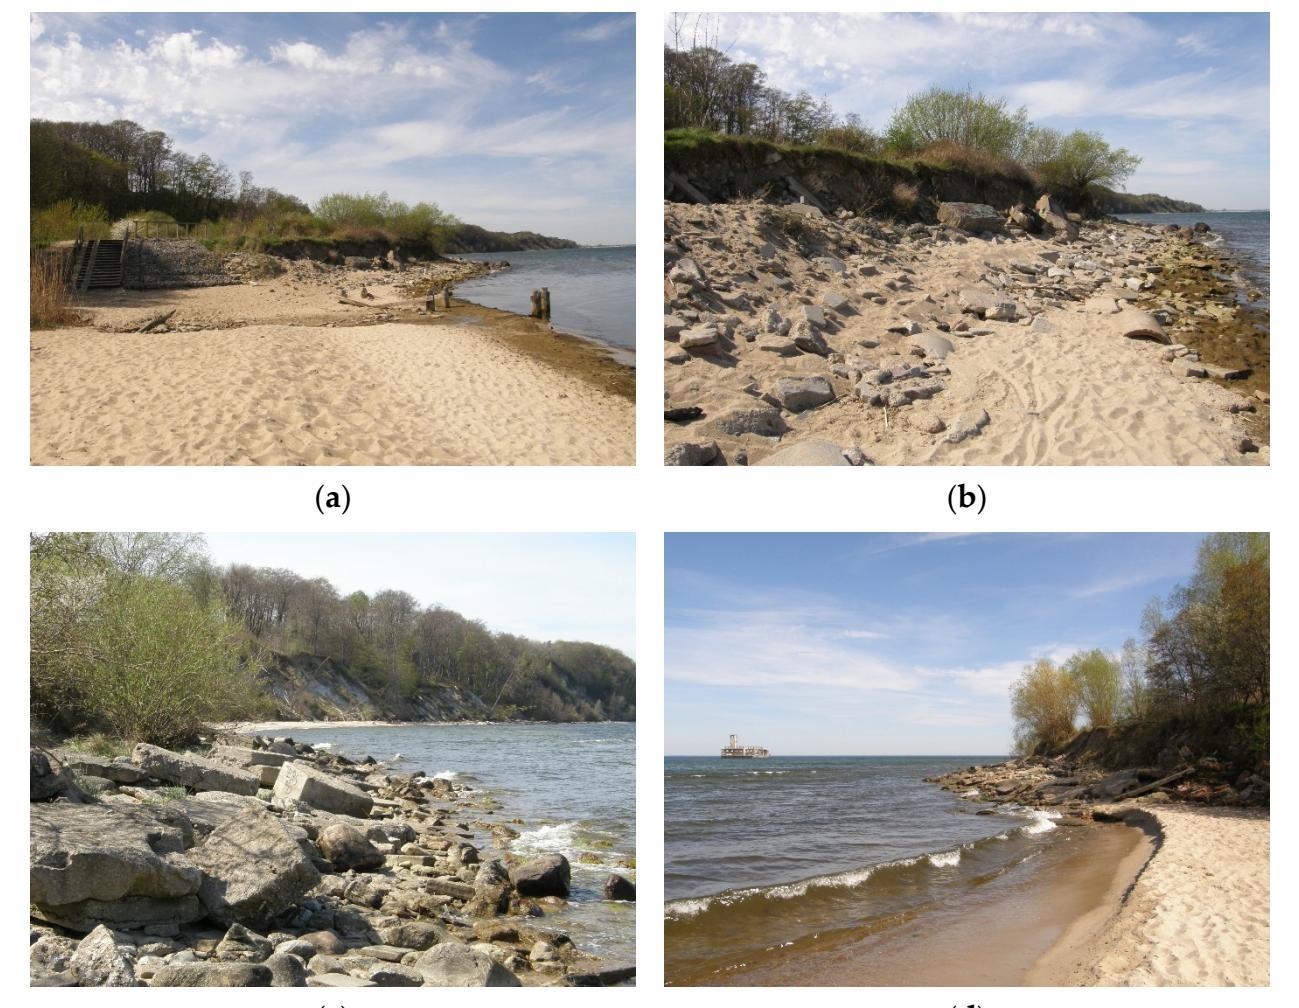
about 150 m northwest of the headland (KM 93.6), the seashore is protected by a revetment built of rubble concrete, approximately 300 m long (Figure 5).

**Figure 5.** Revetment at KM 93.6–93.9; (a) seashore directly before the revetment at KM 93.55; (b) southern end of the revetment at KM 93.6; (c) middle section of the revetment at KM 93.8; (d) northern end of the revetment at KM 93.9; sea state: 501 cm; 13.00 UTC, 10 May 2021 (photo by R. Ostrowski).

On the other hand, however, taking into account the function performed and the effectiveness of seashore protection to date, it is not recommended to disassemble the structure until an alternative structure is designed, e.g., similar to the nearby reinforcement of the shore at KM 92.62–92.95 in the form of a rock–palisade–gabion revetment. It is advisable to preserve the existing protection of the shore in the near future, and possible measures aimed at the modernisation of the protection system should be postponed until plans to build a marina in the area become final. The issue of shore protection should be integrated with the planned marina.

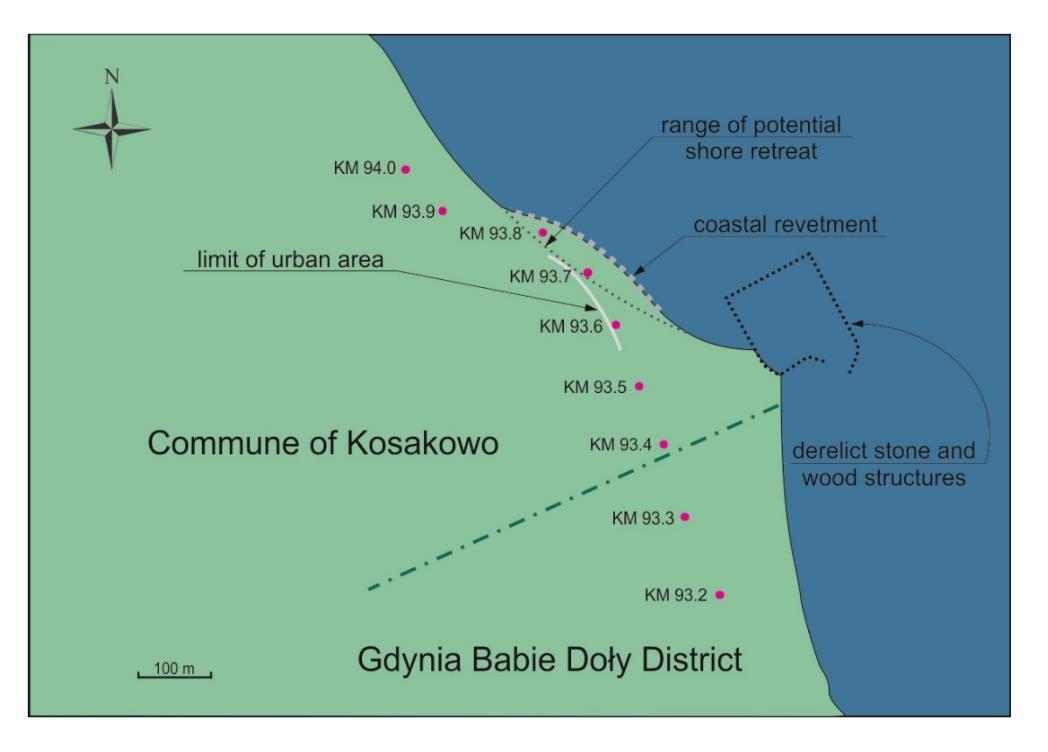
The removal of the revetment, e.g., for aesthetic reasons, will result in coastal abrasion at this location, posing a threat to the safety of buildings situated in the immediate vicinity. The approximate range of potential coastline regression and the range of building development and functional urban areas with a pavement are shown in Figure 13.

**Figure 13.** Range of potential coastal regression and of the existing building development in the section protected by the revetment (KM 93.6–93.9).
