Effect of Flue Gases' Corrosive Components on the Degradation Process of Evaporator Tubes

An inspection was carried out on the device serving for more than 30 years and revealed perforations on the evaporator tube.

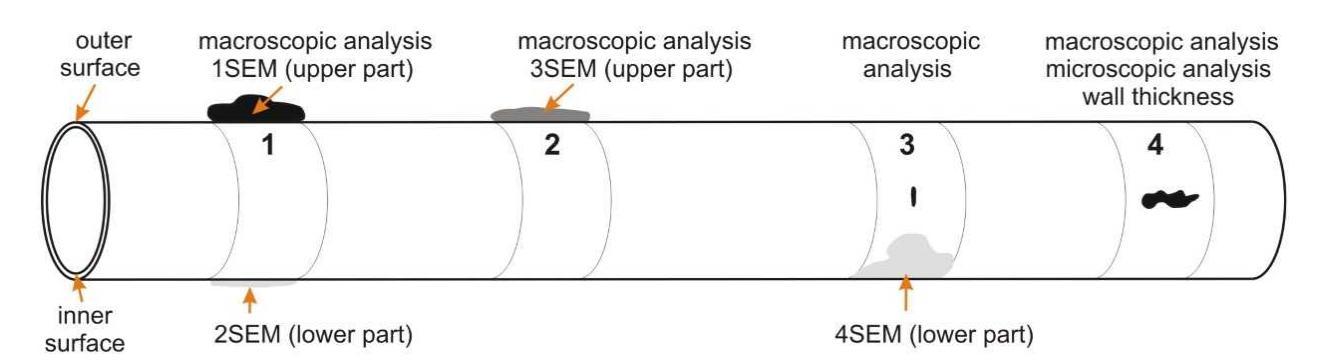
For macroscopic analysis, the small parts were cut from the evaporator tube, with different types of damage nature, and marked as 1, 2, 3, and 4 (Figure 2). Marking of the samples with the description of analyses is presented in Table 3.

Figure 2. Schema of evaporator tube with the location of cutouts assigned for analyses according to Table 3.

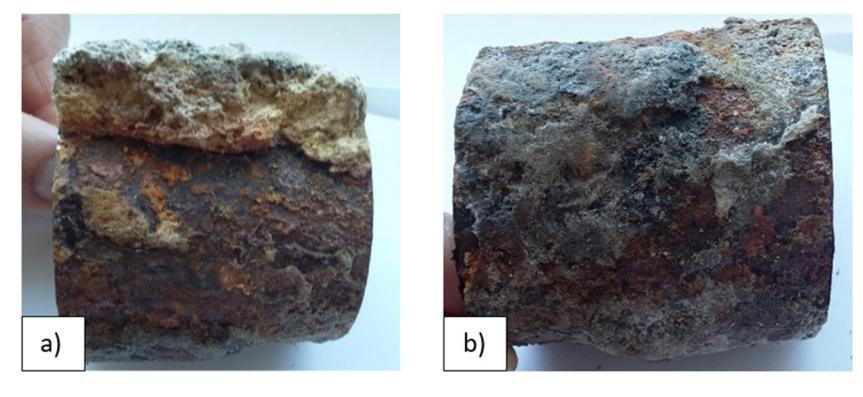
During the combustion process, a thick deposit layer was formed, located on the outer surface of the evaporator tube (Figure 3). This deposit layer was embossed, non-uniform, with different colorations (e.g., light-ocherous coloration corresponds to ash deposit).

Figure 3. The cutout from the evaporator tube: (**a**) massive deposit layer on the cutout 1; (**b**) deposit layer on the cutout 2 (according to Figure 2).

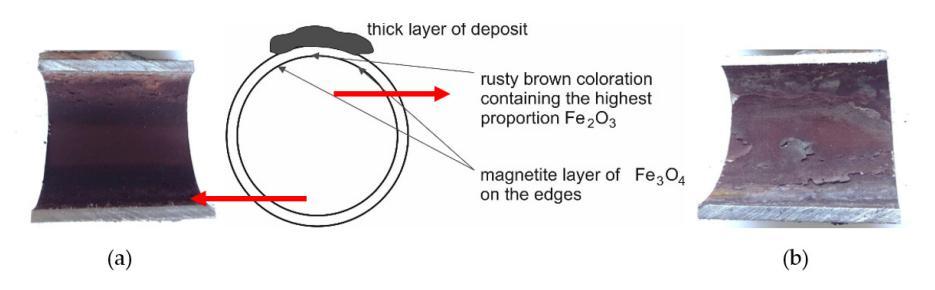
The inner surface of the tube from the cutout in Figure 3a (below the deposit layer) is shown in Figure 4. The color of the corrosive layer formed on the inner surface is rusty brown in the central part, containing the highest proportion of Fe_2O_3 , and at the edges is formed by a magnetite layer of Fe_3O_4 . While in the lower part of the tube (on the left in Figure 4a), the corrosion layer was well adhered, in the upper part of the tube, the corrosion layer was separated from the surface (on the right in Figure 4b). Under the deposit, the steel material was overheated due to the deterioration of heat transfer through the tube wall, resulting in a loss of magnetite adhesion to the inner surface of the water wall tube.

Figure 4. The inner surface of the cutout 1 tube with a massive deposit: (a) the lower part of the tube;(b) the upper part of the tube placed under the deposit layer according to Figure 3a.

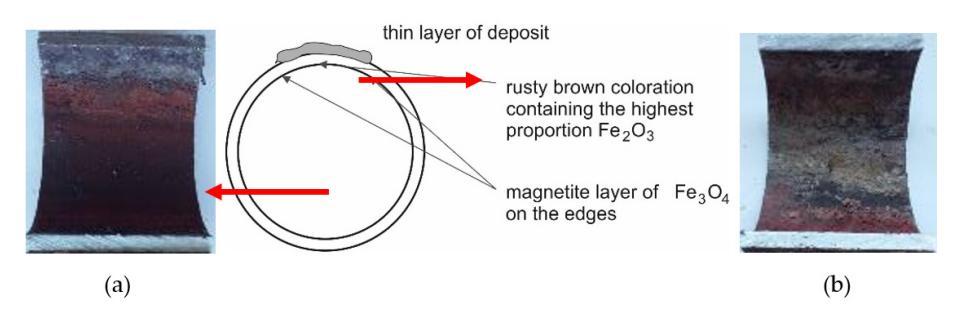
In Figure 5 is a documented inner surface located below the deposit on cutout 2 (Figure 3b). A significant proportion of hematite is visible on the lower part of the tube, while on the upper part, there is mainly magnetite with a surface formed by mineral deposits with a white-gray coloration based on Ca, respectively Mg. This fact was also confirmed by EDX analysis. The figure shows the interface created by the condensation of water vapor during the shutdown.

Figure 5. The inner surface of the cutout 2 tube with the deposit: (**a**) the lower part of the tube; (**b**) the upper part of the tube placed under the deposit according to Figure 5b.

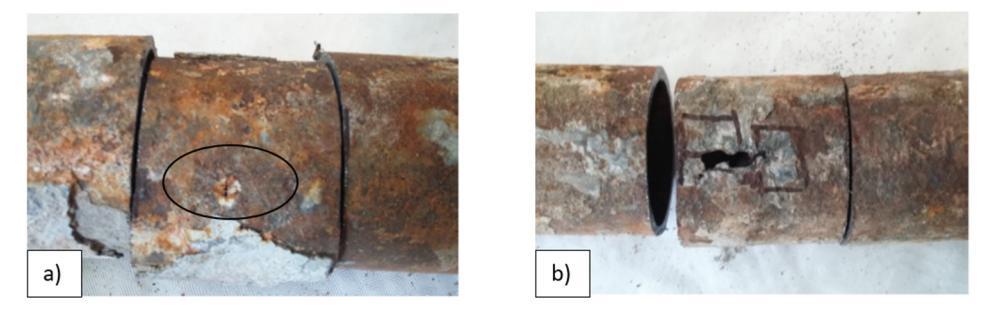
Cutouts 3 and 4 were prepared from areas with the large extent perforations (Figure 6a) and the small extent perforations (Figure 6b) of the tube wall. The small perforation was

covered with a well-adhered corrosion layer on the steel surface, as can be seen in Figure 6a. Therefore, its presence was not detected even with such a size. The large perforation was detected not only because of its extended size but also due to the loss of adhesion of the corrosion layer on the surface.

Figure 6. (a) Cutout 3 with a place of perforation of a small extent; (b) cutout 4 place of perforation of a large extent.

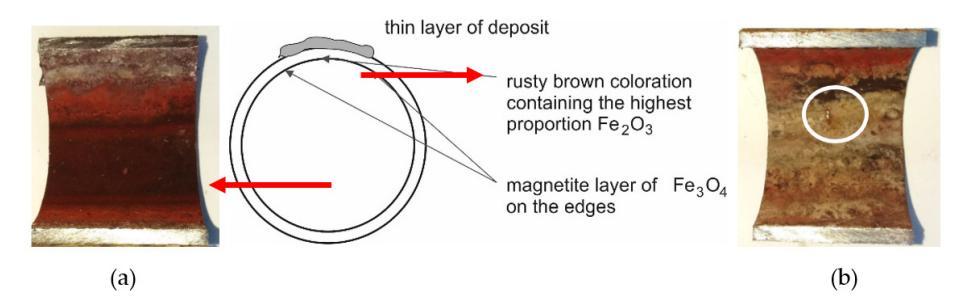
Figure 7 shows the inner surface of the cutout 3 of the tube from a place with a perforation of a small extent (Figure 6a). The image shows a dark gray, very embossed magnetite corrosion layer with pitting defects that can extend to the steel base. This layer is covered with a rusty brown colored hematite in several areas. Areas with light gray to white coloration (mineral salt content) indicate insufficient water treatment (Figure 7b).

Figure 7. The inner surface of cutout 3 with the deposit: (**a**) the lower part of the tube; (**b**) the upper part of the tube placed under the deposited layer according to Figure 6a.

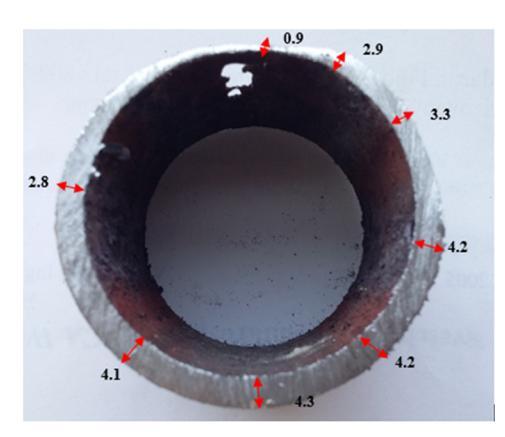
The tube damage of a large extent (Figure 6b) occurred on its upper part, at the place of the smallest wall thickness of the tube (Figure 2, place 4). The surface of the tube was in this area without the cover of corrosion products of greater thickness. Figure 8 documents an ununiformed tube wall thickness with a minimum measured wall thickness of 0.9 mm (the original tube wall thickness at the beginning of operation was 5 mm).

Figure 8. The wall thickness of the evaporator tube at the perforation area; wall thickness (in mm).

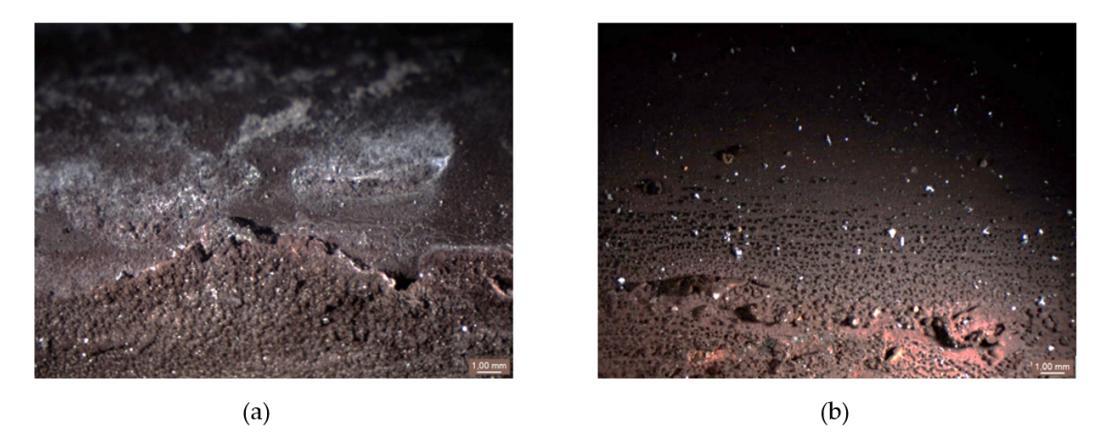
Detailed images of the lower part of the tube, the cutout 4 (according to Figure 2), from the place of a large extent tube wall perforation are shown in Figure 9. The inner surface is covered with a magnetite layer, the thickness of which is the largest on the bottom surface of the tube. Areas with a light gray to white color (mineral salt content) indicate insufficient feedwater treatment. The area with the different morphology of the corrosion layer represents the interface of the condensed water vapor level (Figure 9b).

Figure 9. (a) The overall view of the inner surface of the tube bottom part from Figure 8. This is cutout 4 with a perforation of a large extent, according to Figure 2; (b) the corrosion layer on the interface of the condensed water vapor level.

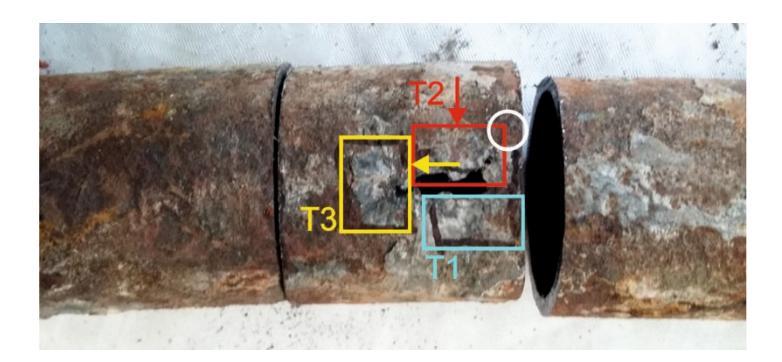
Three samples, marked T1, T2, and T3, were taken from cutout 4, i.e., from a place with a large wall perforation for analyzing the structure of the evaporator tube and the nature of its damage. Sampling points, as well as the indication of analyzed areas, are clear from Figure 10.

Figure 10. Sampling points T2, T3 with observed areas (indicated by arrows). On sample T1, the observed area was parallel with the outer surface of the tube.

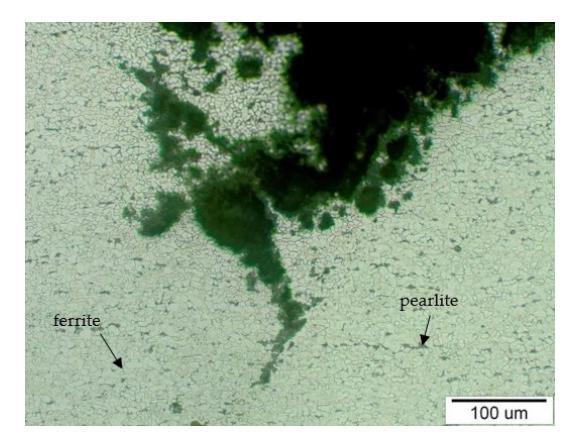
In Figure 11 is documented the structure of steel with ferrite (light grains) and pearlite (dark grains) analyzed on sample T1. The steel structure is relatively uniform in terms of grain size and distribution of structural components and corresponds to the declared steel W. Nr. 1.1148 after normalization heat treatment. The structure refinement was visible in the vicinity of the crack, in the part of the tube where the highest decrease in the wall thickness was found, down to a thickness of 0.9 mm. This structure refinement is the result of an abrasive wear process, which caused the loss of material from the upper part of the outer tube surface, and at the same time during this process, there was a strain hardening of the structure. The structure refinement was observed along the entire crack edge and in the structure bounding the crack, as is documented in Figure 11.

Figure 11. The steel structure corresponded to steel W. Nr. 1.1148 (consisting of the light ferrite grains and the dark pearlite grains) with a crack crossing into the material, sample T1 (etch, Nital).

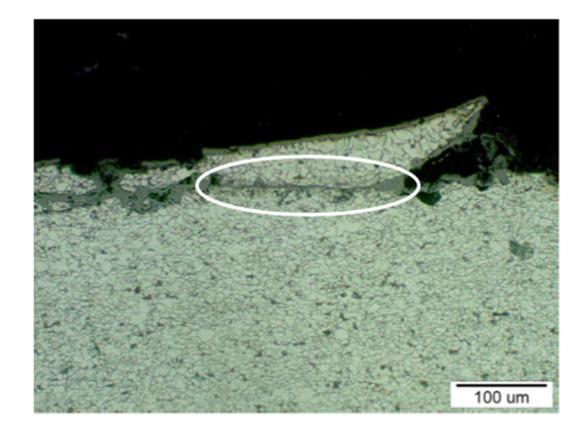
Figure 12 shows the place of the beginning of the crack extension on the sample T2 (in Figure 10, this location is indicated with a white outline). The surface of the crack was covered with a corrosive layer, especially during its extension in the material. A slightly deformed structure, which is color-marked in the figure, was observed in the vicinity of the corrosion layer. Figure 13 shows sample T3 with the edge of the crack separating parts of the material. Gradual polishing reduced the distance of the separated parts of the material due to the wedge-shaped crack growth towards the inside of the steel tube wall.

Figure 12. The area with the beginning of the crack extension in the steel structure, according to Figure 10, where it is marked with a white outline; etch, Nital.

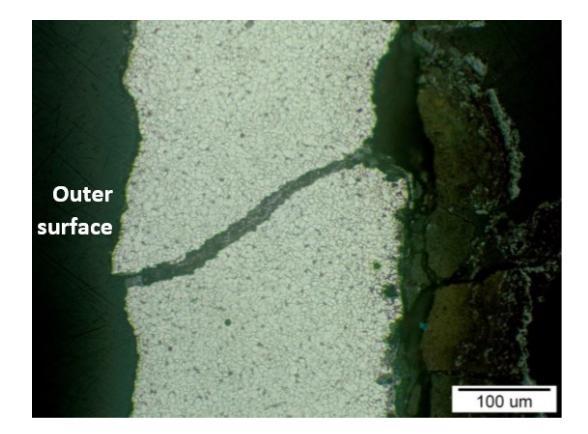
Figure 13. The development of the crack towards the inside of the material with the corrosion layer on the inner surface of the sample T3 (in Figure 10 is the observed area indicated by the yellow arrow); etch, Nital.

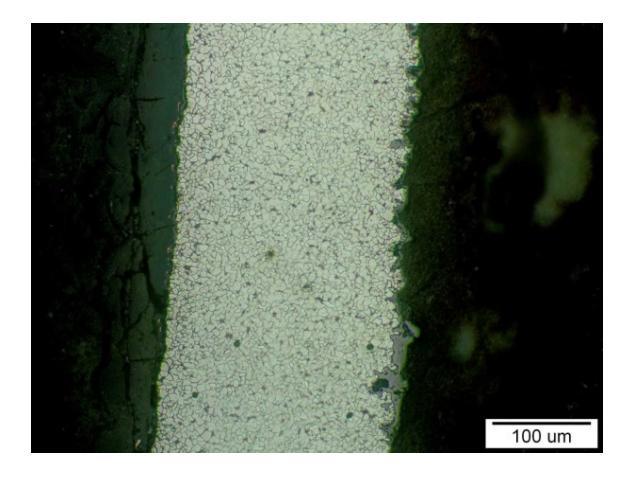
In Figure 14 is documented the sample T3's outer and inner surfaces with the corrosion layer, in the cross-section of the evaporator tube, outside the area of the propagating. After abrasive wear from the flue gas side, only a part of the corrosion layer remained attached to the outer surface. Its good adhesion was also ensured by the proportion of contained mineral components (which was also confirmed by EDX analysis), which with the Fe oxides formed a hard "shell" on the surface. The inner surface is covered with a relatively thick corrosion layer. Its growth has intensified because of the material's local overheating as its thickness decreases.

Figure 14. The outer surface (left) and the inner surface (right) of the T3 sample with a corrosion layer on the inner surface. On the outer surface is a visible part of the corrosion layer that remained attached to the surface; etch, Nital.

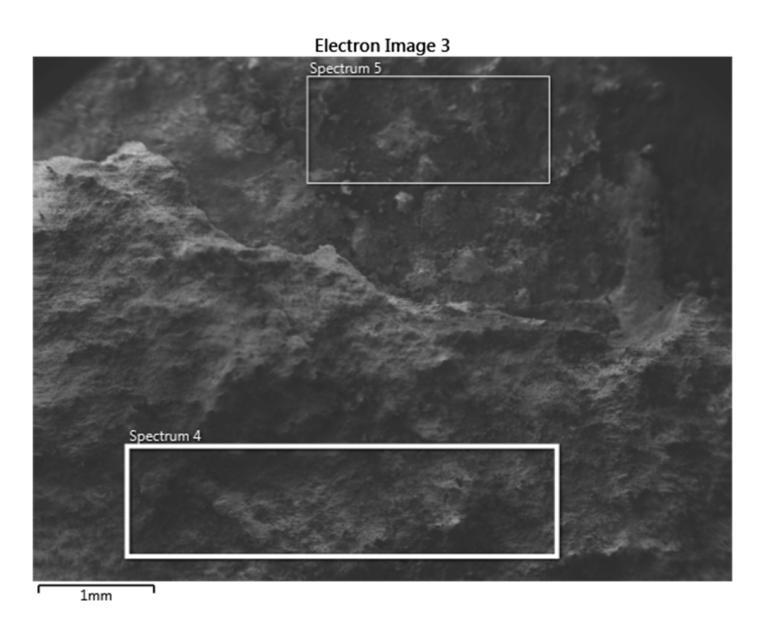
SEM analysis was performed on each outer and inner surface of the tube samples. Figure 15 documents the outer surface of the 1SEM sample (according to Figure 2), and Figures 16 and 17 show the qualitative SEM analysis in the form of Spectrum 4 and 5. Summary quantitative analysis of the chemical composition of all analyzed outer and inner surfaces of the samples according to Figure 2, is shown in Table 4.

Figure 15. The outer surface of 1SEM sample with analyzed Spectrum 4 and 5 areas; SEM.

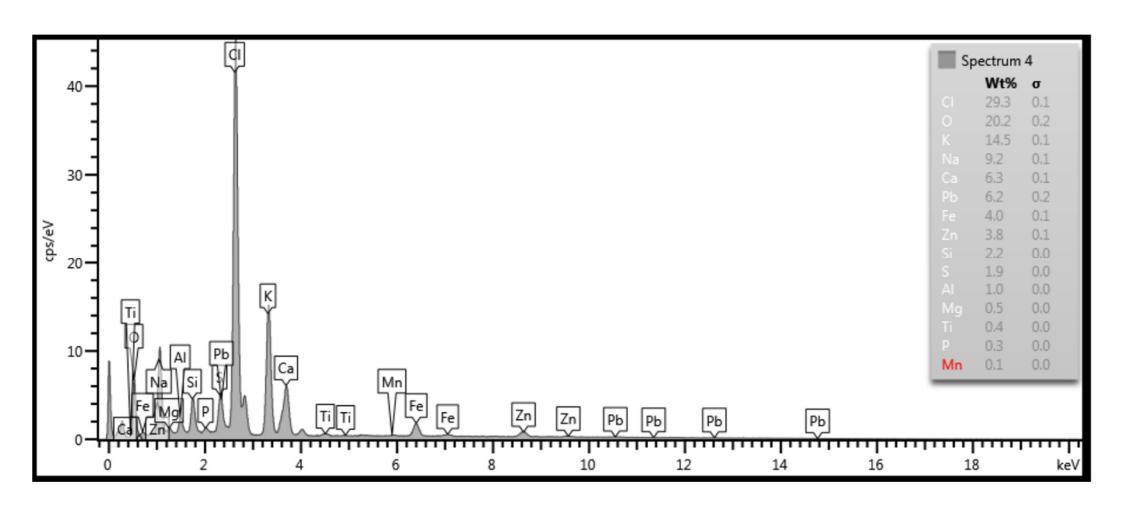
Figure 16. Spectrum 4 according to Figure 15; SEM.

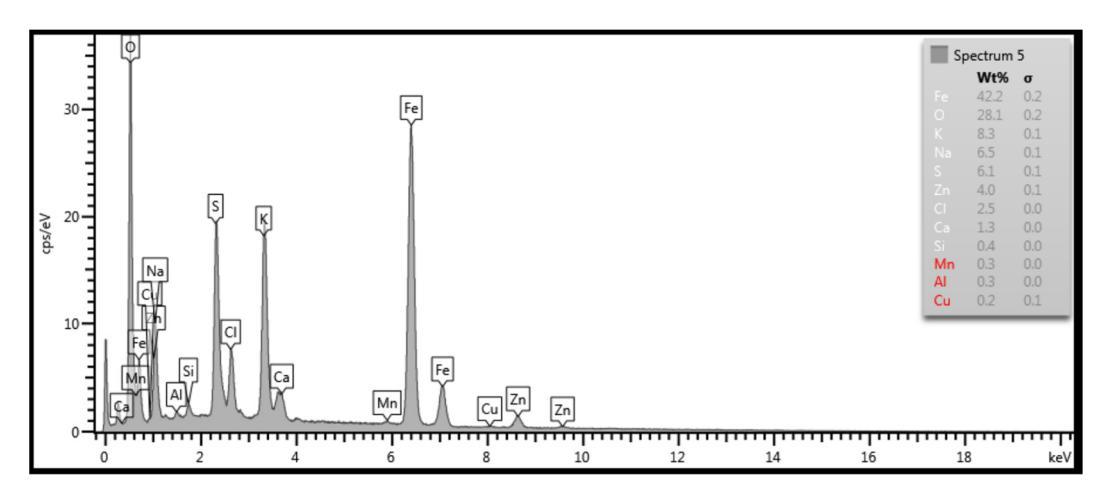
Figure 17. Spectrum 5 according to Figure 15; SEM.
