# Article Static Liquefaction Causes the Flow Failure of a Tailings Dam: A Case Study of El Descargador, Cartagena–La Unión Mining Region, SE Spain (October 1963)

Keywords: dam collapse; flow failure; mine tailings; electrical resistivity imaging

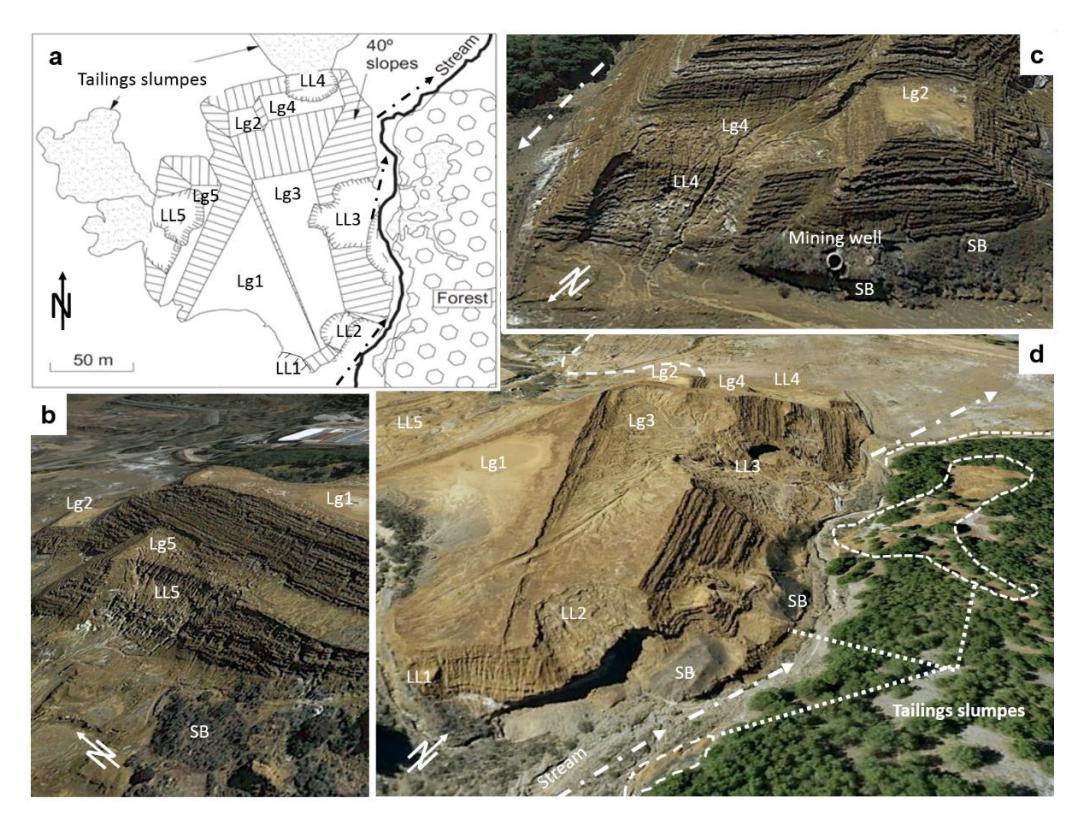
**Figure 2.** (a) Layout of El Descargador tailings dam depicting the localization of different landslides (LL), lagoons (Lg), and fragments of breakwater (SB) and some are affected for flow failure. The discontinuous arrow indicates the direction of the runoff, (**b**–**d**) Obliquus aerial views of the dam from different perspectives; source Spanish National Geographic Institute-IGN and Google Earth©. Schemes follow the same formatting.

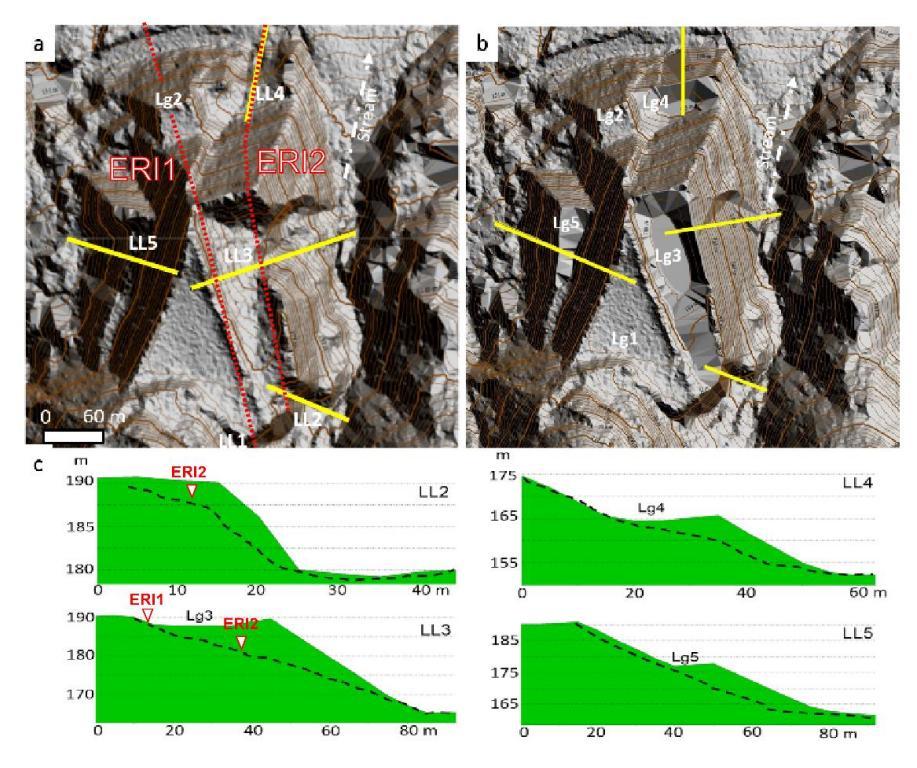
**Figure 3.** (a) ERI profiles layout on a hill shaded elevation models of El Descargador tailings dam; (a) actual state; (b) tentative reconstruction of the relief before the 1963's failure; and (c) Representative topographic profiles of the main landslide before (green) and actual surface of failure dashed lines. The white dashed arrow indicates the stream runoff direction.

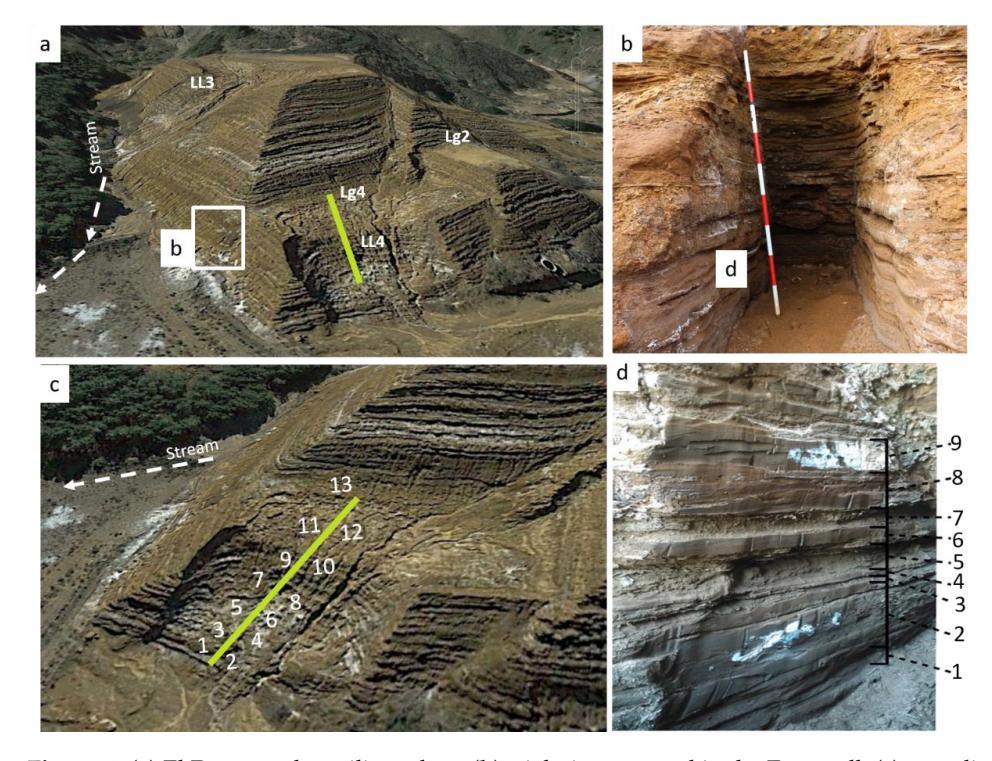
**Figure 4.** (a) El Descargador tailings dam, (b) trial pit excavated in the East wall, (c) sampling points of sand dikes exposed on the surface of the landslide four (LL4), (d) detail sedimentary layer and sampling points by different layer in vertical profile. The white color indicates the precipitation of the different types of sulphates that contribute to the cementation of the tailings in the dam. The discontinuous arrow indicates the direction of the stream runoff.

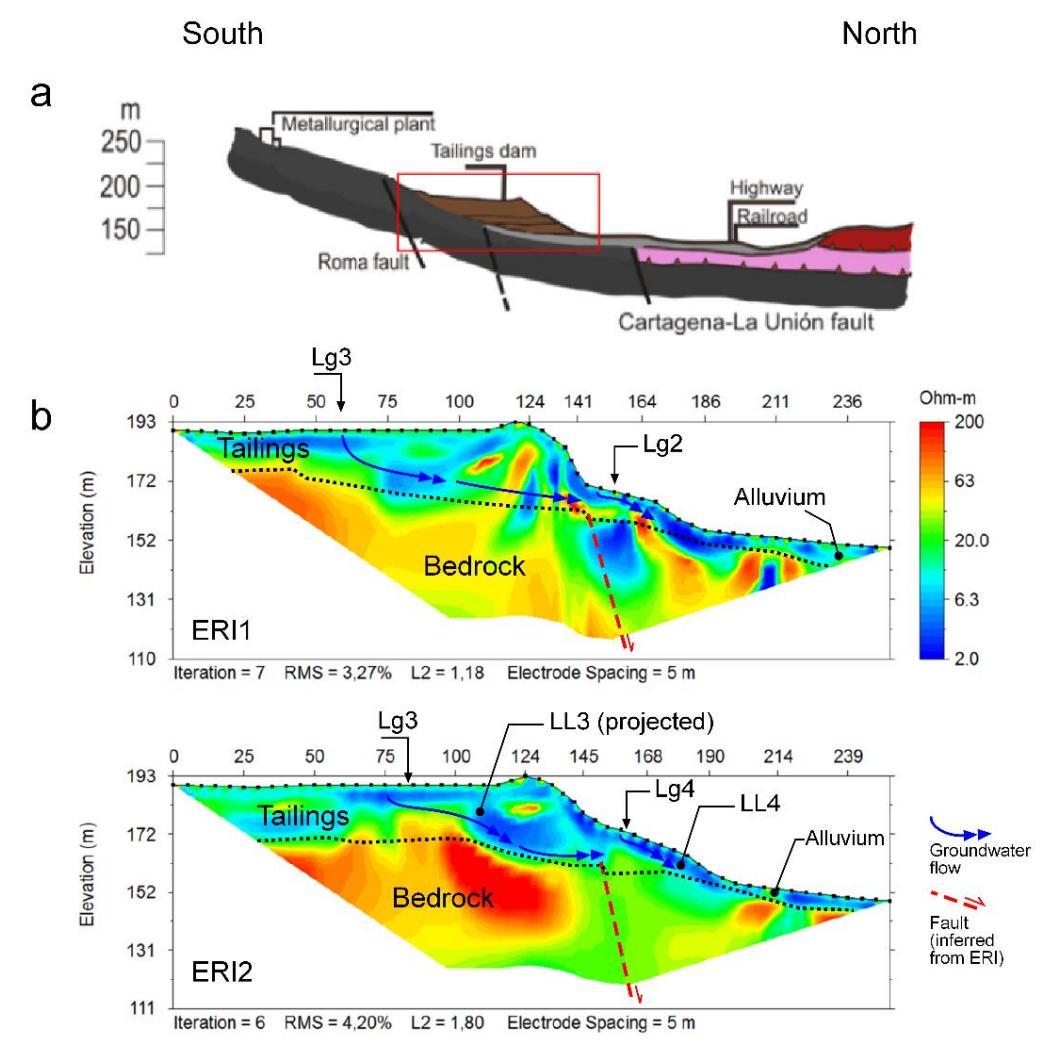
**Figure 6.** (a) Modeled geological profile S–N oriented along the El Descargador tailings dam emplacement. (b) Inverted resistivity images and tentative of geological interpretation of ERI1 and ERI2 collected by Wenner–Schlumberger array on the dam structure (see emplacements ERI1 and ERI2 in Figure 3a).

Therefore, we interpret the inversion artifacts as model misfits caused by rough resistivity variation gradients, which are awkwardly solved by the smoothed-constrained inversion method. Such rough gradients have been frequently related to fault areas, in different geomorphological contexts [28,58,59]. The direct observation of the fault was not possible since the area is covered by the tailings and the alluvial fans sedimented by the two ravines bordering the tailings dam. However, the break in the slope that occurs in the area—even a possible degraded fault facet is observed in the NW–sector—as well as the accommodation of the alluvial fans themselves are considered as the possible geomorphic

expression of the fault imaged by ERI, and which would form part of the East-trending fault system already mapped (e.g., Roma fault) (Figure 6a).

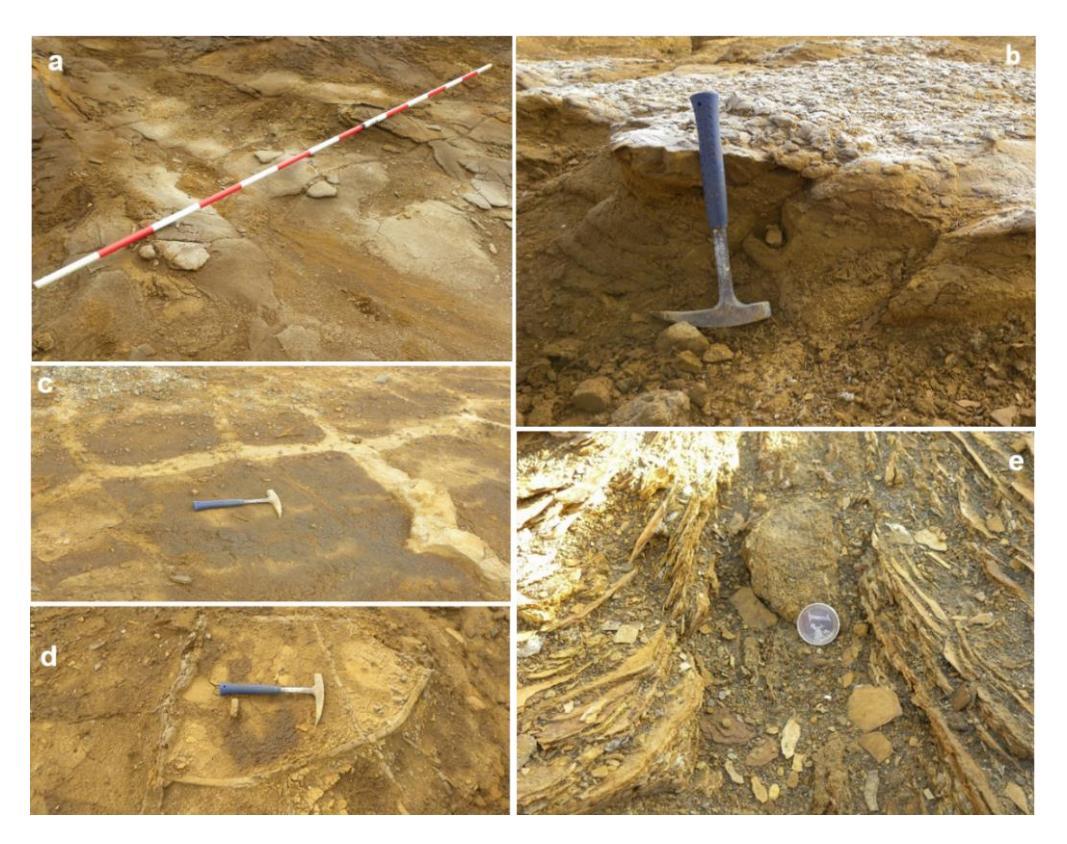
The subhorizontal interbedded sequences of tailings are crosscut by sand dikes, which are typical water-escape structures. Clastic dikes depart from the dam's foot, with a sheet thickness of 5–10 mm that expanded up to 10–20 cm during the upwelling. Interconnected sand dikes forming irregular polygonal shapes (quadrilaterals, pentagons, or hexagons), as well as sand volcanoes, are observable on the exposed surfaces along the fault planes (Figures 7–11). The textural characteristics of the tailings present in the sand dikes are very similar to the sands exposed in the trial pit. There are no sand dams and sand volcanoes in Lg2; it is because the liquefied tailings were released by Lg4, placed at the downstream, while the presence of sand volcanoes has been related to tailings dam failures [13,18,21,66–68], to our knowledge. The manifestation of sand dikes of this magnitude has not been previously reported in the literature [1,2,20,21]. The reconstructed topographic model prior to the dam failure restores the localization of the pre-existent five decantation ponds (Figures 2 and 3b).

**Figure 7.** (**a**) Massive sandy layer in the lagoon one (Lg1). (**b**) Detail of the atypical stratification of sand volcanoes compared with stratigraphic signature of mining tailings. (**c**) Sand dikes in lagoon one (Lg1). (**d**) Sand dikes in landslide one (LL1). (**e**) Detail of the sand dike emplacement, which cut crosses the subhorizontal tailings bedding.

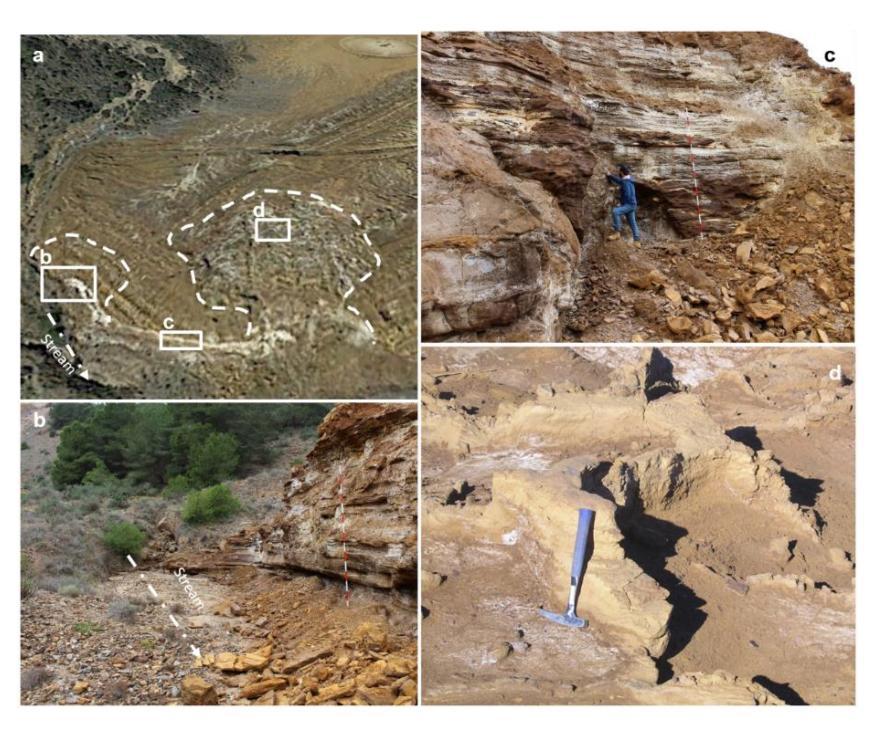
**Figure 8.** (a) Obliquus view of landslide one (LL1) and two (LL2); the discontinuous arrow indicates the direction of the stream runoff; source Spanish National Geographic Institute-IGN and Google Earth© landslide one. Detailed views landslide one (LL1) (b) and landside 2 (LL2) (c). (d) Sand dikes exposed on the surface of landslide two (LL2).

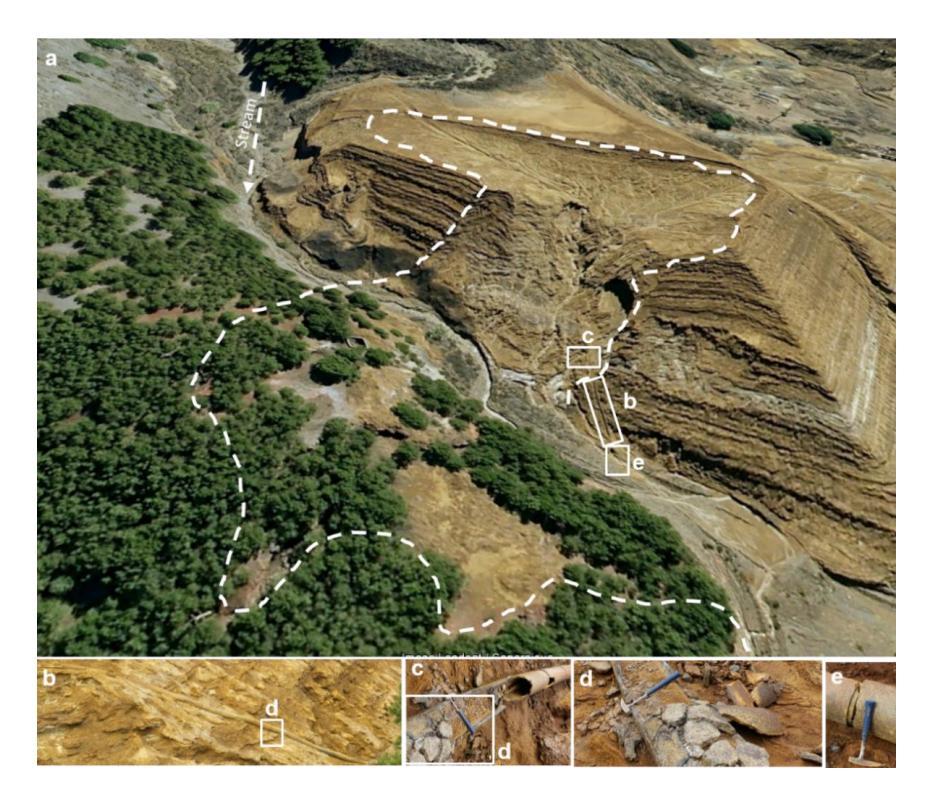
**Figure 9.** (a) Obliquus view of landslide three (LL3); source: Spanish National Geographic Institute-IGN and Google Earth©. Note that the slid mass reached the opposite bank of the stream up to 20 m height from the channel bottom. The obstruction dammed the stream, hindering the mudflow to expand downstream. (b) Remains of the existing drainage pipe at the time of the failure. (c) Close-up views of the broken pipeline that is filled of tailings. (d) Pipeline degradation and collapse due to the inside tailings oxidation. (e) Drainage pipeline decoupling.

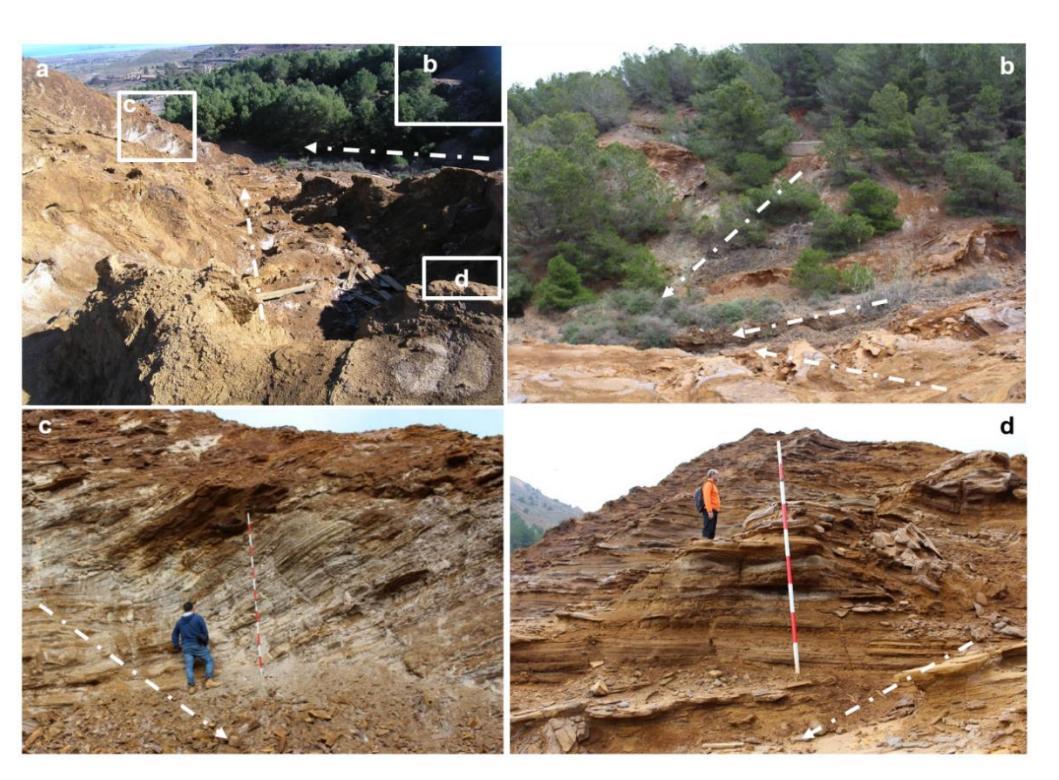
**Figure 10.** (**a**) View of landslide three (LL3) from lagoon one (Lg1). (**b**) View of the dam slide deposit remnants on the opposite stream bank, which caused the stream obstruction. (**c**) View of the tilted tailings bedding in the right margin of the landslide LL3, which is in contrast with the subhorizontal bedding of mining tailings. (**d**) View of the almost horizontal bedding characteristic of the tailings deposition, in the left margin of the landslide. The discontinuous arrow indicates the direction of the runoff.

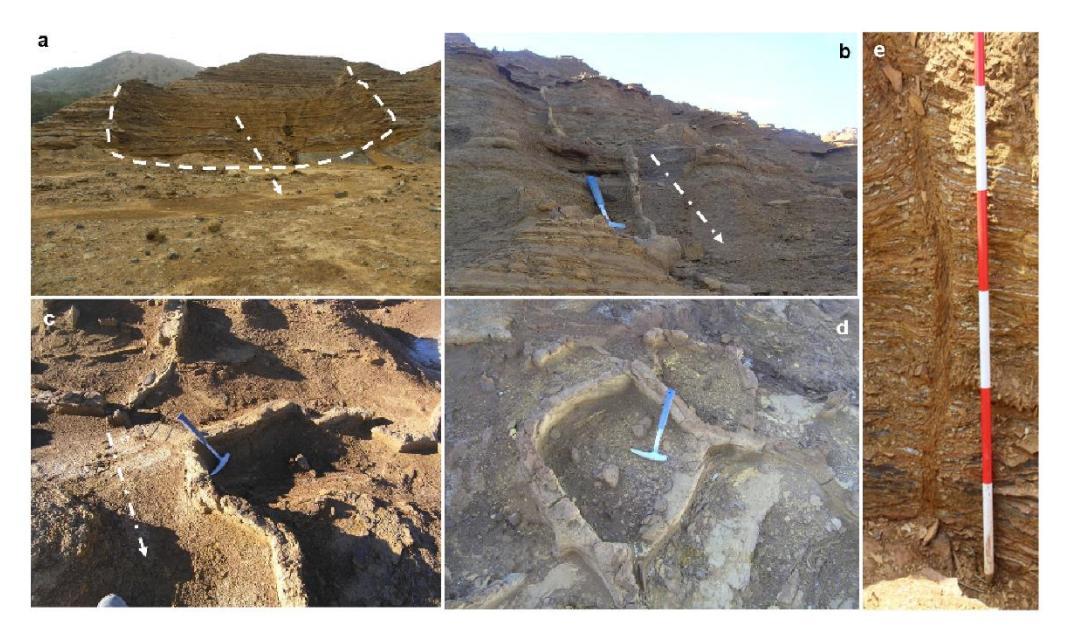
**Figure 11.** (a) View of the breach in the wall of the impoundment in landslide four (LL4). (b) Close-up view of a sand dike cross cutting the subhorizontal tailings bedding. Plan view of the polygonal arrangement of sand dikes on the LL4 surface (c) and lagoon four (Lg4) (d). (e) View of a sand dike exposed on the breach plane of landslide five (LL5). The discontinuous arrow indicates the direction of the runoff.

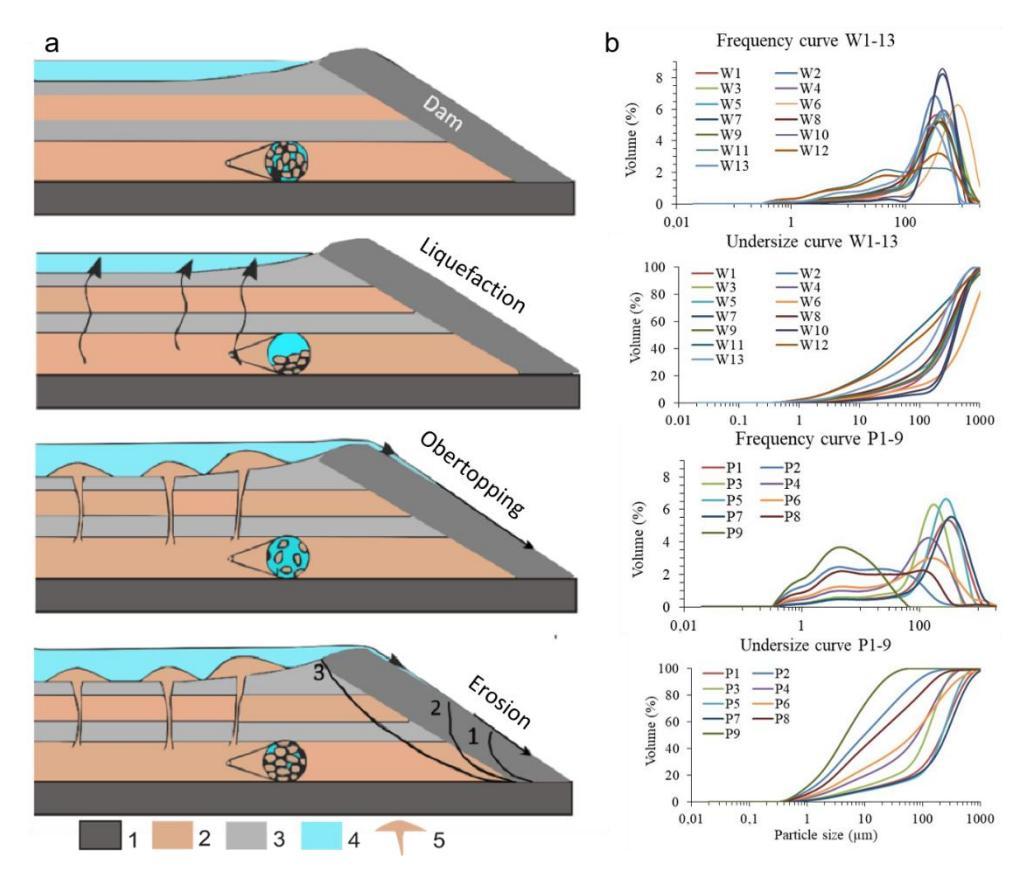
However, this rainwater stored in the lagoons would have contributed to the groundwater recharge and the rise in pore pressure and flowing, which favored the liquefaction processes. The groundwater recharge increases the saturation of the tailings and the granular material forming the foundation. The saturation of the porous material and the rapid increase of load by tailings discharge sustained over time (300 ton/day) in a small area (23,500 m<sup>2</sup>), and the rapid raising of the tailings dam (more than 4.2 m/years), caused the rise in the pore pressure and the static liquefaction of the sandy tailings (Figure 12 stage 2). The liquefied materials ascended vertically crosscutting strata of different textural and sedimentary features and filled the decantation lagoons (Figure 12 stage 3). This implied the collapse of the structure and the overtopping of the three lagoons (1, 3 and 4) affected by landslides. The expulsion of the pore water and sediment from the beds caused an excessive water table rising in the lagoons. Consequently, the embankment overtopping and the toe of the dam become unstable by the erosion, altering the equilibrium of forces and eventually releasing the stress by the mass sliding (Figure 12, stage 4).

**Figure 12.** (**a**) Conceptual model of the "El Descargador" tailings dam flow failure. The model proposes a history of static liquefaction favored by the gain size of tailings at base levels and the rise in the hydraulic head by the effective groundwater recharge from the lagoons (stage 2). The upwelling of sands and water caused the clogging of the lagoons and the freeboards overtopping (stage 3). The flowing of tailings and water on the slopes together with the internal erosion and the pore-fluid over pressuring of the tailings mass triggered the land sliding (stage 4). 1. Basement; 2. Sandy tailings layers; 3. Silty tailings layers; 4. Water and 5. Sand dikes and volcanoes. (**b**) Textural features of mine tailings: samples P1 to P9, collected from the trial-pit profile and W1 to W11, collected from the sand dike from bottom to top on the surface of landslide four (see Figure 4 and Table S2).

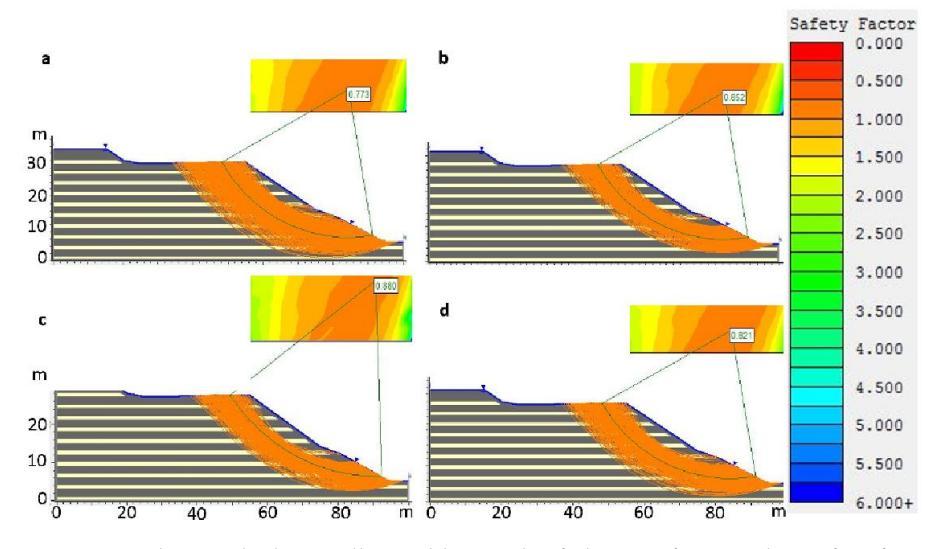
**Figure 13.** The graph shows all possible circular failure surfaces with a safety factor of less than one in orange; look at the vertical scale on the right and the most critical of all is marked in green. Numerical modeling of the stability factors based on the reconstruction of the topography conditions before the failure (back-analysis), considering static scenarios, with the hydraulic head set at the surface. (a) Janbu Method, (b) simplified Bishop Method, (c) GLE/Morgenstern–Price Method and (d) Janbu corrected Method.

The slope stability analysis using the reconstructed topography before the failure shows that the dam broke under static and pseudostatic for 13 boundary conditions (Table S3). The layers and dam with different thicknesses were considered. The calculation acceleration used was 0.18 PGA. The article does not show the images of the results of the pseudo-static analysis, but it does show the results in Table S3 and Figure S2. The geotechnical parameters as specific weight, cohesion, frictional angle of mining tailings were set according to Table S2 and [71]. Figure 13 shows the results of the static stability calculation for the LL4 slip. Four materials have been considered: silty tailings with the internal fraction angle of 27 °C, sandy tailings with the internal fraction angle of 29 °C (see Table S2), dam with the internal fraction angle of 37  $^{\circ}$ C and foundation with the internal fraction angle of 41 °C. The cohesion is zero. The water head was considered at the tailings dam surface, reproducing the hydraulic condition of liquefaction. This is considered a minimum since the hydraulic head could have reached even an elevation higher than that of the lagoons. The achieved numerical simulations are consistent with the hypothesis that the tailings mass sliding occurred due to a combination a dysfunction of the drainage system and static liquefaction. This concatenation of factors caused the ascent of liquefied material to the lagoon and the overflow. The debris caused the erosion of the slope and its foot which altered the stress equilibrium, leading to the tailings dam failure. The geometry of failure is, according to the model, a subcircular type landslide with stability factors ranging from 0.773 to 0.880 (less than one is considered as unstable condition; Figure 13). This geometry is consistent with a failure within the mass of tailings, which can be considered as a reasonably homogeneous material for modeling purposes. Part of the liquefied tailings can be seen on the left side of the stream (Figures 9 and 10). The released tailings caused the obstruction of the valley and the invasion of the national highway. In this regard, the damming of the stream valley had a positive impact from a hazard's perspective since it minimized the ability of the mine wastes to flow and spread downstream of the basin.

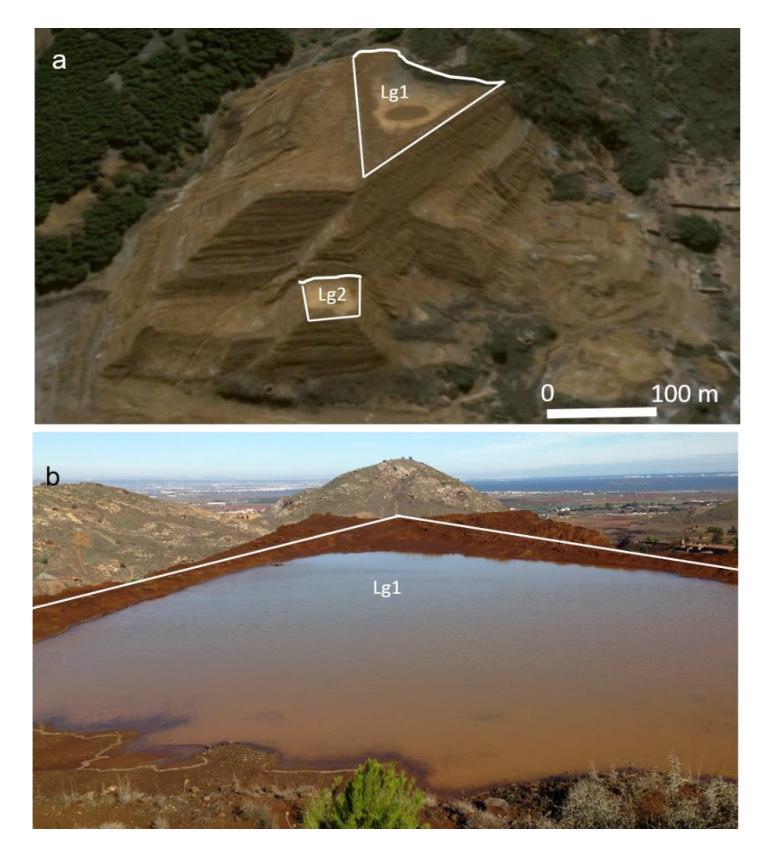
- 5. Geophysical modeling of the tailings dam revealed that the materials remain saturated beneath the lagoons to a 10 m depth or more, even decades after the dam failure. This observation highlights the relevant role of the lagoons in the groundwater recharge in tailings dam (Figure 14).

**Figure 14.** (a) Lagoon Lg1 and Lg3 after a rainstorm and (b) detail an Lg1 (October 2015). The spatio-temporal evolution of drying and wetting of the lagoons can be seen in the Google Earth clock (Since June 2002).
