Article **Reviewing Interference for All Modes of Products for Failure Avoidance**

Kenji Iino ^{1,2,*} and Masayuki Nakao ³

Citation: Iino, K.; Nakao, M. Reviewing Interference for All Modes of Products for Failure Avoidance. *Sustainability* 2022, *14*, 1743. https://doi.org/10.3390/su14031743

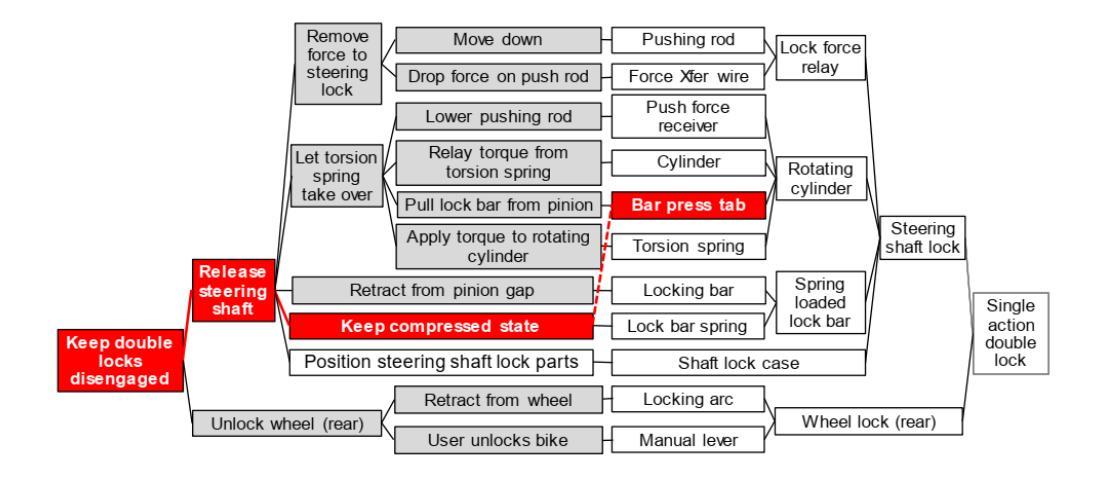
Figure 7. DRG of the "single action double lock" when riding with hidden interference (modified from [6]).

Figure 7 shows the "single action double lock" mechanism when the rider is riding the bicycle. This time, the rear wheel lock has to be disengaged and the steering shaft free to rotate. All parts in the DRG change their functions from those in Figure 5 including the higher level sub-functions to the overall function of "Keep double locks disengaged". One exception is the "Shaft lock case", with the function of "Position steering shaft lock parts".

With the knowledge that the "single action double lock" was responsible for the recall, we examine the system closely in the riding mode. Upon design, the designer overlooked that the "Bar press tab" affected the "Lock bar spring" function of "Keep compressed state" shown with the broken red line segment across the functional and physical spaces. It needed proper alignment with the notch on the locking bar where the two pieces met.

The locking bar in riding mode has the function of retracting itself from the pinion gap it engaged when the user locked the bike. The torsion spring, in the meantime, has to constantly keep its CCW torsional spring force on the rotating cylinder so that the bar pressing tab keeps the locking bar out of a pinion gap.

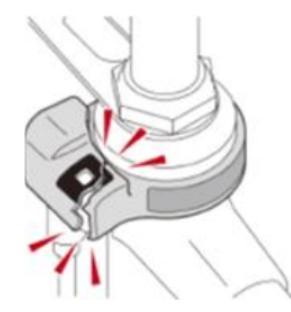
Figure 8. Steering shaft lock with a cracked case [8].

The direct cause of the recall was the shaft lock case. Possibly owing to insufficient strength, the case cracked and lost its function to hold the steering lock parts in place. The Ministry of Economy, Trade, and Industry (METI) of the Japanese government released news [8] with photographs of normal and cracked cases. Figure 8 is the illustration in the news release.

A cracked case causes the parts that it holds inside to lose tight positioning and the bar press tab can easily lose contact against the locking bar. Then, the torsion spring force fails to reach the locking bar and the bar spring pushes the locking bar into a pinion gap. This caused the steering handle to lock while the user was riding the bike. This unexpected failure caused the rider to fall on the road with the bike.

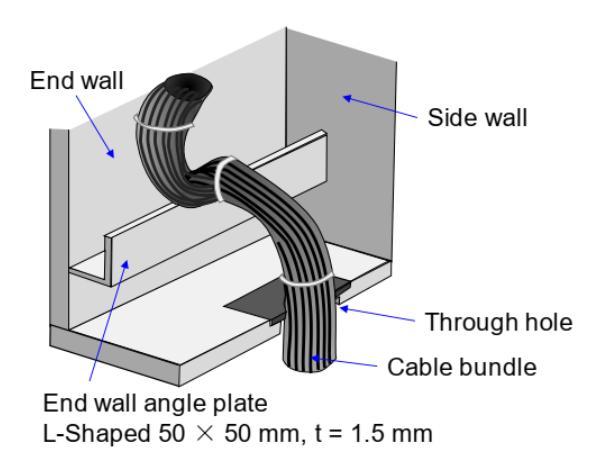
Control Line F was bundled with a number of other cables, as shown in Figure 12. The bundle was scratching against the end wall angle plate, and Control Line F happened to settle at the bottom of the bundle. The edges of this angle plate were cut with a laser cutter, and their mass production left the cut corners sharp without any filing. The through hole on the floor had a plastic fitting on top so cables in the bundle would not scratch against the metal rim of the hole. The designer overlooked that the heavy bundle, although suspended in mid-air, would sag and scratch against the end wall angle plate.

Control line F, when engaged, energizes to a control voltage of DC100 V commonly used for trains. When the coating of the line was cut deep enough, this high voltage must have caused an electric spark between line F and the angle plate electrically at ground level. Observation after the accident found the upstream side of the control line, closer to the DC100 V source, dangling, and the downstream side welded onto the stainless-steel angle plate. Later analysis revealed the weld to contain stainless-steel copper alloy, meaning the spark temperature exceeded the stainless-steel melting point of 1400 $^{\circ}$ C.

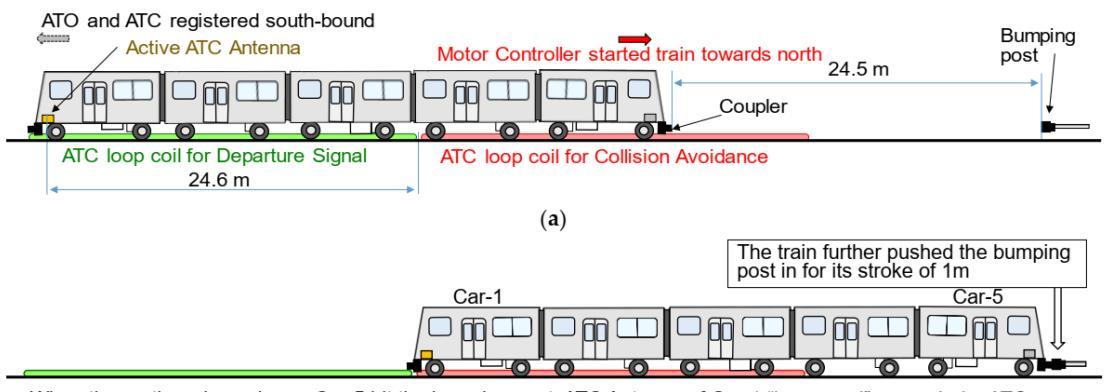
Figure 13 shows the train upon the wrong departure to its collision with the bumping post. When the train system started, it did not detect that it took off in the wrong direction. ATC, registered with southbound direction, detected its active antenna in Car-1 above the ATC loop coil for departure, a normal expectation for heading south. The train kept accelerating until the coupler of Car-5 hit the bumping post. When Car-5 collided with the bumping post, ATC antenna in Car-1 reached the south end of the loop coil for collision avoidance. This loop coil was there for the ATC antenna in Car-5 of incoming trains to detect overrun. The ATC system was not designed for trains starting off in the wrong direction, but, by a lucky coincidence, ATC engaged full brake.

When the north end coupler on Car-5 hit the bumping post, ATC Antenna of Car-1 "happened" to reach the ATC loop coil for collision avoidance, originally intended for Car-5 ATC Antenna on northbound in-coming trains.

When the train hit the bumping post, it had gained a velocity of about 25 km/h. The bumping post was designed to stop a train at a speed of 10 km/h with the train's braking force. Fortunately, the train ATC engaged the brake upon reaching the bumping post; however, at a speed of 25 km/h, the bumping post, after exhausting its full 1 m damping stroke, turned into a sudden wall for the train. The ATC brake and the 1 m damping stroke of the bumping post lessened the severity of the accident to some extent.

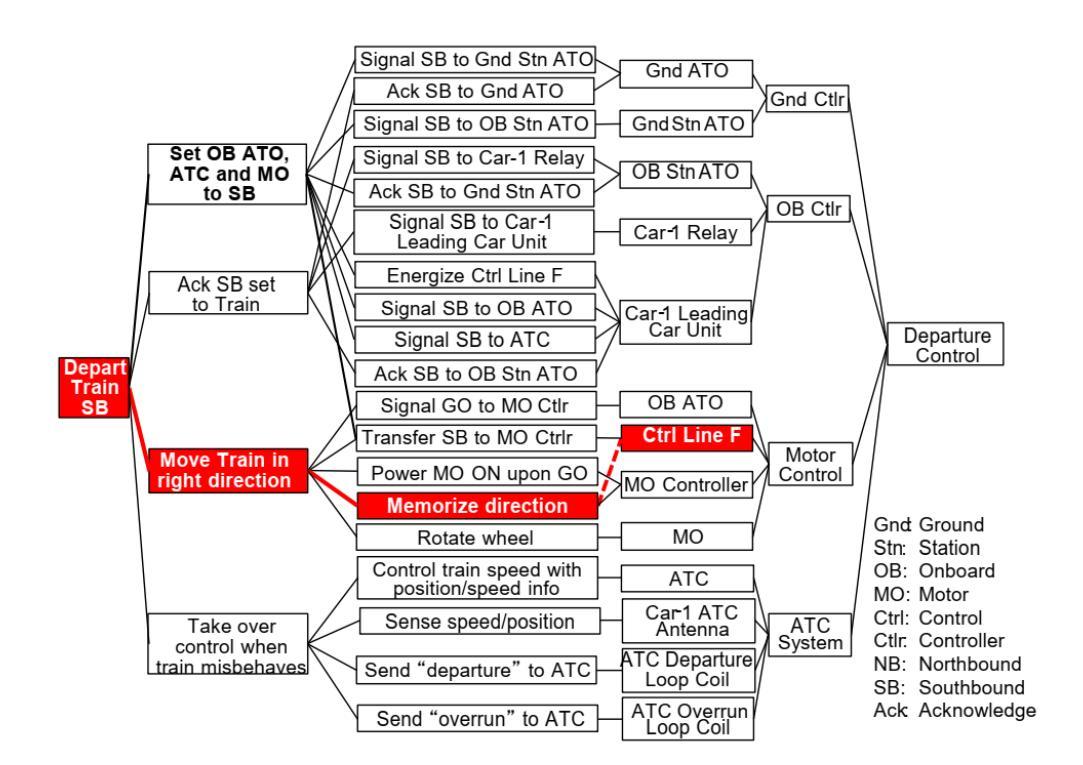
Figure 14. DRG of the train southbound departure control and failure propagation.

Figure 14 shows the DRG of the train control system in setting off the train in the southbound direction. The failure that caused the accident started from Control Line F failure in the physical space. The "Memorize direction" function of the motor controller needed the "Control Line F" to be properly working. Figure 14 shows this reliance with the broken red line segment. The failure propagated into the functional space to disable the overall functional requirement of "Depart Train Southbound".

Figure 14 shows how the failure of Control Line F propagated the design to fail the primary function of starting the train towards south. The figure also shows that a sub-function of "Acknowledging southbound set to train" was successful. This is why the control, without hesitation, commanded to start the motors. This sub-function would have failed if the acknowledgement additionally required signals from Control Line F where it reached the motor controllers. The accident report explained that the acknowledgement was changed, during design, not to require the Control Line F signal, but to be based on a higher-level controller. The reason was because the signal from line F or R would have conflicted with the ATO controllers when the train had overrun a regular stop position and the train had to move back so its doors would align with doors on the platform. The Leading Car Unit then switches power on Control Line F and R. This operation of moving backwards for a small distance is called "back inching".

Once the designer has the DRG or alternatively an AD equation, running FMEA means to assume the failure of each PE in the physical space. The decomposition should be fine and complete. In Figure 14, we omitted the other control lines 194E and 194G to avoid complicating the diagram. Each one of them is also subject to failure analysis of what would happen if it failed, as well as 195E, 195G, and R needed for northbound direction setting. In the case of the runaway train, the result of failure of Control Line F or Control Line R is accelerating in the wrong direction at a terminal station. As this consequence is unacceptable, a design remedy requires detecting the control line failure and stopping the train until the problem is solved, and that was the actual remedy taken.

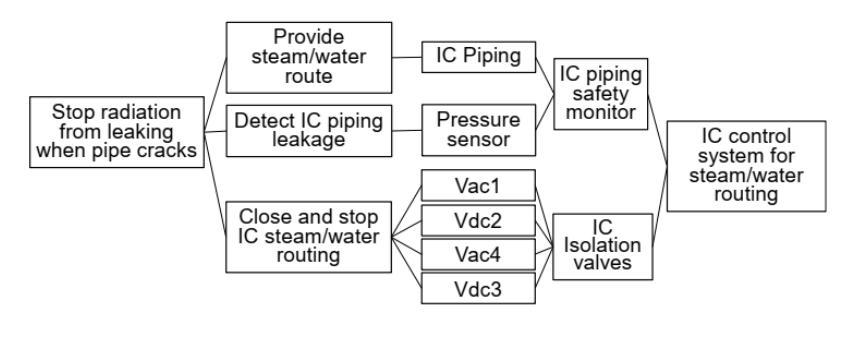
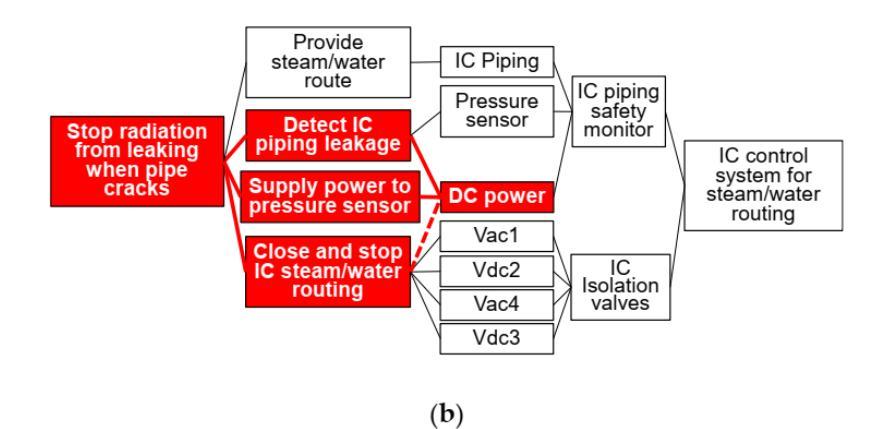
Figure 17. DRG of Fukushima-1 NPP Unit-1 IC safety system upon IC piping leakage (modified from [6]). (a) IC safety system for preventing radiation leakage upon a piping leakage event. (b) IC safety function upon a false piping leakage signal by loss of sensor DC power.

Figure 17a is a typical DRG that a designer would draw. Note that the diagram is missing DC power to the pressure sensor, as well as the higher DC and AC powers to drive the valves. It was difficult for the designer to identify that the four valves' "Close and stop IC steam/water routing" function were dependent on the pressure sensor's "DC power".

Figure 17b shows this dependence with a broken red line segment. The function of "Stop radiation from leaking when pipe cracks" needed "DC power" to the pressure sensor to be working properly; when the DC power was lost, the function activated improperly.

Evidence of this IC system failure upon the tsunami attack revealed the sequence of what happened. The pressure sensor lost its DC power first and the system commanded isolation valve closure to all four IC isolation valves.

Once the designer has a detailed DRG or AD equation of the design, we recommend running FMEA by assuming failure of each PE in physical space with a DRG, equivalent to each element of the DP vector in the case of AD. The designer should also carry out the failure analysis in all modes of operation, especially if the product can affect the lives of the users, other people, our economy, or the environment. In terms of sustainable development, some machines have short lives, whereas others may last for decades, or their byproducts may remain on our planet for centuries. For assuring sustainability to our societies, economy, and the environment, mechanical designers must keep their designs free of flaws, because any failure in one area can cause impact to all the others. In addition, if we use machines from past designs, we need to be aware that they may have problems and not blindly believe in their performances.
