# Multidisciplinary Research for the Monitoring and Preventive Conservation of Cultural Heritage

Edited by  
Silvana Fais and Giuseppe Casula

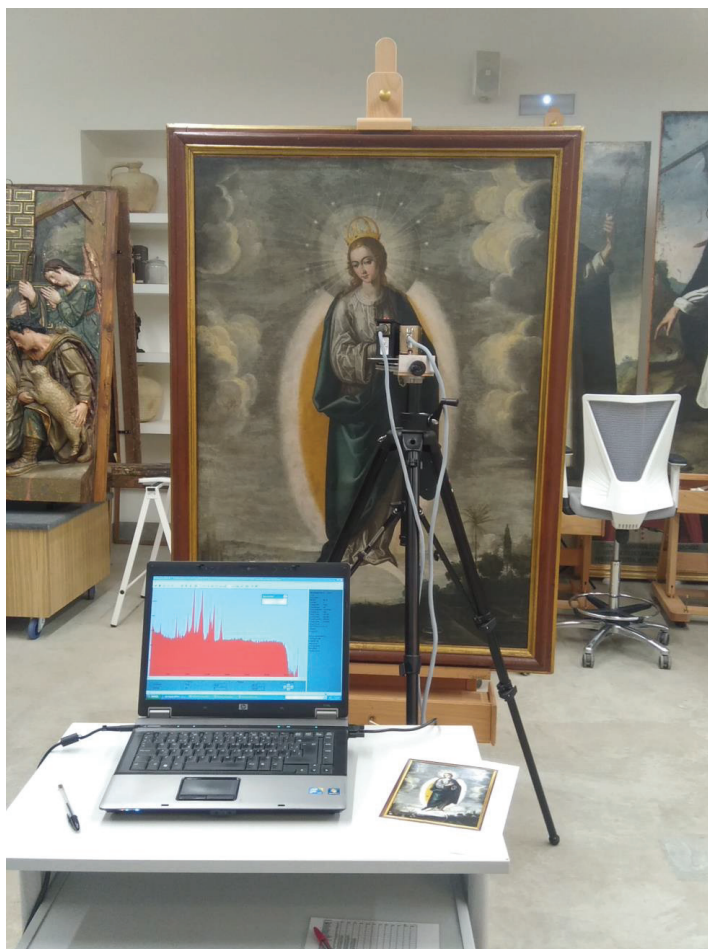
**Figure 2.** XRF in situ analysis of La Inmaculada.

As it was not possible to extract samples, only noninvasive techniques available at that time were used: ultraviolet fluorescence photography, infrared reflectography (IRR), and X-ray fluorescence spectrometry (XRF). They were all applied in situ in the conservation–restoration workshop of the palace (Figure 2).

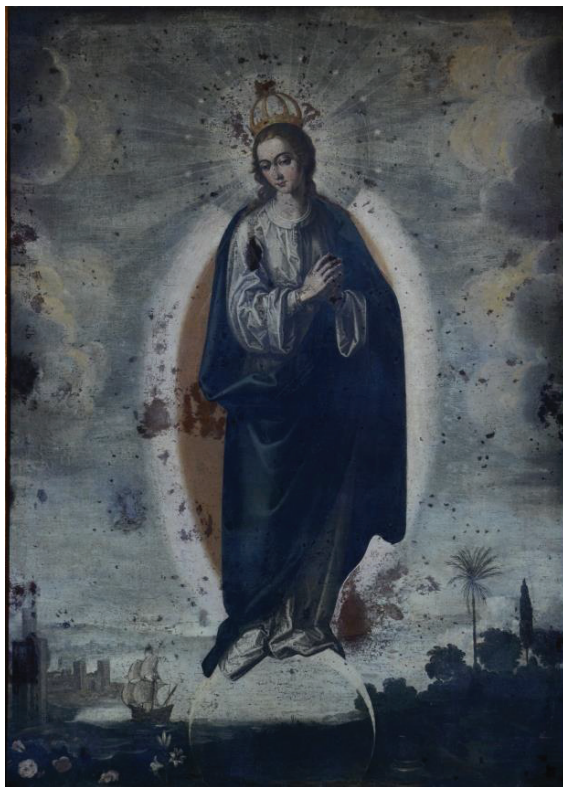
**Figure 3.** UVF image of La Inmaculada, showing many retouched areas, the largest one located next to the Virgin's left foot.

The ultraviolet fluorescence revealed many smaller and larger retouches spread around the surface (Figure 3). They must have been carried out at different times, showing varied tonalities of material fluorescence. The largest interventions can be found on the left margin, next to the Virgin's right hip and left foot, revealing more important damages suffered by the painting. IRR confirmed several retouches and the use of different pigments as well; however, at first sight, no preparatory drawing can be appreciated (Figure 4). At a closer look, an underdrawing can be observed on the half-moon and on the boat (Figure 5a,b), while there is a small *pentimento*, a slight change in the composition of the architecture in the left bottom corner; the painter shortened some of its walls, painted with a reddish-brown color, obtained by mixing earths (Fe), a copper-based green pigment (Cu), lead white (Pb), and a small amount of umber (Mn, Fe) and vermilion (Hg), as studied later by XRF. An interesting observation is that the trees in the lower right corner almost disappear on the IRR image.

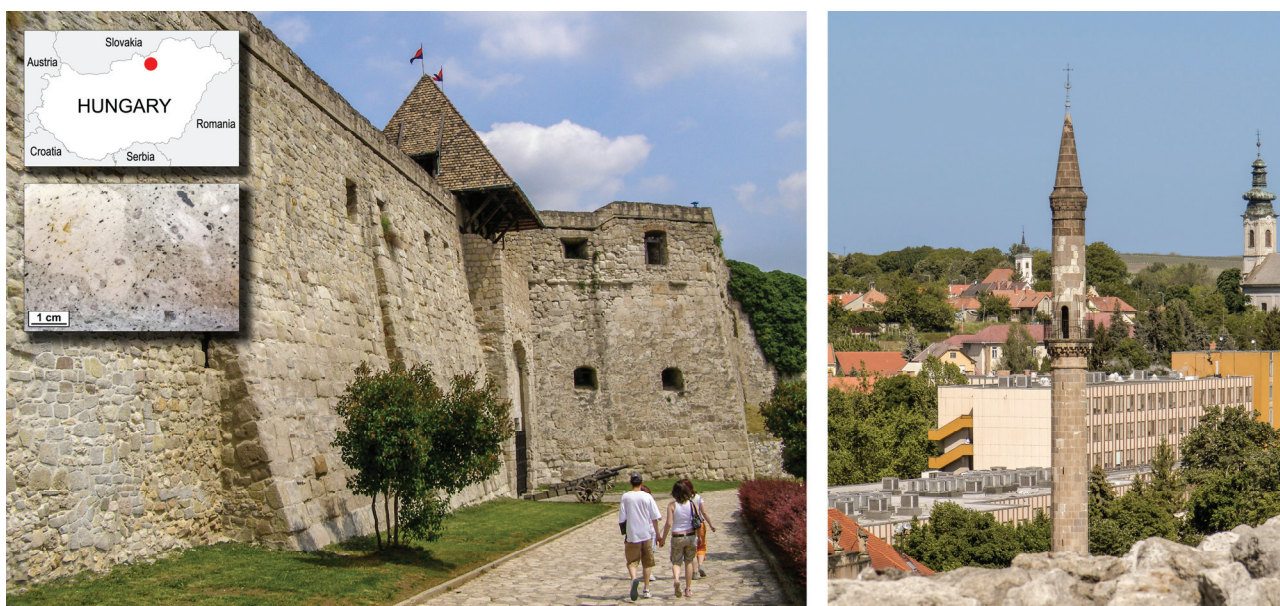
**Figure 1.** Examples of the historical usage of tuffs in the town of Eger: the Medieval castle and the Ottoman minaret. The insets show the location of the study quarry sites (a few kilometers apart) and the macroscopic appearance of Demjén tuff used in the monuments.

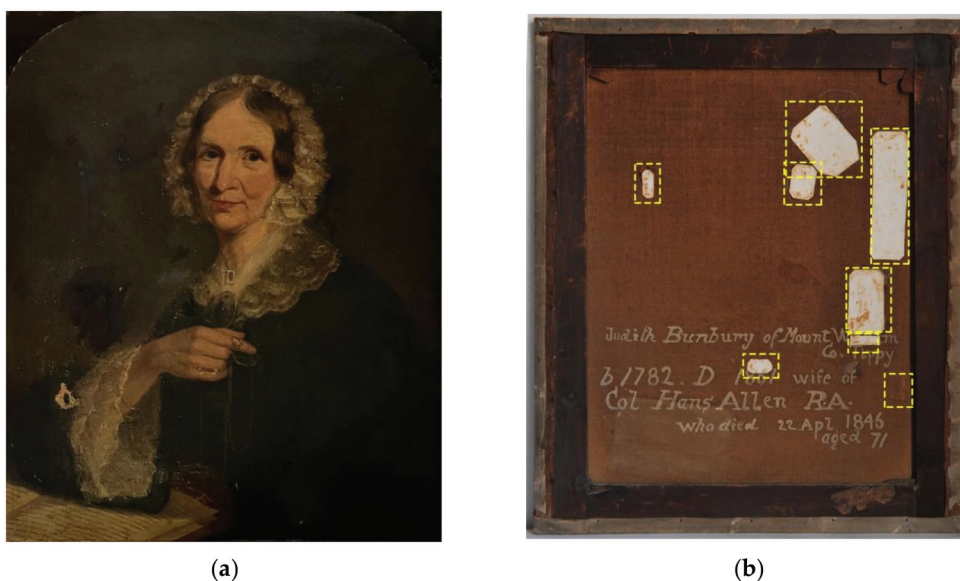
**Figure 2.** The portrait of Judith Bunbury—photographs of the front (a) and back (b) of the painting in visible light.

After photographing the artwork in visible light (Figure 2), it was noticed that the textile support is made out of a single piece of linen fabric that has been perforated in eight spots, mainly in the background area. Of these, seven perforations have been improperly consolidated with a thick layer of oil paint (overpaint) on the front and with unsuitable patches on the back (indicated in Figure 2b by yellow dashed boxes). The oil content of the overpaint has been proven by performing an oil test on an isolated area using a saturated solution of Sudan Black B. The patches were mechanically unsuitable due to the animal glue used to adhere them to the holes and tears. The fact that the adhesive is

protein-based (animal glue) was proven by a protein test performed on a patch using an acid fuchsin reagent. The glue, which lost its elasticity and contracted over time, caused some aesthetically disturbing bulges on the front of the painting and distinctive craquelure in the paint layer. The fact that one of the perforations has not been consolidated indicates that it might be more recent than the others. Additionally, it could be noticed that both the paint layer and the varnish layer were evenly applied. The paint layer has strong adhesion to the preparation layer, with only a few areas on the shoulder and above the right hand in which lacunae and flaking were seen (Figure 3). Due to aging, chromatic (yellowing and darkening) and textural (craquelures) alterations of the varnish layer took place. The chromatic alterations are probably photo-induced due to the fact that the edges of the painting layer that were covered by the frame did not show as severe an alteration as the areas exposed to light and oxygen.

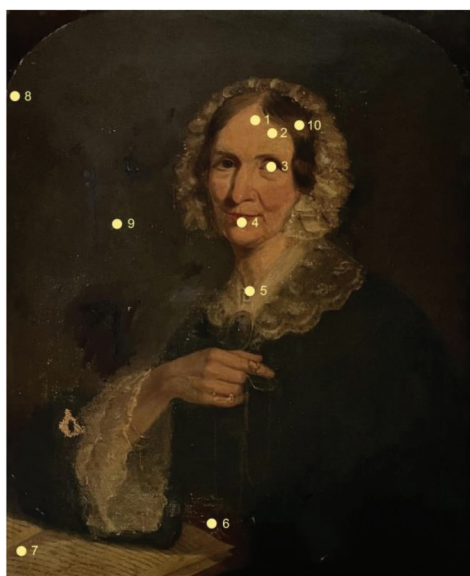
**Figure 10.** Visible light photography with the points analyzed with XRF (numbers represent analysis areas).

X-ray Fluorescence (XRF) spectrometry is a non-destructive method of investigation that allows obtaining an accurate and quick identification of inorganic materials and has been widely used in the study of art objects in past decades [11]. XRF studies have been performed on different types of artworks such as manuscripts, wall paintings, wood panels, and canvas paintings [12–16]. For the aim of this study, the investigation was carried out on 10 distinct analysis zones, covering the entire color range, as can be seen in Figure 10.

The spectrum corresponding to area 6 shows both slightly higher iron (Fe) lines, indicating the use of an iron-based pigment, and traces of mercury (Hg), as can be seen in Figure 10 (scarlet book). Although the high lead lines made it difficult to assess the presence of sulfur, which appears in the same energy range as the Pb M $\alpha$  lines, the occurrence of mercury traces indicates the use of the mercuric sulfide pigment (HgS). This is commonly referred to as cinnabar or its synthetic variant, vermilion [17], a pigment that is known to degrade with time, leading to the darkening of its original color. In Europe, both natural (from the cinnabar mineral) and synthetic vermilion were used simultaneously [22] until the end of the 19th century.

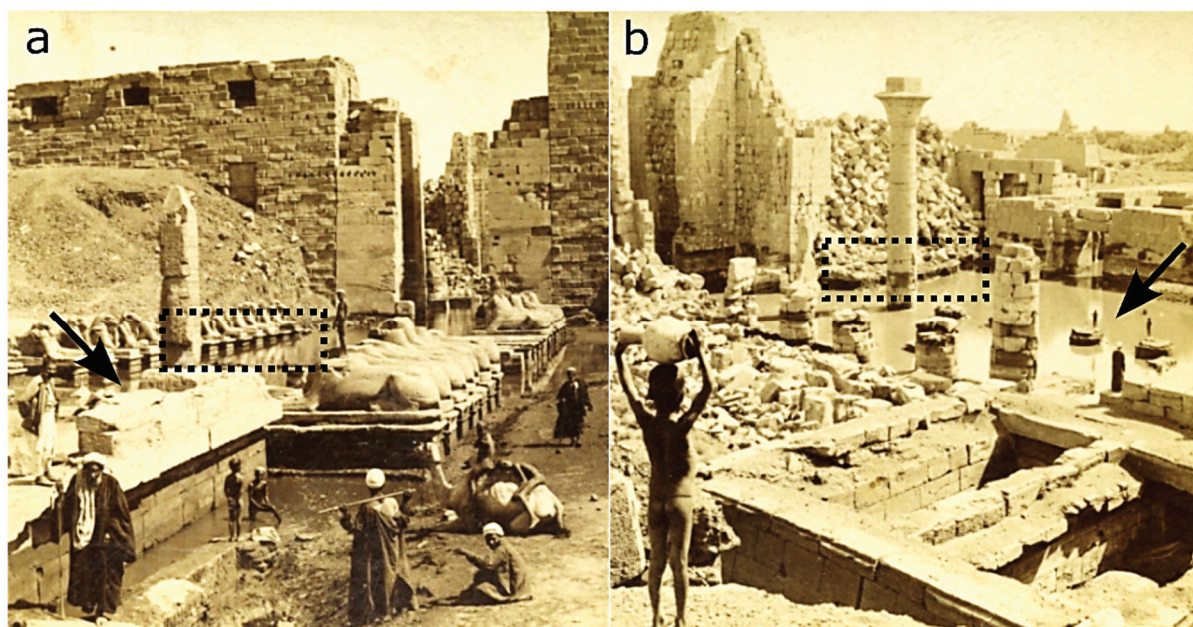
**Figure 5.** Two historical photographs from 1898 by B.W. Kilburn showing the first pylon of the Karnak Temples. The stone building materials are visibly affected by flash flooding, as indicated by black arrows and highlighted within dotted rectangles (a,b). From [59].

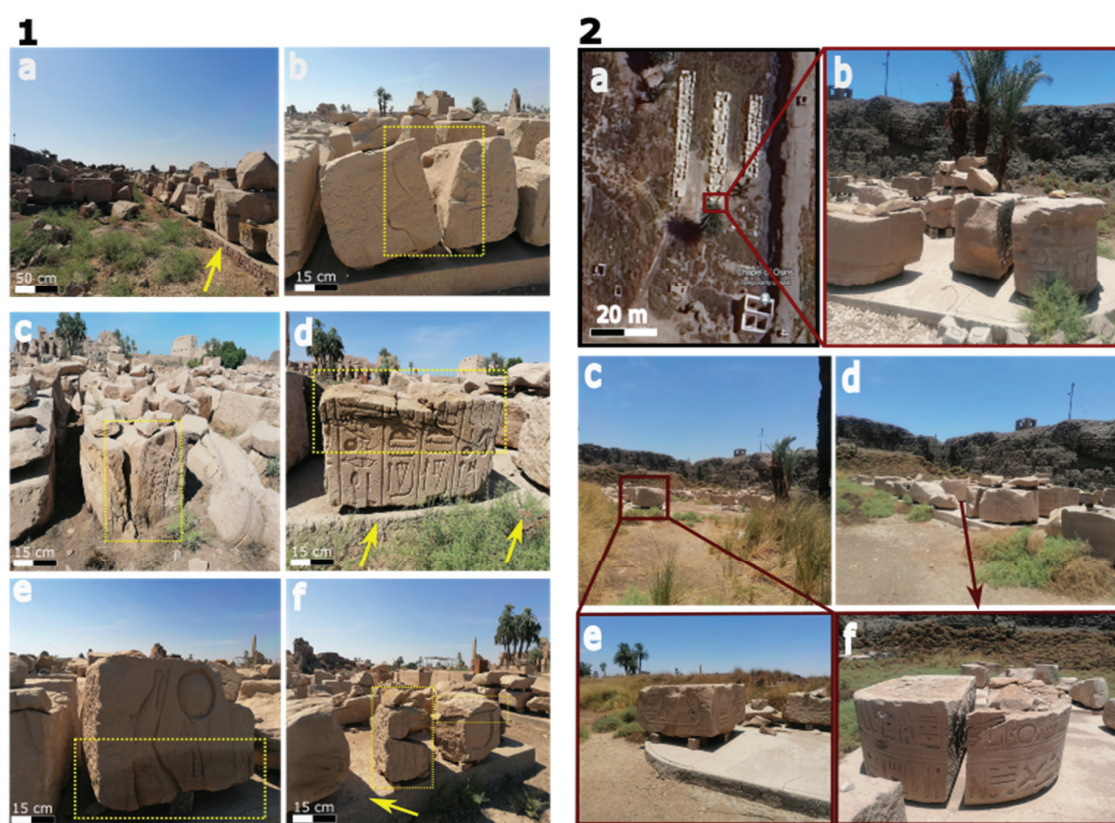
**Figure 9.** (1) and (2) Analysis of the mechanical impact of cumulative earthquakes and flooding events on the structures at Karnak. (1a) A general view showing scattered stone blocks, displaced due to mechanical forces, now resting on a loose red brick mastaba. (1b) Close-up of fractured stone blocks, illustrating the damage. (1c) Various stone blocks that have slid and become embedded in the soil, likely as a result of earthquake tremors or the impact of flooding waves. (1d–1f) Detailed views of mechanical chipping, fractures, and cracking observed on the stone surfaces, highlighting the extent of the damage. (2a) A Google Earth image of the study area, focusing on the northeastern part of Karnak, showing the current state of the stone blocks. (2b–2f) Documentation of various damage aspects of the stone blocks, including splitting, chipping, and fracturing, illustrating the ongoing deterioration of the site due to mechanical forces.

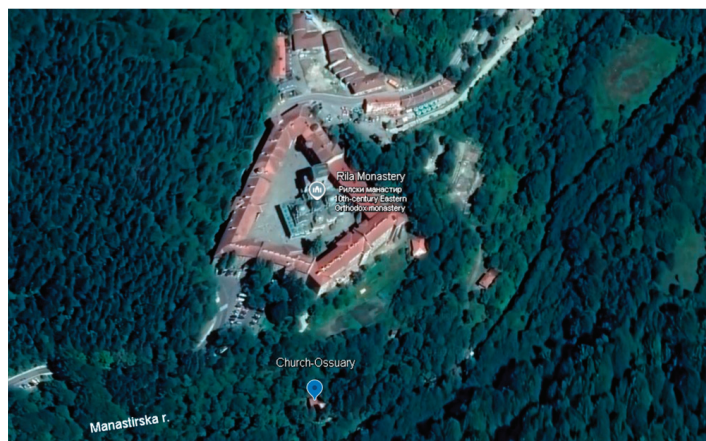
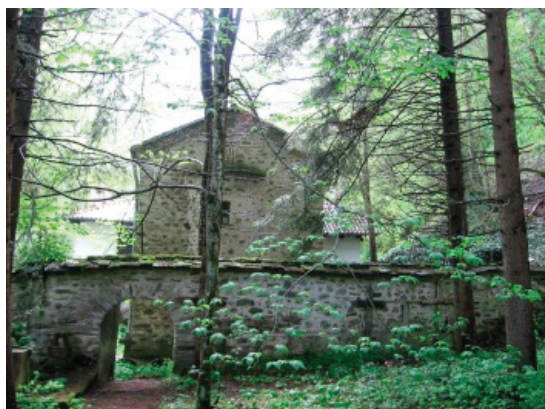
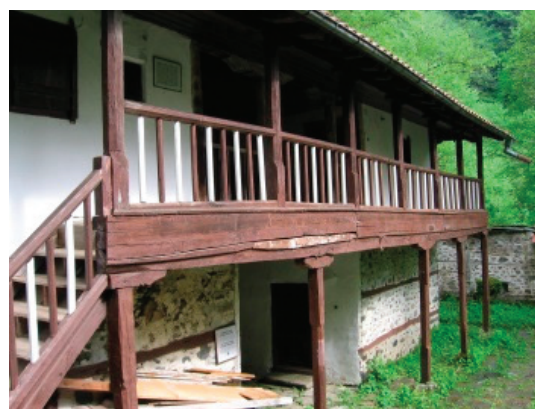
**Figure 1.** The Rila Monastery and the Church-Ossuary: (a) an air view of the Rila Monastery complex with the location of the Church-Ossuary marked by a red circle; (b) a general view of the Church-Ossuary building, east facade; (c) the ossuary and the church upstairs, west facade.

around the pilgrimage route [4]. A notable part of the monastery is the ensemble of the Church-Ossuary (the cemetery church) which also holds great religious and artistic importance. The building is situated to the south of the monastery walls, near the River Manastirska [5] (Figure 1a). The church, dedicated to the Presentation of the Blessed Virgin, was built in the Middle Ages on the foundations of the old ossuary (Figure 1b). The ground storing of the current building comprises a rectangular room housing the monks' ossuary. On the upper store, there is a one-nave church with one apside, an altar space with five niches in the walls, and a long rectangular nave (Figure 1c).
