Special Issue Reprint

Coatings for Cultural Heritage

Cleaning, Protection and Restoration

Edited by Yumin Du

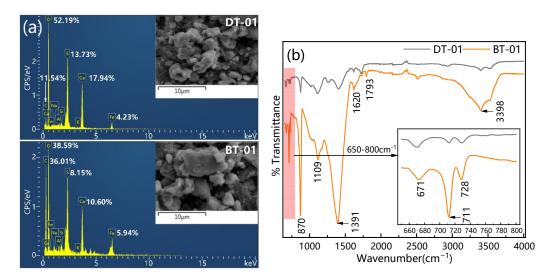
Figure 4. (a) Elemental analysis by SEM-EDS and (b) Infrared spectra by FTIR spectroscopy for the red samples (DT-01 and BT-01).

Iron oxide red (Fe₂O₃), mainly derived from the processing of hematite [22], was found to present in the two red samples (DT-01 and BT-01). The results obtained by EDS analysis showed that the two red samples mainly comprised of C, O, S, Ca, and Fe, with trace amounts of Na, Al, and Si (Figure 4a), thereby suggesting that the red color could be due to the presence of iron oxides. Additionally, the infrared absorption spectra obtained for the two samples contained characteristic peaks at 671 and 1109 ${\rm cm}^{-1}$ (Figure 4b). The above results corresponding to the characteristic peak of iron oxide at 671 cm $^{-1}$ that was attributed to the Fe-O stretching vibration [23]. These analyses above confirmed that the pigment in the two red samples was iron oxide red, similar to the studies of pigments in the Dunhuang frescoes, painted sculptures in the Han dynasty tombs and architectural paintings of the Foguang Temple [4]. In addition, the two samples' characteristic peaks obtained at 711, 870, 1391, and 1793 cm^{-1} were in good agreement with the calcium carbonate characteristic peaks in the infrared spectrum, where the peak at 711 cm⁻¹ was attributed to the C–O inplane bending vibration; the peak at 870 cm⁻¹ was due to the CO₃²⁻ out-of-plane bending vibration; the peak at 1793 cm⁻¹ was the result of C-O symmetric stretching vibration, and the peak at 1391 cm $^{-1}$ was caused by the C–O antisymmetric stretching vibration [24]. The presence of a trace amount of calcium carbonate could be due to previous application during repainting for color adjustment purpose or could be due to particle infiltration from the ground layer.

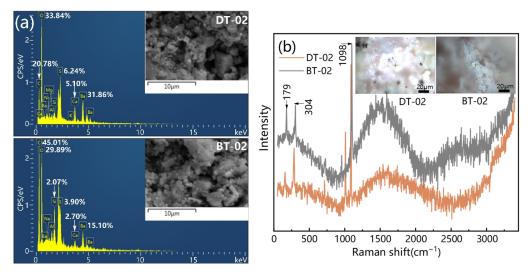
Figure 5. (a) Elemental analysis by SEM-EDS and (b) Raman spectra for the white samples (DT-02 and BT-02).

Chalk, comprised mainly of CaCO₃, also known as Baishan clay, was found to be present in the two white samples (DT-02 and BT-02). The EDS results for the white samples are shown in Figure 5a. DT-02 sample mainly composed of C, O, Ba, Ca, and S, with small amounts of Mg and Si, while C, O, Ba, Ca, S, Si, and trace amounts of Al were mainly found in BT-02. According to the elemental composition, it was estimated that Calcium or Barium salts was used in the white pigment. Further investigation into the chemical compositions of the two white samples revealed the Raman characteristic peaks at 179, 304, and 1098 cm⁻¹, and were generally in good agreement with the characteristic peaks of chalk (CaCO₃) [15,25] (Figure 5b). The peak at 1098 cm⁻¹ was due to the C–O symmetric stretching vibration in the sample while the peak at 304 cm⁻¹ arise from the stretching vibration due to the relative motion between CO₃²⁻ [24]. The above findings confirmed that the white pigment was chalk and that the presence of elements such as Al, Si, Ba, Mg, and S for both samples could have been due to contaminants adhering to the surface.

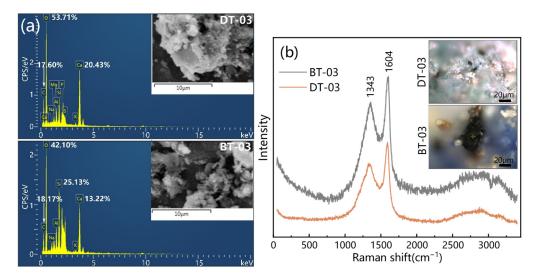
Figure 6. (a) Elemental analysis by SEM-EDS and (b) Raman spectra for the black samples (DT-03 and BT-03).

Carbon black was found to be present in the two black samples (DT-03 and BT-03), generally produced from the burning of plants or animals [26]. Figure 6a presents the main constituent elements of the two black pigments. DT-03 sample consisted of C, O, Ca and small amounts of Mg, Al, Si, P, and S while BT-03 sample contained C, O, Ca, Si and trace amounts of Al and Na. From the results of elemental composition, it can be assumed that carbon or compounds of aluminum and magnesium was used in the black samples. Furthermore, the Raman spectra of the two black samples contained characteristic peaks at 1343 and 1604 cm⁻¹, which matched well with the peaks for carbon black (Figure 6b), confirmed that both samples contained carbon black [27]. Further, the absence of a characteristic peak at 960 cm⁻¹ in the Raman spectra suggested that carbon black was not produced by the burning of animal fat or bone [28]. The presence of elements such as Mg, Al, Si, P, and S might be due to contaminants on the surfaces of the samples, while the high O and Ca contents might be caused by the movement of particles from the ground layer and external environment contaminants.

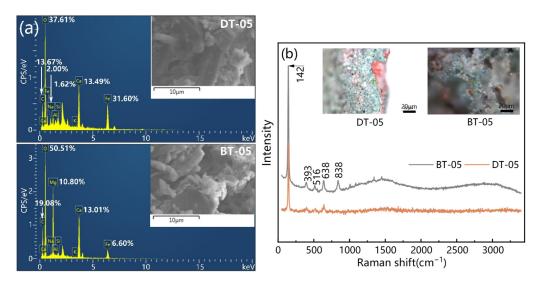
Figure 8. (a) Elemental analysis by SEM-EDS and (b) Raman spectra for the green samples (DT-05 and BT-05).

Green earth, derived from iron silicate-rich sedimentary rocks [32], was found to be present in the two green samples (DT-05 and BT-05). The EDS results for the green samples are shown in Figure 8a. DT-05 sample consisted mainly of Ca, C, O, Fe, and trace amounts

of Si, Na, and Al. In the case of BT-05, high levels of Mg in addition to C, O, Ca, and Fe were observed, while no significant amount of Si, Na, and Al were detected, probably due to their low contents. According to the elemental composition's results, it was estimated that Iron salts were used in the green pigment. Furthermore, the characteristic peaks of the green samples at 142, 393, 516, 638, and 838 cm⁻¹, were in line with the characteristic peaks at 145, 399, 510, 636, and 820 cm⁻¹ for green earth [33] (Figure 8b). The peak at 142 cm⁻¹ was due to Fe–O stretching vibrations while the peak at 393 cm⁻¹ was the result of Al–O stretching vibrations; the peak at 516 cm⁻¹ was caused by the Si–O–Fe stretching vibrations whilst the peaks at 638 cm⁻¹ and at 838 cm⁻¹ were due to Si–O stretching vibrations and Si–O–Al stretching vibrations, respectively. Thereby confirming that the green pigment used in the architectural paintings on the Bell and Drum Towers was green earth. By comparing with the green pigments in the mural paintings on the Eastern Han tomb at Haotan in Dingbian county of Shaanxi province, the absence of potassium in our samples was presumably due to the presence of sodium instead of potassium [34].

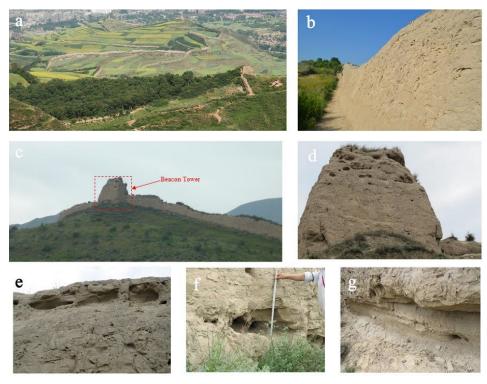
Figure 4. Wind erosion damage to the wall (a) The Wall built along the ridge; (b) Relative well-preserved Wall in spite of long-term nature erosion; (c) Wall and beacon tower on the ridge; (d) sapping of beacon tower; (e) sapping at upper part of the Wall; (f) measurement of sapping area; (g) sapping at bottom of the Wall.

Although built for more than 400 years ago, relevant conservation measures of the Wall in study area were not carried out until 2006 due to local economical and historical background. On the basis of massive field investigation and measurement carried out from 2008 to 2014, obvious difference in sapping quantity was found at both sides of the Wall with identical precipitation, wind field, temperature for a long time, and sapping area is mostly concentrated at upper part of the Wall [33,34]. Existing Wall body generally has a height of 0.5–5.0 m, and a width of 1.5–4.5 m at the bottom and 0.2–1.0 m at the top (Figure 4).

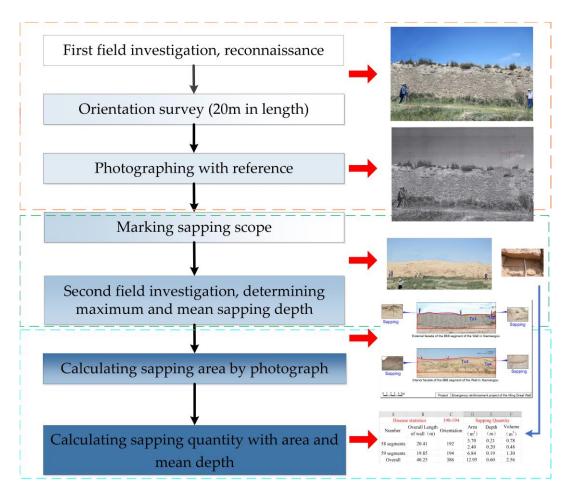
Figure 5. Calculation procedure of sapping quantity of the Great Wall.

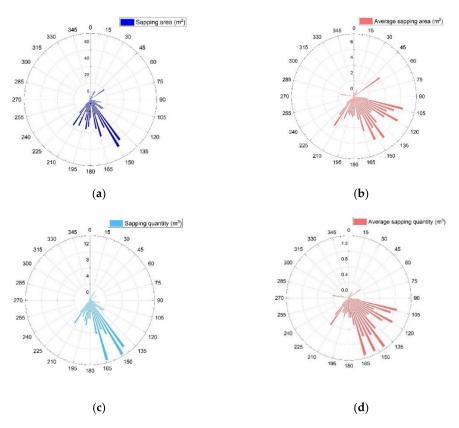
Figure 7. Sapping of the Wall with various azimuth: (a) sapping area of the Wall with various azimuth; (b) average sapping area of the Wall with various azimuth using 20 m as reference unit; (c) sapping quantity of the Wall with various azimuth; (d) average sapping quantity of the Wall with various azimuth using 20 m as reference unit.

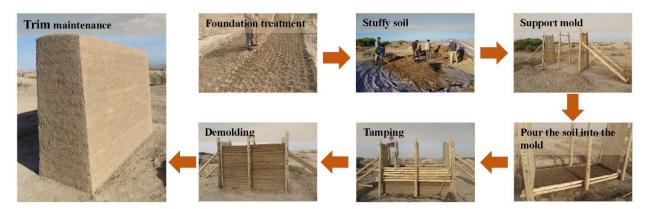
Figure 2. Testing wall tamping process.

height of 2 m, and bottom width of 1.05 m, with a north to south trend; after the ramming, the wall was trimmed to a length of 3.0 m, the height of 2.3 m, and bottom width of 1.1 m (Figure 2).

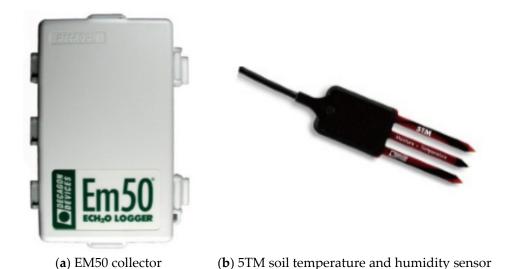
Figure 3. Testing instrument.

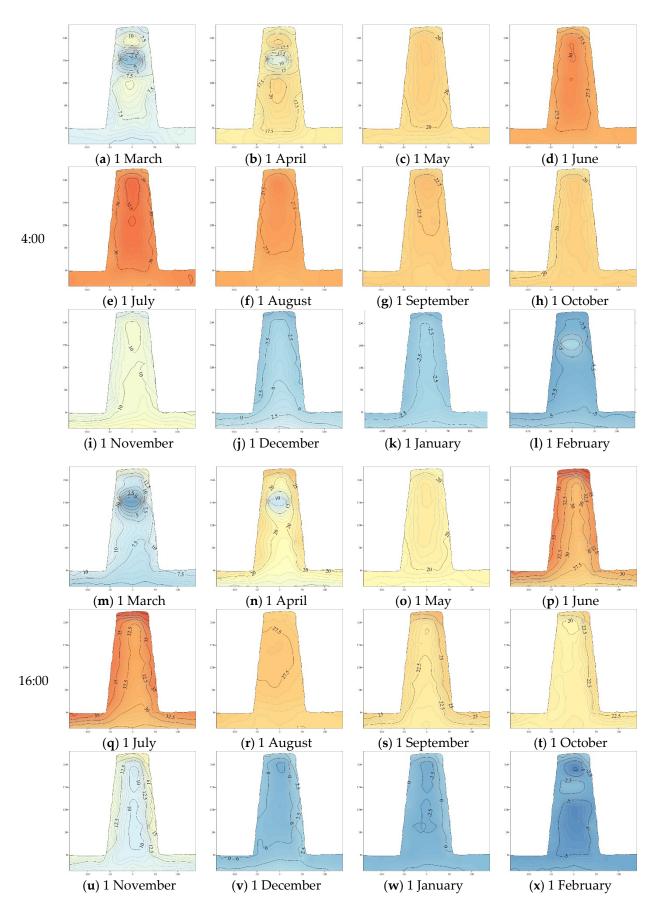
Figure 6. Trend charts showing changes in temperature field isotherms at 4:00 and 16:00 in one year.

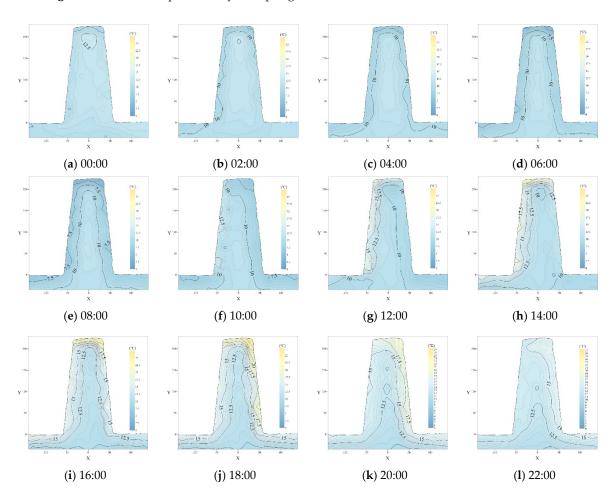
Figure 8. Temperature variations in the test wall on 22 March.

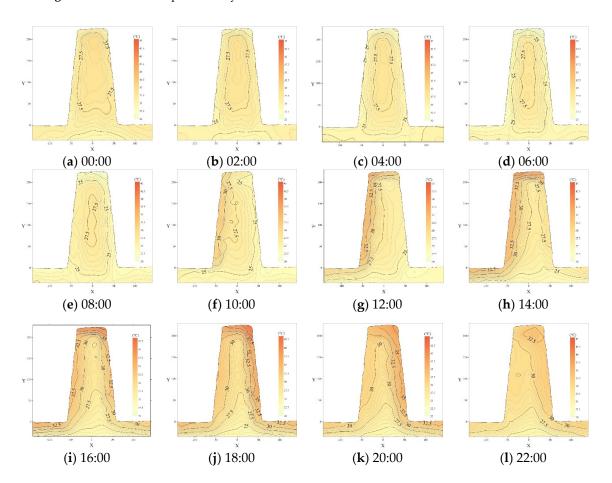
Figure 11. Temperature variation of test wall on June 16.

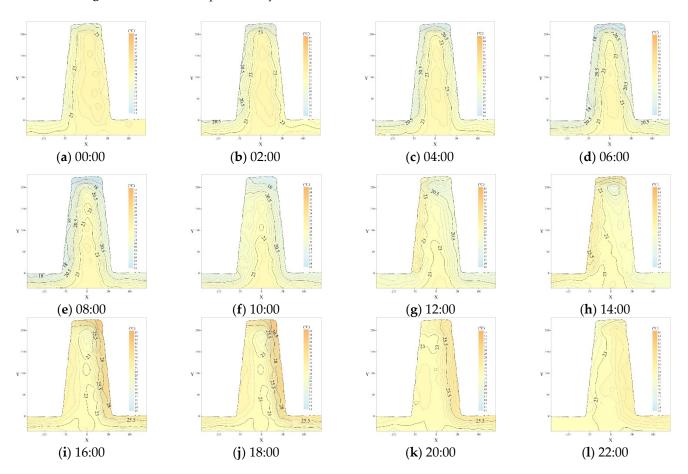
Figure 14. Temperature variations in the test wall on 22 September.

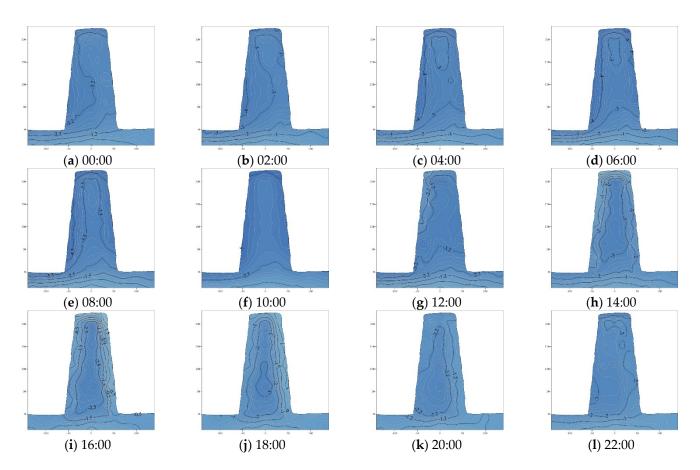
Figure 17. Temperature variations in the test wall on 22 December.

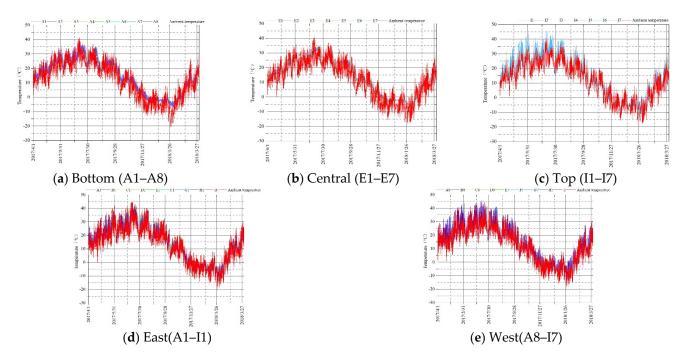
Figure 20. Wall temperature-atmospheric temperature relationship (1 April 2017–31 March 2018).

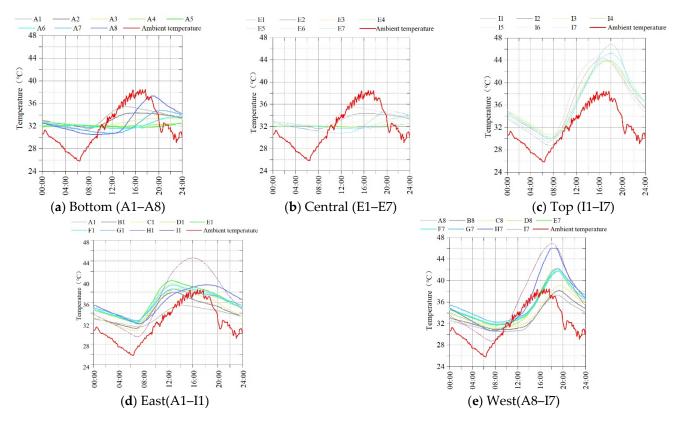
Figure 21. Variation of wall temperature during the highest atmospheric temperature throughout the year (13 July 2017).

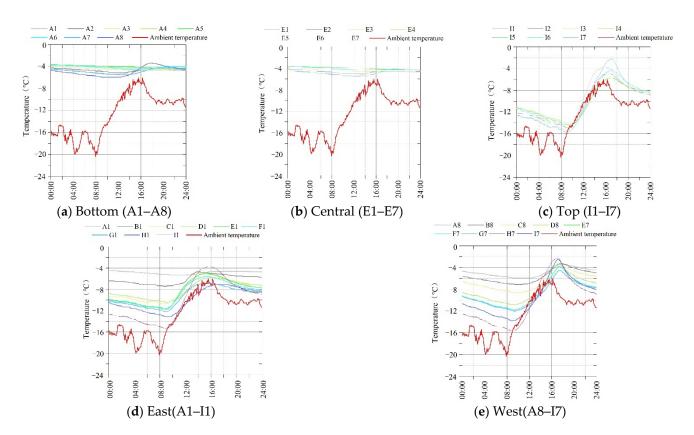
Figure 22. Variation of wall temperature during the lowest atmospheric temperature throughout the year (19 January 2018).

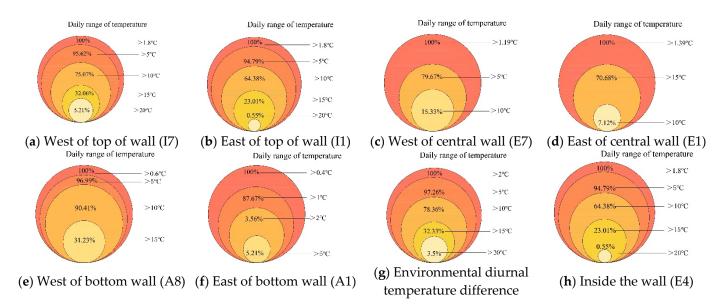
Figure 28. Statistical analysis of the daily temperature difference between the atmosphere and the wall.

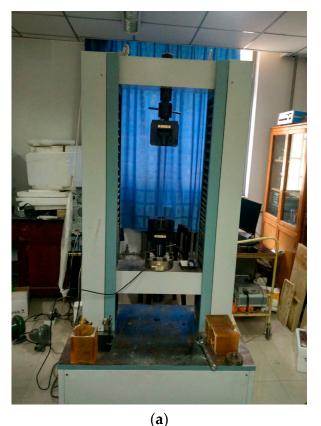
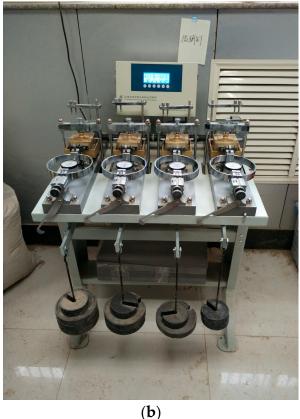
Figure 2. The machine for mechanical tests. (a) Loading machine; (b) shear machine.

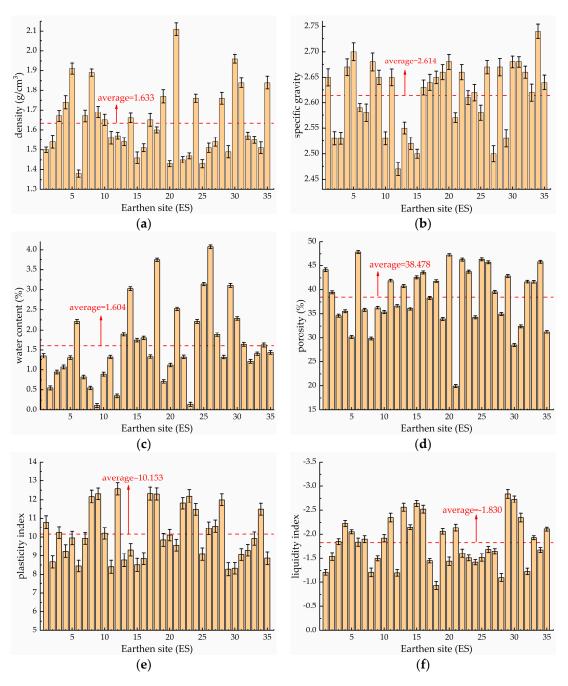
Figure 7. Basic physical properties of 35 site soils. (a) Density; (b) specific gravity; (c) water content; (d) porosity; (e) plasticity index; (f) liquidity index.

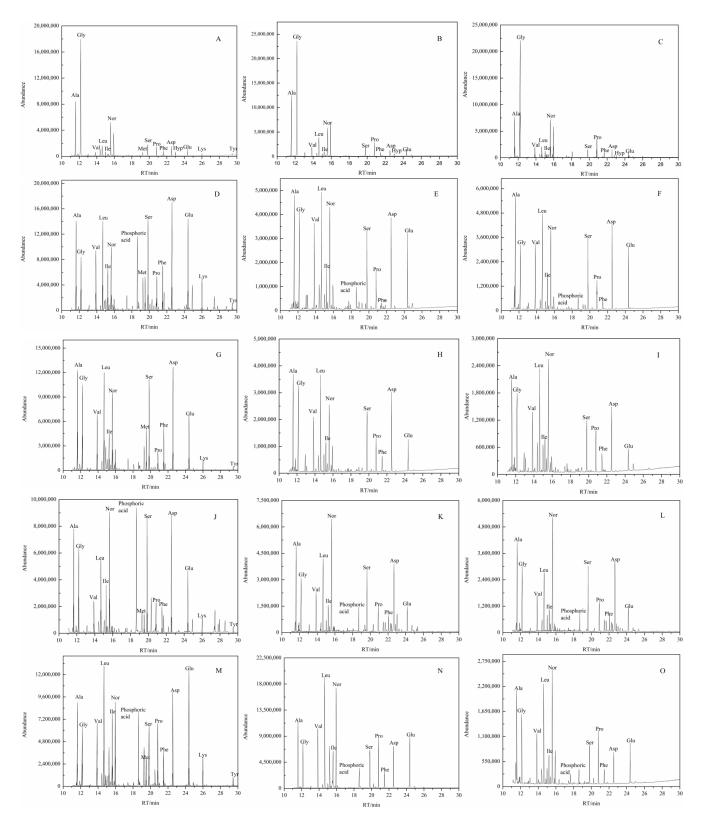
Figure 1. Chromatograms of the five fresh, natural-aged binders ((**A**) fresh pig glu-FPG, (**B**) aged pig glue-APG, (**C**) aged pig glue with ultramarine-APGU,(**D**): fresh whole egg-FWE, (**E**): aged whole egg-AWE, (**F**): aged whole egg with ultramarine-AWEU, (**G**): fresh egg white-FEW, (**H**): aged egg white-AEW, (**I**): aged egg white with ultramarine-AEWU, (**J**): fresh egg yolk-FEY, (**K**): aged egg yolk-AEY, (**L**): aged egg yolk with ultramarine-AEYU, (**M**): fresh casein-FC, (**N**): aged casein-AC, (**O**): aged casein with ultramarine-ACU).

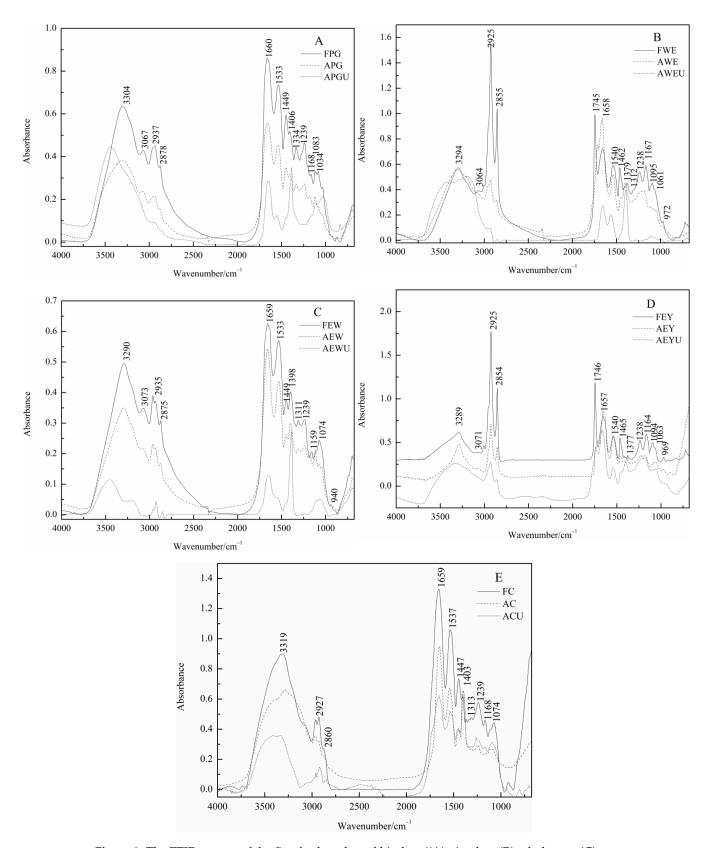
Figure 3. The FTIR spectra of the five fresh and aged binders ((A) pig glue; (B) whole egg; (C) egg white; (D) egg yolk; (E) casein).

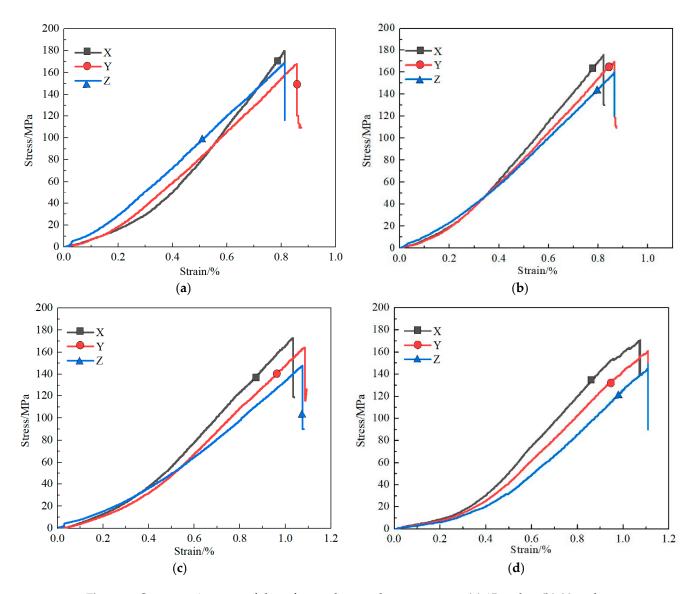
Figure 7. Stress–strain curve of three freeze–thaw cycle treatments at **(a)** 15 cycles; **(b)** 30 cycles; **(c)** 45 cycles; and **(d)** 60 cycles.

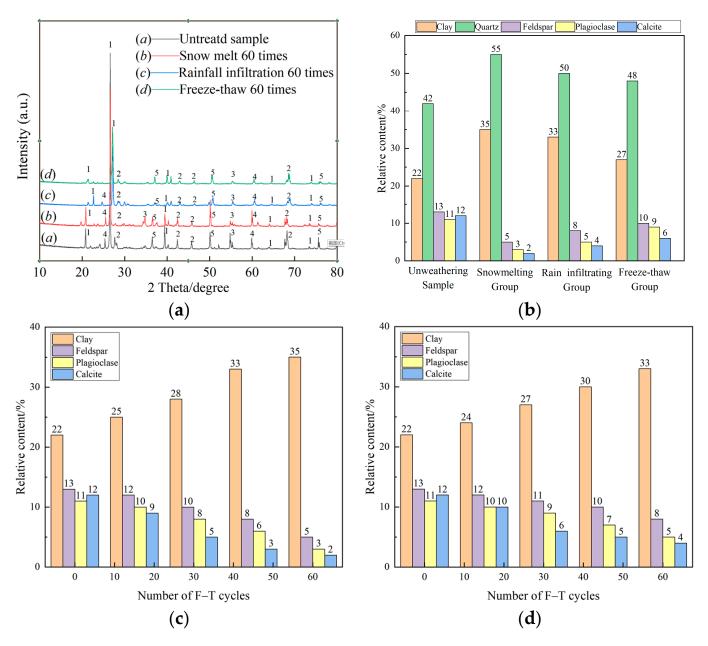
Figure 8. X-ray diffraction (XRD) scans of rock for three F–T cycle treatments. (**a**) XRD spectrogram (1—quartz, 2—clay, 3—feldspar, 4—plagioclase, 5—calcite). (**b**) Mineral content variation after three F–T cycle treatments. (**c**) Mineral content variation in snowmelt group. (**d**) Mineral content variation in rain infiltration group.

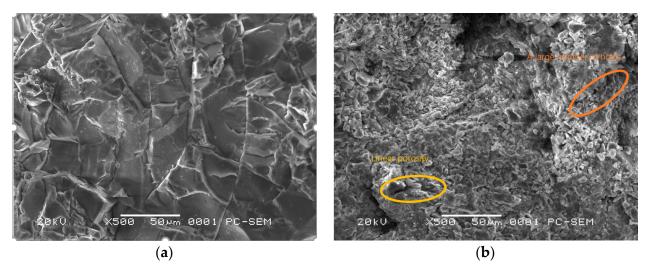
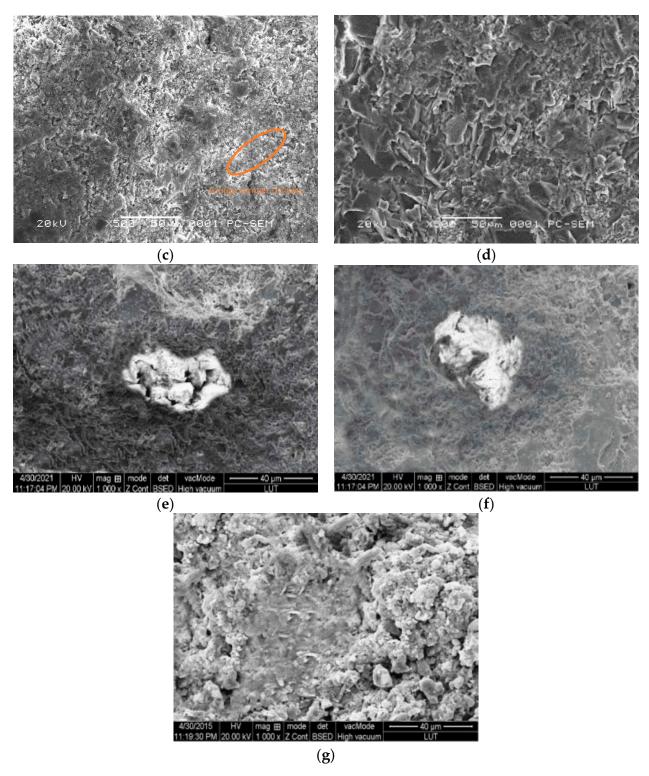
Figure 9. SEM photographs of rock after 60 F–T cycles for three treatments: (a) untreated samples $(500\times)$; (b) snowmelt $(500\times)$; (c) rain infiltration $(500\times)$; (d) normal F–T $(500\times)$; (e) corrosion of feldspar $(1000\times)$; (f) corrosion of calcite $(1000\times)$; and (g) increase in clay $(1000\times)$.

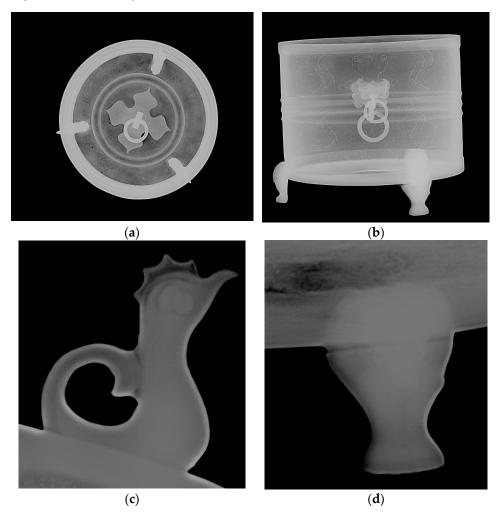
Figure 3. X-ray flaw detection graphs of the bronze Zun: (a) the lid of the bronze Zun; (b) the body of the bronze Zun; (c) the bird-head-shaped component on the lid; and (d) the animal-foot-shaped component on the body of the bronze Zun.

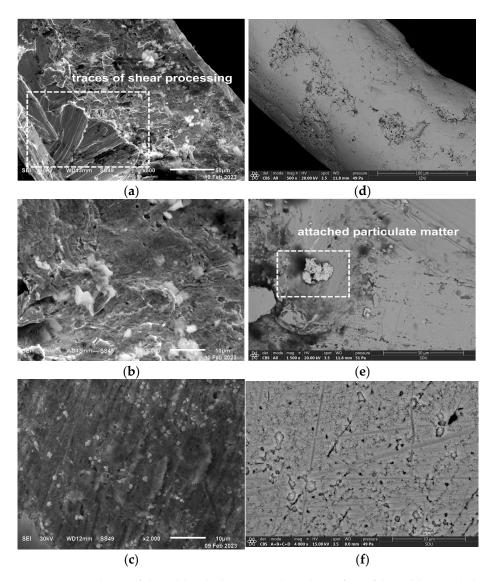
Figure 4. SEM photos of the gold and silver wires: (a,b) the surface of the gold wire; (c) the gold wire profile; (d,e) the surface of the silver wire; and (f) the silver wire profile.

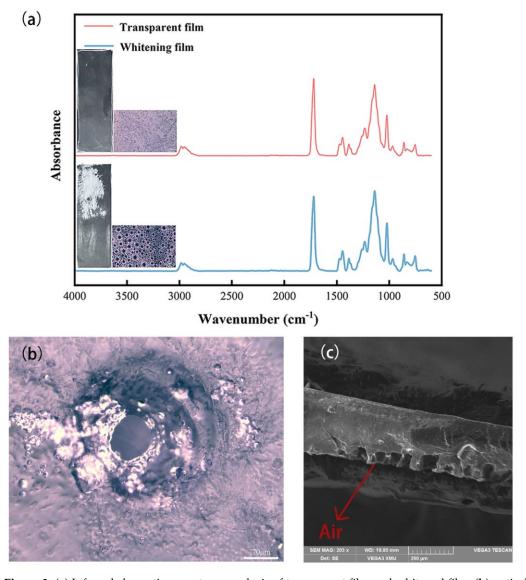
Figure 2. (a) Infrared absorption spectrum analysis of transparent film and whitened film; (b) optical microscopy at pores; (c) pan-white film section microscopy.

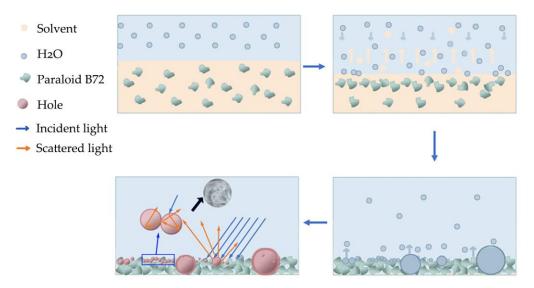
Figure 9. Paraloid B72 film whitening mechanism diagram.

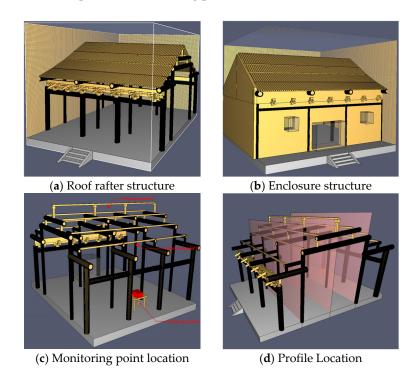
Figure 4. Schematic of FDS building model, temperature monitoring points, and profile locations.

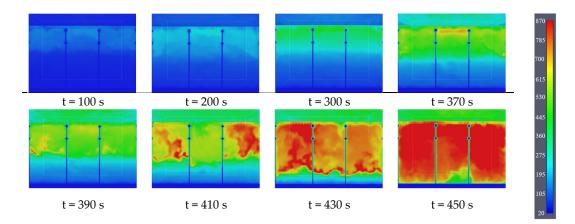
Figure 13. Temperature distribution maps at Y = 4 m profiles of the main hall of Xianqing Temple (timber structural components without various surface treatments).

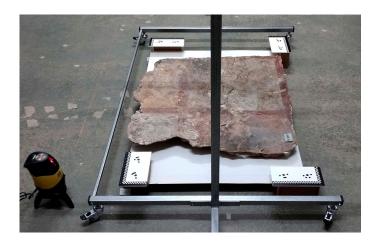
Figure 6. A line laser projecting a linear beam to facilitate the precise alignment of rulers on either side of the mural, ensuring the formation of a straight reference line.

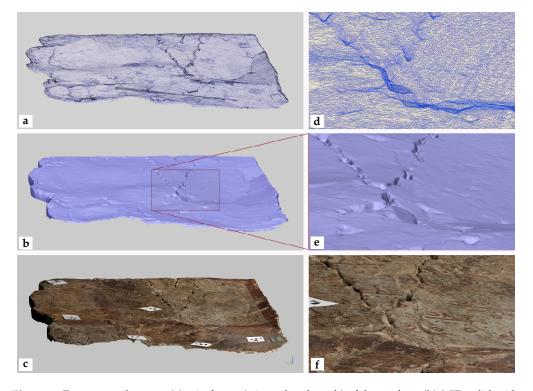
Figure 8. From top to bottom: (a) wireframe (triangulated mesh) of the surface, (b) 2.5D solid without texture, and (c) 2.5D model with texture. (d-f): Detailed views of (a-c), respectively.

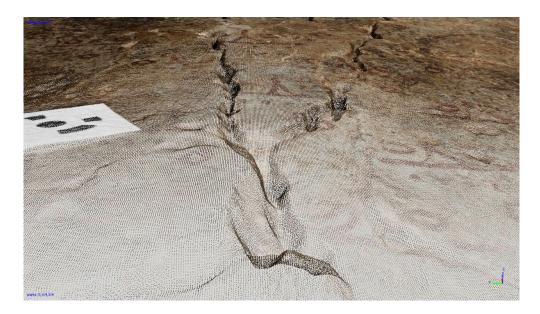
Figure 9. Detailed view of the dense point cloud corresponding to the area depicted in Figure 8d–f. The point cloud consists of points in a three-dimensional space, each carrying color information derived from the source images, providing a high-fidelity representation of the mural's geometry and chromatic characteristics.

Orthomosaics are usually high-resolution photomosaics (see Figure 14) of numerous overlapping photographs and three-dimensional models (see Figure 7a,b, Figure 8, and Figure 9), providing a metric record of the paintings at a single point in time. The most

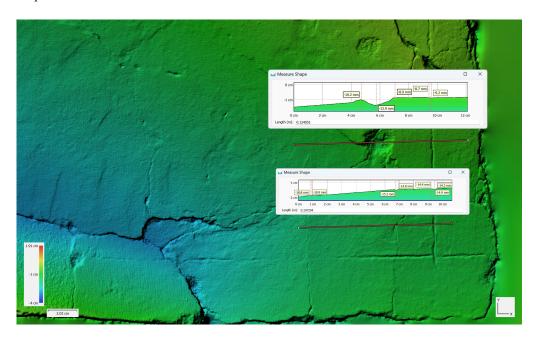
Figure 12. Cross-section providing both visual and metrical data regarding the relief and topography of the mural painting.

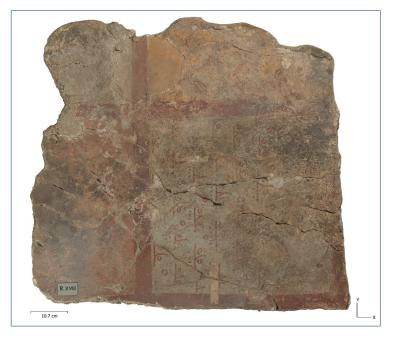
Figure 14. The reconstructed orthomosaic generated from 89 DNG images, with an overall resolution of $26,210 \times 17,852$ pixels and a pixel size of 0.0555 mm. The orthomosaic is orthorectified onto a plane defined by the three targets, 5, 1, and 7 (Figure 5), which are positioned at z=0 in the local coordinate system.

utilized outputs are orthoimages (see Figures 14 and 15a), which are rectified images that are corrected for most distortions [65].
