Masonry Buildings

Research and Practice

Masonry Buildings: Research and Practice

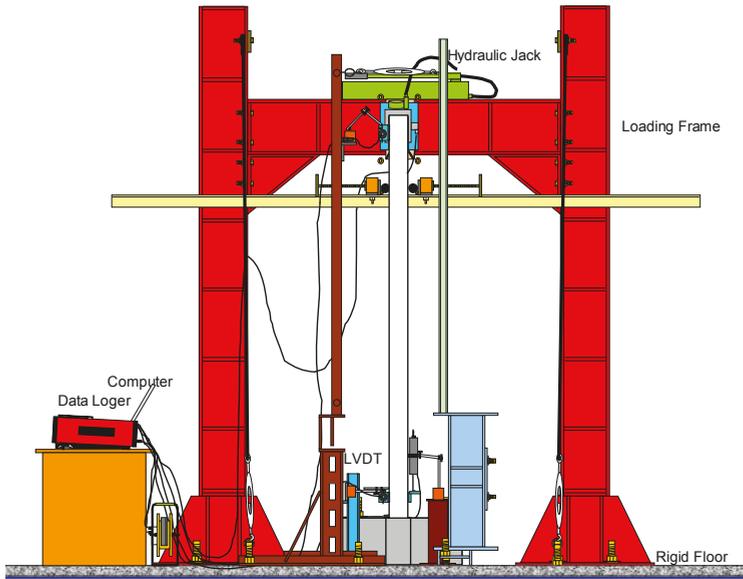
The equipment used in the research is included loading frame, load cell, crane, rigid floor, hydraulic jack and hydraulic pump machine with the capacity of 50 tons, data lodger, and computer. 6 units of 50-mm Linear Variable Differential Transformer (LVDT) with the accuracy of 0.01 mm and all was connected to data lodger were used to measure the level of deflection. Set up of the test on those three specimens can be seen in Figure 5.

Figure 5. Test Setting.

Cyclic lateral load was given as unidirectional with the axis of wall strength referring to American Society for Testing Materials (ASTM) E 2126-02a Method B (amplitudes of the Reversed Cycles). The lateral load was given to the specimen with alternating direction until reaching the yield in which it was then continued to reach a collapse (failure) and loading was based on the displacement control.

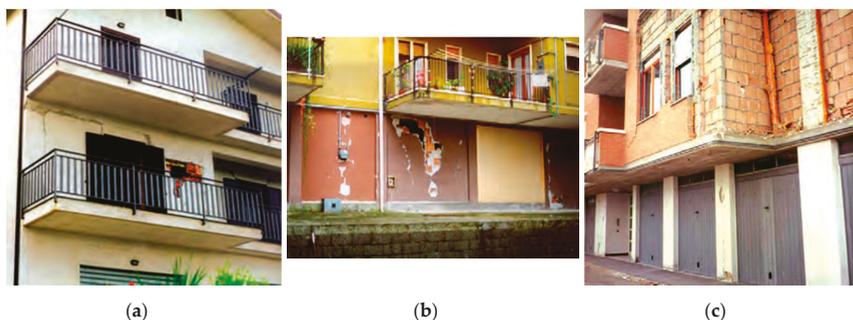
Damage grade D4–D5, defined as “Very heavy” damage, significantly modifies the structural response leading to a possible partial or total collapse of the building. Cracks’ width and extension on the infills are significantly more severe than for the previous damage level. Some examples of Medium-Severe and Very Heavy damage to infills are shown in Figure 2.

Figure 2. Examples of Medium-Severe and Very Heavy damage to infills: horizontal and vertical cracks between infill and beams/columns—widespread damage D2–D3 and locally D4–D5 (a); damage D4–D5 to infills (b); damage D4–D5 with out-of-plane collapse of one infill leaf (c)—adapted from [4].

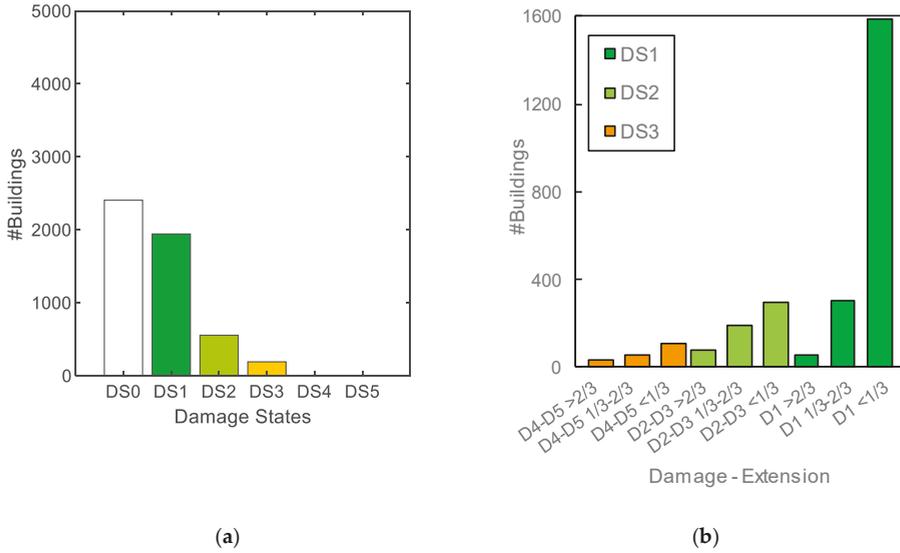
Figure 8. “Observed” maximum damage scenario for “lightly damaged” RC buildings (a), and details about the extent of the maximum damage in each DS (b).

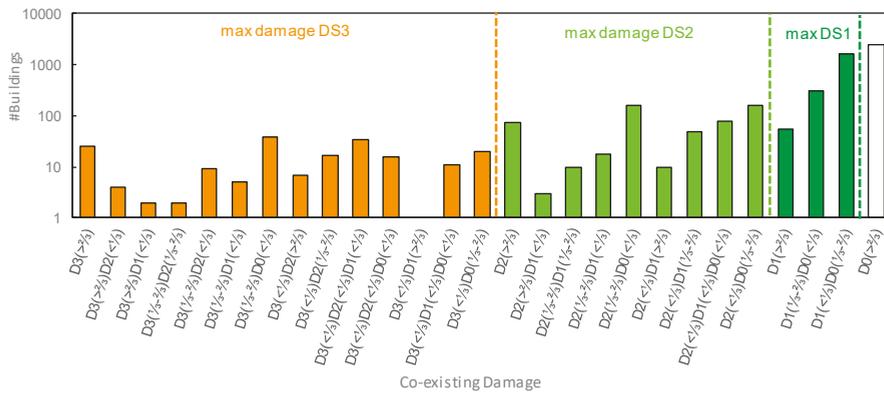
Figure 9. “Coexisting” damage given the maximum damage level (Number (#) of buildings is in logarithmic scale).

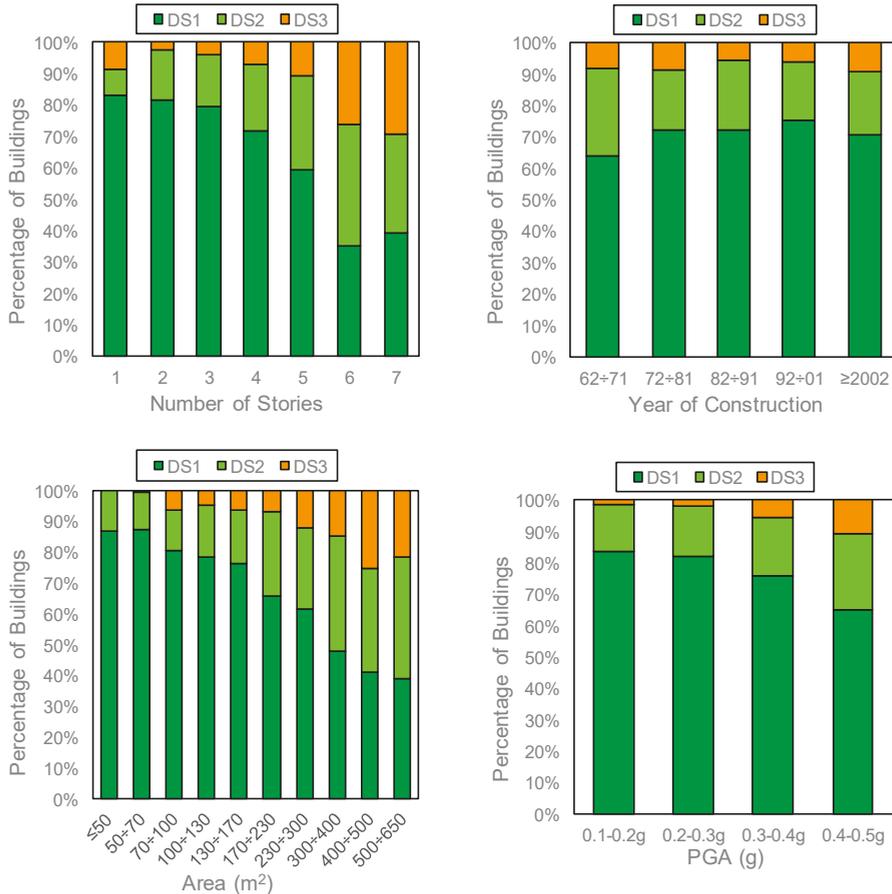
- Construction age is not a significant parameter in the definition of damage trend;
- A higher plan area is associated with more severe damage levels;
- Damage severity increases for higher values of PGA, as expected.

Figure 10. Analysis of the observed damage scenario for “lightly-damaged” RC buildings depending on the PGA of the event, year of construction, number of storeys and plan area of the buildings.

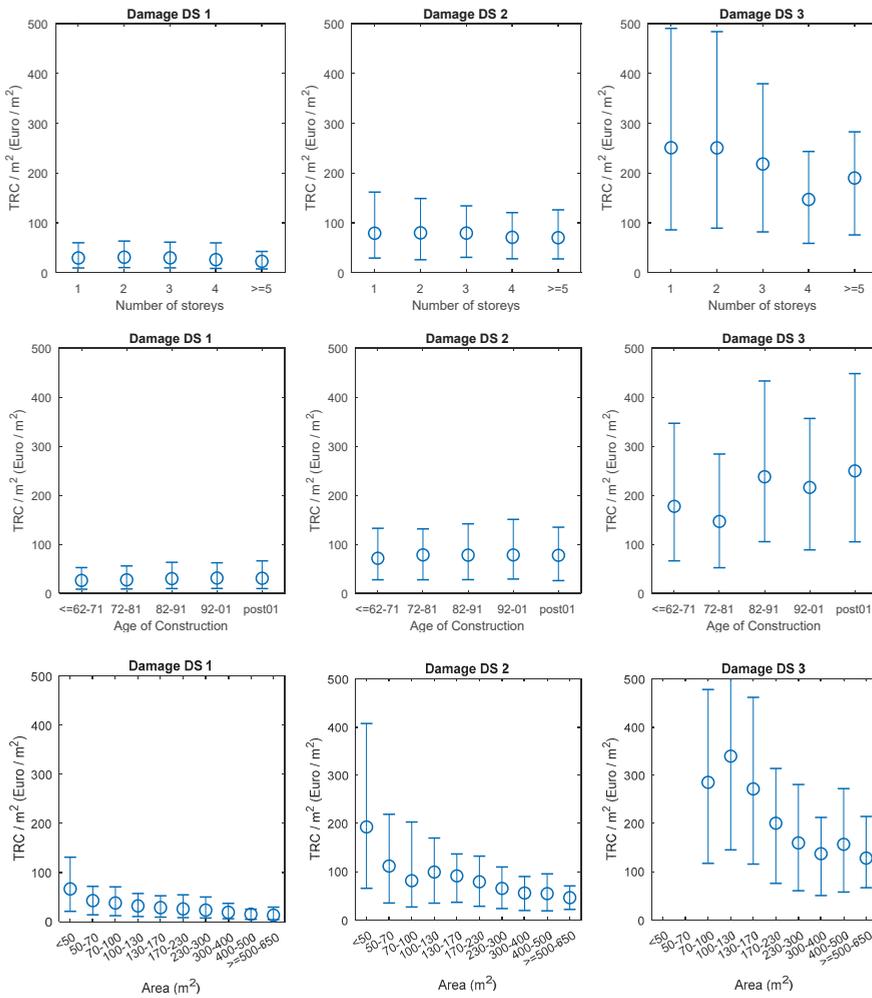
A further de-composition of these costs is performed and explained below. The TRC reported in Figure 12 can be disaggregated as shown in Figure 13, depending on the maximum damage level to investigate about the influence, if any, of the parameters number of stories, age of construction, and average plan surface on the outcome TRC/m².

Figure 13. Trends of TRC/m² with number of storeys, age of construction, and average plan surface depending on the maximum achieved DS (the figure shows 50th, 16th and 84th percentiles).

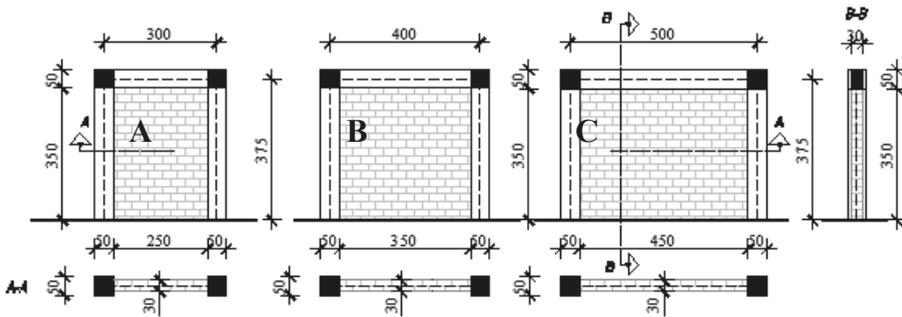
Reinforced concrete frames with height of 375 m has different bay length (A frame—3 m, B frame—4 m, C frame—5 m). Cross-section dimensions are kept constant for all three bay lengths, columns with 50 × 50 cm, and beams with 30 × 50 cm. The RC frames are designed according to seismic regulations [34]. Therefore, material properties for concrete members are based on concrete class C30/37 with reinforcement B500, with reinforcement ratio of 2% of the cross sections. Pushover analysis was carried out in order to evaluate the capacity of infilled frames.

Figure 3. Infilled frame models.

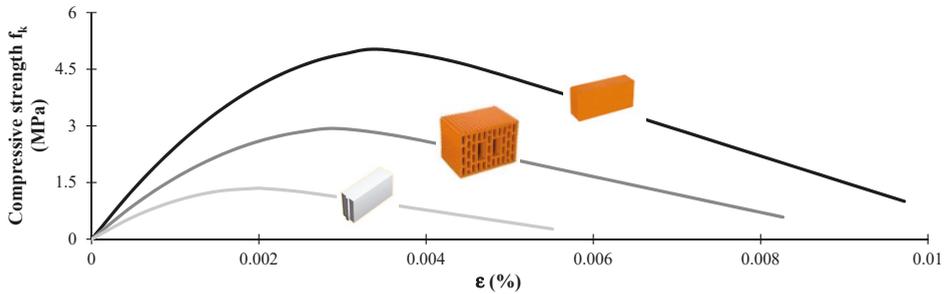
Figure 4. Stress-strain relation for three masonry infill types according to Kaushik [36].

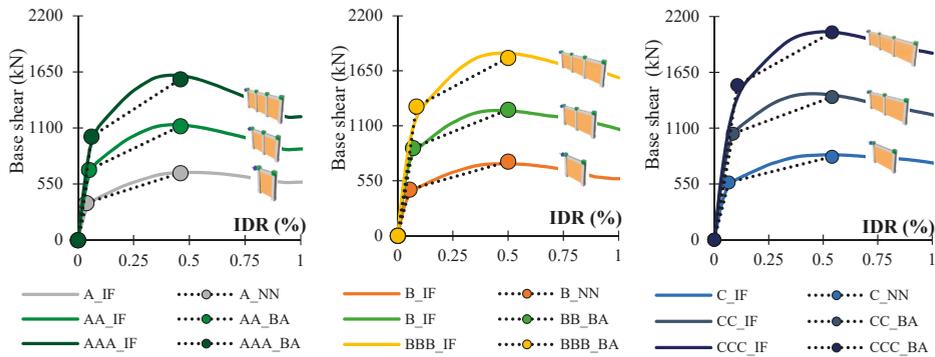
Figure 8. Capacity curves for multi-bay frames with same bay length.

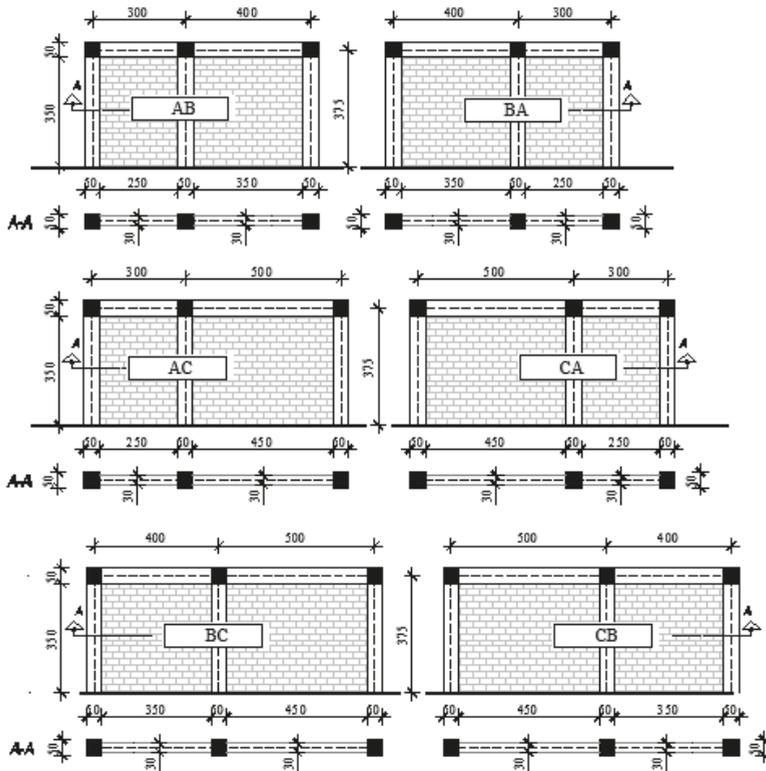
Figure 9. Infilled frame models—multi-bay models with different bay length.

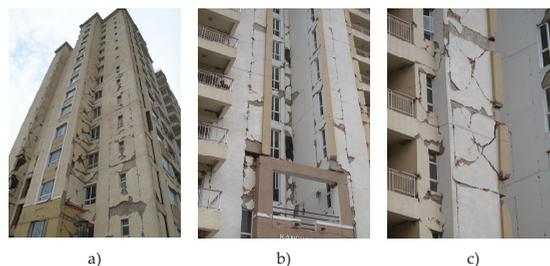
Figure 1. Fourteen-storey reinforced concrete structure damaged after the Gorkha earthquake: (a) distribution of the damages from the first to the seventh storey; (b) detachment of the walls from the envelope frame; (c) diagonal cracking with slight out-of-plane detachment of the wall.

Regarding the high-rise RC buildings' (with 10–18 storeys) performance from the earthquake of April 25, 2015, it was observed that most of the damage was related to the infill walls [6–8]. Figure 1 shows the structure damage of a 14-storey RC and from the observation of the vertical profile of the building, the damages are concentrated the first seven floors of the structure, as can be seen in Figure 1a. The damages are composed by detachment of the walls from the envelope frame (Figure 1b), diagonal cracking (Figure 1c) and some slight out-of-plane detachment of the wall from the frame. The reduced level of damage suits the proper seismic behaviour of these structures, which were designed as per the Indian National rules and standards. Even though, in many cases, damage was limited to the infill panels, it is worth noting that in many of these structures, the occupants had to be moved for temporary shelter (for some, more than a year) due to safety issues related to possible failure of the panels and until all repairs are complete. In some cases, the high costs associated with the repair of the buildings exceeded the structural costs of construction.

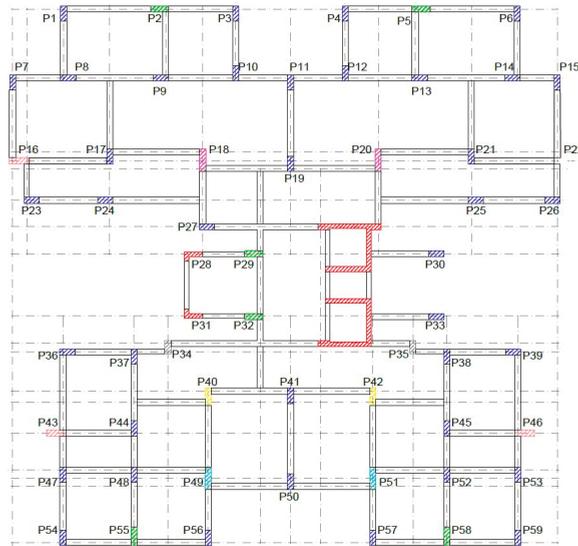
Figure 3. Case study: columns cross-section.

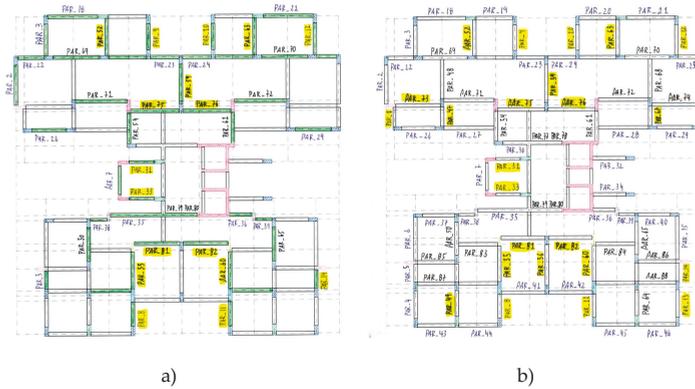
Figure 4. Distribution of the infill masonry walls: (a) ground floor; and (b) remaining floors. Where Par_€ means infill panel number €.

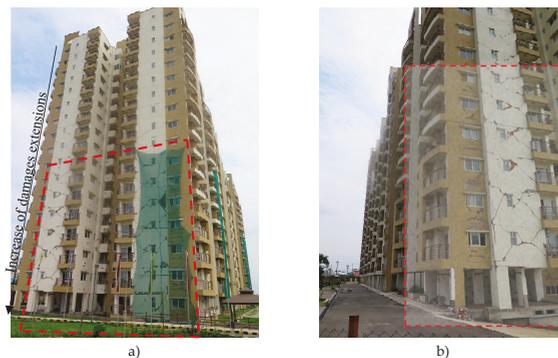
Figure 5. Survey damage assessment of the building: (a) north façade; (b) south-east façade.

Globally, the structural seismic performance was positive since the structural damages observed were slight to moderated. Figure 5 shows the vertical profiles of the structure from two different orientations, from which it becomes clear that the damage extension is higher in the bottom storeys (until 7th storey). Regarding the damages observed throughout the building’s façades, only a few RC columns located in the ground floor suffered cracking and spalling of the concrete. It was not observed any column affected in the top storeys of the structure. Otherwise, the infill masonry walls suffered extensive damages. Diagonal cracking occurred in most of the cases followed by the detachment from the envelope frame. Out-of-plane collapse along the buildings’ façade was not observed, which is justified by the robustness of the façade walls.

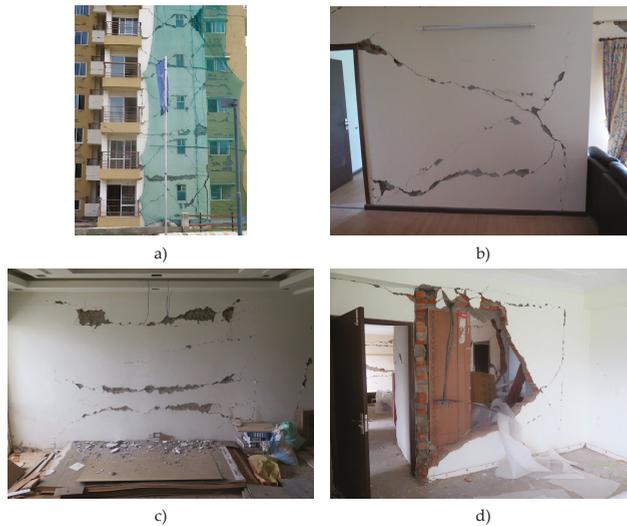
Figure 6. Survey damage assessment of the interior of the building: (a) diagonal cracking in façade wall; (b) diagonal cracking in interior partition wall; (c) sliding cracking in interior partition wall of storey 1; and (d) out-of-plane collapse of interior partition wall.

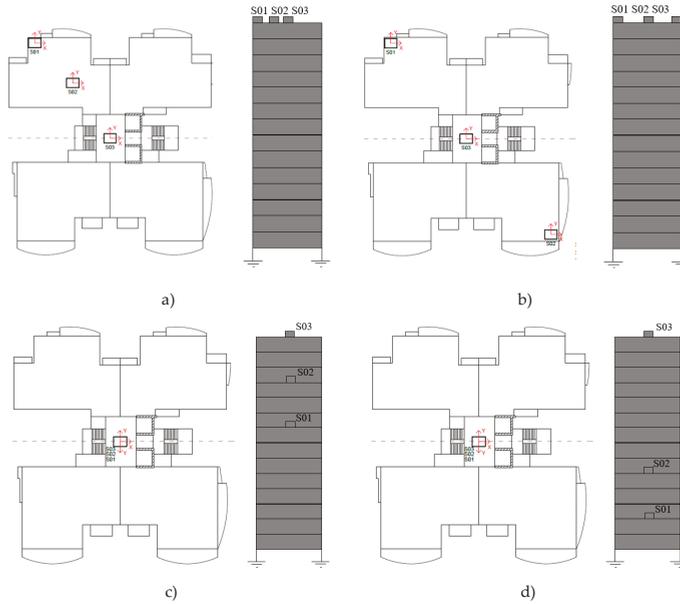
Figure 7. Ambient vibration tests: schematic layout of the seismometers disposition (a) Setup 1; (b) Setup 2; (c) Setup 3, and (d) Setup 4.

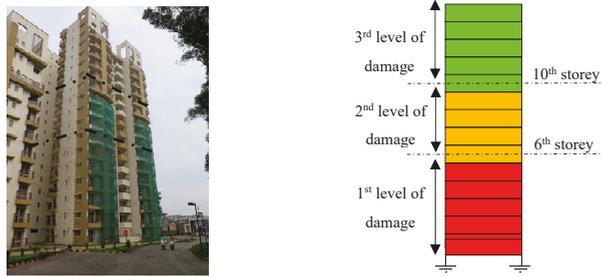
Figure 12. Schematic layout of the infill masonry wall level of damages assumed.

reduction factor for each panel. Thus, three different levels of damages were assumed based on the survey damage assessment (Figure 12).

For the first level of damage, a reduction factor of 0.3 was assumed between the 1st and 6th storeys. For the second level of damage, between the 6th and 10th storeys, a reduction factor of 0.5 was assumed. Finally, for the third level of damage, a coefficient of 0.7 was assumed. From the modal analysis of the model with infill masonry walls (damaged), the first four vibration modes and the corresponding natural frequencies were collected and are summarized in Table 6.

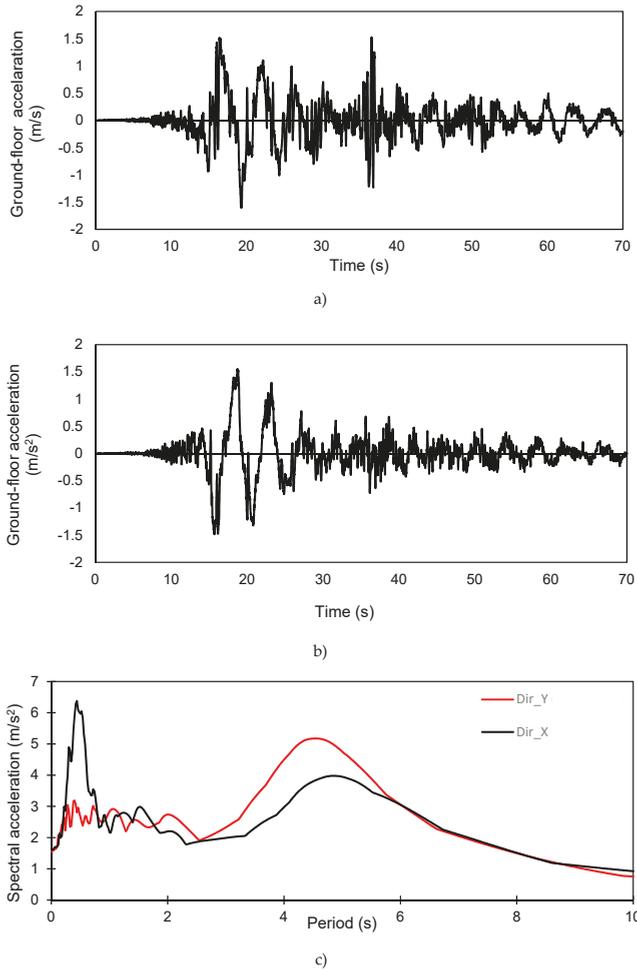
Figure 13. Linear elastic dynamic analysis: (a) accelerogram (direction X); (b) accelerogram (direction Y); and (c) spectral acceleration.

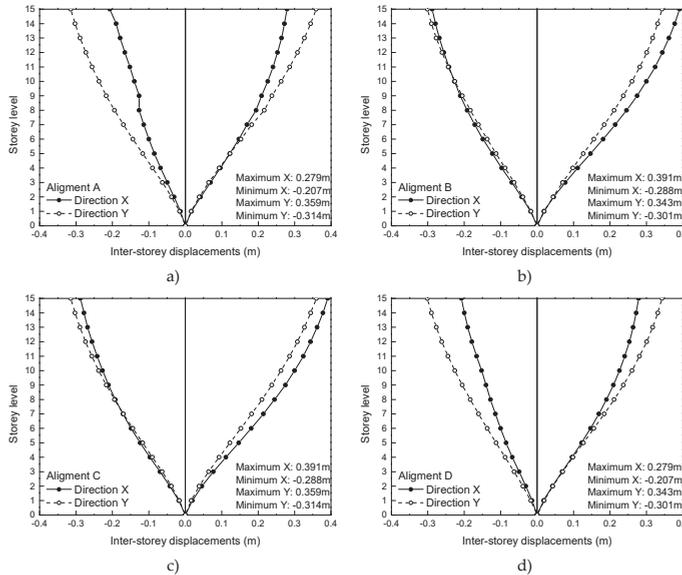
Figure 15. Linear elastic dynamic analysis result: maximum inter-storey displacement of Model 3 (a) alignment A; (b) alignment B; (c) alignment C and; (d) alignment D.

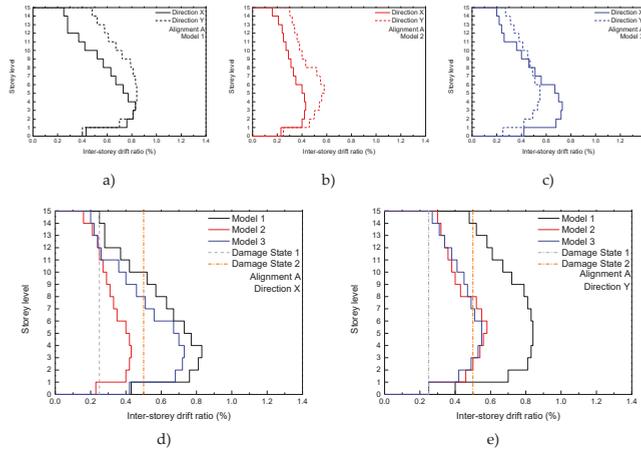
Figure 17. Linear elastic dynamic analysis result: maximum inter-storey drift ratio (alignment A) (a) Model 1; (b) Model 2; (c) Model 3; (d) global comparison (Direction X); and (e) global comparison (direction Y).

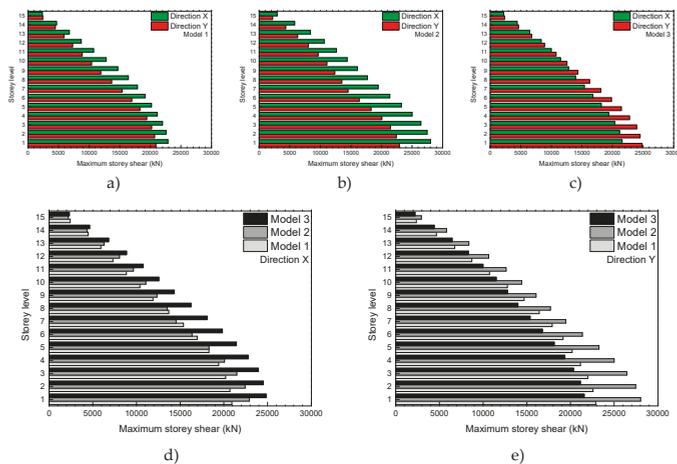
Figure 19. Linear elastic dynamic analysis result: maximum storey shear (a) Model 1; (b) Model 2; (c) Model 3; (d) global comparison (Direction X); and (e) global comparison (direction Y).

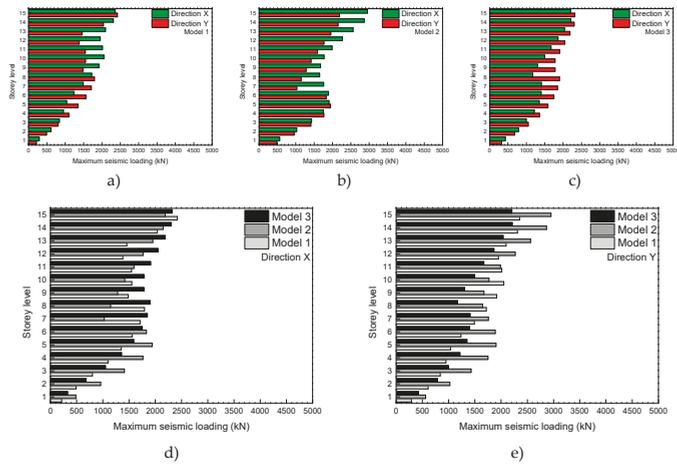
Figure 20. Linear elastic dynamic analysis result: maximum seismic loading envelope (a) Model 1; (b) Model 2; (c) Model 3; (d) global comparison (Direction X); and (e) global comparison (direction Y).

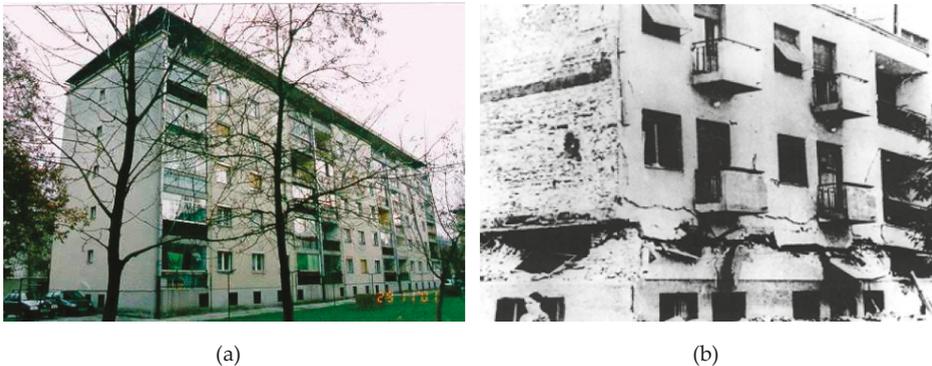
Figure 2. (a) Typical building in Slovenia; (b) devastation of a typical building after the 1963 Skopje earthquake [4].

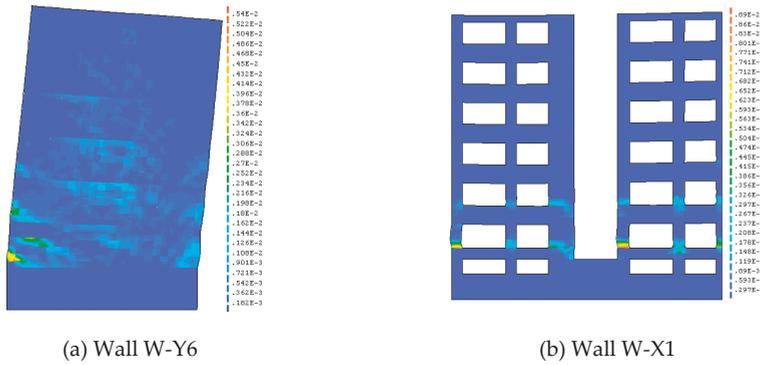
Figure 10. (a) Damage of the perpendicular wall; (b) longitudinal wall due to 0.2 g scaled accelerogram.

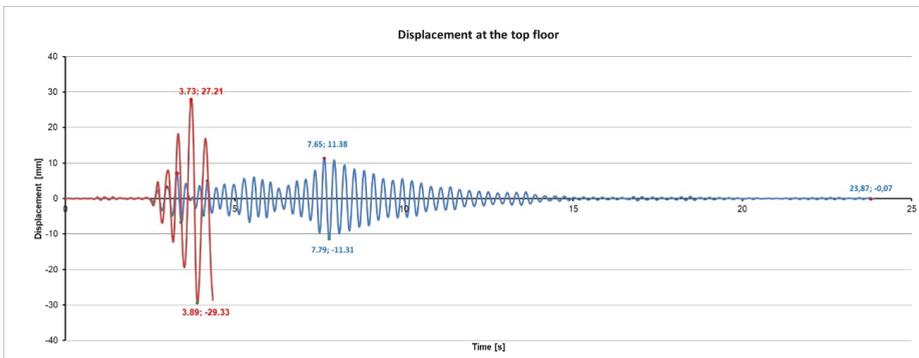
Figure 11. Displacement of the node 44014 at the top floor due to action of 0.1 g (indicated by a blue color) vs 0.2 g scaled accelerogram (indicated by the red color).

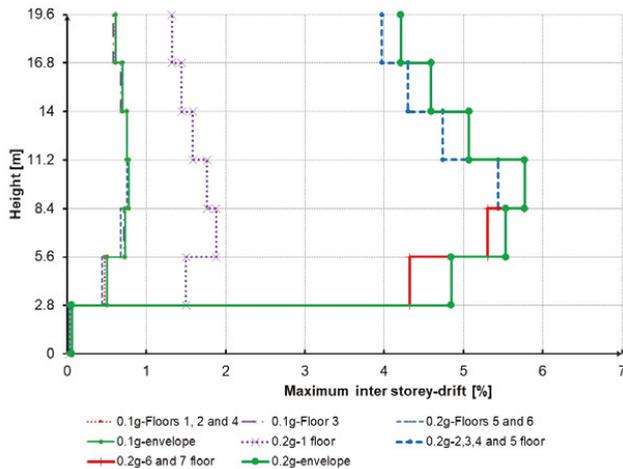
Figure 12. Maximum inter-storey drift for PGA 0.1g and PGA 0.2g scaled accelerograms.

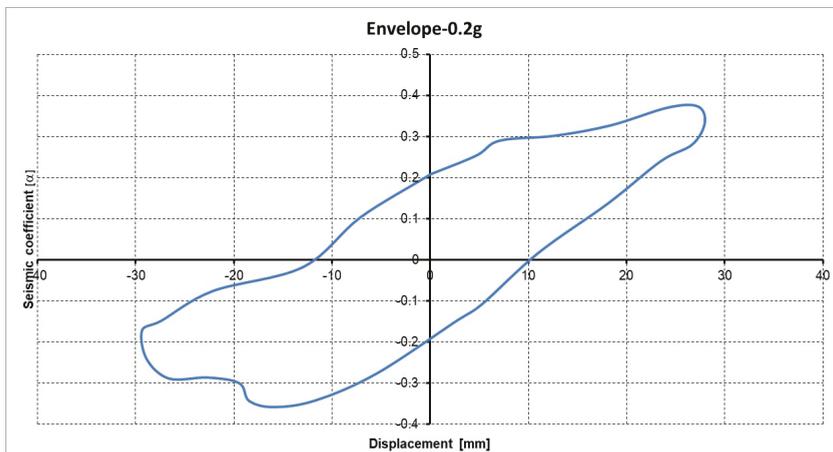
Figure 13. Envelope of the hysteresis curve in the transversal direction.

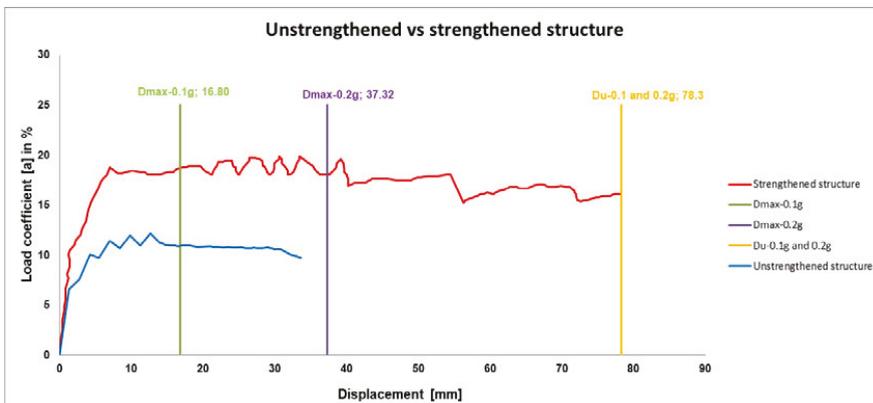
Figure 16. Pushover curves of the unstrengthened and strengthened structures, with performance points for PGA = 0.1 g and PGA = 0.2 g (D_{max} —demand displacement and D_u —ultimate capacity displacement).

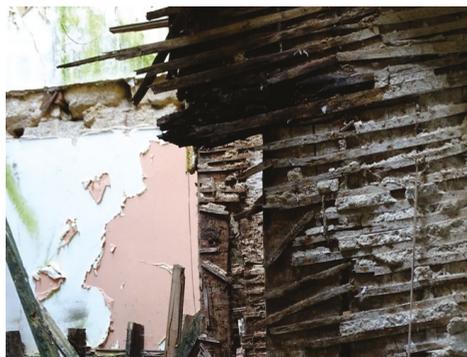
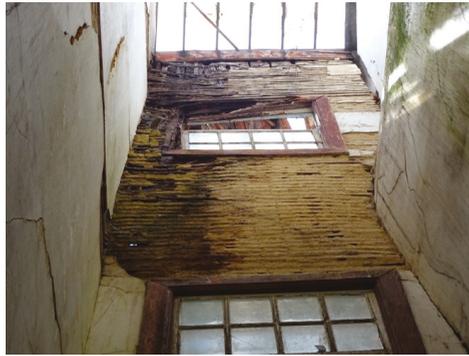
Figure 7. Severely decayed structural elements.

Despite it being classified as a structure with “relevant architectural and heritage value”, the building is presently in an advanced state of degradation, see Figure 7.

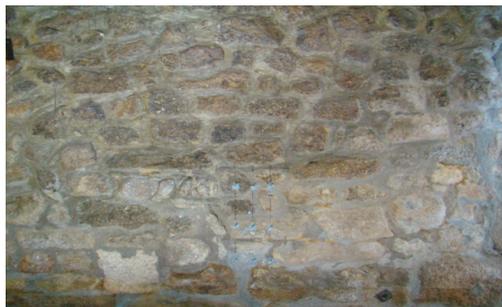
Figure 8. *Águas de Viseu*: (a) building plan with the identification of the studied wall; (b) view to the wall.

As in the previous case study, an internal load-bearing wall was studied, this time located at the ground floor and perpendicular to the façade facing Rua D. Duarte, Figure 8a. As can be seen in Figure 8b, also in this case, stone masonry was visible without the need to remove any plaster. Due to the presence of different minerals, such as quartz, mica and feldspar, stones present various colors, ranging from gray to yellow and pink. The mortar, of a gray color, appears to evidence recent repointing. Stones were rather irregular, both in shape and dimensions. The assemblage was markedly irregular, at times with stones laid with their larger dimension alongside the vertical. The presence of wedges was not significant.

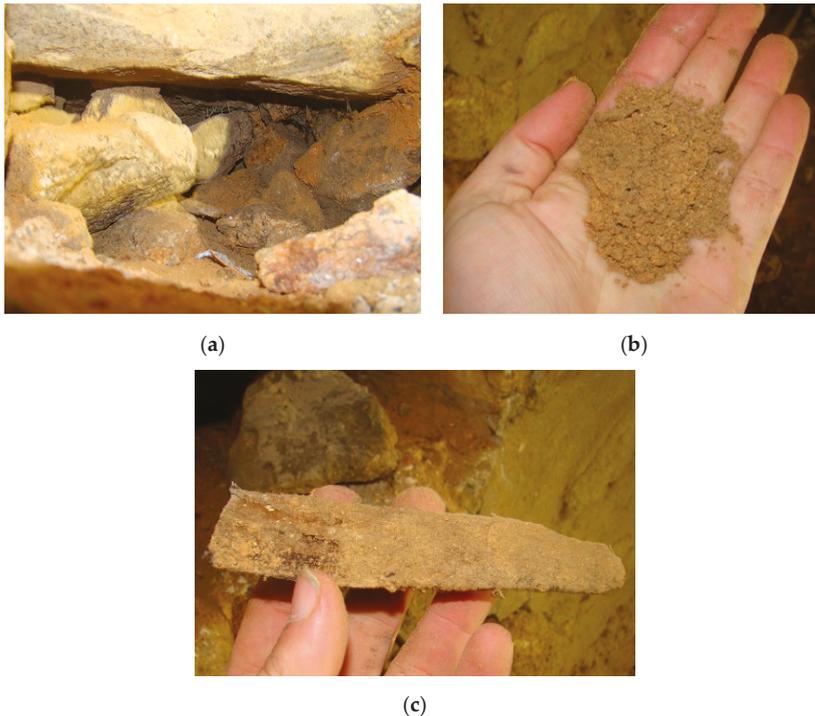
Figure 9. Wall's inner core. (a) roughly-shaped granite stones; (b) lime mortar and earth; (c) wood splinters.

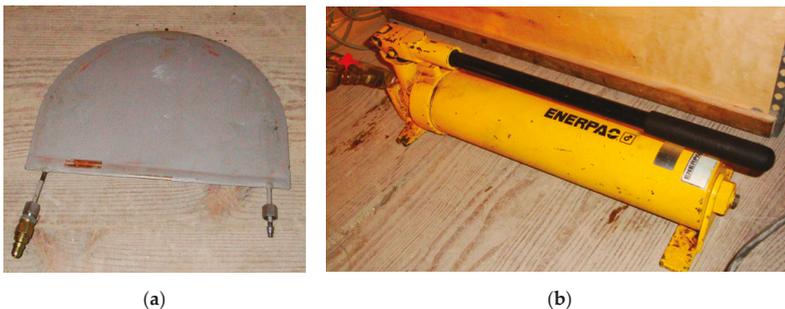
Figure 11. Equipment used in this campaign: (a) semicircular flat-jacks and (b) hydraulic pump.

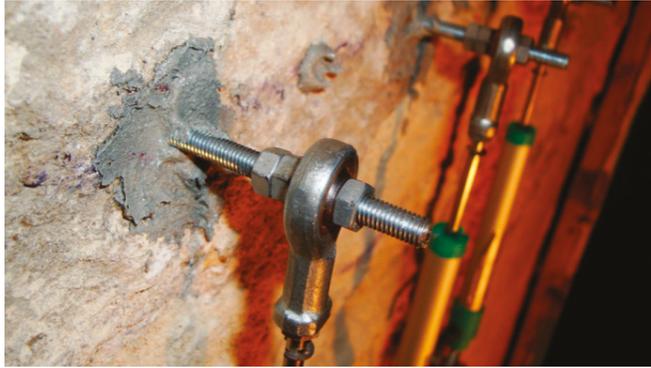
Figure 12. Displacement transducers attached to the wall.

- Displacement transducers: GEFTRAN displacement transducers, with a 50 mm stroke, provided with self-aligning ball-joints. The displacement transducers were attached to the masonry by means of 5 mm threaded rods, applied with chemical anchor, at a depth of 50 mm, Figure 12.

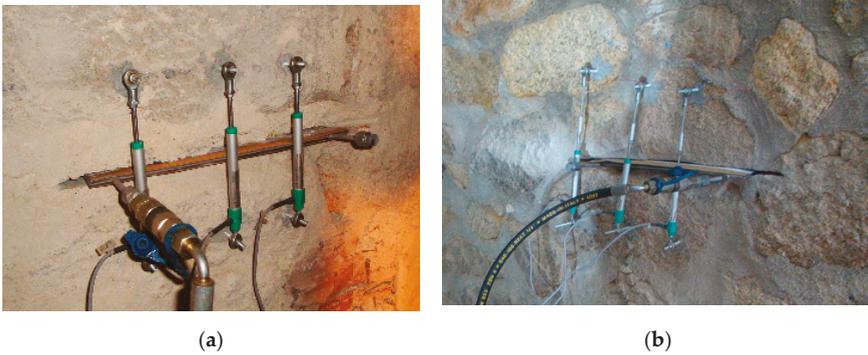
Figure 13. Single flat-jack testing: (a) conducted in the Órfeão de Viseu and (b) in the Águas de Viseu (b).

Figure 13 shows the single flat-jack testing. As presented, three vertical reference alignments were considered. In order to estimate the effective flat-jack loaded area, the procedure proposed by Gregorczyk and Lourenço [29] was adopted: a sheet of carbon paper, sandwiched between two sheets of ordinary paper, was placed between the jack's surface and the surrounding masonry (this set was prepared in the shape of the jack). In this way, the areas where the jack comes into contact with the masonry are marked in the paper and can be measured (Figure 14).

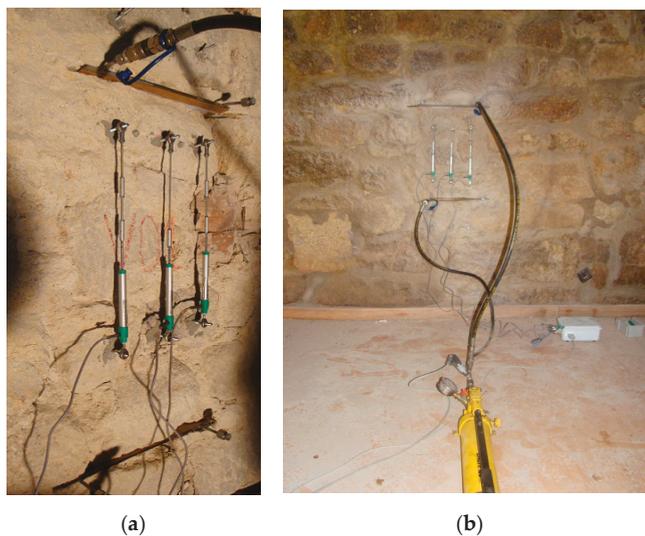
Figure 15. Double flat jack testing conducted in Orfeão de Viseu (a) and in Águas de Viseu (b).

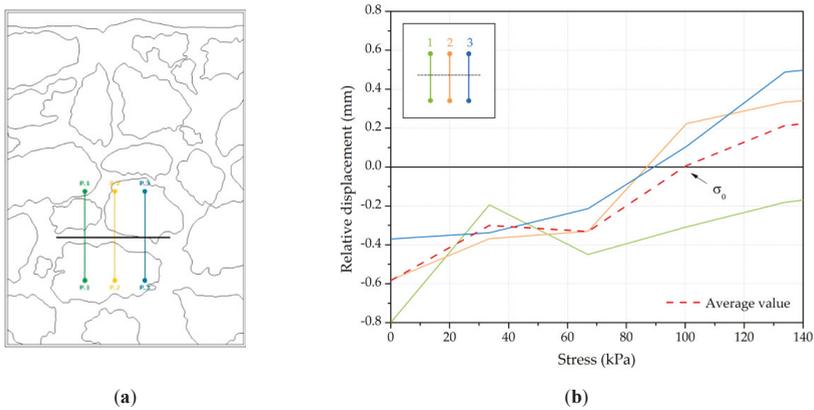
Figure 18. Single flat-jack test AS1: (a) identification of the vertical alignments; (b) evolution of the relative displacements for each vertical alignment and estimation of the in-situ stress.

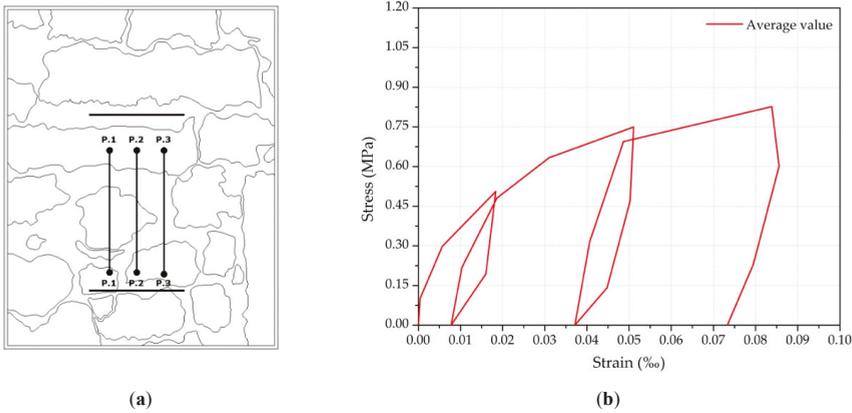
Figure 19. Double flat-jack test OD1: (a) identification of the vertical alignments; (b) average stress-strain curve.

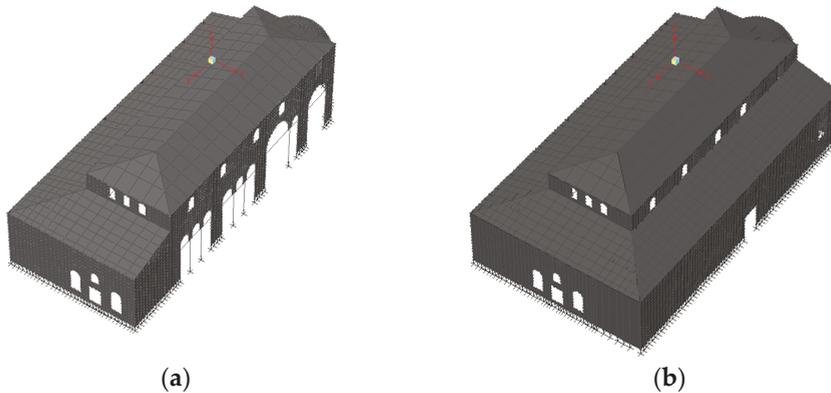
Figure 1. (a) The Basilica structural system with the interior colonnade of the central nave; (b) The Basilica structural system with the peripheral longitudinal and transverse walls.

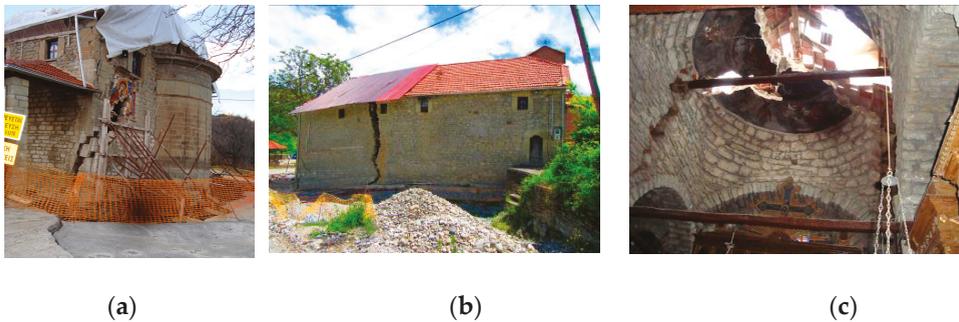
Figure 3. (a) Heavy damage of the East wall. South-East view; (b) Heavy damage of the North wall. North-West view; (c) Heavy damage of the vaulting superstructure.

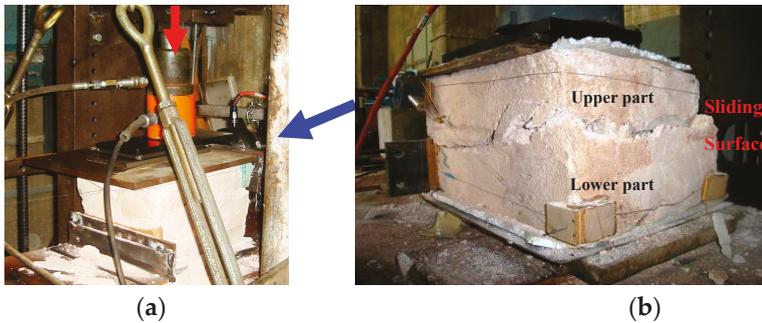
Figure 10. (a). Short stone masonry specimen subjected to sliding shear; (b) Sliding mode of failure of short stone masonry specimen.

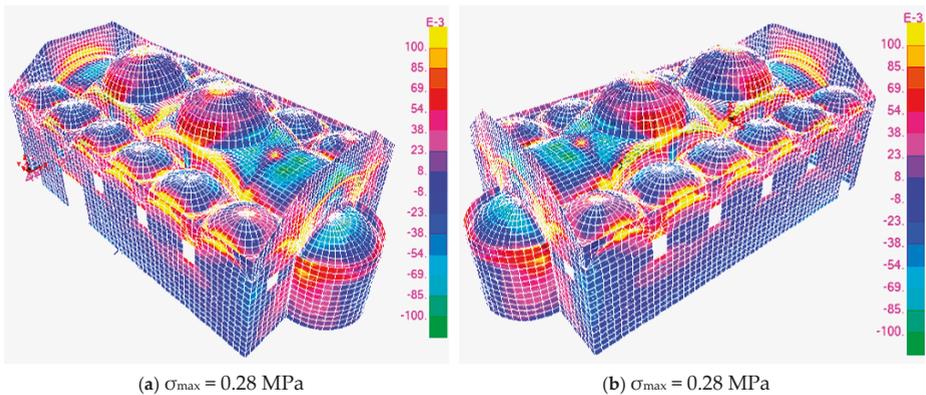
Figure 11. Non-deformable foundation (a) distribution of maximum tensile stresses South-East view (b) distribution of maximum tensile stresses North-East view. The scale at the far right of each plot indicates that the colours used to represent stress values in this numerical representation of the structure are ranging from 0.1 MPa to -0.1 MPa . Yellow colour indicates stress values exceeding 0.1MPa.

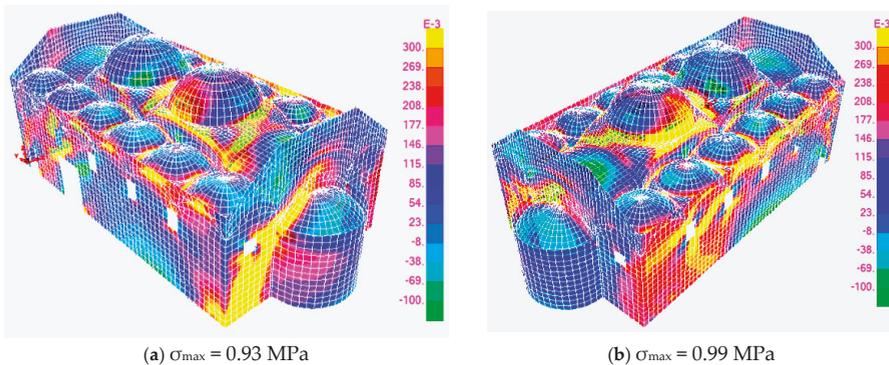
Figure 12. Deformable foundation (a) distribution of maximum tensile stresses South-East view (b) distribution of maximum tensile stresses North-East view. The scale at the far right of each plot indicates that the colours used to represent stress values in this numerical representation of the structure are ranging from 0.1 MPa to -0.1 MPa . Yellow colour indicates stress values exceeding 0.3 MPa.

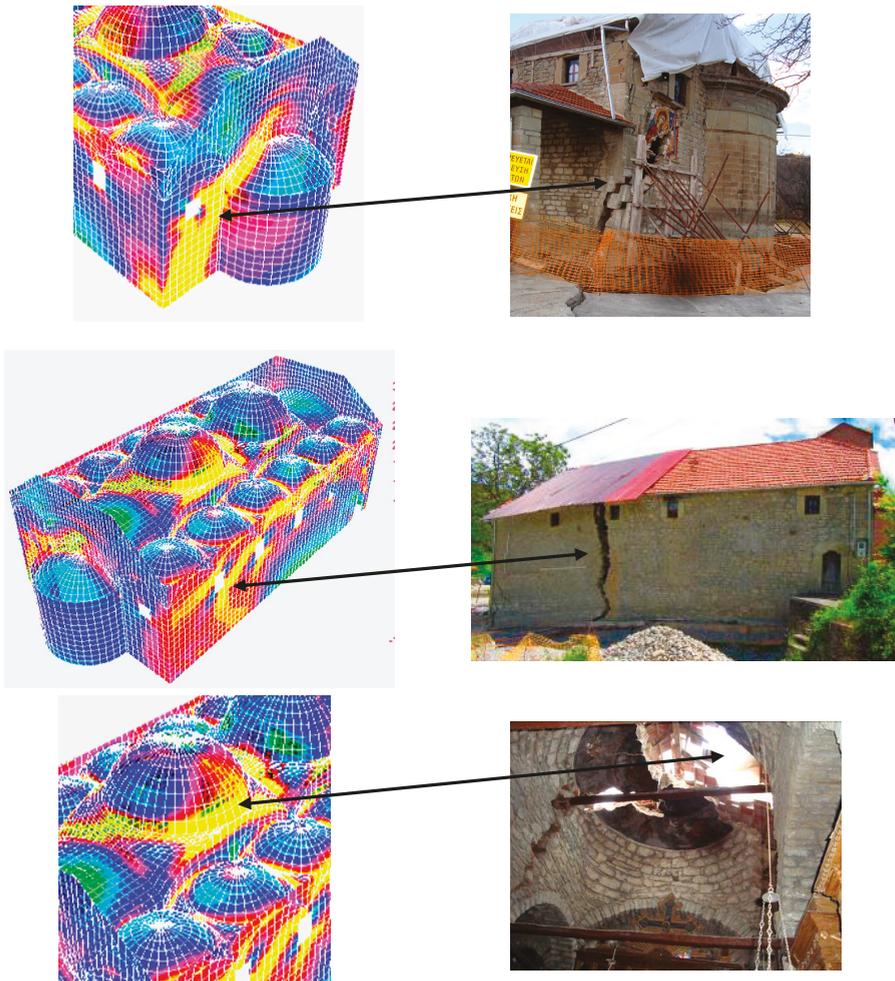
Figure 13. Correlation between predicted (deformable foundation) and observed damage.

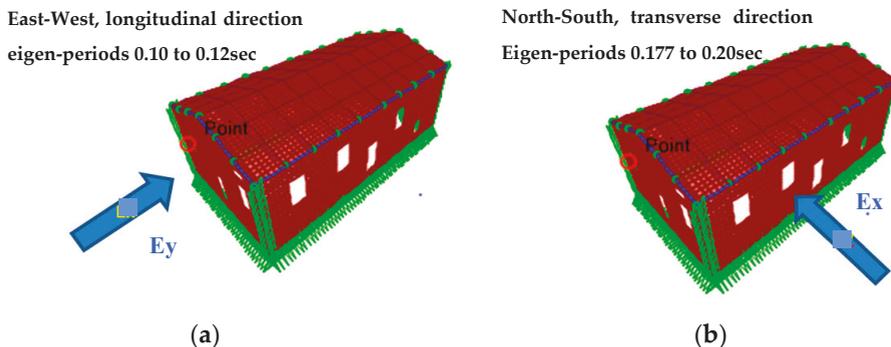
Figure 14. The numerical simulation of the “Basilica” church of St. Marina in Soullaroi in Kefalonia. (a) Longitudinal direction; (b) Transverse direction.

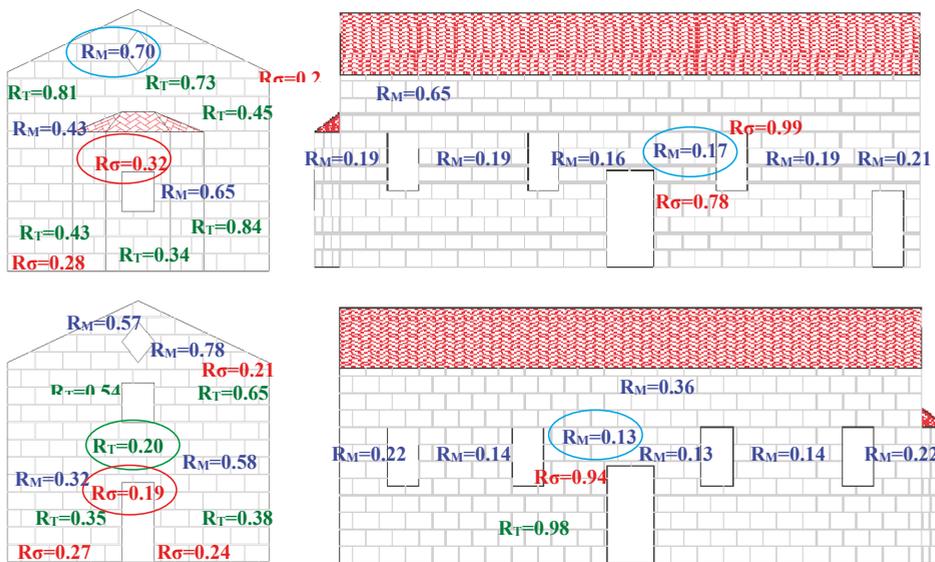
Figure 16. Summary results of the evaluation process in terms of R_τ , R_σ , R_M ratio values, for moderately deformable foundation (axial stiffness value of supporting links equal to 24.5 KN/mm).

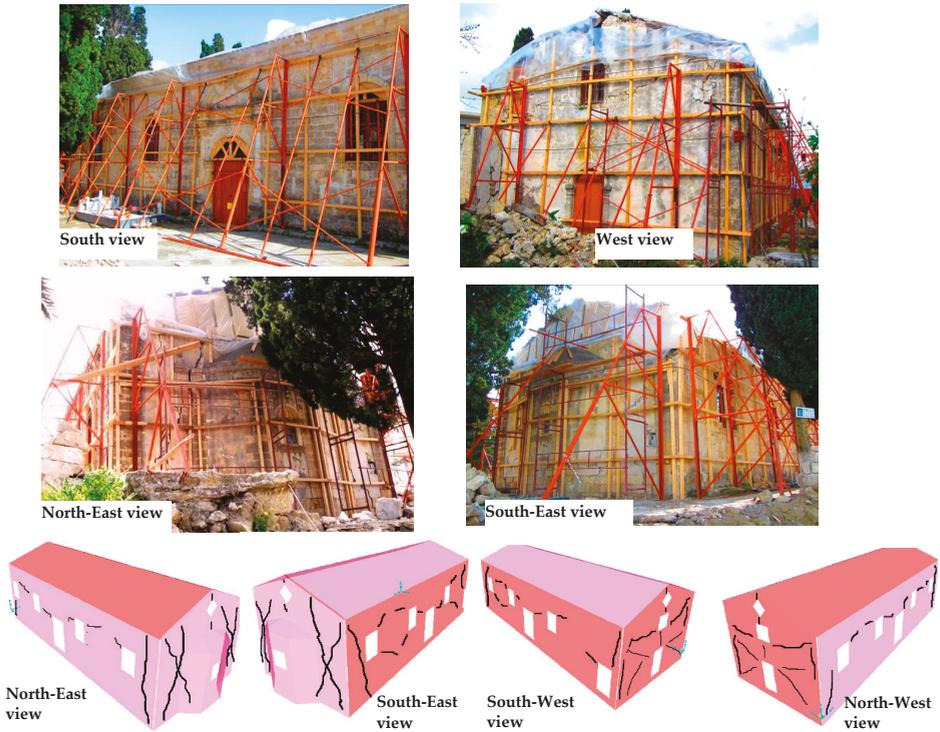
Figure 17. Photographs and sketches of the most severe structural damage.

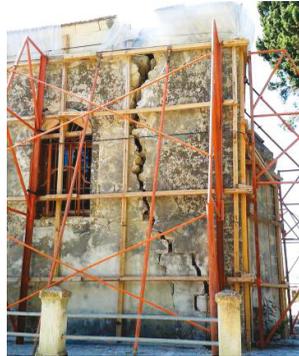
Figure 18. Damage at the N-W corner.

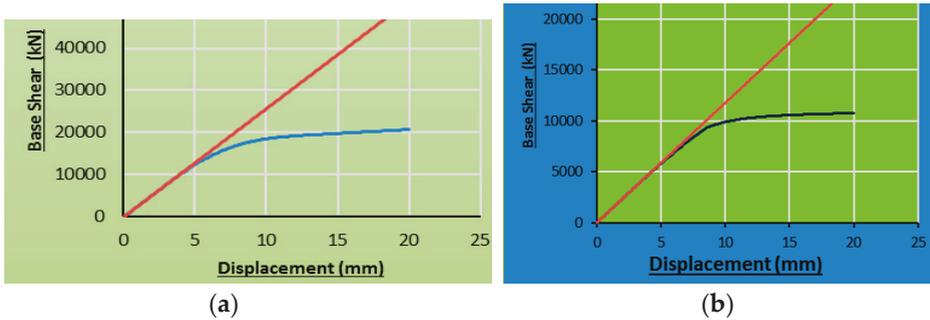
Figure 20. (a) Push-over in the East-West direction (E_y), foundation uplift; (b) Push-over in the North-South direction (E_x), foundation uplift.

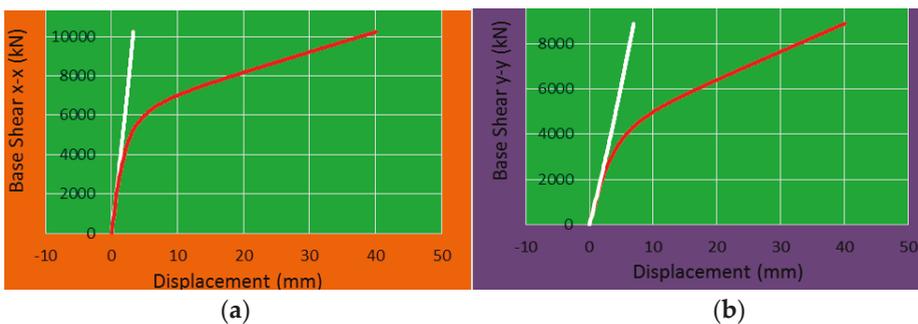
Figure 21. (a) Push-over in the East-West direction (E_y)—detachment of the West wall; (b) Push-over in the North-South direction (E_x)—detachment of the North wall.

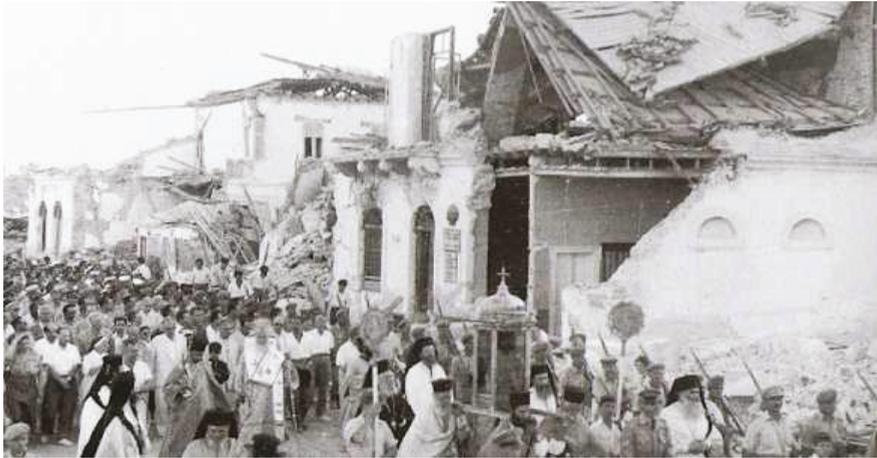
Figure 22. Images of total destruction to old masonry construction in Argostoli, Kefalonia island during the 1953 earthquake sequence.

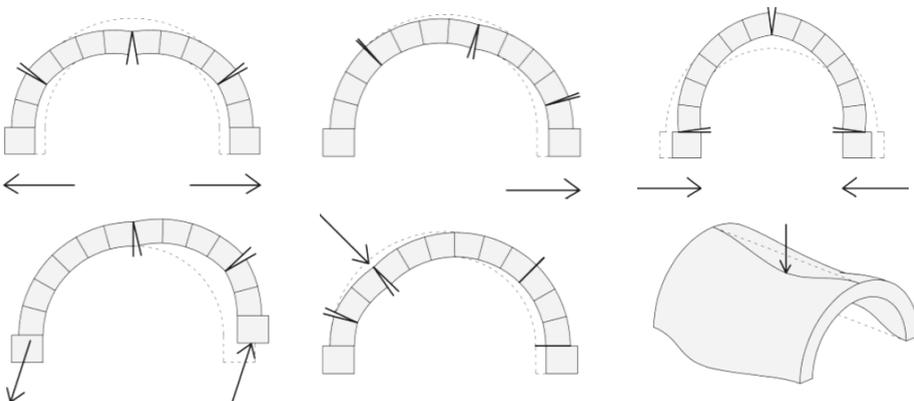
Figure 2. Some typical crack configurations for barrel vault [4].
