Masonry Buildings

Research and Practice

Masonry Buildings: Research and Practice

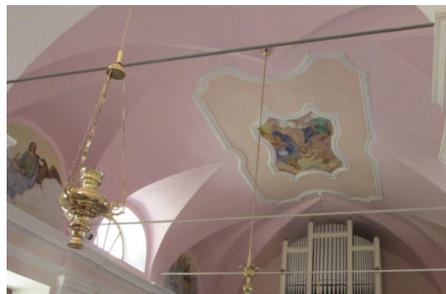
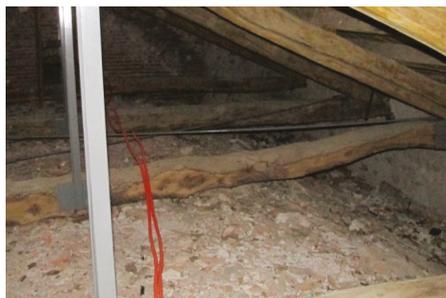
Figure 3. Analysed stone masonry barrel vault from bottom (a) and top (b).

For the analysis, a barrel vault in St. Jacob Church in Dolenja Trebuša in Slovenia was chosen. The Church was built in 1786 and retrofitted in 2013 in order to simultaneously rehabilitate and strengthen its structure after the earthquake in 2004. In spite of the renovation in 2013, cracks in the considered vault reopened. The stone masonry barrel vault is built out of limestone and leech stone in lime mortar. Geometry and materials of the vault are shown in Figure 3. The length of the vault is 10 m (above the nave) with a span of 7.75 m. The thickness of the vault is changing from 30 cm at the base and to 8 cm at the top.

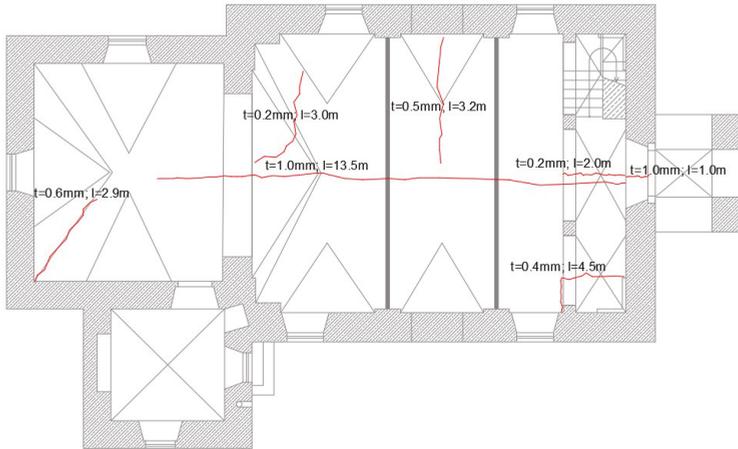
Figure 4. Registered crack pattern of analysed barrel vault before rehabilitation in 2013 [6].

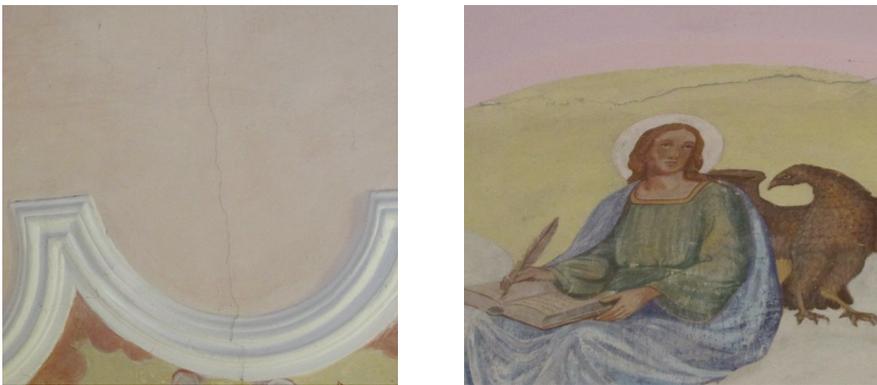
The cracks although to a lesser extent, reopened in the same places after the repair works in 2013 (Figure 5).

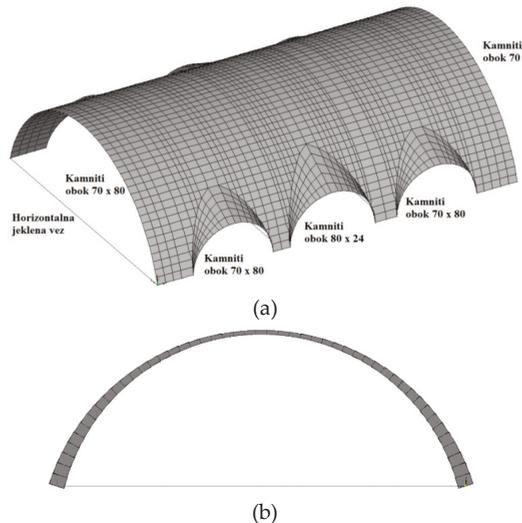
Figure 6. 3D FE model (a) and cross section (b) showing changing thickness of analysed barrel vault.

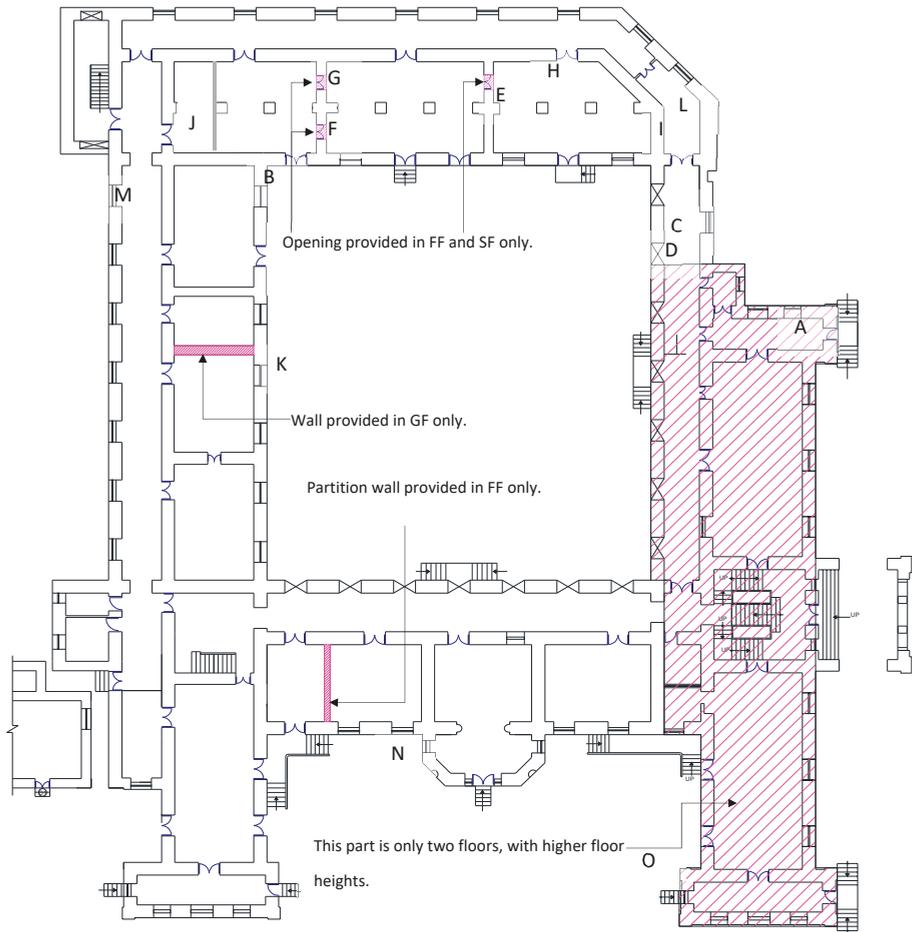
Figure 2. Major damage locations in the monument (capital letters represent the damage mechanisms as shown in Figures 3–6). In the figure, GF, FF, and SF respectively represent the ground floor, first floor, and the second floor.

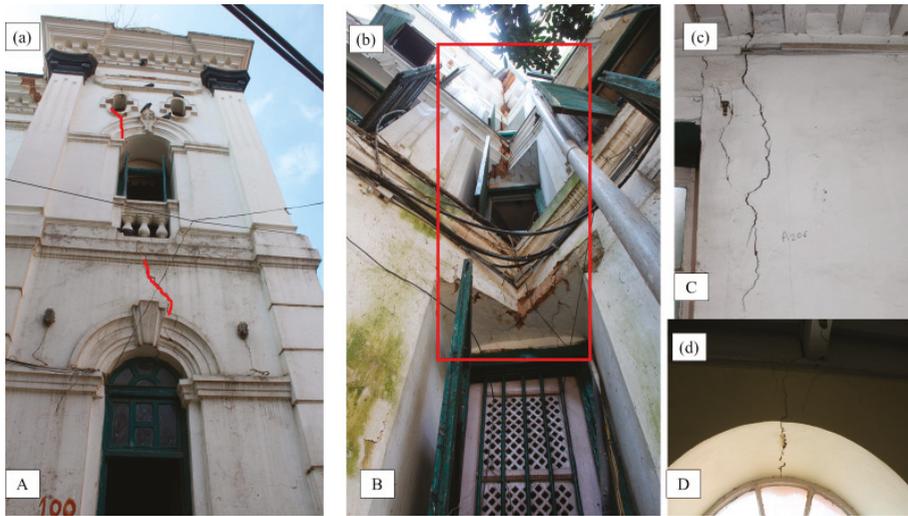
Figure 3. Local damages in the monument (a) damage above the crown of arches, (b) corner damage at the junction of north and west lounge, (c) vertical crack, (d) crown damage (uppercase indications at the bottom of the structures are the location indications as shown in Figure 2).

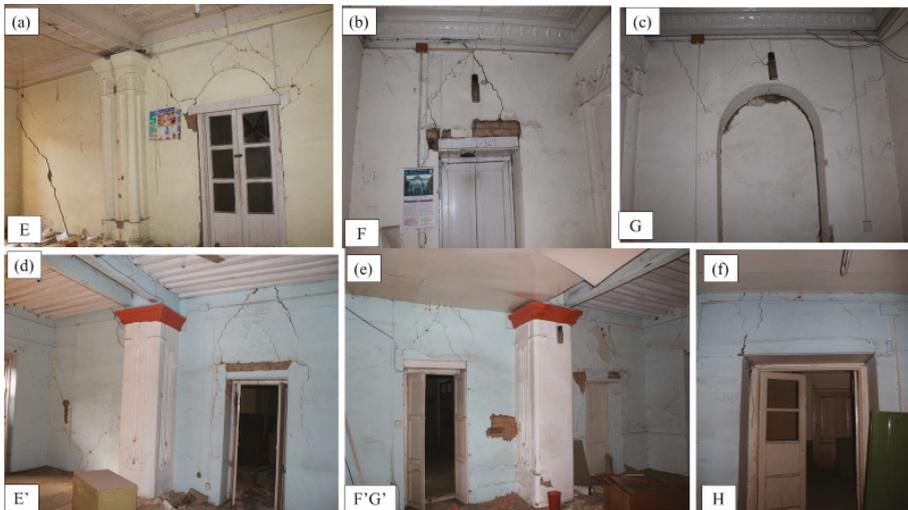
Figure 4. Local damages in the monument (a) diagonal cracks on cross-wall, (b) damaged wall above the opening, (c) damage above the crown of the arch on cross wall, (d–f) damages around the openings (uppercase indications at the bottom of the structures are the location indications as shown in Figure 2).

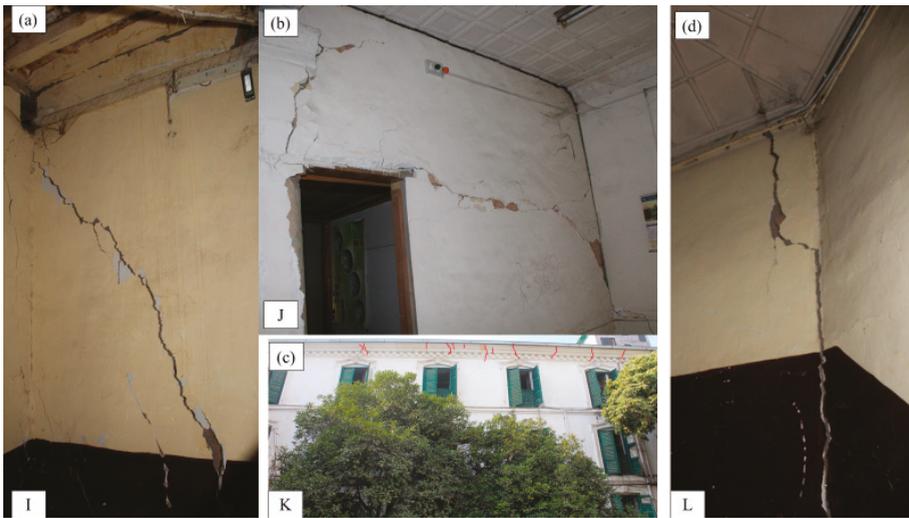
Figure 5. Local damages in the monument (a) diagonal crack on the third-floor wall, (b) horizontal and vertical cracks beside the opening, (c) exterior wall damage at the top floor, (d) corner damage (uppercase indications at the bottom of the structures are the location indications as shown in Figure 2).

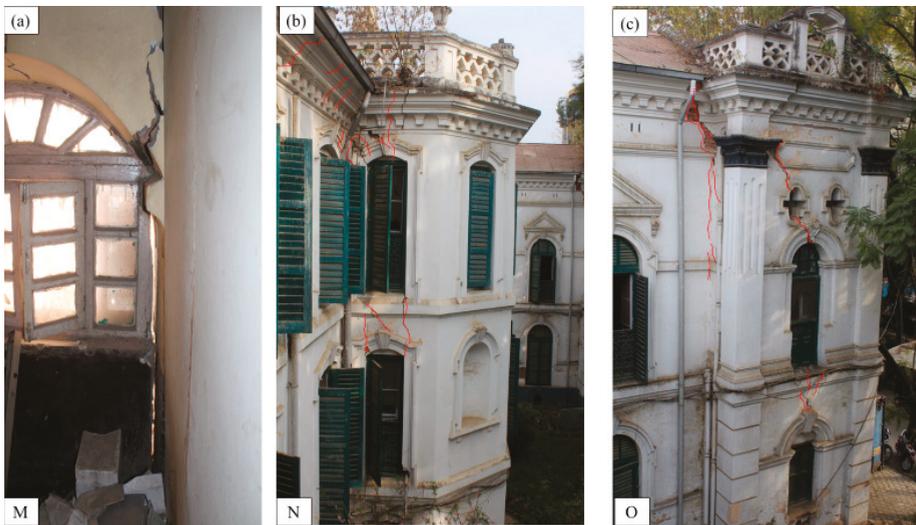
Figure 6. Local damages in the monument (a) corner damage, (b) corner damage and crack propagation in the projection part, (c) cracks developed above the arch. In figure, uppercase indications at the bottom of the structures are the location indications as shown in Figure 2.

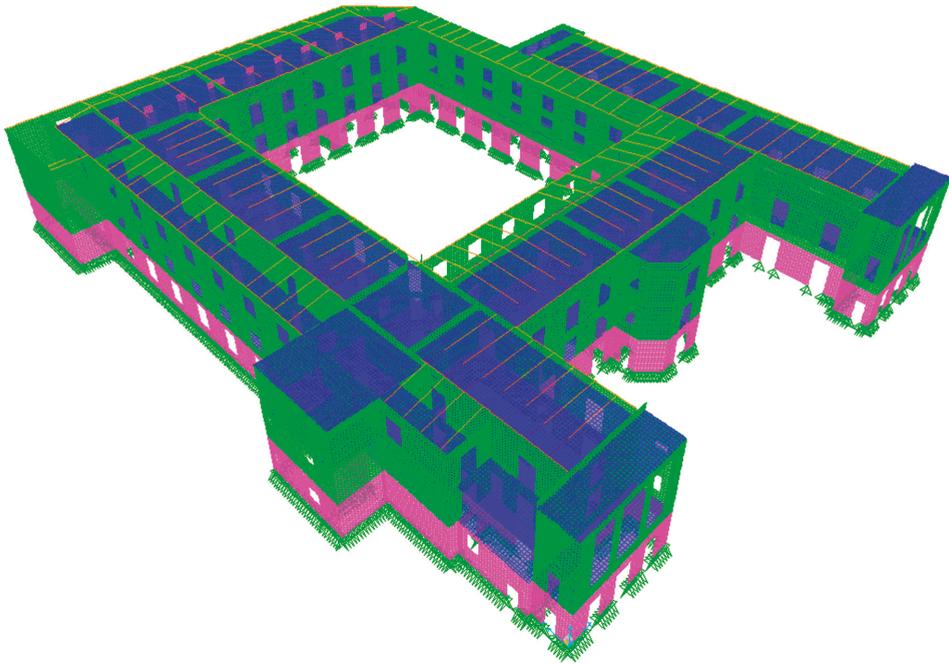
Figure 7. Three-dimensional finite element model of Bagh Durbar.

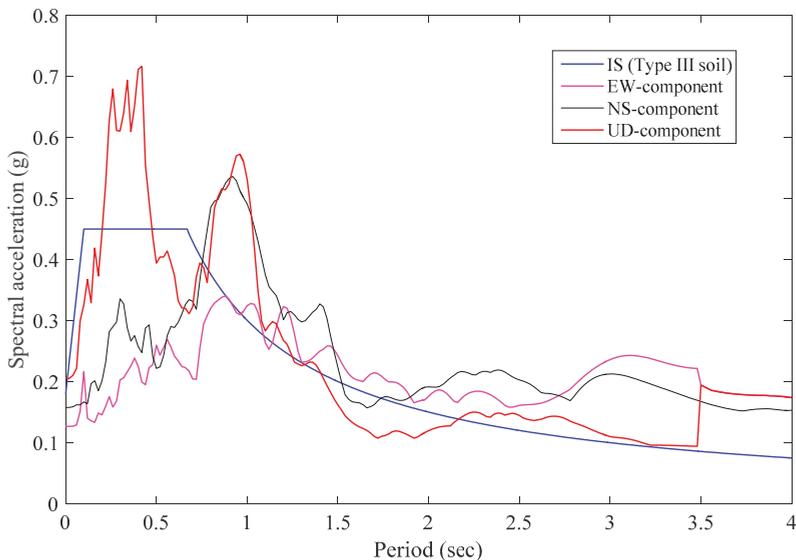
Figure 8. Response spectra of the recorded accelerogram at the Department of Mines and Geology plotted along with Indian Standard code response spectrum for soft soil. In the figure, EW indicates the east-west component of acceleration, NS indicates the north-south component of acceleration, and UD indicates the vertical acceleration component.

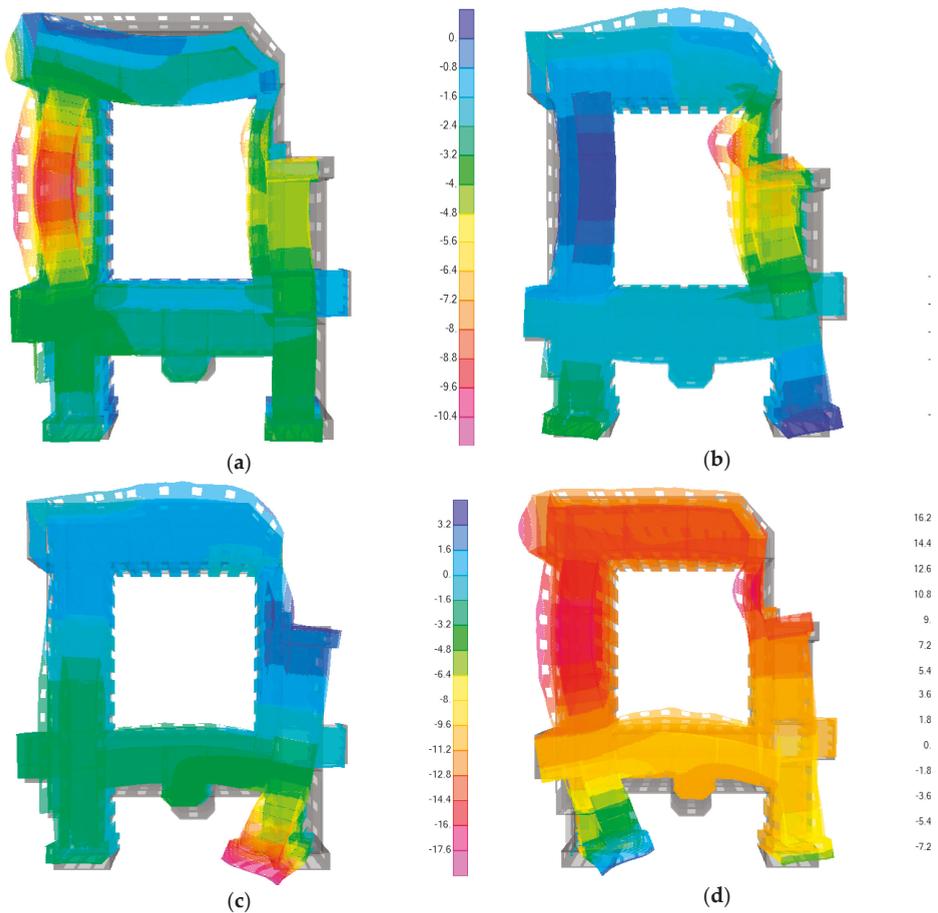
Figure 9. Deformed shape (a) mode 1 at the period of 0.295 s, (b) mode 2 at the period of 0.292 s, (c) mode 3 at the period of 0.276 s, and (d) mode 4 at the period of 0.272 s.

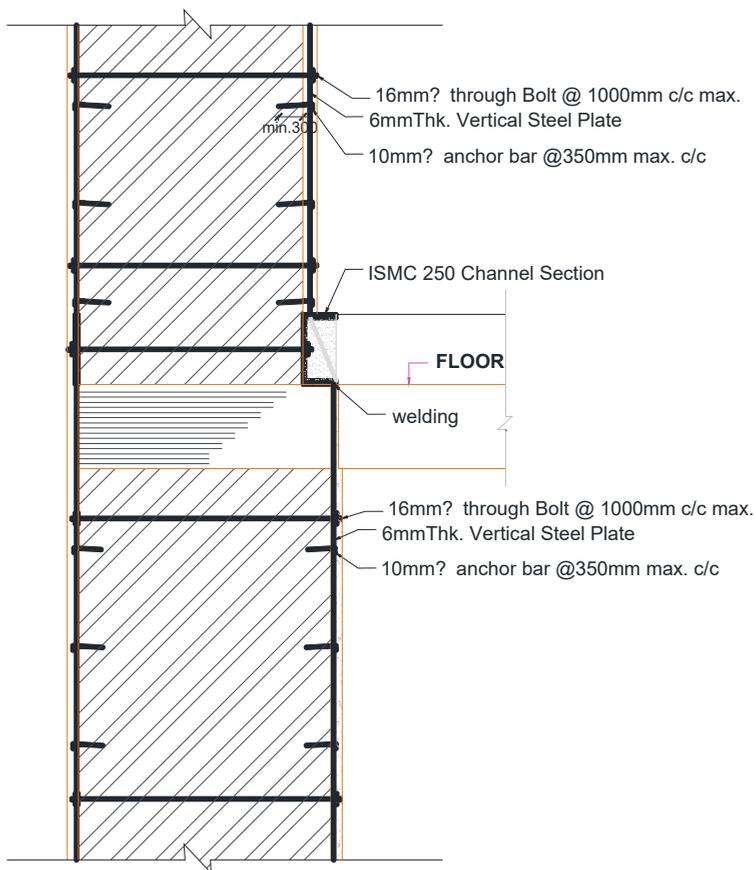
Figure 11. Details of band per floor.

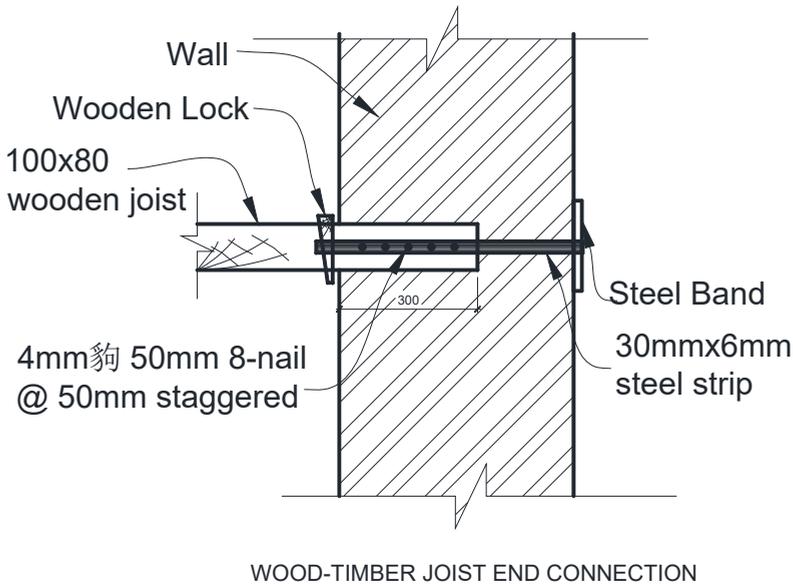
Figure 13. Details of timber joist end connection.

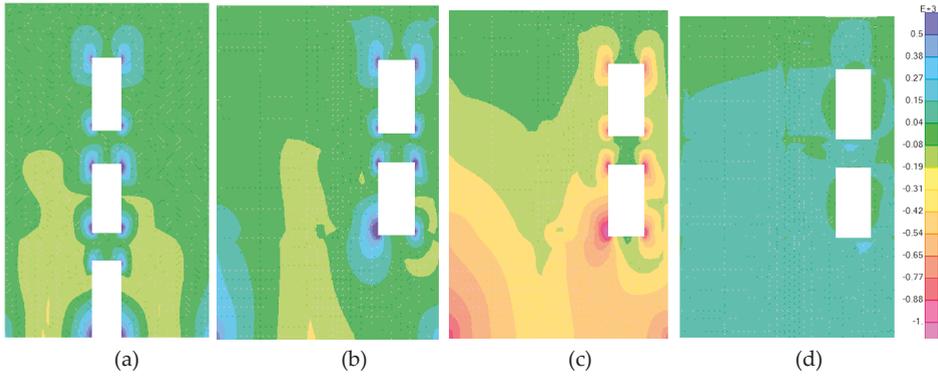
Figure 14. Force per meter under load combination dead + live + response spectrum-x (a) tensile force at section cut-1, (b) tensile force at section cut-2, (c) compressive force at section cut-2, and (d) shearing force at section cut-2. (See Figure 10 for section cuts).

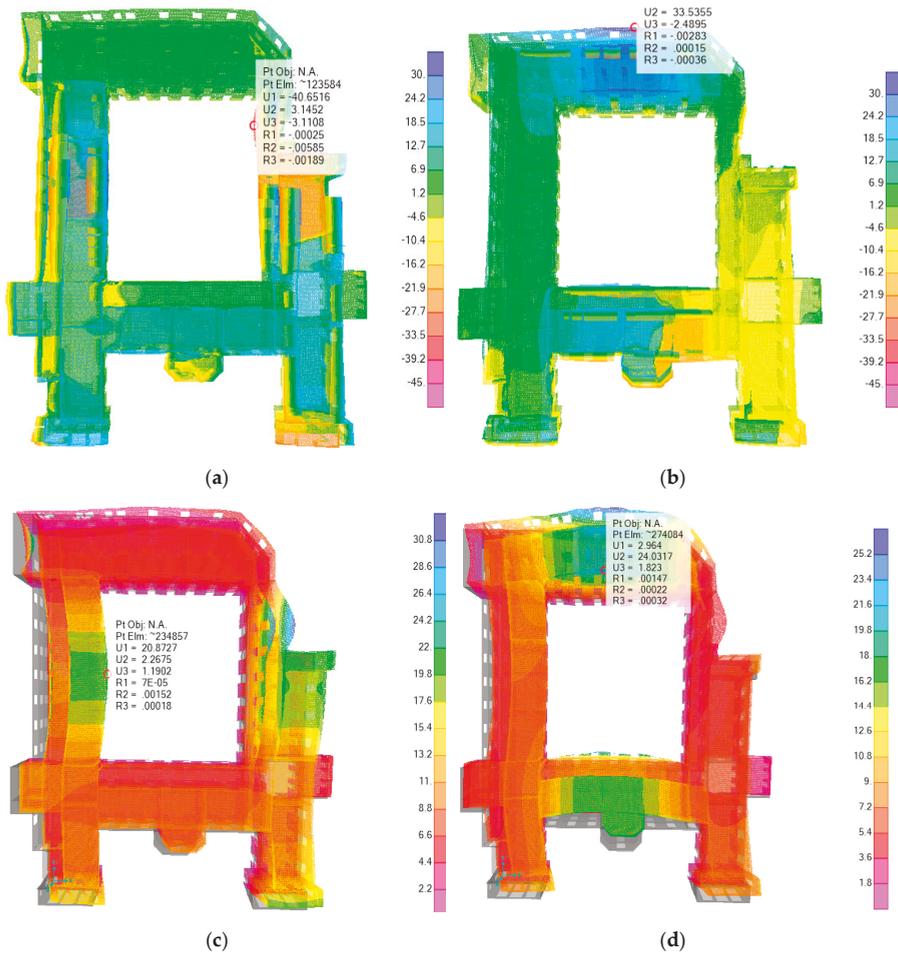
Figure 17. Deformation of the monument (a) before retrofitting along the x-direction, (b) before retrofitting along the y-direction, (c) after retrofitting along the x-direction, and (d) after retrofitting in the y-direction.

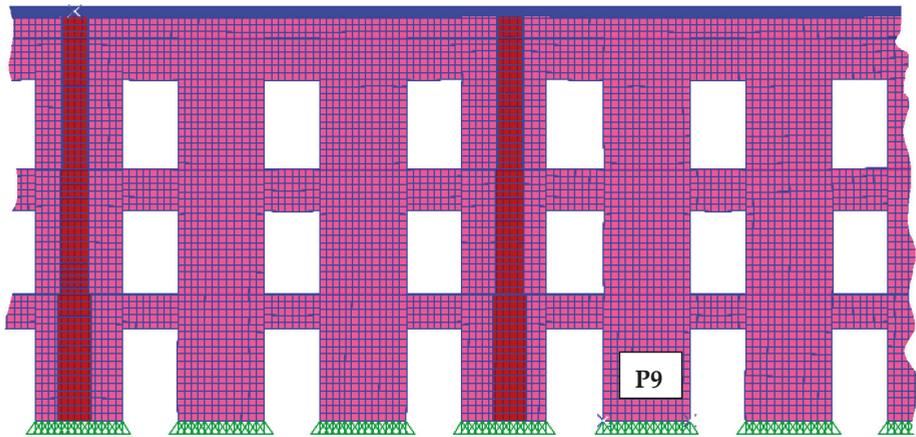
Figure 18. Elevation of wall showing the considered pier P9 (see Figure 10).
