# Coatings for Harsh Environments

Printed Edition of the Special Issue Published in *Coatings*

# Influence of Lamellar Interface Morphology on Cracking Resistance of Plasma-Sprayed YSZ Coatings

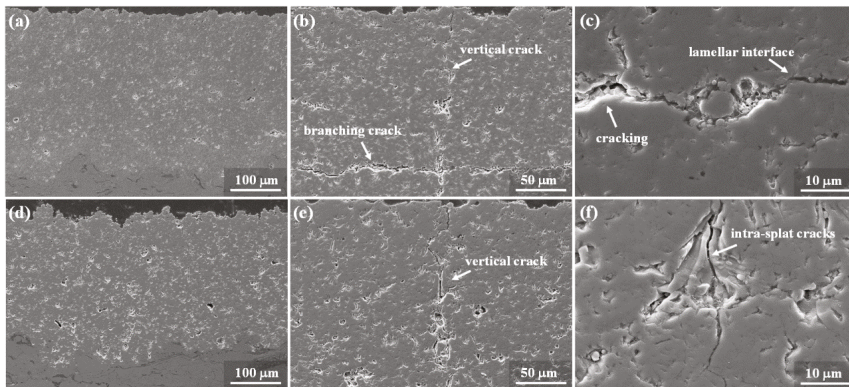
Figure 2. Cross-section microstructure of the as-sprayed YSZ coatings: (a–c) F-TBC; (d–f) C-TBC.

Figure 2 shows the cross-section microstructure of as-sprayed coatings. It can be seen that more macro-pores are present in the coating prepared from the coarse YSZ powder (Figure 2d). The porosity of the coating prepared by the fine powder (Figure 2a) is lower than that by the coarse powder. Vertical cracks are the common in the structures of plasma-sprayed coatings and are caused by the release of residual stress during the deposition process [11,23]. In this study, vertical cracks were observed in the coatings prepared from both fine and coarse YSZ powders. However, some vertical cracks in F-TBC were accompanied by branching cracks, as shown in Figure 1b. Some branches were formed by cracking along the lamellar interface (Figure 2c). In contrast, no branching cracks were found in C-TBC. Instead, some intra-splat cracks were observed near the vertical cracks (Figure 2f).

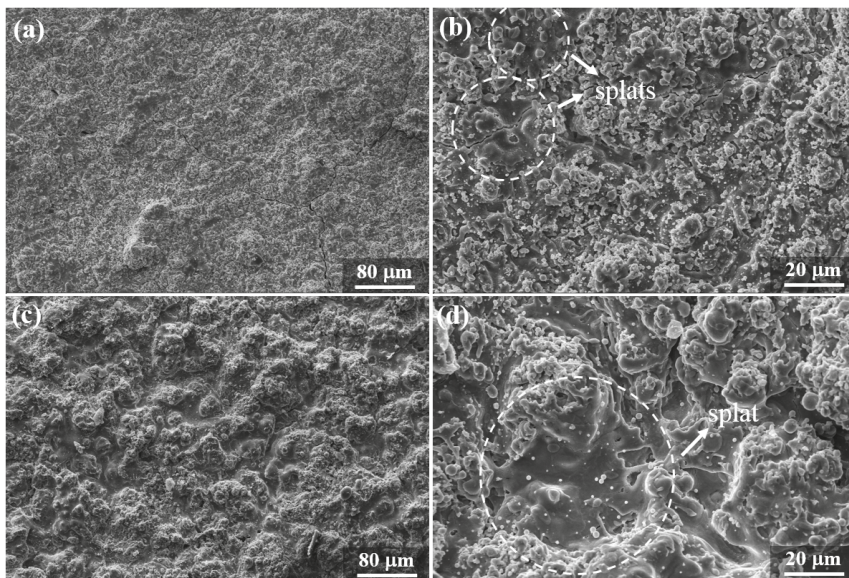
Figure 3. Surface morphology of the YSZ coatings: (a,b) F-TBC; (c,d) C-TBC.

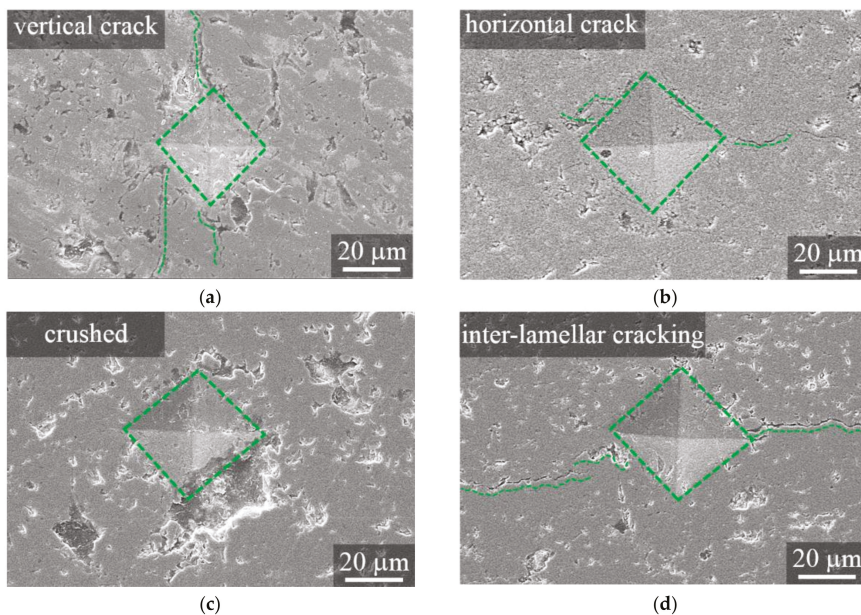
**Figure 6.** Four types of typical indentation morphology of F-TBC and C-TBC: (a) indentation with vertical cracks, C-TBC; (b) indentation with horizontal cracks, F-TBC; (c) crushed indentation, C-TBC and (d) indentation with inter-lamellar cracking, F-TBC.

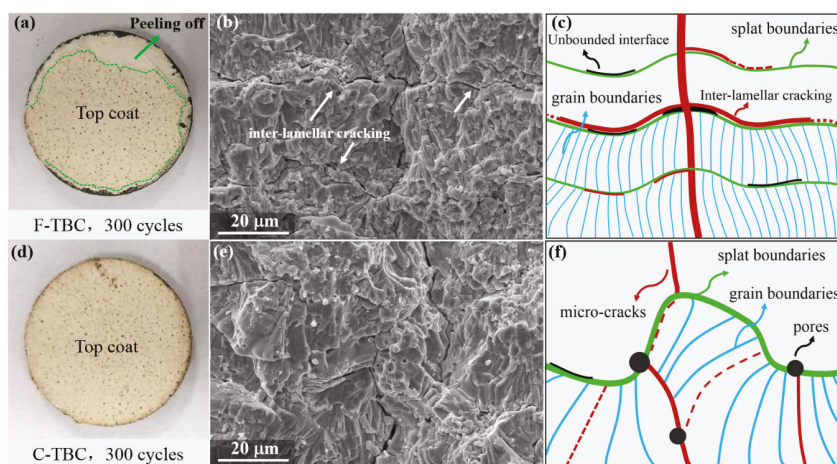
**Figure 8.** Illustration of thermal shock failure modes of two kinds of coatings. Macro image of F-TBC (a) and C-TBC (d) after 300 thermal cycles; fracture morphology of F-TBC (b) and C-TBC (e); schematic of crack behavior of F-TBC (c) and C-TBC (f).

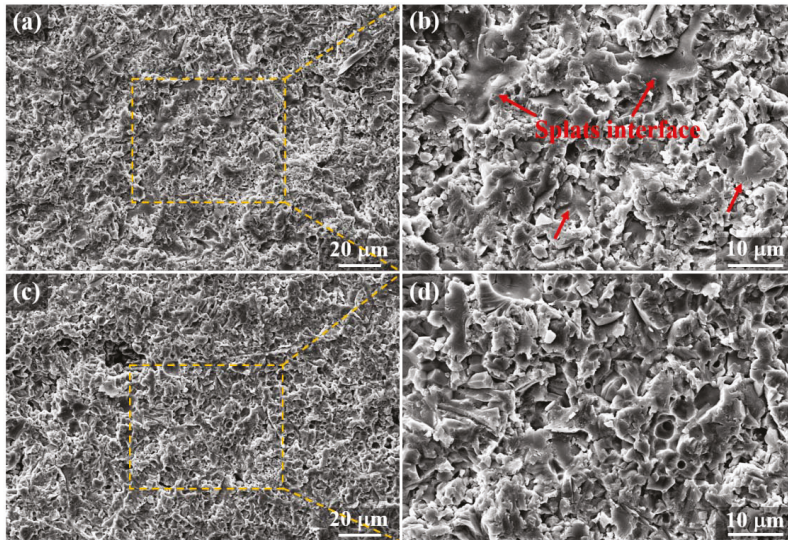
Figure 10. Surface morphology of the coatings after the erosion test. (a,b) F-TBC; (c,d) C-TBC.

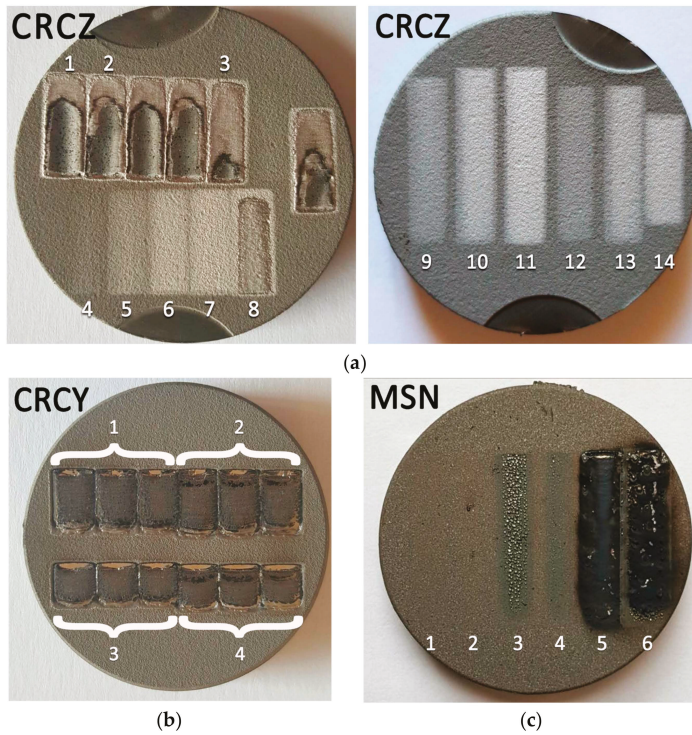
**Figure 1.** Laser treatment optimization tests: (a) CRCZ, (b) CRCY, and (c) MSN coating composition. Test numbers conditions are reported in Tables 3–5, respectively.

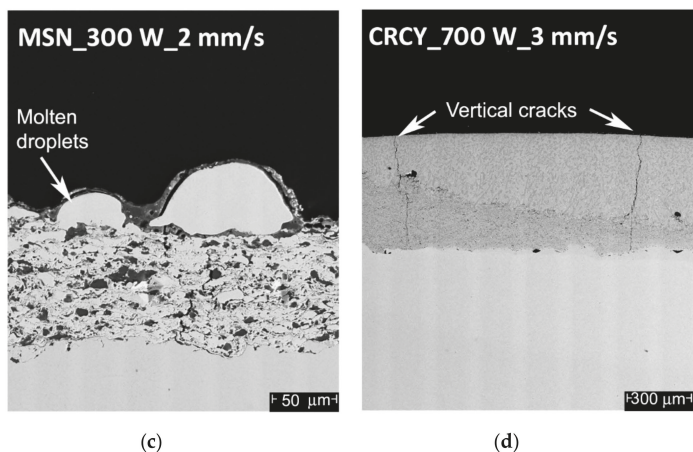
**Figure 2.** Potential undesired effects of the laser interaction with the coating: (a) Vertical cracks; (b) incorporation of the assist gas inside the molten material and formation of the residual macro-porosity; (c) selective remelting or evaporation and recondensation of the low melting material in surface droplets; and (d) partial remelting of the coating with the formation of vertical cracks.

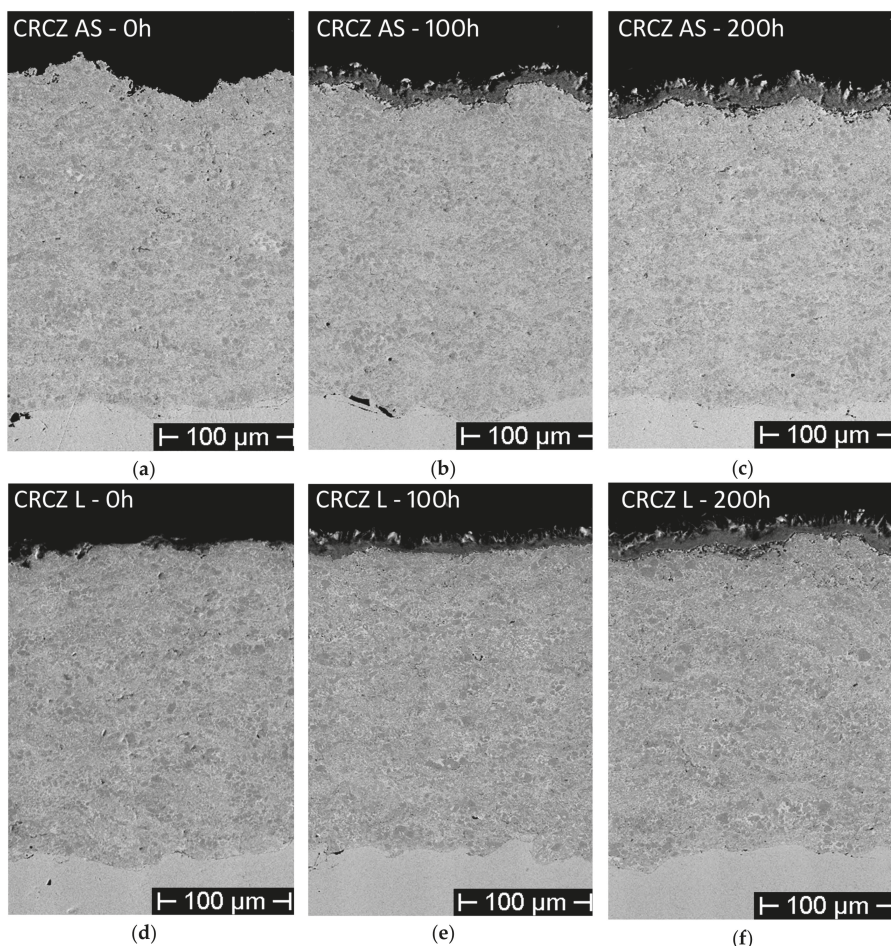
**Figure 3.** Cross-sections of the CRCZ samples: (a) As-sprayed; (b) as-sprayed after 100 h of hot corrosion test; (c) as-sprayed after 200 h of hot corrosion test; (d) laser-treated; (e) laser-treated after 100 h of hot corrosion test; and (f) laser-treated after 200 h of hot corrosion test.

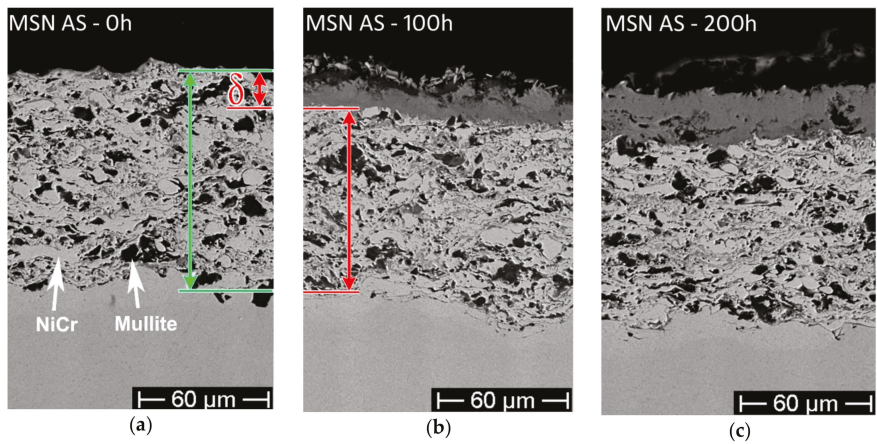
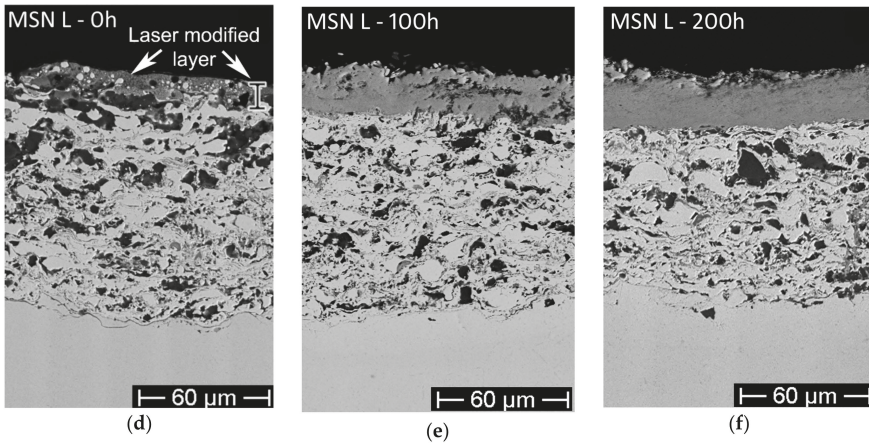
**Figure 5.** Cross-sections of the MSN samples: (a) As-sprayed; (b) as-sprayed after 100 h of hot corrosion test; (c) as-sprayed after 200 h of hot corrosion test; (d) laser-treated; (e) laser-treated after 100 h of hot corrosion test; and (f) laser-treated after 200 h of hot corrosion test.

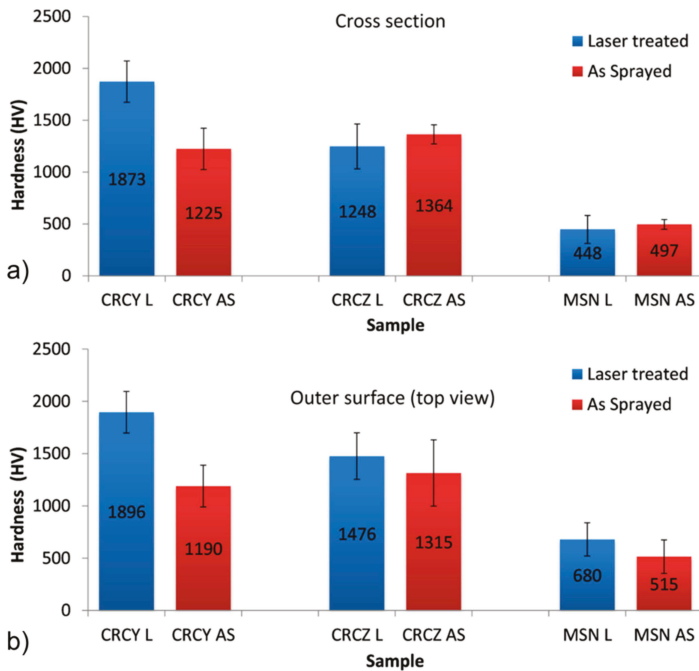
**Figure 6.** Microhardness of the as-sprayed (AS) and laser-treated (L) samples measured on the cross-section (a) and the top surface (b) (error bars indicate  $\pm$  standard deviation).

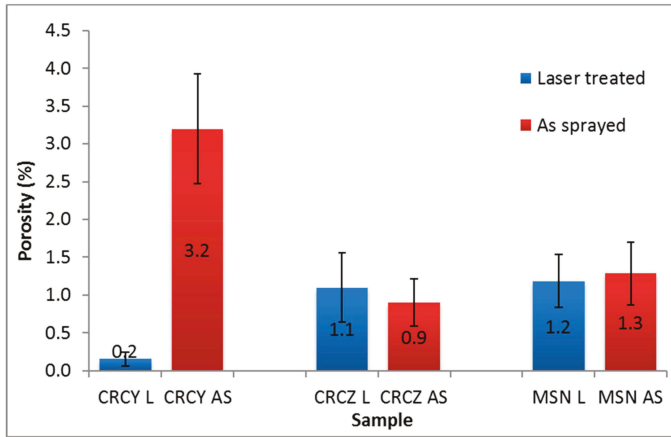
**Figure 7.** Porosity of the as-sprayed (AS) and laser-treated (L) samples. (error bars indicate  $\pm$  standard deviation).

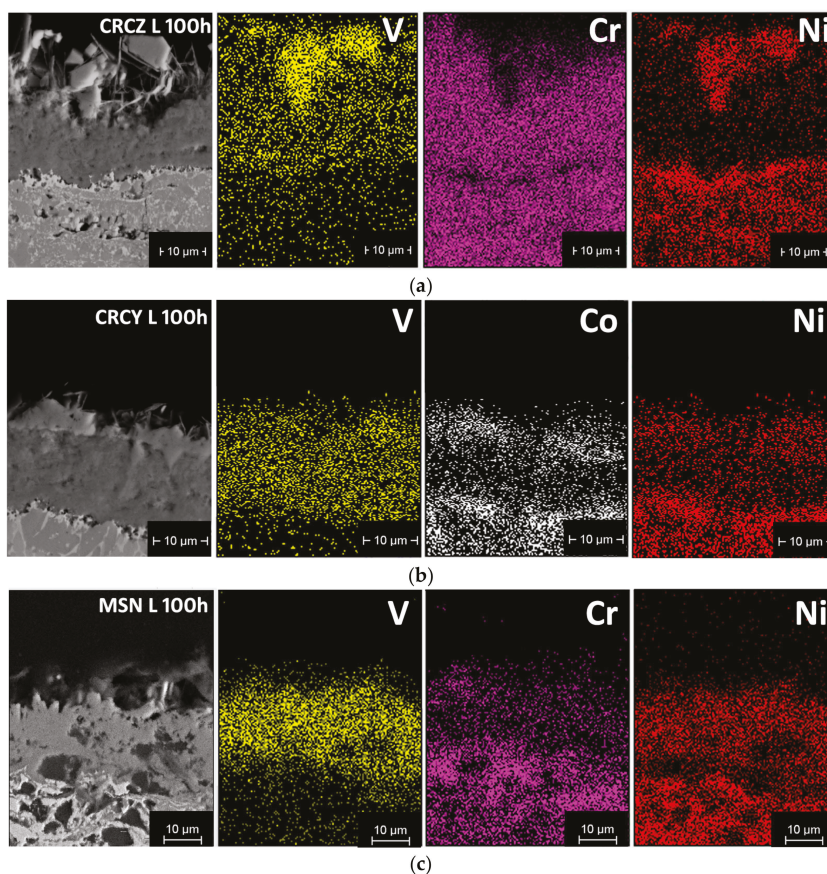
**Figure 11.** EDS analysis of the corrosion scale for laser-treated samples, after 100 h of the corrosion test: (a) CRCZ; (b) CRCY; and (c) MSN.

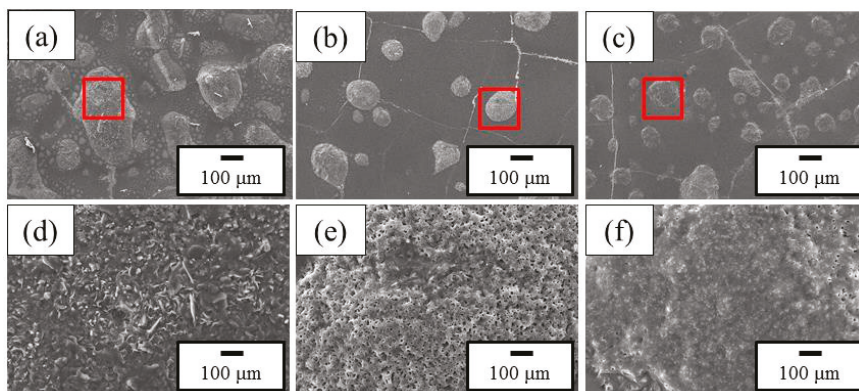
**Figure 5.** Surface morphology of MoSi<sub>2</sub>-coated TZM alloys oxidized at 1350 °C for (a) 5, (b) 20, and (c) 50 h; (d–f) show the enlargements of the marked areas in (a–c), respectively.

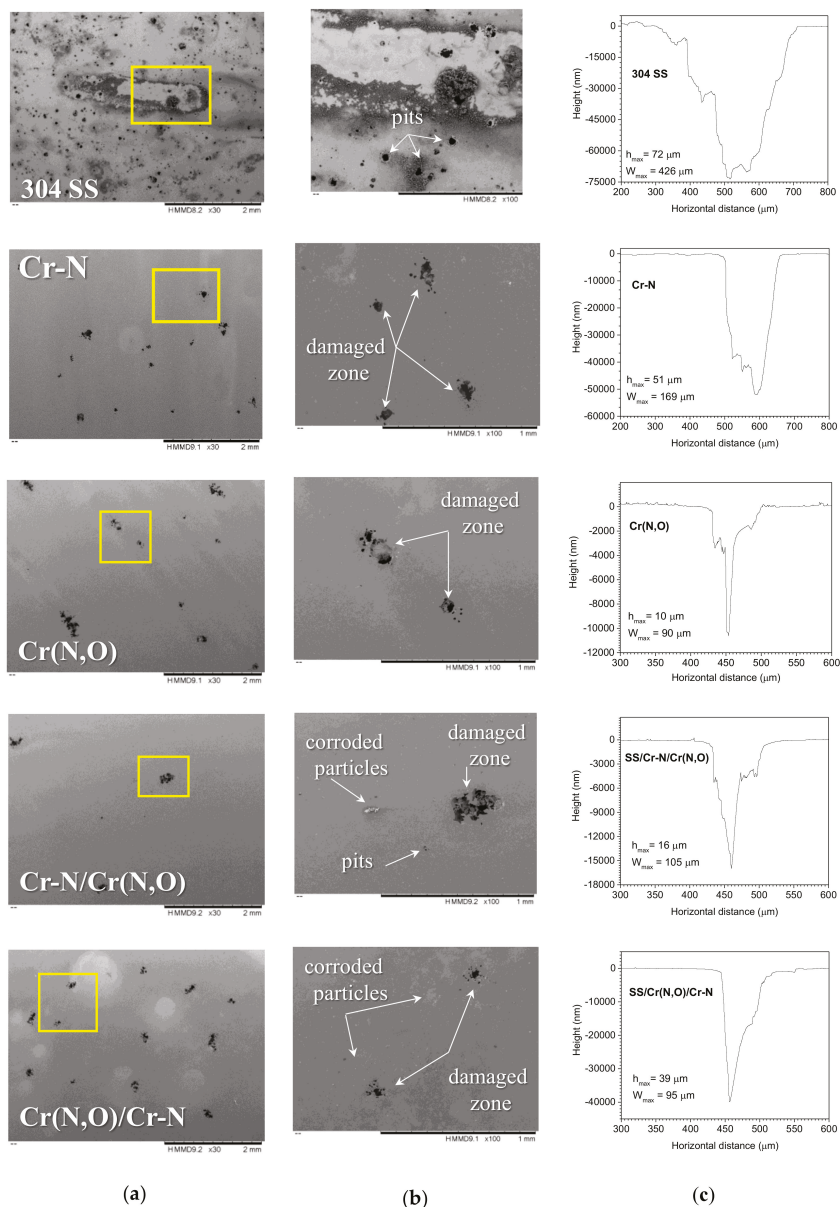
**Figure 11.** Investigation of the Cr-based coatings surfaces after the corrosion tests: micrographs of: (a) SEM micrographs at 30× magnification; (b) SEM micrographs at 100× magnification; (c) profilometry lines on selected pits.

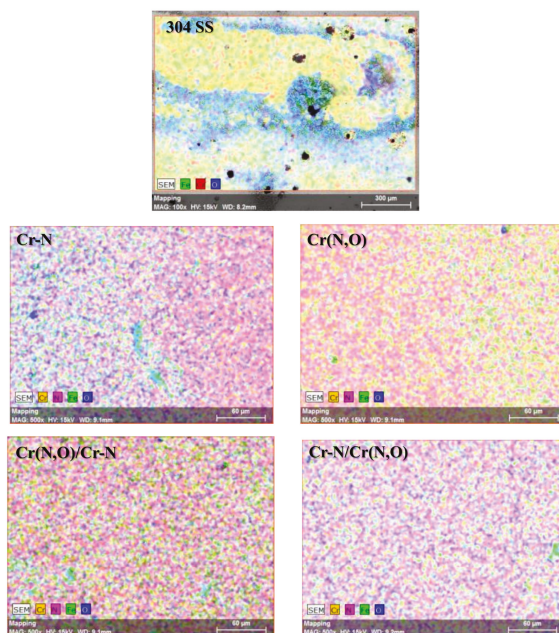
**Figure 12.** Energy dispersive X-ray spectrometry (EDS) mapping micrographs of the Cr-based coatings after the corrosion test.

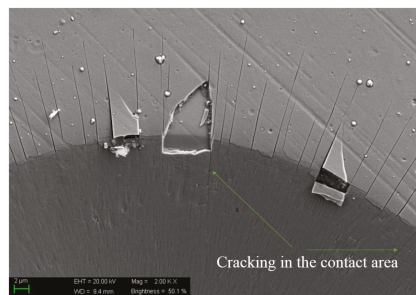
**Figure 12.** SEM observation of the indented surface of 2 µm CrN coated M50 disks under a load of 15 N and temperature of 500 °C.

Taking the 2 µm CrN coated M50 disks as an example, under an external load of 15 N, which just exceeded its load bearing capacity at 500 °C, the stripping and piling up of the oxide film was observed, as illustrated in Figure 11c2. As pointed by Holmberg [29], this kind of thin film failure is related to the tensile fracture and subsequently detachment from the interface. Cracks on the interface were an essential factor triggering this kind of failure. SEM observation verified that radical cracks were generated on the coating surface when the 2 µm CrN coated M50 disk was indented under a load of 15 N at 500 °C (see Figure 12).

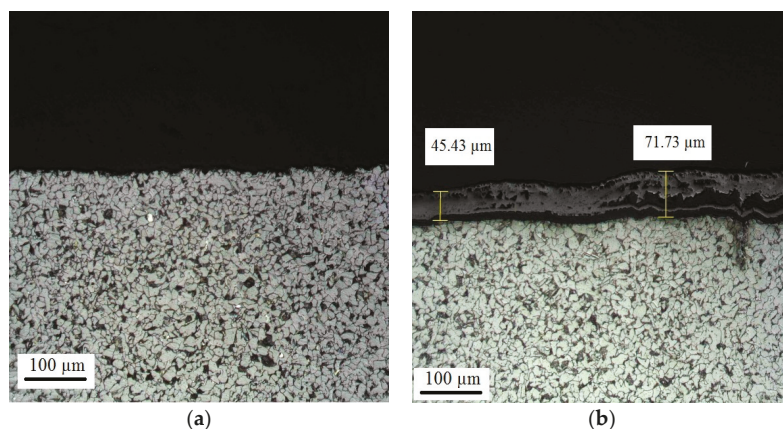
**Figure 4.** Microstructure images of the cross-section of CS-Bare (a) before, and (b) after the high-temperature corrosive attack after 168 h.

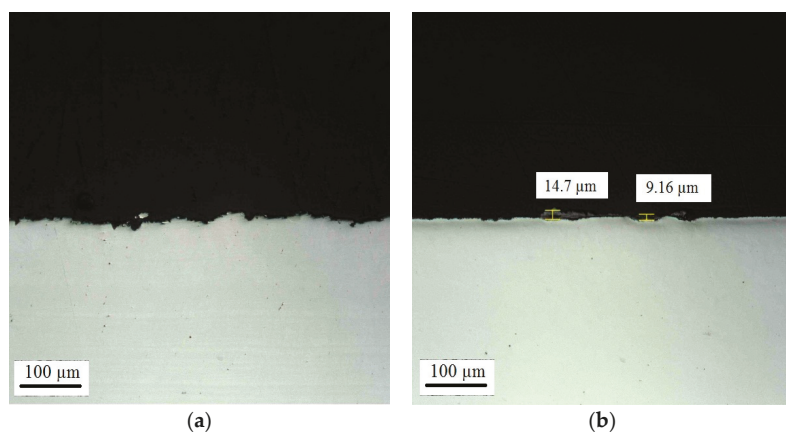
**Figure 5.** Microstructure images of the cross-section of 316-Bare (a) before, and (b) after the high-temperature corrosive attack after 168 h.

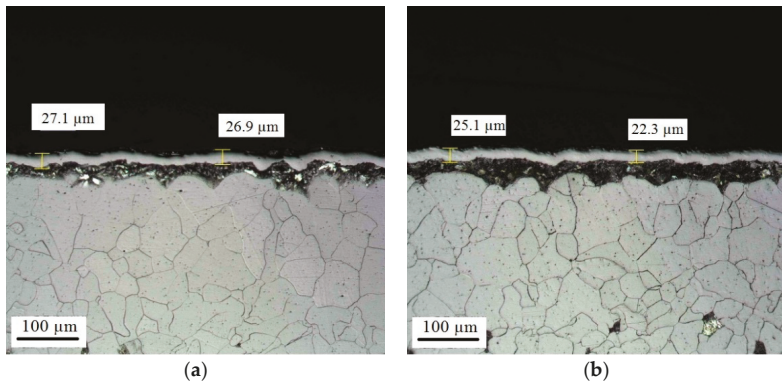
**Figure A17.** Microscopic images of the cross-section of CS-Cr (a) before and (b) after the high-temperature corrosive attack after 168 h.

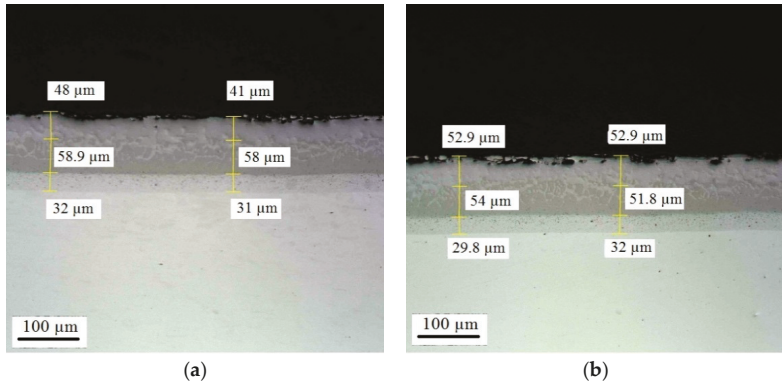
**Figure A18.** Microscopic images of the cross-section of 316-A (a) before and (b) after the high-temperature corrosive attack after 168 h.

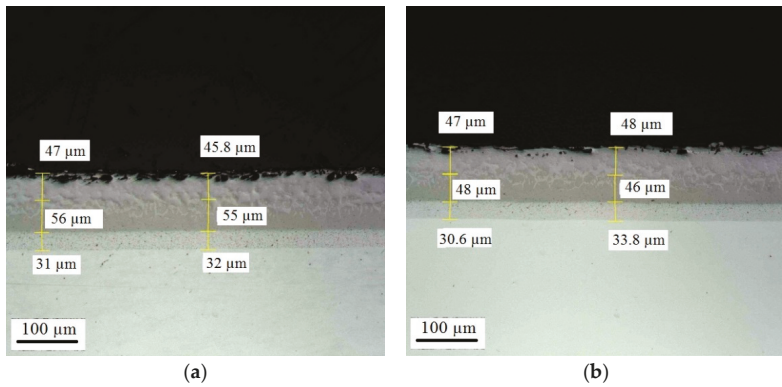
**Figure A19.** Microscopic images of the cross-section of 316-A-Sn (a) before and (b) after the high-temperature corrosive attack after 168 h.

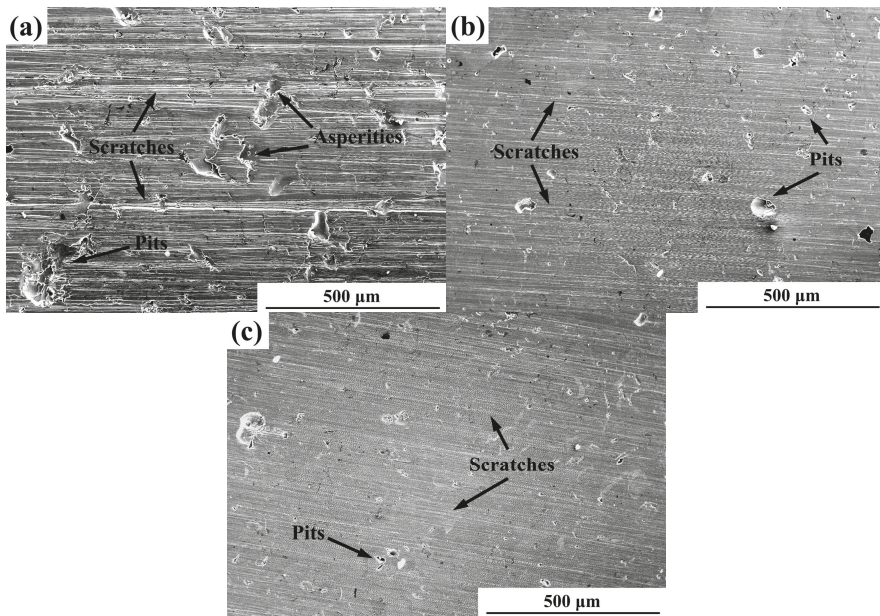
**Figure 4.** SEM images of the surface morphology of as-sprayed coatings under three surface conditions before the cavitation erosion test: (a) 80 grit grinding; (b) 600 grit grinding; and (c) 1000 grit grinding.

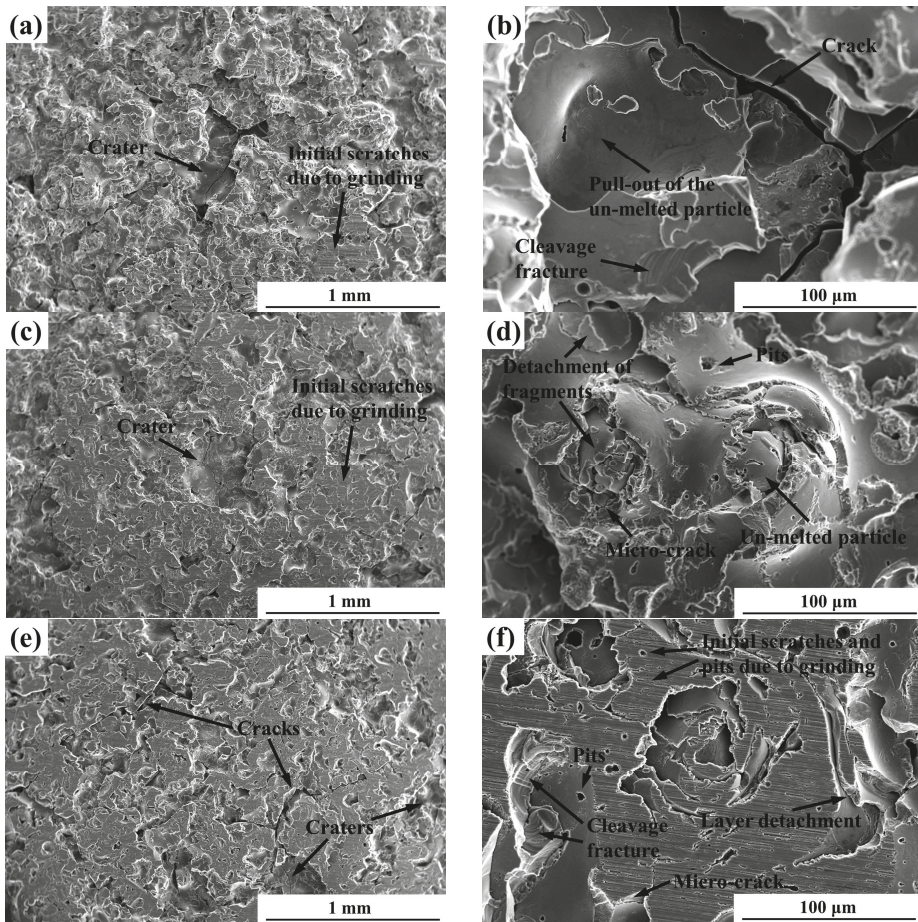
**Figure 5.** SEM images of the surface morphology of as-sprayed coatings under three surface conditions eroded for 120 min: (a,b) 80 grit grinding; (c,d) 600 grit grinding; and (e,f) 1000 grit grinding.

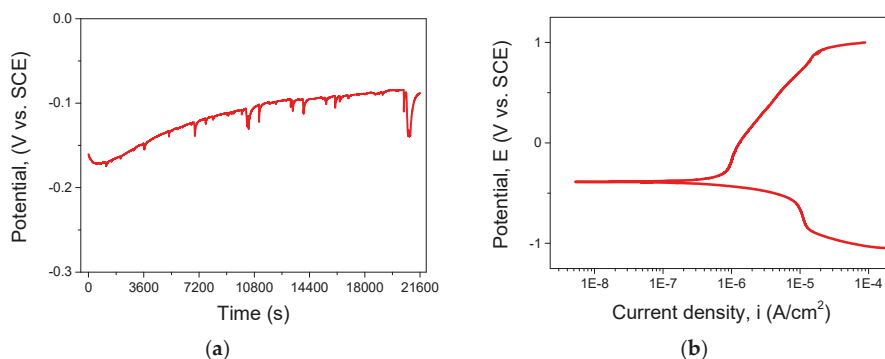
**Figure 4.** (a) Open circuit potential variation and (b) potentiodynamic polarization curve for the bulk CoCrFeNiMo alloy tested electrochemically in 3.5% NaCl solution.

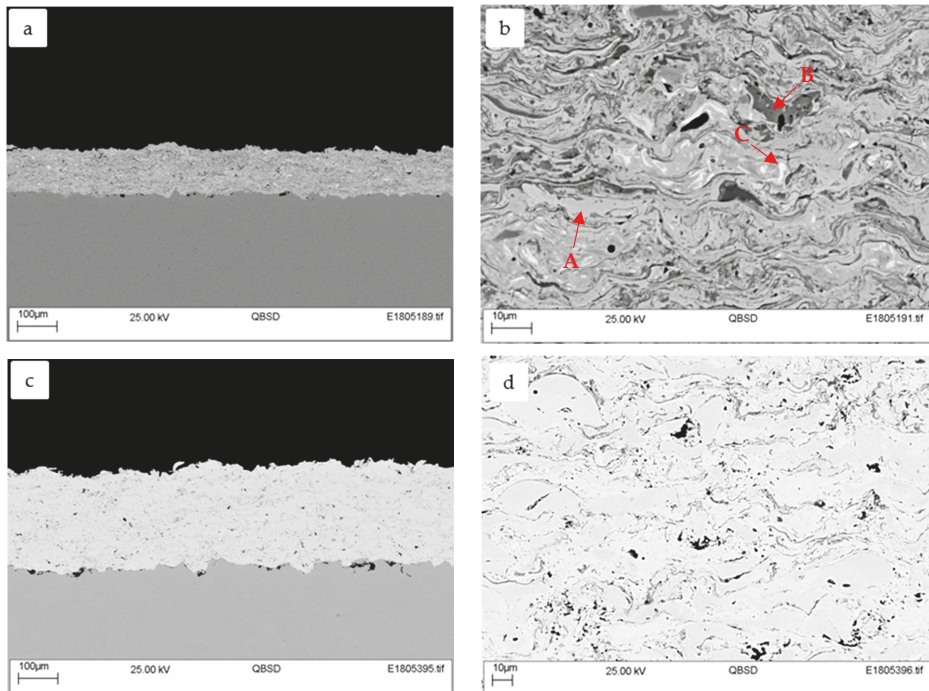
**Figure 3.** SEM micrographs of coatings cross-section for (a,b) MA and (c,d) GA coatings. For the MA powder, the inhomogeneity of the initial powder was also observed in the resulting coating, while a more uniform phase distribution was observed for the GA system.

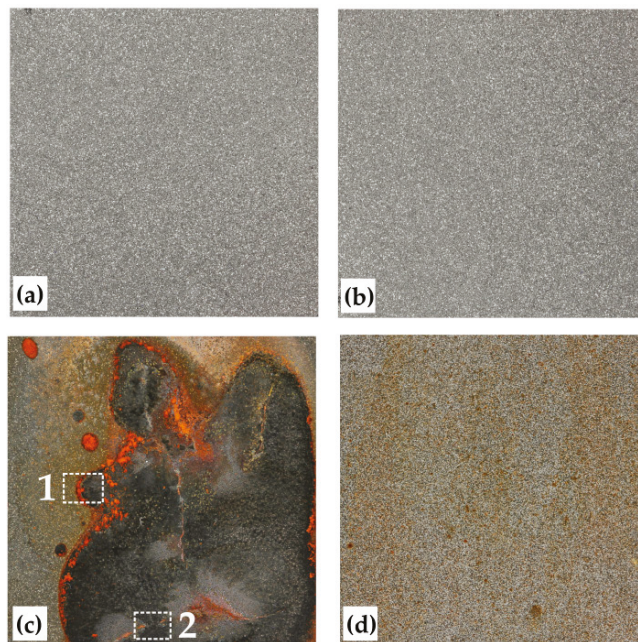
**Figure 5.** Photographs of the exposed surface of MA (a,c) and GA (b,d) coatings before (a,b) and after exposure (c,d). A notable structural damage linked to development of corrosion products is observed on the surface of the MA coating, while a more uniform type of attack is noted on the GA specimen.

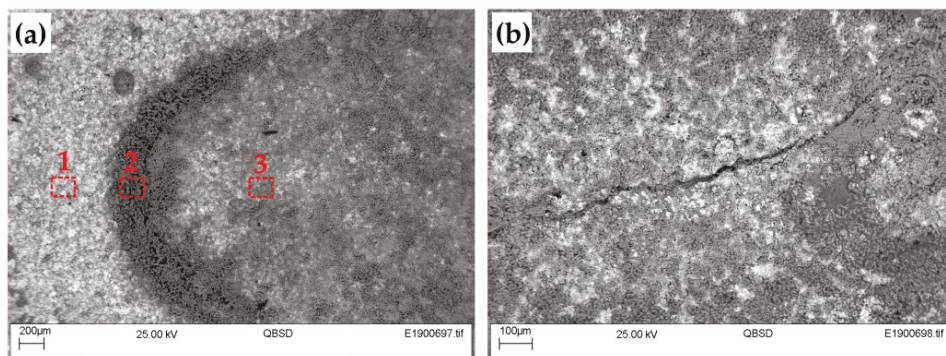
**Figure 6.** SEM micrographs of MA coating after exposure (Figure 5c), corresponding to the highlighted regions (a) 1, showing the presence of different corroded regions and (b) 2, showing cracks on the surface.

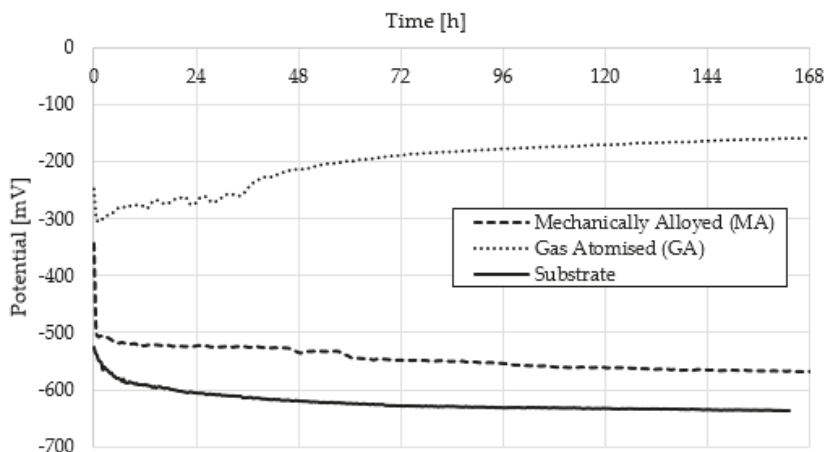
**Figure 10.** Graph of corrosion potential over time for MA, GA and substrate only specimens demonstrating corrosion at the substrate/coating interface for specimen MA, and possibly passivation and closure of open porosity for specimen GA.

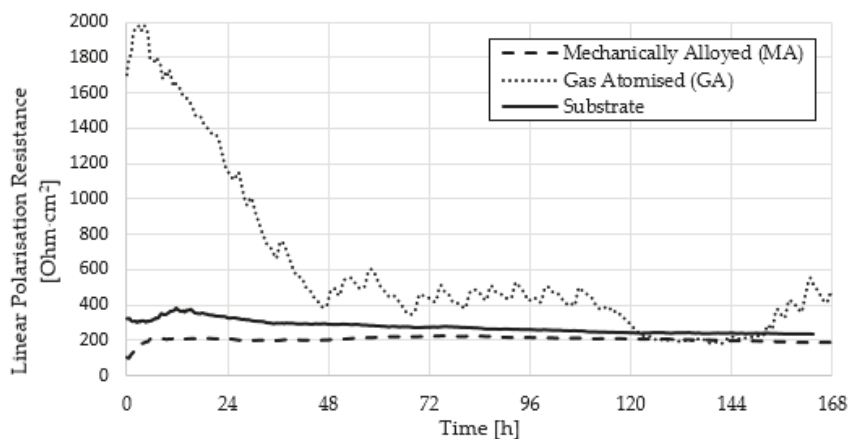
**Figure 11.** Graph of linear polarisation resistance over time for MA, GA and substrate only specimens.

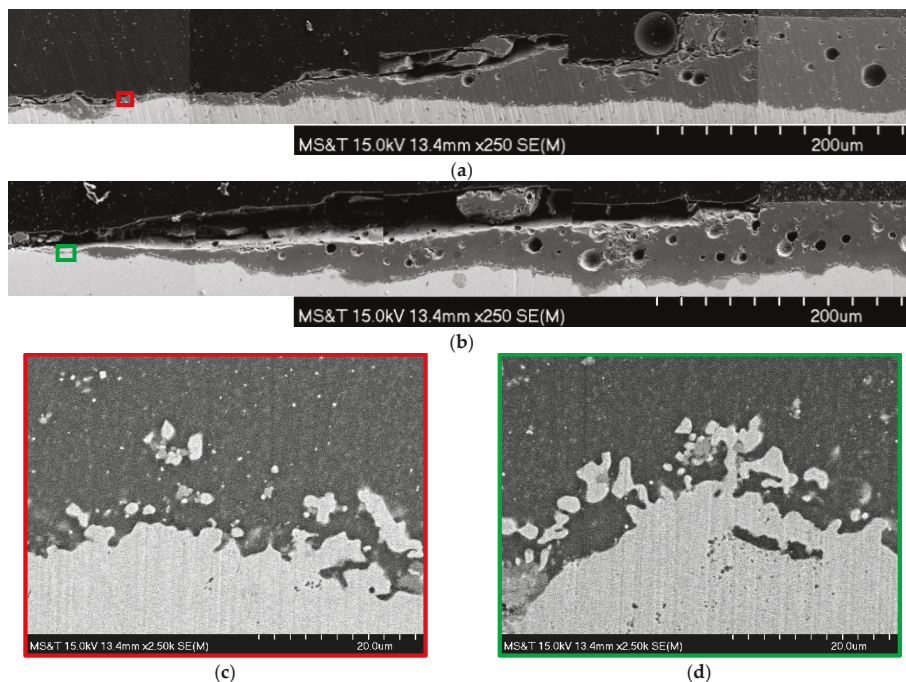
**Figure 4.** Cross-sectional SEM images of enamel-coated samples under the OCP (a,c) and −1.15 V/SCE (b,d) with a magnification of 250× (a,b) and 2500× (c,d).

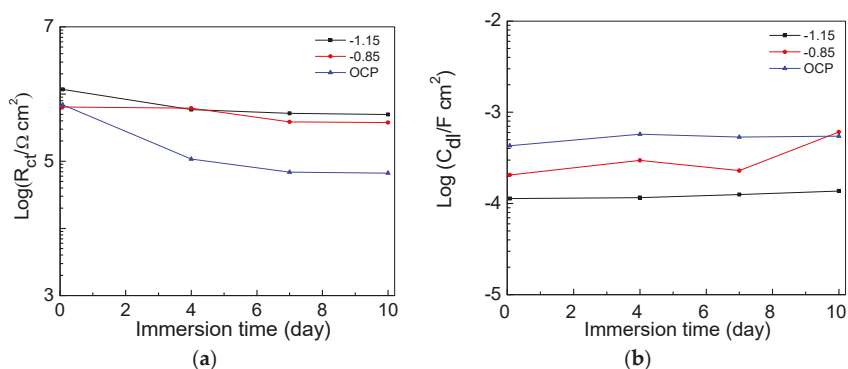
**Figure 10.** Properties of the steel-electrolyte interface under damaged enamel coating: (a) charge transfer resistance  $R_{ct}$  and (b) double layer capacitance  $CPE_{dl}$ .

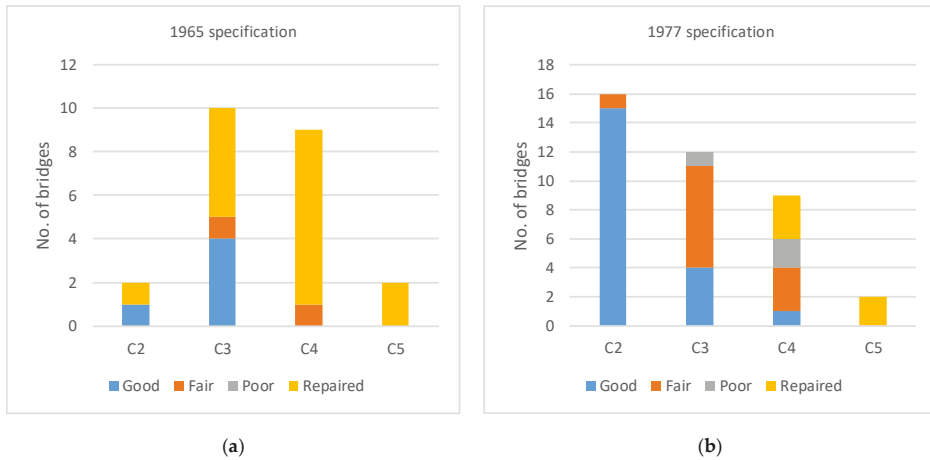
**Figure 3.** The summary of coating condition for the two specifications as a function of corrosivity: (a) 1965 specification; (b) 1977 specification.

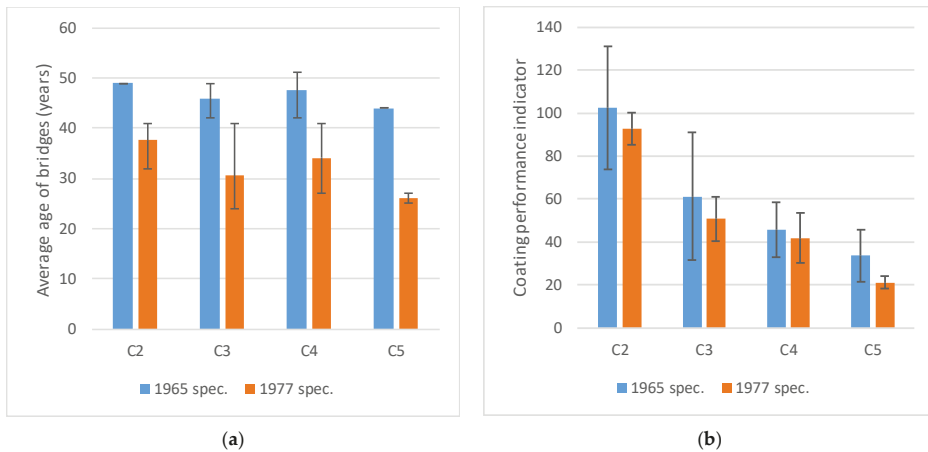
**Figure 4.** The coating age and performance: (a) Average age of the bridges. The bars show the highest and lowest age within each category of corrosivity; (b) Coating performance indicator as a function of corrosivity. The bars indicate standard deviation.

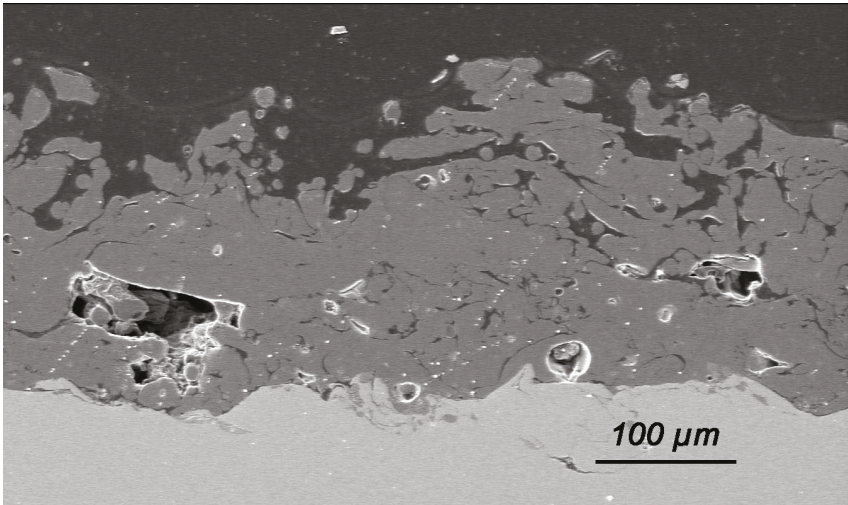
**Figure 5.** The cross-section of Thermal spray zinc (TSZ) coating. The very rough microstructure affects the conductivity of the coating, which results in a very large variation in paint film thickness measurements with Eddy current gauge.

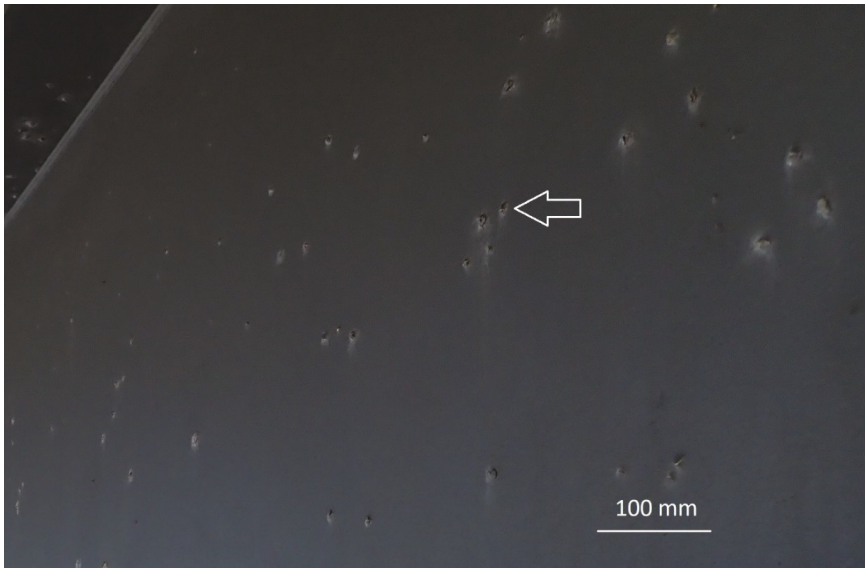
**Figure 6.** The corrosion of the TSZ due to “spitting” during thermal spraying. All the protrusions in the coating, one of them marked with an arrow, is due to spitting during thermal spraying. The paint film is too thin over the zinc protrusions and the zinc starts to corrode. Photo: NPRA.

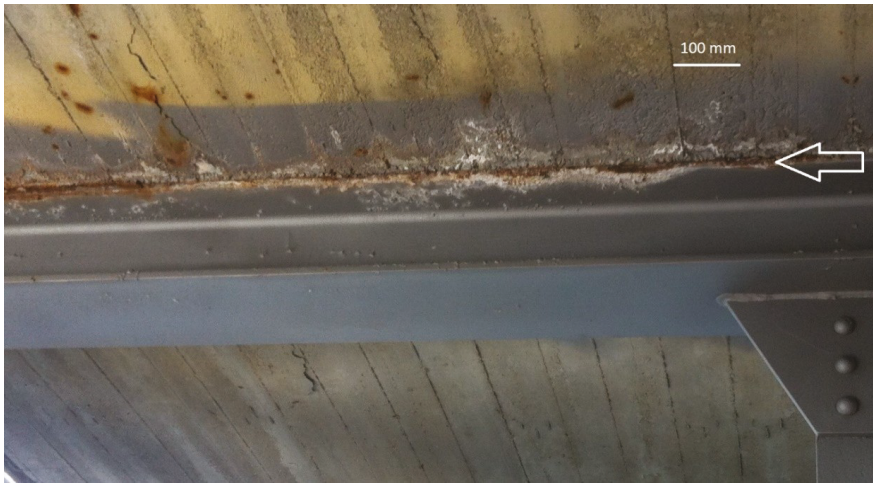
**Figure 7.** The saponification of alkyd paint where the painted H-beam is in contact with the concrete (marked with an arrow) and subsequent corrosion of zinc and steel.
