# Nondestructive Testing in Composite Materials

Edited by  
Carosena Meola

Printed Edition of the Special Issue Published in *Applied Sciences*

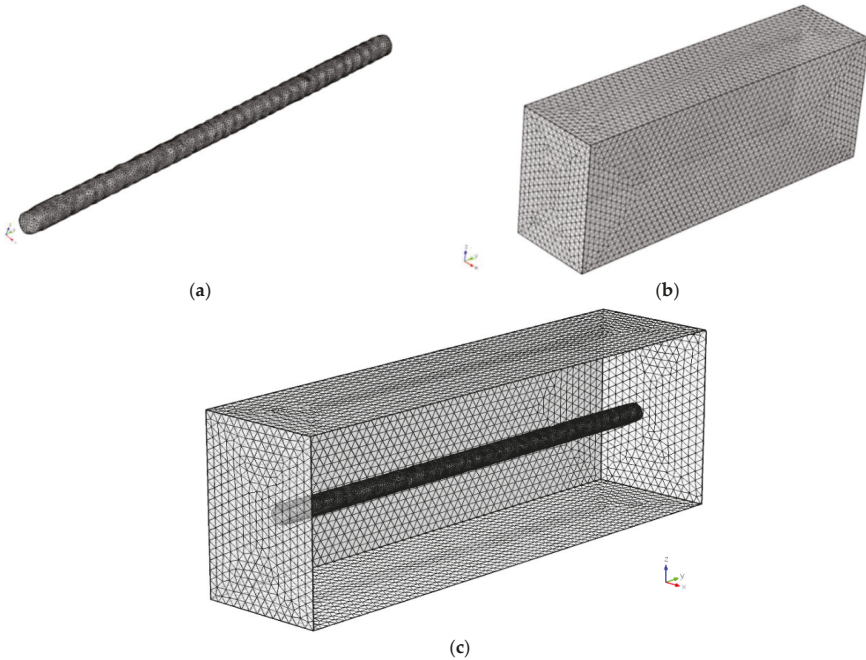
**Figure 4.** Initial meshes of the system: (a) rebar mesh with its initial sizes; (b) box mesh with its initial sizes; (c) rebar and box meshes as a single system (front face of the box is removed for better visualization).

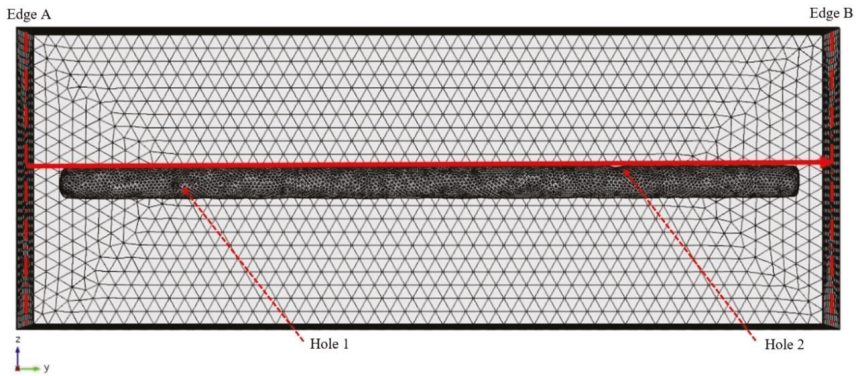
Figure 5. Path of the data recording (at the surface of the rebar in the Y direction).

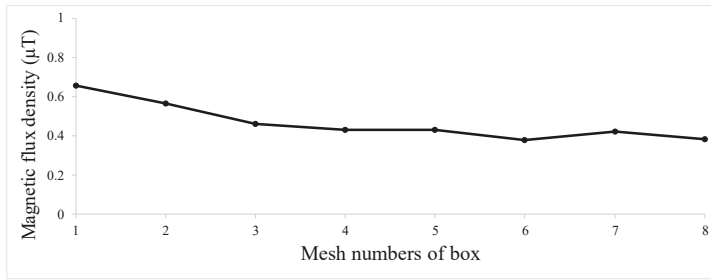
**Figure 14.** Difference between the maximum and minimum values of Z-component magnetic flux density, from 295.0592 mm to 307.0592 mm (values related to Hole 2), for different box mesh specifications with fixed rebar mesh #8 (Table 4).

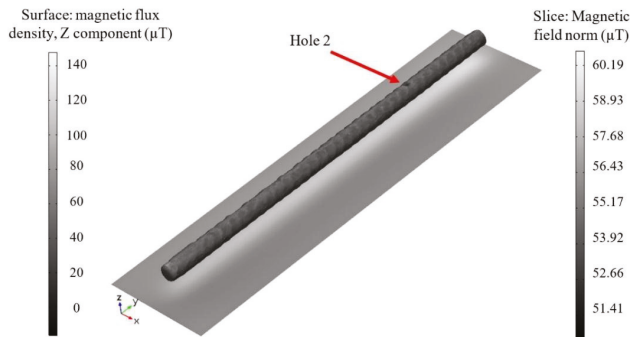
**Figure 15.** Behavior of Z-component magnetic flux density and normal magnetic field around the rebar (rebar mesh #8 and box mesh #5).

Carrying out simulations with optimum mesh specifications led to a graphical representation (Figure 15), which shows the behavior of the Z-component magnetic flux density at the location of Hole 2. Also, a planar slice of the magnetic field under the rebar in Figure 15 shows the conditions of the stray magnetic field around the rebar. As the distance from the rebar increases, the stray magnetic field around the rebar decreases relatively uniformly and symmetrically.

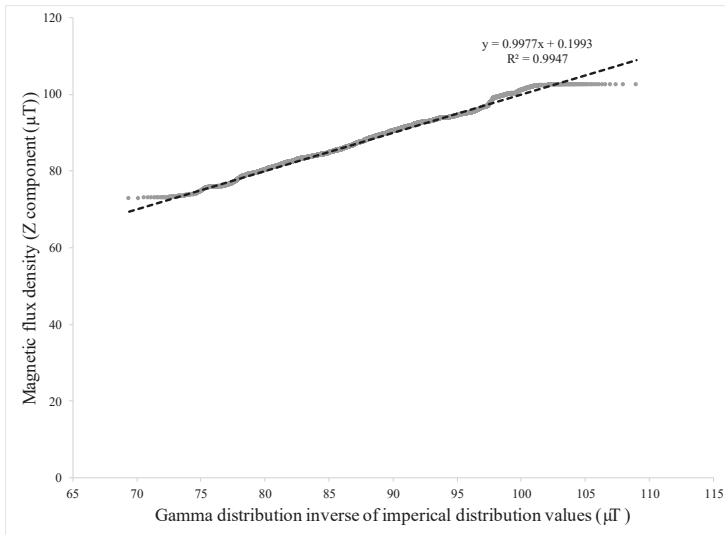
**Figure 20.** Probability plot for investigating the correlation of data with a gamma distribution.

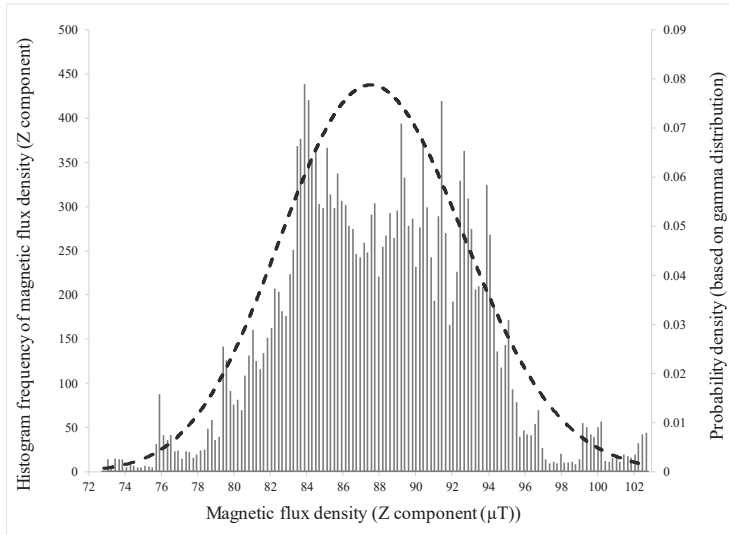
Figure 21. Histogram frequency of data in conjunction with gamma distribution probability density.

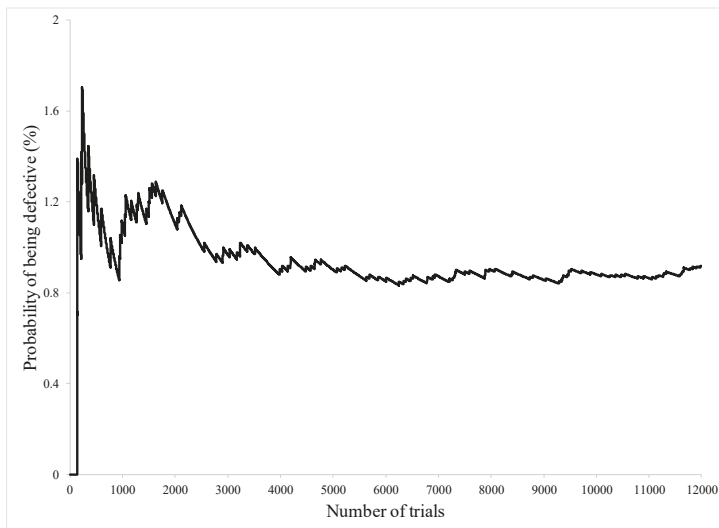
Figure 22. Defectiveness probability for the inspected rebar based on the Monte Carlo simulation method.

be verified by the Monte Carlo simulation method (based on inverse values of the obtained gamma distribution function). Figure 22 presents the probability of defects considering the mean, SD, and limit state, showing that the probability of defectiveness fluctuates until the first 300 trails are completed, and then stabilizes at the value of ~0.75%.

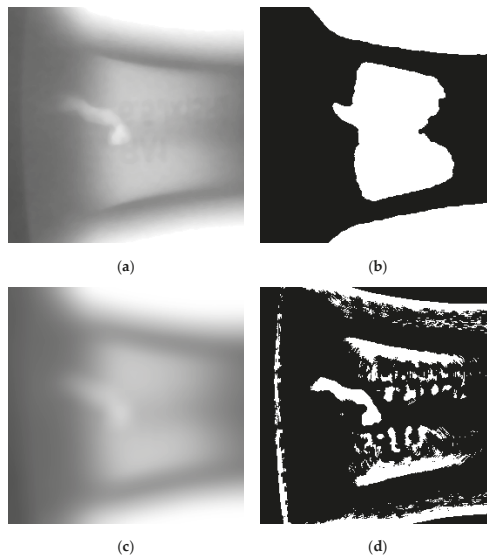
**Figure 2.** Segmentation results using adaptive threshold and OTSU methods: (a) original image with defect; (b) result of OTSU method; (c) smoothing image by a  $25 \times 25$  mean filter; (d) result of adaptive threshold method.

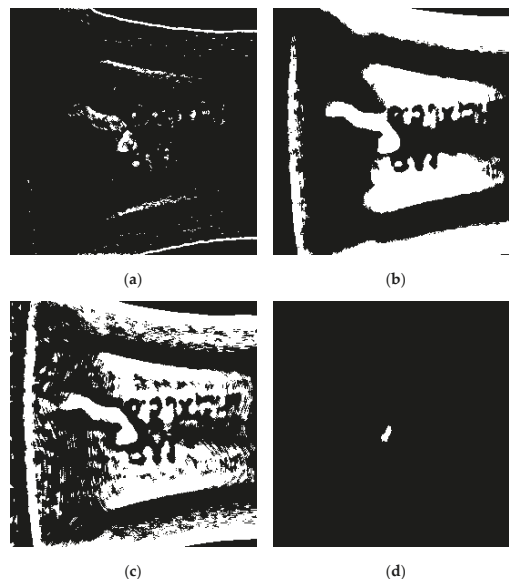
**Figure 3.** Results of adaptive threshold with different parameters: (a) result of the smaller size filter; (b) result of the bigger size filter; (c) result of the smaller threshold; (d) result of the bigger threshold.

The above analysis shows that the smoothing factor size and the threshold value are two determining factors in the adaptive threshold segmentation algorithm. Suitable operators for image smoothing are mean filtering, Gaussian filtering, or median filtering operators, the size of which is the size of the local area. This size determines the size of the objects that can be segmented. Too small a filter size is unable to give an accurate estimate of the local background brightness at the center of the object, resulting in segmentation failure. The larger the filter size, the better the filtered result will represent the local background, and the more likely the object is accurately segmented out. But too large a filter size will result in higher computational load, and adjacent objects, too, may have an undesirable effect on the filtering results. Experience suggests that when the filter is about the size of the object to be recognized, an accurate estimation of the background gray level of the defect and an accurate segmentation of the defect can be obtained at once. The value of the threshold  $T$  varies with the object to be segmented. A larger threshold suppresses the noise better, but may lead to the loss of the edge pixels of the target object, resulting in incomplete segmentation. A smaller threshold ensures that the target object is completely segmented, but noise and light and dark edges may exert some influence. For Figure 2a, the segmentation results of a smaller and a larger filter size but with the  $T$  value maintained at 2 are shown in in Figure 3a,b, respectively, while the segmentation results of a smaller  $T$  value and a larger  $T$  value but with the filter size maintained unchanged are shown in in Figure 3c,d, respectively. Figure 3a shows the segmentation result when the filter for smoothing is set at  $9 \times 9$ , the smaller size. Too small a filter window leads to local background estimation inaccuracy, and compared with Figure 2d, the defect is not a whole one but consists of discrete pieces. Figure 3b shows the segmentation result when the filter size is increased to  $51 \times 51$ . Although the defect is segmented out as a whole compared with Figure 2d, too large a filtering window makes the hub geometry interfere with the defect area, such that the two come together, resulting in segmentation failure. Figure 3c shows the segmentation result when the threshold  $T$  is set to 0, and the noise interference and the effect of the light and dark edges are significantly stronger than in Figure 2d. Figure 3d shows the segmentation result when the threshold  $T$  becomes 20, and it can be seen that both noise and edge interference disappear, but the defect is just partially segmented out.

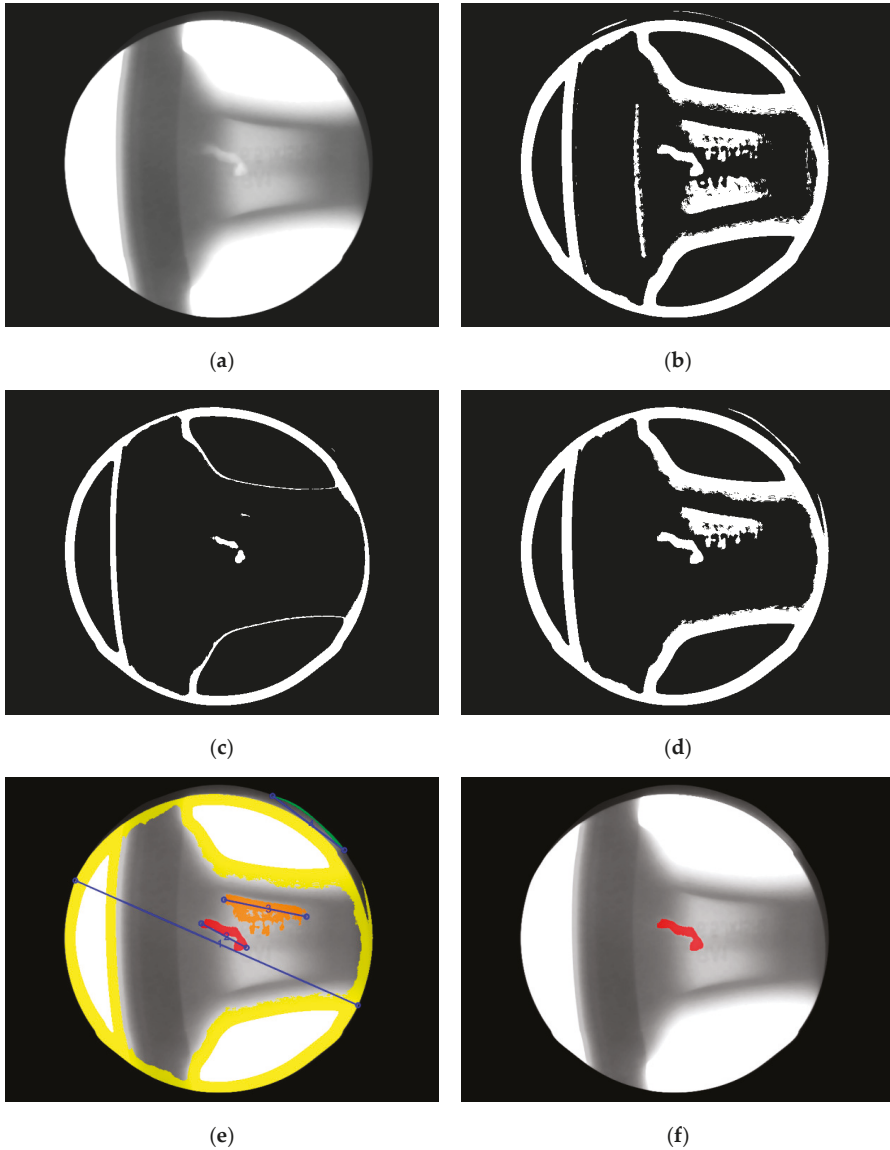
**Figure 5.** Segmentation result of proposed method: (a) original image; (b) result of  $T_s = 1$ ; (c) result of  $T_b = 12$ ; (d) result of reconstruction; (e) pseudo-color image of preliminary defects; (f) final result of proposed method.

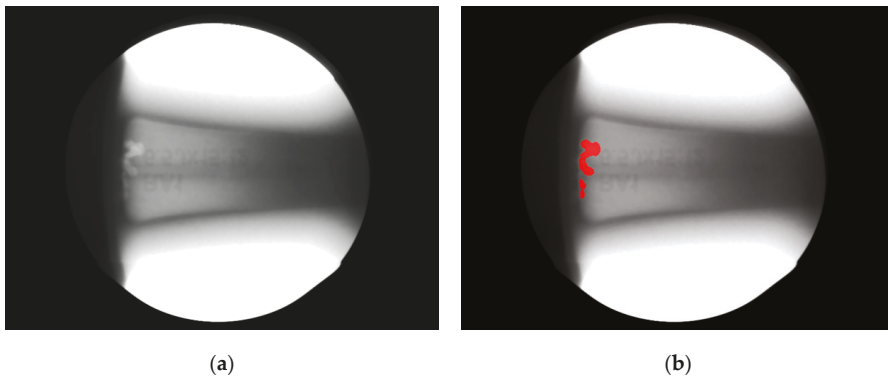
Figure 6. Another result of proposed method: (a) original image; (b) result of proposed method.

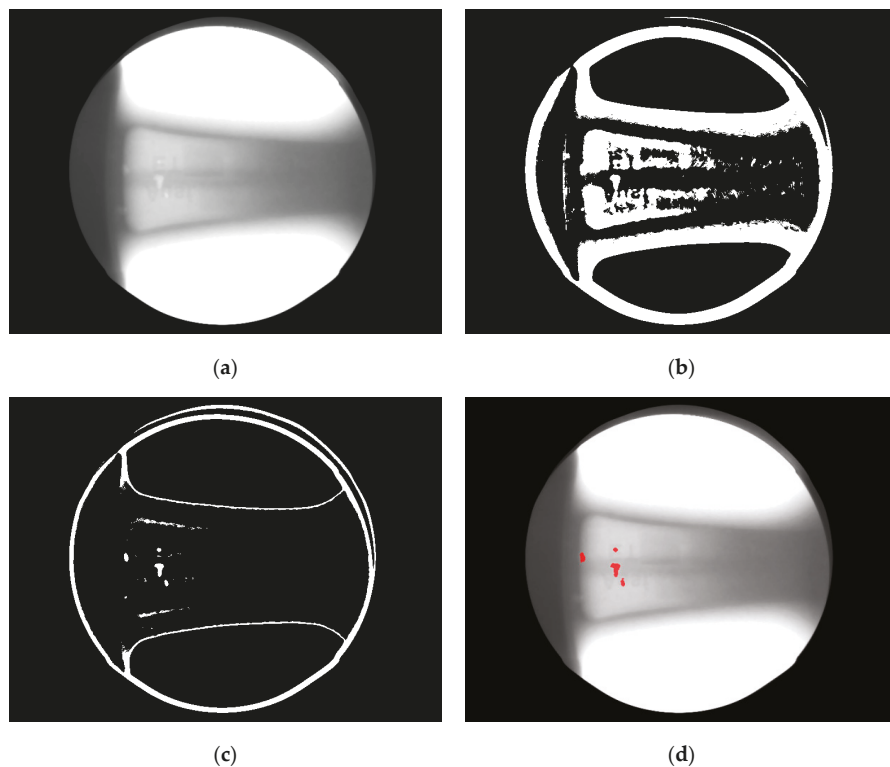
**Figure 7.** Another result of proposed method: (a) original image; (b) segmentation result of  $r = 39$  and  $T_s = 1$ ; (c) segmentation result of  $r = 19$  and  $T_s = 5$ ; (d) final result of proposed method.

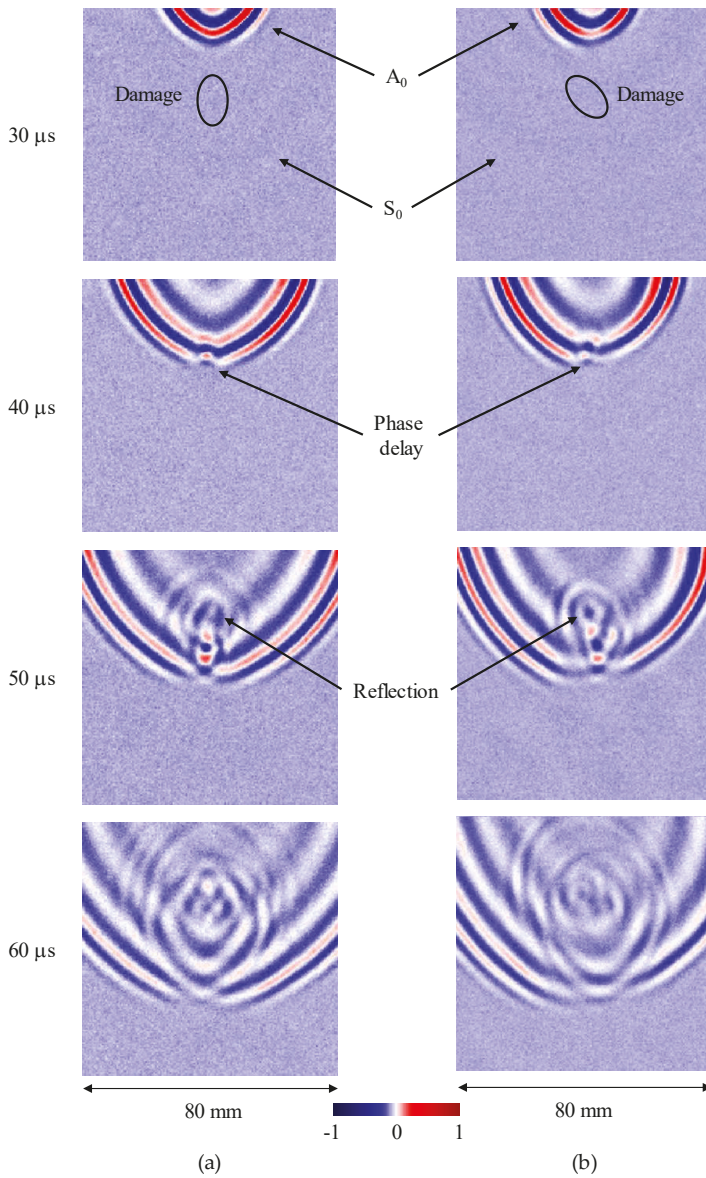
**Figure 4.** Lamb wave propagation in the impacted carbon fiber reinforced polymer (CFRP) laminates using the non-contact laser imaging system. Interactions between Lamb waves and impact-induced damages are clearly visible. (a)  $[0/90]_{2S}$ , (b)  $[0/45/90/-45]_S$ .

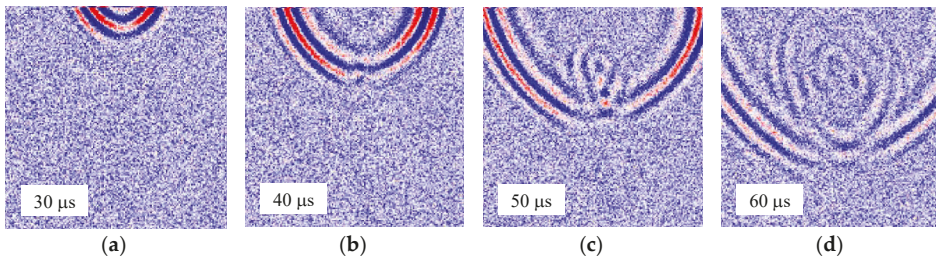
**Figure 5.** Lamb wave propagation in the impacted carbon fiber reinforced polymer (CFRP) quasi-isotropic laminate without signal averaging. (a) 30  $\mu$ s; (b) 40  $\mu$ s; (c) 50  $\mu$ s; (d) 60  $\mu$ s.

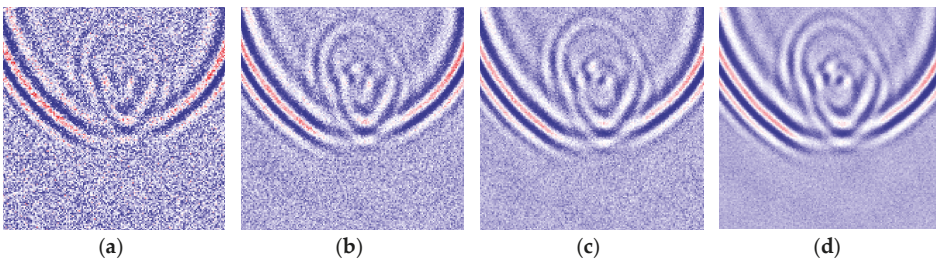
**Figure 6.** Effects of the averaging times on the ultrasonic images at 55  $\mu$ s for carbon fiber reinforced polymer (CFRP) quasi-isotropic laminate. (a) non-averaged; (b) 5 times; (c) 10 times; (d) 30 times.

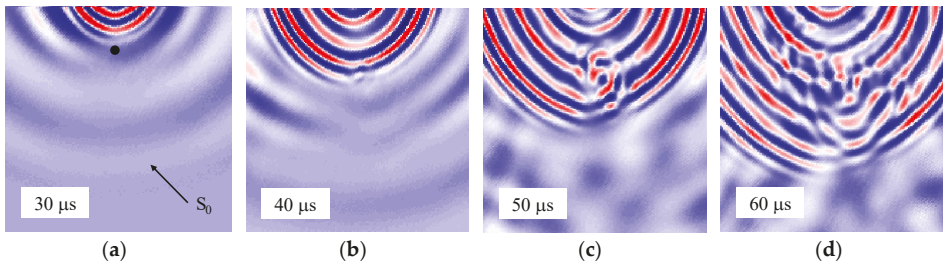
**Figure 7.** Lamb wave propagation in the impacted carbon fiber reinforced polymer (CFRP) quasi-isotropic laminate using a contact resonant ultrasonic transducer. (a) 30  $\mu$ s; (b) 40  $\mu$ s; (c) 50  $\mu$ s; (d) 60  $\mu$ s.

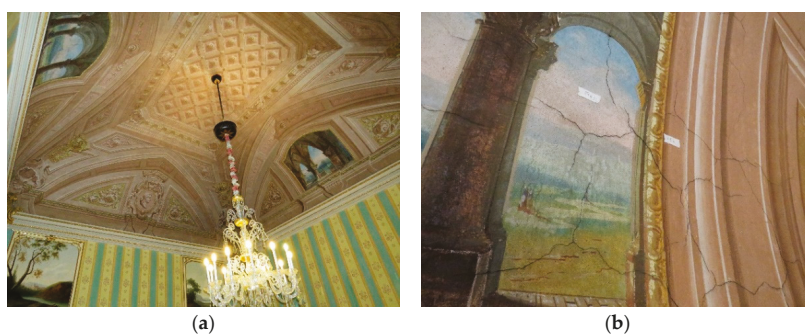
**Figure 1.** (a) Pelagi room at Birago Palace; (b) cracks branched in the decorated plaster of the masonry vault in the Pelagi room.

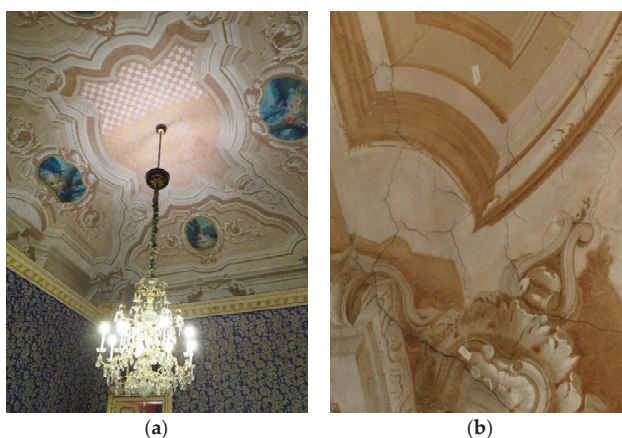
**Figure 2.** (a) Blu room at Birago Palace; (b) cracks branched in the decorated plaster of the masonry vault in the Blu room.

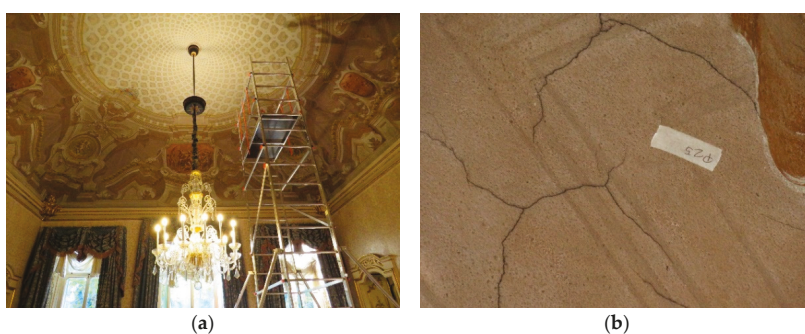
**Figure 3.** (a) Giunta room at Birago Palace; (b) cracks branched in the decorated plaster of the masonry vault in the Giunta room.

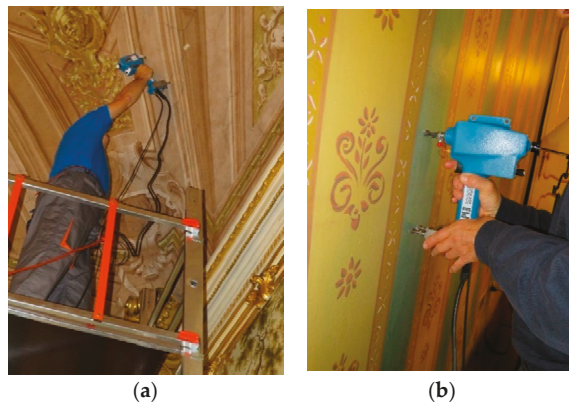
**Figure 5.** (a) Use of the electric impact hammer for the adherence test of the frescoed plaster of the masonry vaults at Birago Palace; (b) calibration test where it is possible to see the positioning of the electric impact hammer on the test surface.

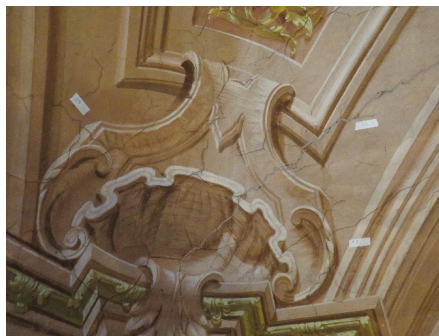
Figure 7. Survey area on the Pelagi room vault.

In the impact test carried out at Birago Palace in Turin (Italy), every masonry vault was divided into survey areas as shown in Figure 7, labeled with alphabet letters, within which both apparently intact and potentially damaged points were tested. For each point, at least three impacts were performed to obtain a better statistical response, and the return coefficient  $e$  was evaluated. The maps of the areas tested and the force–time curves of some tested points are shown, respectively, in the Pelagi (Figures 8 and 9), Blu (Figures 10 and 11), and Giunta rooms (Figures 12 and 13). Tables 1–3 show the coefficient averages for each point.

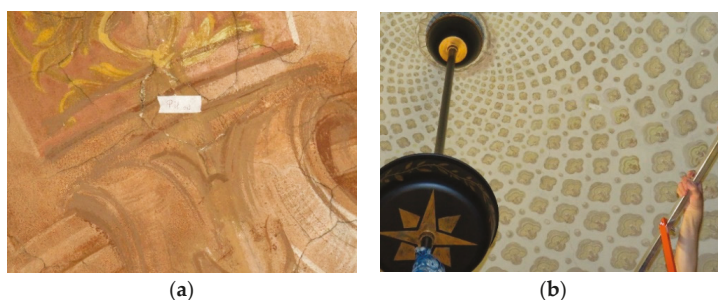
**Figure 14.** Points of potential plaster detachment: (a) P11 vault Pelagi room; (b) P15 vault Giunta room.

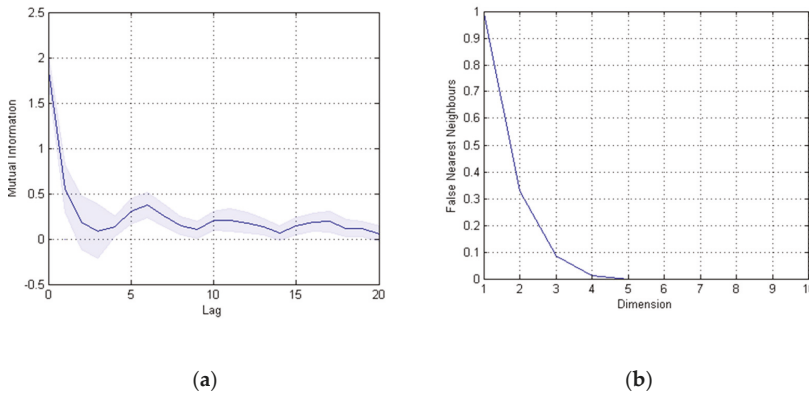
**Figure 7.** (a) The relationship between the mutual information value and the delay time (Lag). (b) The relationship between the ratio of false nearest neighbors and the value of embedded dimension.

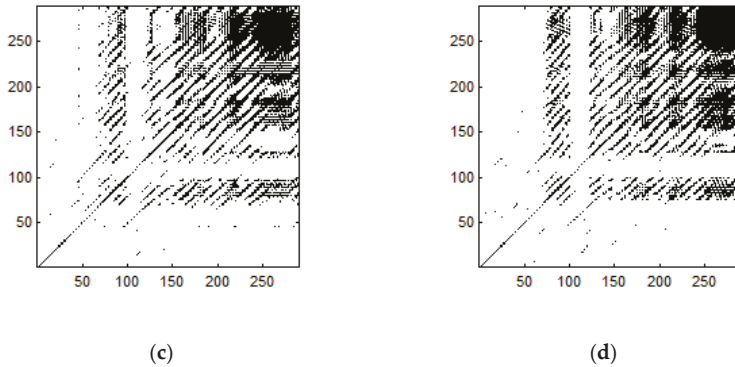
**Figure 12.** RPs of the second half of backscattered signals of defect areas with different diameter: (a) 0 mm; (b) 0.5 mm; (c) 0.7 mm; and, (d) 1 mm.

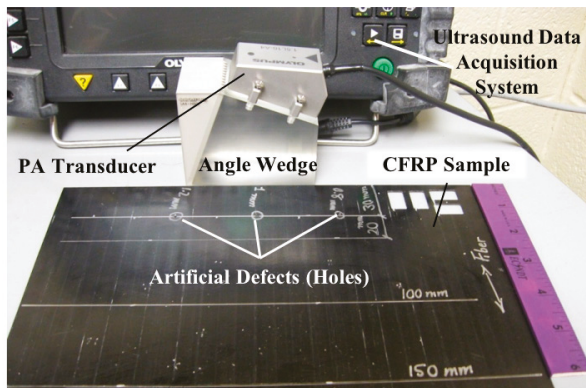
Figure 4. Experimental setup for flaw detection in CFRP sample using PAUT guided wave method.

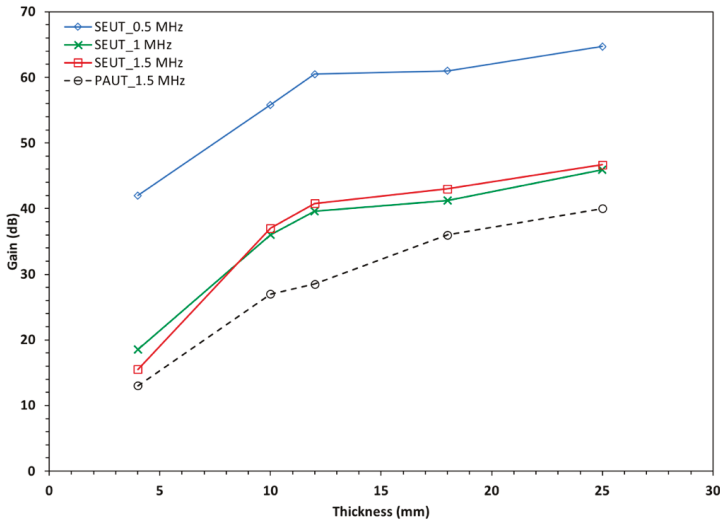
**Figure 7.** Gain (dB) value for back wall reflection detection in different sample thickness for attenuation characteristics evaluation using SEUT and PAUT techniques.

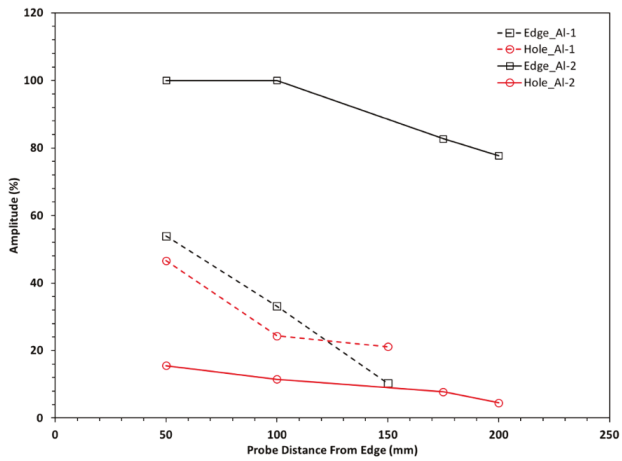
Figure 9. Change of signal amplitude over distance for Al-1 and Al-2 samples.

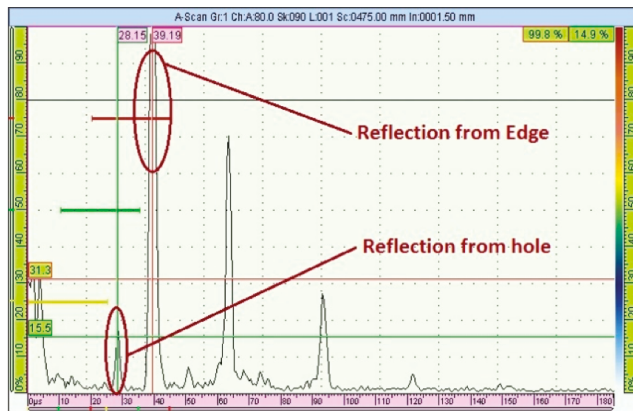
Figure 10. Typical PAUT guided wave signal of flaw detection for (a) Al-1 sample and (b) Al-2 sample.

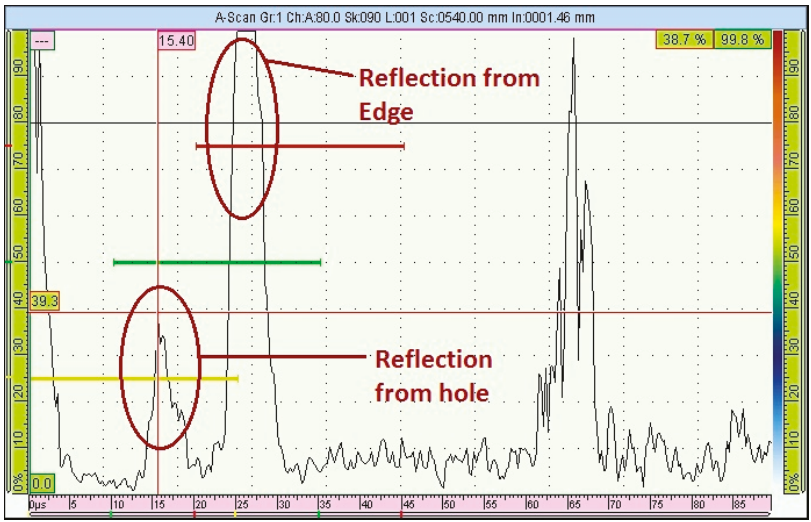
Figure 11. Typical PAUT guided wave signal of flaw detection for CFRP sample.

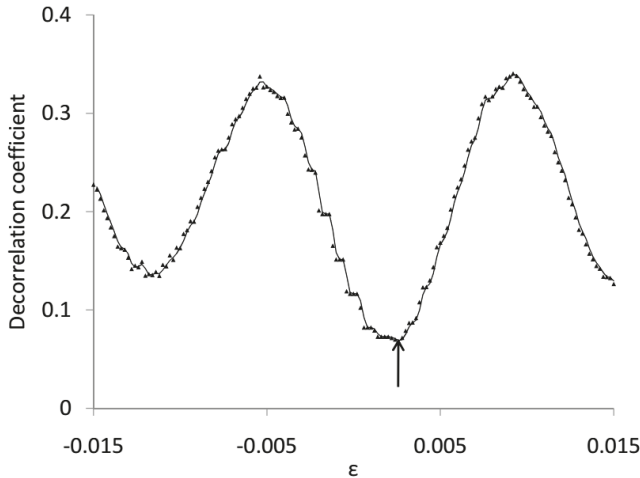
**Figure 4.** Decorrelation coefficient calculation example for the waveforms presented in Figure 2 when  $t_1 = 45 \mu\text{s}$  (decorrelation coefficient = 0.0679 when  $\varepsilon = 0.0026$ ).

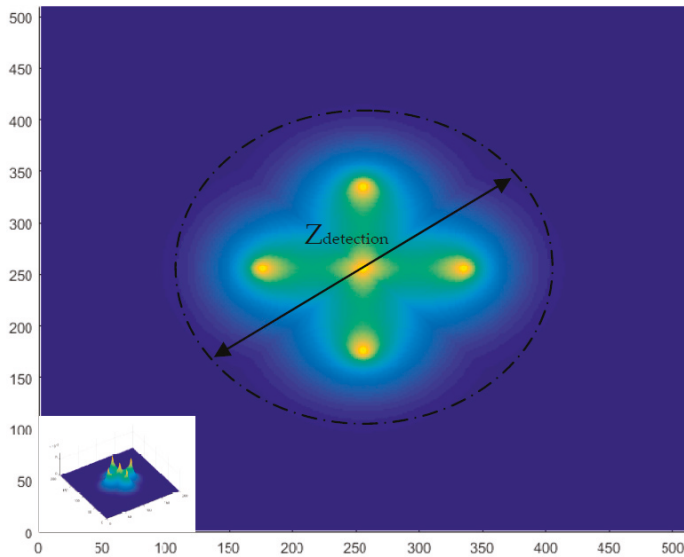
Figure 6. Sensitivity kernels and detection zone.

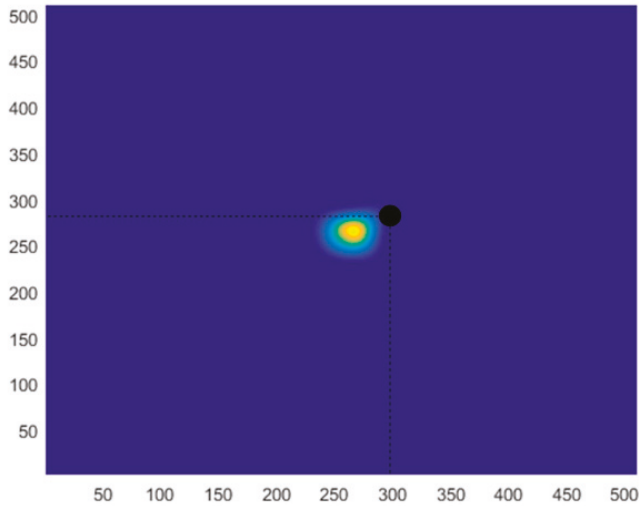
Figure 7. Localization image when  $t = 45 \mu s$ .

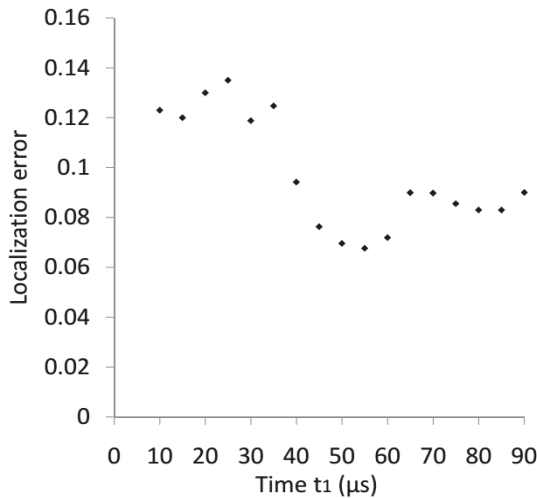
Figure 8. Localization error varied with time window.

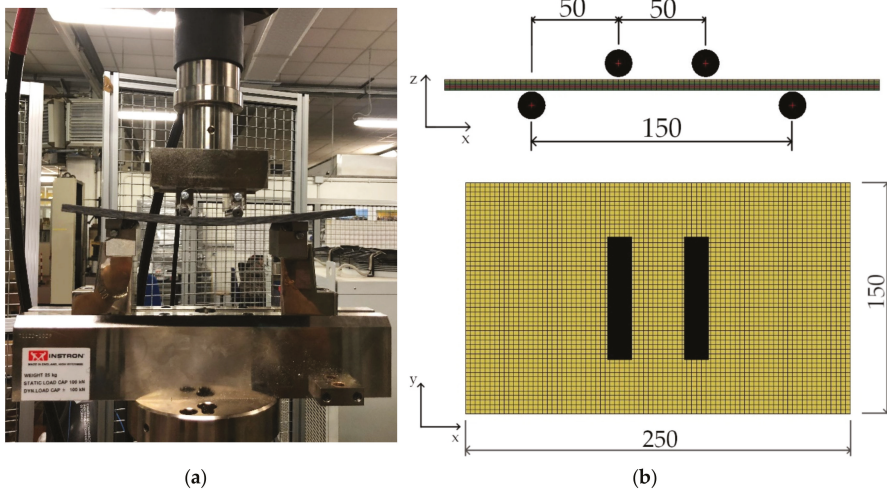
Figure 1. Four-point bending test: (a) experimental setup; (b) numerical model.

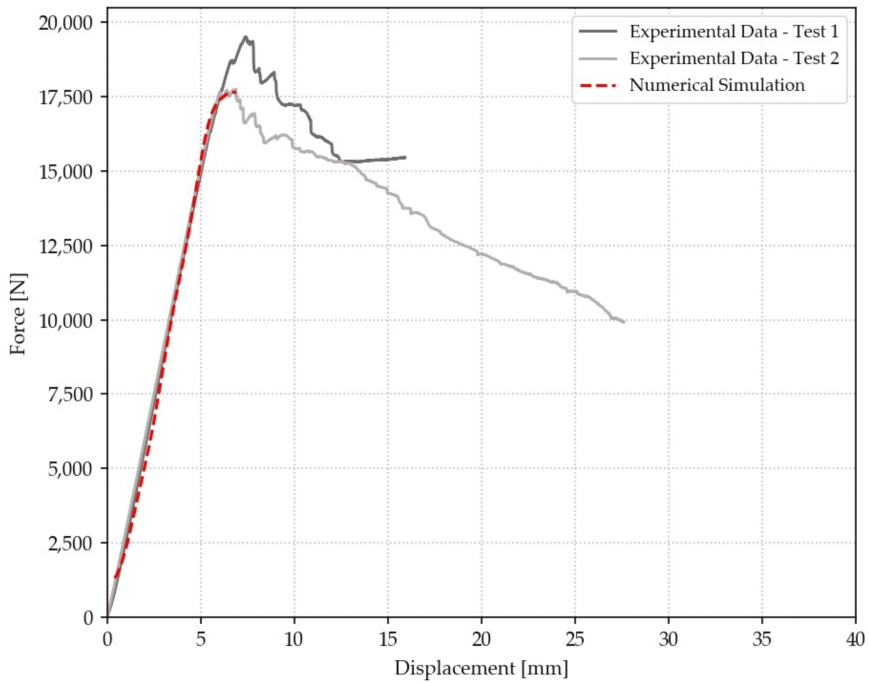
Figure 3. Experimental and numerical results of the four-point bending tests.

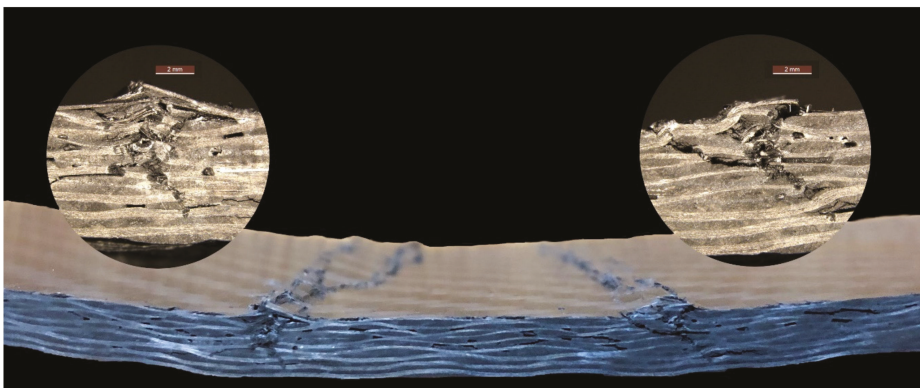
Figure 4. Magnification of intralaminar cracks: failure of the upper four layers.

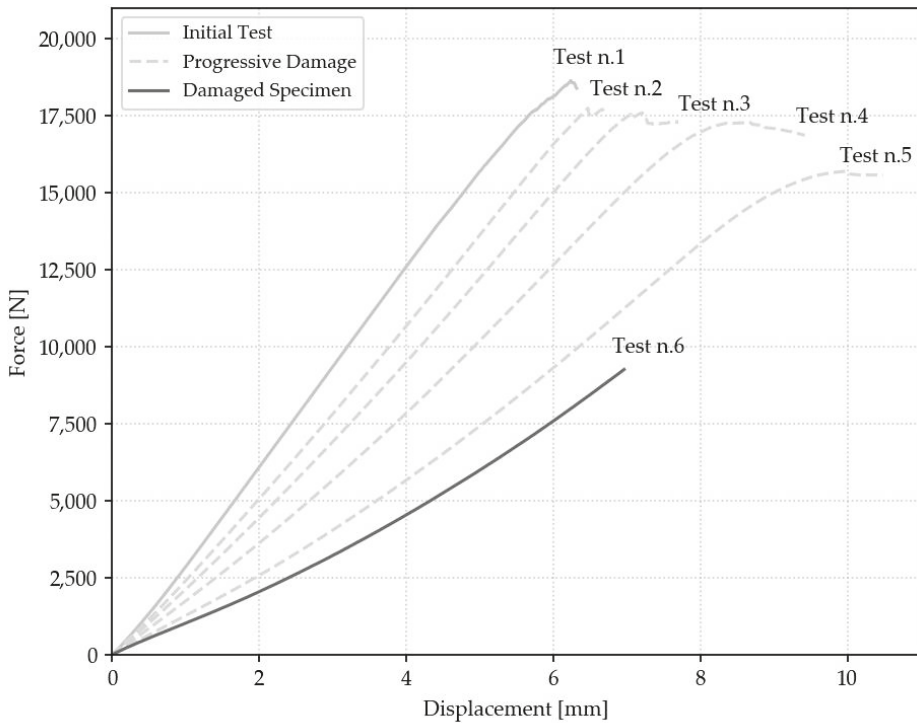
Figure 5. Progressive damaging of composite plate through four-point bending tests.

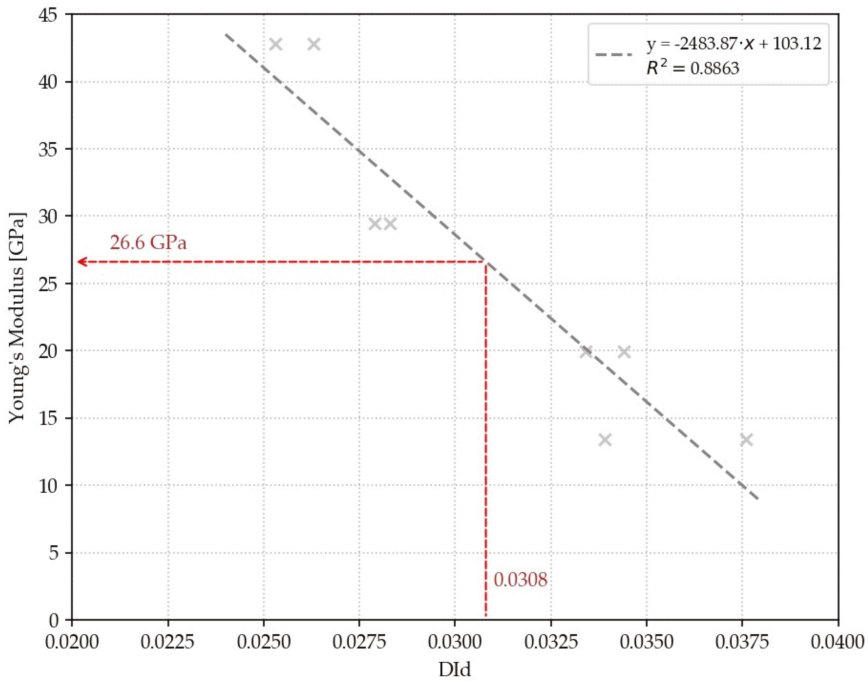
Figure 6. Residual Young’s modulus evaluation with  $DI_d$ .

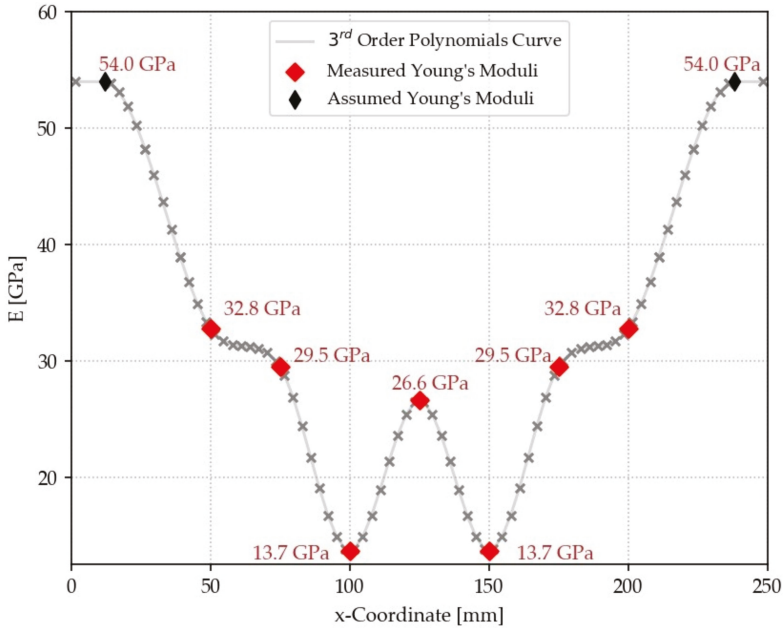
Figure 7. Variation of residual Young's modulus with respect to the x-coordinate.

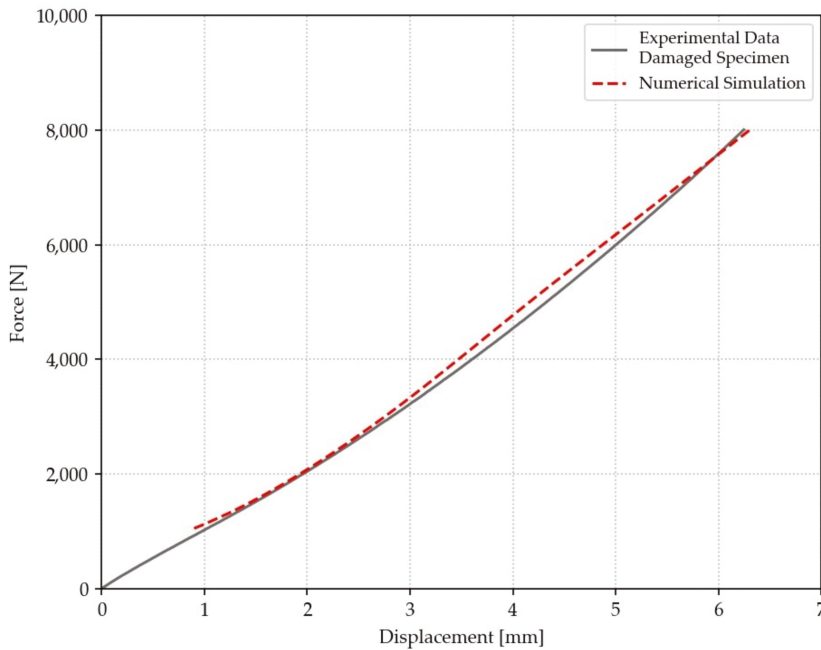
Figure 9. Comparison of experimental and numerical results of damaged specimen.

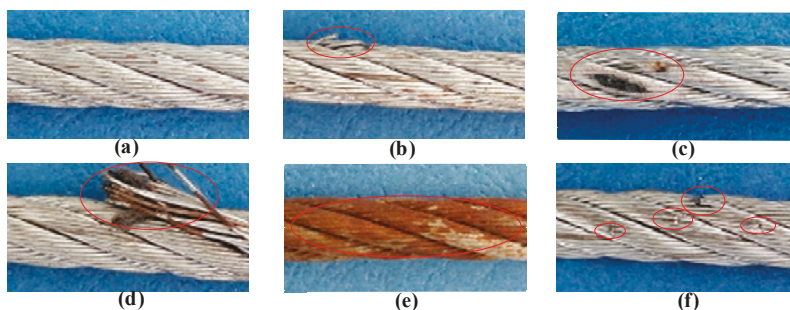
**Figure 1.** Sample pictures of wire rope damage. (a) Health; (b) wire breakage; (c) wear; (d) deformation (broken strand); (e) rust; and (f) fatigue (fatigue breaking).

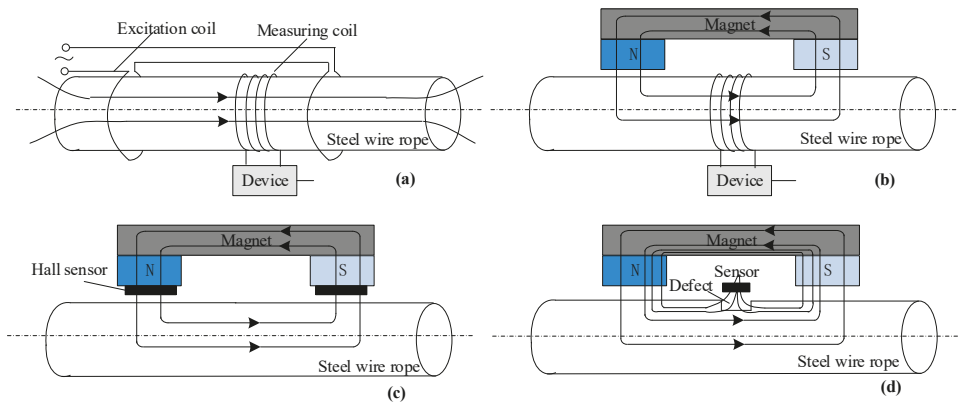
**Figure 2.** Electromagnetic non-destructive detection principle of steel wire rope. (a) Main magnetic flux detection method based on coil excitation; (b) main magnetic flux detection method based on permanent magnet excitation; (c) return magnetic flux detection method based on permanent magnet excitation; and (d) leakage magnetic flux detection method based on permanent magnet excitation.

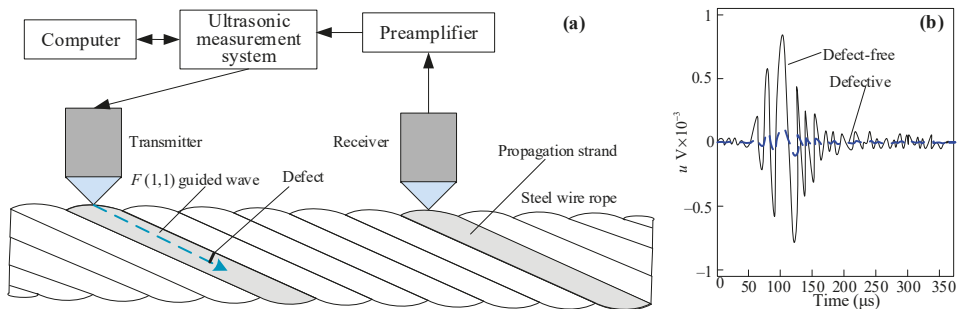
**Figure 4.** Non-destructive testing principle of steel wire rope by ultrasonic guided wave method [52]. (a) Detection system schematic diagram; (b) sketch map for waveforms of defect-free and defective signal.

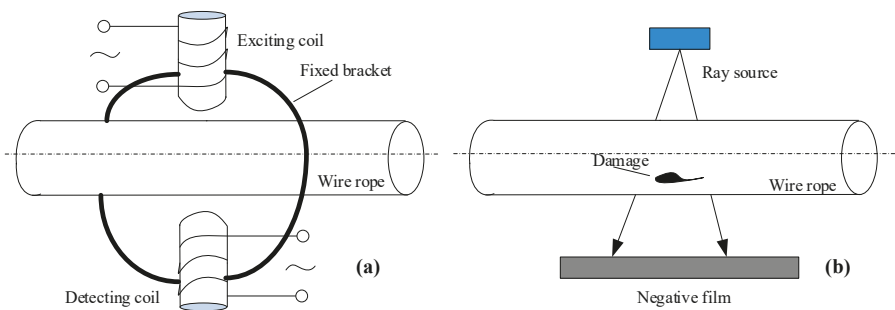
**Figure 6.** The other detection method principles. (a) Eddy current method [74]; (b) ray method [75].

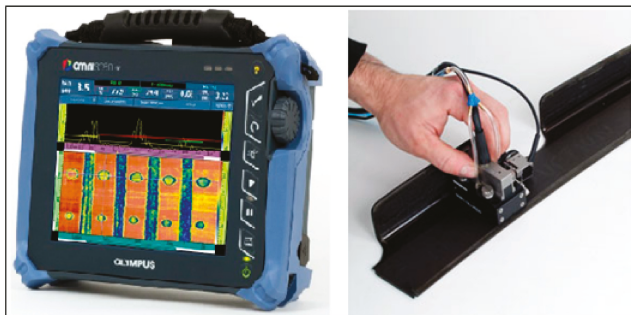
Figure 3. Some details of the ultrasonic (UT) testing setup.

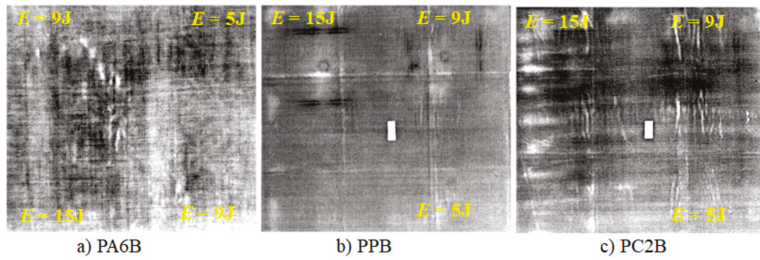
**Figure 9.** Phase images taken at  $f = 0.19$  Hz on the rear side of the three specimens; (a) PA6B; (b) PPB; (c) PC2B.

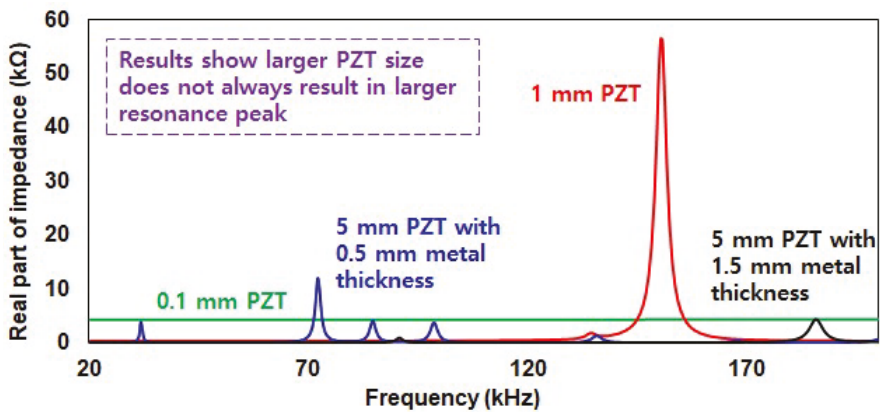
Figure 7. Simulation results for the impedance signatures of the four FEM models.

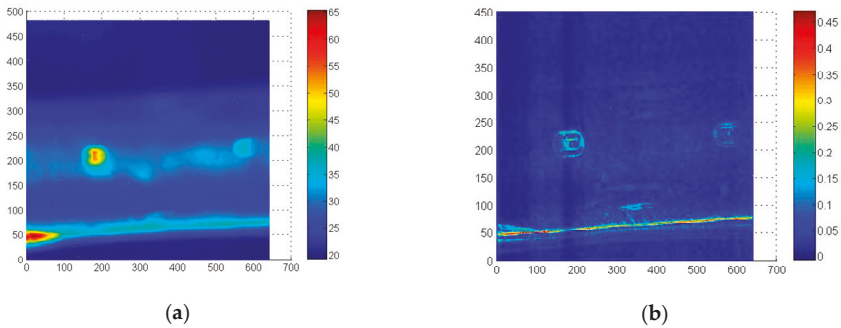
Figure 9. Comparison of initial and processed images: (a) Initial infrared image; (b) Infrared image after processing.
