Application of Biology to Cultural Heritage

Printed Edition of the Special Issue Published in *Applied Sciences*

Atlas of Micromorphological Degradation of Archaeological Birch Bark

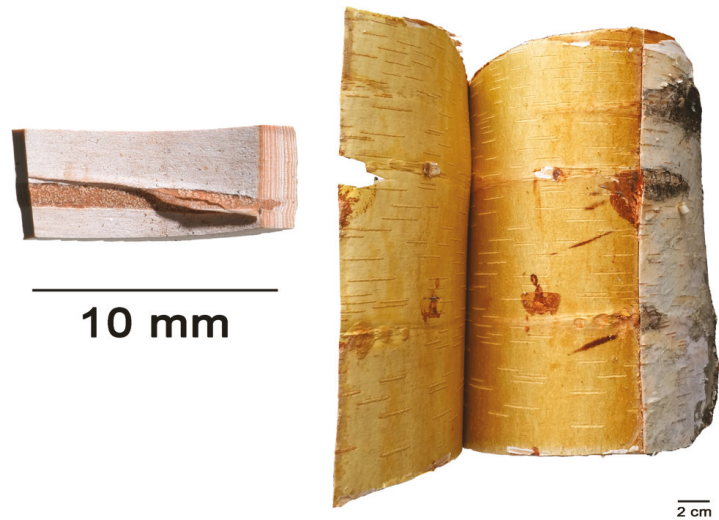
Figure 2. Reference sample (left) was extracted from contemporary outer birch bark harvested from a mature tree with strong and pliable phellem (right). Sample has white powdery surface due to betulin content and slight delamination is present at the lenticel. Thick- and thin-walled cell bands are recognizable macroscopically as red and white bands, respectively, along the radial section.

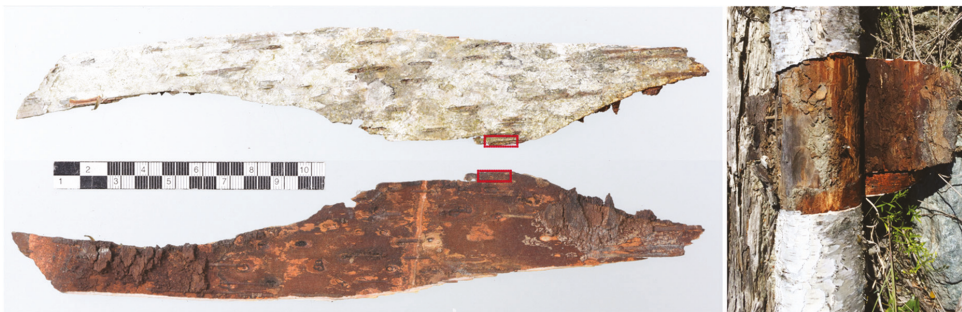
Figure 3. Birch bark fragment harvested from fallen trunk degraded in nature. Outer surface, especially when in contact with the ground, shows green, grey and brown discoloration and vertical cracks. Lenticels have cracks and overlays and are areas no longer clearly defined. On the inner side, remains of brittle and brown-black stained phloem are present and black circular deposits indicate areas of increased degradation. Location of analysed sample 0 is indicated with red rectangle.

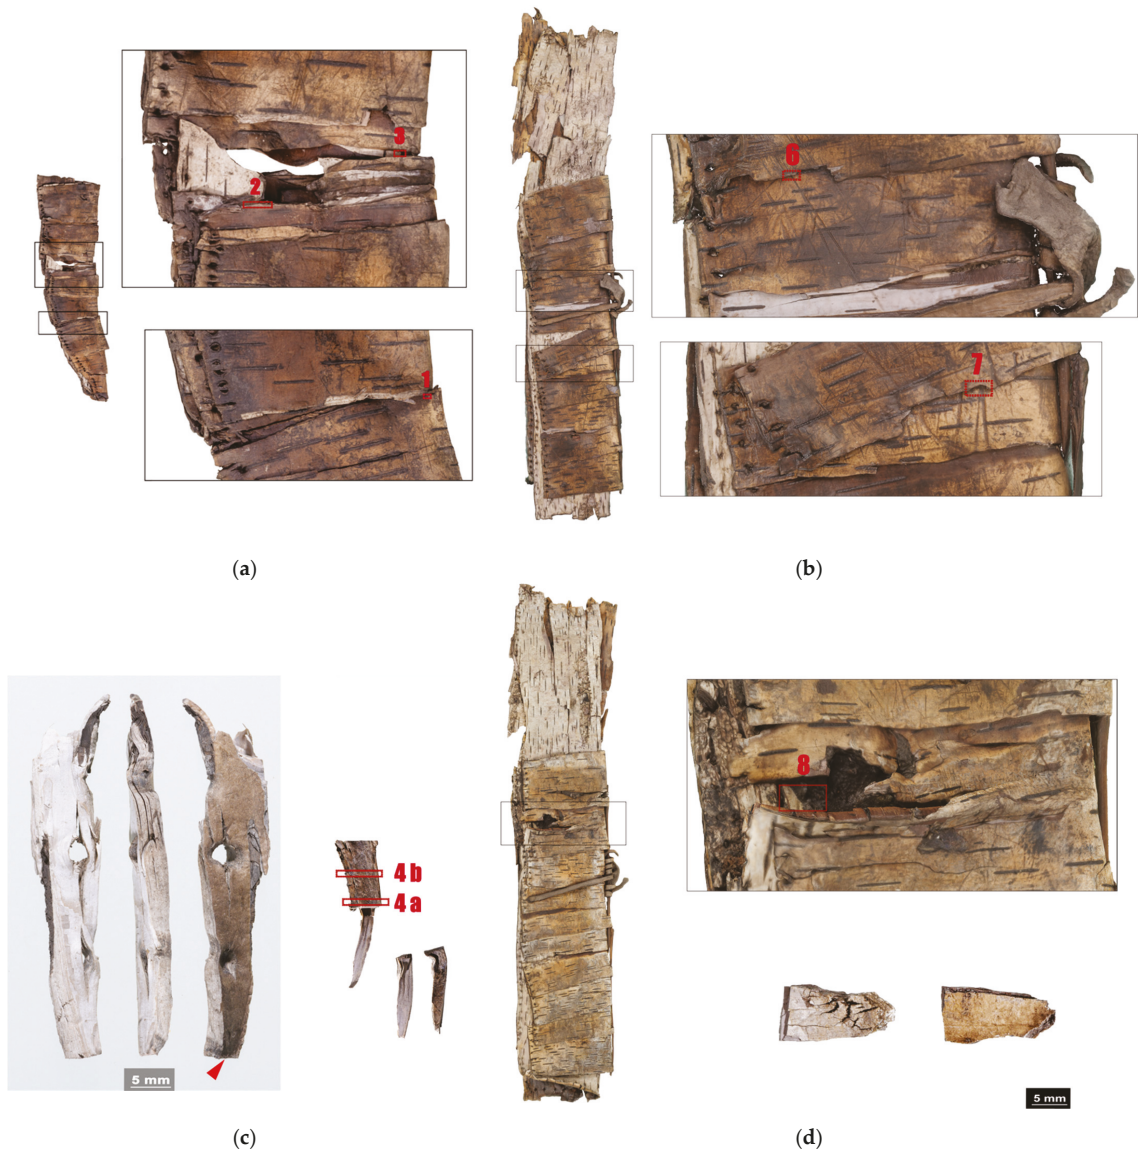
Figure 4. (a) Lower and (b) upper part of Schnidejoch bow case body, ground-facing side; (d) upper part, upward facing. Samples were taken from outer bark strips (1, 6, 7), middle bark strips (2) and inner lining (3, 4, 8). Outer and middle bark strips of bow case body have outer bark surface oriented towards inside, and inner lining has outer bark surface oriented towards outside. Sample 4 was extracted from a fragment probably from (c) lid inner lining. Sample 5 was a loose fragment found close to the lower part (not shown).

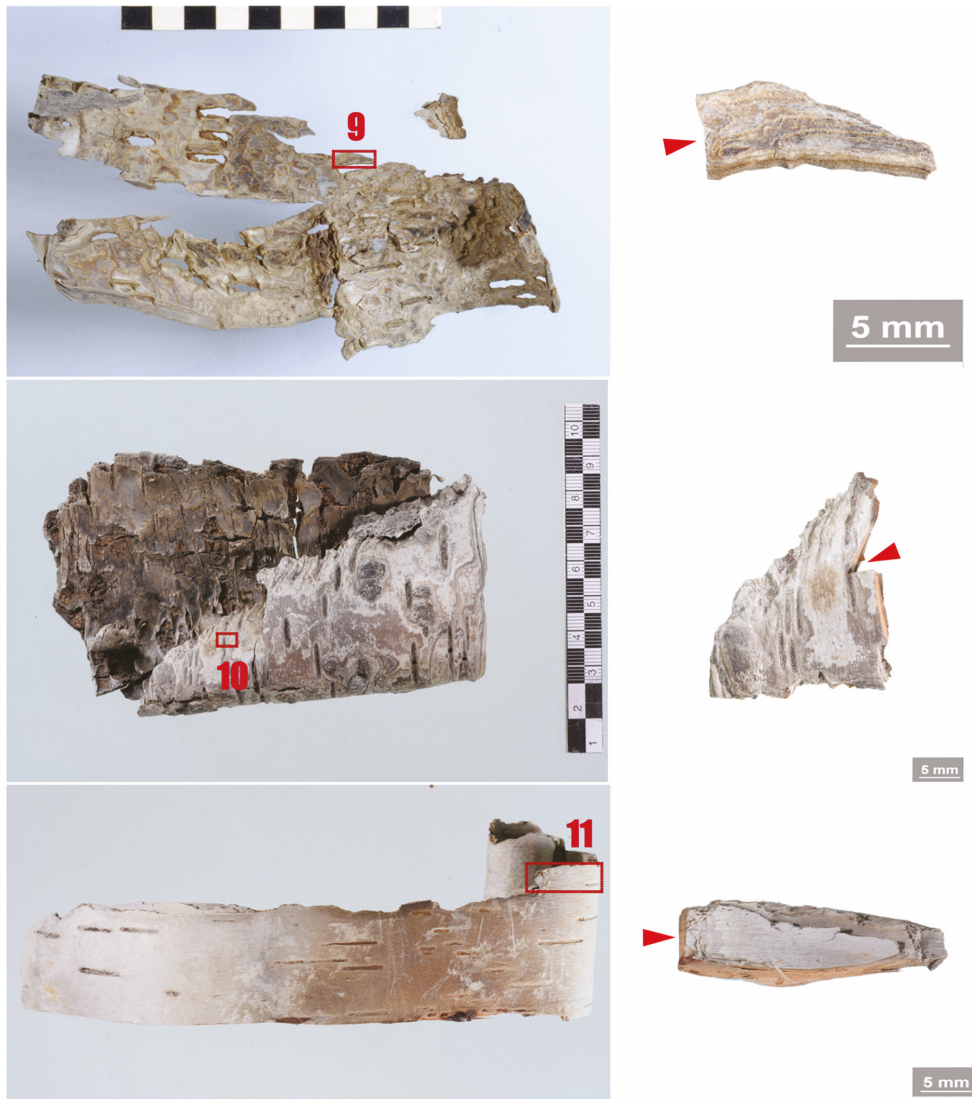
Figure 5. Left: Lendbreen fragments; right: analysed samples. Sample 9 was taken from a weathered fragment; lenticels were fully eroded but sample was not brittle. Surface and cambium side were grey and faded. Cut surface was dark brown with a few reddish-brown areas. Sample 10 was taken from a rolled birch bark fragment, stiff but not brittle, with delaminated areas and large cracks. Cambium side (outer side in image) was compact and with a light, mainly grey-brown and white colour. Some holes from insect damage were present and normally elevated lenticels were recessed. On cut surface, outer layers were grey-brown, and only inner layers still exhibited original red-brown colour. Sample 11 was taken from a long narrow strip rolled on one end. Fragment was very strong, hard to cut and still pliable. Surface was weathered, coloured matte whitish-grey; red and brown colours were missing. Cut surface revealed unaltered colours in inner layers and grey outer layers.

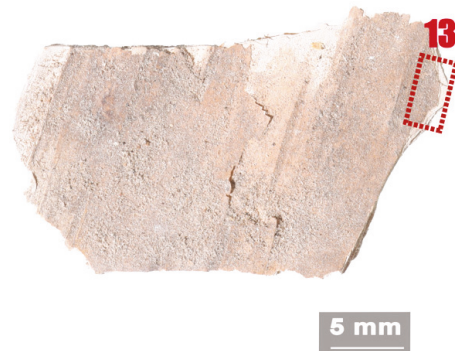
Figure 7. Sample 13 was extracted from a birch bark fragment recovered in the Kosackenberc cave. Inner and outer surfaces have reddish-brown overlay with white blooming. Normally alternating white and reddish-brown layers are not present, as reddish-brown colouring of thick-walled cells is completely lost. Lenticels have also lost their normally dark colour and are hardly distinguishable from normal phellem. Fragment is very light and extremely fragile; handling leads to fragmentation and loss.

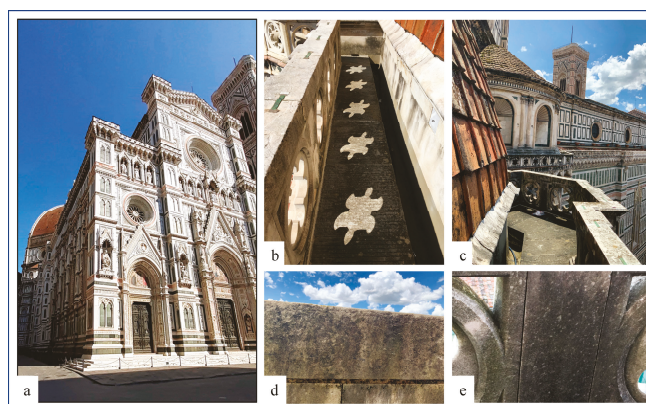
Figure 1. The Cathedral of Santa Maria del Fiore and the study sites. (a) The façade; (b) the external gallery running around the apses of the SE exposed façade; (c) the external gallery on the NW exposed façade; (d) a detail of the marble surface of the inner face of the openwork parapet of the SE exposed gallery; (e) a detail of the openwork parapet at the NW site showing a widespread dark patina.

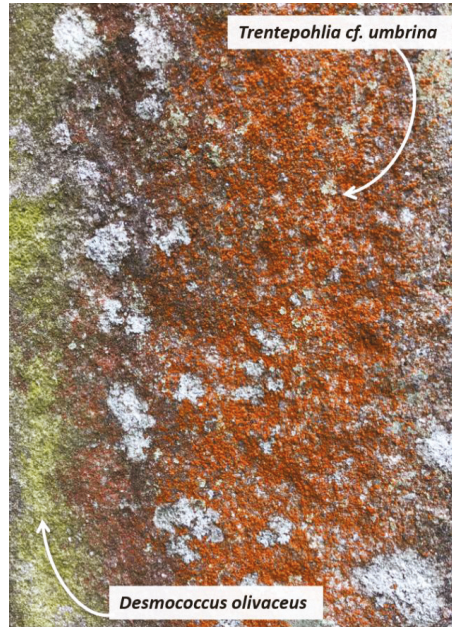
Figure 3. Example of dominance of *Trentepohlia cf. umbrina* on the N-facing wall of the BAR church.

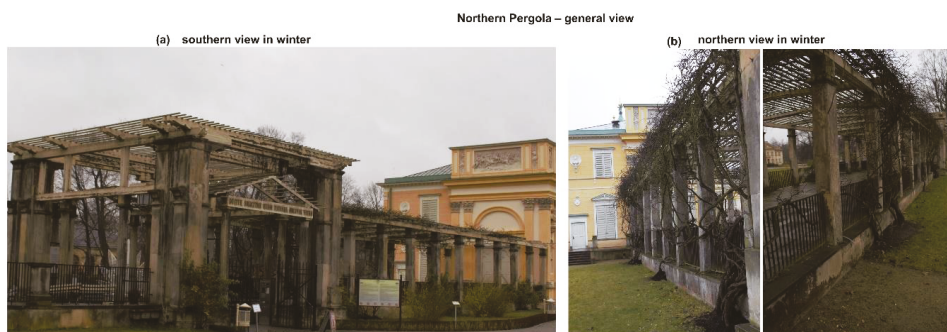
Figure 1. General view of the Northern Pergola in winter from the southern (a) and the north-facing side (b).

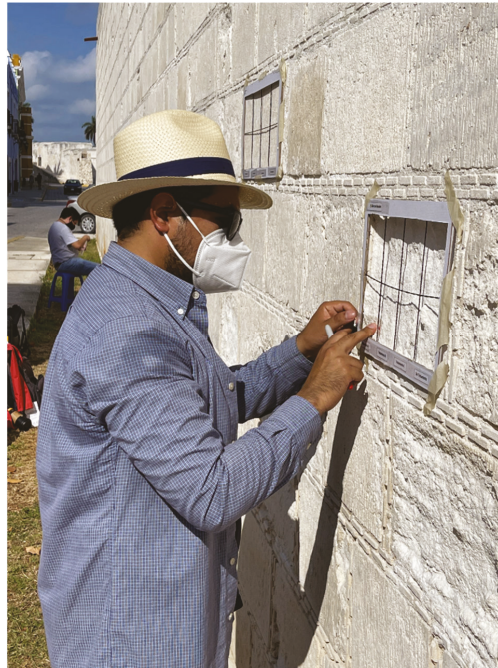
Figure 1. Limestone wall in Campeche, southern México, exhibiting a range of deterioration pathologies. Formers are being used to demarcate panels prior to treatment by spraying with carbonatogenic bacterial suspension or control solution. Replicate panels will allow statistical analysis. The aim is to increase surface hardness and reduce the detachment rate of flaking material.
