Assessment, Diagnosis and Service Life Prediction

Edited by
Ana Silva

Printed Edition of the Special Issue Published in *Buildings*

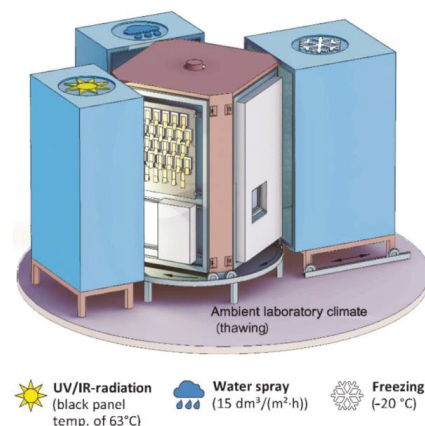
Figure 1. Climate simulator with four climate zones used for testing according to NT Build 495 as illustrated by Kvande et al. [6]. The mid-section is rotating clockwise.

During the accelerated artificial climatic ageing test NT Build 495, specimens are positioned vertically in a rotating carousel and exposed to four degrading factors repeatedly for 1 h each (see Figure 1). In the first chamber, UV radiation is applied using fluorescent UV tubes with a relative spectral distribution in the UV band close to that of global solar irradiance. The black panel temperature rises to its designated temperature (normally $63 \pm 5 \text{ }^\circ\text{C}$) in 45 min from the beginning of exposure to UV light and heat radiation. If required, the black panel temperature may be chosen as $35 \pm 5 \text{ }^\circ\text{C}$, $50 \pm 5 \text{ }^\circ\text{C}$, or $75 \pm 5 \text{ }^\circ\text{C}$, cf. ISO 4892. The temperature is controlled using infrared halogen lamps. In the second chamber, the specimens are wetted with a spray of demineralised water. The suggested strain was $15 \pm 2 \text{ L/m}^2\cdot\text{h}$, but various spraying conditions may be used if required. To allow water to drip off, the spraying is terminated 10 min before the specimens rotates in to the third chamber. In the third chamber, an air temperature of $-20 \pm 5 \text{ }^\circ\text{C}$ is suggested, but other specified air temperatures may be used if registered and reported. In the fourth chamber, the specimens are thawed at a laboratory climate of $23 \pm 5 \text{ }^\circ\text{C}$ and $50 \pm 10\% \text{ RH}$.

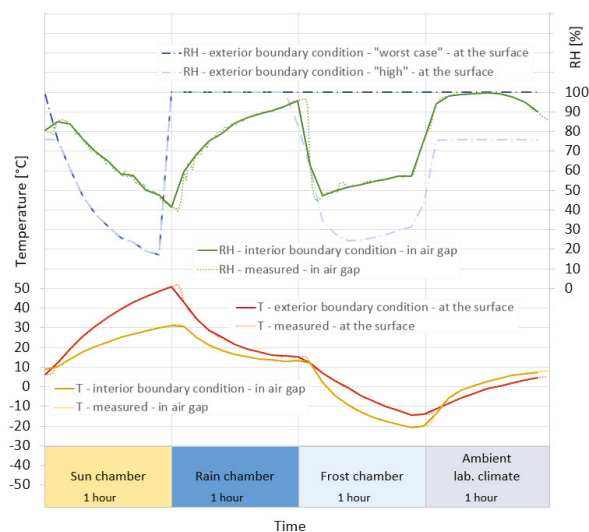
Figure 3. Interior boundary conditions used in the current test setup and exterior boundary conditions used in both the current and the modified test setup. The 4-h period (6-min intervals) corresponds to one rotation in the climate simulator and was repeated for 12 months in the simulations.

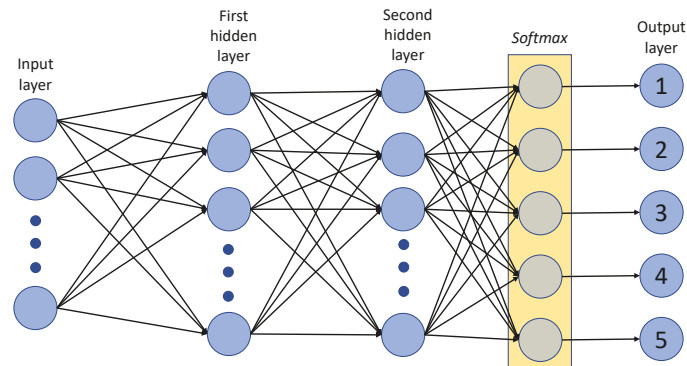
Figure 2. Multilayer perceptron with two hidden layers and softmax activation function.

The ANN prediction model can be designed to predict the state condition of highway bridges. In this work, it was used a multiclass classification neural network (Figure 2) to develop the ANN prediction model. The Python language [20] and Scikit-learn package [21] were used to construct the ANN prediction model.

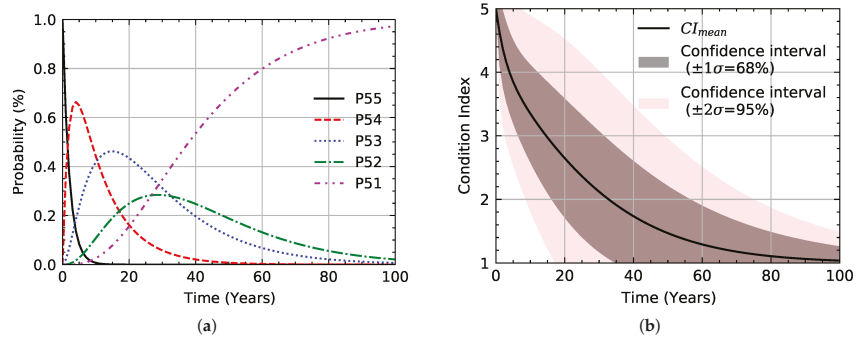
Figure 11. Results from Markov model. (a) Transition probability over time; (b) expected condition over time.

Figure 11a shows the probability of a bridge to be in a determined CI over time. It is possible to observe that the probability of a bridge remaining in the CI equal to 5 drops significantly in just a few years. For the case of the CI equal to 3 and 2, it is possible to observe a more flat curve, meaning that these CIs remain for a longer period. Brazilian standards do not specify a lifespan for the structures, but in principle, it seems to be assumed as 50 years. Considering 50 years as the lifespan, 70% of bridges reach the CI equal to 1. In Figure 11b, the average of the bridges reaches the CI equal to 3 in 14 years and the CI equal to 2 in 32 years. Additionally, it is possible to observe a high dispersion in the time that the bridge reaches the CI equal to 2, ranging from 10 to 75 years.

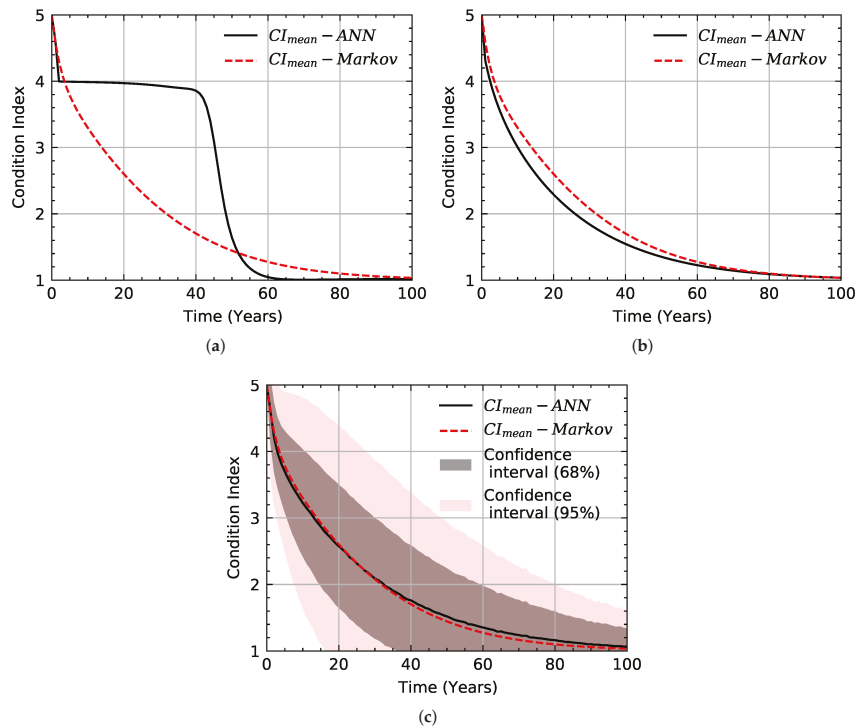
Figure 13. Evolution of the degradation over time by ANN model. (a) Extrapolation approach; (b) 1 year approach; (c) Monte Carlo approach.

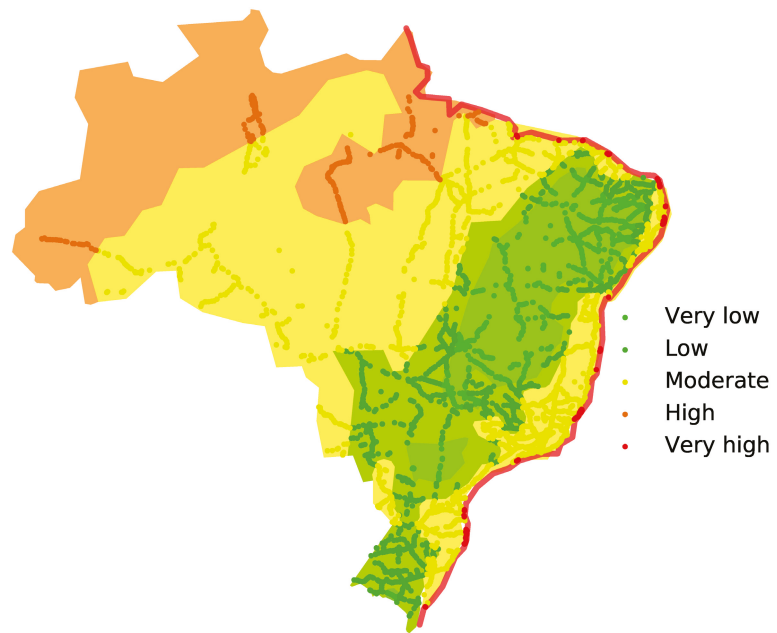
Figure 16. Modified Brooks atmospheric corrosivity index (adapted from [36]).

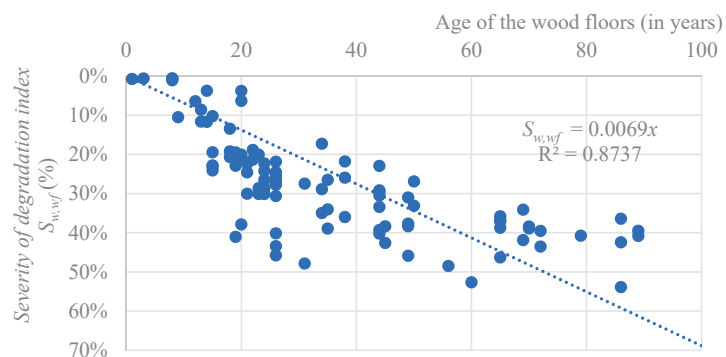
**Figure 2.** Regression analysis between the numerical index that expresses the degradation of the 96 wood flooring systems ($S_{w,wf}$) and their age.

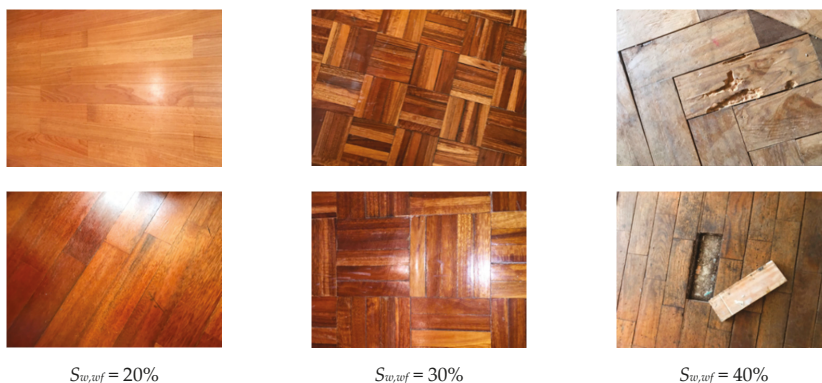
Figure 3. Illustrative examples of the overall condition of the wood floorings for different levels of the severity of degradation index.

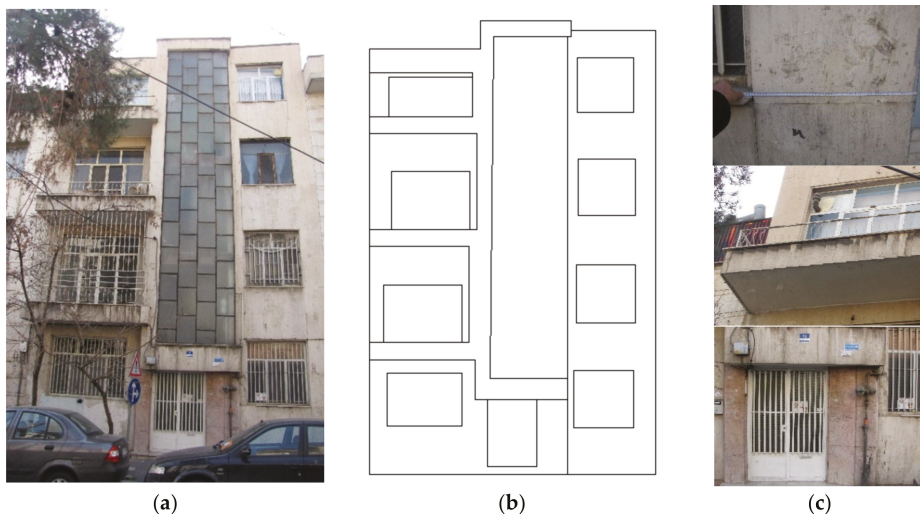
Figure 2. Illustrative example of one case study analysed in Tehran: (a) photograph of the façade; (b) diagrammatic sketch to represent the anomalies observed; (c) direct measurements and identification of different anomalies in the natural stone cladding.

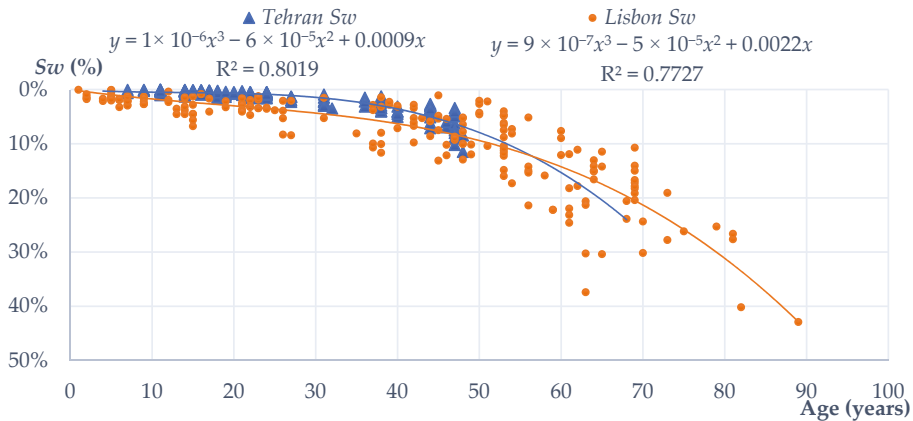
Figure 8. Degradation curves of the Tehran and Lisbon samples.

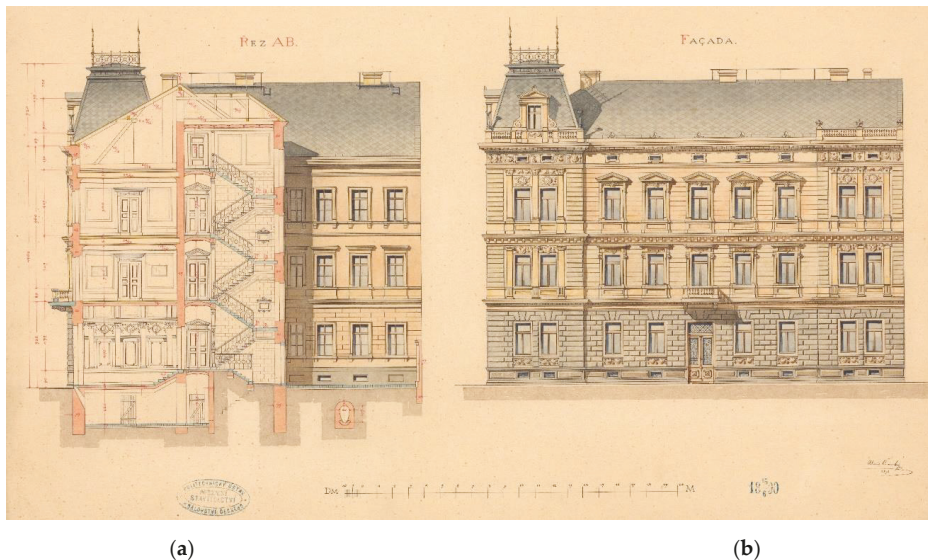
Figure 1. Section (a) and elevation (b) of a typical four-storey tenement house from the end of the 19th century on the student work of A. Censky, 1890 [3].

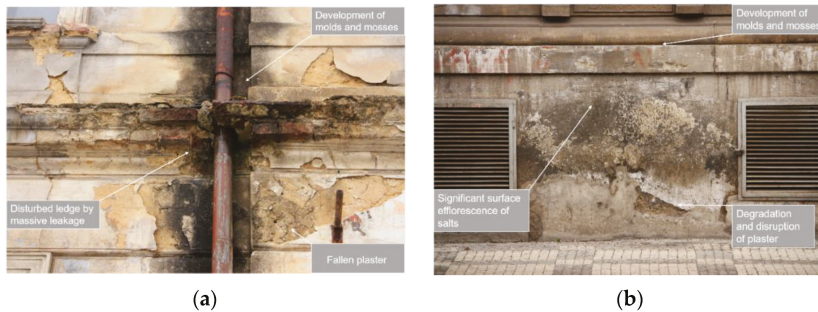
Figure 2. Images clearly showing the most common failures of structures from the second half of the 19th and the early 20th centuries caused by degradation processes initiated in these cases by the combination of moisture, an incorrect design solution and neglected maintenance. The following are clearly visible on images: (a) fallen plaster, damaged ledge by massive leakage, mold and mosses; (b) degradation and disruption of plaster, significant surface efflorescence of salts, mold and mosses.

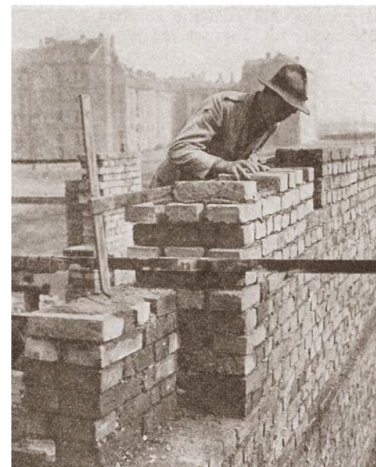
Figure 4. The wall and beam ties: (a) the beam wrought iron ties in the drawing on the school work of V. Vasatko from 1910 [13]; (b) the detail of the wall ties and their location (red lines) in the floor plan of the house [14]; (c) wall ties made of wrought iron, including adjustment with a lock, on a period photograph (1932) when performing a masonry structure [15].

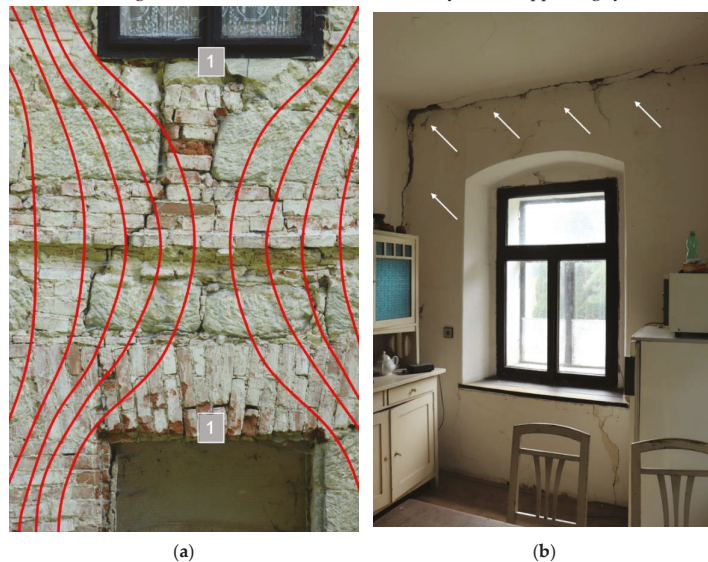
Figure 6. Examples of structural failures of structures from the second half of 19th and the start of the 20th century: (a) prominent tensile cracks in masonry weakened by openings, with the representation of pressure trajectories, 1—area of normal stresses and tensile cracks; (b) crack between the perimeter structure and the ceiling caused by forced deformation due to the effect of a change in the footing bottom.

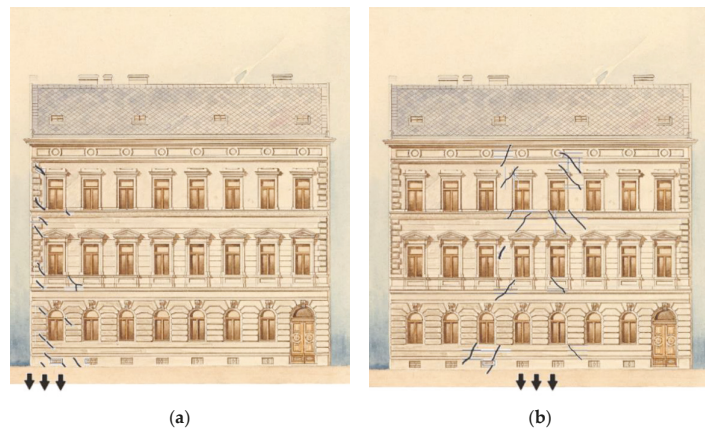
Figure 7. Graphical representation of the course of cracks and failures of vertical masonry - characteristic tensile cracks on the side (a), resp. in the middle (b) parts of the building, which arose as a result of the decrease of the affected part and thus the change in the shape of the foundation joint, e.g., an uneven foundation conditions (sands – rock), uneven compaction of the substrate or waterlogging of the soil, etc. (arrows indicate the place of decline of part of the foundations) [41].

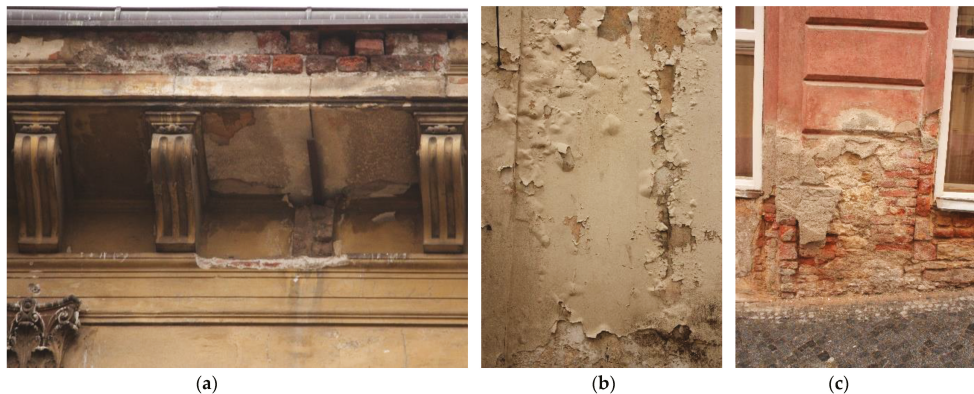
Figure 9. Examples of non-structural failures caused by the effects of the external environment, especially the synergic effect of increased moisture levels and temperature, which are accompanied by chemical, mineralogical and biological processes in structures from the second half of 19th century and the start of 20th century: (a) damage of the ledge and its surface finishes, visible salt efflorescence; (b) closed and open blisters in the surface layers due to their low diffusion permeability; (c) extensive damage to the plinth part caused by the long-term effect of humidity and salts.

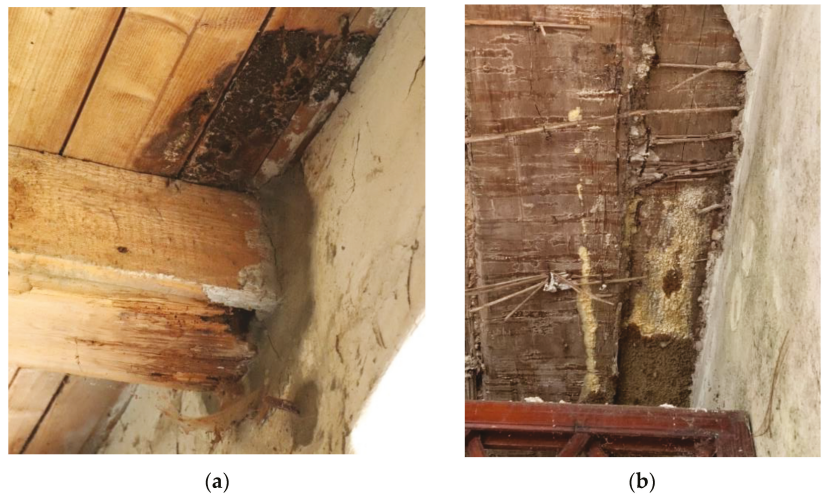
Figure 10. Examples of failures of wooden parts of horizontal load-bearing structures caused by mounting wood without a natural possibility of drying and with insufficient permeability of the structure: (a) rotting head of a wooden ceiling beam; (b) yellow patch of wet rot on ceiling wooden panel.

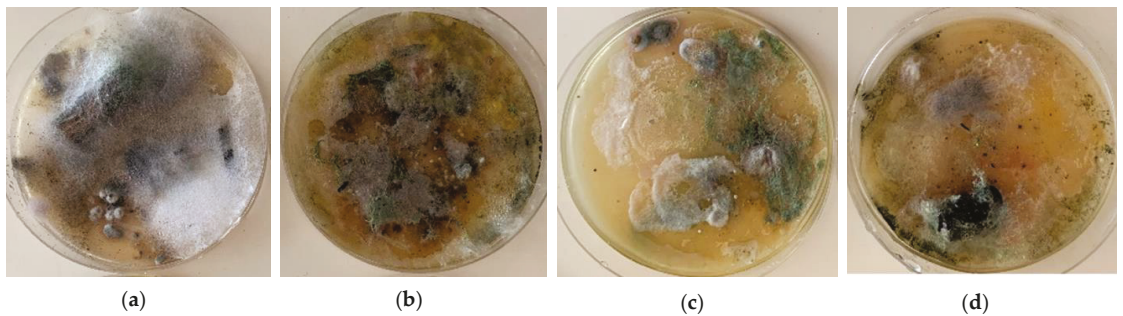
Figure 11. Example of laboratory evaluation of bioderivogens in cultures of a sample of a damaged ceiling structure in Prague 7—confirmed presence of bacteria and fungi. In all cases, massive development and growth of microscopic fibrous fungi was noted. In cultures of samples were identified: (a) *Trichoderma* sp. and bacteria; (b) *Trichoderma* sp., *Mucor* sp., wood-destroying fungus and bacteria; (c) *Mucor* sp. and wood-destroying fungus; (d) *Penicillium* sp., *Acremonium* sp., *Aspergillus* sp. and bacteria [52].

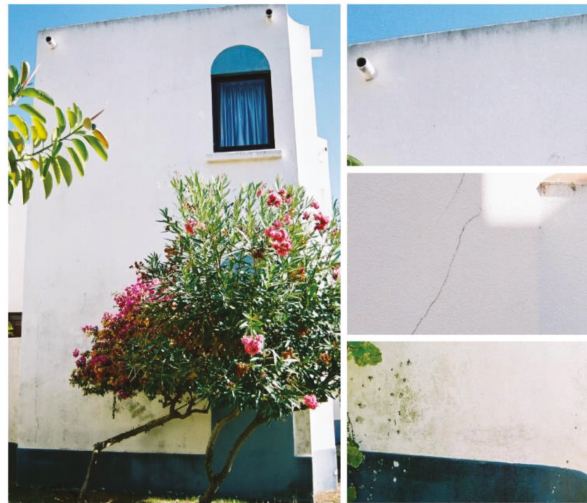
Figure 1. First case study: rendered façade (data sourced from Reference [46]).

Table 1 presents the defects in the rendered façade (Figure 1) observed during the visual inspection carried out during the fieldwork survey. The surveyor recorded the area of rendering affected by each group of defects (A_n). The degradation condition level of each defect found (k_n), according to its condition (taking into account the classification of defects proposed in Table 2), and the factor corresponding to the relative weight of each defect in the overall degradation of the façade ($k_{a,n}$), according to Table 3. In summary, Table 1 presents the weighted degraded area ($A_n \times k_n \times k_{a,n}$), taking into account the defects observed. In order to calculate the severity of the degradation (S_w) index of this cladding, Equations (2) and (3) are used.

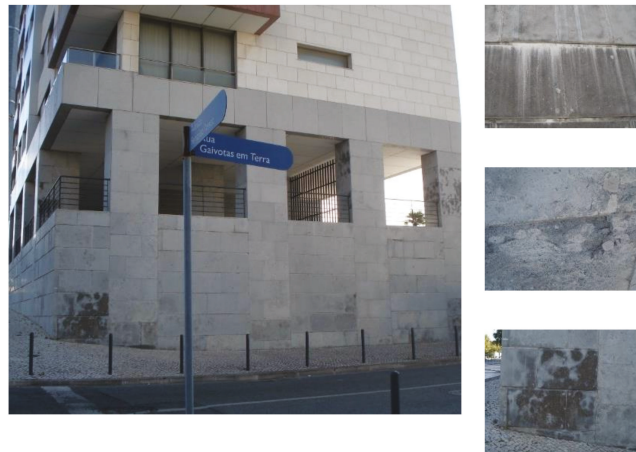
Figure 2. Second case study: natural stone cladding.

Figure 2 describes another case study, a natural stone cladding, directly adhered to the substrate, which was inspected using the global inspection system. This case study refers to a building located in Parque das Nações, Lisbon (Centre of Portugal). The façade is oriented toward the east and presents an average level of protection against the combined action of wind and rain. In terms of environmental factors, the inspected building is located at less than 3 km from the sea, in an urban environment, and exposed to unfavourable conditions of air temperature and relative humidity. The total area of the facade analysed is 75 m² and the natural stone cladding is 12 years old.

The defects observed in the natural stone cladding inspected (Figure 2) are synthesized in Table 5. The surveyor recorded the area of natural stone affected by each group of the defect (A_n): A_v —visual anomalies, A_j —joint anomalies, A_f —bond-to-substrate anomalies, and A_i —loss-of-integrity anomalies. The degradation condition level of each defect found (k_n) and the factor corresponding to the relative weight of each defect on the overall degradation of façade ($k_{a,n}$) are assigned according to the condition classification in Table 6. In summary, Table 5 presents the weighted degraded area ($A_n \times k_n \times k_{a,n}$) in order to calculate the severity of the degradation (S_w) index (Equations (4) and (5)).

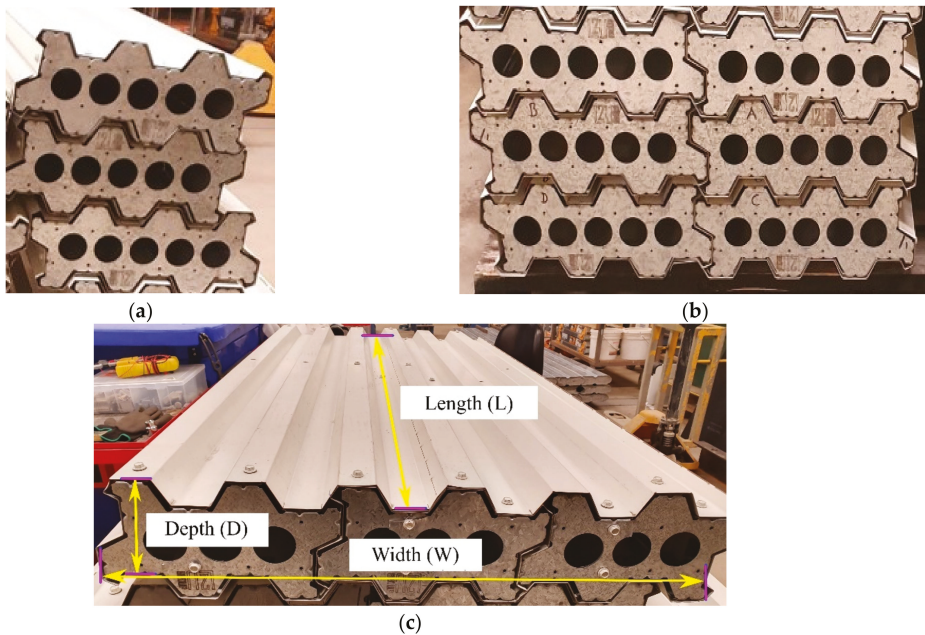
Figure 2. (a) Single-cell panels. (b) Double cell panels. (c) Triple Cell Panels with annotations of dimensions used.

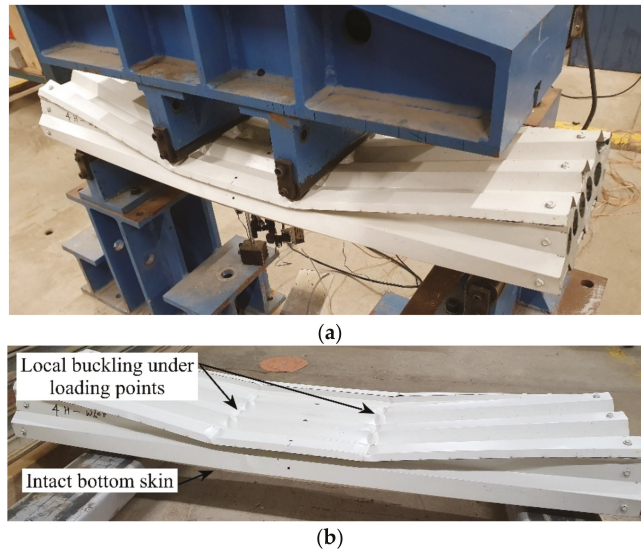
Figure 8. (a) Failure of SC panel. (b) Failed SC panel with the intact bottom skin.

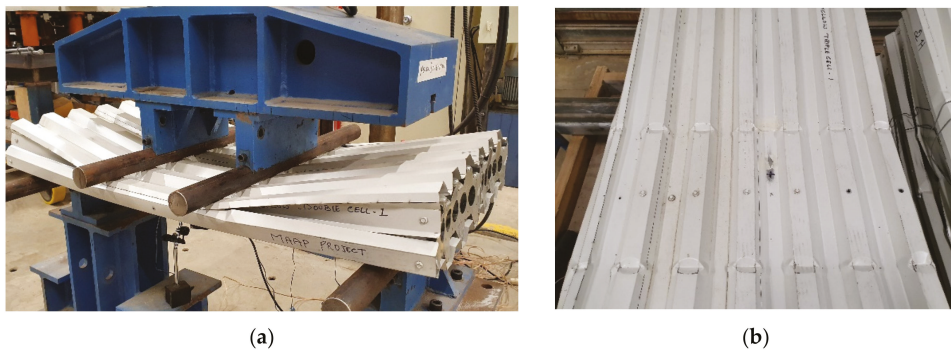
Figure 9. (a) Failed double cell panel. (b) Local buckling in triple cell panel. (c) Open triple cell sample with the intact bottom skin. (d) Flattening of bottom skin at slots. (e) Separation at the overlap of double cell-1.

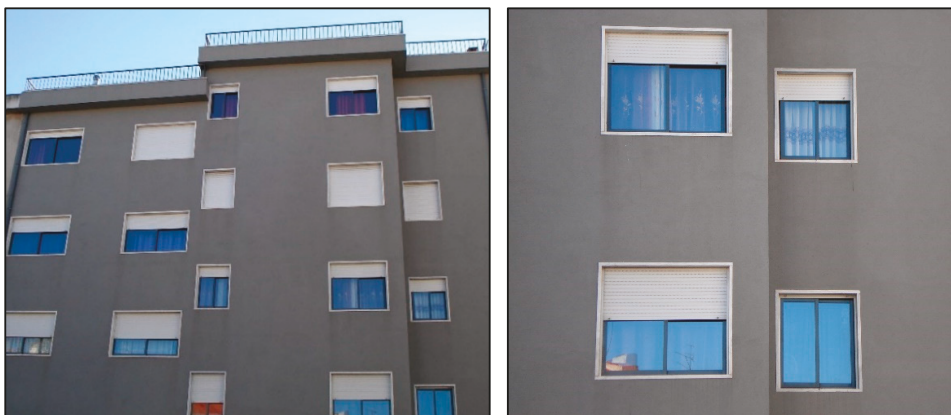
Figure 3. Case study of an ETICS inspected in 2016.

In order to illustrate the calculation of the insurance premium applied, an example building was used, as shown in Figure 3. The studied facade of the building has a cladded area corresponding to 77.35 m². The building was inspected for the first time in 2016, when it was in a good degradation condition ($S_w = 2\%$). The building construction date is 2011 and consists of ten housing units (i.e., condominium with ten owners).

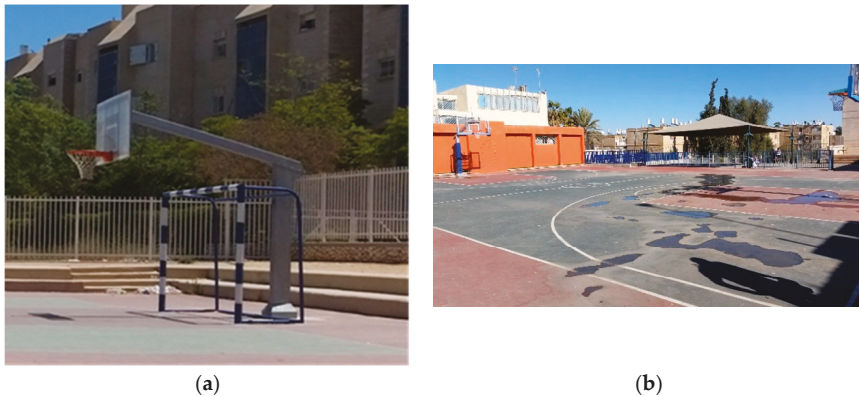
Figure 5. Sports—(a) unprotected basket column and (b) poorly maintained basketball surface.

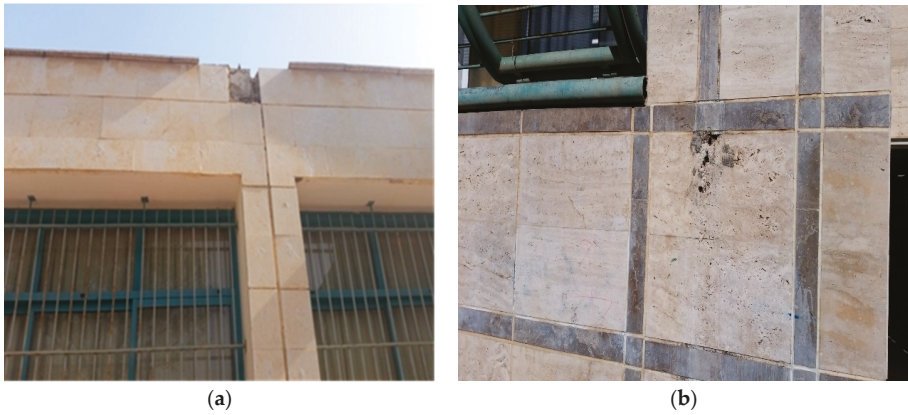
Figure 6. (a) Deteriorated exterior stone cladding. (b) Cracked stone claddings.

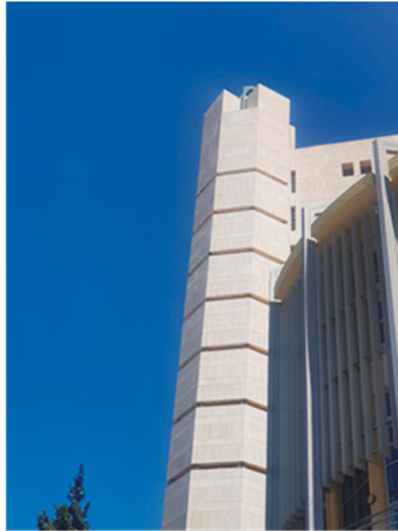
Figure 10. Exterior envelope (Maintenance Indicator = 2.5).

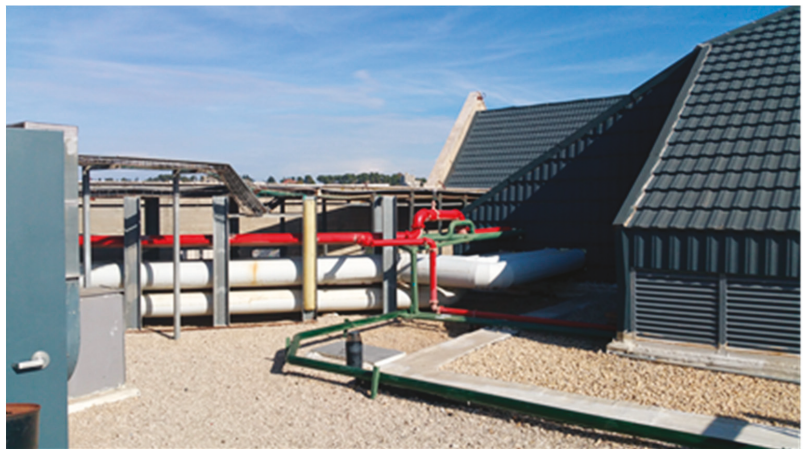
Figure 11. Roofing and installations (Maintenance Indicator = 2.5).

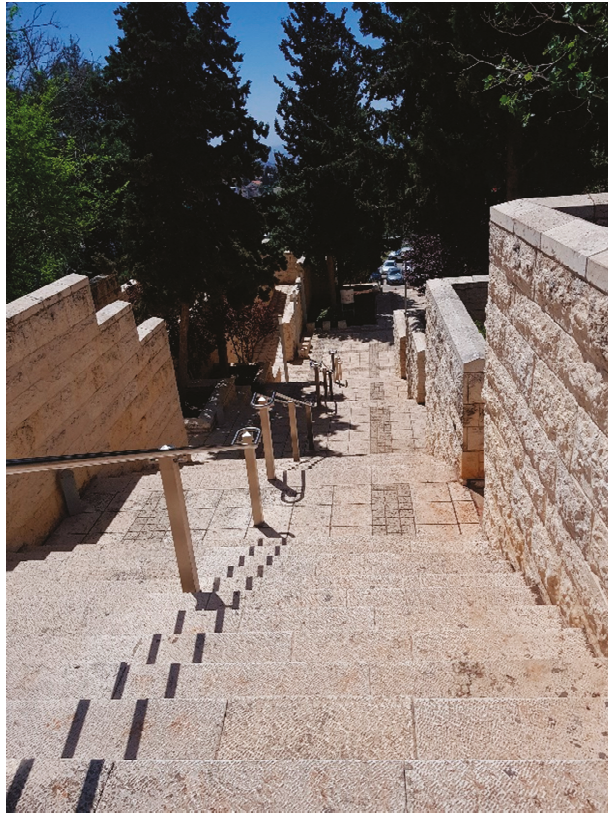
Figure 12. Stairs and drainage infrastructures around the building (Maintenance Indicator = 2.75).
