Special Issue Reprint

Results of the II National Research Project of AIAr

Archaeometric Study of the Frescoes
by Saturnino Gatti and Workshop at the Church
of San Panfilo in Tornimparte (AQ, Italy)

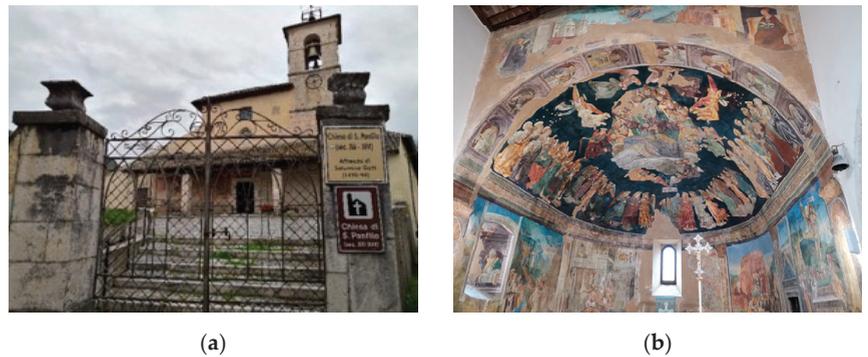
Figure 1. (a) Church of San Panfilo in Villagrande di Tornimparte in the province of L’Aquila. (b) Cycle of frescoes in the apse by Saturnino Gatti (1463–1518) object of study and research activities.

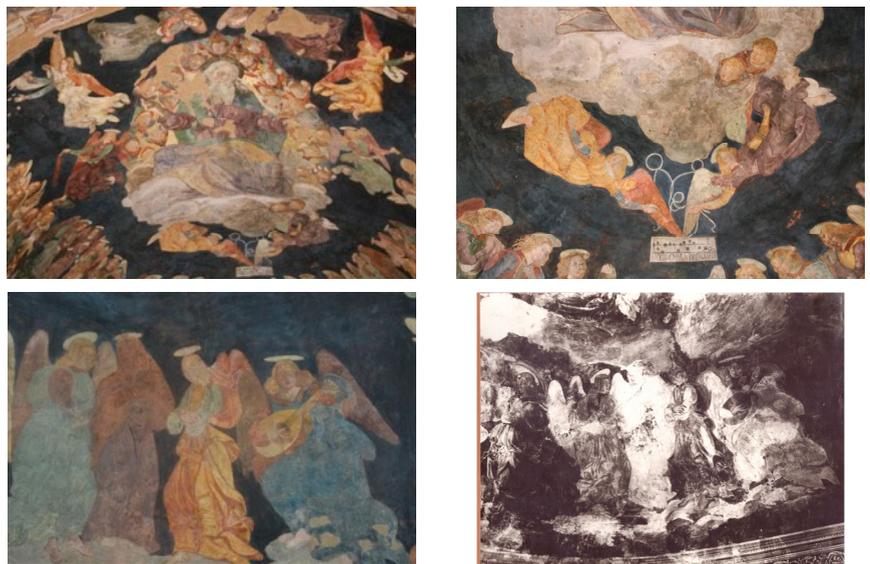
Figure 2. Details of the vault affected by a dark blue background and comparison between the current conditions and the ICR pre-intervention status in a historical image (**bottom right**), taken from Archivio storico e Archivio fotografico della Soprintendenza Archeologia Belle Arti e Paesaggio di L'Aquila e Teramo.

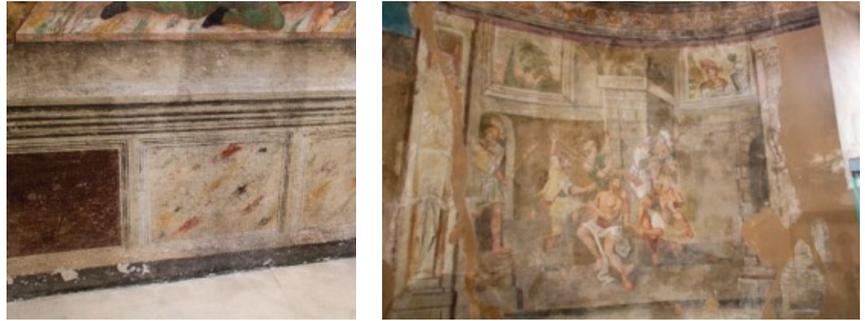
Figure 3. Examples of typical alterations found in the lower and upper portions of the apsidal basin.

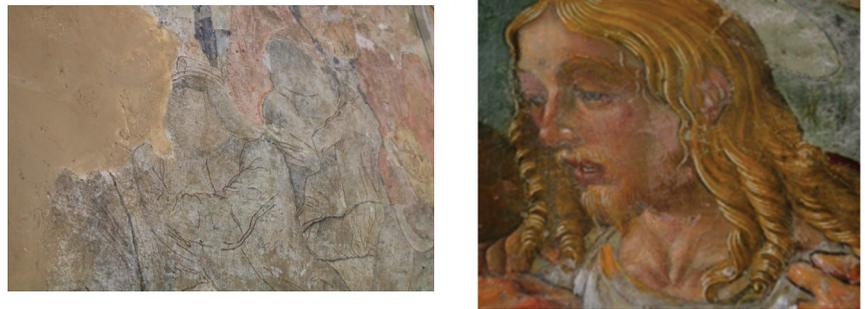
Figure 4. Examples of the several engravings visible both in the pictorial portions characterized by total collapse and in those with a good state of conservation.

This first evidence was deepened during the *in situ* photographic and multispectral investigation. This diagnostic approach based on multispectral imaging also allows for a better iconographic interpretation, highlighting the volumetric effects of the figures and the perspective relationships altered by degradation phenomena or repainting that has overlapped over time. Furthermore, in order to obtain a deeper identification of artist technique and understanding of the technical choices of the workshop, the study envisaged the characterization of the plasters (number of layers, type of aggregates, binders, presence of primers, etc.) through mineral–petrographic analyses.

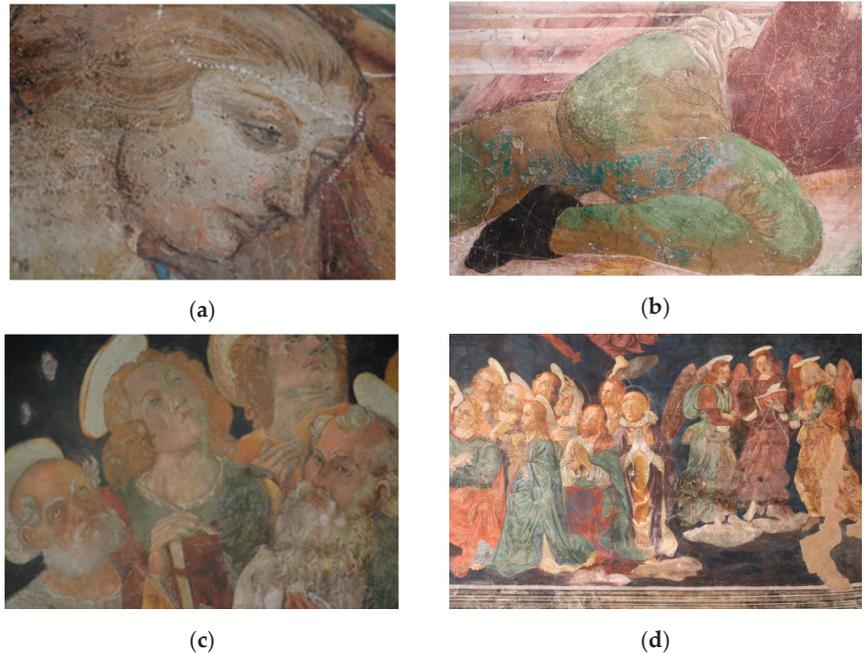
Figure 5. Details of the alterations observed at the different levels of the pictorial surfaces: (a,b) details of the pictorial surfaces altered along the apse; (c,d) details of the alterations affecting the pictorial surfaces of the vault.

they stand (Figure 5). This phase of the study returned a lot of fundamental information to document the different types of degradation, to guide the design choices and to guarantee the durability of the future restoration intervention. In fact, suitable analytical methodologies were used to locate the pictorial or wall areas affected by water infiltration from windows or roofing and capillary rising damp.

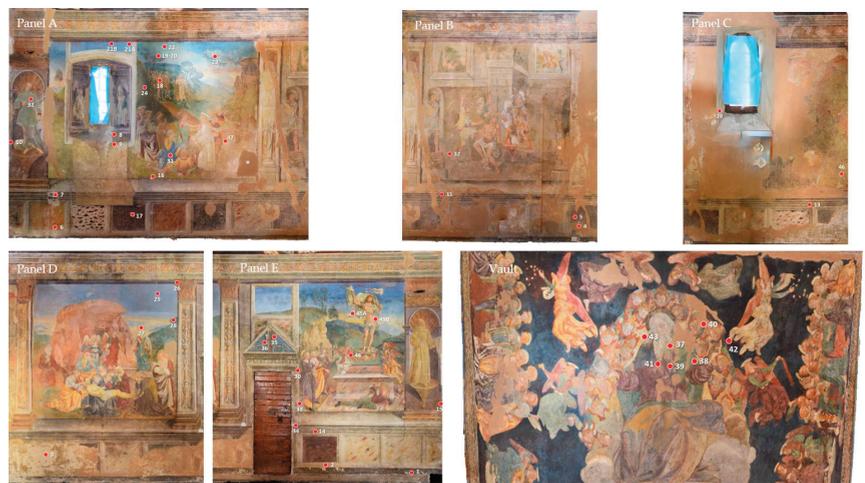
Figure 6. Panels (from left of the apse) (A–E) and (vault): Location and denomination of the areas where the 47 fragments of plaster and pictorial layers were taken. Each sampling areas have been selected on the basis of the first results of the in-situ investigations.

- Panel A—first painting from the left of the apse basin, depicting “Christ in the Garden of Gethsemane”;
- Panel B—depicting the “Coronation with Thorns”;
- Panel C—depicting the “Crucifixion” (no longer visible due to deterioration and previous interventions);
- Panel D—fourth panel from the left of the apsidal basin, depicting the “Lamentation over the Dead Christ”;
- Panel E—fifth panel from the left of the apse basin—Resurrection;
- Vault—central part depicting “God the Father Blessing”.

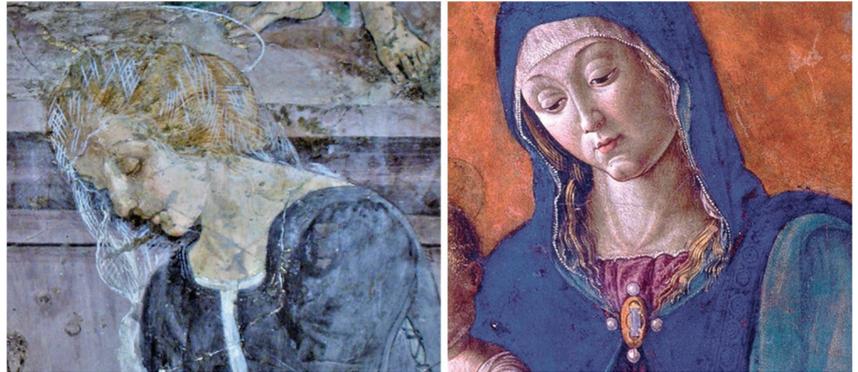
Figure 7. A comparison between Mary Magdalene in the Lamentation panel (left) and the detached fresco Madonna with standing Child (L'Aquila, church of Santa Margherita) (right) reveals identical executive technique in highlights made in "bianco di calce" (calcium white) for the finest details like the veils, and traces of gold leaf used for the gilding of halos and edges of robes.

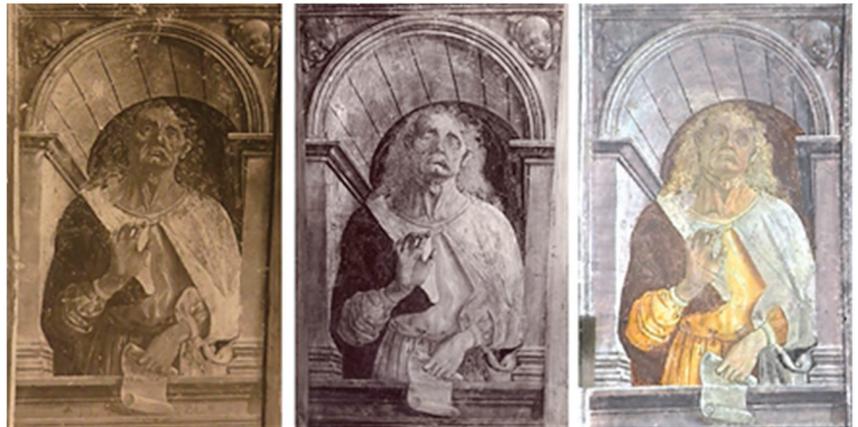
Figure 8. Prophet Daniel appearing in the sub-arch reveals, through the comparison of pictures dating back from 1920 to 2020 (from left), the almost total loss of the "a secco" finishes located in the incarnate, eyes, hair and in the scroll held in the left hand.

Other retouches almost certainly took place at the same time, for which zinc white was used and therefore cannot be dated before the mid-19th century [17]. Another interesting aspect that emerges from the surveys is the possibility of recognising and consequently preserving the finishing touches applied "a secco": the petrographic and chemical studies have demonstrated the tendency of Saturnino to apply colour corrections onto the dry plaster [18].

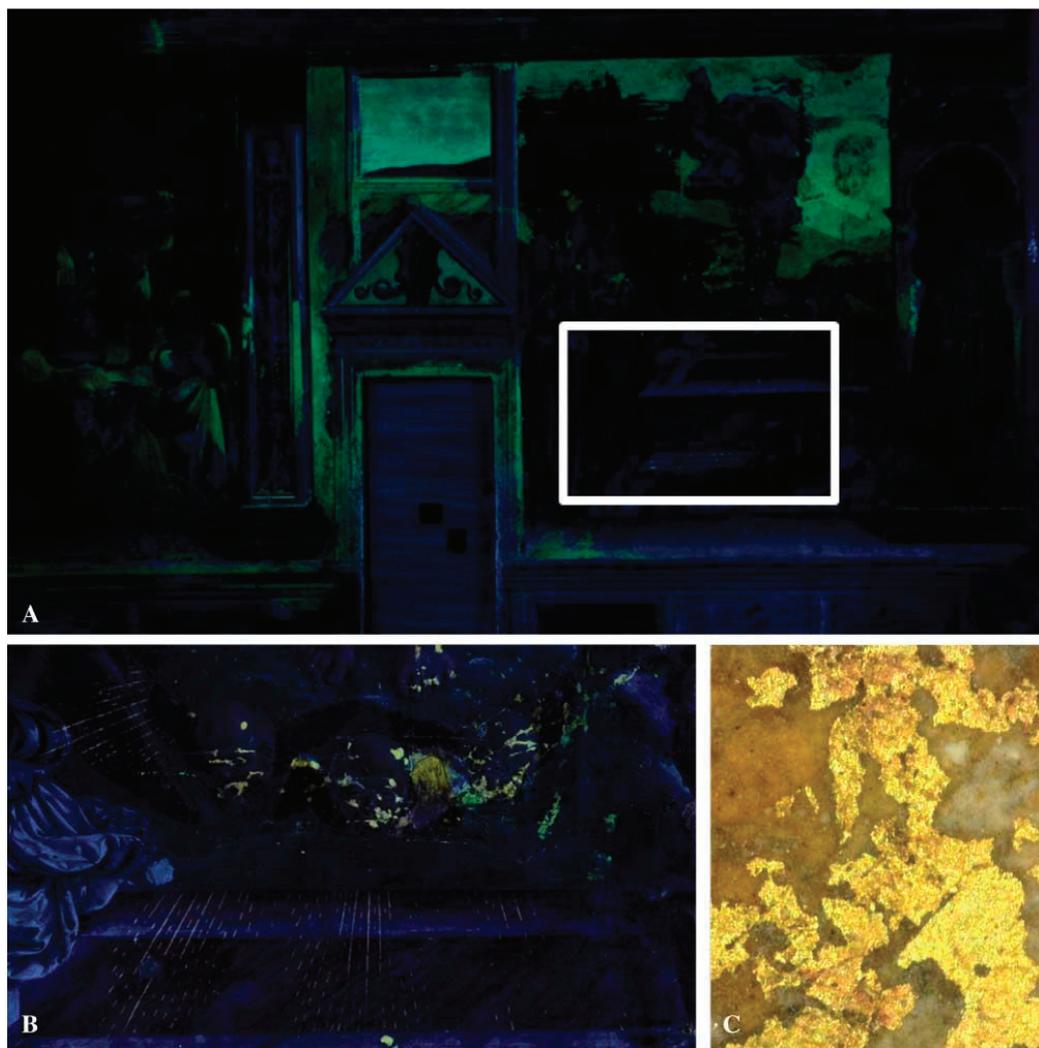
Figure 3. The UVF image of panel E, the Resurrection: (A) general view; the white rectangle indicates the detail shown in (B). (C) Detail of the golden traces found via OM in the rays.

A detail was acquired in panel 4 wherein some fluorescent lines were observed in the general view of the wall (Figure 3A). The image in Figure 3B shows how the rays that emanate from the angels are characterized by a yellow-orange fluorescence which could be due to the presence of organic material. In accordance with art historians, the presence of possible original gilding work was hypothesized, and therefore, the organic substance whose fluorescence is observed could be referred to as the so-called *missione*, which was used to make the adhesive for the gold. Optical microscopy revealed the presence of golden traces in the rays (Figure 3C); indeed, the X Ray Fluorescence analyses, performed after the first round of image analyses, confirmed the theory that gilding had taken place. In fact, XRF spectroscopy detected the presence of gold (Au) as a chemical element that characterized those same areas [2]. The glue used for gilding was generally made of siccative oil and terpene resin; therefore, the yellow fluorescence may be associated with the lipidic component of the *missione* [35–37].

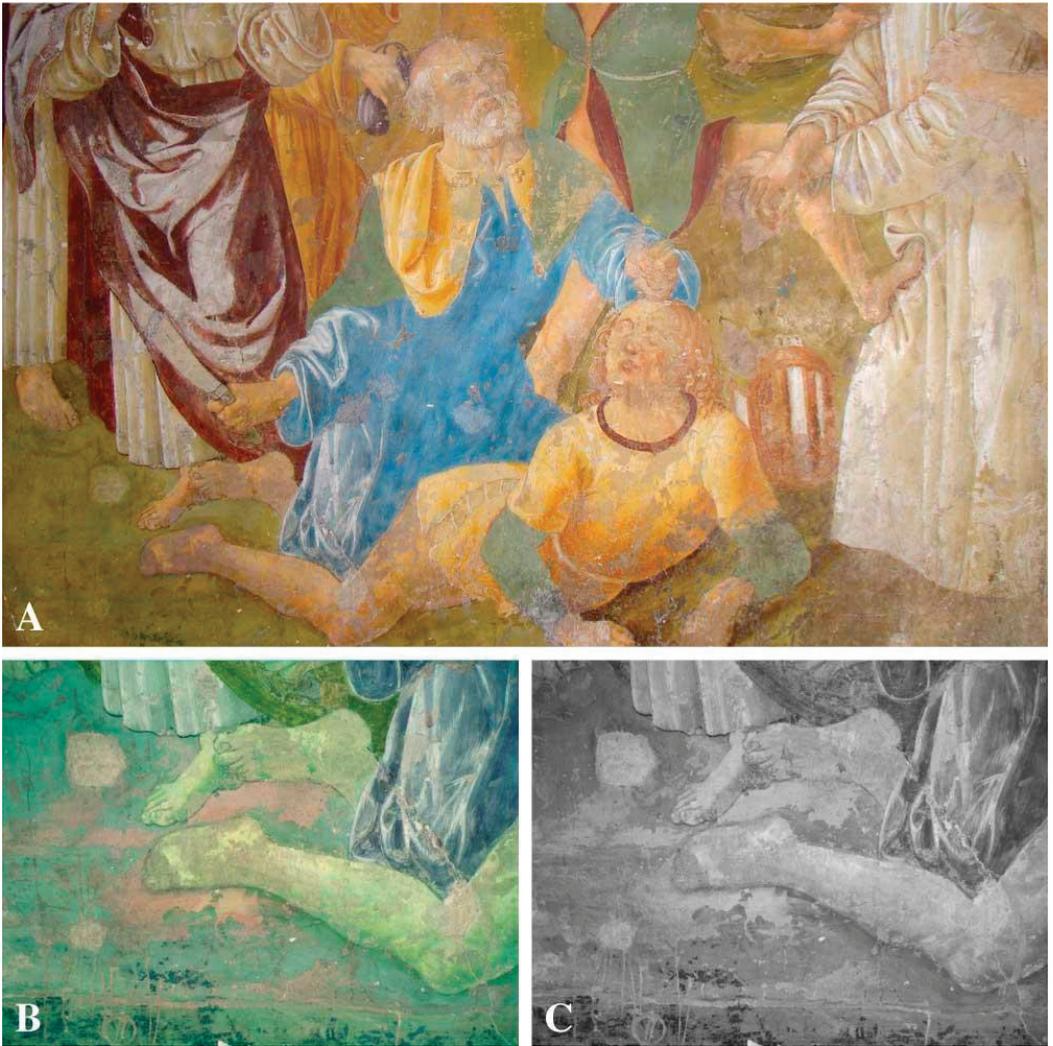
Figure 4. Detail of Panel A, Garden of Olives (A) in visible light, (B) IRR, and (C) IRFC.

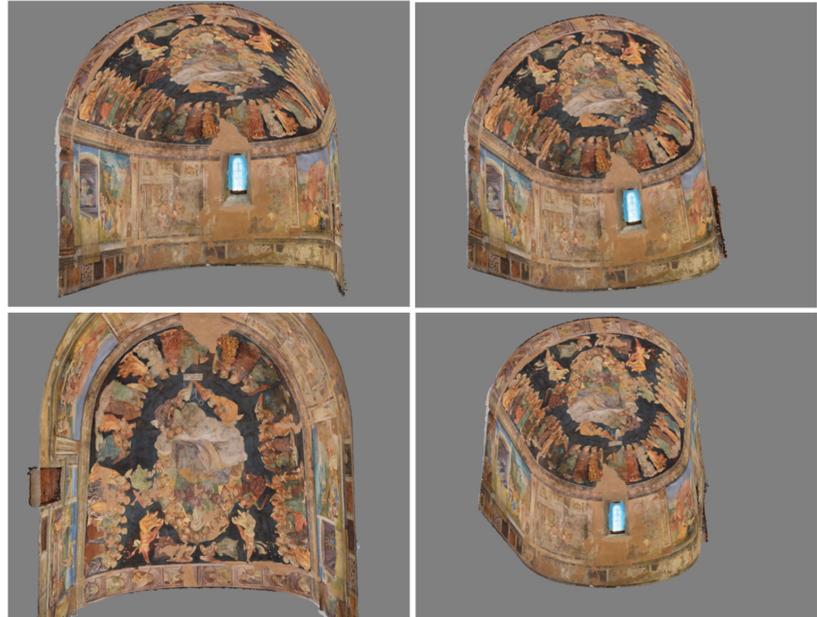
Figure 1. Four views of the apsidal conch from the 3D rendering model.

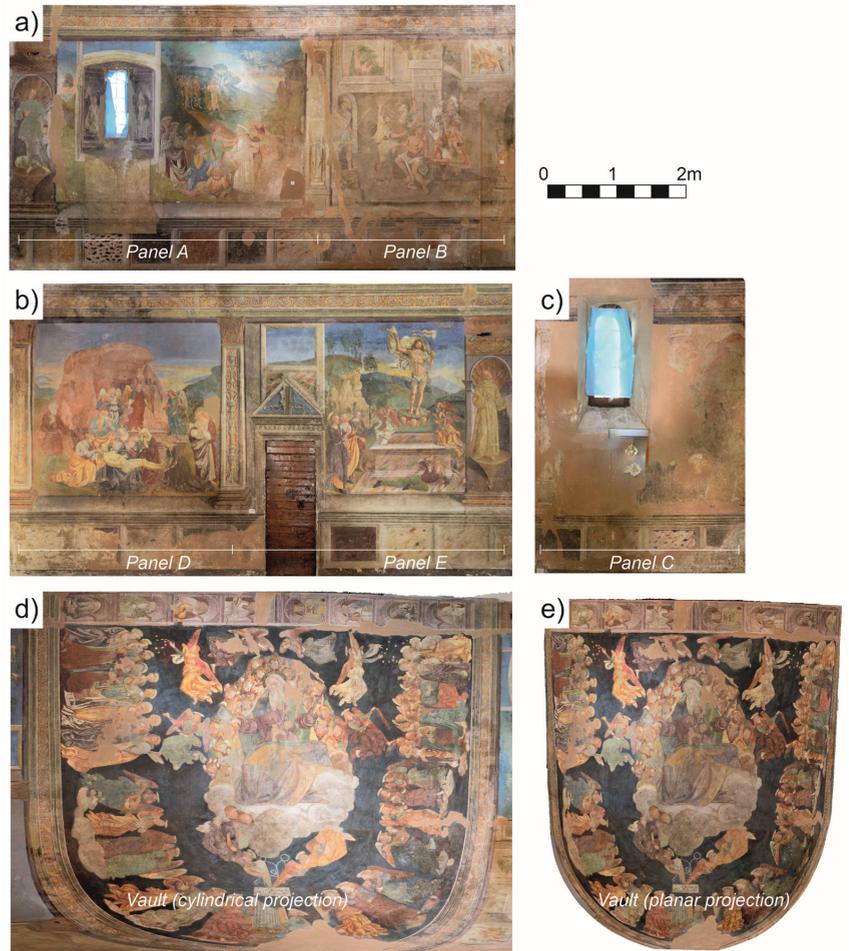
Figure 2. Orthomosaics of the apsidal conch: (a) panels A and B depicting the Taking and the Flagellation of Christ, respectively; (b) panels D and E depicting the Deposition and the Resurrection of Christ, respectively; (c) panel C originally depicting the Crucifixion; (d,e) cylindrical and planar projections of the vault (not to scale) depicting God the Father along with the Angels and Blessed in Paradise.

The wall paintings, the objects of this study, were produced by Saturnino Gatti and his workshop in a period between 1491 and 1494 [1,2] in the apsidal conch of St. Panfilo Church. The wall paintings in the lower part consist of five panels (labeled from A to E) displaying some moments of the Passion of Jesus, whereas on the vault are depicted God the Father along with the Angels and Blessed in Paradise (Figures 1 and 2).

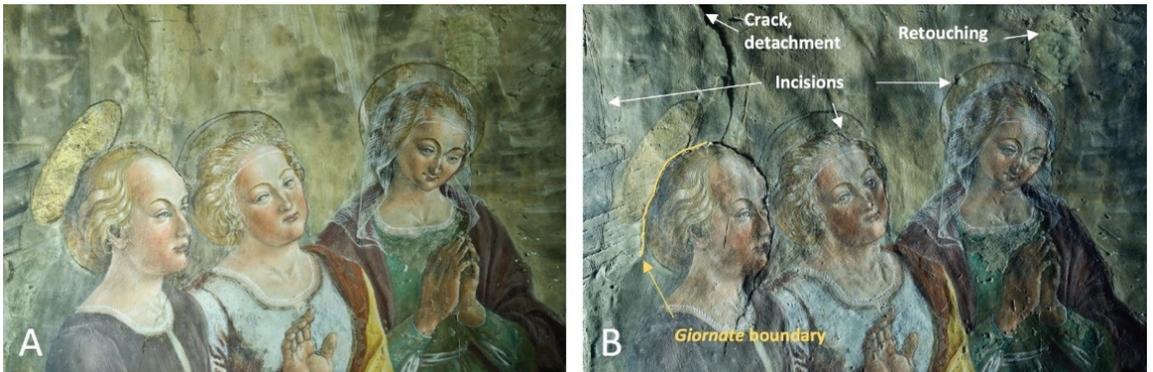
Figure 3. Detail of panel E. (A) image obtained in straight light; (B) image obtained in raking light. All the details of the picture are emphasized in (B) where it is possible to observe the *giornata* boundary, incisions, detachment, retouching and crack.

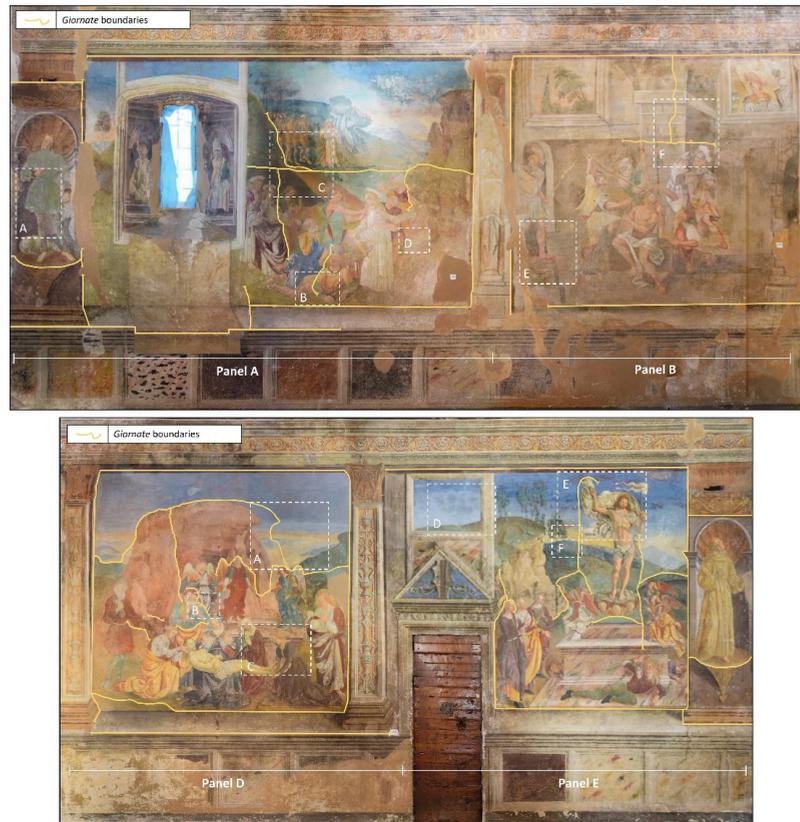
Figure 4. Orthomosaics of panels A,B (up) and panels D,E (down) report the boundaries of *giornate* and *pontate*; the details of the squared areas are shown in Figures 5 and 7, respectively.

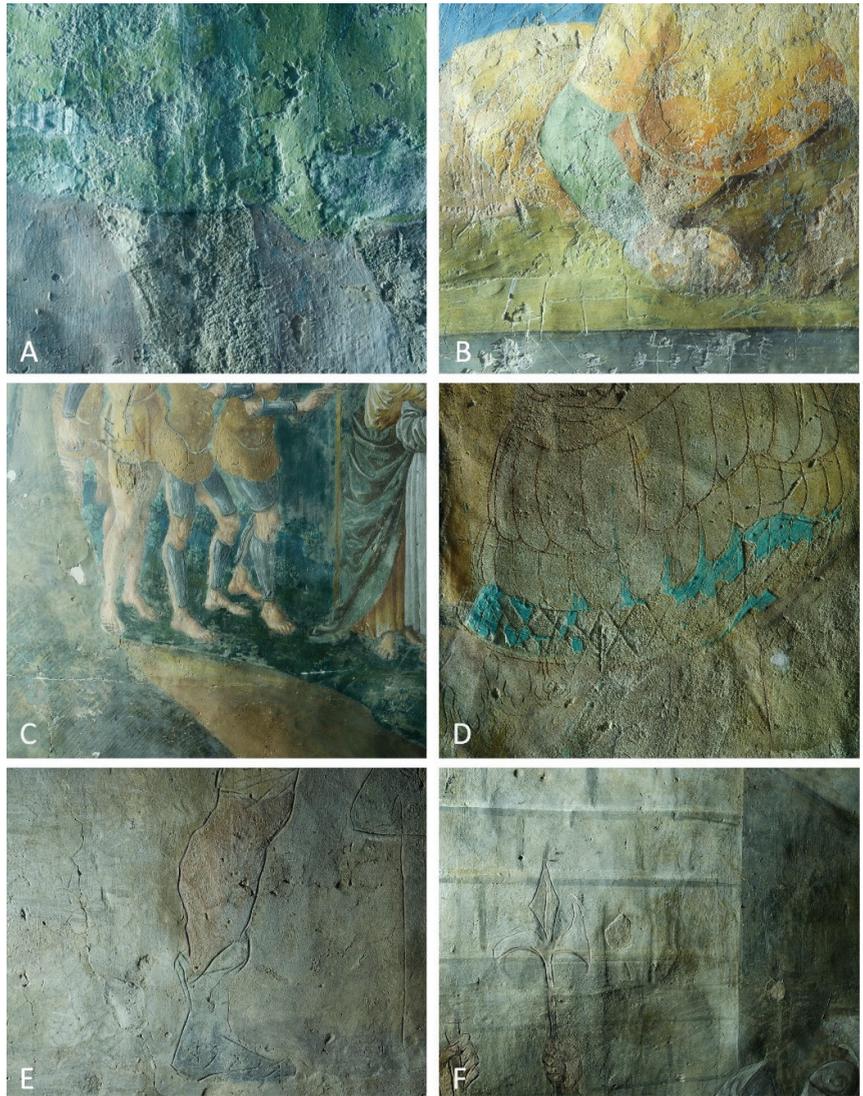
Figure 5. Raking light photos obtained on the niche (left of panel A) and panels A and B showing retouchment (A), incisions (A,D–F), loss of colours (A–D), graffiti (B), thick brushstrokes of paint and a network of small cracks (E).

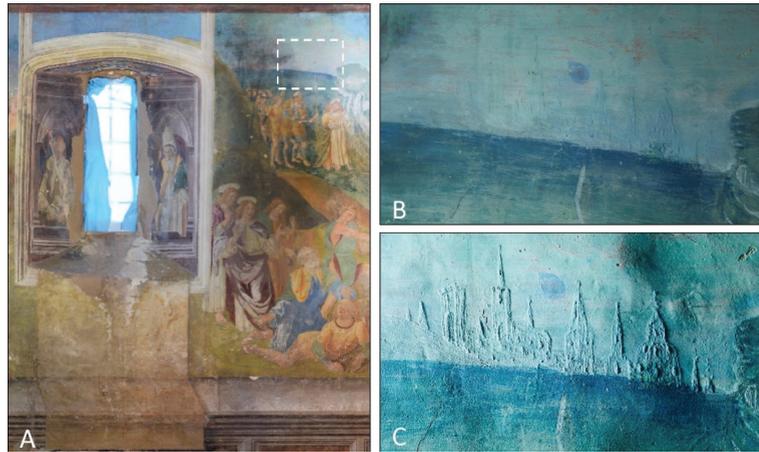
Figure 6. (A) Image of panel A; (B) Enlarged image of the squared area reported in A; (C) Raking light photo of the B area.

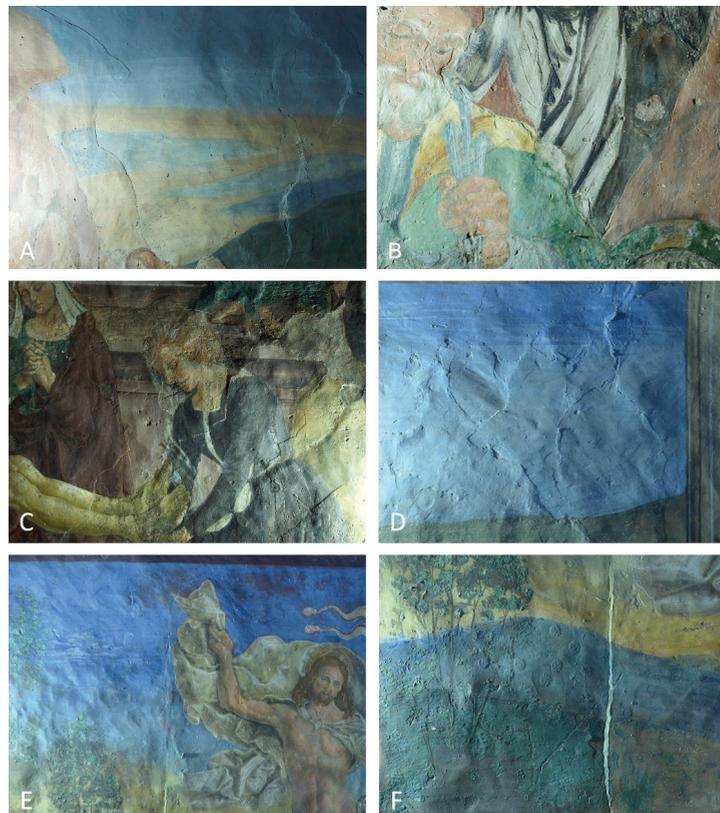
Figure 7. Raking light photos obtained on the panels D and E showing *giornate* and *pontate* boundaries (A,B,E,F), rethinking (A,F), network of small cracks (C), spatula signs (D), colour loss (F). In (E) is also visible a layer of *morellone* under the blue sky.

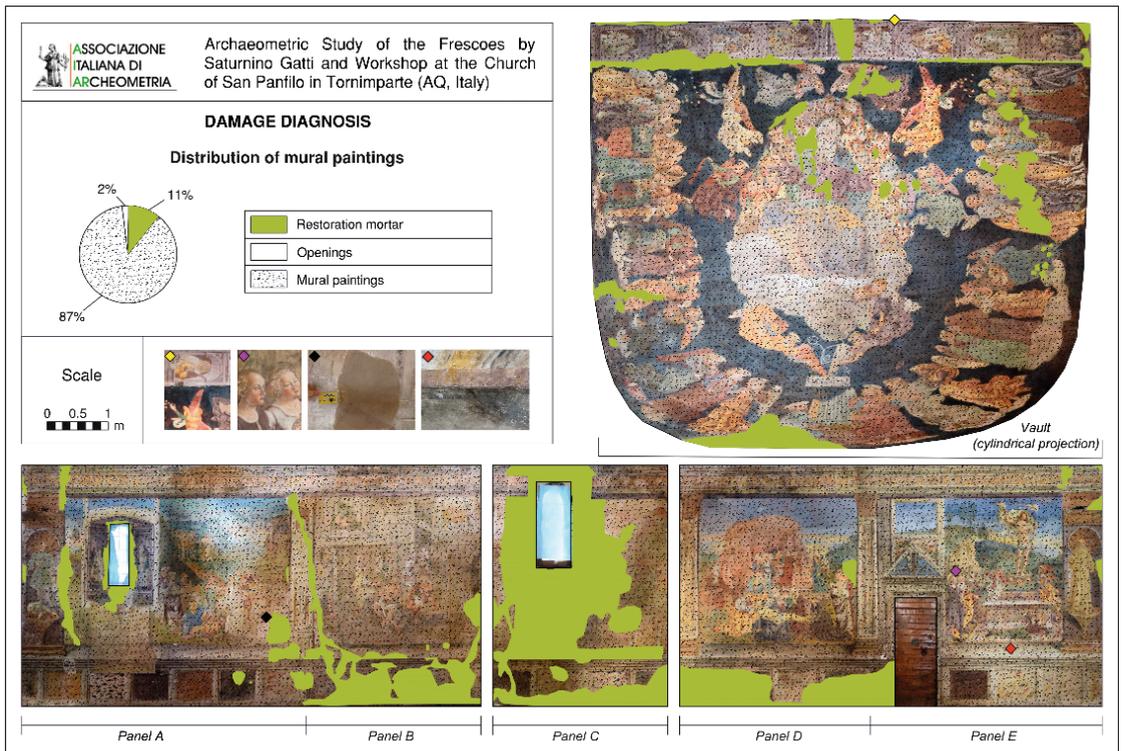
Figure 8. Distribution of geomaterials for the five panels and the vault of the apsidal conch of St. Panfilo Church in Tornimparte (AQ, Italy). Coloured dots indicate the position of the acquired pictures in the wall paintings.

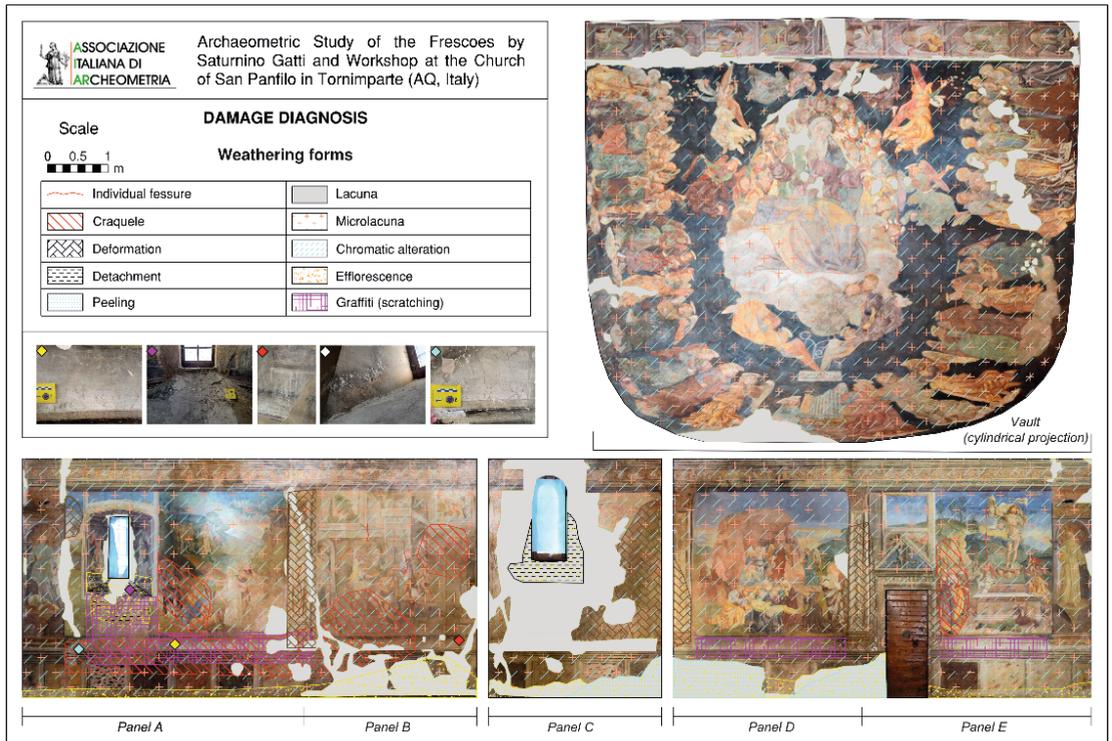
Figure 9. Distribution of the weathering forms affecting the five panels and the vault of the apsidal conch of St. Panfilo Church in Tornimparte (AQ, Italy). Coloured dots indicate the position of the acquired pictures in the wall paintings.

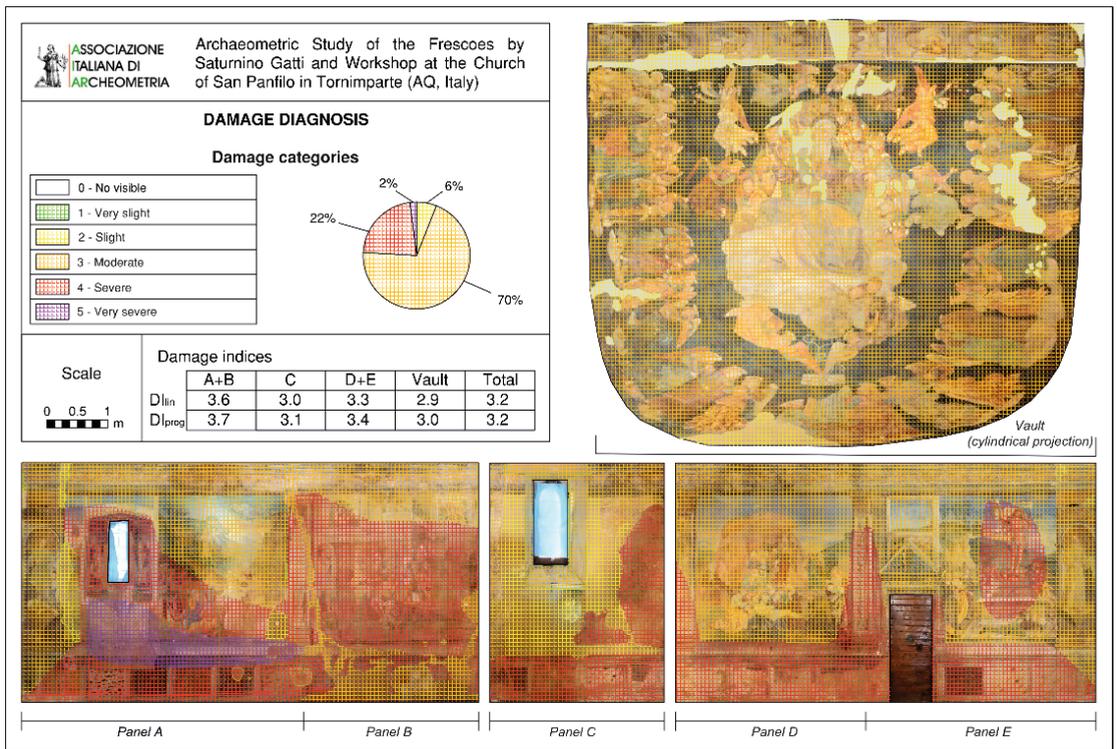
Figure 10. Distribution of the damage categories for the five panels and the vault of the apsidal conch of St. Panfilo Church at Tornimparte (AQ, Italy).

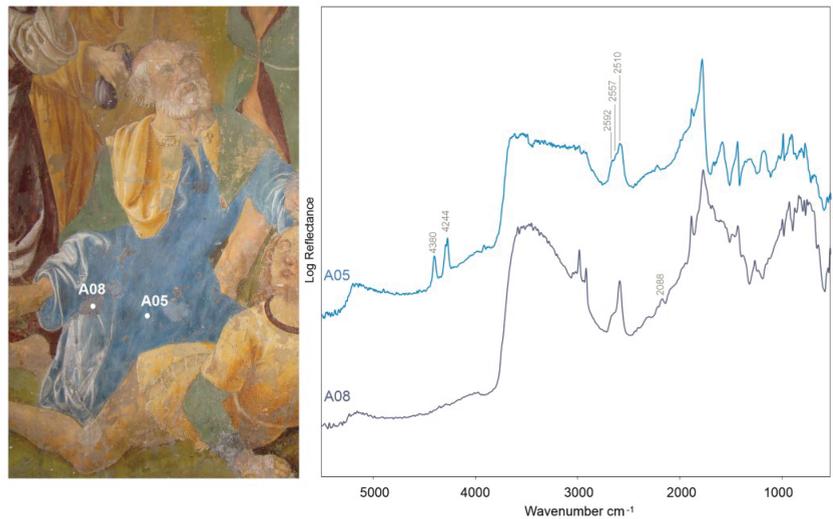
Figure 4. ER-FTIR spectra, acquired on a figure with the blue clothing on panel A, reveal the spectral evidence of azurite in the original area (A05) and Prussian blue in the restored part (A08).

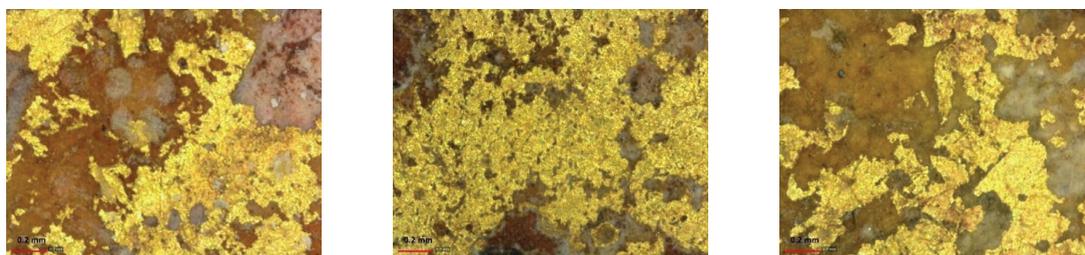
Figure 5. Digital optical microscope images for residual gildings: from the left, panel A, panel D, and panel E. Red scale bars correspond to 0.2 mm.

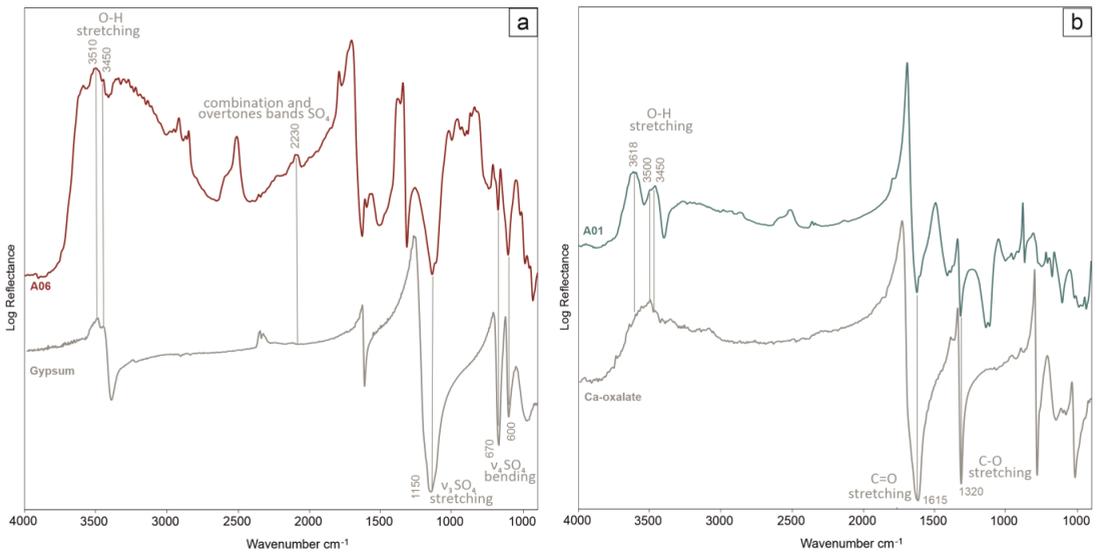
Figure 7. ER-FTIR spectra acquired on panel A show the spectral evidence of Ca-sulfates (a) and Ca-oxalates (b). Reference spectra [22] were also reported for comparison.

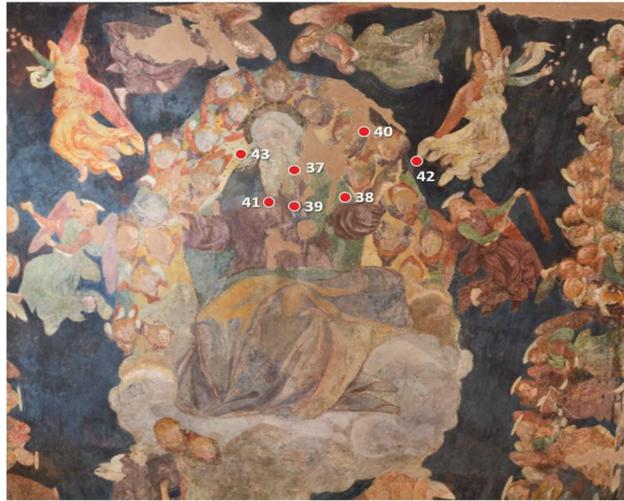
Figure 1. Area of the vault where the microsamples have been collected. The number corresponds to the ID microsamples.

The six microsamples were selected on the basis of the results given by the multispectral investigation, reported in [4–6]. All microsamples were collected in the upper part of the vault, as reported in Figure 1.

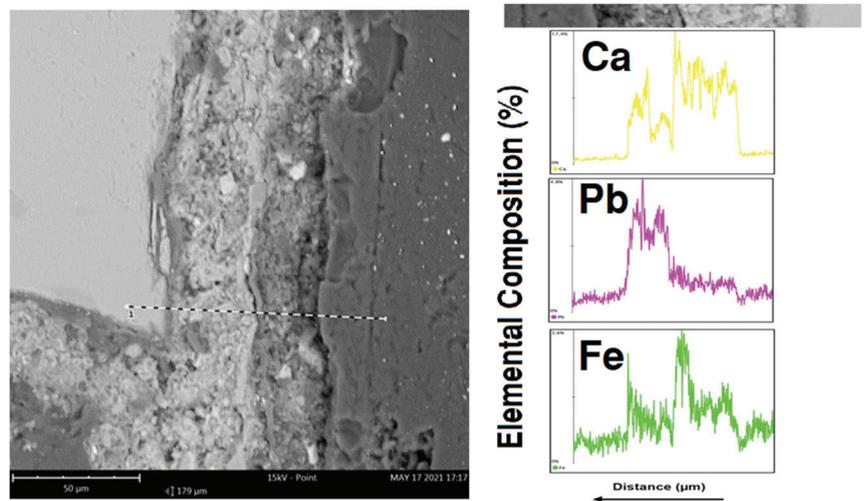
Figure 4. (left) SEM micrograph and (right) the corresponding EDS profile of SG_39A cross-section. The EDS investigation was performed along the dashed line to evaluate the distribution of Ca, Pb, and Fe from the back to front of the sample.

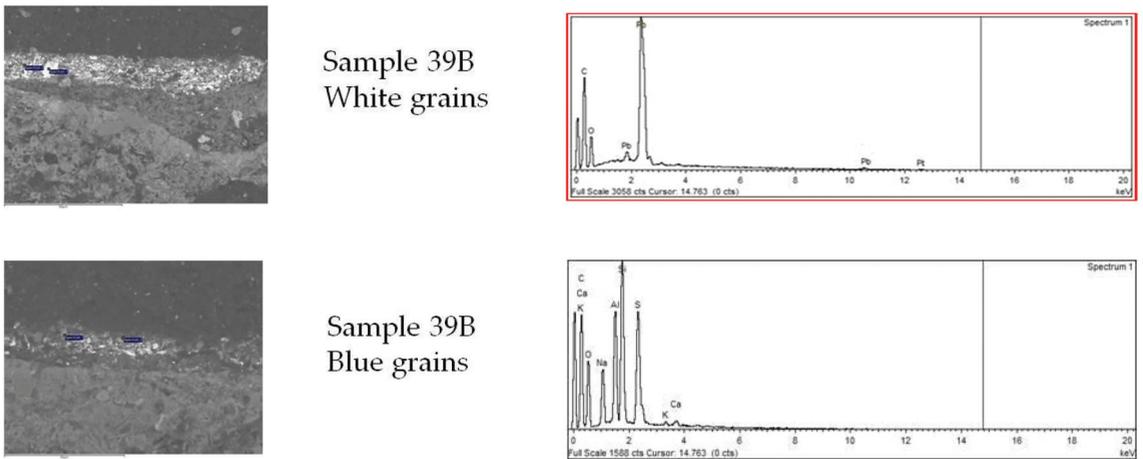
Figure 6. (left) SEM micrographs and (right) the corresponding EDS spectra of the SG_39B microsample cross-section.

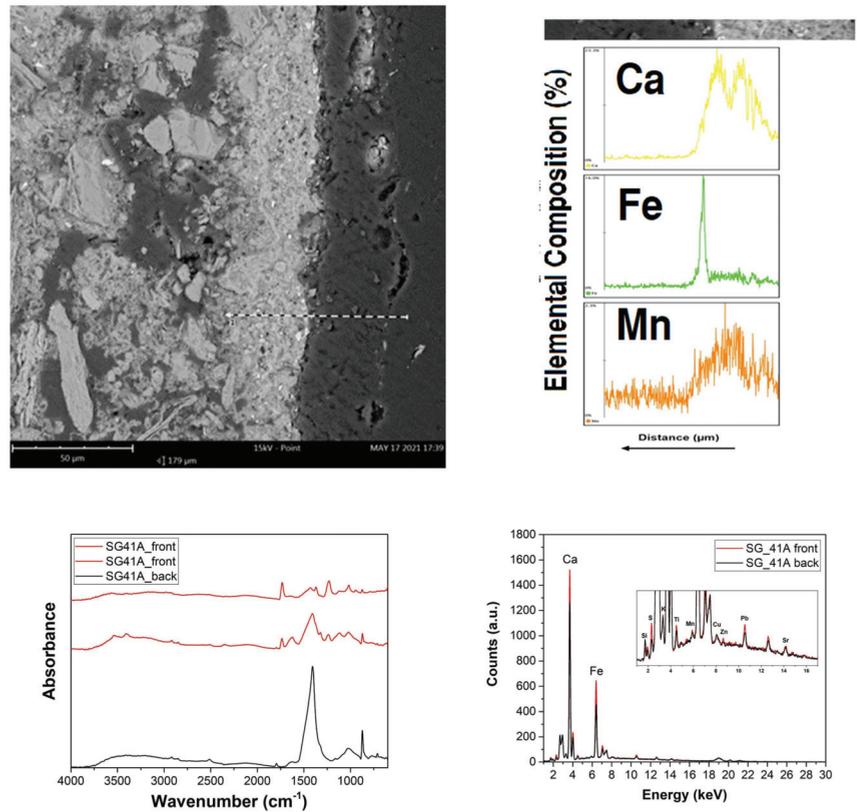
Figure 7. (top left,right) SEM micrograph and the corresponding EDS profile of the SG_41 microsample cross-section. The EDS investigation was carried out on the dashed line to evaluate the distribution of Ca, Fe, and Mn from back to front of the sample. (bottom left) FT-IR and (bottom right) XRF acquired on the front and back of the SG_41 microsample before preparation of the cross-section.

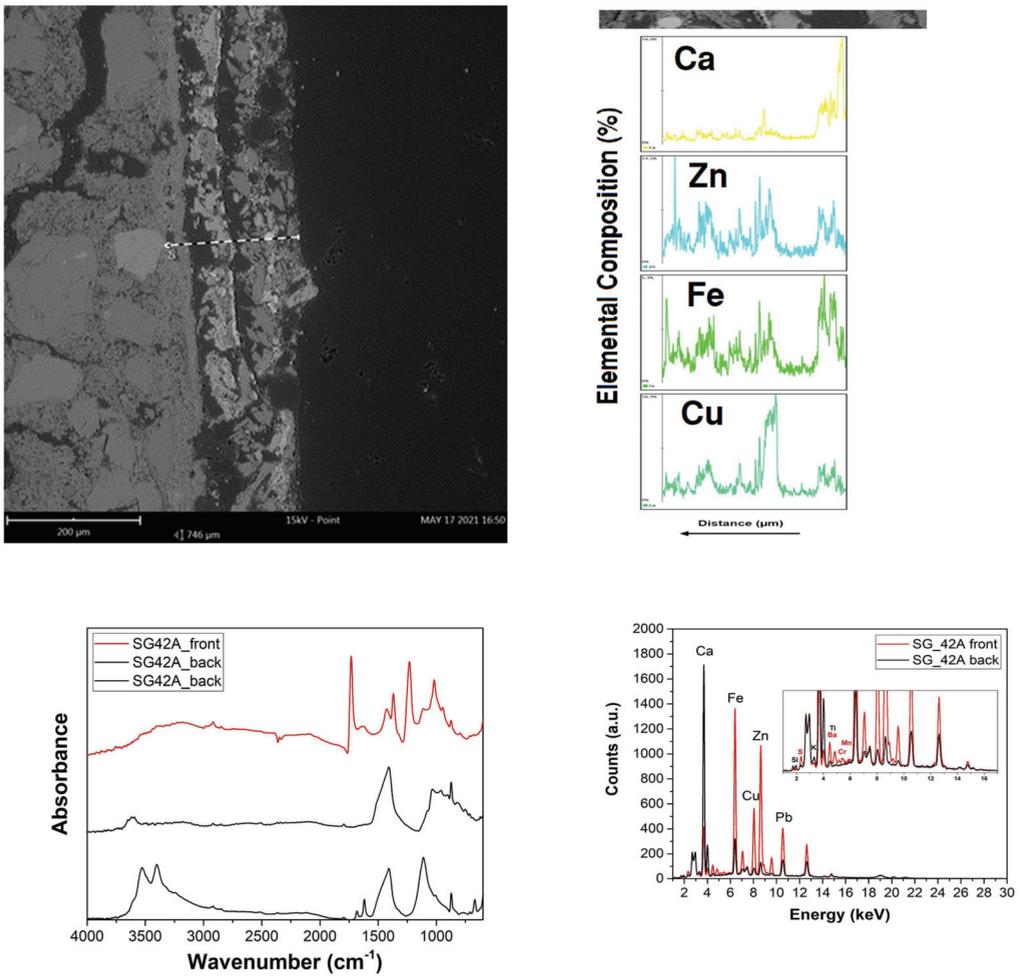
Figure 8. (top left,right) SEM micrograph and the corresponding EDS profile of the SG_42 microsample cross-section. The EDS investigation was performed on the dashed line. (bottom left) FT-IR and (bottom right) XRF spectra acquired on the front and back of the SG_42 microsample before preparation of the cross-section.

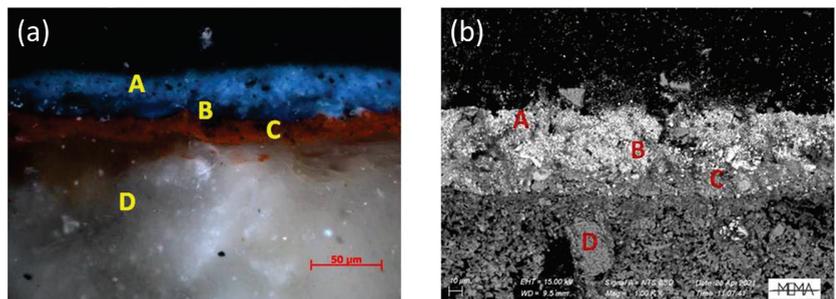
Figure 5. (a) Micrographs of SG_21A cross section obtained using OM, showing the four-layer stratigraphy; (b) SEM-EDS back-scattering electron image showing the four layers.

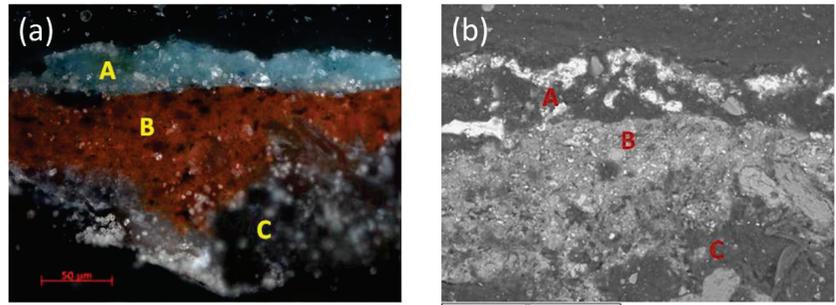
Figure 6. (a) Micrographs of SG_22 cross section obtained using OM, showing the three-layer stratigraphy; (b) SEM-EDS back-scattering electron image of the three layers.

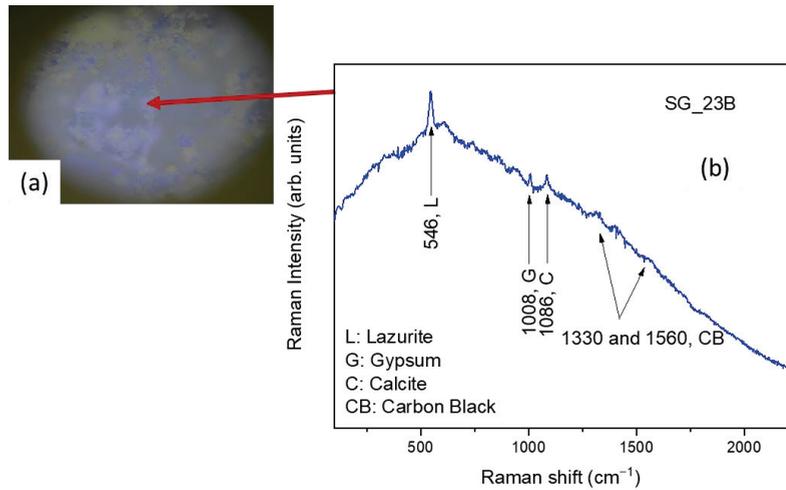
Figure 7. (a) Micro-photo of the analyzed blue area, (b) μ -Raman spectrum collected on the blue area of SG_23B sample.

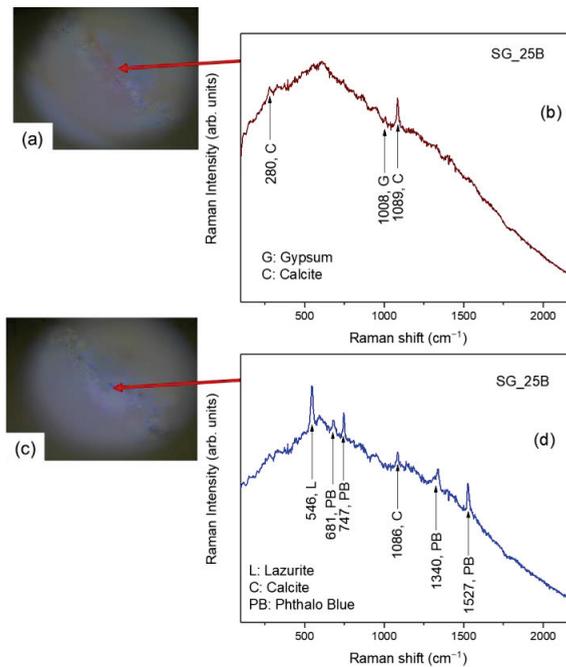
Figure 11. (a) Micro-photo of the analyzed red area, (b) μ -Raman spectrum collected on the red area of SG_25B sample, (c) micro-photo of the analyzed blue area, (d) μ -Raman spectrum collected on the blue area of SG_25B sample.

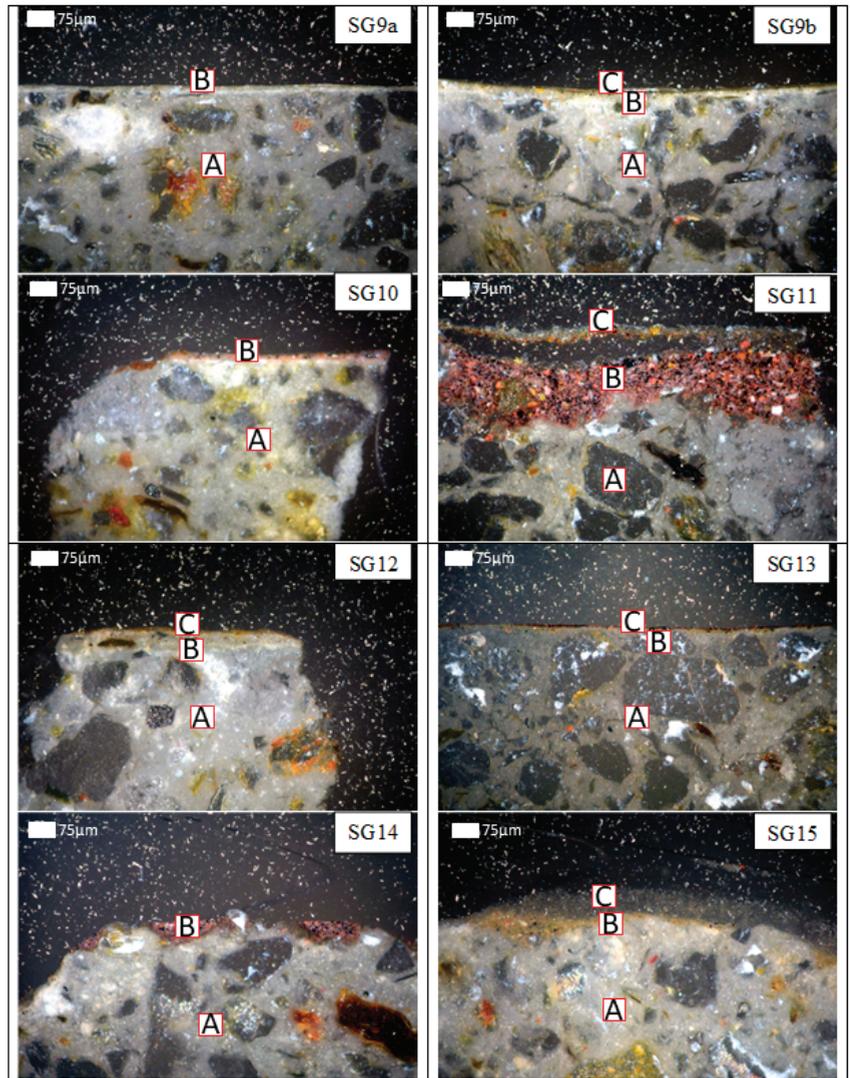
Figure 2. Microphotographs of thin sections of the samples SG9a, SG9b, SG10, SG11, SG12, SG13, SG14, and SG15. The capital letters “A”, “B”, and “C” indicate the different layers visible in cross-section, with “A” being the innermost (the plaster) and the others (mostly pigmented) ordered by decreasing depth.

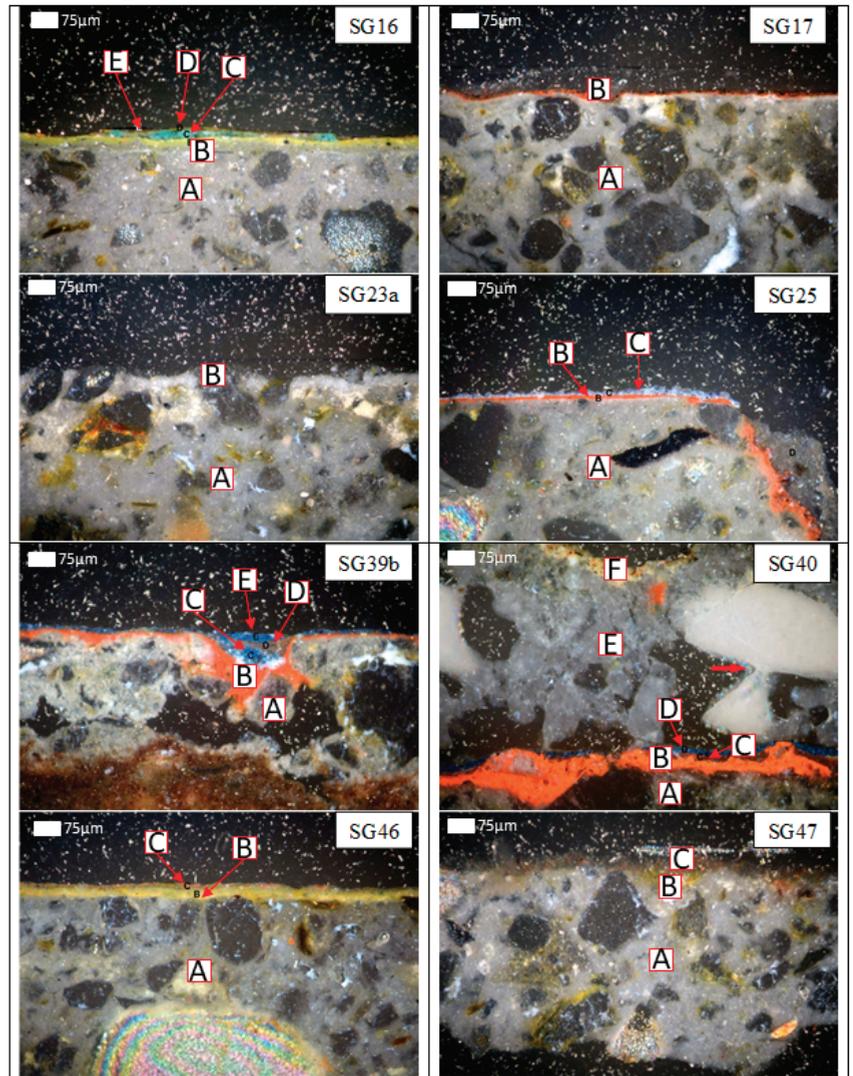
Figure 3. Microphotographs of thin sections of the samples SG16, SG17, SG23a, SG25, SG39b, SG40, SG46, and SG47. The capital letters “A”, “B”, “C”, “D”, “E”, and “F” indicate the different layers visible in cross-section, with “A” being the innermost (the plaster) and the others (mostly pigmented) ordered by decreasing depth. Sample SG40 shows a break between the layers consisting of highly purified plaster (E) in which remnants of a blue pigment can be seen (indicated by the red arrow), probably due to the use of a dirty brush or the mixing of pigments from the underlying layer (D).
