Special Issue Reprint

Results of the II National Research Project of AIAr

Archaeometric Study of the Frescoes
by Saturnino Gatti and Workshop at the Church
of San Panfilo in Tornimparte (AQ, Italy)

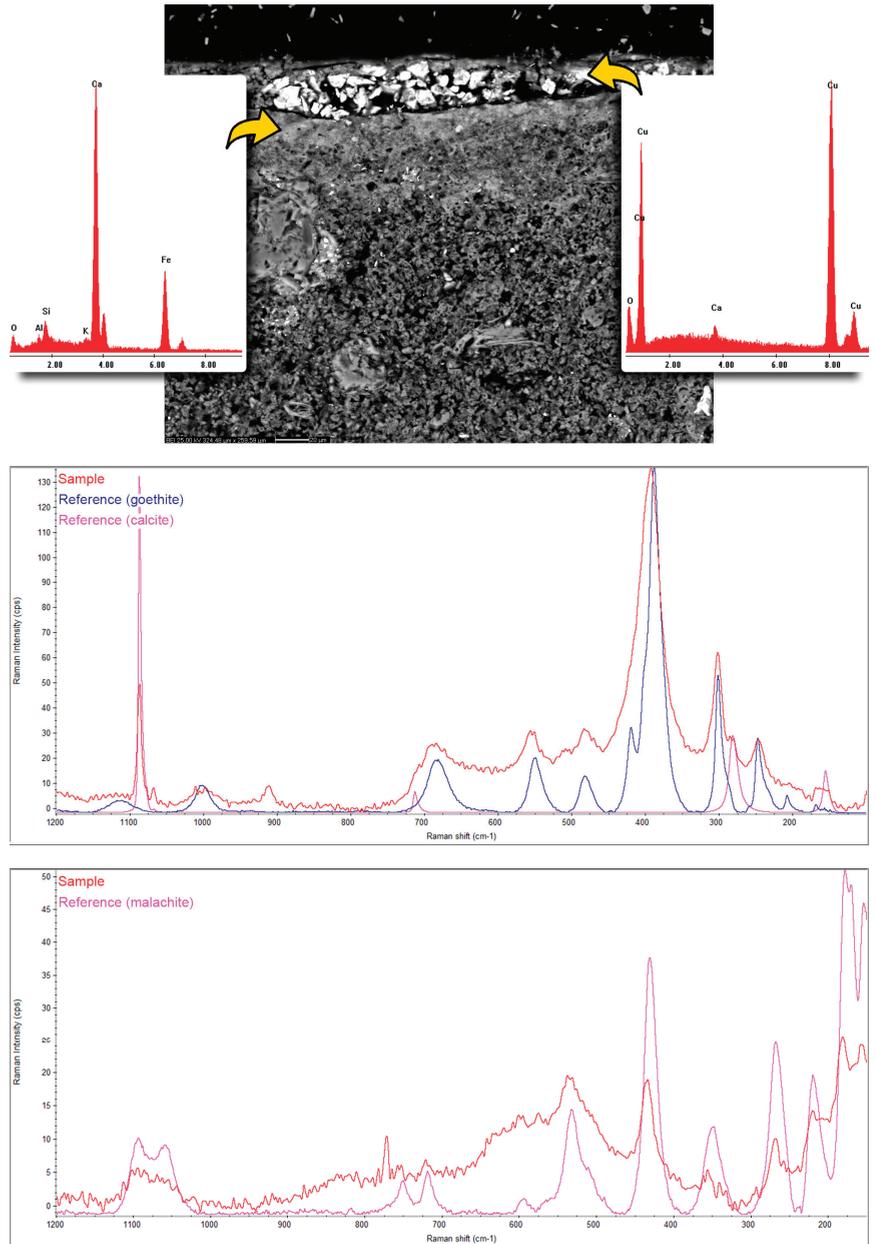
Figure 4. Sample SG16: SEM-BSE image with associated SEM-EDS spectra from the spots indicated, and μ -Raman spectra calculated on two different paint layers (actual analyses in red, reference spectra from mineral databases in blue and pink).

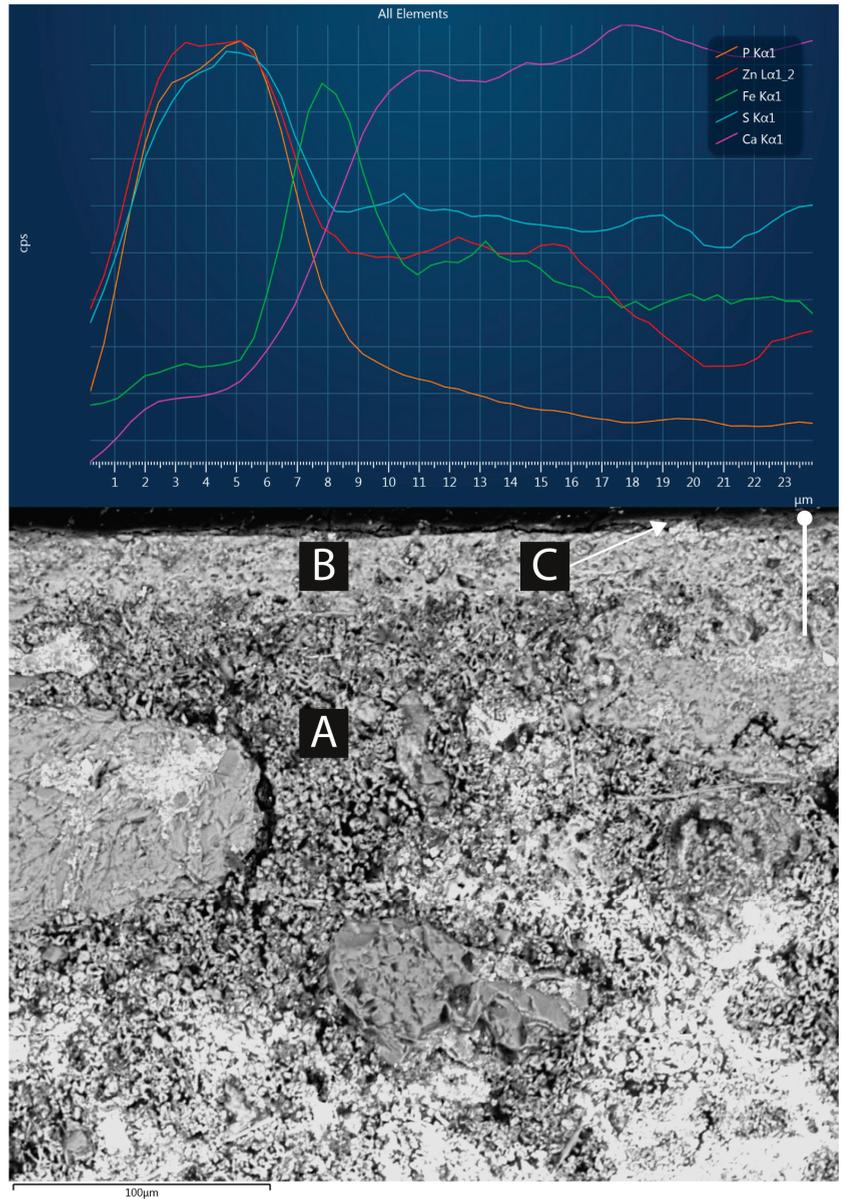
Figure 5. SG9A, SEM-BSE image (**bottom**) of the outer portion of the sample (plaster layer “A” and paint layers “B” and “C”) and the EDS traverse across the identified layers (**top**). The intensities of the K and L lines of the elements in the legend are normalized to better detect lateral variation in the painted layers.

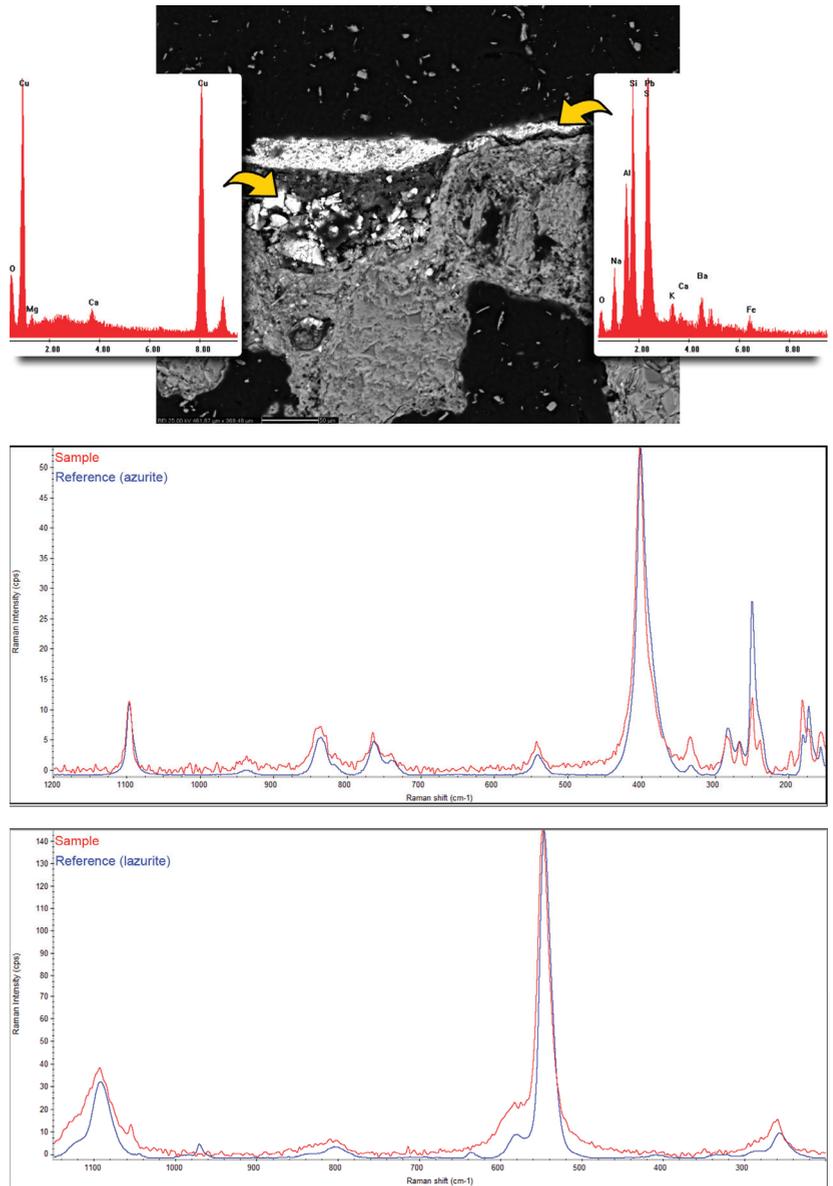
Figure 8. Sample SG39B: SEM-BSE image with associated SEM-EDS spectra from the spots indicated, and μ -Raman spectra calculated on two different paint layers (actual analyses in red, reference spectra from mineral databases in blue).

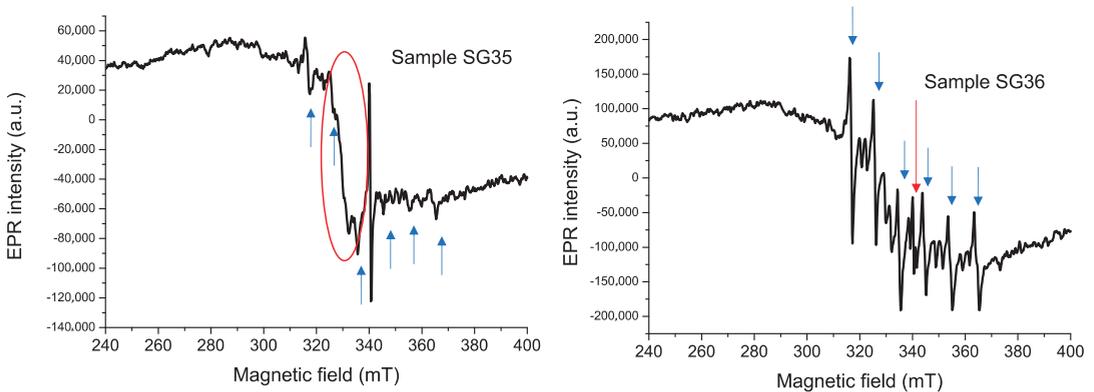
Figure 10. Left: EPR of SG35. Red asterisk marks the sharp signal of a C radical; blue arrows mark the sextet of Mn^{2+} ; the red circle highlights the signal of Cu^{2+} . Right: EPR of SG36. Red arrow marks a C radical; blue arrows mark the sextet of Mn^{2+} .

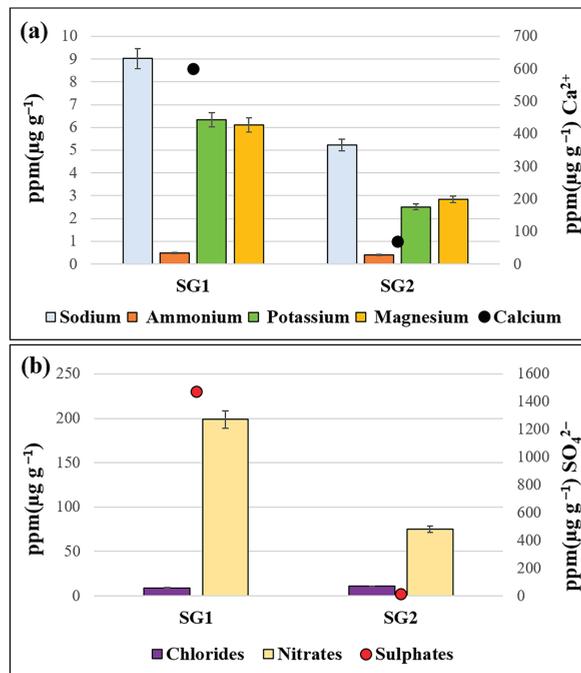
Figure 2. Ion concentration of samples SG_1 and SG_2 taken from Panel E. (a) Ppm (µg g⁻¹) concentrations of sodium, ammonium, potassium, magnesium and calcium cations; (b) ppm concentrations (µg g⁻¹) of chloride, nitrate and sulphate ions.

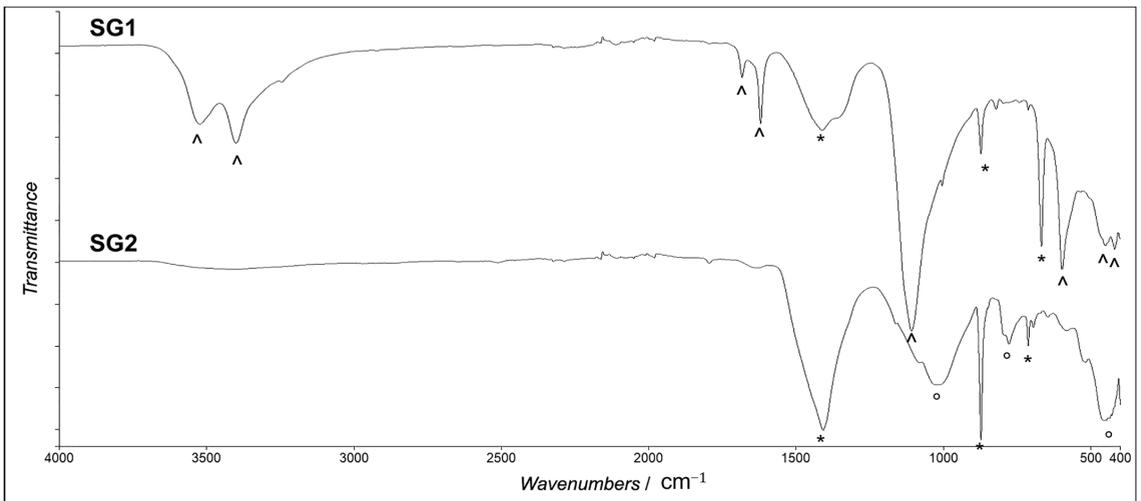
Figure 3. ATR-FTIR spectra of samples SG_1 and SG_2 taken from Panel E. Marker bands of carbonates (*), silicates (°) and sulphates (△) are highlighted.

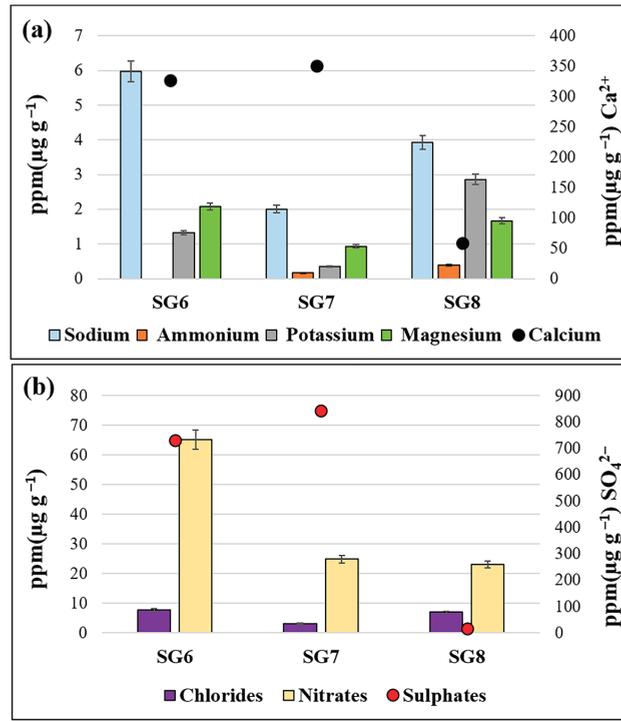
Figure 4. Ion concentration of samples SG_6, SG_7 and SG_8 taken from Panel A. (a) Ppm ($\mu\text{g g}^{-1}$) concentrations of sodium, ammonium, potassium, magnesium and calcium cations; (b) ppm concentrations ($\mu\text{g g}^{-1}$) of chloride, nitrate and sulphate anions.

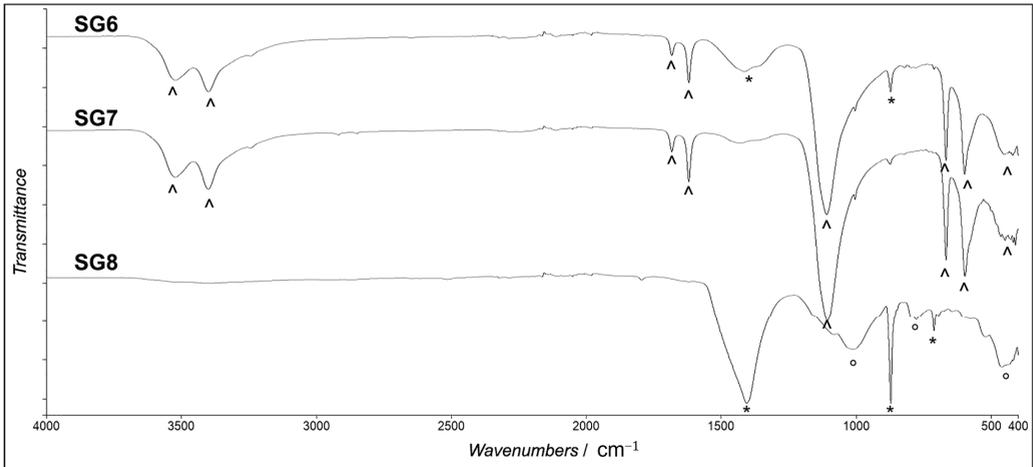
Figure 5. ATR-FTIR spectra of samples SG_6, SG_7 and SG_8 taken from Panel A. Marker bands of carbonates (*), silicates (Δ) and sulphates (\circ) are highlighted.

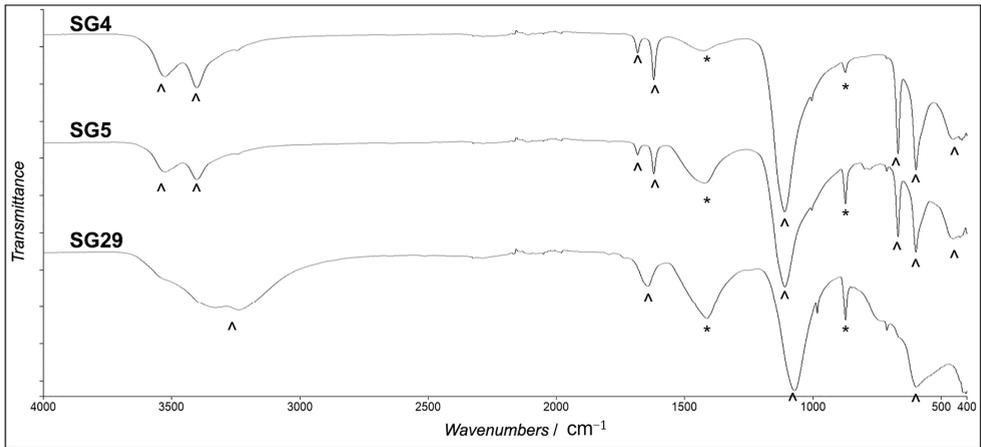
Figure 7. ATR-FTIR spectra of samples SG_4, SG_5 and SG_229 taken from Panel C. Marker bands of carbonates (*) and sulphates (°) are highlighted.

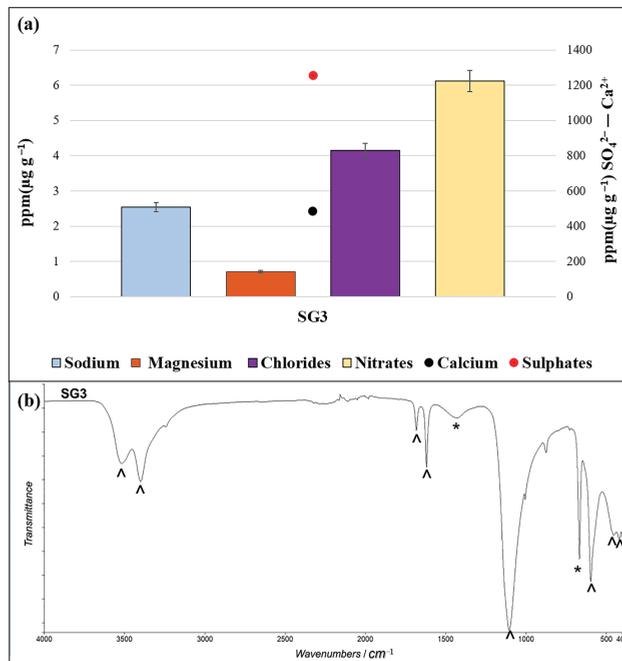
Figure 8. Sample SG3 taken from Panel D. (a) Ion concentrations of sodium, magnesium, chlorides, nitrates, calcium, sulphate in ppm ($\mu\text{g g}^{-1}$); (b) ATR-FTIR spectrum: marker bands of carbonates (*) and sulphates (°) are highlighted.

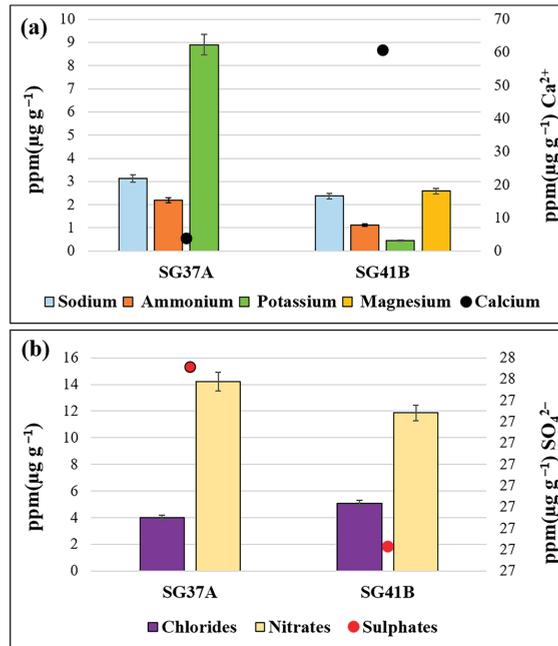
Figure 9. Ion concentration of samples SG_37A and SG_41B taken from the top of the vaults. (a) Ppm ($\mu\text{g g}^{-1}$) concentrations of sodium, ammonium, potassium, magnesium and calcium cations; (b) ppm concentrations ($\mu\text{g g}^{-1}$) of chloride, nitrate and sulphate anions.

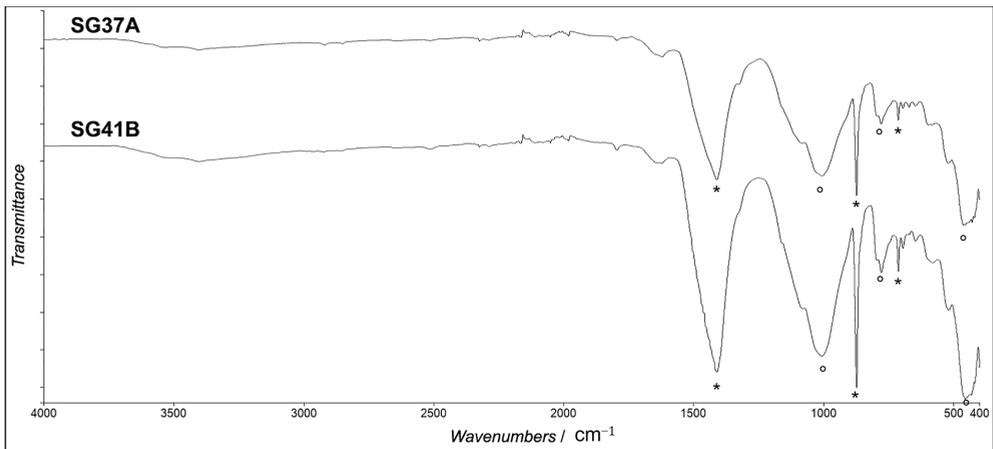
Figure 10. ATR-FTIR spectra of samples SG_37A and SG_41B taken from the top of the vaults. Marker bands of carbonates (*) and silicates (°) are highlighted.

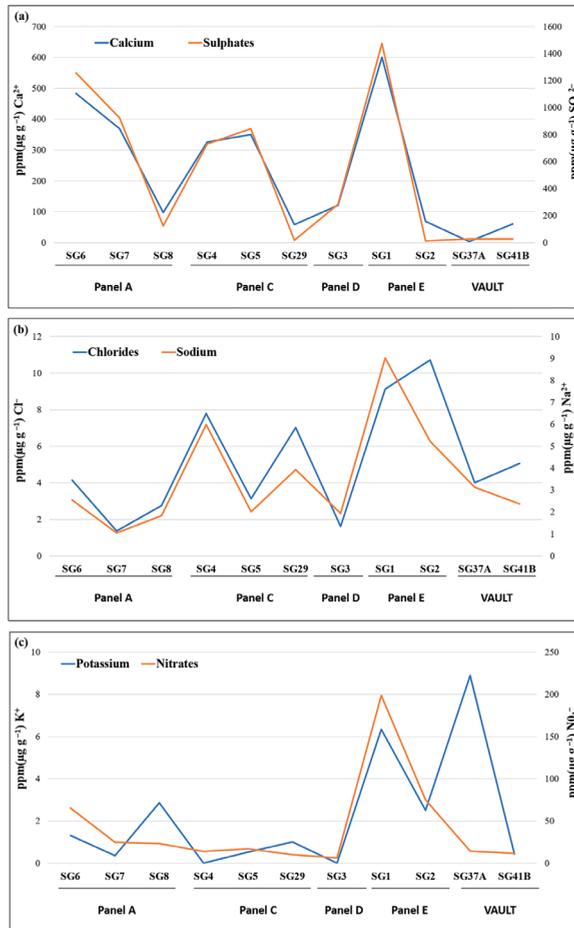
Figure 11. Trend of the concentrations ($\mu\text{g g}^{-1}$) of certain ions observed in the samples analyzed. (a) Calcium and sulphate; (b) chloride and sodium; (c) potassium and nitrates.

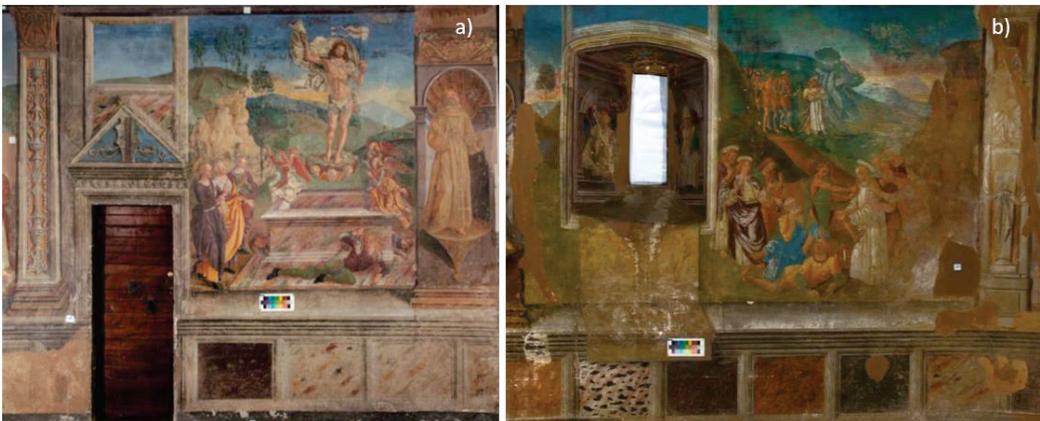
Figure 1. Visible image of Area 1—Panel E (a), and Area 4—Panel A (b).

The experimental sections are divided into two subsections: one dedicated at the identification of the original binding media and aged coatings, and the other to study the materials from the lacunae, as well as retouched and restored areas. Samples from the original paintings were collected mainly from the upper part of the vault and Area 1—Panel E (Figures 1a and 2), while for the consolidation/restoration ones they were collected mainly from Area 4—Panels A (Figure 1b), D and E (Figure 3). The bad state of conservation and severe legibility problems due to degraded pictorial varnishes, retouching and stuccos are clearly visible.

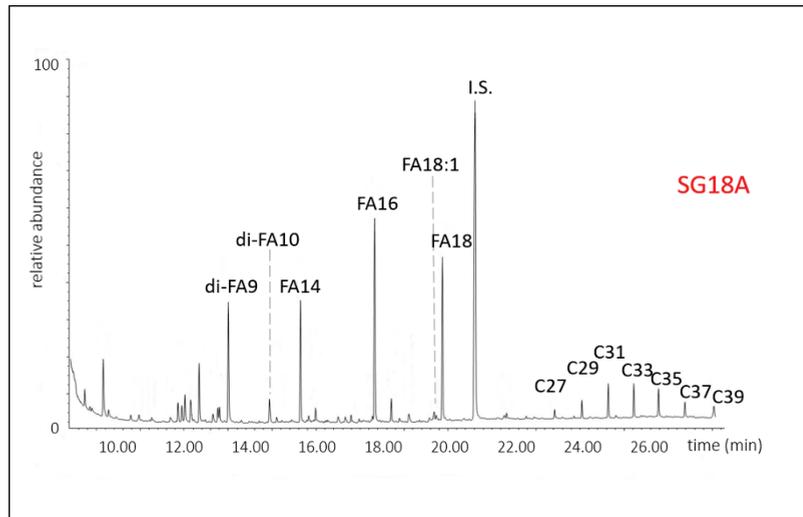
Figure 7. Total Ion Current (TIC) Chromatogram of sample SG_18A after methyl ester derivatization (ME). IS: internal standard: nonadecanoic acid–ME; di-FA9: azelaic acid–ME; di-FA10: sebacic acid–ME; FA14: myristic acid–ME; FA16: palmitic acid–ME; FA18:1: oleic acid–ME; FA18: stearic acid–ME; Cn linear aliphatic hydrocarbon with n atoms of carbon.

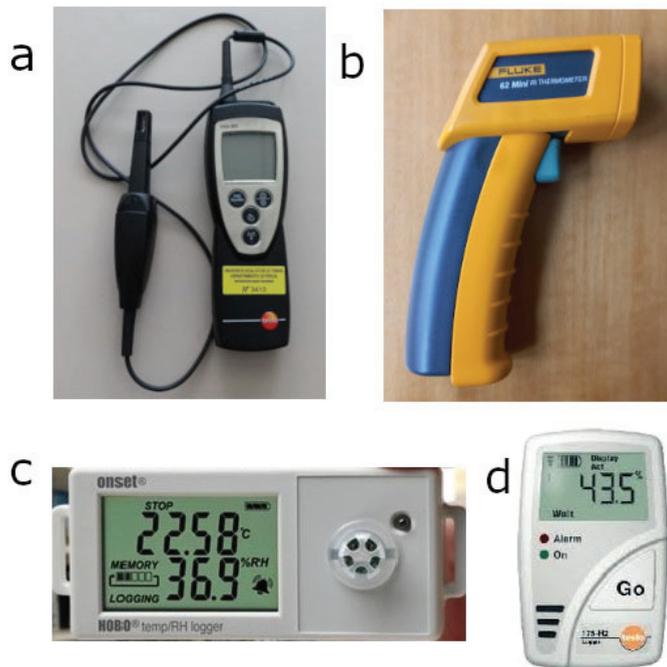
Figure 3. Instruments: (a) Testo 625 thermo-hygrometer, (b) Fluke 62 Mini infrared thermometer, (c) HOBO-UX100-011 thermo-hygrometer, and (d) Testo 175-H2 thermo-hygrometer.

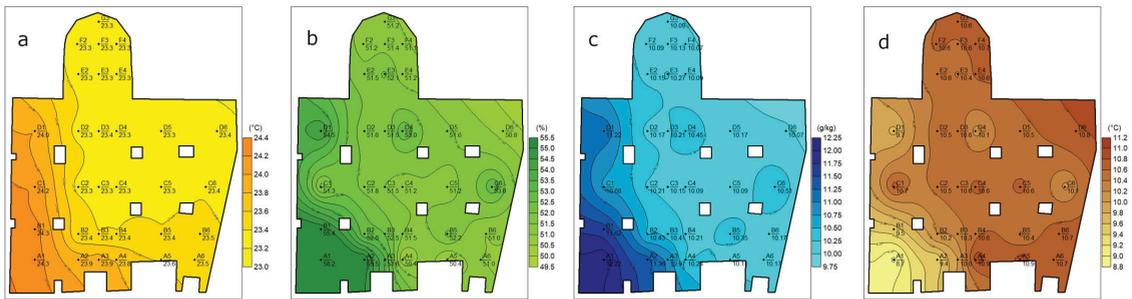
Figure 4. (a) Temperature, (b) relative humidity, (c) specific humidity and (d) dew point spread at 2.0 m from the floor on 6 July 2021 at 9:00 UTC+1.

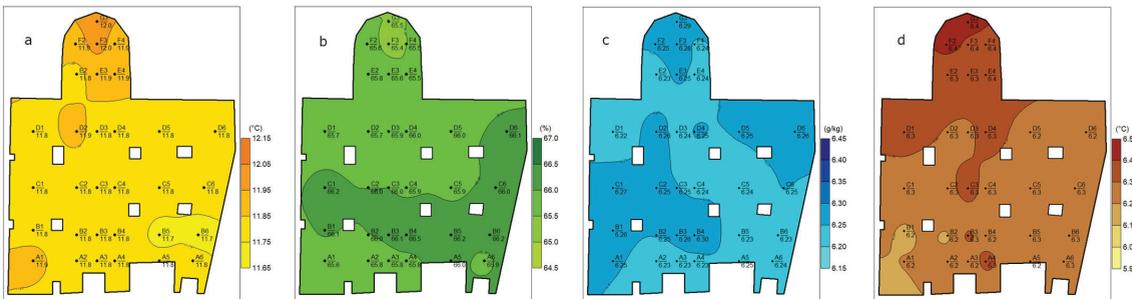
Figure 5. (a) Temperature, (b) relative humidity, (c) specific humidity and (d) dew point spread at 1.2 m from the floor on 22 November 2021 at 14:30 UTC+1.

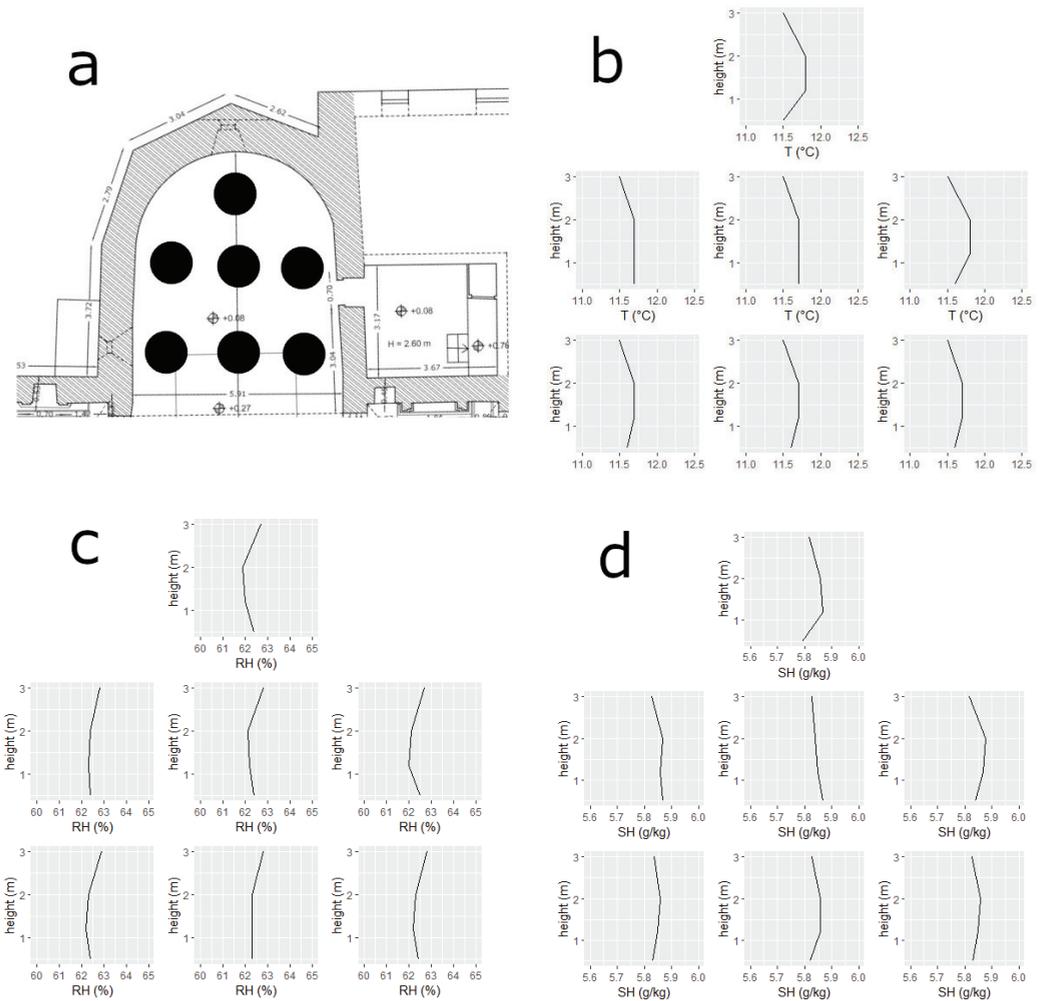
Figure 6. (a) Positions of the vertical profiles, (b) temperature profiles, (c) relative humidity profiles and (d) specific humidity profiles on 22 April 2022 at 14:30 UTC+1.

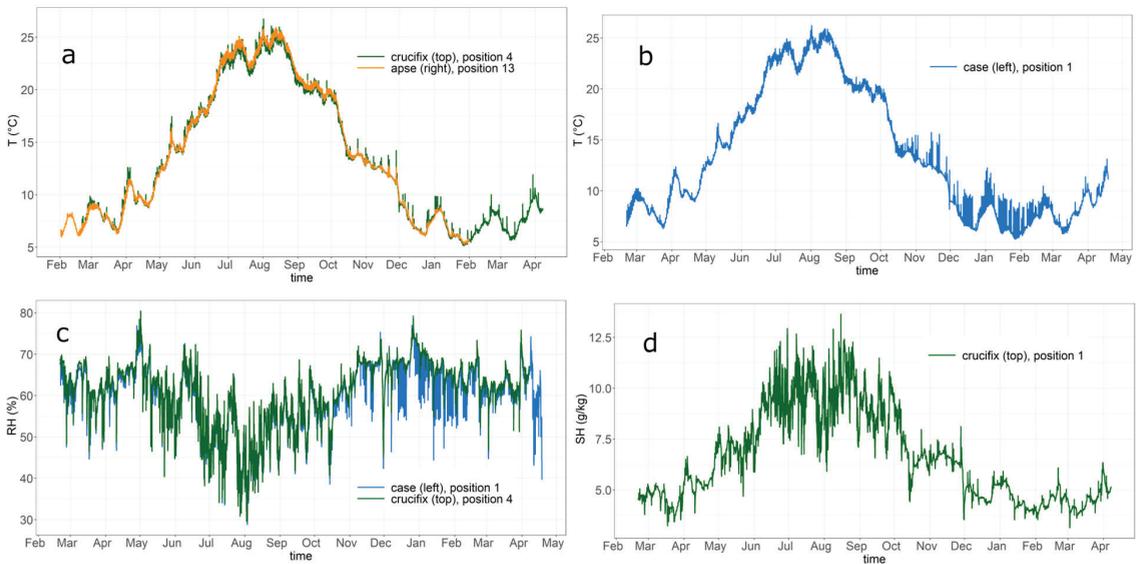
Figure 8. (a) Temperature at crucifix top (green line) and apse near wall right (orange line); (b) temperature on the case (blue line); (c) relative humidity at the crucifix top (green line) and on the case (blue line); (d) specific humidity at crucifix top.

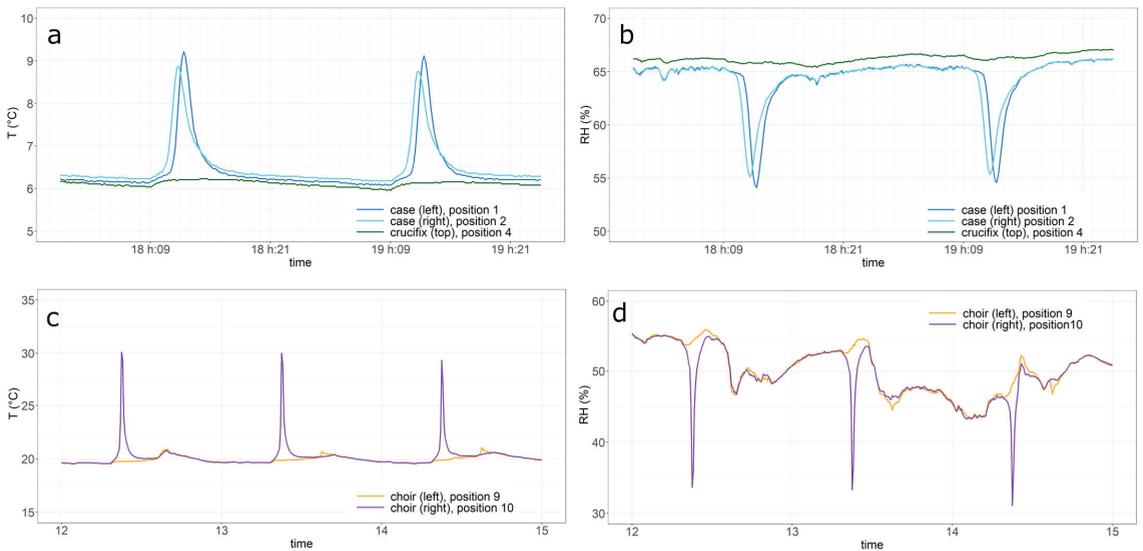
Figure 9. (a) Temperature on the case and at crucifix top on 18 and 19 January 2022; (b) relative humidity on the case and at crucifix top on 18 and 19 January 2022; (c) temperature at the choir from 12 to 14 September 2021; (d) relative humidity at the choir from 12 to 14 September 2021.

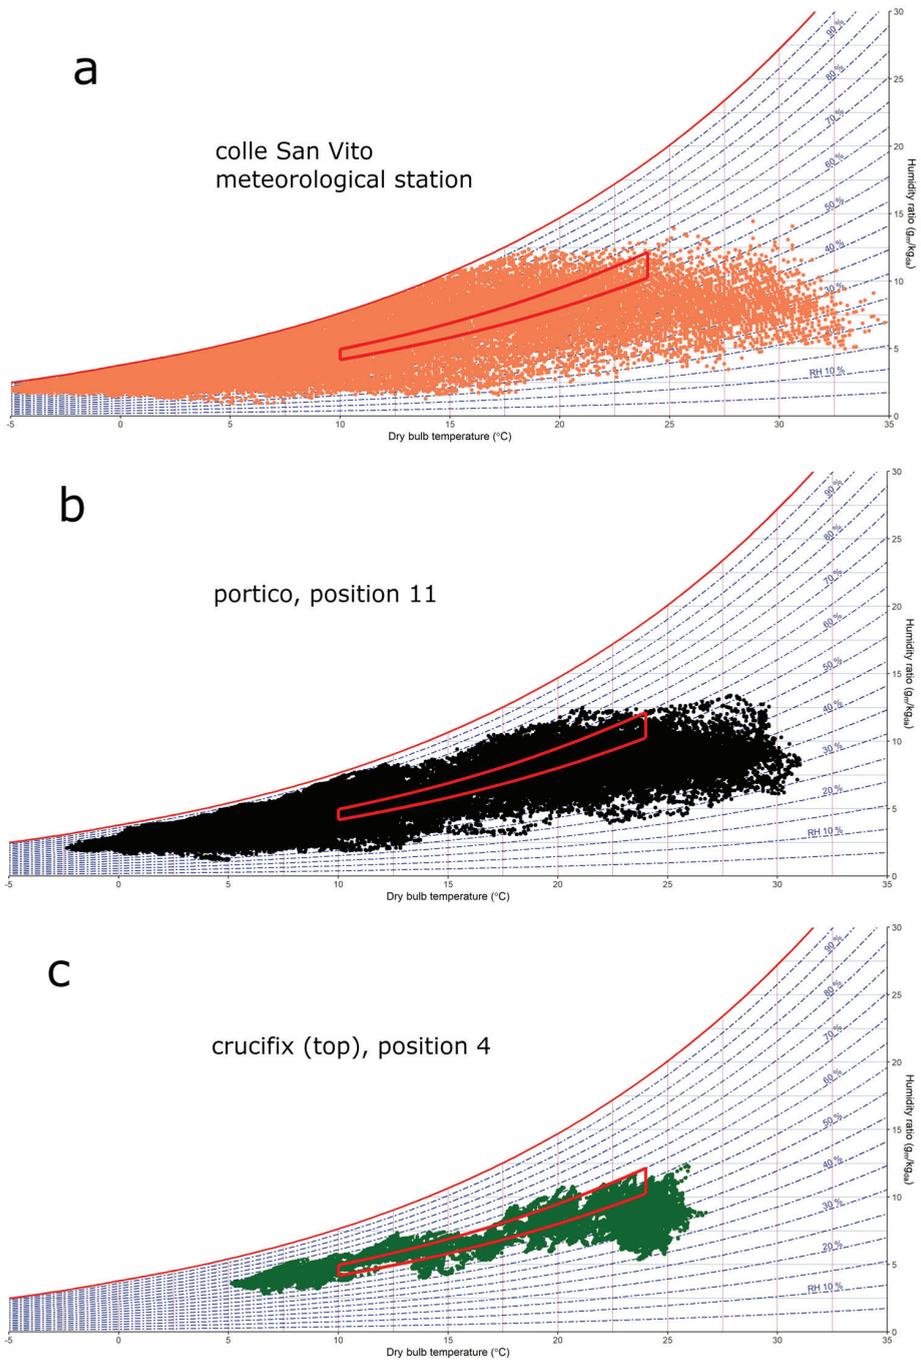
Figure 10. Psychrometric chart (a) at San Vito meteorological station, (b) outside San Panfilo church below the external portico and (c) inside the church at the crucifix top. The red perimeter identifies the conditions permitted by the UNI 10828 standard.

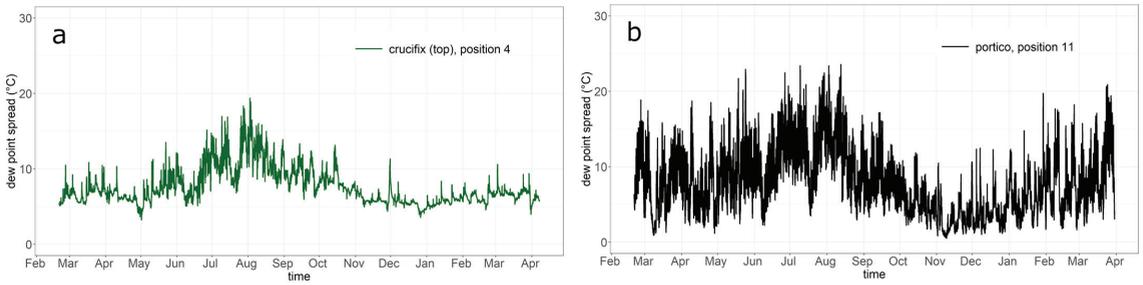
Figure 11. (a) Dew point spread at crucifix top and (b) dew point spread below the external portico.

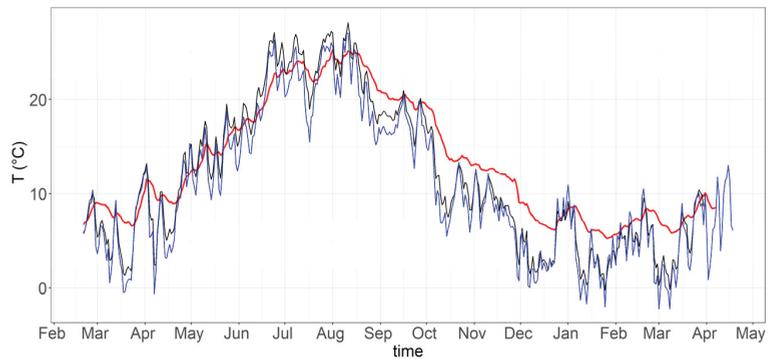
Figure 12. Daily temperature inside the church (red), outside below the external portico (black) and at the S. Vito meteorological station (blue).

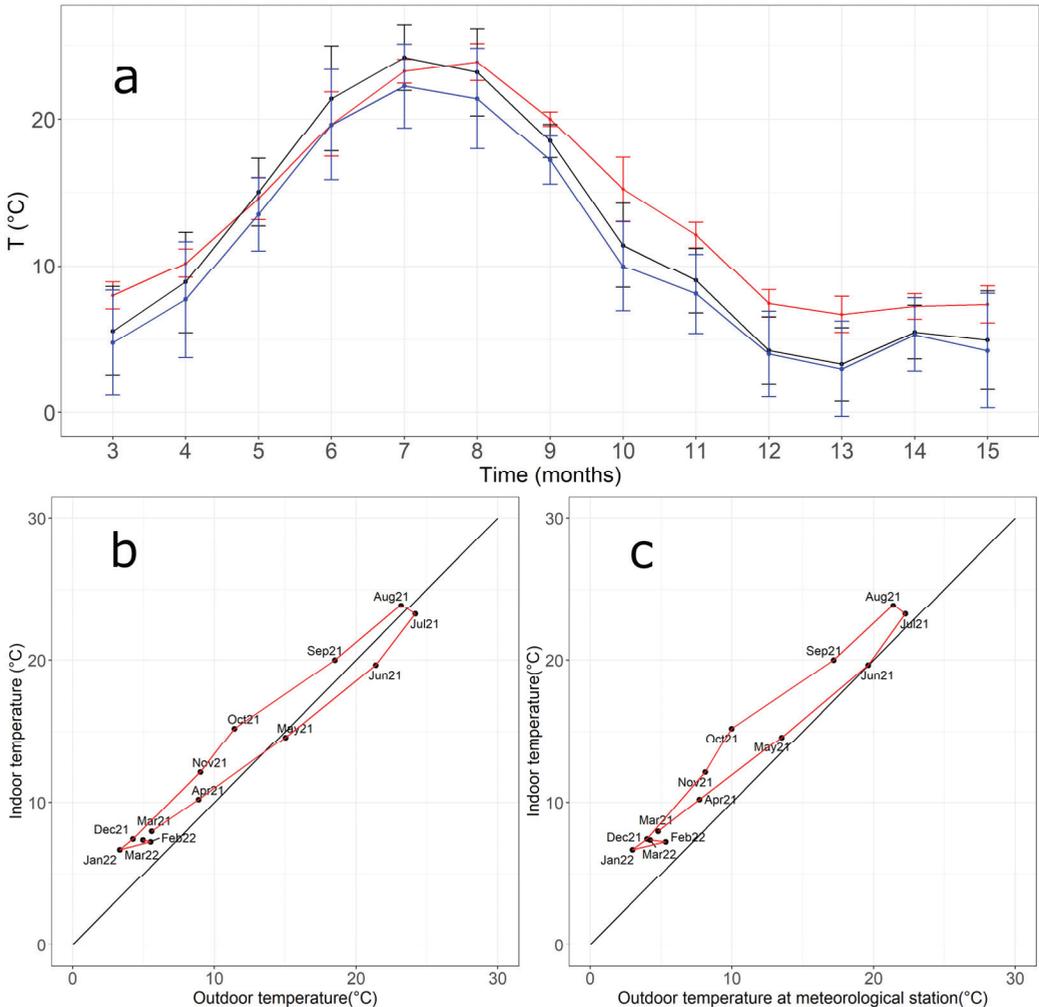
Figure 13. (a) Temperature monthly averages inside the church (red), below the external portico (black) and at the S. Vito meteorological station (blue); (b) scatter diagram with inside and outside (portico) monthly temperature; (c) scatter diagram between inside and outside (meteorological station) monthly temperature.

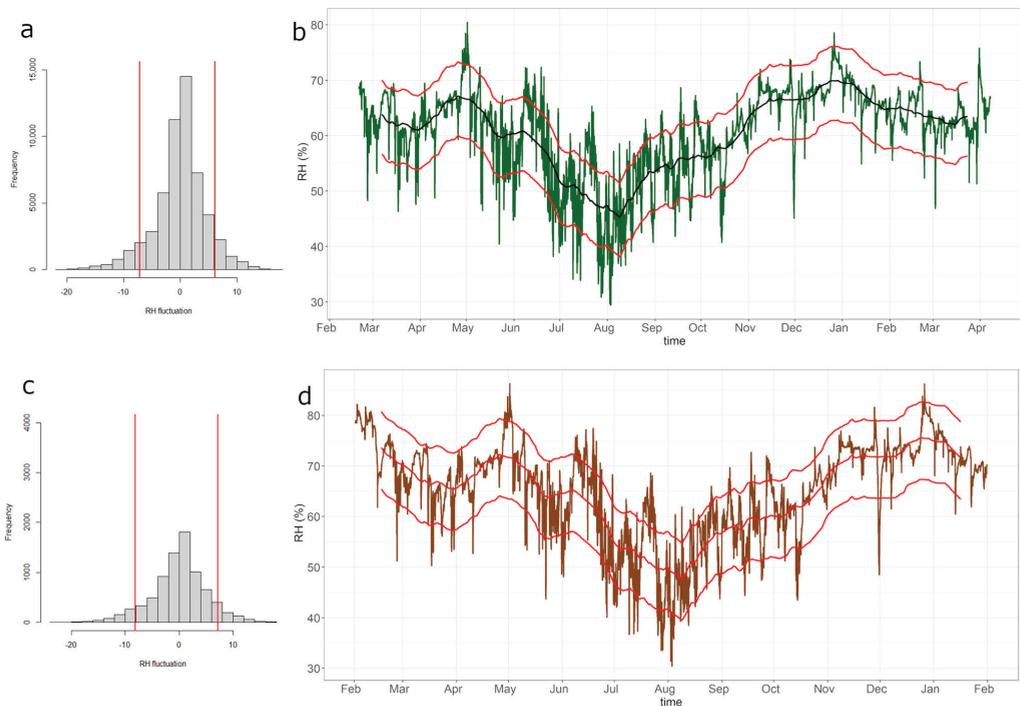
Figure 14. Historical relative humidity variability according to EN 15757 standard, in the figures red lines and curves show the 7th and 93rd percentiles; (a) distribution of relative humidity fluctuations at crucifix top site; (b) relative humidity variability at the crucifix top side (green line); (c) distribution of relative humidity fluctuations in the left side of the apse; (d) relative humidity variability at the left side of the apse (brown line).

outdoor temperatures and the application of the EN 15757 standard [2,3] supply the restorers with information regarding the range of historical variability of relative humidity that should be respected during the restoration project.
