# Investigation of Microstructural and Corrosion Properties of Steels and Light Alloys

Edited by  
Claudio Gennari and Luca Pezzato

# Investigation of the Microstructural and Corrosion Properties of Steels and Light Alloys

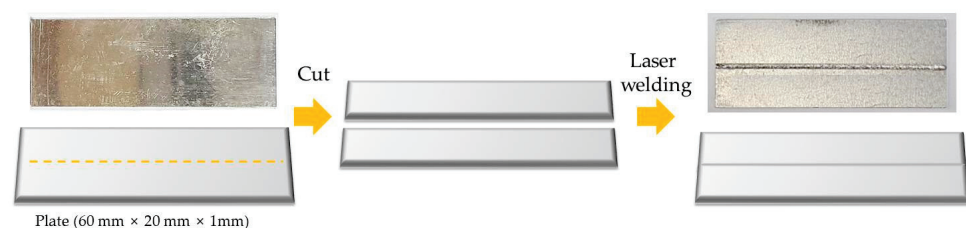
**Figure 1.** Procedure for laser-welded specimen preparation.

The laser-welded specimens were plate shaped with a size of 60 mm × 20 mm × 1 mm, and the center was welded in the longitudinal direction. Figure 1 shows the specimen preparation procedure.

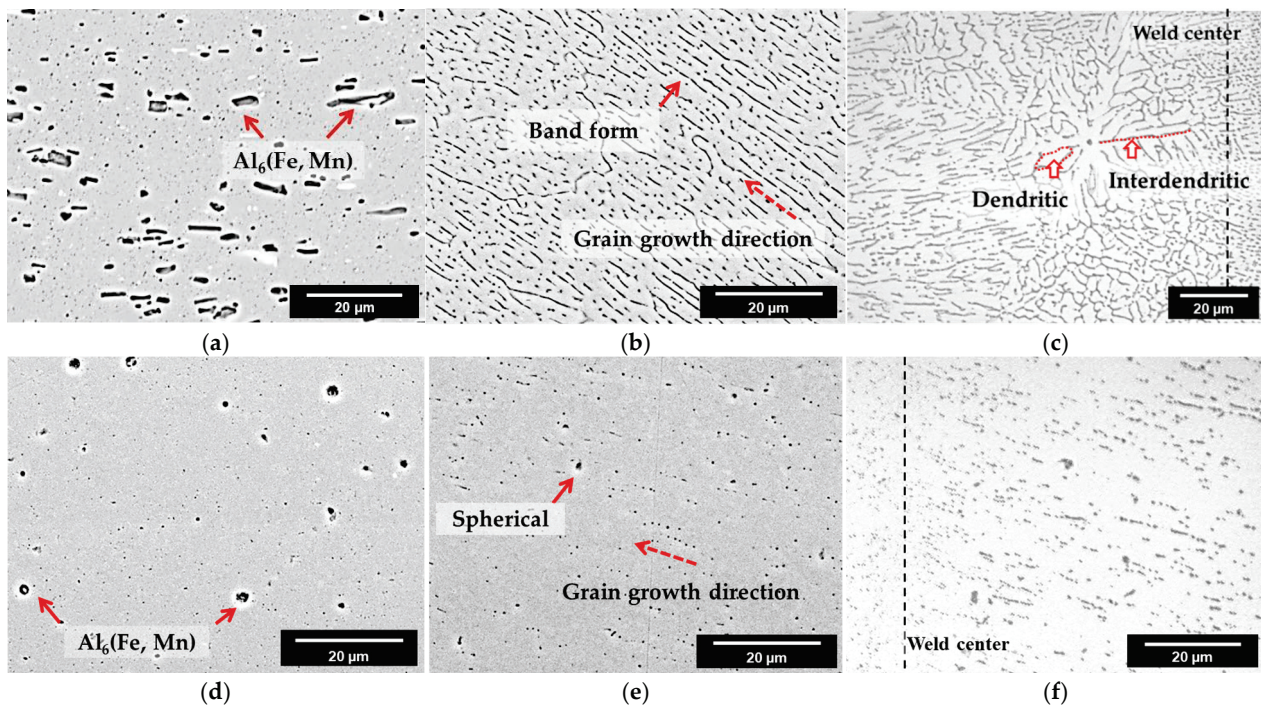
**Figure 4.** Microstructures of laser-welded specimens. AA3003 (a) BM, (b) FZ, near BM/FZ interface, and (c) FZ, weld center; U3003 (d) BM, (e) FZ, near BM/FZ interface, and (f) FZ, weld center.

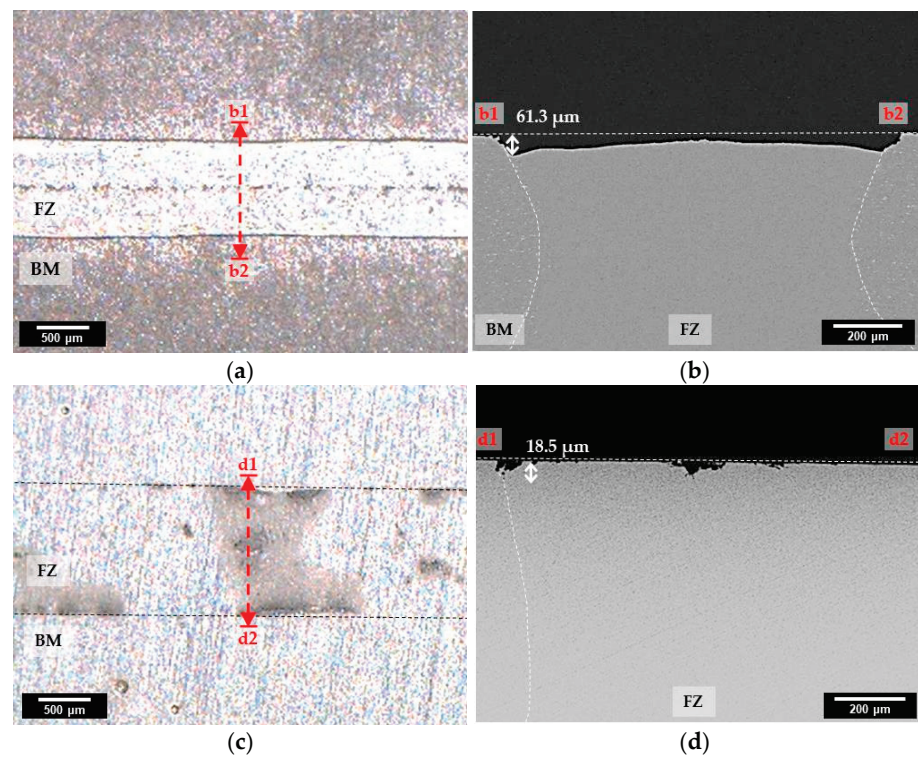
**Figure 6.** Surface and cross-sectional images of specimens after 12 weeks' immersion test. (a) Surface image of AA3003 and (b) cross-sectional image at the b1–b2. (c) Surface image of U3003 and (d) cross-sectional image at the d1–d2.

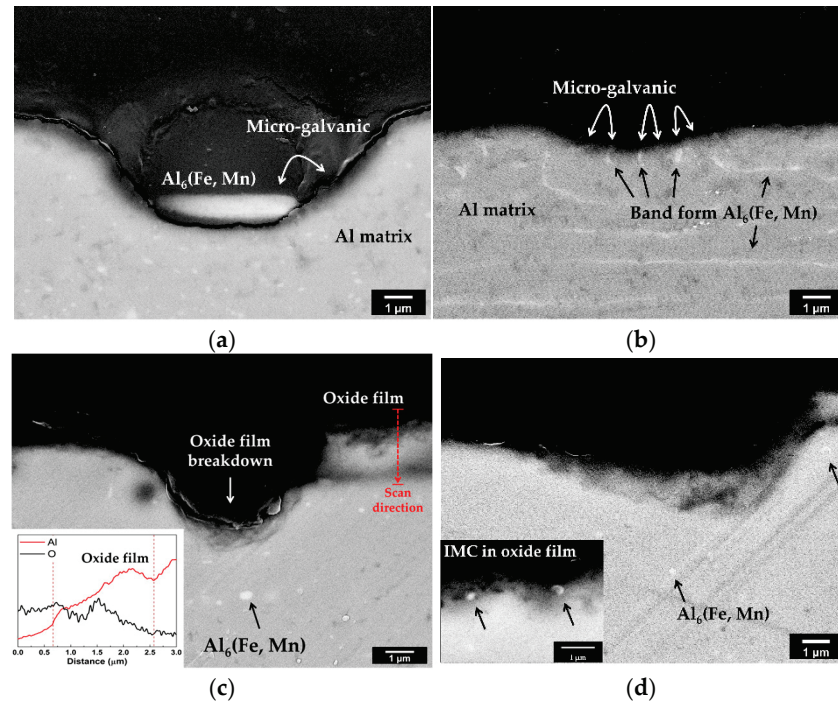
**Figure 8.** High-magnification images of cross sections of specimens after 12 weeks' immersion testing. AA3003 (a) BM and (b) FZ; U3003 (c) BM and (d) FZ.

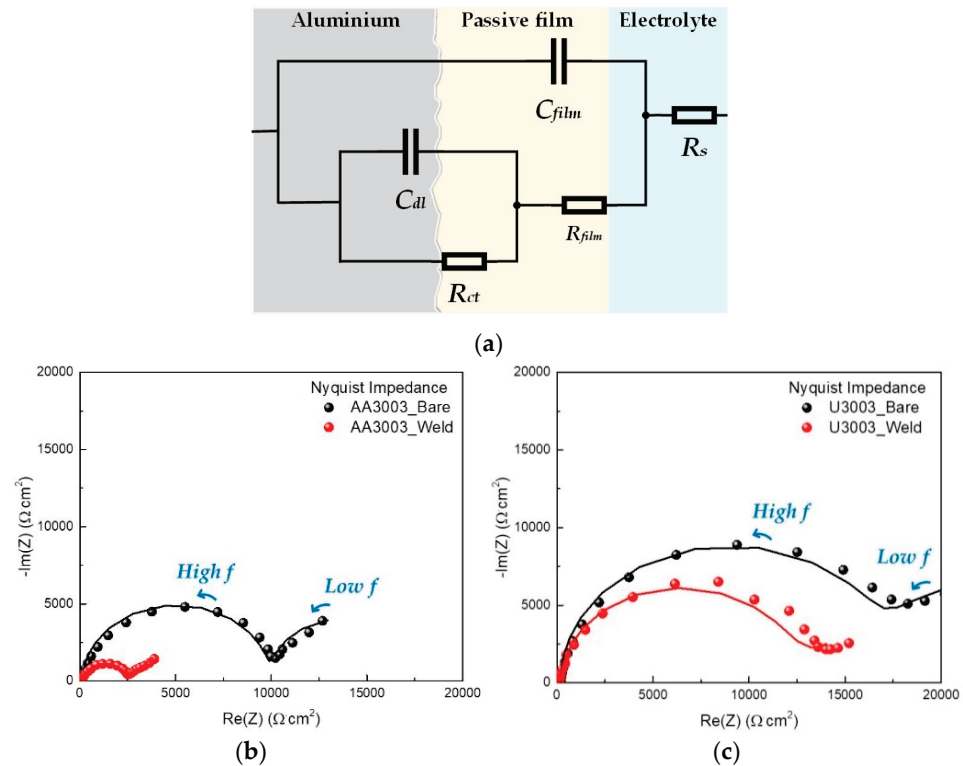
**Figure 9.** (a) Equivalent circuit to fit the EIS data. EIS Nyquist plots of (b) AA3003 and (c) U3003. Scatter plots are experimental values and line plots are calculated values.

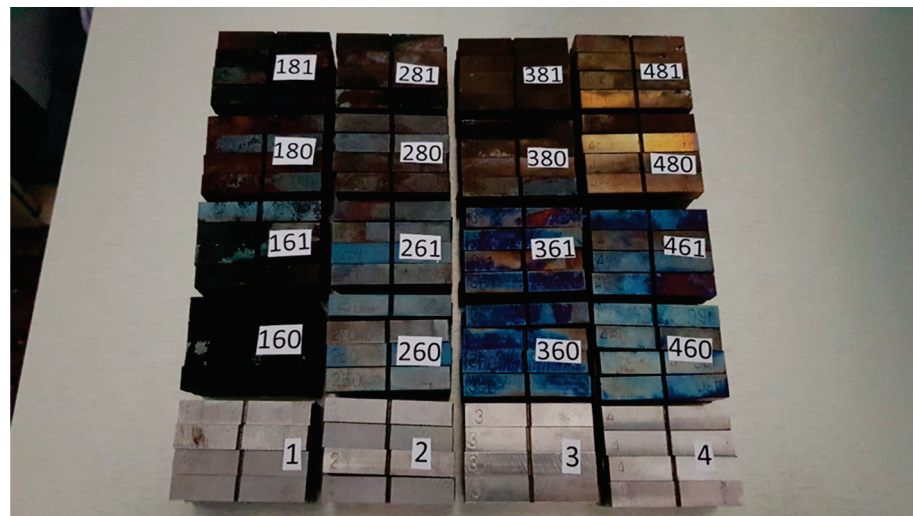
**Figure 2.** Samples prepared for impact strength testing, made of S355J2+N steel (1st set), X20Cr13 steel (2nd set), X6CrNiTi18-10 steel (3rd set), and X2CrNiMoN22-5-3 steel (4th set), from left to right.

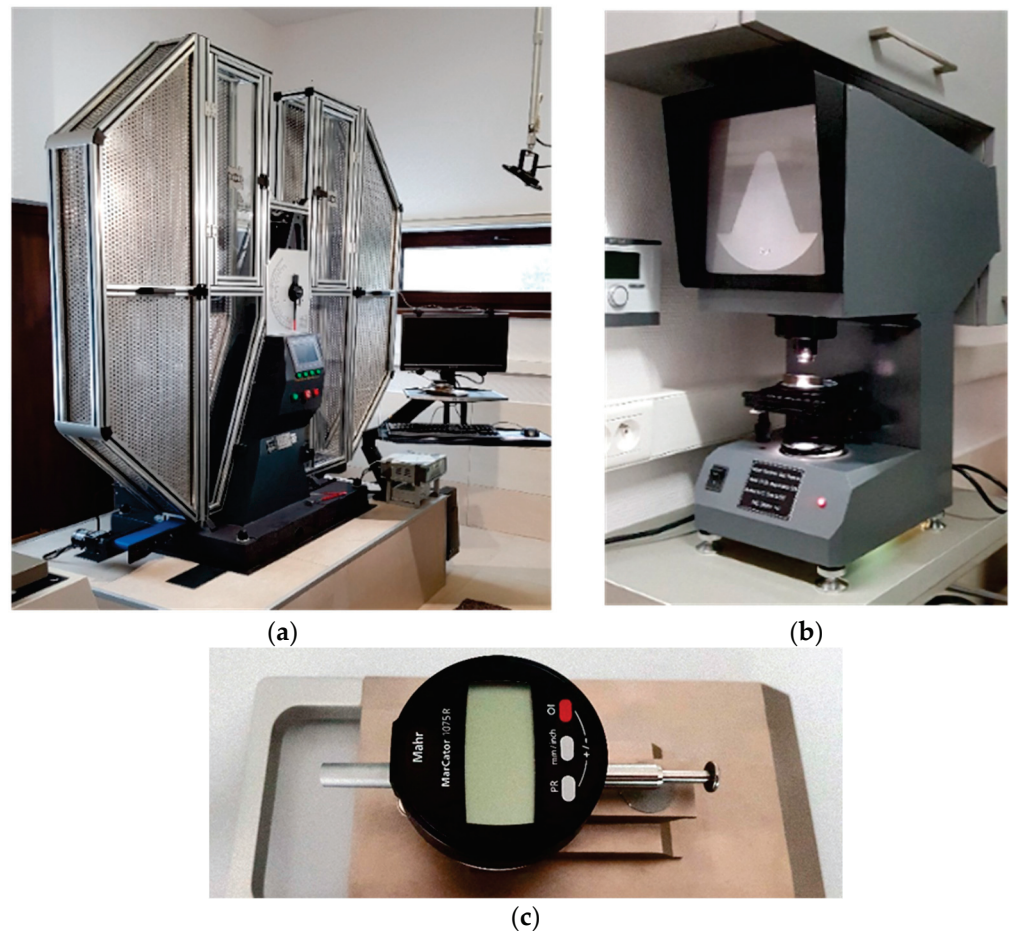
**Figure 4.** Testing equipment used during research: (a) instrumented Charpy hammer of the JB-W450E-L type, (b) XT-50 notch profile projector, (c) the gauge used to measure the lateral expansion of a sample (according to [7]).

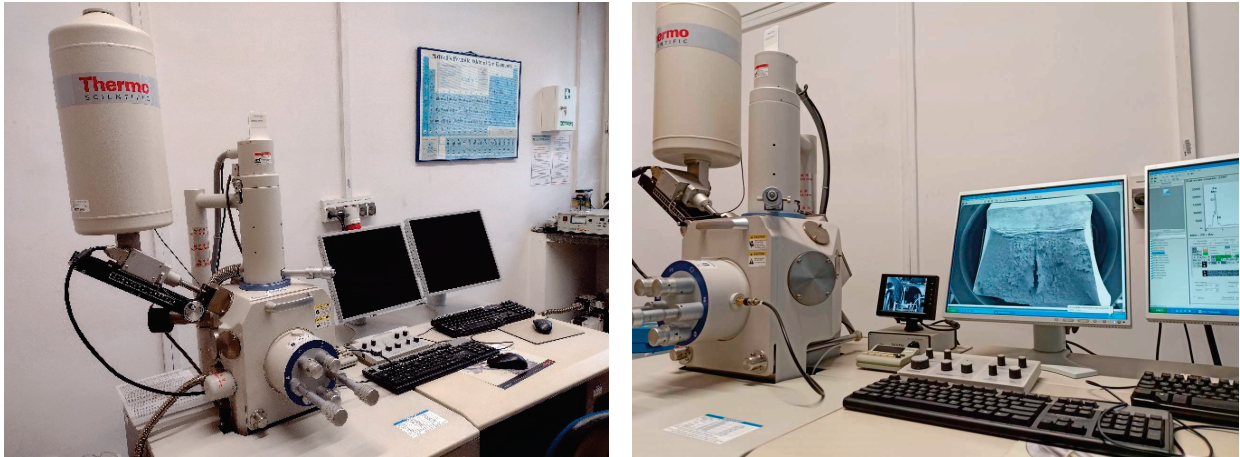
**Figure 9.** Scanning electron microscope (SEM) used to analyze the microstructure of considered steel.

The microstructure of each impact fracture surface obtained in our experiment was analyzed using a scanning electron microscope (SEM) Hitachi S-3400N VP-SEM (Figure 9).

This device may be set up to work under both high vacuum conditions and variable pressure. It typically yields magnifications of 10 to 20,000 times, with a very good surface contrast and depth of field for resolutions of 4 to 10 nm. To perform the chemical analysis, the microscope described above was equipped with an energy dispersive spectroscopy (EDS) *ThermoScientific* Si(Li) detector with a resolution of 135 eV and with the *Noran System 7* (NSS) analytical software.

The SEM works on the principle of generating an electron beam in the thermo-emission gun. This beam, while passing through the electromagnetic lens system, hits the tested sample placed in a vacuum chamber. Depending on the accelerating voltage of the primary beam (from 0.3 kV to maximum 30 kV), the electrons bombarding the sample surface penetrate the tested material to a depth of several micrometers. Secondary (SE) and backscattered (BSE) electrons, as well as characteristic X-rays, are then emitted from the excited volume of a sample. Those signals are used to image the sample surface topography (SE detector), to reveal the contrast of the atomic number of the tested sample (BSE detector), and to identify the micro-sample elemental composition (EDS detector) [55,56].

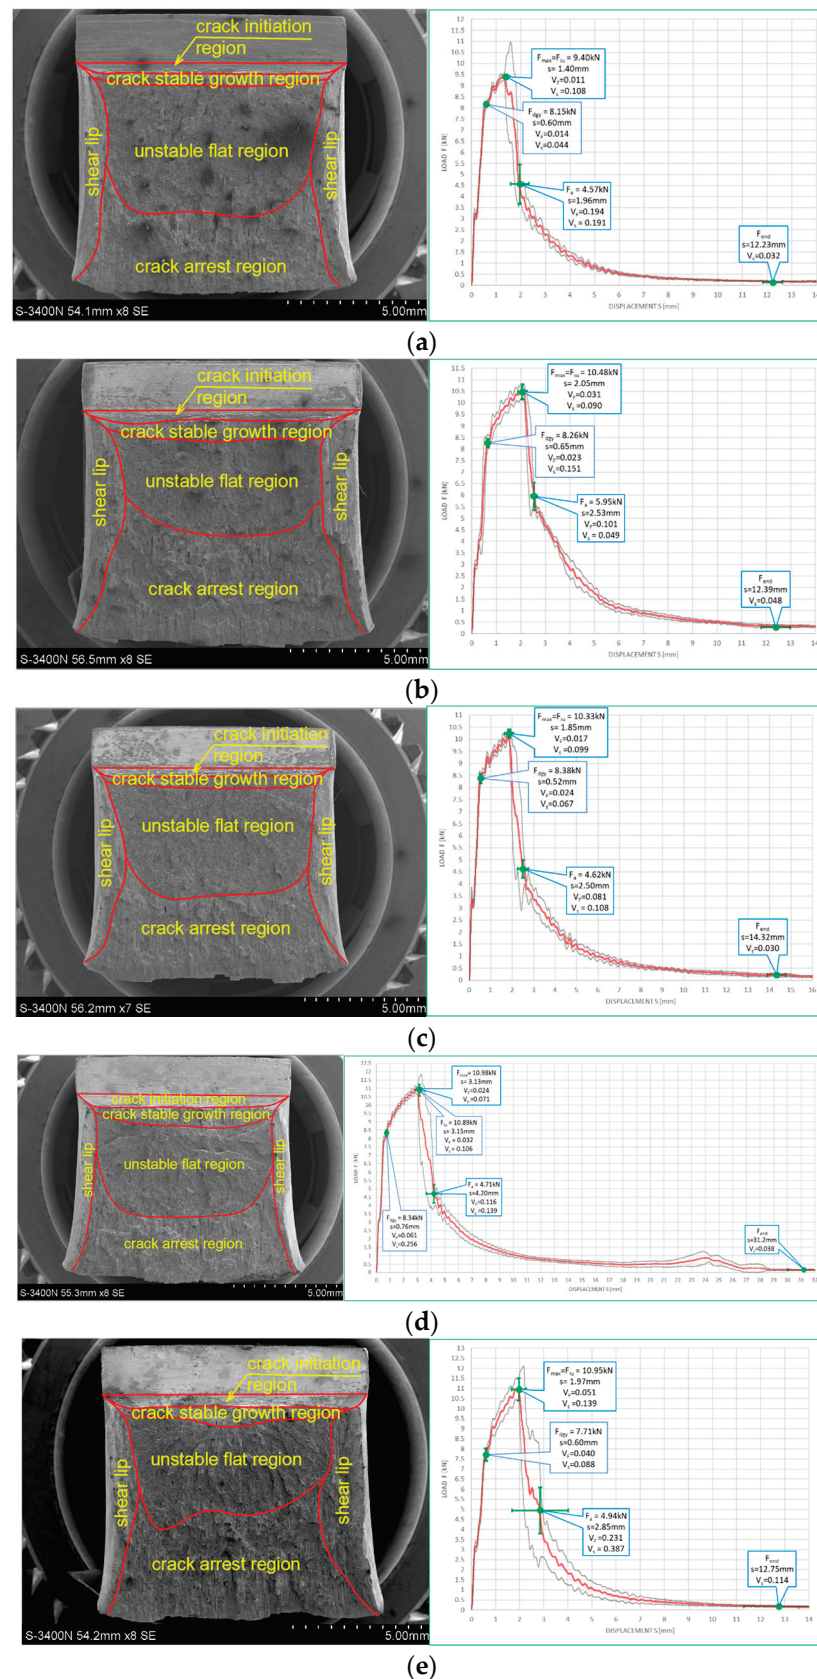
Figure 11. Morphology of the impact fractures obtained during the tests conducted at  $-20\text{ }^{\circ}\text{C}$  on the samples made of S355J2+N steel—denotations follow the key listed in Table 1. (a) 1 ( $-20$ ); (b) 160 ( $-20$ ); (c) 161 ( $-20$ ); (d) 180 ( $-20$ ); (e) 181 ( $-20$ ).

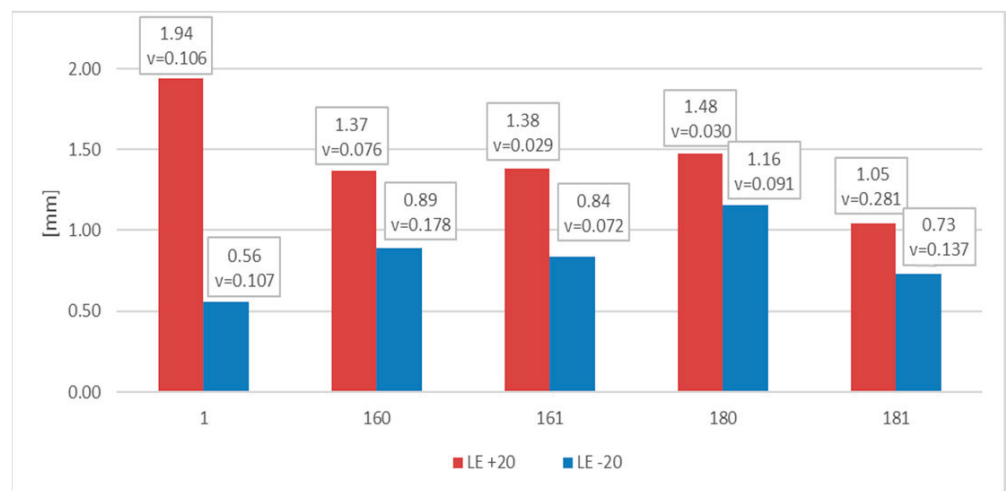
**Figure 12.** Averaged values of the  $LE$  parameter and coefficients of variation corresponding to them (estimated on a statistical sample) obtained on impact toughness test samples made of S355J2+N steel.

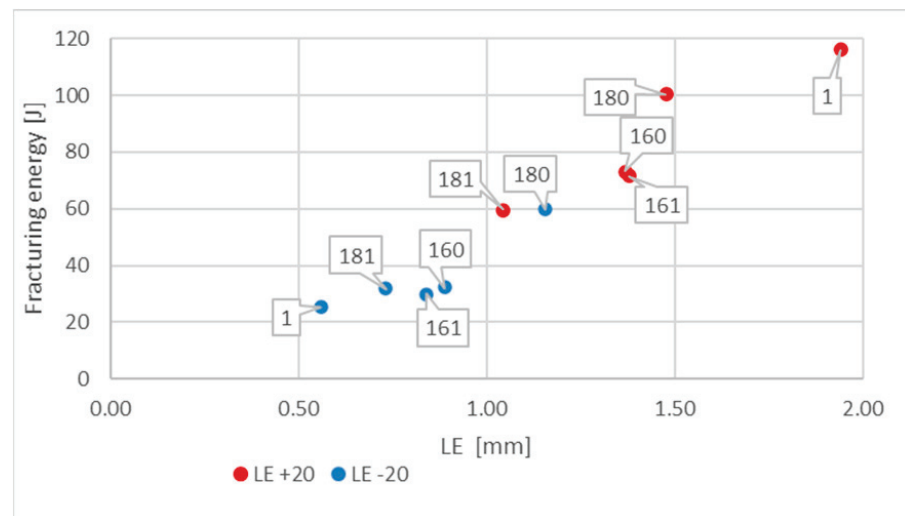
**Figure 13.** Relationship between averaged values of  $LE$  parameter and related values of fracturing energy  $W_t$  obtained for S355J2+N steel at different testing conditions.

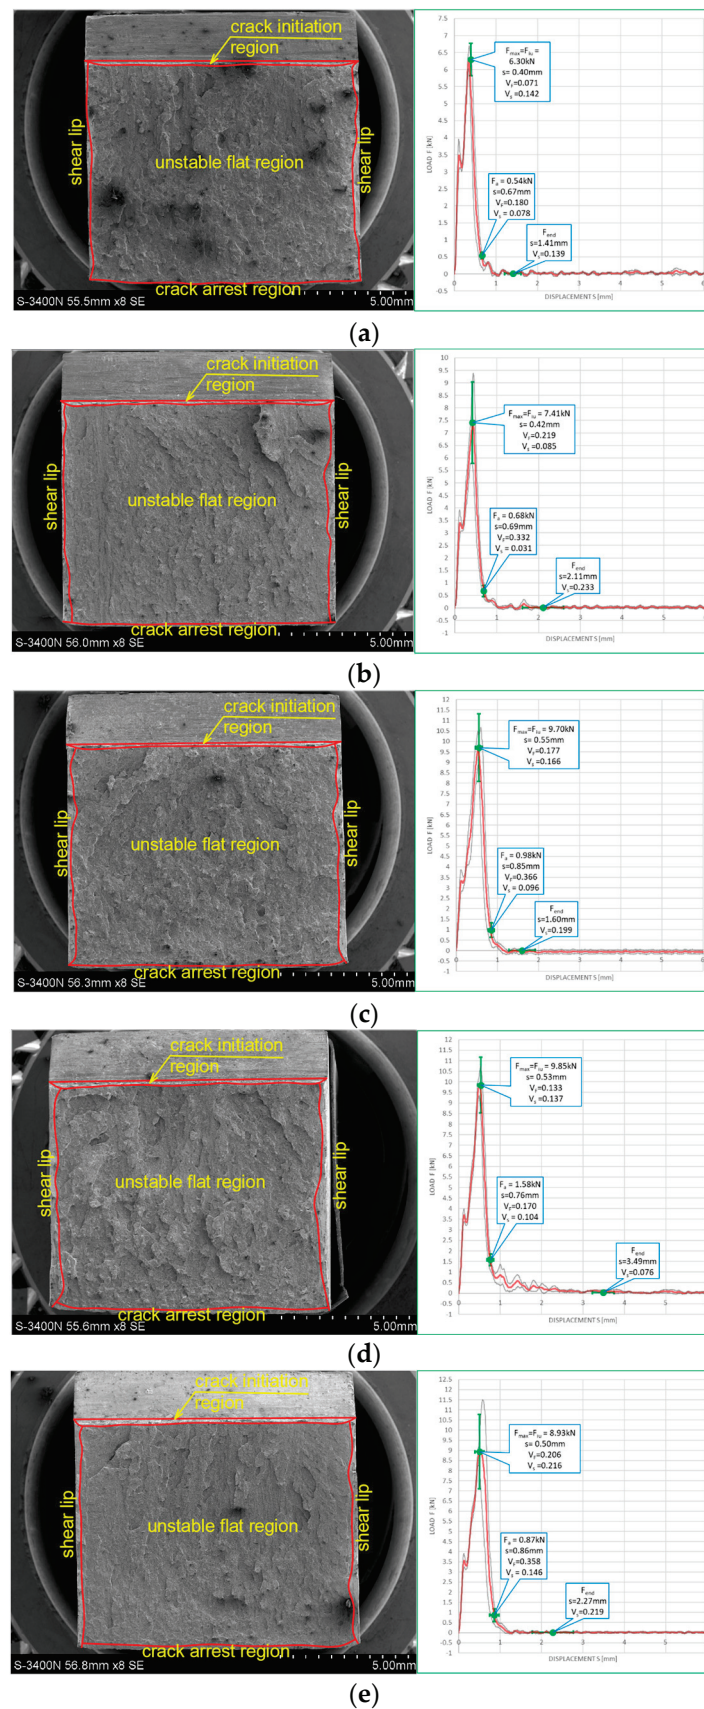
Figure 15. Morphology of the impact fractures obtained during the tests conducted at  $-20\text{ }^{\circ}\text{C}$  on the samples made of X20Cr13 steel—denotations follow the key listed in Table 1. (a) 2 ( $-20$ ); (b) 260 ( $-20$ ); (c) 261 ( $-20$ ); (d) 280 ( $-20$ ); (e) 281 ( $-20$ ).

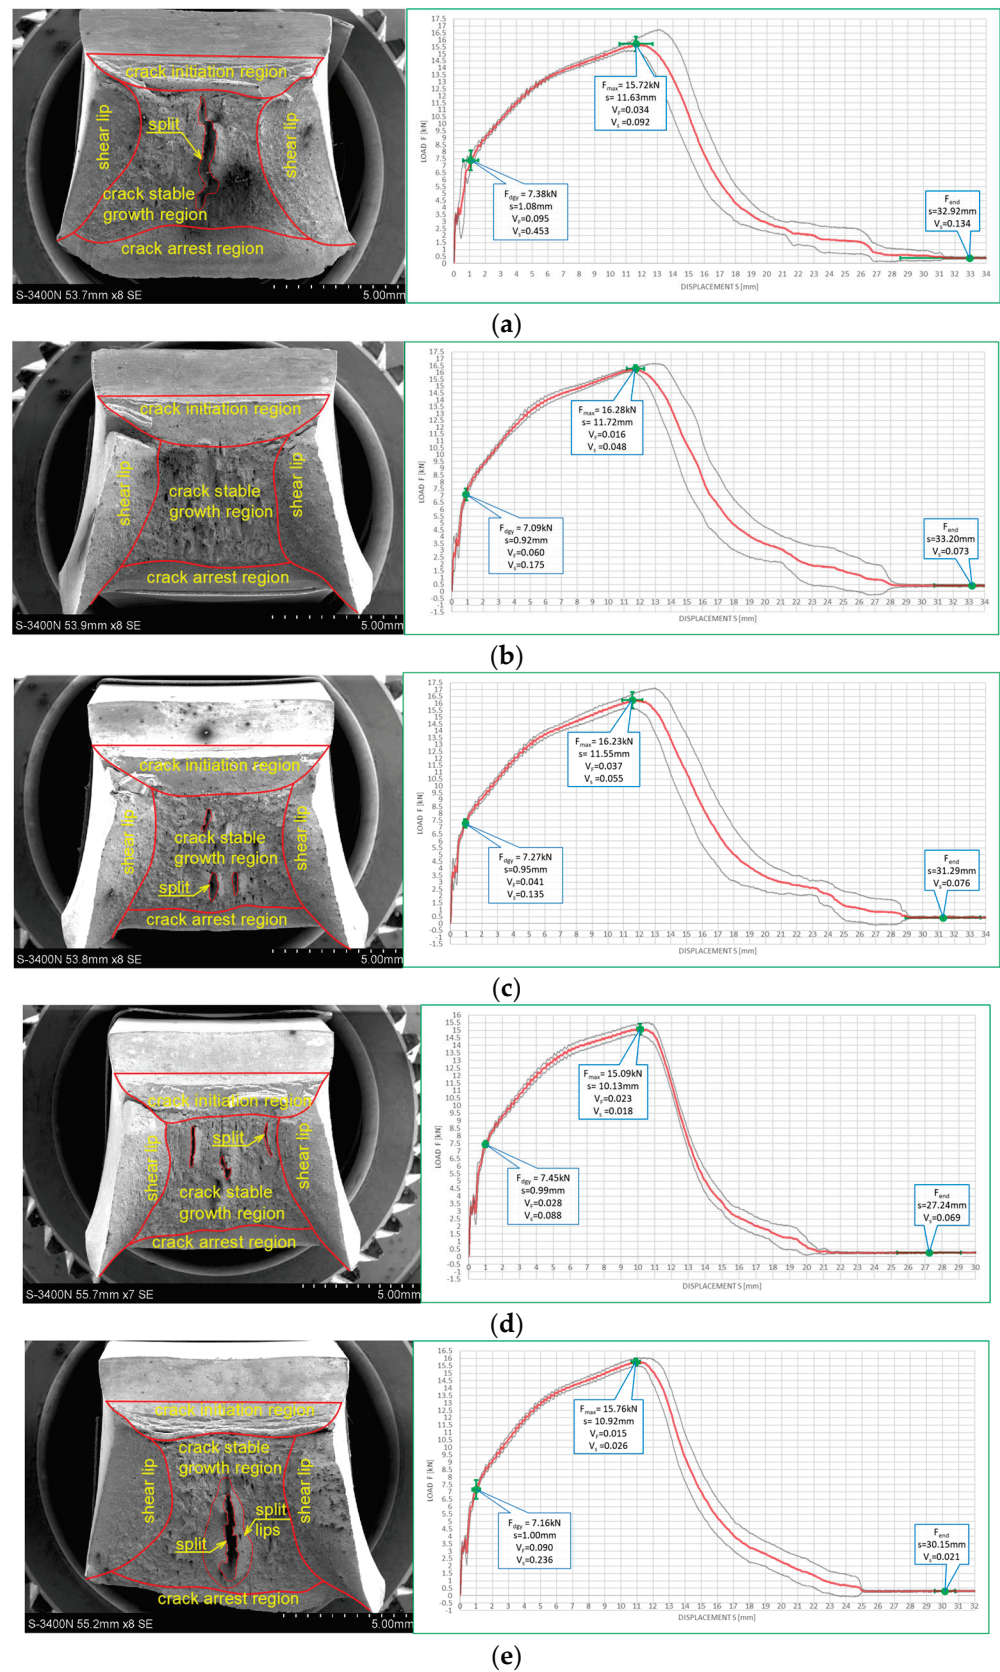
Figure 19. Morphology of the impact fractures obtained during the tests conducted at  $-20\text{ }^{\circ}\text{C}$  on the samples made of X6CrNiTi18-10 steel—denotations follow the key listed in Table 1. (a) 2 ( $-20$ ); (b) 260 ( $-20$ ); (c) 261 ( $-20$ ); (d) 280 ( $-20$ ); (e) 281 ( $-20$ ).

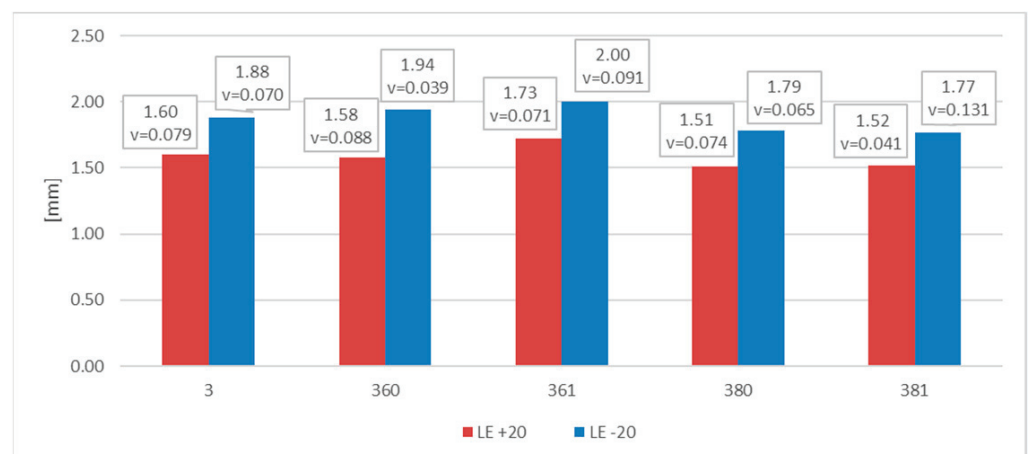
**Figure 20.** Averaged values of the  $LE$  parameter and corresponding coefficients of variation (estimated on a statistical sample) obtained on impact toughness test samples made of  $X6CrNiTi18-10$  steel.

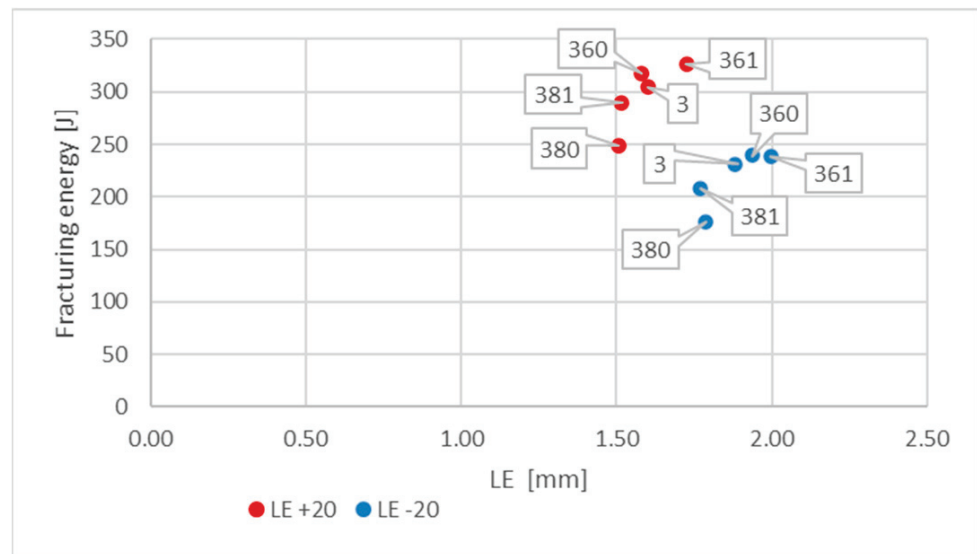
**Figure 21.** Relationship between averaged values of *LE* parameter and related values of fracturing energy obtained for *X6CrNiTi18-10* steel at different testing conditions.

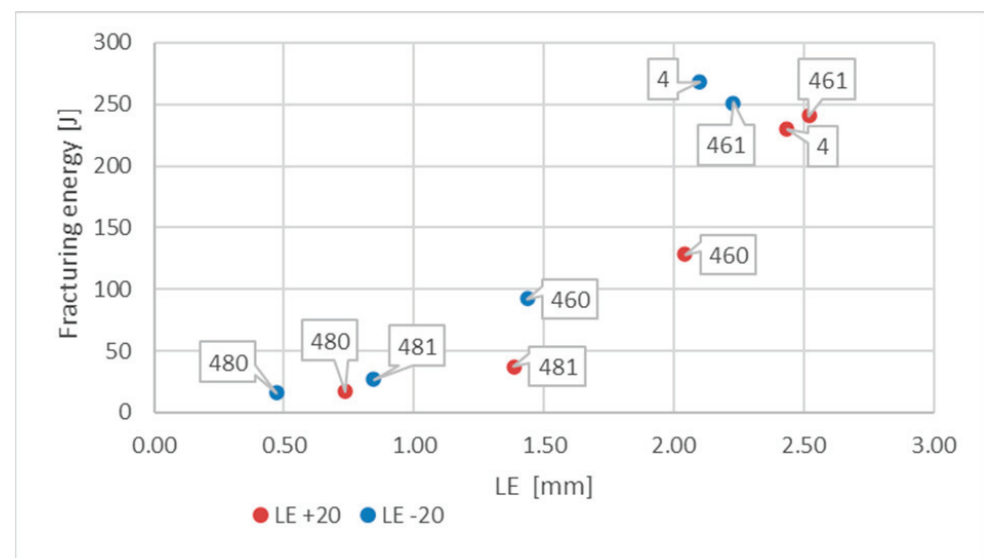
**Figure 25.** Relationship between averaged values of LE parameter and related values of fracturing energy obtained for X2CrNiMoN22-5-3 steel at different testing conditions.

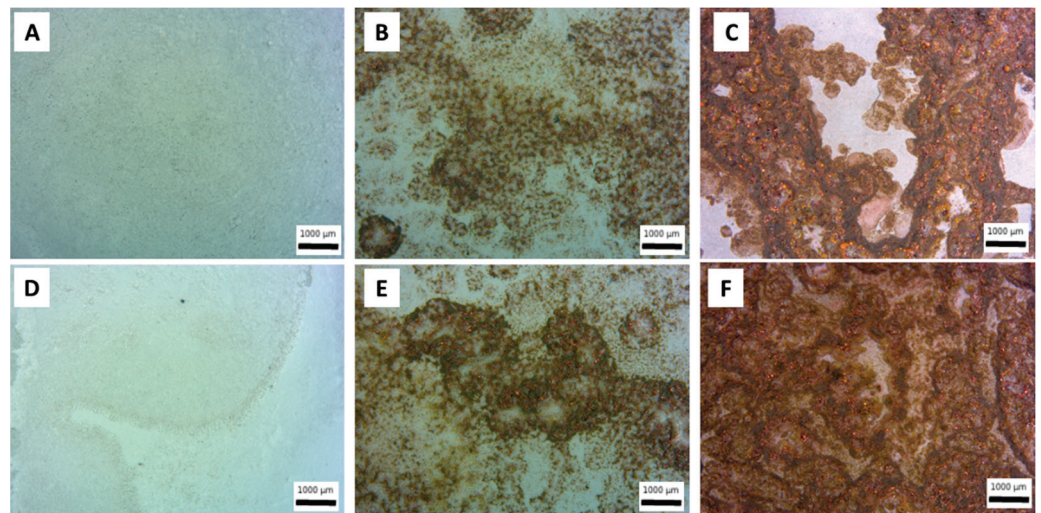
**Figure 2.** Stereo microscope images of the surfaces of PEO coatings obtained working at 0.5 A/cm<sup>2</sup> in DC mode without particles (A), with large particles (B) and with small particles (C) and working at 1 A/cm<sup>2</sup> in UPC without particles (D), with large particles (E) and with small particles (F).

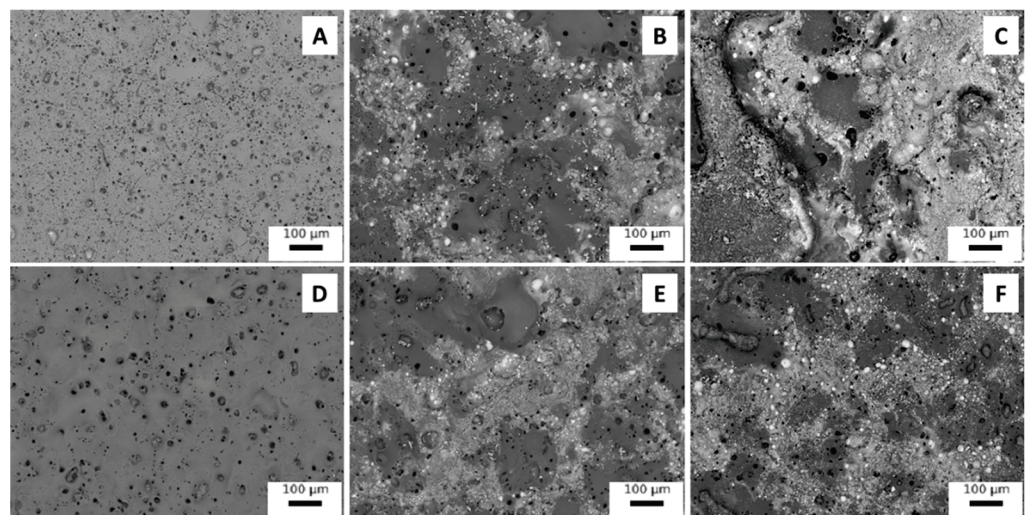
**Figure 3.** SEM images of the surfaces of PEO coatings obtained working at 0.5 A/cm<sup>2</sup> in DC mode without particles (A), with large particles (B) and with small particles (C), and working at 1 A/cm<sup>2</sup> in UPC without particles (D), with large particles (E) and with small particles (F).

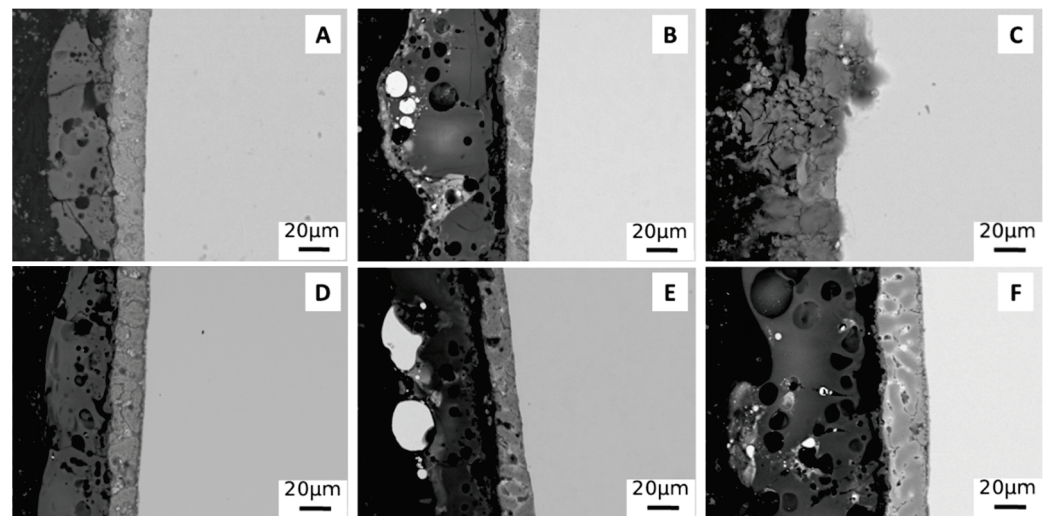
**Figure 4.** SEM images of the cross section of PEO coatings obtained working at  $0.5 \text{ A/cm}^2$  in DC mode without particles (A), with large particles (B) and with small particles (C), and working at  $1 \text{ A/cm}^2$  in UPC without particles (D), with large particles (E) and with small particles (F).

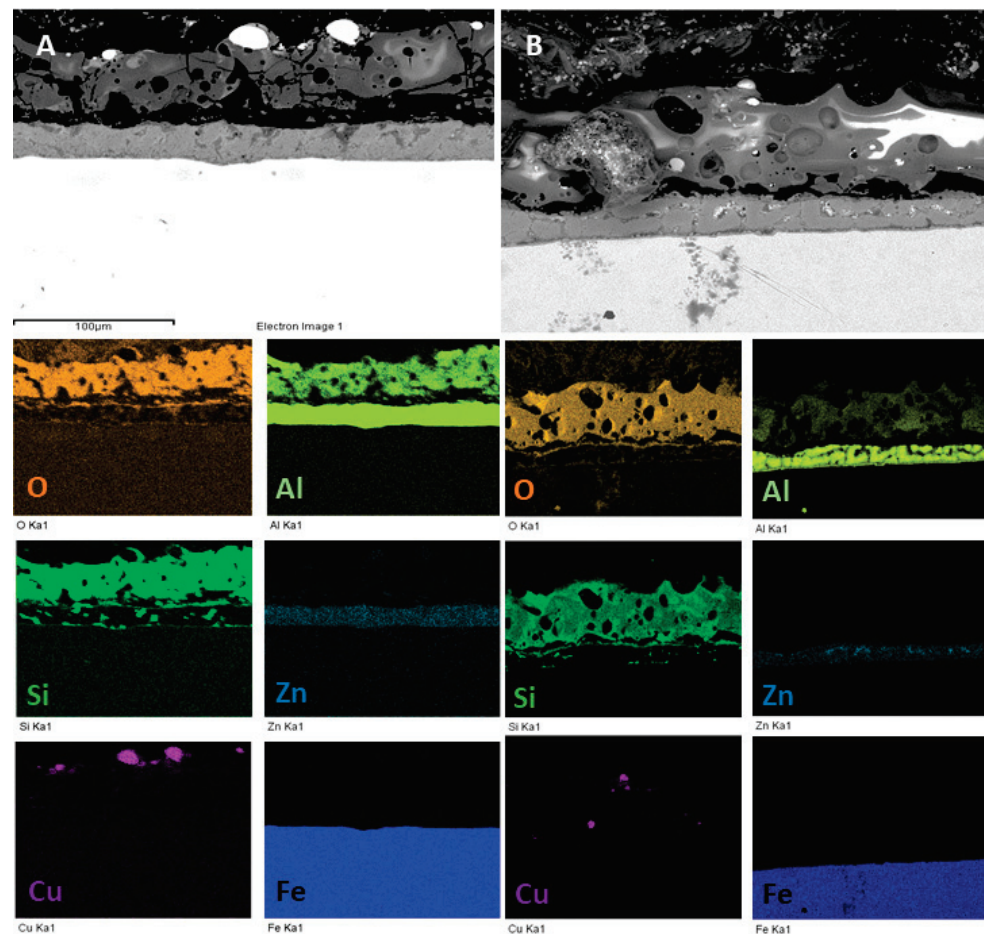
**Figure 5.** EDS elemental maps of the samples obtained working at  $1 \text{ A/cm}^2$  in UPC with large particles (A) and with small particles (B).

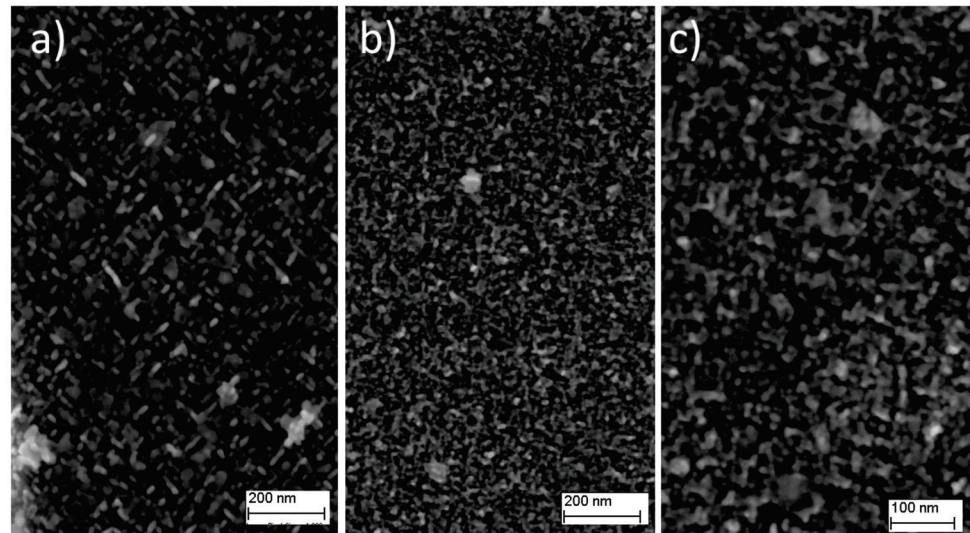
**Figure 13.** FESEM image of (a) 4AH and (b,c) 1DAH samples of micro-LPBF Inc718.

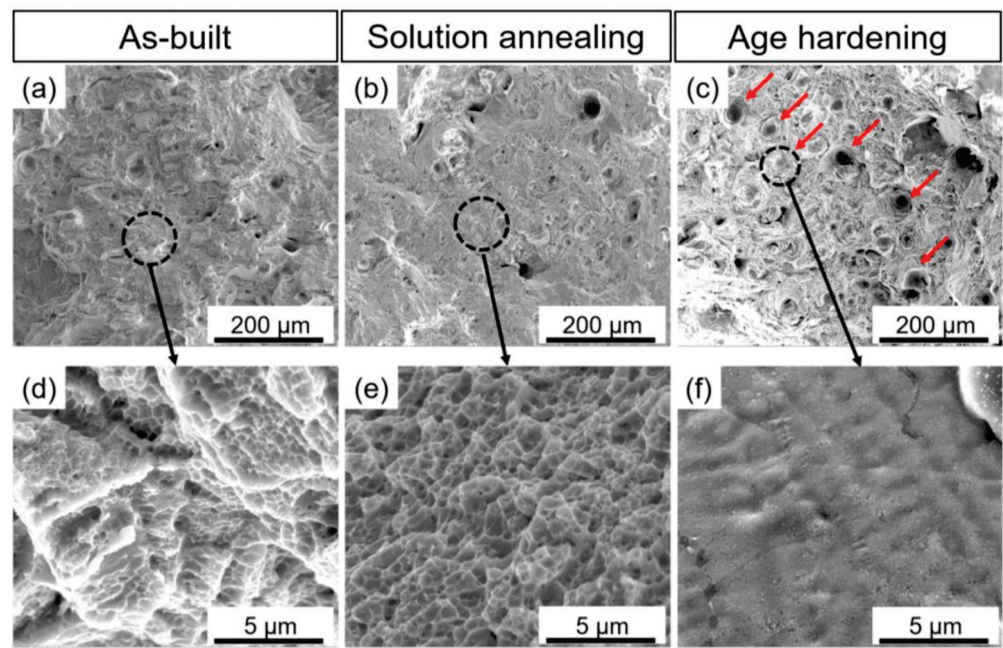
**Figure 18.** Fracture surfaces of micro-LPBF processed Inc718 samples after uniaxial tensile tests; (a,d) as-built sample, (b,e) solution annealed sample, (c,f) single-step age hardened sample at 720 °C for 8 h (4AH).

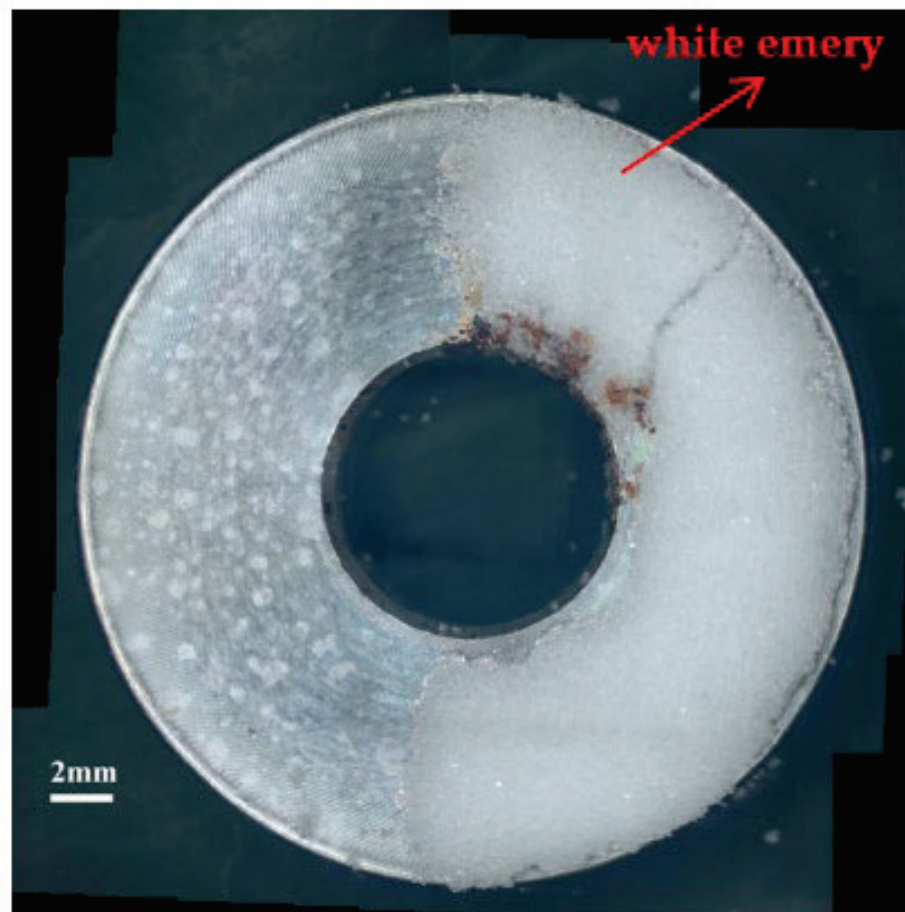
**Figure 3.** Macrographs of the specimens with a  $1 \text{ g/m}^2$  chloride concentration after 7000 h of testing a relative humidity (RH) of 70%.

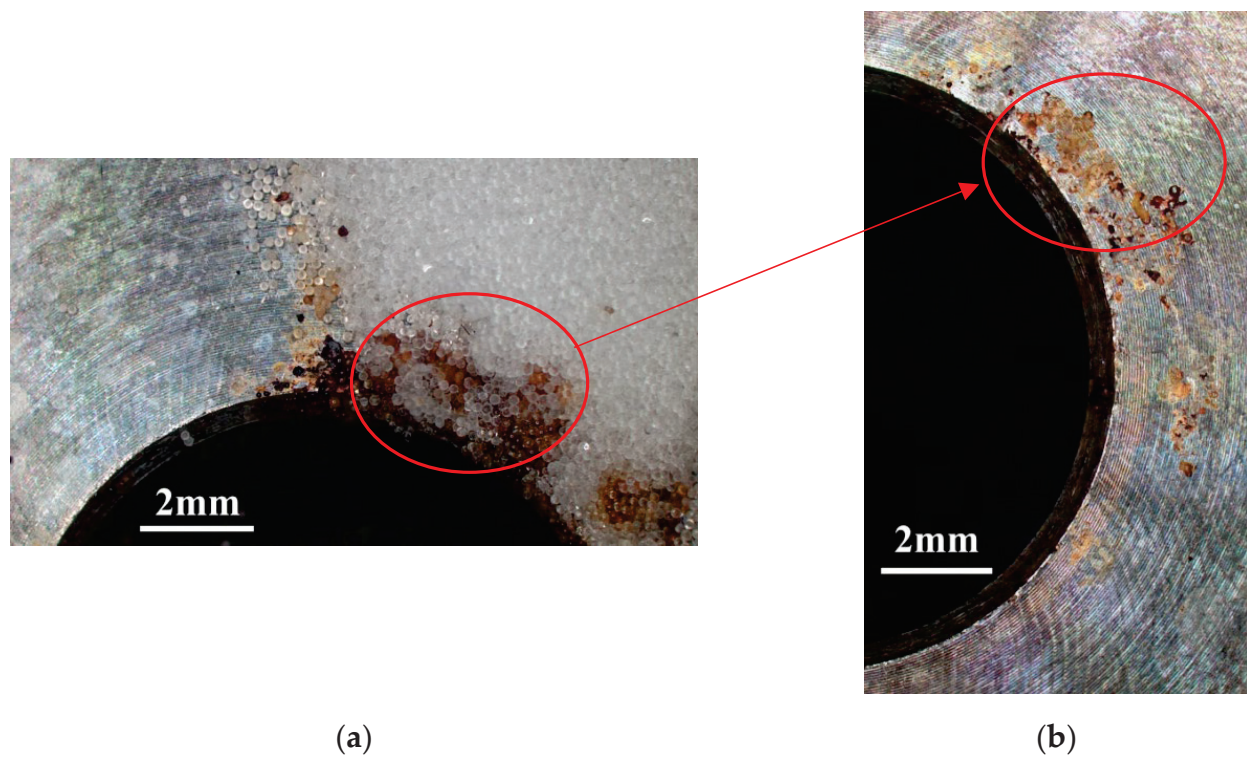
**Figure 4.** Macrographs of the corrosion regions of those samples with a chloride concentration of  $1 \text{ g/m}^2$  at RH = 70%: (a) Specimen before cleaning and (b) specimen after cleaning.

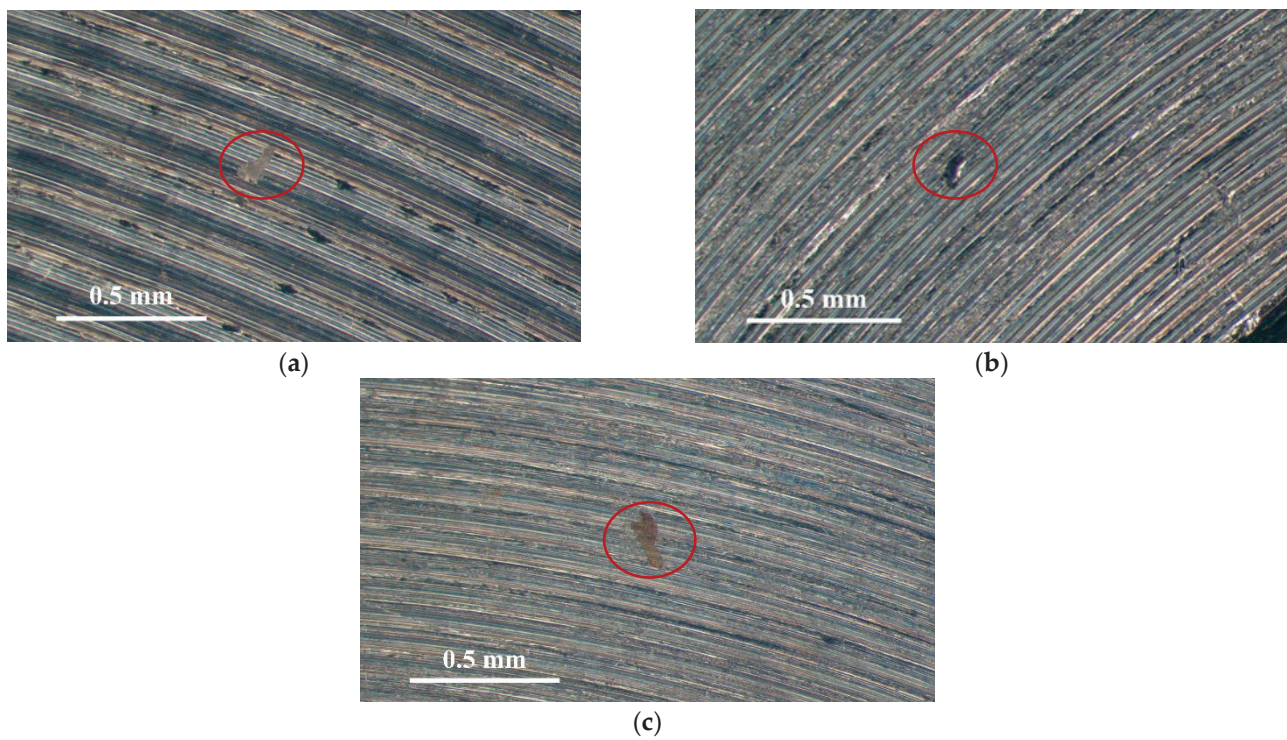
**Figure 5.** Macrographs of the corrosion regions of those samples with a  $0.1 \text{ g/m}^2$  chloride concentration at: (a) Relative humidity = 45%, (b) relative humidity = 55%, and (c) relative humidity = 70%.

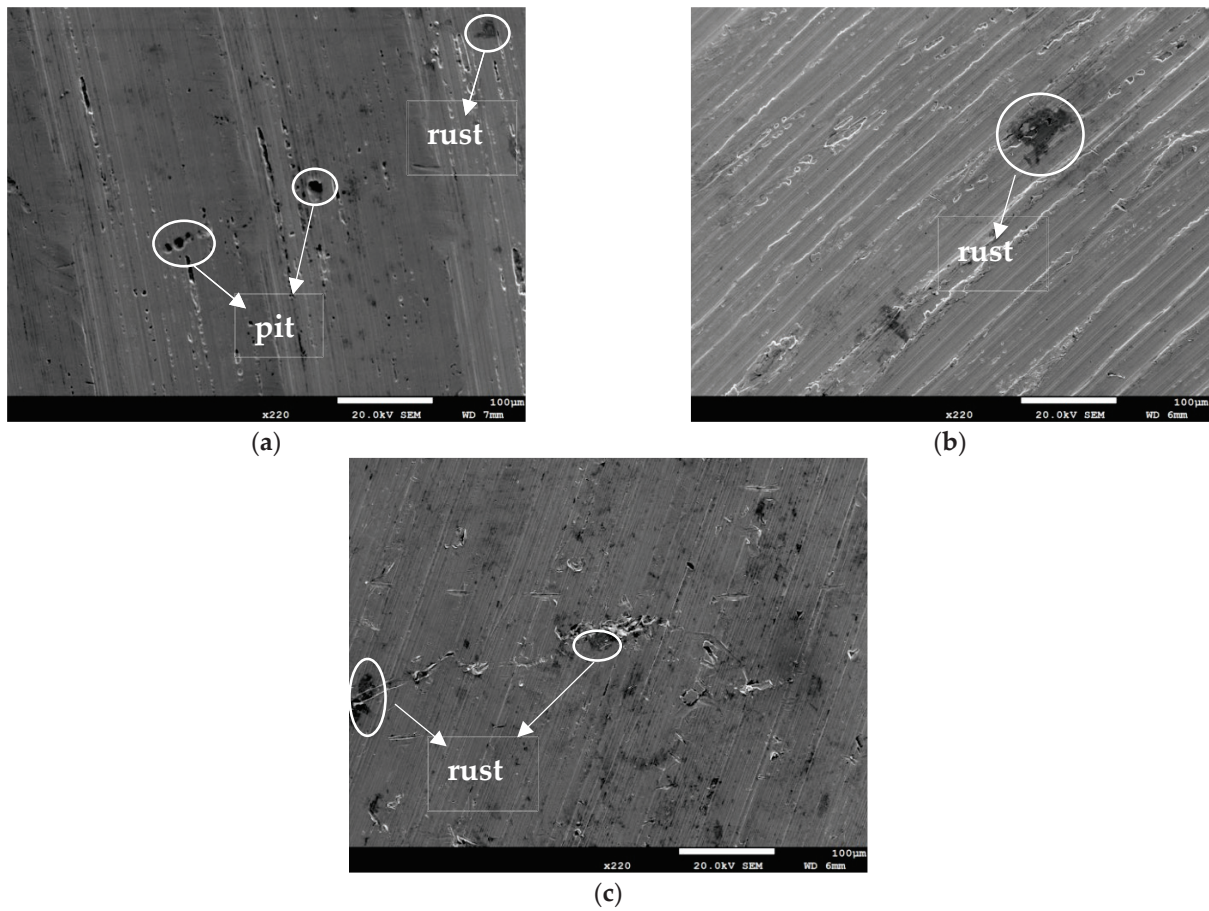
**Figure 6.** SEM micrographs of those specimens with a  $0.1 \text{ g/m}^2$  chloride concentration at: (a) Relative humidity = 45%, (b) relative humidity = 55%, and (c) relative humidity = 70%.

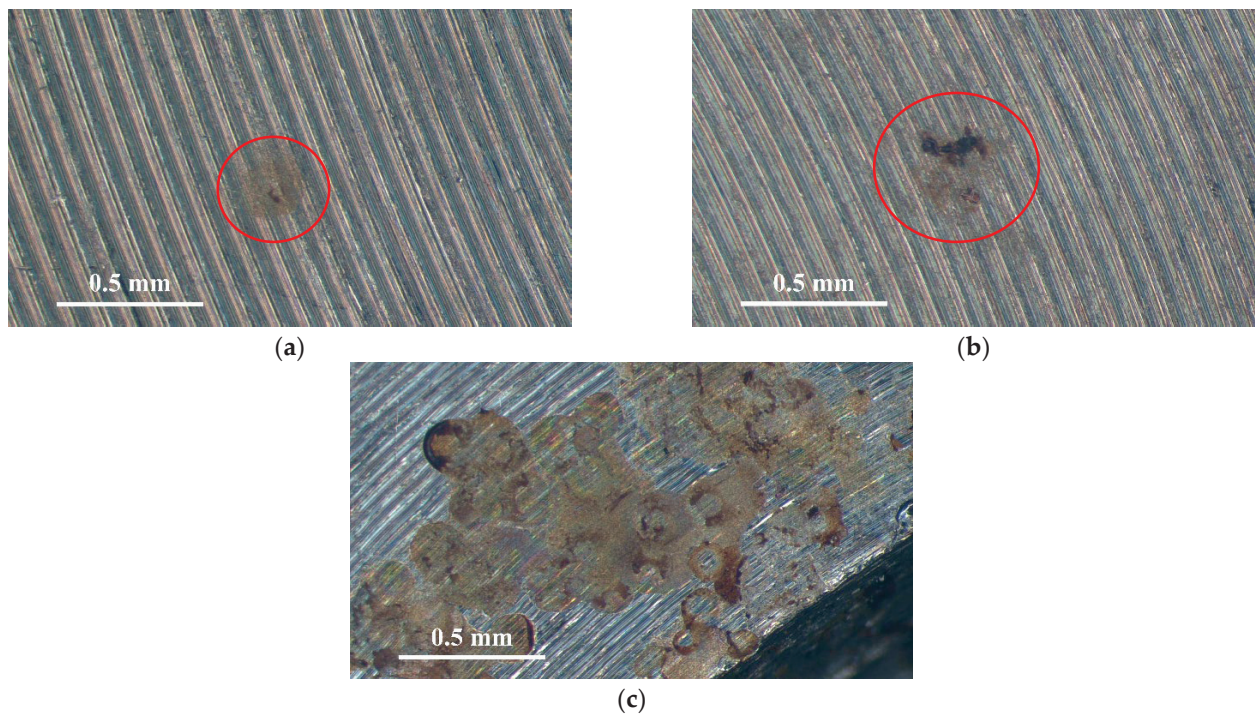
**Figure 7.** Macrographs of the corroded regions of those samples with a  $1 \text{ g/m}^2$  chloride concentration at: (a) Relative humidity = 45%, (b) relative humidity = 55%, and (c) relative humidity = 70%.
