# Investigation of Microstructural and Corrosion Properties of Steels and Light Alloys

Edited by  
Claudio Gennari and Luca Pezzato

# Investigation of the Microstructural and Corrosion Properties of Steels and Light Alloys

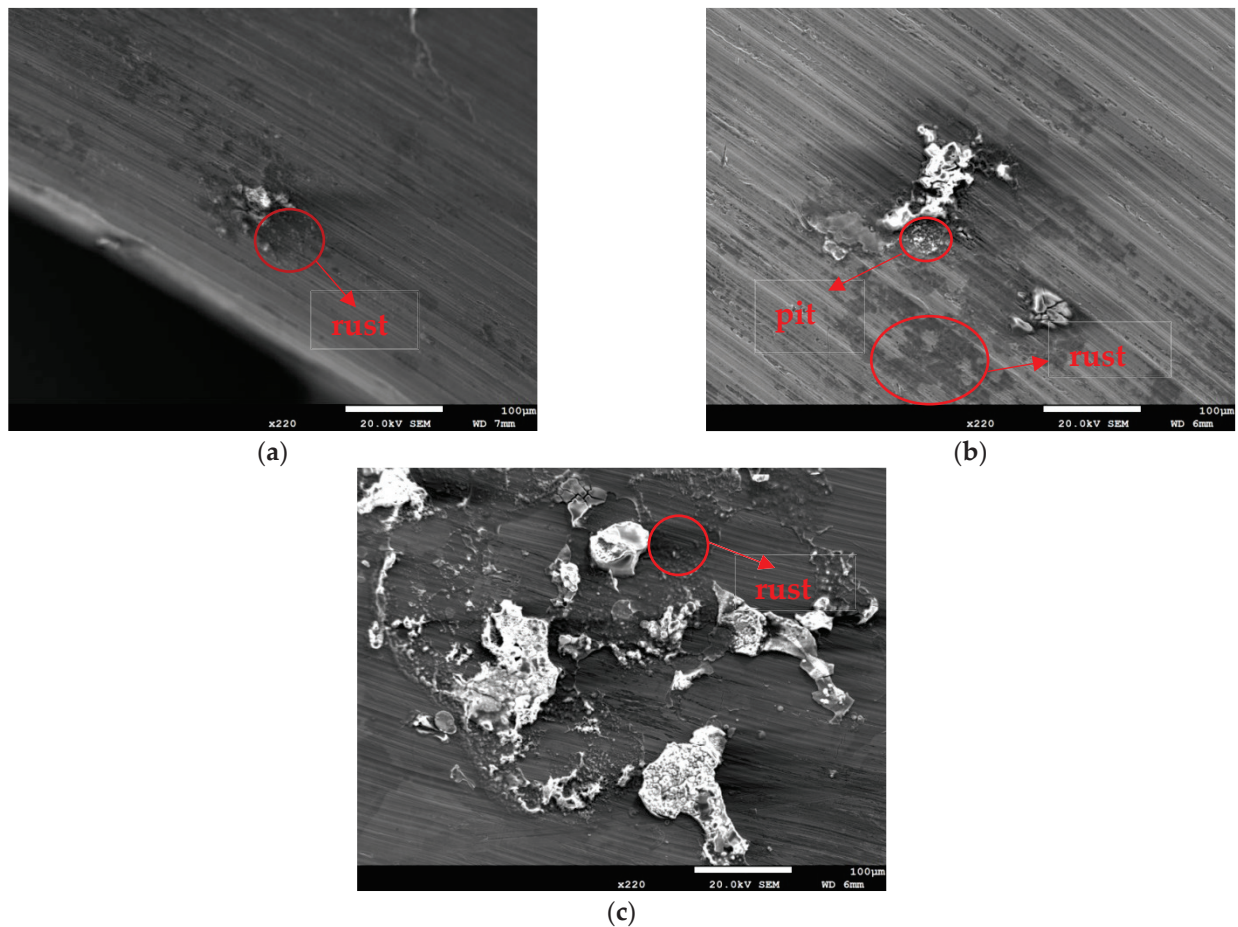
**Figure 8.** SEM micrographs of those samples with a chloride concentration of  $1 \text{ g/m}^2$  after 7000 h of testing at: (a) RH = 45%, (b) RH = 55%, and (c) RH = 70%.

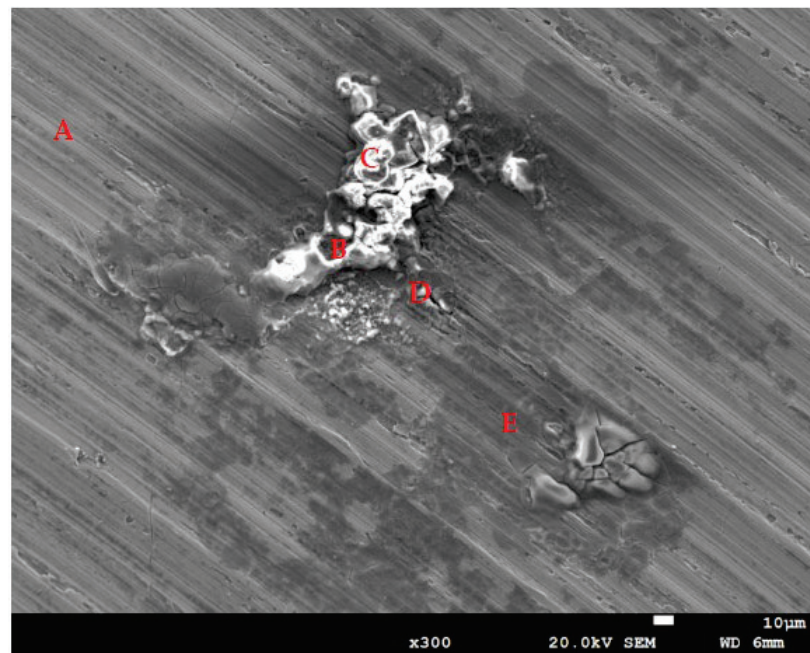
**Figure 9.** Energy dispersive X-ray spectrometry (EDS) analysis of the corroded regions on those specimens with a  $1 \text{ g/m}^2$  chloride deposit after testing at 55% relative humidity for 7000 h.

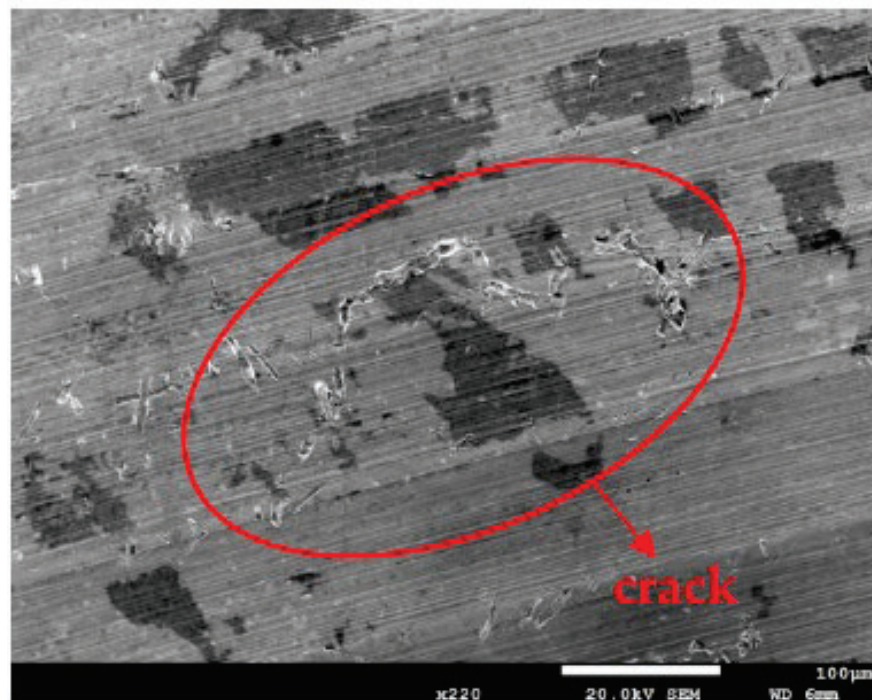
**Figure 10.** SEM morphology of the SCC in those samples with  $0.1 \text{ g/m}^2$  of chloride deposited after 7000 h of testing at RH = 70%.

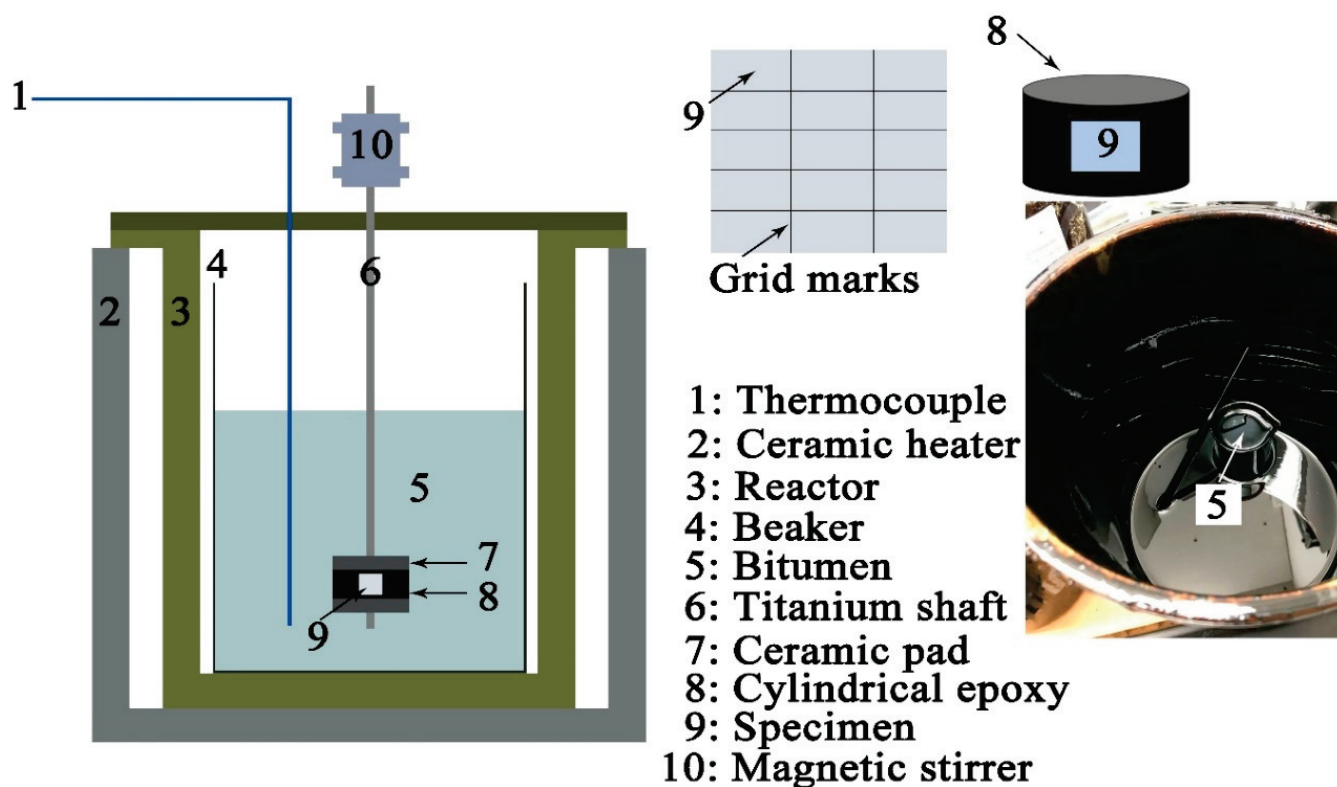
**Figure 1.** Schematic of the autoclave setup used to examine the corrosion of API-X100 pipeline steel in bitumen at 60 and 120 °C. Bitumen is shown at right in an unrelated separate bucket.

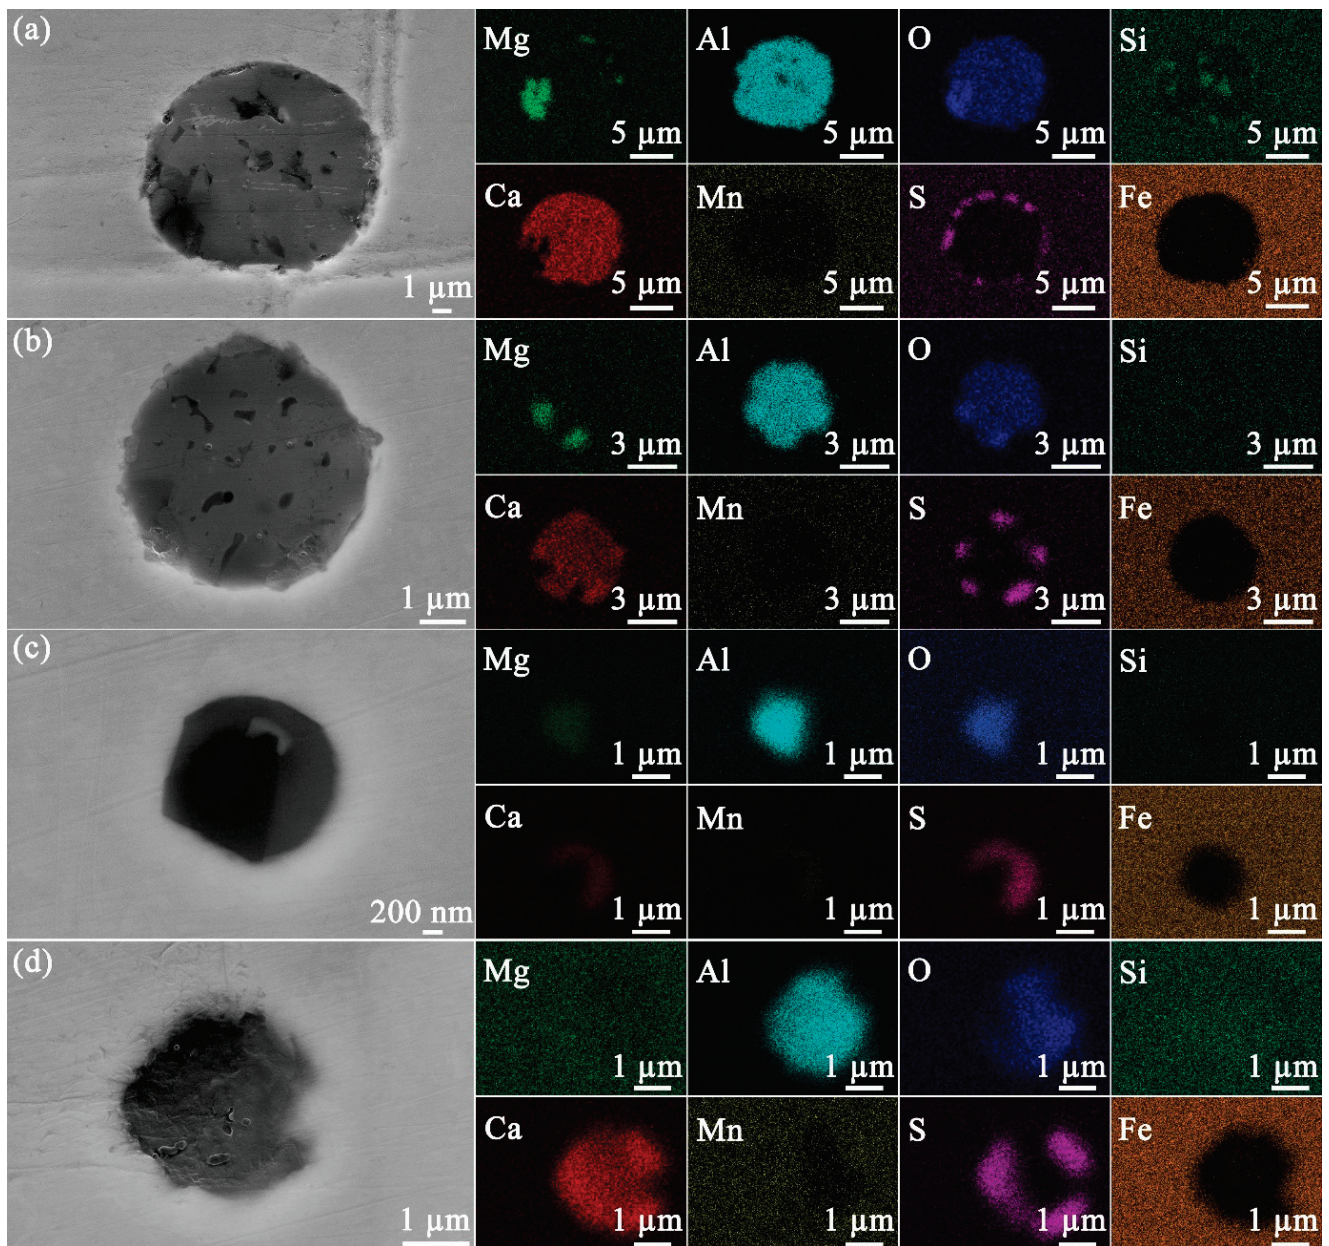
**Figure 2.** SEM/SE (secondary electron) images of inclusions containing (a) Mg–Al–Si–O–Ca–S, (b) Mg–Al–O–Ca–S, (c) Mg–Al–O–Ca–Mn–S, and (d) Al–O–Ca–S on unexposed steel. The elemental distributions of the inclusions are given at right.

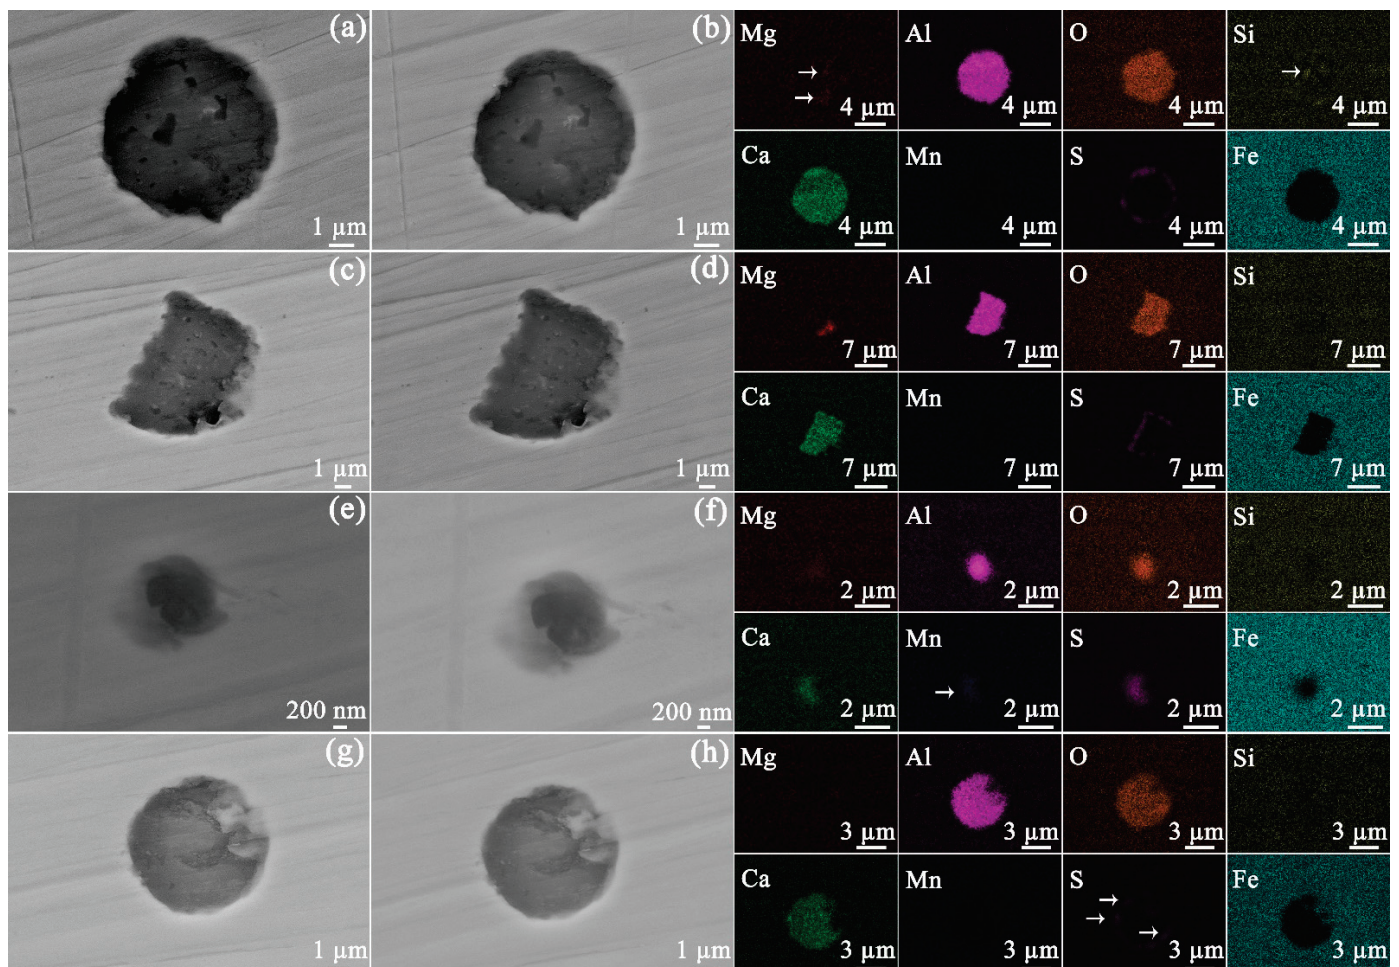
**Figure 3.** SEM SE images of the inclusion containing Mg–Al–Si–O–Ca–S before (a) and after (b) exposure to bitumen at 60 °C, of the inclusion containing Mg–Al–O–Ca–S before (c) and after (d) exposure to bitumen at 60 °C, of the inclusion containing Mg–Al–O–Ca–Mn–S before (e) and after (f) exposure to bitumen at 60 °C, and of the inclusion containing Al–O–Ca–S before (g) and after (h) exposure to bitumen at 60 °C. The elemental distributions of the inclusions are given at right. In the EDS maps given at right, the areas with low signal intensity are marked with arrows.

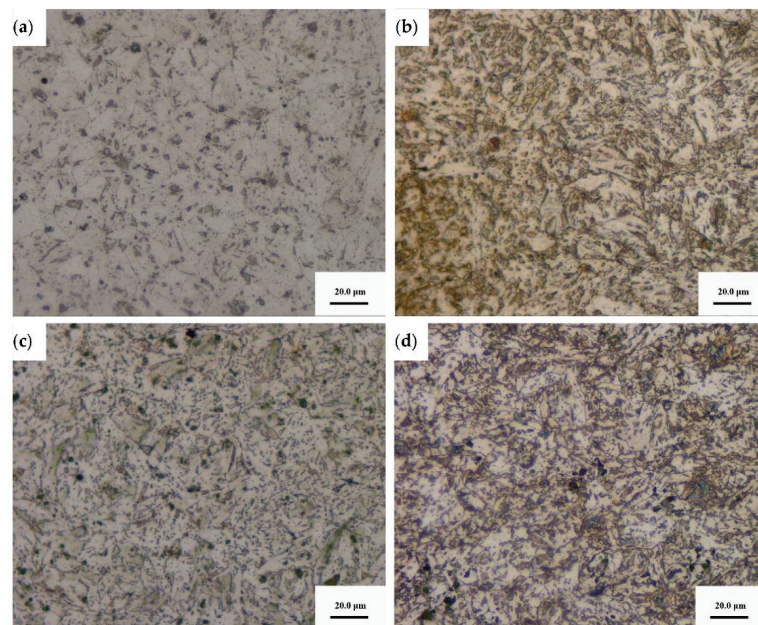
**Figure 2.** Metallographic structures of the four types of niobium bearing steels (a) No. 8 steel (b) No. 9 steel (c) No. 10 steel (d) No. 11 steel.

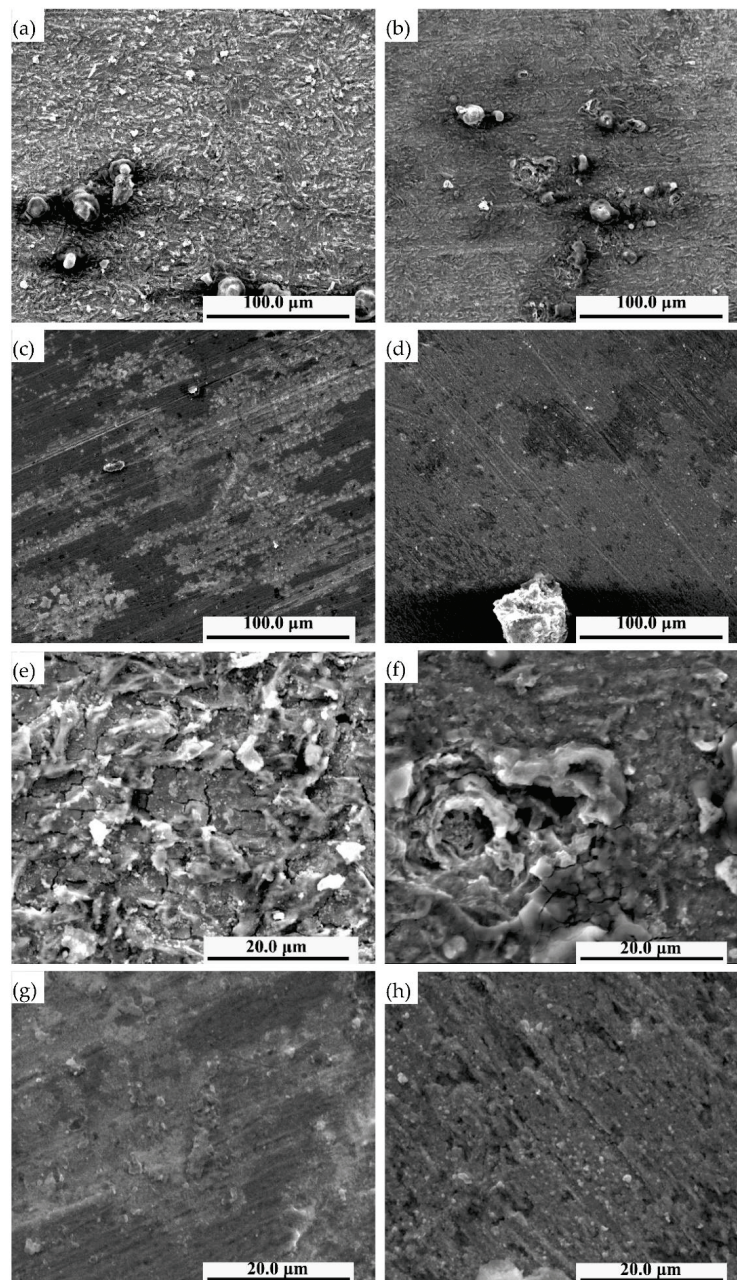
**Figure 7.** Surface corrosion morphology of No. 8 steel (a,e), No. 9 steel (b,f), No. 10 steel (c,g) and No. 11 steel (d,h) after 240 h corrosion.

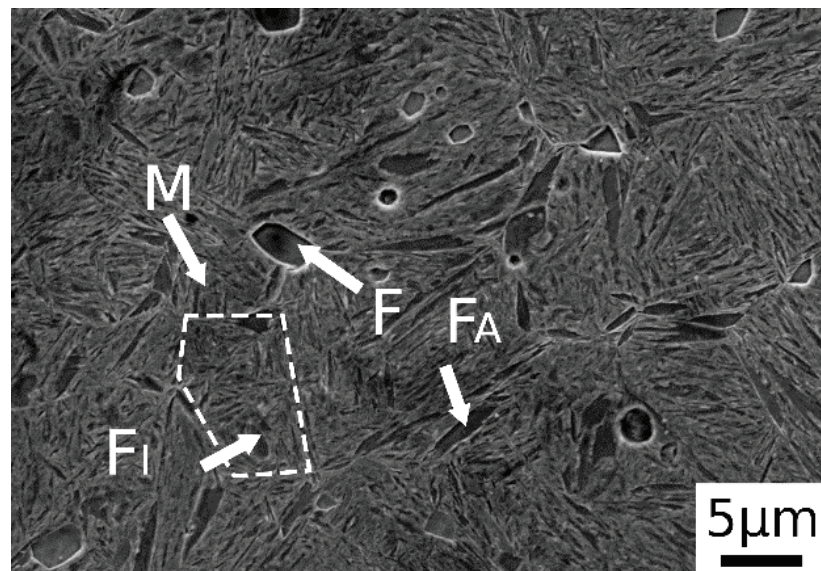
**Figure 2.** SE-SEM image of material after normalization (M martensite, F ferrite,  $F_A$  alloyed ferrite and  $F_I$  idiotropic ferrite).

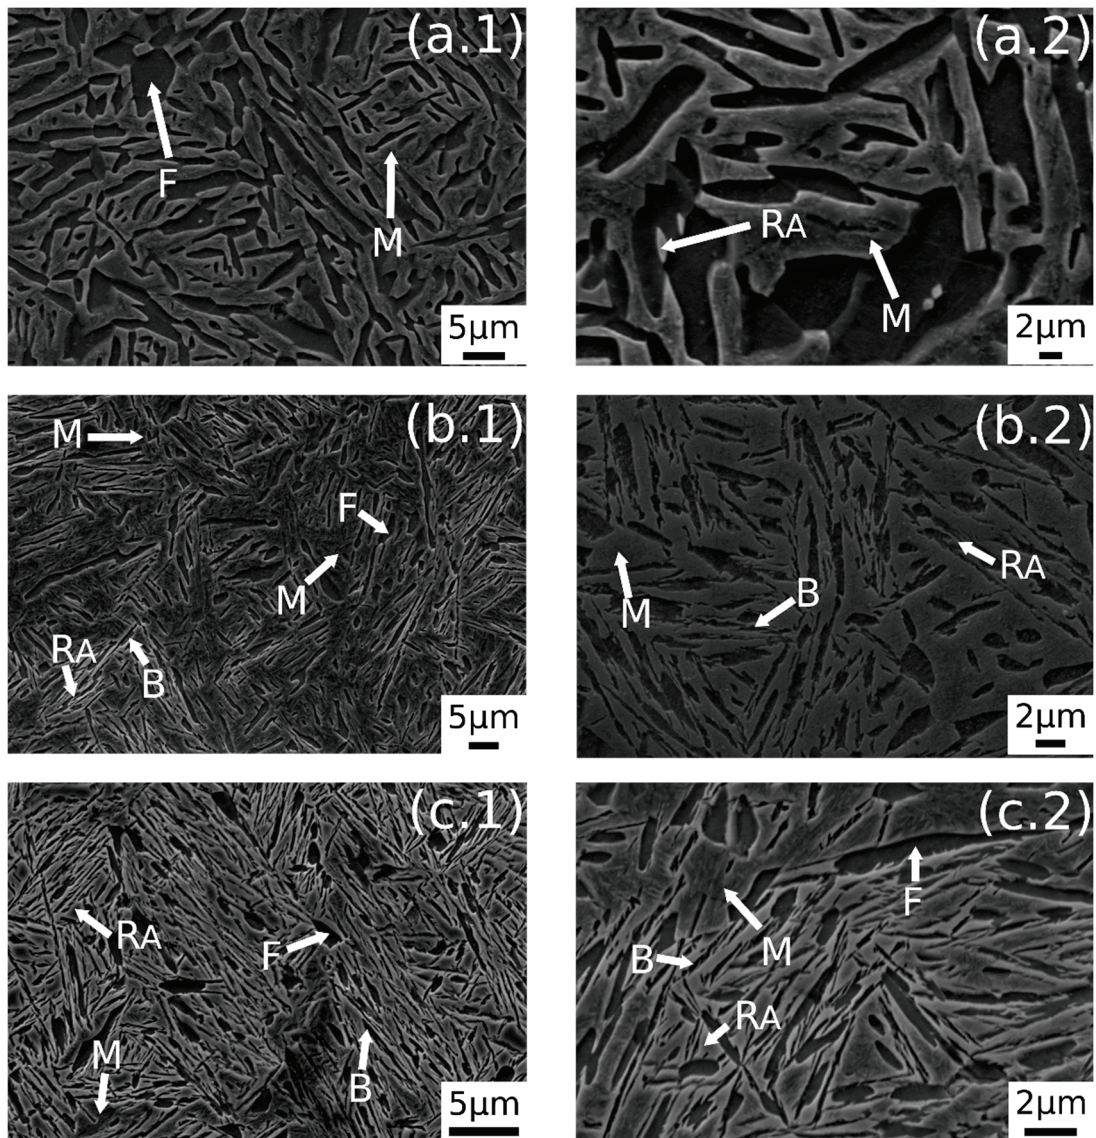
**Figure 3.** SE-SEM images of the surfaces of the samples: (a.1,a.2) 780 °C + 350 °C, (b.1,b.2) 830 °C + 350 °C, (c.1,c.2) 850 °C + 350 °C. (M martensite, F ferrite,  $R_A$  retained austenite, B carbide free bainite).

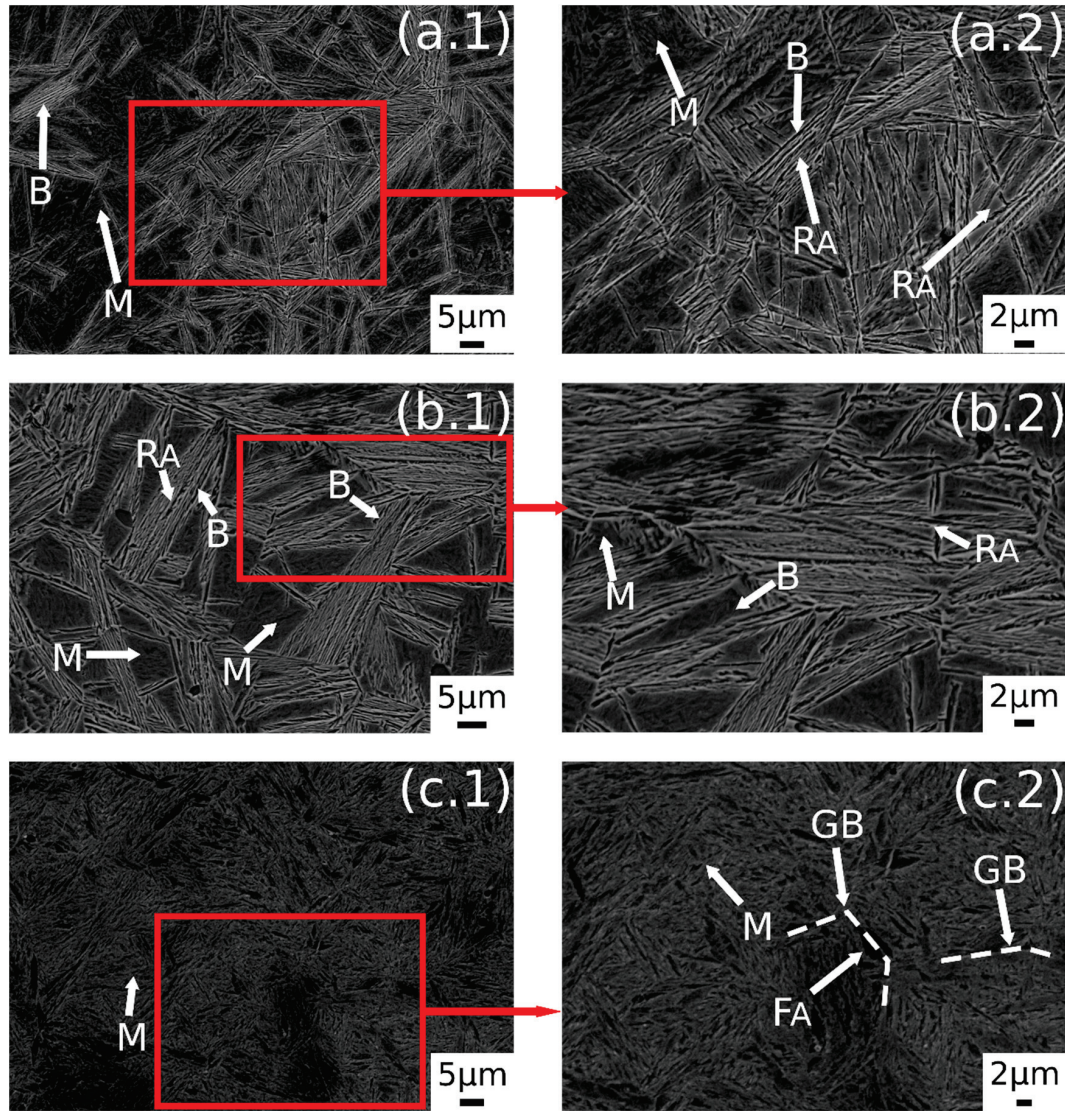
**Figure 5.** SE-SEM images of the surfaces of the samples: (a.1,a.2) 900 °C + 300 °C, (b.1,b.2) 900 °C + 350 °C, (c.1,c.2) 900 °C + 400 °C. (M martensite, F ferrite, R<sub>A</sub> retained austenite, B carbide free bainite, GB prior austenite grain boundary, F<sub>A</sub> allotriomorphic ferrite).

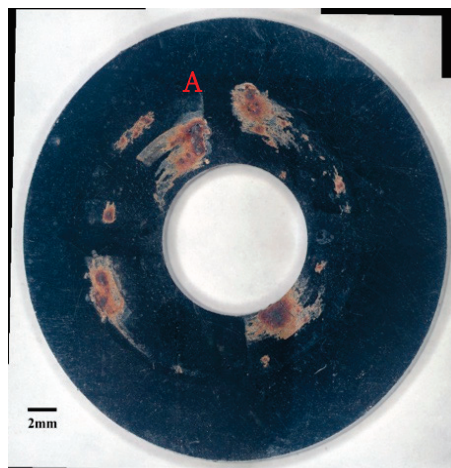
**Figure 3.** Macrographs of the corroded regions of the specimens with chloride concentration of  $0.1 \text{ g/m}^2$  after 10,000-h testing at: (a) RH = 45%, (b) RH = 55%, and (c) RH = 70%.
