Topical Collection Reprint

Assessment, Reconstruction and Decision Procedures for the Preservation of Existing Structures after Earthquakes

Edited by
Mislav Stepinac, Chiara Bedon, Marco Francesco Funari,
Tomislav Kišiček and Ufuk Hancilar

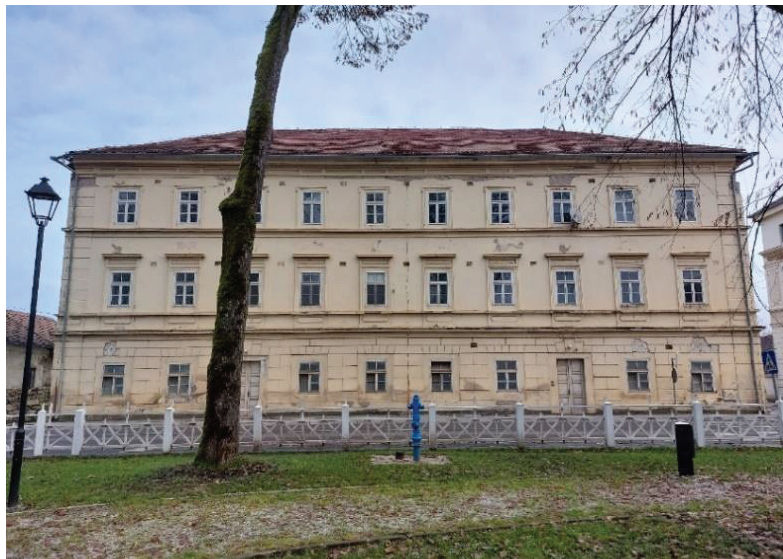
Figure 2. South-west facade of case study building.

The case study building (Figures 2 and 3), which is the subject of an ongoing condition assessment study, was inspected after a devastating series of earthquakes in Petrinja and its surroundings. The subject of this study is an isolated structure located at Trg bana Josipa Jelačića 21 in Glina. The building is a combined private and public property, and is a protected individual cultural asset of the Registry of Cultural Assets of the Republic of Croatia. The available existing documentation of the building shows that the building dates back to the 19th century. After a thorough reconstruction, the building took on its present form in 2000.

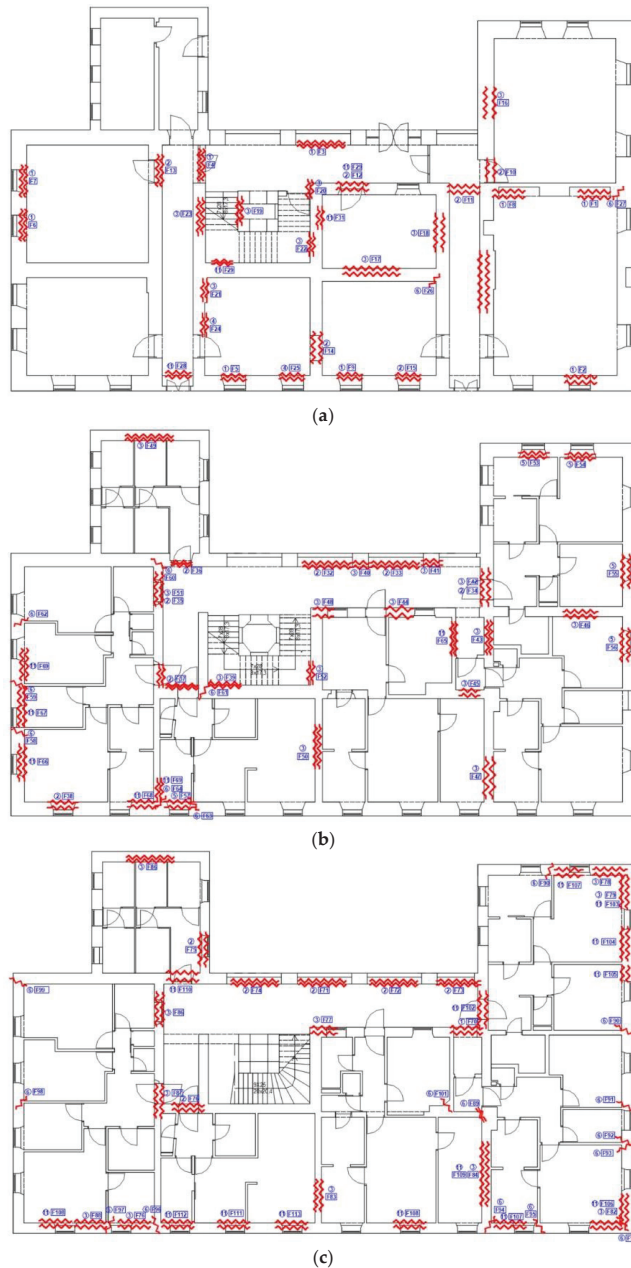
Figure 7. Damage patterns (red marks): (a) ground floor, (b) first floor, and (c) second floor.

After a rapid inspection, a detailed inspection of the building was carried out in May 2022. All instances of damage, structural and non-structural (Figure 7), were photographed and described in reports on the floors of the building and the individual rooms in which they are located, and proposed measures for their repair were given. A detailed recording of the existing condition was also made for the purpose of creating digital floor plans of the building.

Detailed inspections of the residential building (former gymnasium building) revealed the following recorded instances of damage: on the ground floor, there is visible damage in the form of cracks in the wall coverings (Figure 8), arches, vaults and ceilings, as well as separation and localized falling off of the plaster. Minor local damage to structural elements (walls, columns, and arches) is also visible. Damage is visible on all floors in the form of cracks and falling plaster on the walls. Minor local damage to the walls is also visible, and there are locally visible cracks at the junctions of load-bearing walls and ceilings (Figure 9). At the edges of the building, oblique cracks are visible on the load-bearing walls, and can also be seen on the facade of the building. In addition to the previously documented damage to the construction elements of the building, damage to other elements was observed. The partition walls are mostly damaged. Other instances of damage include the chipping of plaster on structural and non-structural elements, damage to the finishing coverings on the walls and floors, and the collapse of part of the cornice and other decorative elements (Figure 10). The roof was damaged in several places, and the roof covering near the chimneys collapsed (Figure 11).

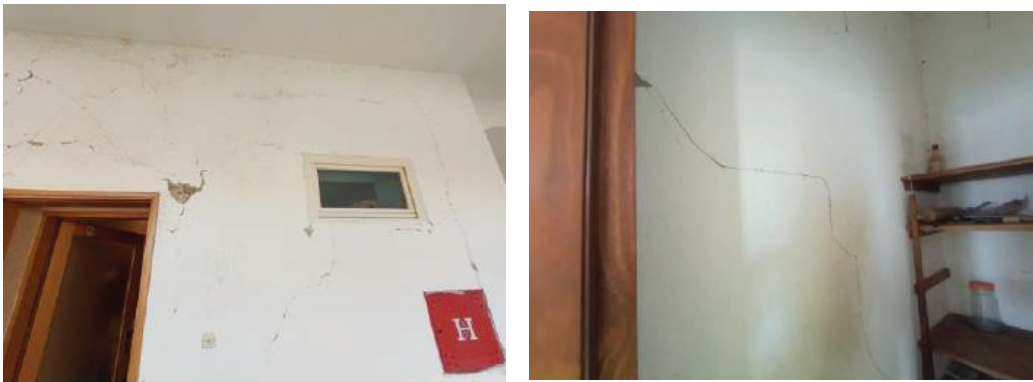
Figure 8. Cracks on the load-bearing walls on the first floor.

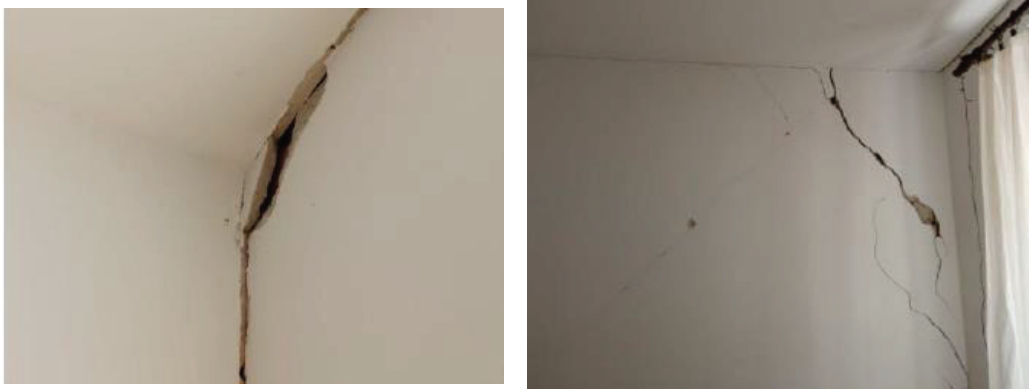
Figure 9. Cracks at the junctions of load-bearing walls.

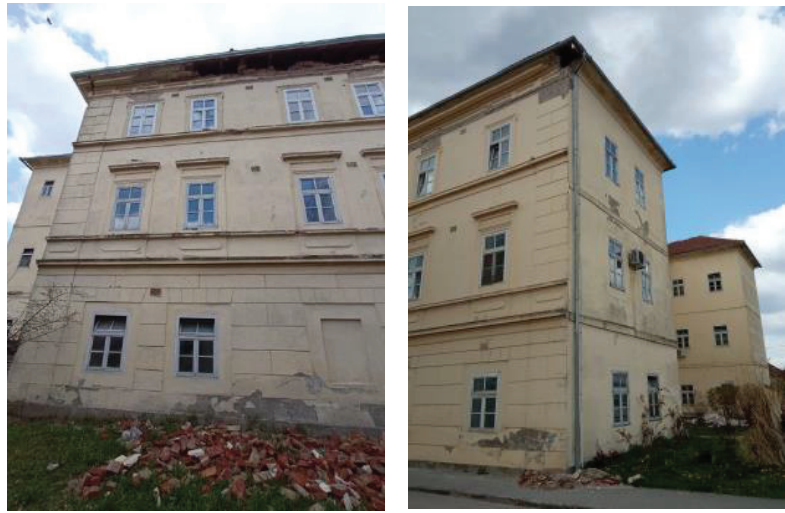
Figure 10. Damage to the facade.

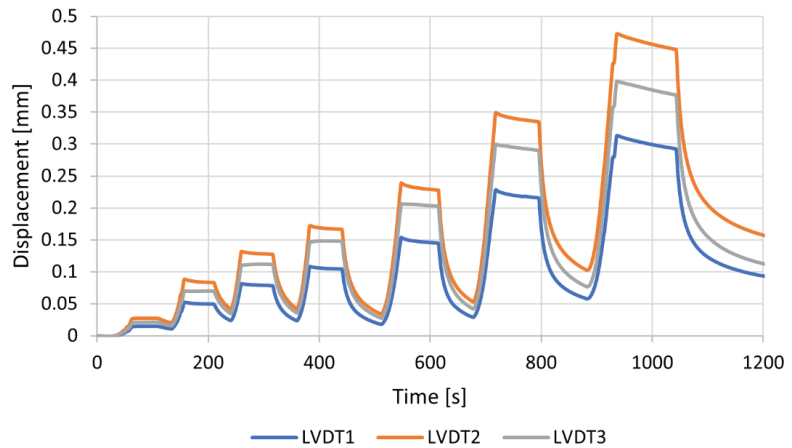
Figure 13. Measured displacement during double flat-jack test.

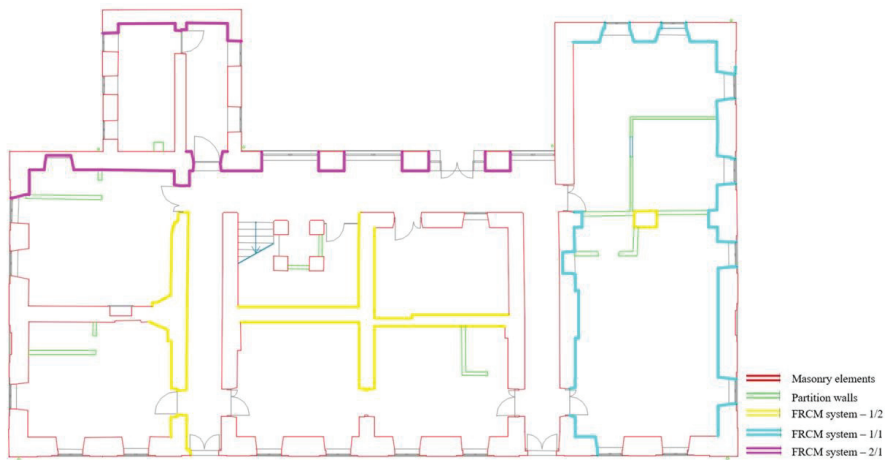
Figure 19. Strengthened structure of the ground floor.

is characterized by crushing in the compression area. The minimum value of the three is considered the resistance of the element. If the internal forces are higher than the resistance, the FRCM composite has been applied to the wall. The contribution of the FRCM system to the resistance of the wall layer was calculated. The number of layers is increased until a resistance greater than the internal forces is achieved. The FRCM composite was applied to the walls in the software, which caused the redistribution of the internal forces. Hence, the calculation of the strengthening is an iterative procedure. The proposed solution is displayed in Figures 19 and 20. The walls on which the FRCM system is applied are marked according to the legend, and denoted l/n . l represents the number of layers applied per side of the wall, while n indicates if the FRCM system is applied to a single side of the wall ($n = 1$) [45,46] or on both sides ($n = 2$). Although the system is placed asymmetrically regarding the floor plan, the solution does not cause additional torsion, as the fibers have a low individual weight, and 0.5 cm of the cementitious matrix is applied per layer of the fibers. The system exclusively affects the in-plane capacity.

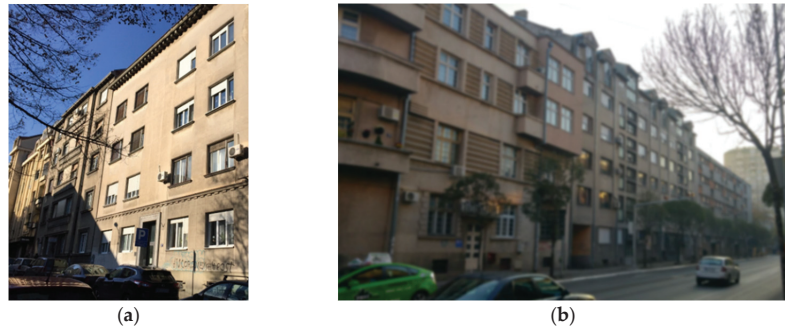
Figure 1. Examples of URM multi-family residential buildings in Serbian cities: (a) Belgrade and (b) Niš.

semi-prefabricated RC floor systems. Buildings of this type constitute a significant fraction of the building stock in urban areas of Serbia and neighboring countries and are the focus of this study. A few examples of typical urban URM multi-family residential buildings from Serbian cities Belgrade and Niš are shown in Figure 1a and Figure 1b respectively.

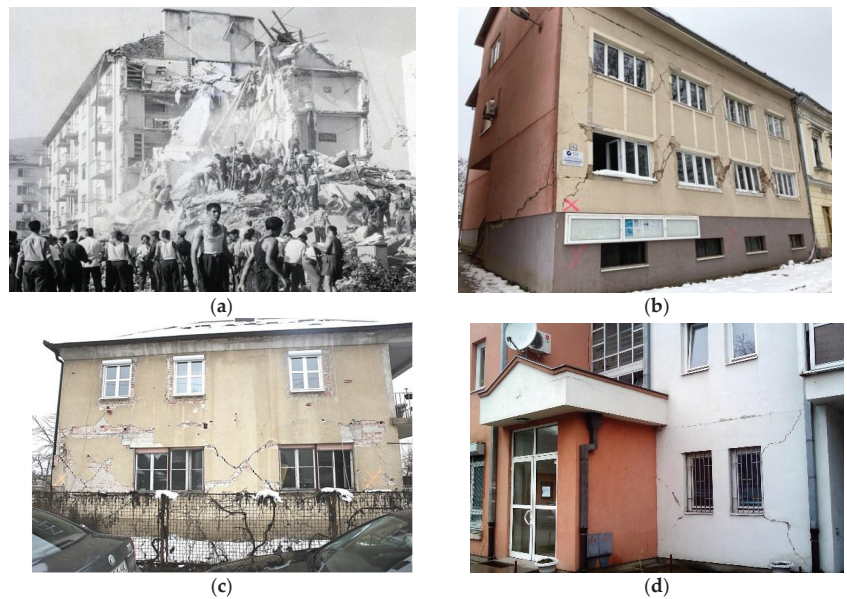
Figure 2. Seismic performance (DSs) of URM residential buildings in past earthquakes in the Balkan region: (a) DS5—a collapsed building in Skopje due to the 1963 Skopje earthquake (credit: Z. Milutinović); (b) DS4—a URM building in Petrinja experienced extensive cracking in wall piers due to the 2020 Petrinja earthquake (credit: SUZI-SAEE); (c) DS3—a URM building in Petrinja experienced a major shear-induced cracking in piers at the ground floor level due to the 2020 Petrinja earthquake (credit: SUZI-SAEE), and (d) DS2—a moderately damaged URM building which experienced moderate shear-induced cracking due to the 2010 Kraljevo earthquake (credit: P. Blagojević).

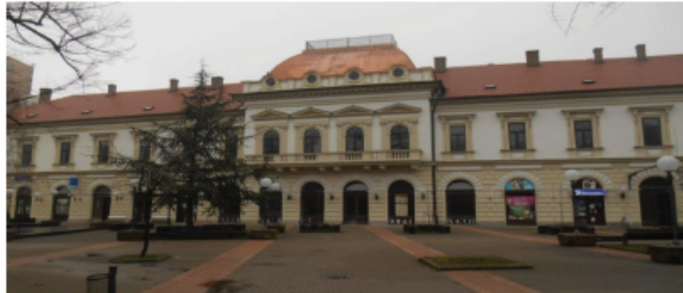
Figure 9. The Diocese in Pančevo, Serbia—a view of the front façade.

This approach was used to increase the seismic resistance of the Diocese in Pančevo, Serbia, an existing URM building of cultural and historical importance which was constructed in 1832 (Figure 9) [63]. Loadbearing URM walls were 62 cm thick and were constructed in lime mortar. Due to earlier interventions, significant portions of load-bearing walls were removed and openings were formed in transverse walls (shown in solid red

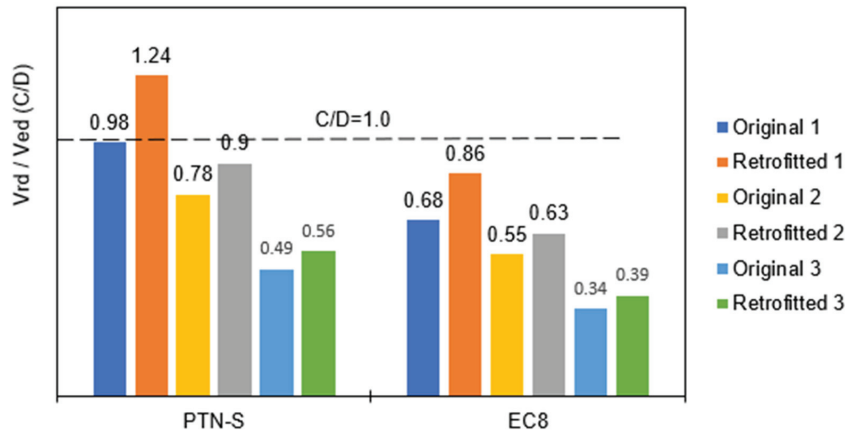
Figure 29. Seismic capacity versus demand (C/D) ratio in the analyzed wall for the original and retrofitted building.

Based on the example of this wall and other similar walls in the building, it can be concluded that the presented seismic retrofit solution, which was developed based on the PTN-S and PTN-R codes from former Yugoslavia, does not meet the EC8-3 requirements for retrofitted masonry buildings.

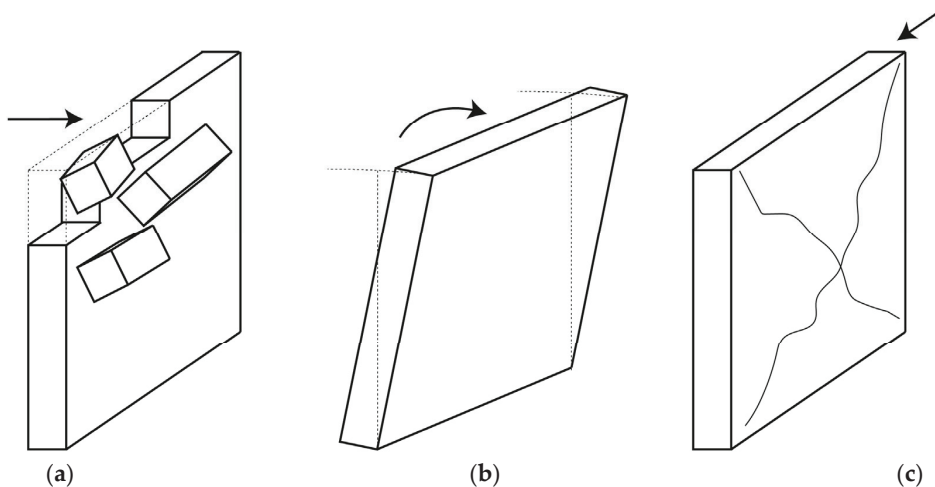
Figure 3. Masonry failure mechanisms—(a) masonry disintegration, (b) out-of-plane kinematic mechanism, and (c) in-plane failure.

After the input data have been entered in the assessment form, the processing takes place in the background (it is not visible to the user). One of the key aspects of the processing stage is determination of the most critical masonry failure mechanism for a specific building. The Adriseismic method takes into account realistic seismic behaviour and failure mechanisms for URM structures, including (i) masonry disintegration, (ii) out-of-plane kinematic mechanisms, (iii) and in-plane failure. Figure 3 shows a schematic representation of these failure mechanisms.

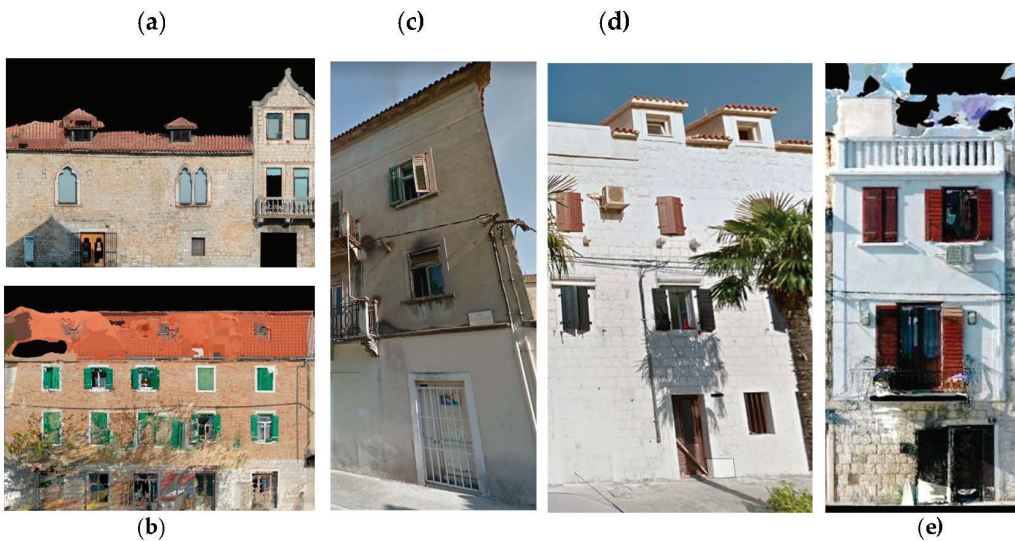
Figure 8. Selected five buildings for the Kaštela study area. Elevations photographed or reconstructed by photogrammetry.

The area dates back to the 15th century and was built at the behest of Archbishop Bartul Averaldo, who intended to create fortifications at the centre of the present Archbishop's palace. The assessment was carried out on five buildings, characterised by different construction techniques, construction periods, and functions; see Figure 8.

The first building (a) is public which dates back to the 15th century (Figure 8). Configuration is irregular both in height and plan, with one side being much longer than the other. The building has stone masonry walls and wooden floors and roof.

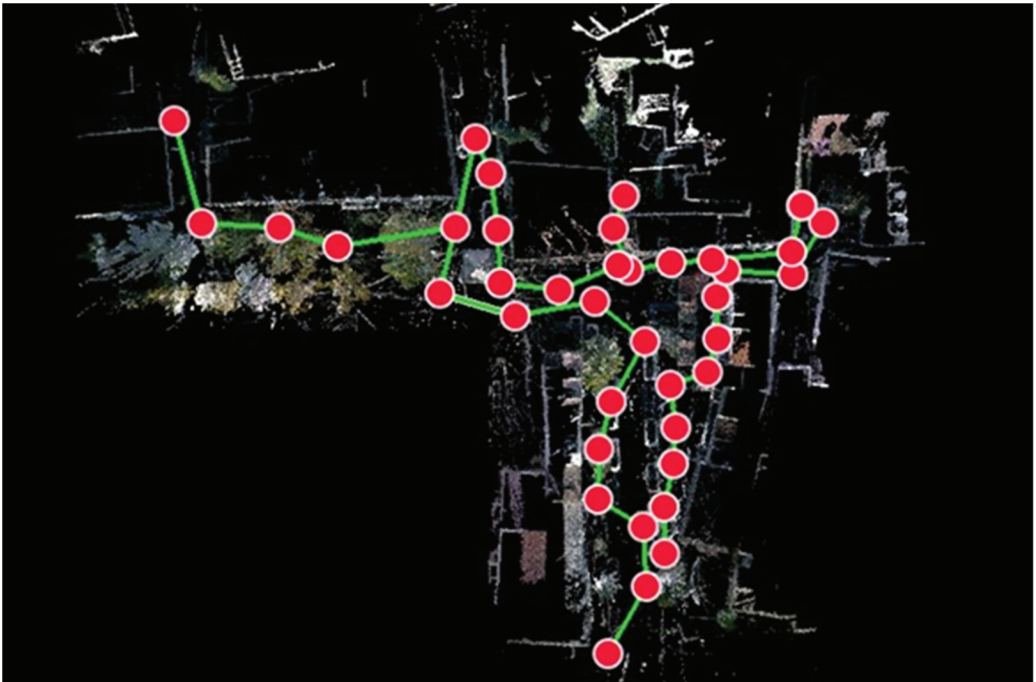
Figure 9. Plan view of the point cloud showing camera stations.

The input information was obtained using: (i) historical surveys which were used to find information to demonstrate the building modifications that have occurred over time or the presence of structural interventions; (ii) physical surveys such as on-site measurements and aerial-photogrammetric surveys. The full laser scanning of the area from the ground was conducted to create a 3D cloud of points (Figure 9). The laser scanner was a compact Leica BLK360 3D imaging laser scanner with an integrated spherical imaging system and thermography panorama sensor system. Laser scanning facilitates and speeds up, documenting and reviewing geometry, especially for large and complex buildings [51]. The point cloud was used to create an accurate 3D model of the area (Figure 8). Similarly, full 3D photogrammetry scanning was performed by unmanned aerial devices (drones), which produced several 360° images that were used in the post-analysis stage [52].

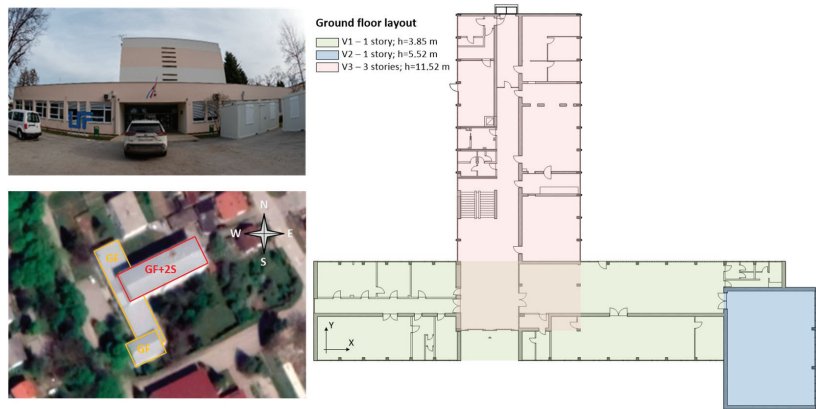
Figure 3. Case study building.

The building of the higher education institution in Petrinja, Croatia, was built in 1963 and underwent energy renovation in 2018. The building consists of the ground, 1st, and 2nd floors; the area on the ground floor is 1294.3 m² and on the upper floors 603.4 m². The total gross floor area of the building is 2501.1 m², while the useful heated area of the building is approximately 2130 m². The building has an irregular T-shaped layout and consists of three volumes connected into one whole (Figure 3). In the northwest–southeast direction (hereafter X-dir), there are two volumes that have only the ground floor. The volume marked as V1 is 3.84 m high, while the volume V2 in the southeastern part of the building is 5.52 m high and consists of a one large hall. The central volume V3 of the building is arranged in a northeast–southwest direction (hereafter Y-dir) and has three stories with a total height of 11.52 m.

The load-bearing structure consists of interconnected reinforced concrete (RC) columns and beams that form façade frame systems at the building edges. Within the floor plan, the load-bearing system in the longitudinal direction consists of masonry brick walls with a thickness of 38 and 30 cm. In the transverse direction, the system consists of brick walls 30 cm thick, while the partition walls are 20 cm thick and are arranged irregularly within the floor plan. Columns and walls have RC strip foundations, most of which are interconnected. The floor structure is monolithic reinforced concrete, the so-called thin ribbed RC floor.

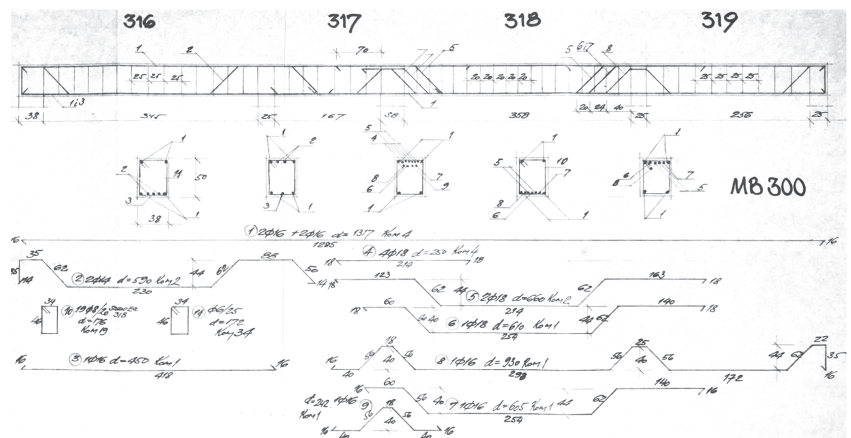
Figure 4. Reinforcement layout form original static design.

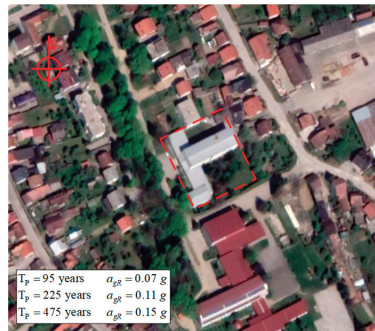
Figure 10. Horizontal peak ground accelerations for soil class A at the location [Google maps].

As for the seismic actions on the site, Figure 10 shows the peak ground acceleration values for soil class A (a_{gR}). Since this is an educational building, the importance factor γ_I is 1.2. For the calculation of the seismic action, the MASS combination of vertical forces is used.

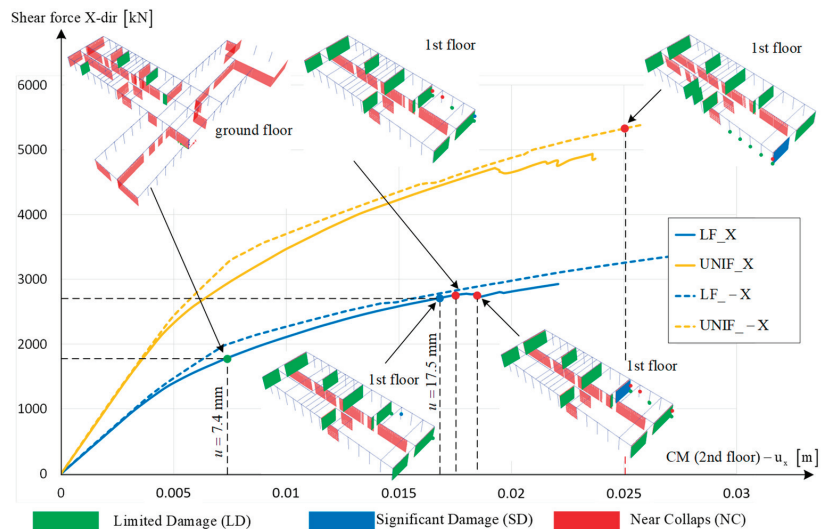
Figure 15. Pushover curves in X-dir for as-built structure.

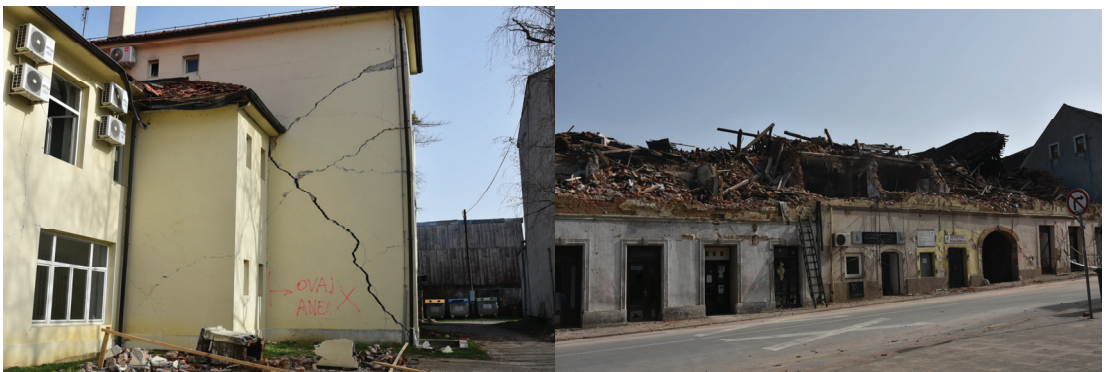
Figure 2. Damaged buildings in the historical center of Petrinja.

The Petrinja earthquake was devastating for buildings in the education sector, which suffered the greatest damage in Zagreb and Sisak-Moslavina counties. According to the data from the World Bank report [10] and HCPI [11], as many as 271 buildings were damaged in the earthquake, including 70 kindergartens, 160 primary schools, 32 secondary schools, 3 higher education buildings, and 6 student dormitories in the Sisak-Moslavina, Zagreb, Karlovac, Krapina-Zagorje Counties, and the City of Zagreb. All buildings are public assets, except for six kindergartens in Zagreb County. Most of the buildings were designated as usable or usable with a recommendation. In Sisak-Moslavina County, 109 buildings were damaged. In total, 18 were marked as temporarily unusable and 14 as unusable (1 kindergarten, 9 primary and 4 secondary schools). Some of these buildings require complete reconstruction or should be demolished and rebuilt again. Two photos of damaged buildings after the Petrinja earthquake in the historical center of the city of Petrinja are shown in Figure 2.

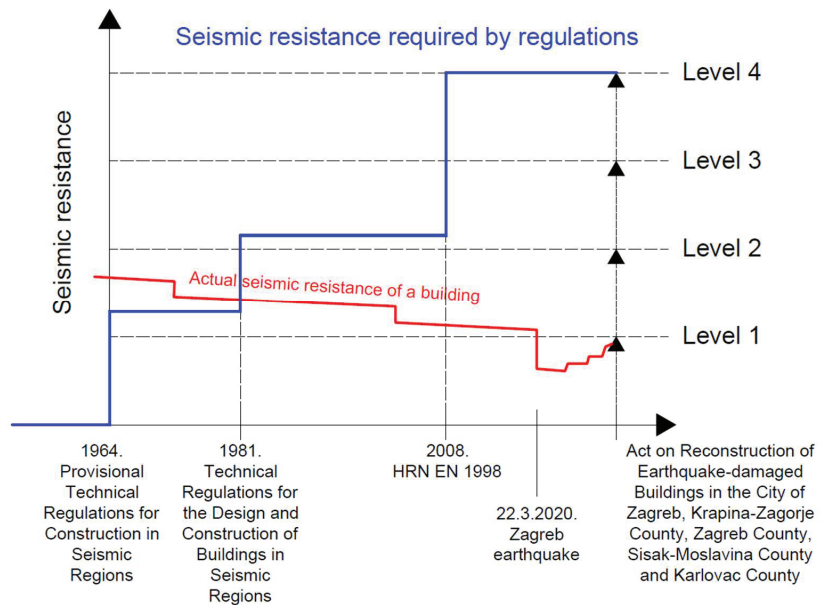
Figure 4. Schematic representation of the reconstruction levels in relation to the actual level of the building's seismic resistance capacity.

Figure 4 shows the difference between the actual seismic resistance level of the building and the seismic resistance ensured by different levels of reconstruction.

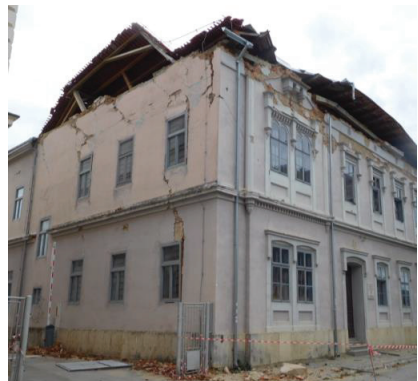
Partial overturning of the gable walls

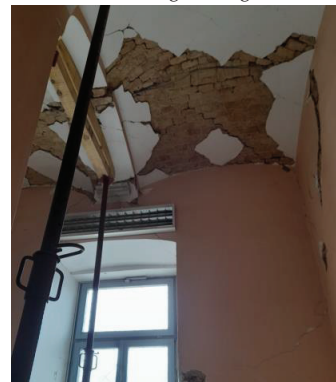
Vault damage/collapse

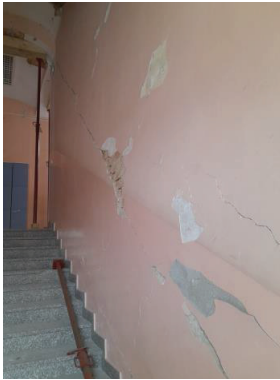
In-plane shear failure of interior walls

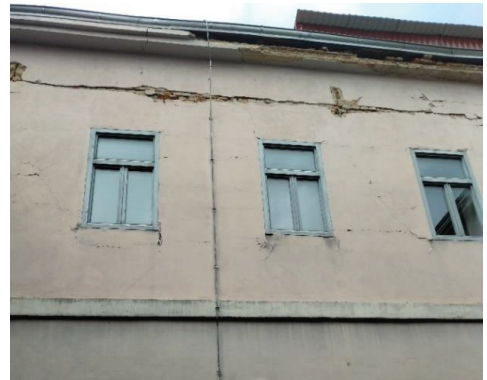
In-plane sliding failure (horizontal cracks)

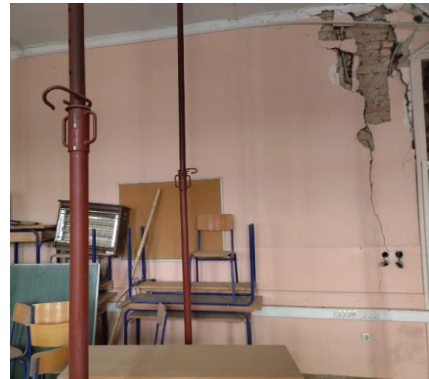
Tensile failure of masonry and vertical cracks at the corners

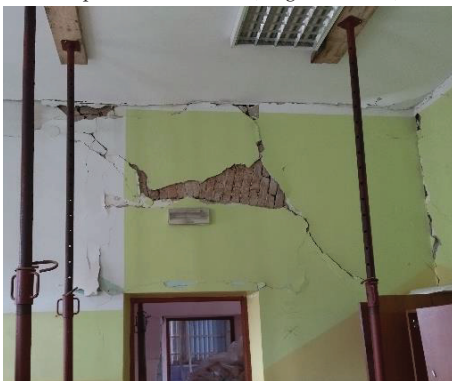
Shear failure of spandrels (diagonal cracks)

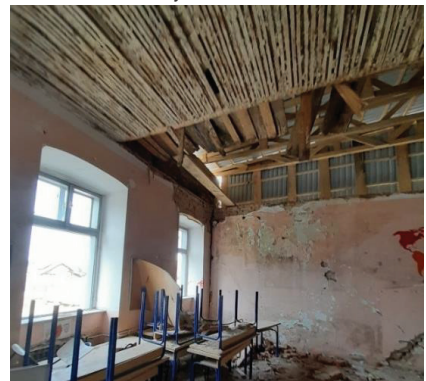
Partial collapse of the floor structure

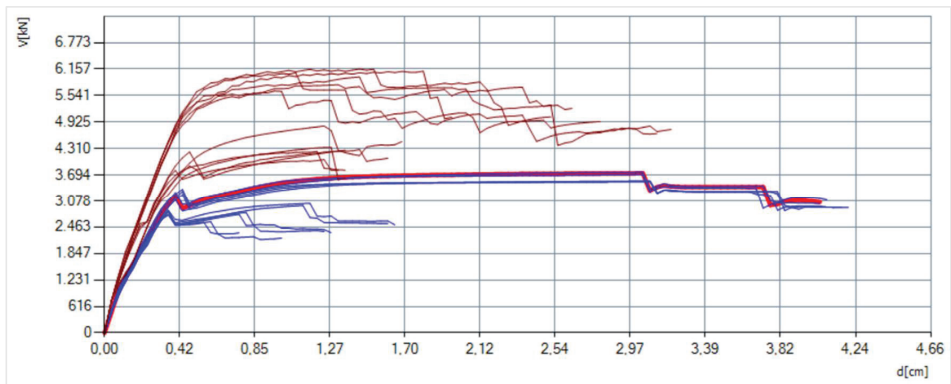
Figure 14. Capacity curves for x (blue) and y (red) direction. The bright red color represents a critical result.

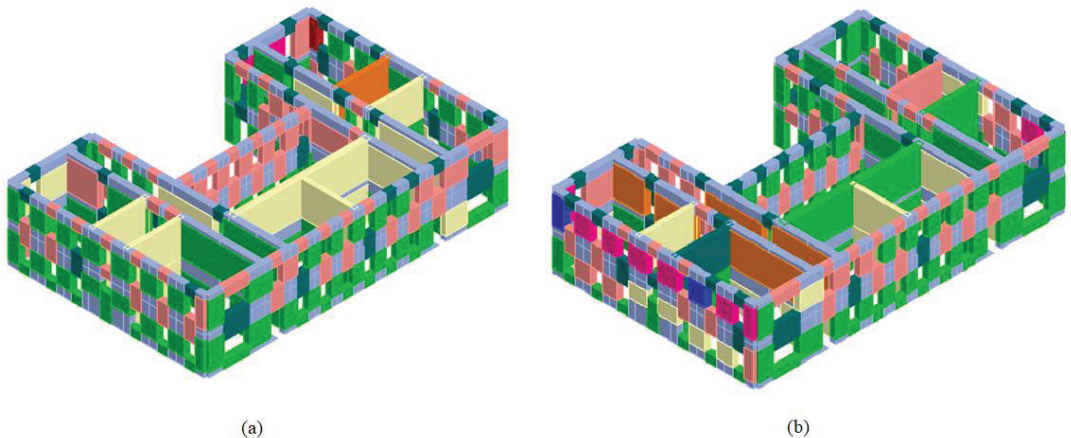
Figure 15. 3D view of damage for the most significant pushover analysis: (a) in x -direction; (b) in y -direction.

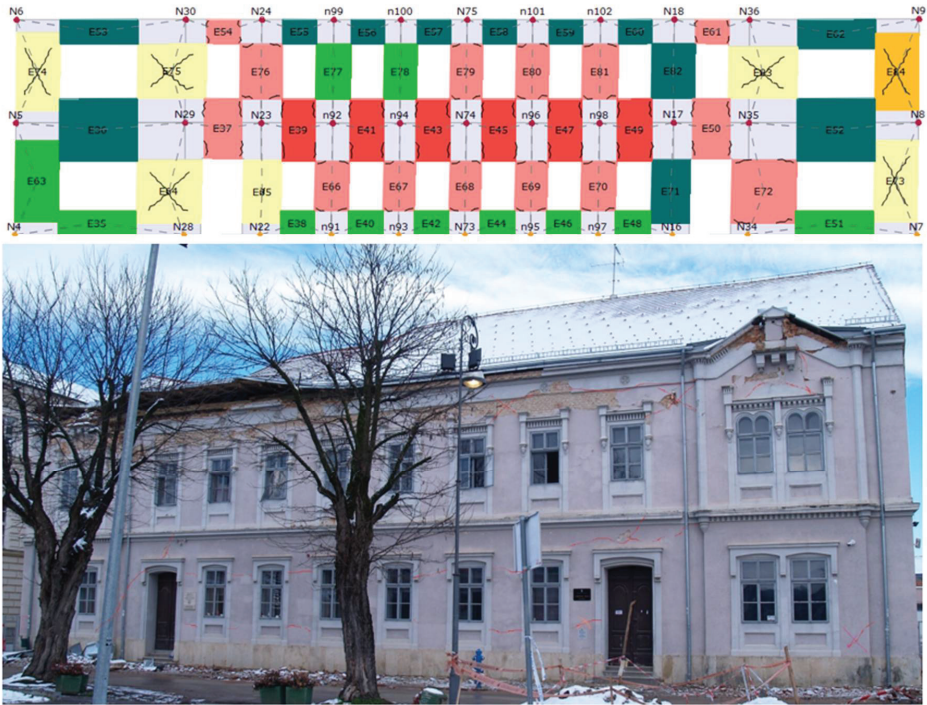
Figure 16. Detailed display of street facade damage in the 3Muri software package and actual damage to the street facade of the building in question.

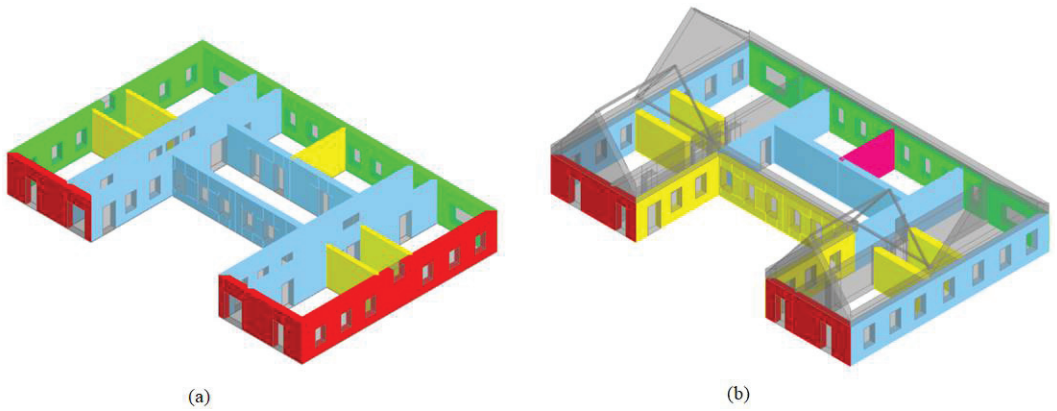
Figure 18. Configuration of different FRCM systems: (a) on the ground floor; (b) on the first floor.

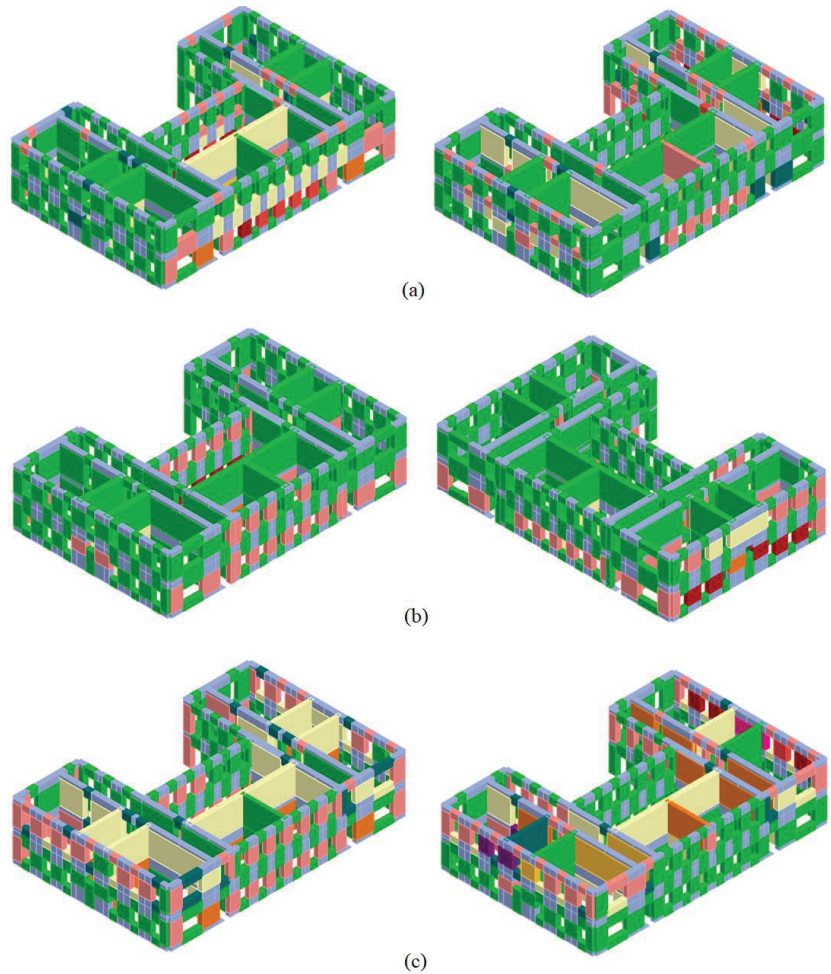
Figure 24. Three-dimensional visualization of damage in the last step of the most significant pushover analyses in x and y direction: (a) FRCM strengthening; (b) FRP strengthening; (c) shotcrete strengthening.

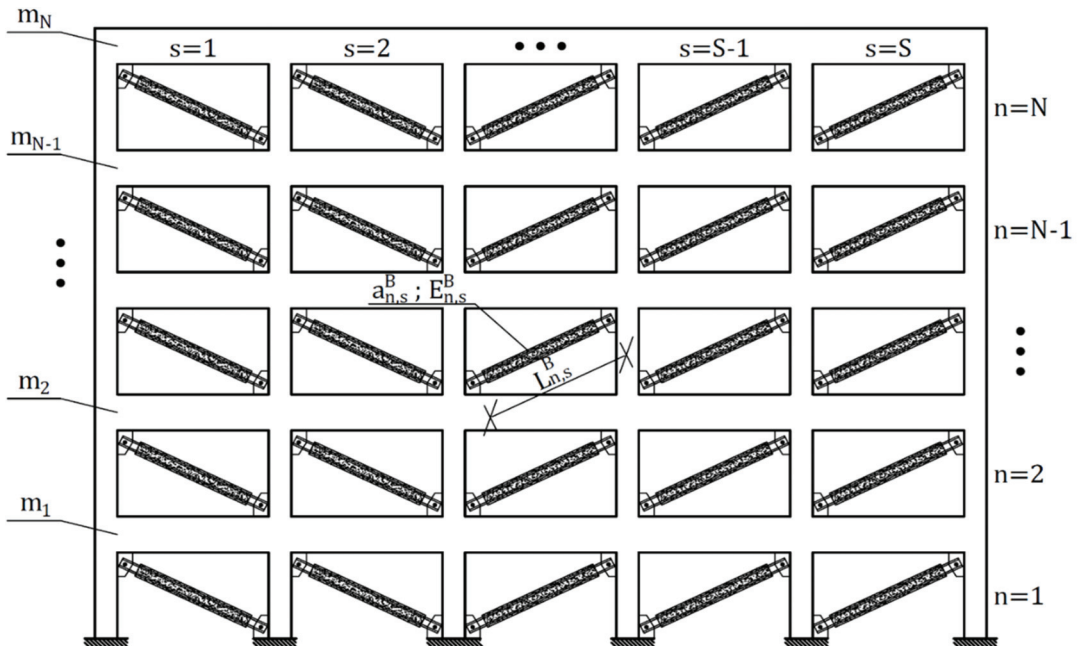
Figure 4. Rigid frame system elevation scheme equipped with BRBs.

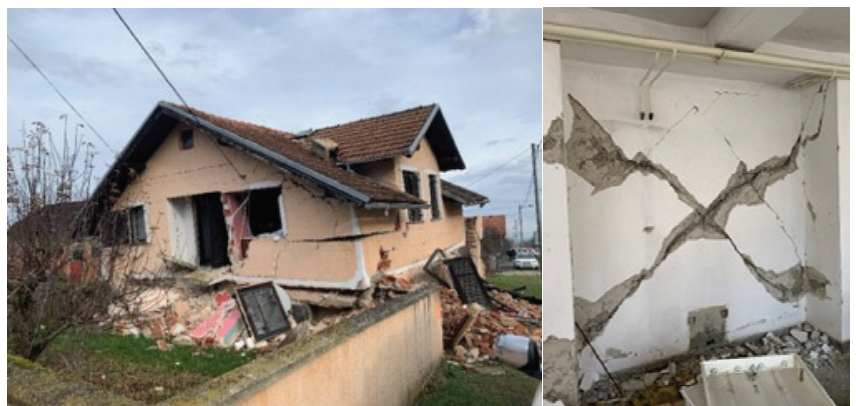
Figure 1. DG4 and DG5 damage from the December 2020 earthquake in Sisak-Moslavina county.

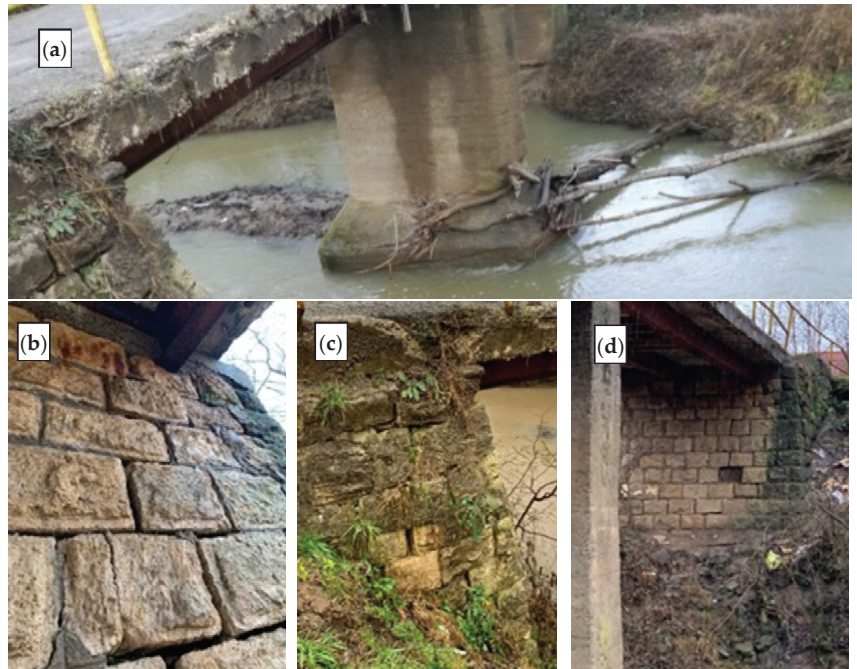
Figure 8. Matija Gubec street bridge: (a) columns—large foundation for the column in the middle of the riverbed and scour visible on the east column; (b) abutment stone wall damage; (c) abutment sliding signs; (d) evidence of subsequent abutment sliding—stone wall integrity compromised.

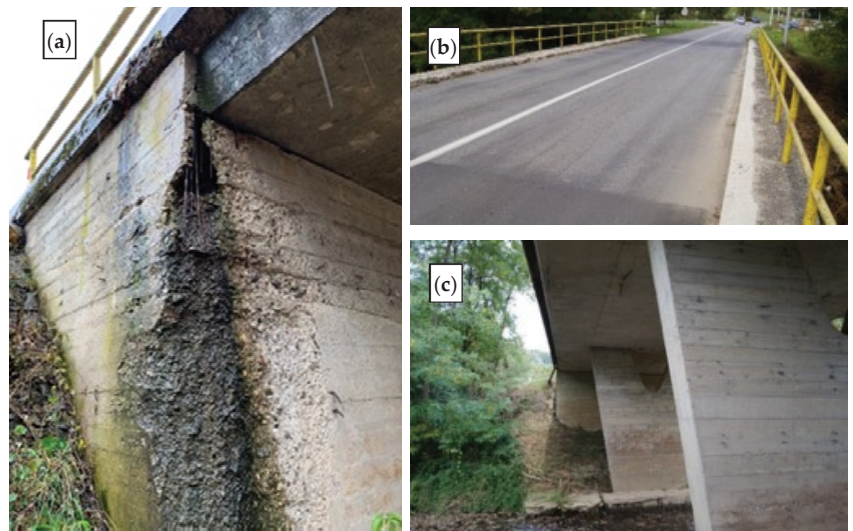
Figure 9. Roviška bridge: (a) damage to the abutment wall and wing, as well as drainage problems; (b) degraded footway (left) and new footway (right); (c) substructure without signs of earthquake damage.

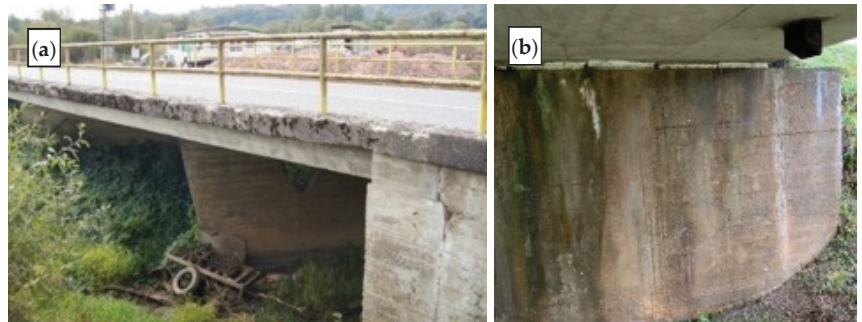
Figure 10. Maja bridge: (a) side view of the bridge; (b) abutment wall.

Maja bridge is located just south of previous Roviška bridge (Figure 5), and it is of similar type but smaller length. The bridge is also a continuous girder slab bridge with over two spans of 7.5 + 7.5 m (Figure 6). The slab girder is 35 cm thick and 7.7 m wide, with short consoles on both sides. The superstructure is skewed in regard to abutments, columns, and the riverbed (Figure 10a). Height of the columns and abutments is about 3.5 m. There were no bearings or expansion joints causing dilatation cracks in the asphalt. There was also a visible vertical dilatation crack between the abutment wall and wing, suggesting that they were not fixed together and moved separately. The superstructure concrete was seen to be in relatively good condition, without signs of progressive reinforcement corrosion or concrete spalling but with visible signs of discoloration due to water leakage. Although drainage was present on the bridge, gutters were clogged and caused water to seep through the concrete slab. The slab consoles (footways) were observed to be heavily degraded due to a lack of waterproofing and poor concrete quality. Abutment walls were exposed to water draining from above (Figure 10b). There was no visible damage due to the earthquake. No new cracks or movements of the substructure or superstructure elements were detected. No restrictions regarding traffic were given. Further inspection and maintenance were recommended due to the noticeable water leakage due to failed waterproofing and drainage.

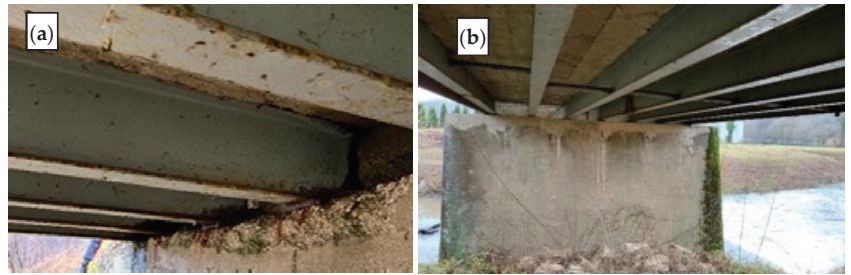
Figure 11. Svračica bridge main girder support: (a) abutment; (b) column.

Svrāčica bridge is the furthest south bridge from town Glina that was examined (Figure 5). Its superstructure is a series of two continuous composite girders with over four even spans of 7.7 m (Figure 6). Dilatation is in the middle of the bridge. The superstructure comprises a multi-girder composite cross-section with 7 I280 steel girders placed 0.7 m apart, and a 20 cm thick reinforced concrete deck slab. The superstructure is 5.45 m wide in total, with 4.05 m wide roadway and asymmetric footways of 0.55 and 0.85 m partly supported by deck consoles (Figure 6). Columns are massive, 4 m high reinforced concrete structures with a variable cross-section ranging from 6×1 m at the bottom to 5.8×0.6 m at the top. All columns have a joint foundation slab that covers the whole riverbed (two spans), approximately 18 m long and 10 m wide. Abutments are minimal structures, about 2 m high and 4 m long with variable width and skewed abutment wings due to a road junction located immediately at their end. The superstructure is directly supported on the substructure elements without bearings. The bridge was in fairly good structural condition, showing moderate signs of steel girder corrosion, mostly in the vicinity of their supports (abutments) due to the longitudinal displacements at the ends of the bridge not being properly managed (no bearings) and water leakage from behind the abutment wall (Figure 11a). Since expansions joints are not present on the bridge, cracks

were visible in the asphalt at the end of the superstructure. The deck slab concrete was in good condition. The concrete columns showed signs of reinforcement corrosion, with protective layer only locally spalling. The main reason for this problem is heavy water leakage due to non-existent drainage and waterproofing. Since there was a dilatation in the superstructure above the central column, the water is draining through the asphalt directly onto the column. The spalling of concrete showed a different type of concrete underneath and occurred at the contact of these different materials, so it very likely that columns had undergone rehabilitation work in the past. There was no visible damage from the earthquake, either in permanent deformations or movements of the superstructure or substructure elements. Therefore, the bridge was maintained for operation without restrictions. Further inspection and maintenance were recommended due to steel girder corrosion and signs of column reinforcement corrosion.

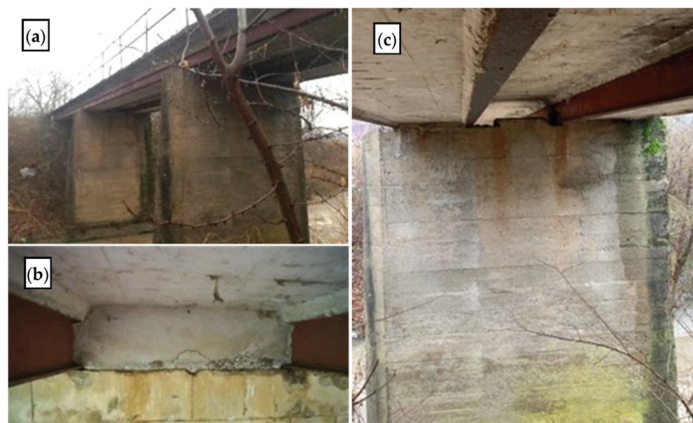
Figure 12. Nikola Tesla street bridge: (a) view of the bridge; (b) main girders to abutment support; (c) superstructure under view.

Nikola Tesla street bridge is located in the northeast part of town (Figure 5). It is a three span continuous girder bridge of $9.2 + 10 + 9.2$ m (Figures 6 and 12a). Its superstructure comprises four I280 steel girders and two 52 cm high concrete ribs that are concreted in between two pairs of steel girders (Figure 6). Steel girders are thus partly concreted inside these ribs, also serving as a side formwork for concrete. The width of the concrete ribs is 1.0 m, and the inside distance between the ribs is 1.3 m. The width of the superstructure is 4.1 m, with an asymmetrical traffic area and footway only on one side. The superstructure is directly supported by columns and abutments. Columns are 5.2 m high, 4.3–4.6 m wide in the transverse, and 0.8–1 m wide in the longitudinal direction.

Abutment walls are 1.4 m high, and abutment wings are 2.9 m long. The bridge superstructure was found to be in a moderate-to-poor condition, with problems regarding structural steel corrosion and water leakage due to non-existent waterproofing and drainage. The asphalt layer was heavily worn out and almost completely missing in the footway area. The edges of superstructure consoles were missing a cornice, and reinforcement bars were protruding out of the concrete. Columns and abutments were found to be in fairly good condition, with no visible cracks or concrete spalling. Discoloration was visible due to water leakage from the superstructure onto columns, thus causing long-term damage to the column concrete and possibly reinforcement corrosion (Figure 12c). The bridge showed no signs of serious damage caused by the earthquake on the superstructure, substructure, or embankment slopes around abutments. Visible cracks were detected in the area of connection between the superstructure and abutment, where the superstructure is supported on the abutments, between the abutment wall and the cross girder (Figure 12b). Since this connection was not assumed as fixed in the statical system, it was expected that the opening of this crack occurred and was of no importance regarding bearing capacity. After inspection, the bridge was maintained for operation without restrictions. Further inspection and maintenance were recommended due to the poor state of the traffic surface (asphalt layer and footways), column reinforcement corrosion, failed waterproofing, and possible scour developing on column foundations.

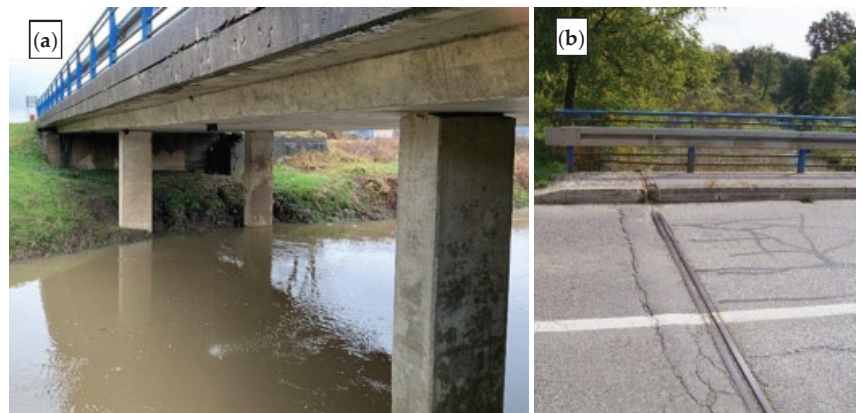
Figure 13. Prekopa bridge: (a) side view of the bridge; (b) expansion joint.

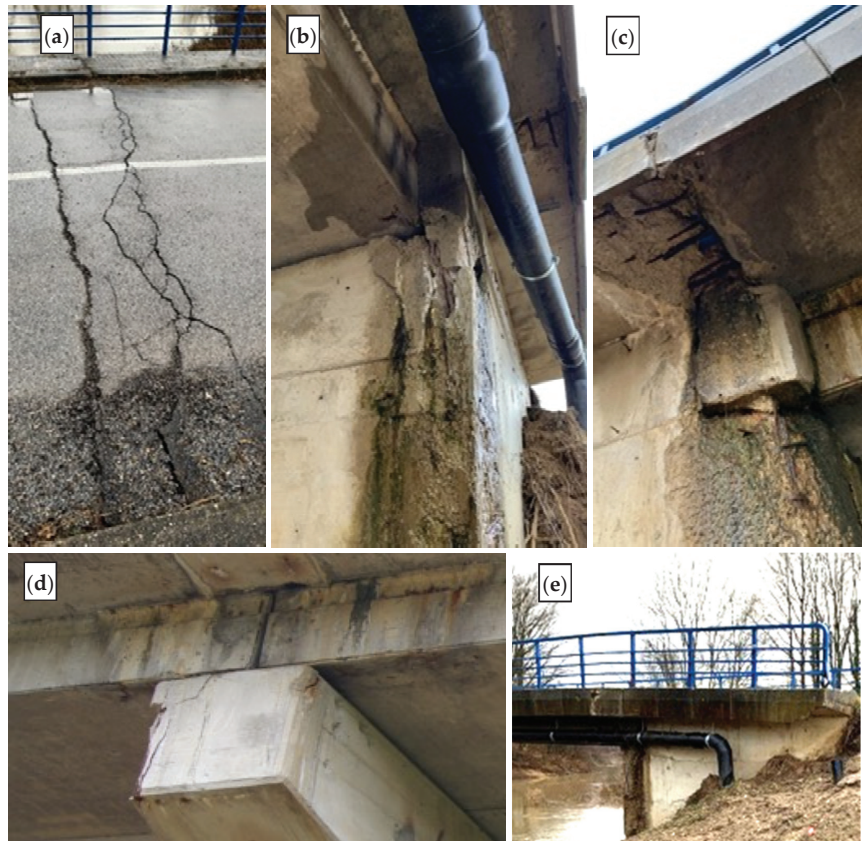
Figure 14. Hader bridge: (a) damage caused by earthquake in the asphalt; (b) fractured abutment side wall due to the earthquake; (c) water leakage from superstructure end, causing damage to abutment; (d) uneven support length for the girders; (e) cracked cornice due to earthquake movement.

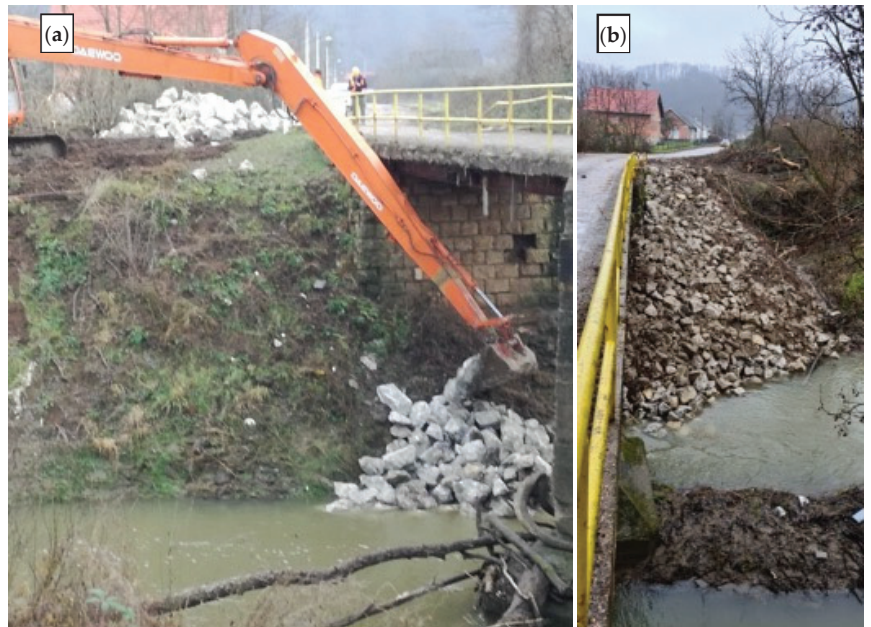
Figure 15. Immediate measures to secure the abutment of Matija Gubec street bridge: (a) beginning of the work; (b) completed infill.
