Topical Collection Reprint

Assessment, Reconstruction and Decision Procedures for the Preservation of Existing Structures after Earthquakes

Edited by
Mislav Stepinac, Chiara Bedon, Marco Francesco Funari,
Tomislav Kišiček and Ufuk Hancilar

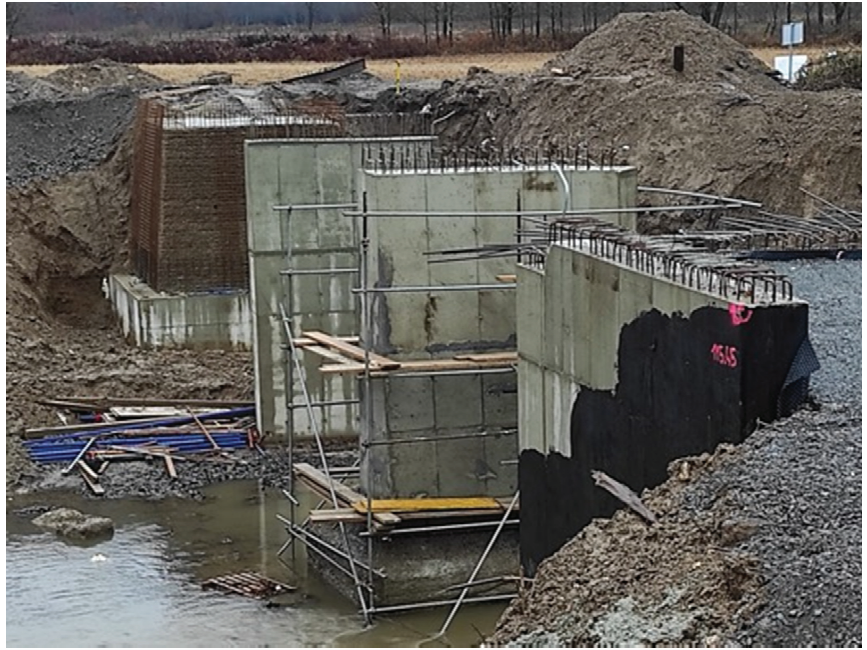
Figure 16. Progress of rehabilitation work of Matija Gubec street bridge.

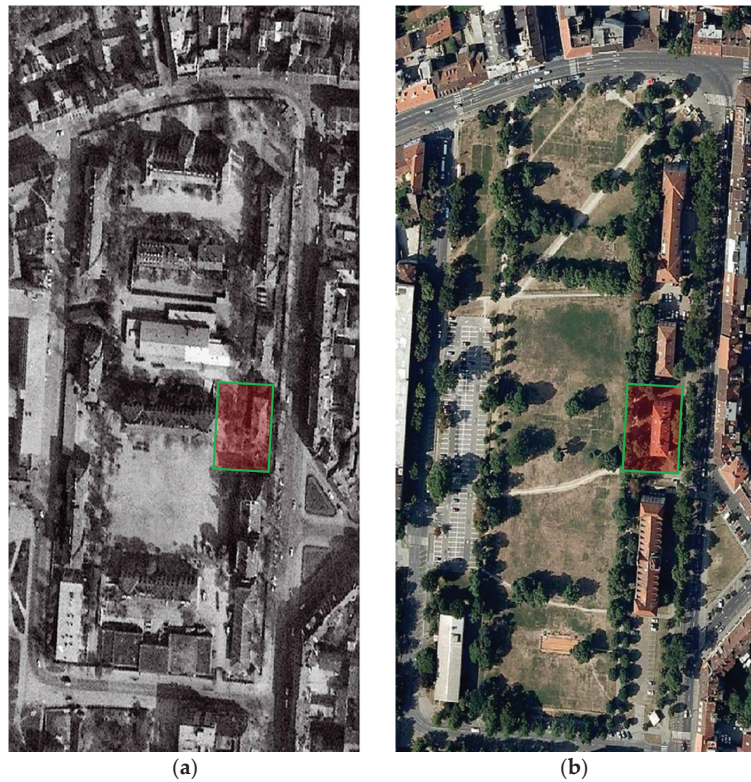
Figure 3. (a) Barracks from the end of the 19th century [30]; (b) Today's situation.

In the late 1970s, a decision was made to demolish Rudolf's barracks (Figure 2c) to make the area a secondary city center, but it was converted into a park without new constructions. Part of the complex was demolished in 1978, and what is left are four buildings, the main representative and three more modest buildings, all built in the neoromantic style. One of these buildings is the case study of this paper located at Republic Austria Street No. 18 (Figure 3).

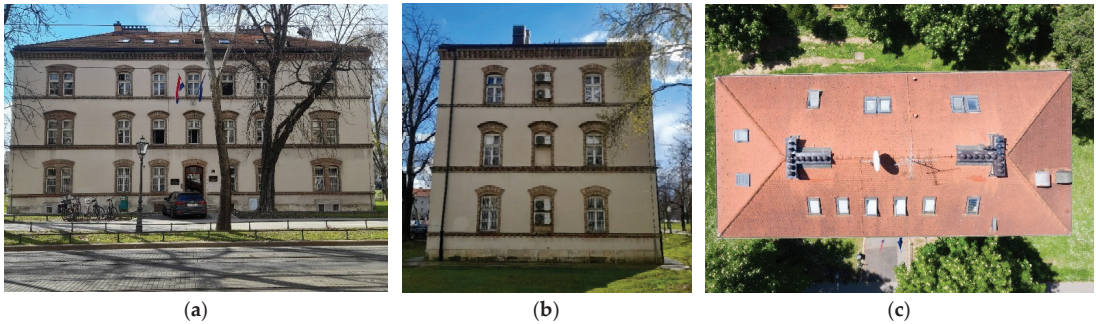
Figure 5. (a) View of the east façade; (b) View of the north façade; (c) View of the roof (photo credit: Mislav Stepinac).

The case study building (Figure 5) is a public-purpose building with a rectangular floor plan of $25.18 \text{ m} \times 11.42 \text{ m}$ and a height of approximately 15.50 m. The floor area is approximately 290.00 m^2 , and the total gross area is approximately 1450 m^2 . The building consists of five floors, all floors of the building are used as office space. The building has undergone minor changes in the original geometry and space over time and has been properly maintained.

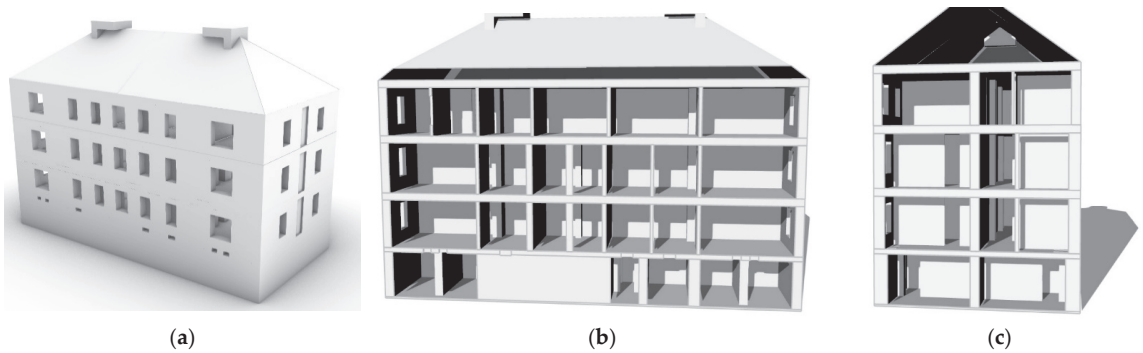
Figure 7. (a) Three-dimensional (3D) model; (b) 3D model—longitudinal cross-section; (c) 3D model—transversal cross-section.

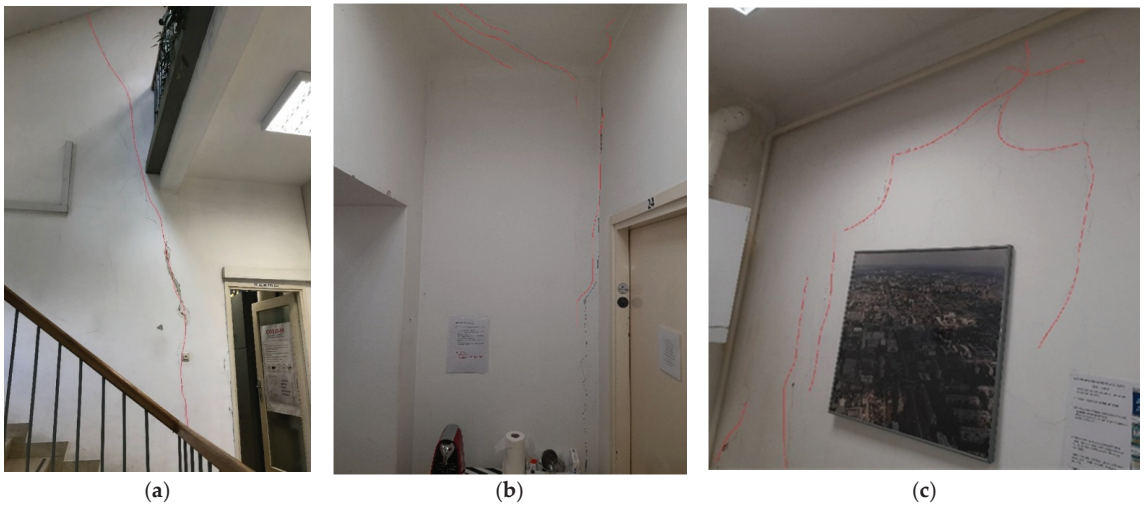
Figure 8. (a) Damage to the stair system; (b) Damage at the connections of load-bearing and partition walls; (c) Slight damage to the load-bearing walls.

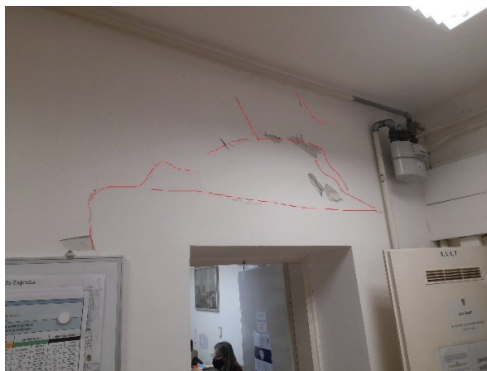
(a) Ground floor damage

Figure 20. Damage to the central wall in the x -direction.

To compare the actual damage and the damage obtained using the 3Muri software, a uniform lateral load distribution was selected. It is assumed that the peak ground acceleration of the earthquake in Zagreb in 2020 was about 0.18 g. The results of damage are shown in Figure 19, with locations of real damage shown in Figure 20a,b.

Figure 20a shows the actual damage to the right part of the load-bearing wall on the ground floor corresponding to the shear damage. Figure 20b shows the actual damage to the middle part of the load-bearing wall on the first floor, which corresponds to the damage due to bending. Similar damage is detected in height in the building itself, and damage corresponds to the model.

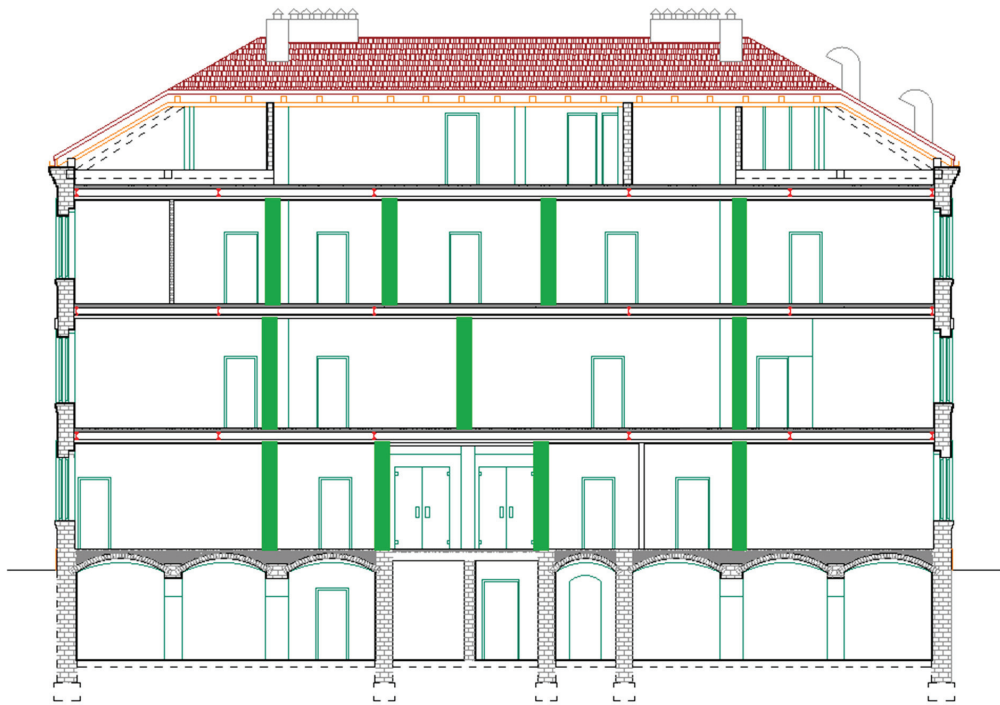
Figure 23. Proposal for the position of the new load-bearing walls and proposal for the removal and replacement of partition walls (cross-section).
