Renovation Problems in Constructions and Historic Buildings

Edited by
Krzysztof Schabowicz

Material Testing of Historic Bricks and Mortars in Degraded Masonry Structures

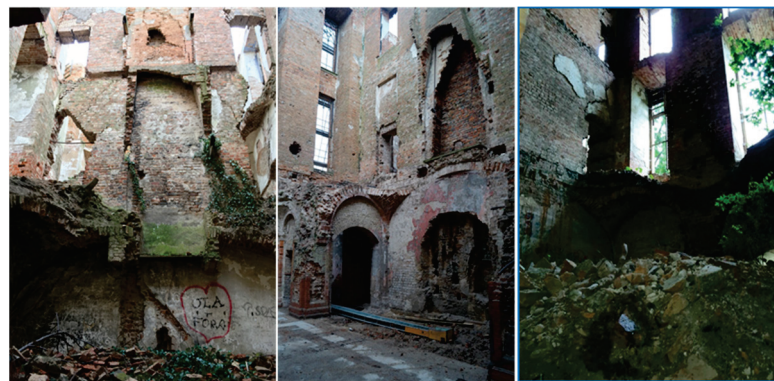
Figure 2. View of walls and vaults—as of 2018 (photos by authors).

The medieval walls of the original structure of the facility have survived to this day, and it was decided to secure them. Already in 2018, the technical condition of the castle’s masonry structure was considered disastrous. The threat here was the exposed slender walls 19 m high without stiffening in the form of vaults, wooden ceilings, and a roof. Chimney walls were particularly at risk of losing stability, while the remains of the vaults

contained a large layer of rubble and vegetation growing on them (Figure 2). In 2021, the building was protected with a temporary wooden roof and covered with roofing felt, which resulted in the quick drying of bricks and mortars with intensive ventilation caused by the lack of windows and doors. The remains of the vaults, like the rest of the building, were on the verge of a construction disaster. The above-mentioned loss of wooden ceilings, vaults, and large fragments of walls significantly weakened the stiffness of the remaining structure of the building, which was due to the walls being left unprotected for the last 45 years. The facility required urgent protection and reinforcement of walls and lintels, as well as reinforcements and additions to the vaults. Carrying out this work turned out to be an extremely difficult and dangerous activity due to the additional threat associated with the not fully recognized and heavily debris-covered surfaces of the structure, which already lost its character as a building. Debris was lying on the ground floor and on the remains of the vaults, which made it very difficult to inventory places that were then inaccessible, hence scanning the facility [23] turned out to be very helpful as it did not have archival documentation (Figure 3).

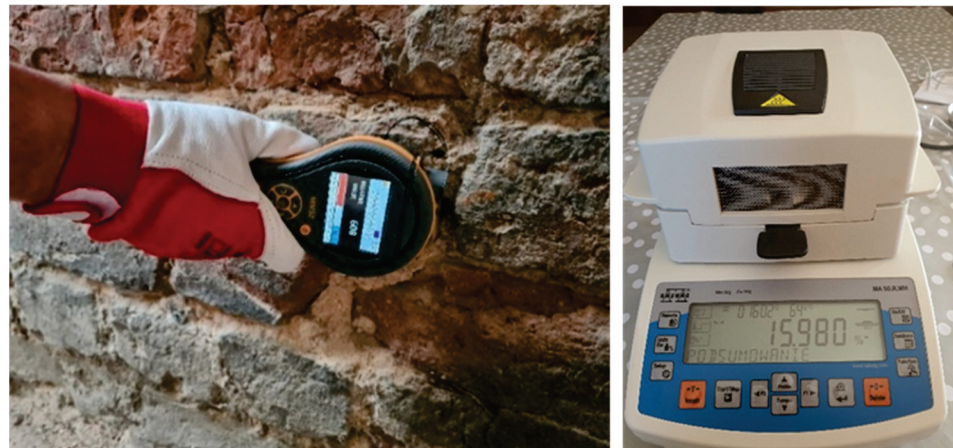
Figure 8. Assessment of the moisture level of walls using the radio and laboratory dry-oven test method (photos by the authors).

The graph in Figure 8 shows significant differences in the moisture content in bricks at different measurement points. Until the roofing over the building structure was completed, the walls and vaults showed a very high level of moisture, so they were considered wet.

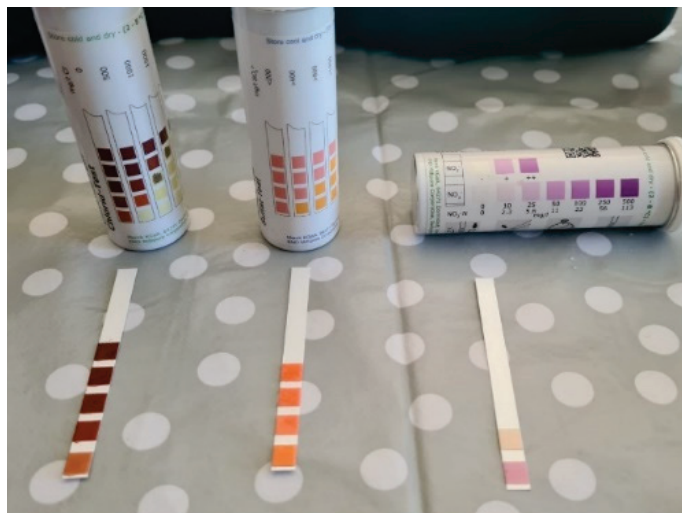
Figure 10. Assessment of salt content carried out on 20 samples taken from various places in the building (photo by authors).

As part of the tests carried out, the level of salt content was determined using the chemical indicator method (Figure 10), the test results are presented in Table 3.

Since the level of nitrates, sulphates, and chlorides was low, these compounds were excluded as the cause of the damage, which confirms the previously stated thesis that the direct cause was the variability of weather conditions and the lack of a roof over the facility.

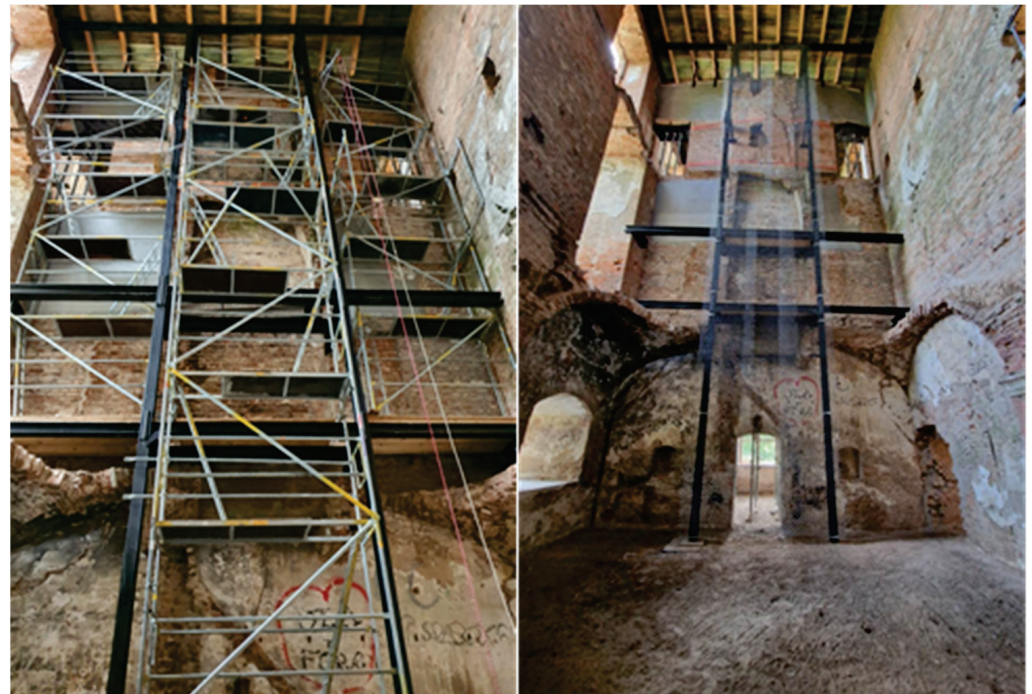
Figure 14. Current view of the strengthened wall and the strengthening structure (photos by authors).

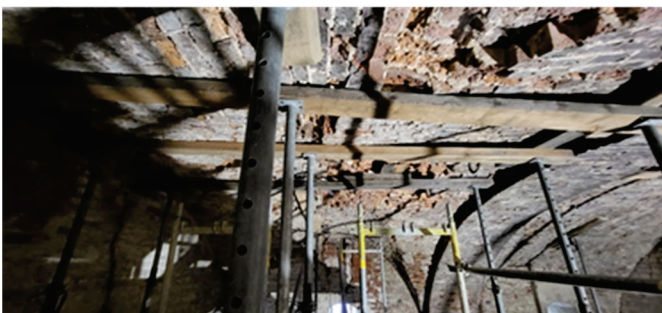
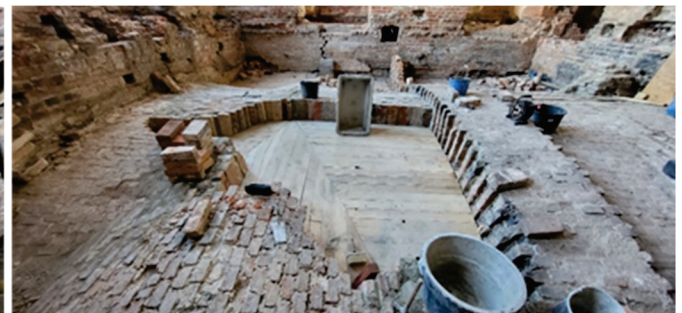
Figure 16. Fragments of the vaults above the ground floor of the castle: (a) view of the damaged bricks from below; (b) filling in (photos by authors).

Some of the vaults required additions (Figures 14–16). This was achieved by reproducing the original, using the recovered bricks.

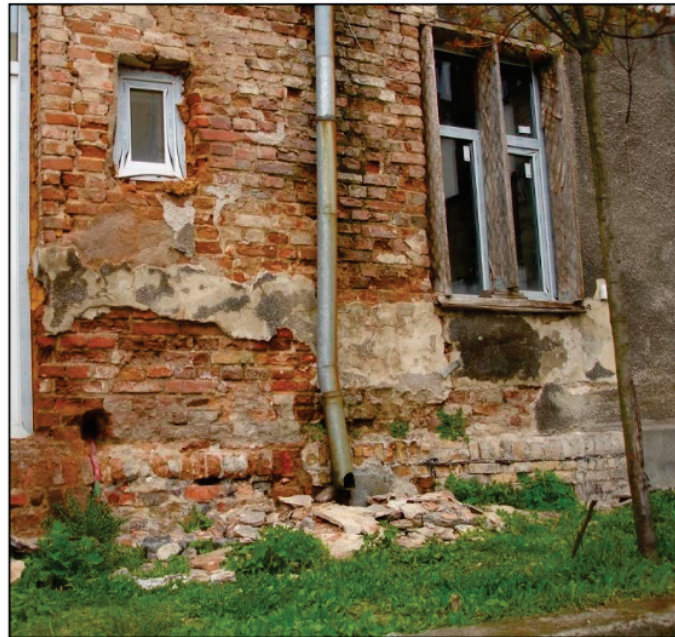
Figure 3. Damage to a plaster and brick wall due to leaking drainpipes.

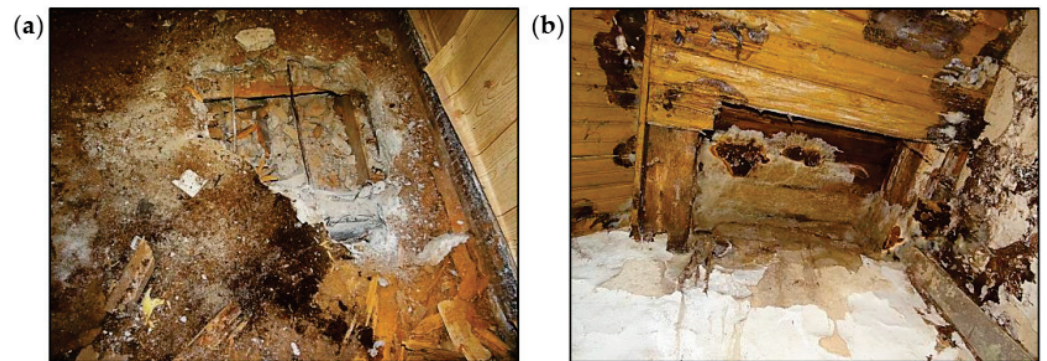
Figure 11. Ceiling opencasts: (a) from the top of the reinforcement concrete ceiling and (b) from the bottom of the wooden ceiling.

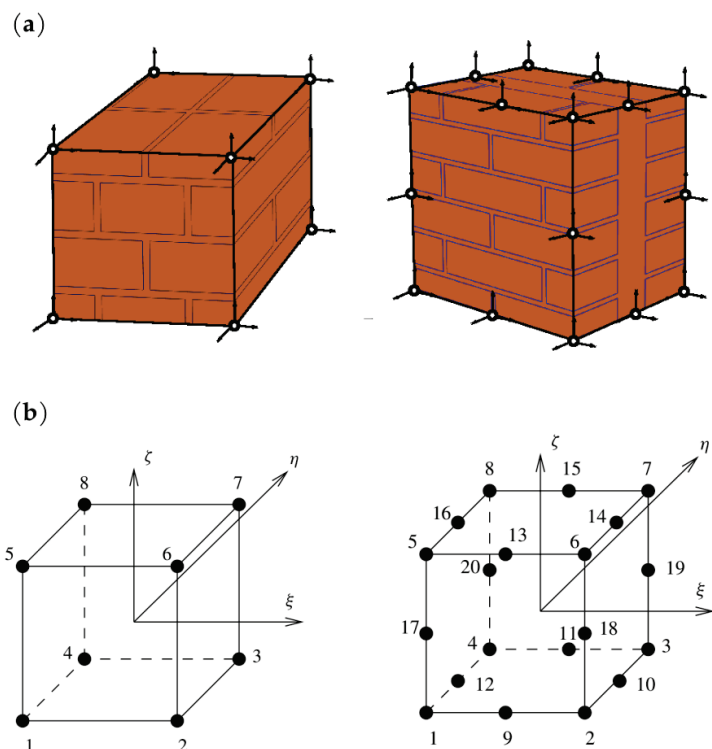
Figure 3. Proposed finite macro-elements describing segments of a structure: (a) internal structures of macro-elements in general cases; (b) 8- and 20-node finite elements.

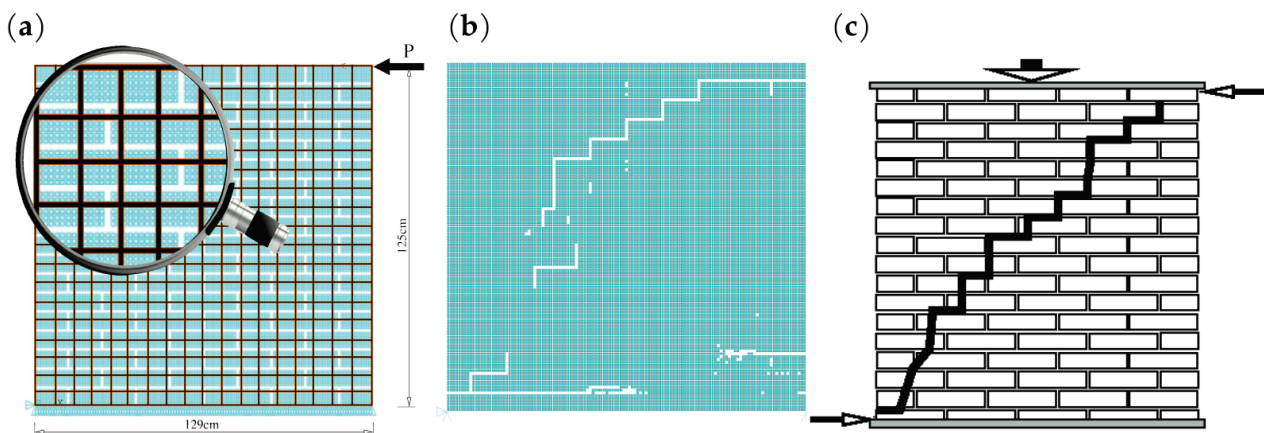
Figure 10. Shear wall: (a) model discretisation; (b) damage propagation pattern according to the adopted algorithm; (c) a form of typical failure mechanism in masonry under shear and compression.

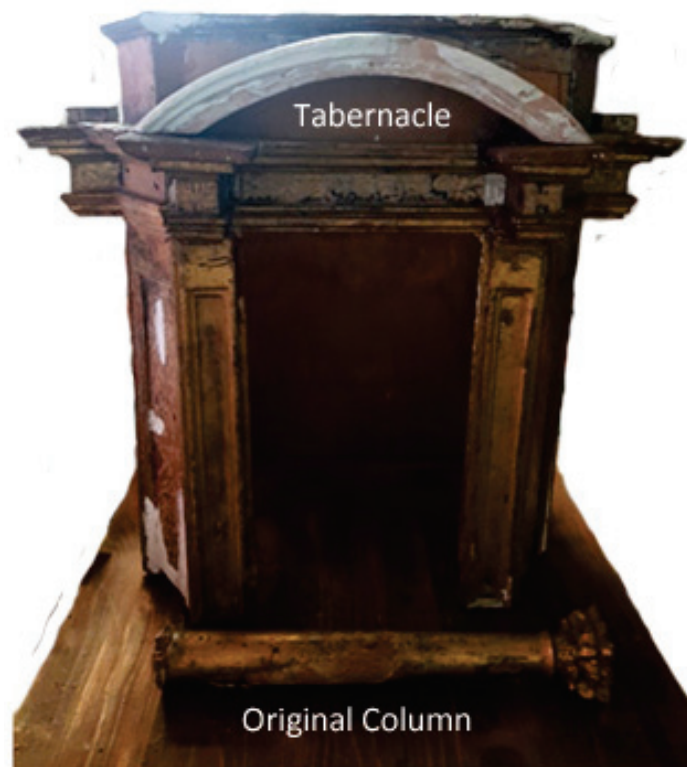
Figure 1. 17th-century polychrome wooden tabernacle and original column.

This research aims to evaluate the general effectiveness of the two different methodologies in the restoration and conservation of artistic heritage; specifically, it assesses the advantages and disadvantages of each selected technique (fused filament fabrication (FFF) and computer numerical control (CNC) milling) in the reproduction of missing columns of an ancient 17th-century polychrome wooden tabernacle (Figure 1). The tabernacle is made of pine wood and according to oral sources it was handed down. With preliminary observation under the optical microscope [23], it can be seen to be decorated with an artistic technique called “Estofado de Oro”.

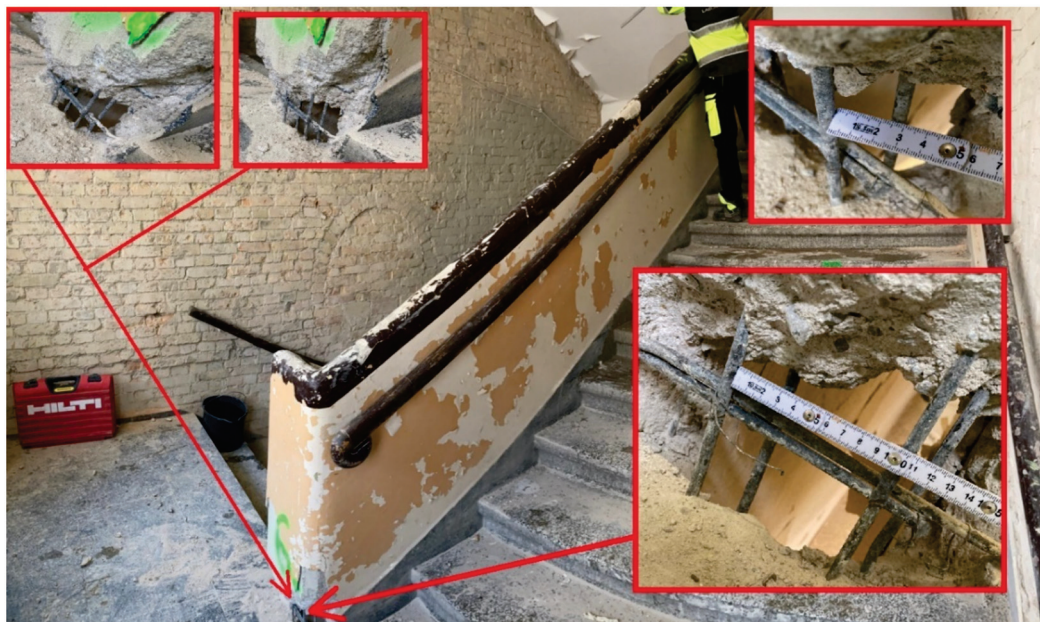
Figure 3. A view of a staircase with a sample 8 location.

On Figure 2b. The diagram of K2 staircase indicates the place of collecting the research samples. Sample No. 8 was taken from the landing slab. A core sample was taken (Figure 5) and then tested in a strength press. Representative sample No. 9 was taken from the landing.

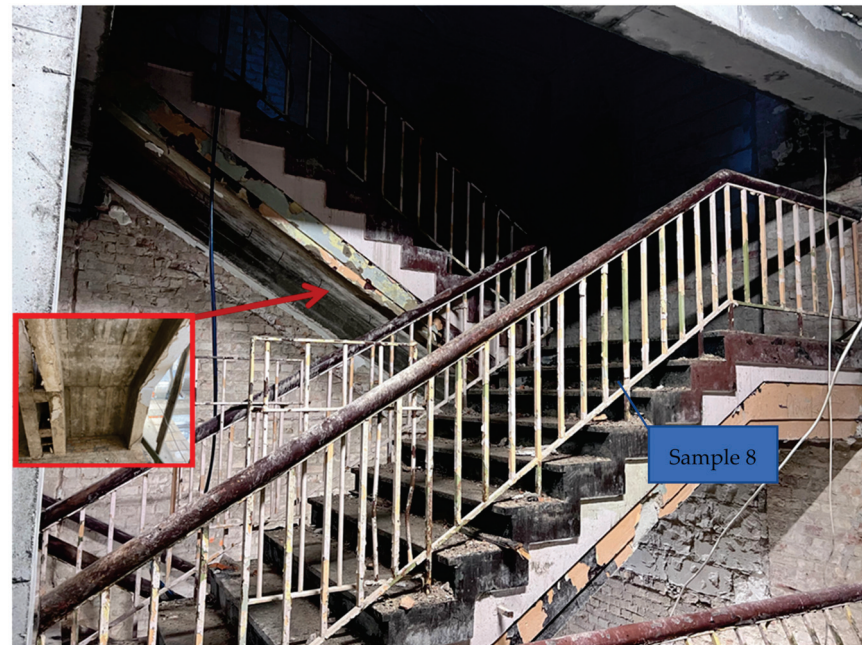
Another tested element of vertical communication was the K-2 staircase, which is fully monolithic. It was built by the P-3 slab (13 cm thick, with 16 cm thick landing and the following layers: 13 cm reinforced concrete slab and 3 cm of finishing layers). On both sides, it rests on 2 B-3 reinforced concrete stringers. In the level of the platforms the slabs rest on the new supporting structure, and the other side on the wall. They were connected with a massive B-3.1 reinforced concrete beam in the space between the running plates of

the landing, probably in order to stiffen the entire structure. The staircase diagram is shown on Figures 2b and 4. Sclerometric and destructive tests were carried out on the concrete of running and landing slabs as well as reinforcement iron (steel) inserts.

Figure 4. A view of the K2 staircase.

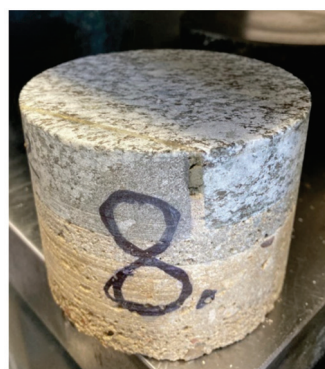
Figure 5. Core concrete sample No. 8 (borehole diameter 98 mm).

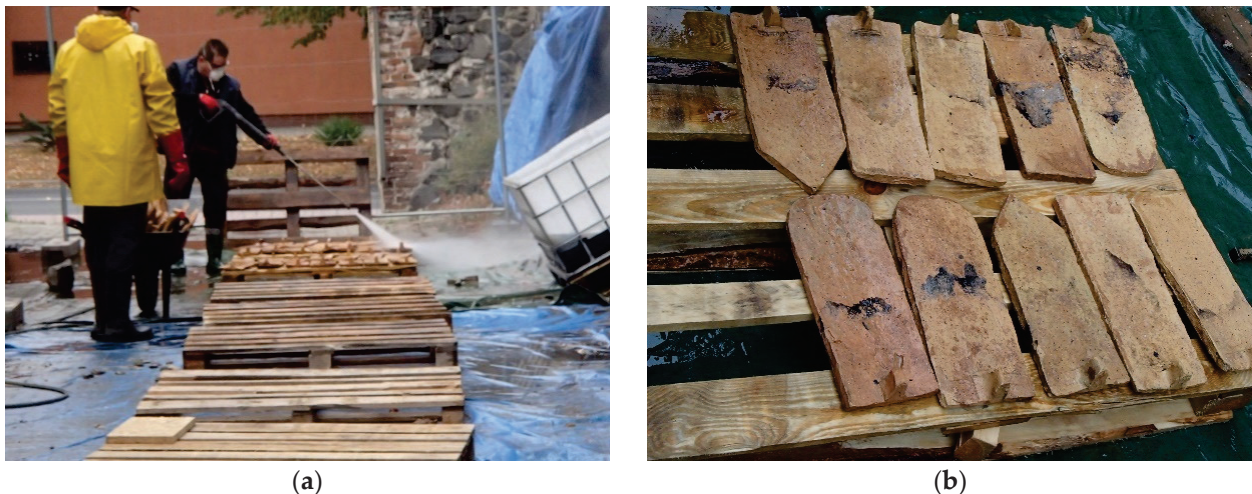
Figure 3. Revitalization of historic roof tiles: (a) cleaning; (b) maintenance.

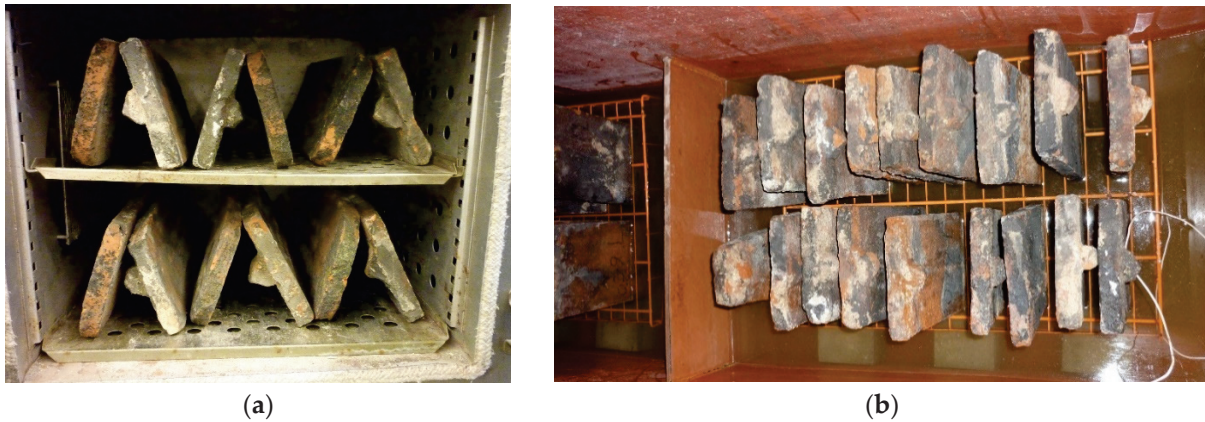
Figure 5. Absorption test: (a) drying of tiles to constant weight at a temperature of $110\text{ °C} \pm 5\text{ °C}$; (b) roof tiles in a chamber with 100% humidity.

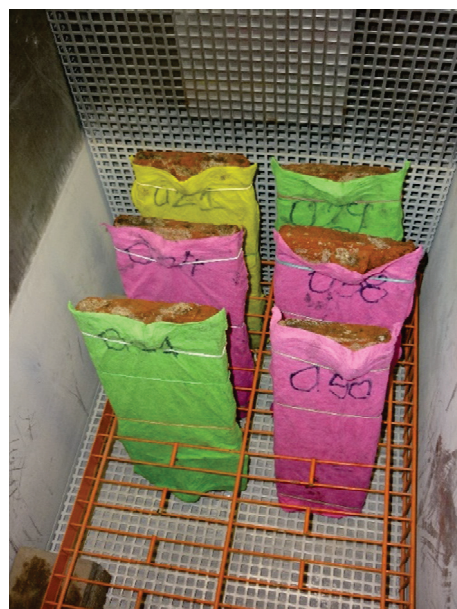
Figure 7. Roof tiles in a climate chamber.

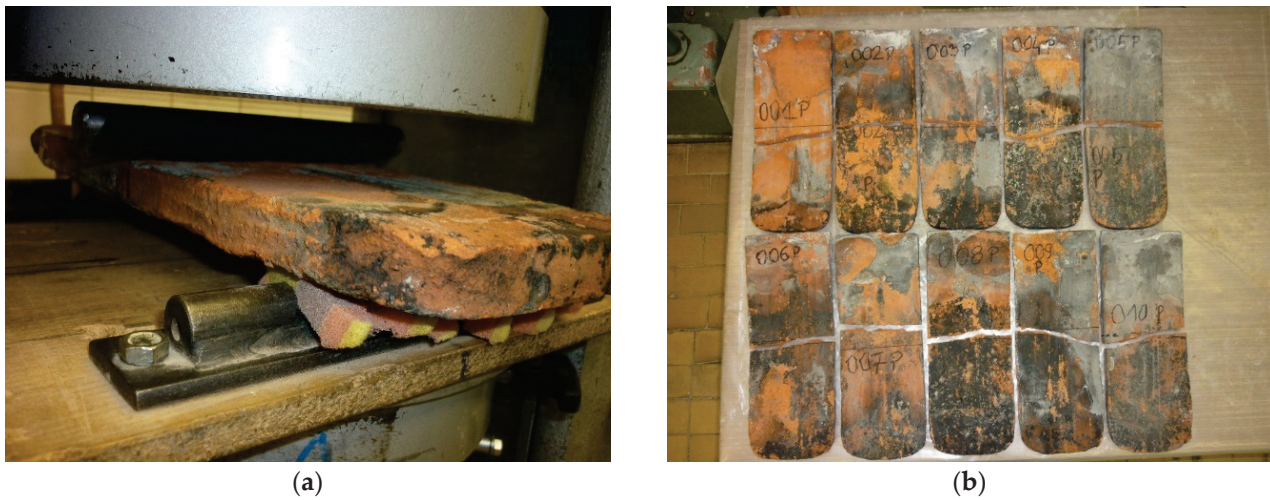
Figure 11. Flexural load capacity test: (a) tile in the testing machine during flexural capacity tests; (b) tiles (Nos. 001–010) after flexural strength tests.

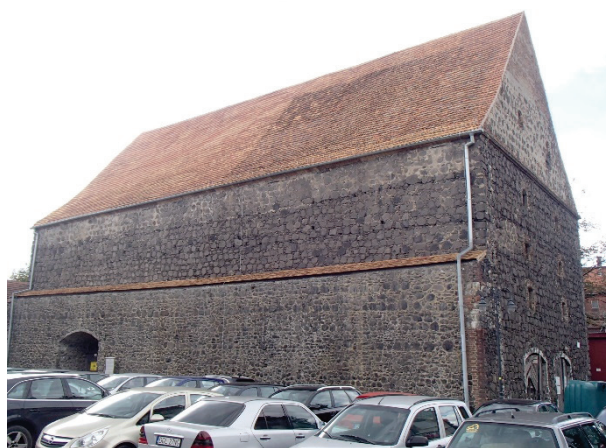
Figure 13. The Salt House elevation view.

To illustrate the applicability of new ceramic tiles produced with old technology, a short case study of the application of this type of tile in a historic building is presented below. The reference object is the Salt House (Figure 13) of 1539, located in southern Poland [11]. It is located in a space between two rows of medieval defense walls erected before 1220. In 1566, there was a fire in the town, but the building was not damaged besides a few wooden elements. Extended in 1698, the building was used as a storage house for salt and grain until the end of the 18th century. In the 19th century, it was partly converted for use as a prison and the headquarters of the town's fire brigade. The building served as the firemen's headquarters up to the 1990s of the twentieth century.

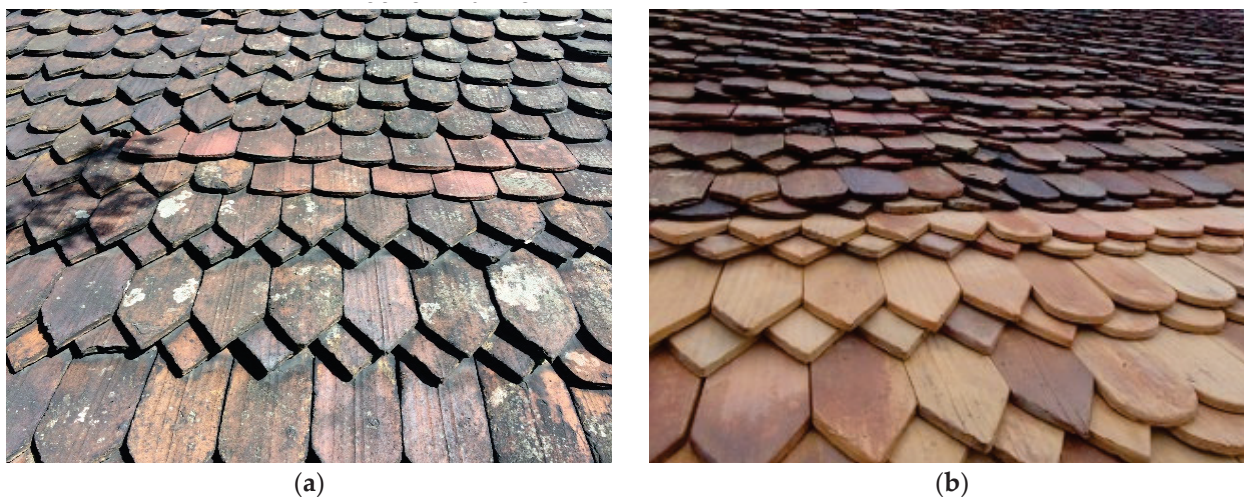
Figure 14. Different types of roof tiles: (a) historical; (b) new roof tiles in historic dimensions.

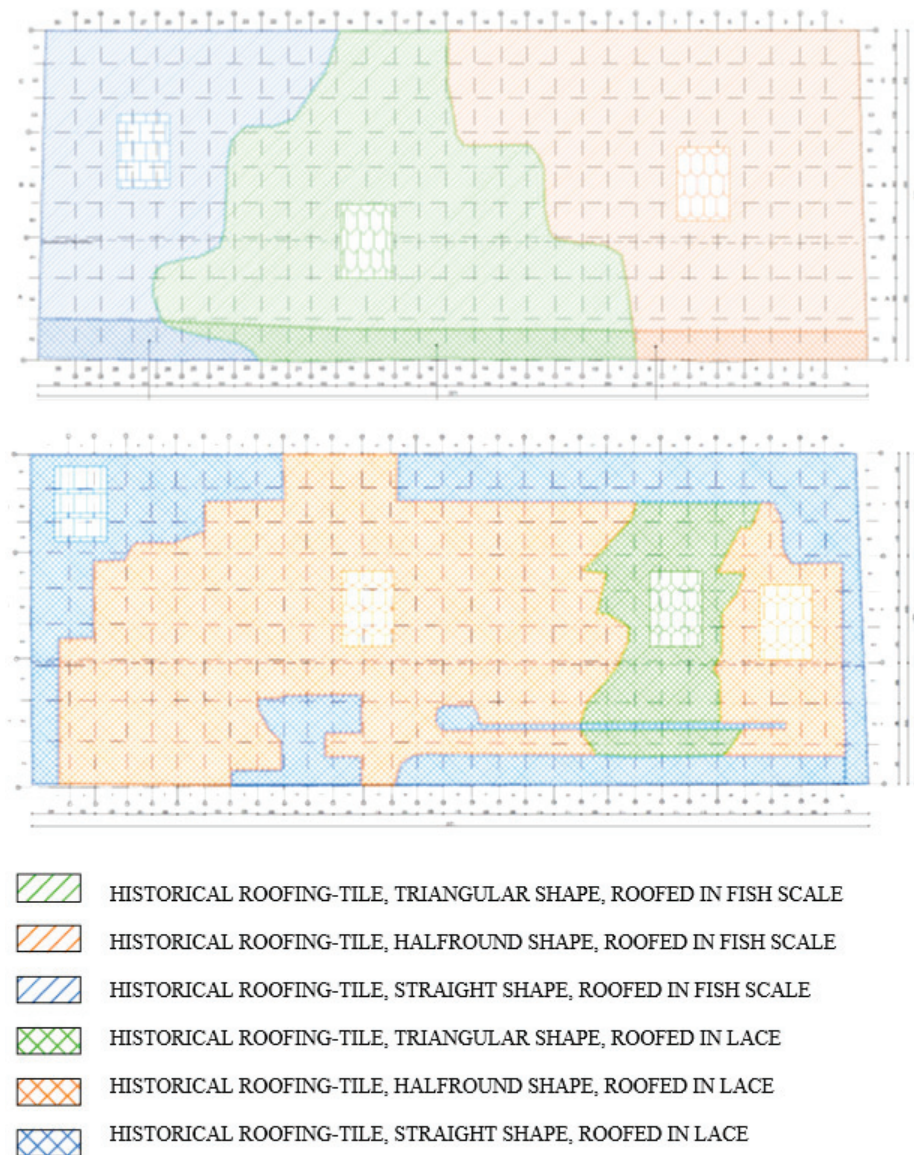
Figure 15. Arrangement of tiles on roof slopes.

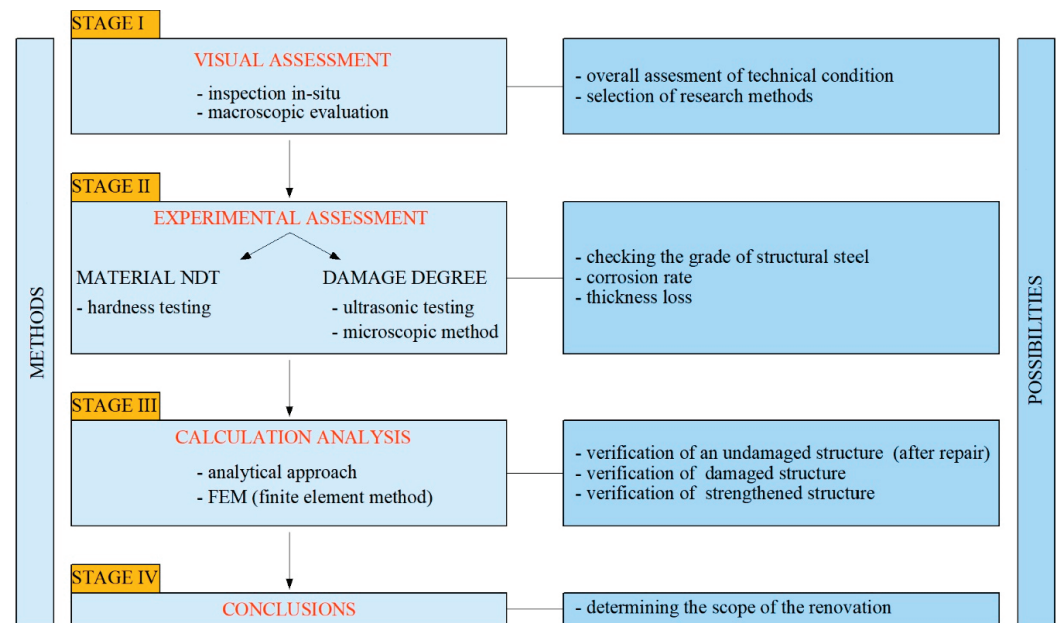
Figure 1. Stages of analysis of the technical condition of the structure.

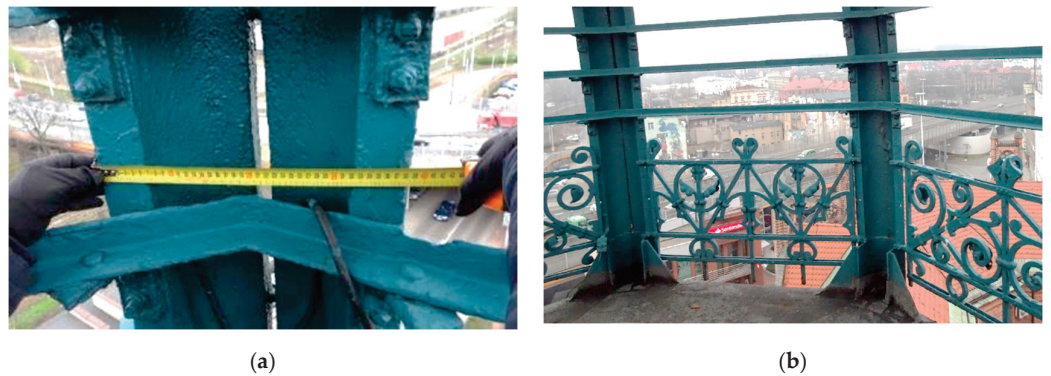
Figure 4. Steel dome structure. (a) View of the balustrade surrounding the dome; (b) the 38 cm width of one of the dome's eight supporting ribs.

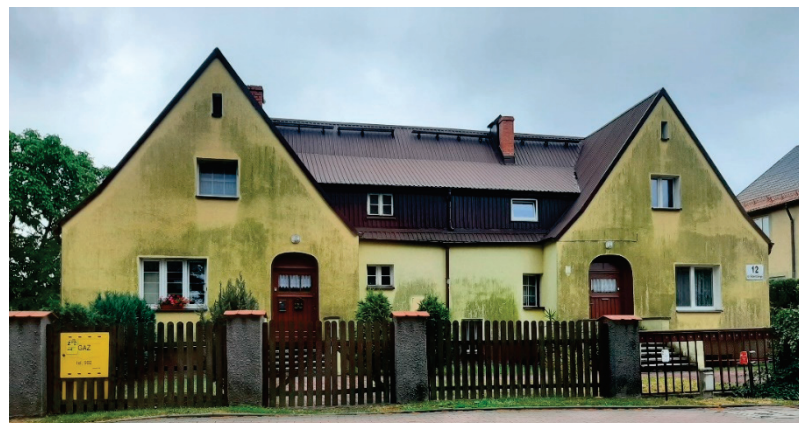
Figure 1. Changes in the exterior wall's finished surface (author's archives).

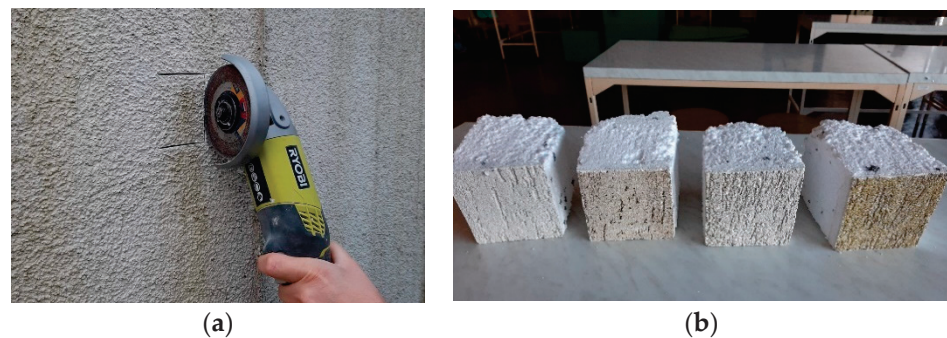
The test sample was obtained with the quartering method. To conduct the tests, samples of 10 cm \times 10 cm were taken from the site, from the north and south elevations. Sampling began by cutting the plaster surface with an angle grinder and then using a knife to cut out the fragments along with the thermal insulation layer (Figure 4).

Figure 4. Sampling at the field site: (a) cutting the plaster surface; (b) samples that were cut out.

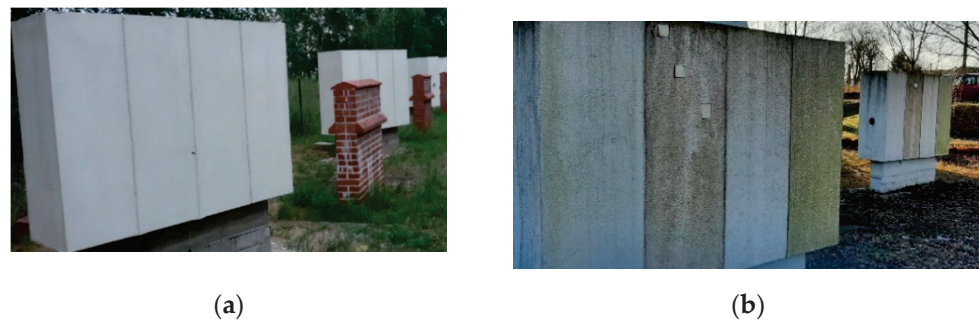
Figure 6. Test site for natural aging test: (a) 2016; (b) 2022.

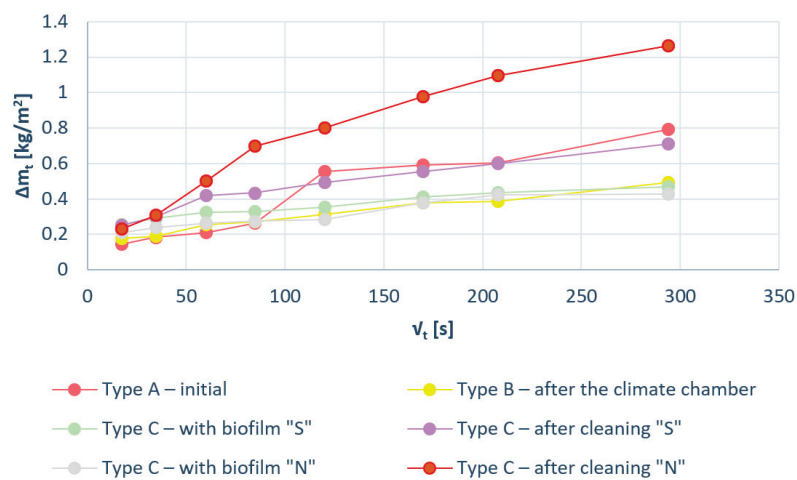
Figure 7. Graphs of $\Delta m_t/F$ as a function of the time element $t^{0.5}$ related to mineral-based plaster samples.

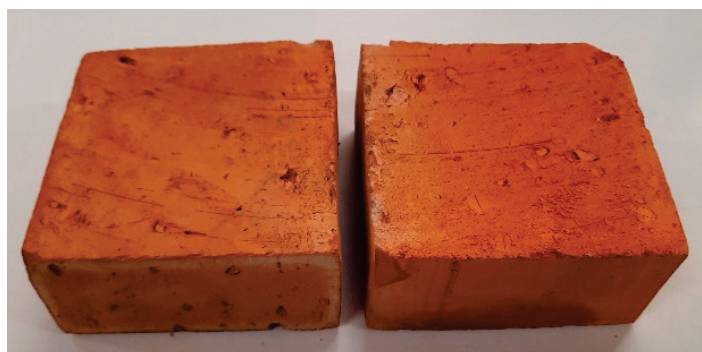
The tested products belong to the group of masonry units to be used in walls protected against water penetration [1], with dimensions 250 × 120 × 65 mm (Figure 1). Their quality parameters are summarized in Table 2.

Figure 1. A brick sample used for tests.

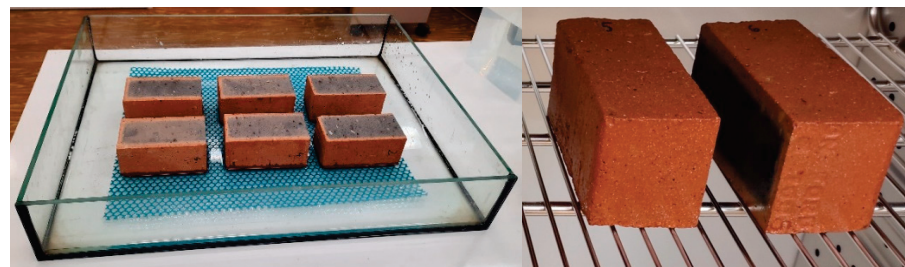
In the first case, the samples were placed in a water container and saturated to a fixed weight. Then, the brick surfaces were dried from excess water and placed in a freeze–thaw durability test chamber (Figure 4). Fifty freeze–thaw cycles were assumed in the temperature range of -18 to $+18$ °C.

Figure 4. Sample conditioning in the authors' freeze–thaw durability method.
