# Analysis of Microscopic Characteristics of Pepper Seedling Root Systems and Study on Transplanting Gripping Injury Based on Micro-CT

**Keywords:** Micro-CT; pepper seedlings; root system characteristics; gripping injury; transplanting

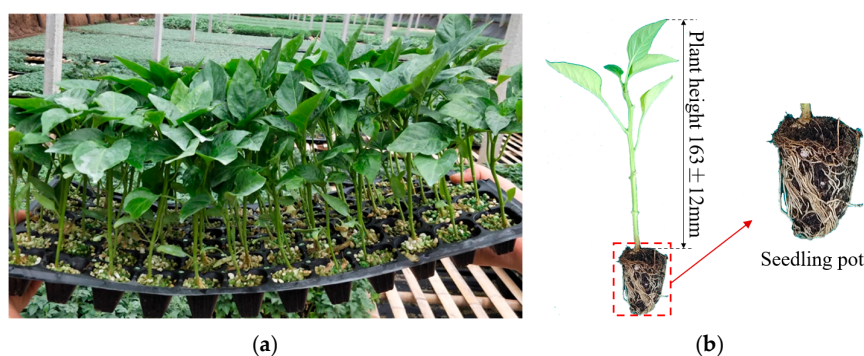
**Figure 1.** Pepper seedlings and seedling pot: (a) pepper seedlings in the seedling tray. (b) pepper seedling and seedling pot.

Figure 1 shows that the experimental material consisted of pepper seedlings with a growth period of 40–50 days. The plant material used in this study was the helical-shaped pepper (*Capsicum annuum* L.), a corkscrew chili characterized by its deeply wrinkled and twisted pod shape, sourced from Hiers (Shandong) Seedling Co., Ltd. (Shouguang, China). The seedling tray measured 540 mm in length and 280 mm in width, featuring a total of 128 cells arranged in 8 columns and 16 rows (Figure 1a). Each individual pepper seedling, along with its substrate, had a total weight of  $18.6 \pm 3.5$  g, a plant height of  $163 \pm 12$  mm, and a substrate moisture content of  $35 \pm 3\%$  (Figure 1b).

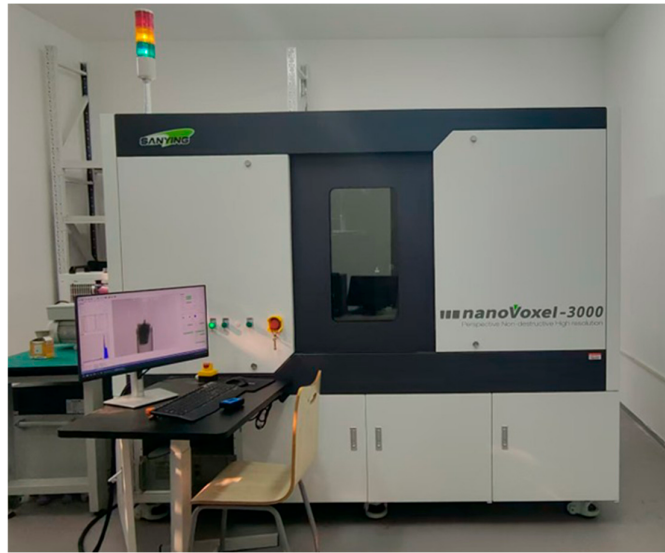
**Figure 2.** Experimental instrument.

A nanoVoxel-3000 series instrument (Tianjin Sanjing Precision Instrument Co., Ltd., Tianjin, China; Figure 2), was used in the experiment. This instrument is equipped with an open micro-focus X-ray source, with a maximum voltage of 190 kV and a maximum power of 25 W. The system is fitted with a dynamic flat-panel detector, with an active area of 300 mm × 250 mm (length × width) and a rated resolution of 0.5  $\mu$ m. The instrument's operating system is equipped with three software packages: the scanning software VoxelStudio-Scan and the reconstruction software VoxelStudio-Recon (both are integrated components of the NanoVoxel-3000 system), and the 3D visualization analysis software Dragonfly (version 2024.1, Object Research Systems, Montreal, QC, Canada). This integrated suite enables the reconstruction and image post-processing of the acquired CT data.
