# Analysis of Long-Term Deterioration Characteristics of High Voltage Insulators

**Abstract:** The deterioration of the cement that bonds the cap, pin, and porcelain shell of the porcelain insulators can be observed by three-dimensional computed tomography (3D-CT), a non-destructive test. When porcelain insulators are used for a long duration, the size of the pores existing in the cement increase as the cement expands due to the alkali-silica reaction (ASR). It is possible to visually confirm the corrosion of caps and pins. The degree of corrosion is divided into four noticeable stages (I–IV), and deterioration of cement includes one of the four stages of corrosion. The standard time of replacement of insulator vs. continued use is presented. As a result of X-ray diffraction (XRD) analysis, Fe is oxidized to Fe<sub>2</sub>O<sub>3</sub> at 36, 43, 54, and 70 degrees. The corrosion in cement is caused by factors including the value of pH, oxygen content, and temperature. For the caps and pins, although a zinc coating is applied to prevent the corrosion of iron, corrosion of zinc is caused by substances present in the external environment. When the zinc coating begins to corrode, the

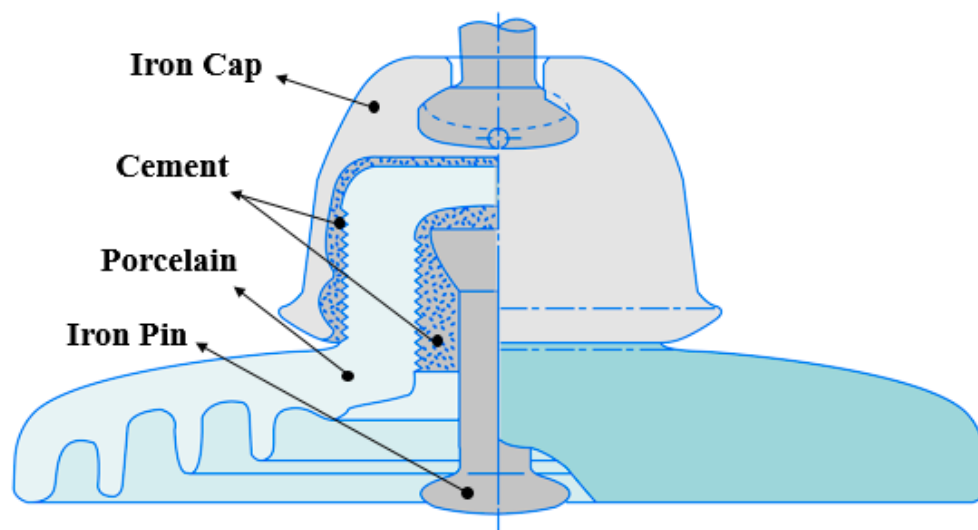
**Figure 1.** Section showing the four components of the porcelain insulator.

The porcelain insulator for 154 kV power transmission, shown in Figure 1, has been in use since the 1950s. It is composed of an iron cap, cement, an iron pin, and porcelain material with a diameter of 250 mm [9].

The iron cap and iron pin are coated with zinc, which is widely used for corrosion prevention in industry. This paper focusses on the analysis of deterioration characteristics and deterioration

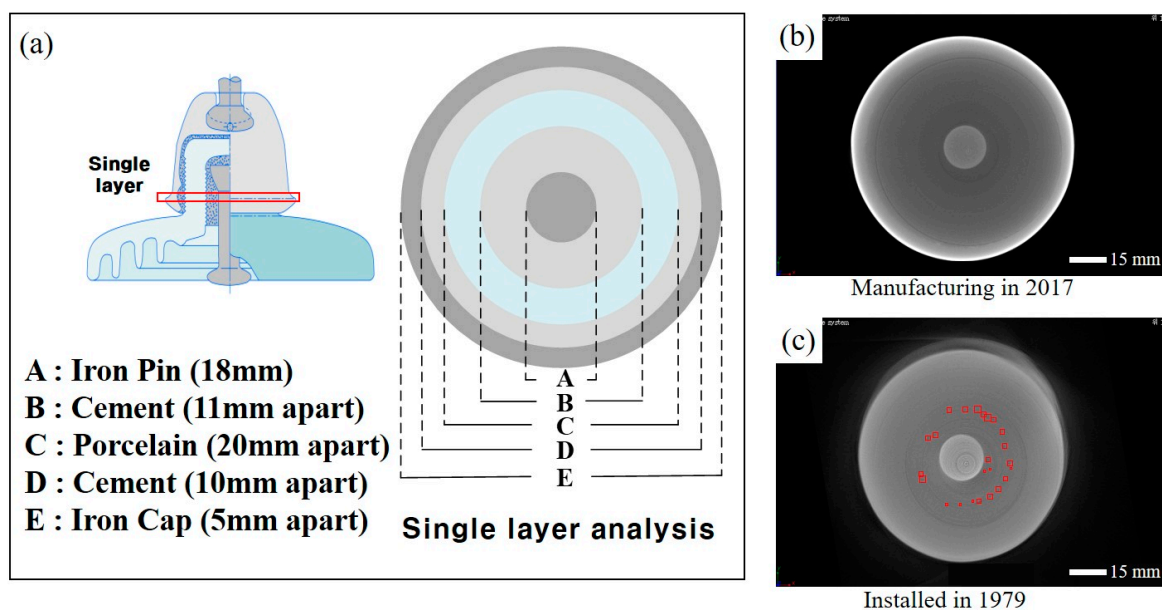
**Figure 2.** Cross-sectional composition and three-dimensional computed tomography (3D-CT) analysis photo of new and aged of porcelain insulator. (a) Cross sectional analysis; (b) 3D-CT of new porcelain insulator; (c) 3D-CT of aged porcelain insulators.

Figure 2a shows the 3D-CT analysis of the single layer. Figure 2b shows a new product that was manufactured in 2017 and has never been in service, a small air pocket of less than  $3 \text{ mm}^2$  appears inside, but this can occur during the curing process of the cement. The insulator shown in Figure 2c has been in use for 38 years from 1979 to 2017; the 3D-CT analysis revealed more than 20 pores with sizes of more than  $3 \text{ mm}^2$  inside the cement. In the case of porcelain insulators produced in 2017, pores smaller than  $3 \text{ mm}^2$  occur in the curing process, and in the case of porcelain insulators installed in 1979, pores larger than  $14 \text{ mm}^2$  are increased by the alkali-silica reaction (ASR) reaction. In the case of porcelain insulators that have been used for a long time, the cement degradation and the size of the pores increases.

This is because the silica and alkali components in the cement react with water to form alkali-silica gel, and the gel reacts with water to cause expansion of the cement, and thereby, cracking. This reaction is called an alkali-silica reaction (ASR). In general, a pH of higher than 12, moisture, and reactive silica are required to generate an ASR reaction in the cement. When these conditions are satisfied, the mechanism of reaction in the cement is as described in the following section [12,13].

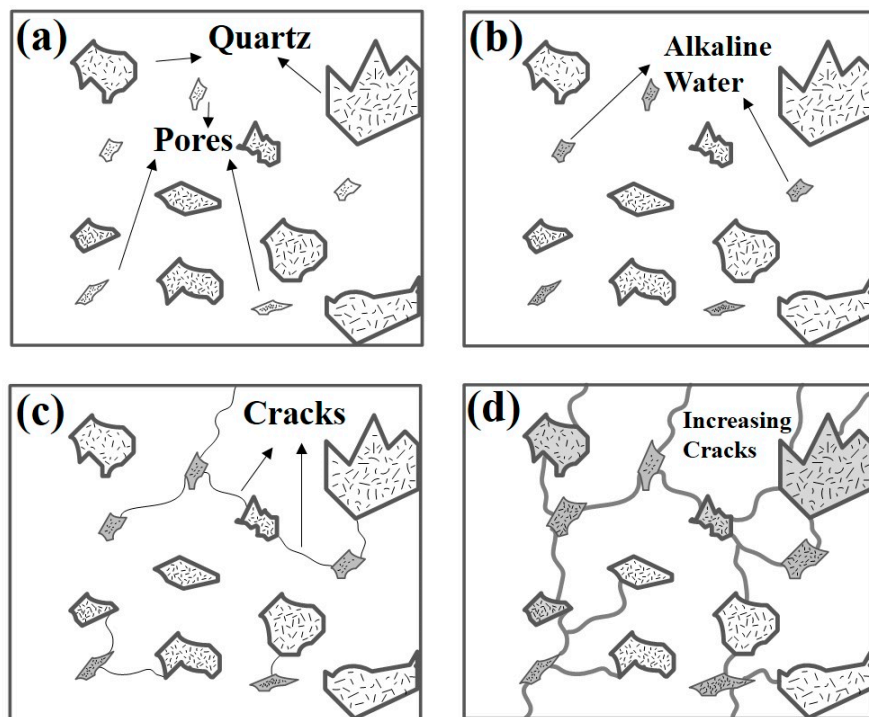
**Figure 3.** A schematic diagram of the progression of the alkali-silica reaction (ASR) in the cement inside the porcelain insulator (a) Stage I, (b) Stage II, (c) Stage III and (d) Stage IV.

Figure 3 shows the mechanism of the process by which ASR occurs in the porcelain insulator. Stage I is the stage where internal pores are generated by deterioration during the cement curing process, a long service period, or mechanical/electrical stress. These also include the micro-pores created mainly in the initial stage of the manufacturing process and then enlarged by water permeation. In Stage II, alkali-silica gel is formed by reaction with water. The  $\text{SiO}_2$  component within the cement reacts with high pH  $\text{Na}^+$  and  $\text{K}^+$  ions and generates  $\text{Na}_2\text{SiO}_3 \cdot 2\text{H}_2\text{O}$ . Stage III is a process in which alkali-silica gel erodes silica and alkali components in the cement causing the expansion of the cracks. Solid state  $\text{SiO}_2$  and aqueous solutions of  $\text{Na}^+$  and  $\text{OH}^-$  form  $\text{NaHSiO}_3$ . Then, volume expansion occurs. Finally, Stage IV is crack propagation or growth due to water permeation.

The high stresses inside the cement expand the volume of the cement and lead to cracks. In general, it has been reported that amorphous silica is highly susceptible to ASR. The silica that reacts in these four steps is mostly amorphous, which is the cause of accelerated deterioration. The subsequent deterioration of the cement inside the porcelain insulator has the greatest influence on the mechanical characteristics and it may cause the insulation resistance of the porcelain insulator to deteriorate [20].

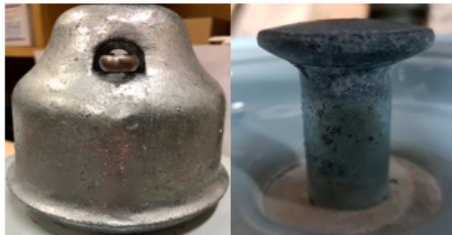
| I | II |
|---|---|
| <p>Since 2017<br/>(New product)<br/>New porcelain insulator<br/>No corrosion<br/>Fit for use</p> | <p>Since 1979<br/>(Pollution Level A)<br/>Zinc plating corrosion<br/>Minor occurrence<br/>Monitor for further damage</p> |

In the case of the new product (Stage I), which had never been used, no corrosion is detected by the eye. The porcelain insulator pictured in Stage II is a Pollution Level A product. Zinc plating is shown at an early stage of corrosion. The insulator does not need to be replaced immediately but must be cleaned and monitored periodically because there is some damage. The porcelain insulator pictured in Stage III is a Pollution Level B product; it has begun to degrade as corrosion progresses, and its removal from the service line should be considered. The porcelain insulator pictured in Stage IV is a

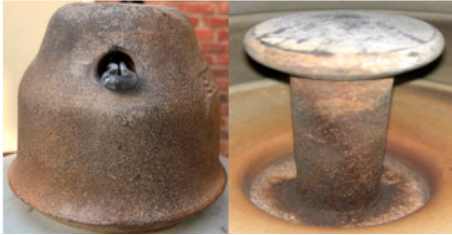
| I | II |
|---|---|
| <p>Since 1979<br/>(Pollution Level B)<br/>Phase with significant corrosion<br/>Insulation degradation characteristics start to occur<br/>Consider removal</p> | <p>Since 1979<br/>(Pollution Level C)<br/>Corrosion melted to porcelain and cement, insulation degradation characteristics have occurred<br/>Remove insulator from service</p> |

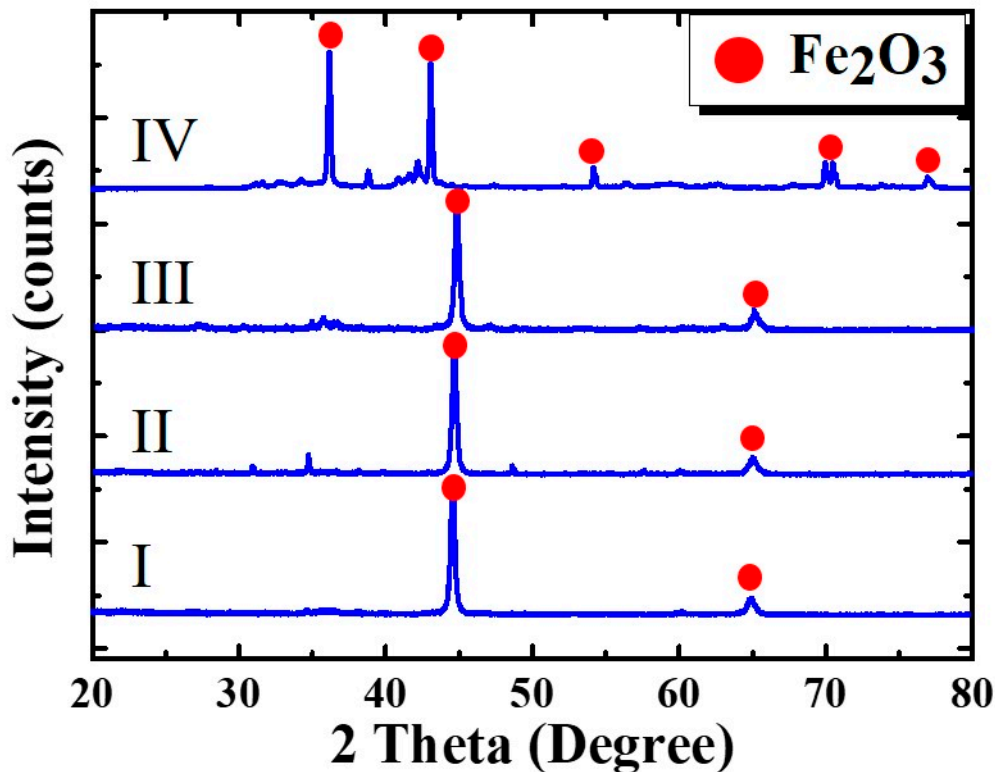
**Figure 4.** XRD analysis of  $\text{Fe}_2\text{O}_3$  crystal phase due to corrosion of the iron cap.

The more pollution, the more various peaks in the  $\text{Fe}_2\text{O}_3$ . In the case of a Pollution Level C, the peak was doubled compared to other cases. Even though the iron surface is zinc-coated to prevent corrosion, depending on the degree of service and the degree of contamination, corrosion occurs on the iron cap and iron pin when iron and oxygen react to form  $\text{Fe}_2\text{O}_3$ .

The values of  $m$ ,  $n$ , and  $p$  vary depending on factors including the temperature, pH value, and oxygen content. Iron oxide, a major component of the corrosion of the metal cap, was measured by X-ray diffraction. If the oxidation of the metal in the porcelain insulator is severe, the ability to support
