Article

Feasibility of Artificial Slope Hazards Identification in Regional Mountainous Highway Using SBAS-InSAR Technique: A Case Study in Lishui, Zhejiang

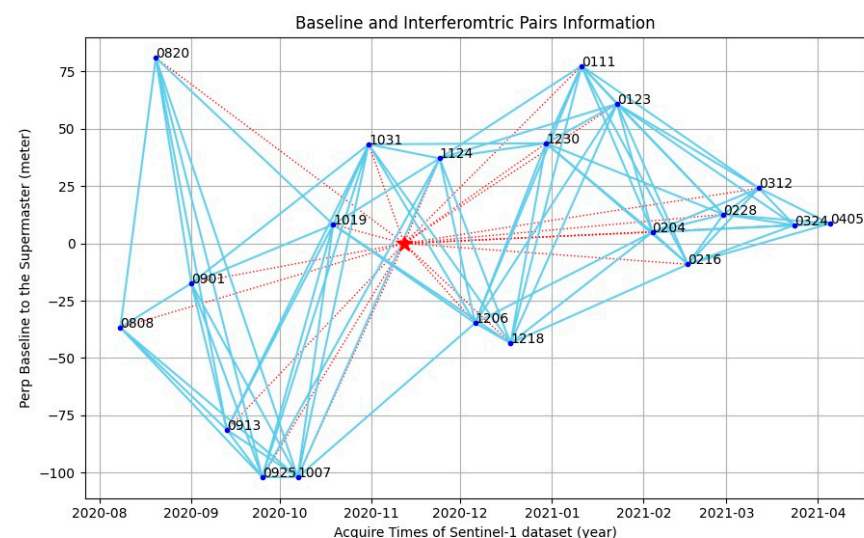
Figure 4. Temporal and spatial baselines of SAR datasets.

Taking the image of 12 November 2020 as the super-master image, the time baseline threshold is set to 72d, and 90 interferometric pairs can be obtained. The small baseline dataset combinations are shown in Figure 4.

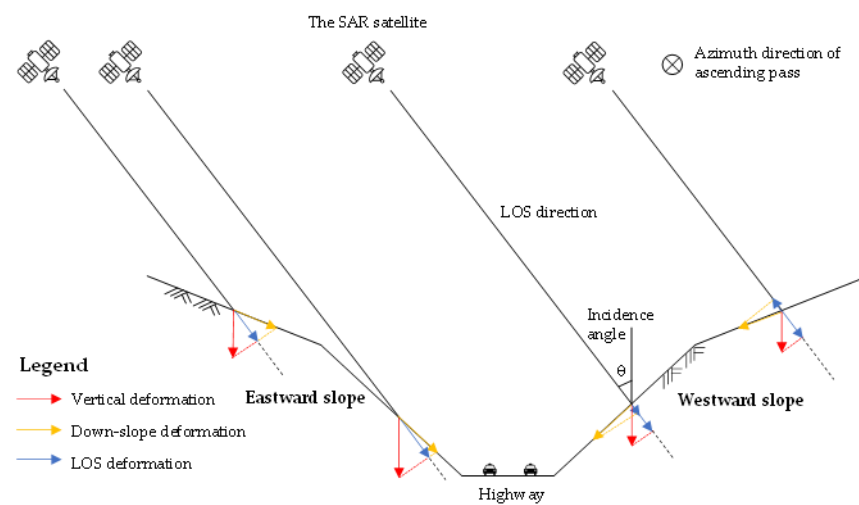
Figure 10. Ground deformation decomposition illustration.

As the highway from Chatian to Zhukou is approximately parallel to the azimuth direction of Sentinel-1A satellite, the cutting slope can be classified into two types, i.e., westward slope and eastward slope. Figure 10 illustrates the decomposition of vertical deformation and down-slope deformation for both westward and eastward slopes [37,38]. The unit deformation vectors along down-slope or vertical direction and the corresponding projections to the LOS direction for four situations are shown in the figure. Then, the possible movement process can be traced back from the LOS deformation according to Figure 10. According to Figure 7, P1~P3 and P5~P6 are covering the areas of westward slope. In this case, vertical and down-slope deformation are both negative value in LOS direction (away from the satellite) in any slope dip angle. Unlike other slopes, the dip direction of P4 is mainly westward. As ascending orbit data are used in the study, for westward slope, a vertical deformation on the slope always appears to be away from the satellite in the LOS direction (see Figure 10). However, a down-slope deformation can be either close to or away from the satellite when the slope dip angle is larger or smaller than the incidence angle. In terms of P4, the dip angle is around 34° ~ 39° and less than the average incidence angle 43.1° . Thus, the down-slope deformation dominated deformation is positive value in LOS direction. Back to Figure 9, it is suggested that the area may experiences downward movement with decreasing LOS deformation (during 7 October to 30 December 2020) and down-slope movement with increasing LOS deformation (after 28 February 2021).

However, there remain several limitations of SBAS-InSAR. As discussed in Figure 10, the orbit track and slope dip influences the deformation detection significantly [38]. In specific cases of slope dip and dip angle, the InSAR method can be insensitive to the deformation. Additionally, most artificial slopes should be regreened after excavation; therefore, high-density coverage of vegetations also reduce the accuracy of InSAR interpretation. In the situation, corner reflector (CR) can be an aid to natural ground objects to supplement PS candidates and to remove the residual topographic phase error [41,42]. From an economic point of view, the cost of SBAS-InSAR method is relatively low, by saving part of the labor input. Nevertheless, the SBAS-InSAR method cannot replace manual inspections in the maintenance of highway, as signs of drainage leakage and cracking on slope surface can be hardly detected by SBAS-InSAR. In addition, the InSAR method has a capability of deformation velocity detection at the level of mm/yr to m/yr; thus, it can be useful for slow to extremely slow slope events rather than fast slope movement. For fast slope movement, approaches with higher monitor frequency should be adopted, such as terrestrial laser scanning (TSL), unmanned aerial vehicles (UAV), ground-based InSAR, and GNSS [21,43].

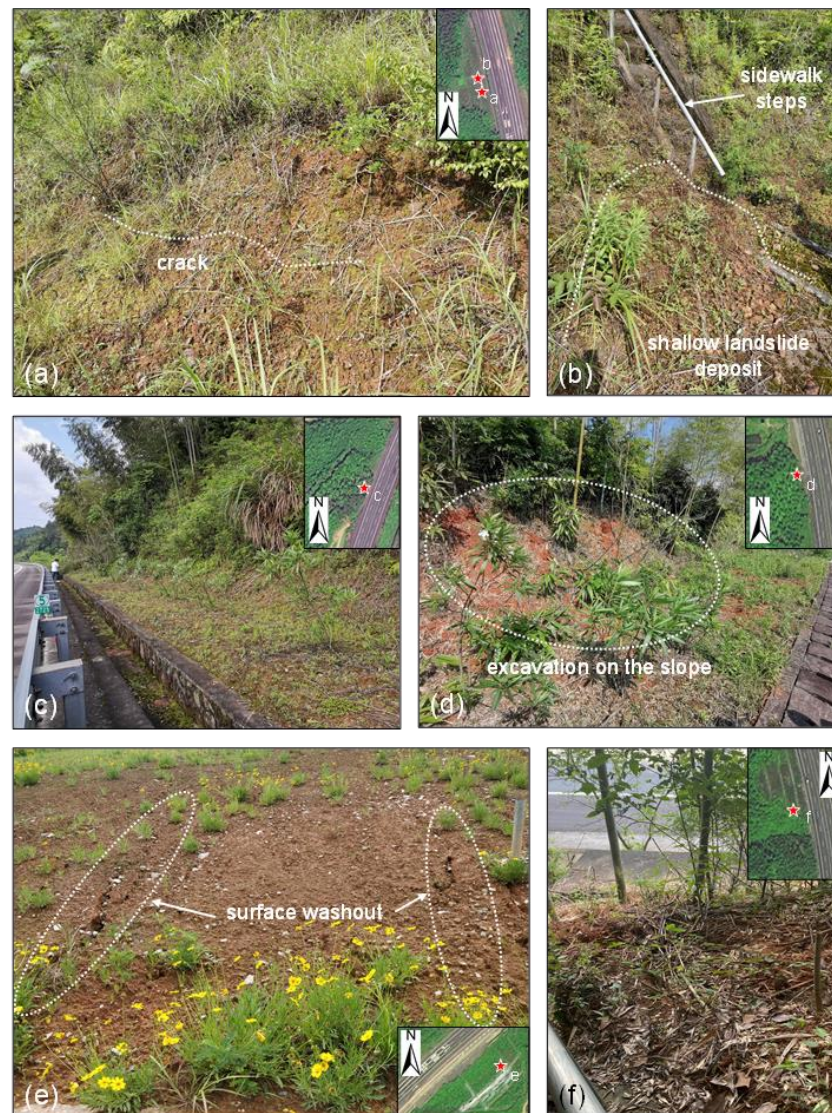
Figure 11. Field validation photographs of potential hazards P1~P5. (a) Joint crack at the 2nd-level slope. (b) Shallow landslide on top of the 2nd-level slope. (c) Full view of P2. (d) Excavation on the slope. (e) Slope surface washout. (f) Vegetation cover on slope.

Figure 11a show obvious joint cracks on the second-level slope with a width of about 1 cm and an extension of about 5 m. The cracks are located roughly at the same area where the deformation velocity of InSAR results is the largest. In addition, shallow landslides were also found near the sidewalk (Figure 11b).

From Figure 11c,f, dense vegetation can be seen on the slope for both P2 and P5, but there was no obvious sign of slope deformation or instability. Therefore, the possibility of slope hazards P2 and P5 is ruled out.

Field investigations showed that there were obvious excavation traces on the slope surface (see Figure 11d). Based on consultations from highway maintenance staffs, the slope surface was damaged by artificial excavation around January 2021. It can be indicated that the highway slope deformation identification based on InSAR technology can well reflect the dynamic status of the slope.

Through field survey on P4, it is found that the slope has been well vegetated, and there are local surface washout and cracks on the slope (Figure 11e).

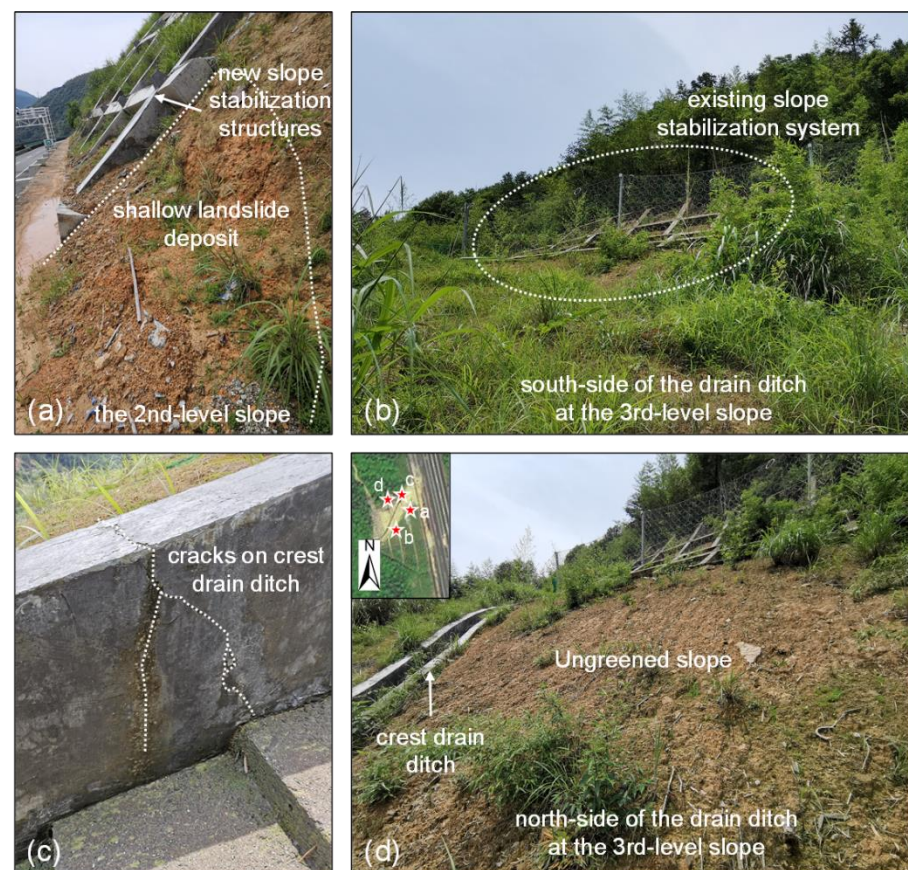
Figure 12. Field validation photographs of potential hazard P6. (a) Shallow landslide on top of the 2nd-level slope. (b) Full view on south-side of drain ditch. (c) Cracks on crest drain ditch. (d) Full view on north-side of drain ditch.

Figure 12 is for potential hazard P6, and it is reported that the several historical hazards has occurred on the slope. Two slope stabilization systems can be found in Figure 12a,b, and the new structure began to build in 2020 and was finished around August 2020. As described in Figure 8, the crest drain ditch can be the dividing line of area P6, and the south-side of the drain ditch is artificially regreened (Figure 12b), while the vegetation on the north-side is sparsely covered (Figure 12d). It is found that the no vegetation coverage zone is basically consistent with the abnormal deformation area identified by InSAR method. The field investigation also found that there were local shallow landslides (Figure 12a) and cracks on the drain ditch structure (Figure 12c) at the 2nd-level slope. There is a rocky

layer exposed on the 3rd-level and 4th-level slope, and it has been stabilized by a flexible protection net combined with grid beams (Figure 12b). Since the begin date of the InSAR calculation is just near the completion date of the new slope stabilization structure, it is speculated that the slope deformation may be postconstruction settlement caused by construction disturbance.
