# Bearing Characteristics and Ground Deformation Computation of Recyclable Steel-Pipe Piles during Pit Excavation

**Abstract:** In the context of increasing environmental awareness and the demand for sustainable construction practices, the use of recyclable materials in civil engineering projects has gained significant attention. This study focuses on the bearing characteristics and deformation behavior of recyclable steel-pipe piles during the excavation of foundation pits. Field experiments and numerical simulations were conducted to comprehensively analyze the stress characteristics and surface settlement patterns behind the piles. The results reveal critical insights into the interaction between the steel-pipe piles and the surrounding soil, providing a detailed understanding of the stress distribution and deformation mechanisms. An empirical method for calculating the surface settlement value, induced by foundation pit excavation under the support of steel-pipe slope protection piles, has been proposed. This method improves the accuracy of settlement predictions and enhances the reliability of foundation pit design.

**Keywords:** recoverable steel-pipe piles; supporting stru

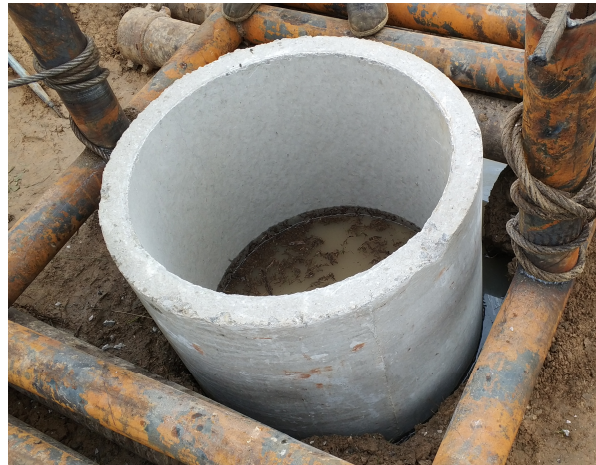
**Figure 3.** Concrete wall-protective pipe.

A reverse circulation drill is used for the steel-pipe pile hole drilling. The wall of the hole is protected by the slurry. To prevent the collapse of the pile holes before the steel-pipe piles are inserted, a wall-protective pipe is set inside the pile holes. The wall-protective pipe texture selected in this test is C25 concrete. Its inner diameter is 700 mm, the wall thickness is 60 mm, and the length of each segment of the concrete wall-protective pipe is 2 m. Figure 3 demonstrates the concrete wall-protective pipe.

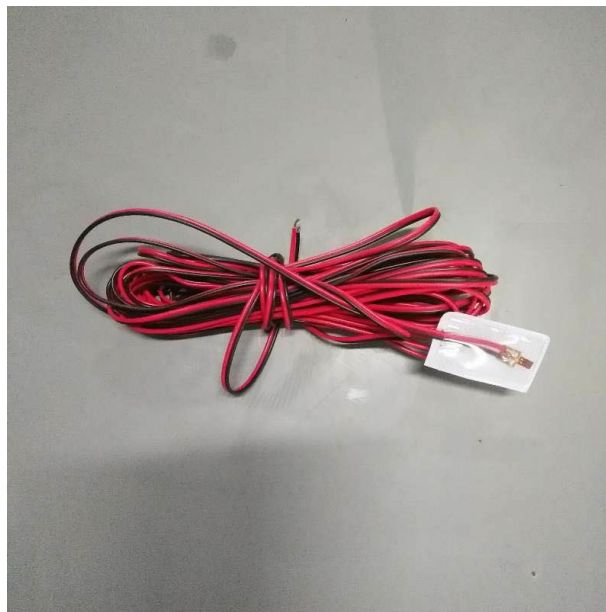
**Figure 4.** Resistance-type strain gauge.

To explore the mechanical performance of the steel-pipe piles during the foundation pit excavation process, 10 strain monitoring points were arranged at the front and rear sides of each steel-pipe pile. A resistance-type strain gauge was pasted on each strain monitoring point. Figure 4 displays the strain gauge. The pile body strain data were collected using a DH3816N static strain testing system, as exhibited in Figure 5. Figures 6 and 7 illustrate the layout of the pile body strain gauge.

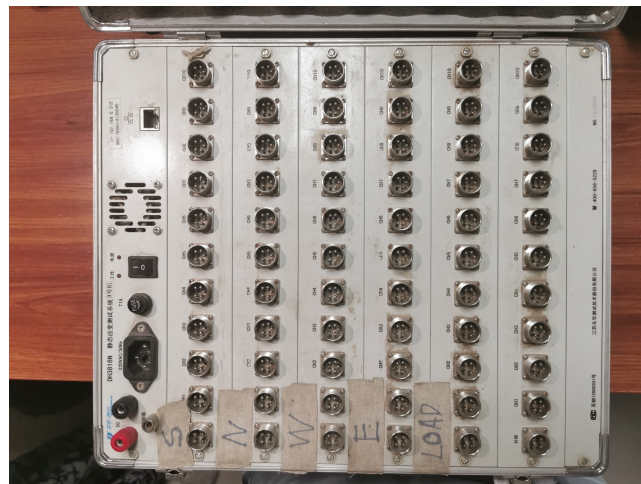
Figure 5. DH3816N static strain testing system.

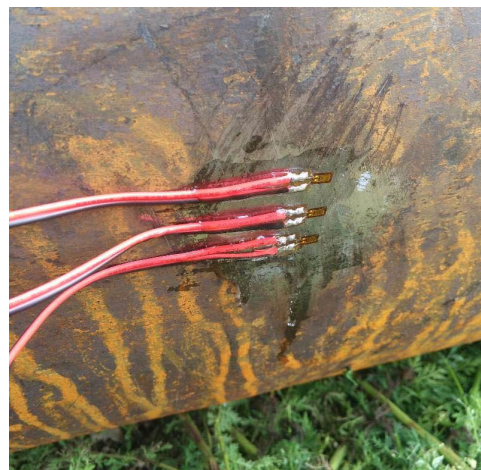
Figure 7. Strain gauge glueing.

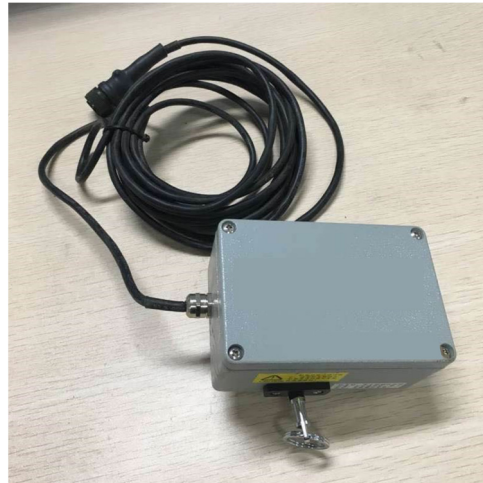
**Figure 8.** Guyed displacement sensor.

The horizontal displacement of the pile top was collected using a guyed displacement sensor (range: 0–100 mm, accuracy: 0.01 mm) and a YT-1 absolute displacement acquisition meter during the test process, as presented in Figures 8 and 9, respectively.

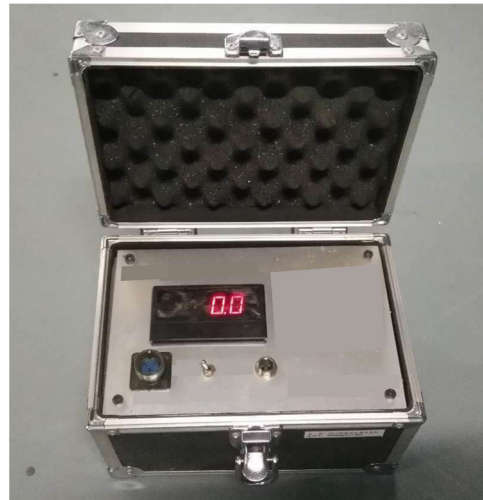
**Figure 9.** Yt-1 absolute displacement acquisition meter.

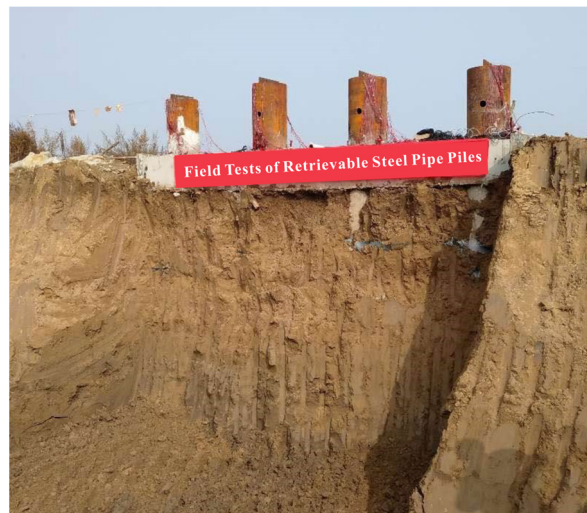
Figure 12. Excavation of the foundation pit.

After arranging the strain gauges on the steel-pipe pile body, the pile was hung in the pile hole set with a wall-protective pipe. Cement paste filled the gap between the steel-pipe pile and wall-protective pipes. A cap beam was created after the cement paste hardened. Its dimensions (width  $\times$  height) were 0.9 m  $\times$  0.6 m, and the concrete grade of the cap beam was C25. After the cap beam reached the design strength, the foundation pit was excavated, and the excavation depth was 6.5 m. The excavation was implemented in three steps. The excavation depth in the first and second step was 2 m, whereas that in the third

step was 2.5 m. Data of the monitoring points were acquired during the excavation process. Figure 12 exhibits the foundation pit excavation.

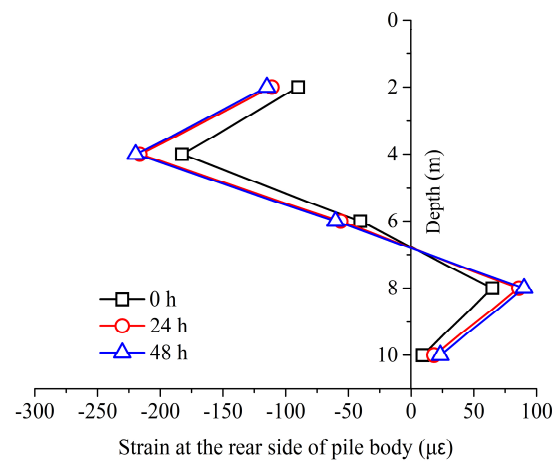
**Figure 15.** The strain at the rear side of the pile body.

Through an analysis of the rear-side strain of the pile body, the following conclusions were drawn. After completing the foundation pit excavation, the tensile region at the rear side of the pile body was mainly distributed below the undersurface of the foundation pit. However, the compressive region at the rear side of the pile body was mainly distributed above the undersurface of the pit. The maximum compressive strain at the rear side of the pile body occurred at 4 m below the ground surface, whereas the maximum tensile strain occurred at 1.5 m below the undersurface of the foundation pit. Zero strain at the rear side of the pile body occurred near the undersurface of the foundation pit. The strain value at the rear side of the pile body was smaller below the undersurface of the foundation pit than above.

Through a comparative analysis of the front-side and rear-side strains of No. 2 pile body, the front side was under the tensile state above the undersurface of the foundation pit, whereas its rear side was under the compressive state. The pile body experienced negative bending, and the maximum bending deformation of the pile body occurred at  $0.62 H$  ( $H$  is the depth of the foundation pit excavation) below the ground surface. This result was due to the fact that the supporting structure underwent bending deformation toward the foundation pit under the action of a constraining effect of the cap beam and the active earth pressure behind the supporting structure. Below the undersurface of the foundation pit, the front side of the pile body was under the compressive state, whereas its rear side was under the tensile state. The pile body experienced positive bending, and its maximum bending deformation occurred at  $0.23 H$  below the undersurface of the foundation pit. The front-side and rear-side strain curves of the pile body were relatively symmetrical.
