# Construction Technology and Service Performance of Waterproof Curtain for Foundation Pit in Large-Particle Pebble Gravel Layer of Yangtze River Floodplain

**Abstract:** A foundation pit is constructed in the floodplain of Yangtze River, and a deep and thick layer of large-particle pebble gravel exists below the base slab, thus forming a connected supply channel with the adjacent Yangtze River. The large water volume, high water pressure, and strong permeability of this layer bring great risks to the foundation pit construction. In view of the fact that conventional waterproof curtain construction technologies such as the deep mixing column and high-pressure jet grouting column cannot meet the engineering requirements under these kinds of geological and environmental conditions, a new waterproof curtain construction technology that combines the trenching technology of the diaphragm wall with the TRD (Trench cutting Remixing Deep wall) technology is proposed, i.e., the trenching-and-replacing-style TRD technology, as well as the construction process of this technology, is presented. After the waterproof curtain is built using the proposed technology, the strength, integrity, unifo

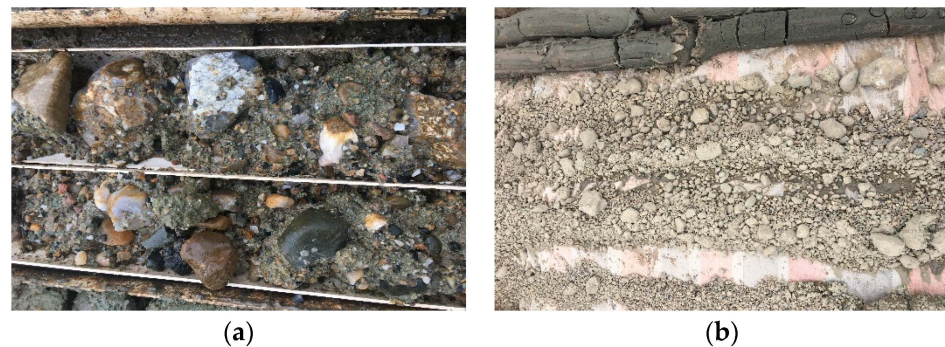
The construction site of the foundation pit is located at the junction of the Nanjing Yangtze River floodplain and the Laoshan Mountain range. According to the comprehensive analysis of drilling, as well as field and laboratory tests, the strata within the exploration depth have been classified into six layers and twelve sublayers from top to down, which are: ①-1 miscellaneous fill, 1-② plain fill, ② silty clay, ③-1 muddy silty clay mixed with silt, ③-1a silty sand mixed with silt, ③-2 silty clay, ④-1 silty clay, ④-2 silty clay, ⑤-1 pebble gravel, ⑤-2 gravelly sand, ⑥-1 strongly weathered argillaceous siltstone, and ⑥-2 strongly-moderately weathered argillaceous siltstone. Among them, the ⑤-1 layer of pebble gravel has a particle size of 20~100 mm, and individual particles can reach 150~300 mm; the ⑤-2 layer of gravelly sand has a particle size of 10~50 mm, and individual particles can reach more than 80 mm, as shown in Figure 2.

**Figure 2.** Representative core samples of ⑤-1 and ⑤-2 layers: (a) Core samples of pebble gravel. (b) Core samples of gravelly sand.

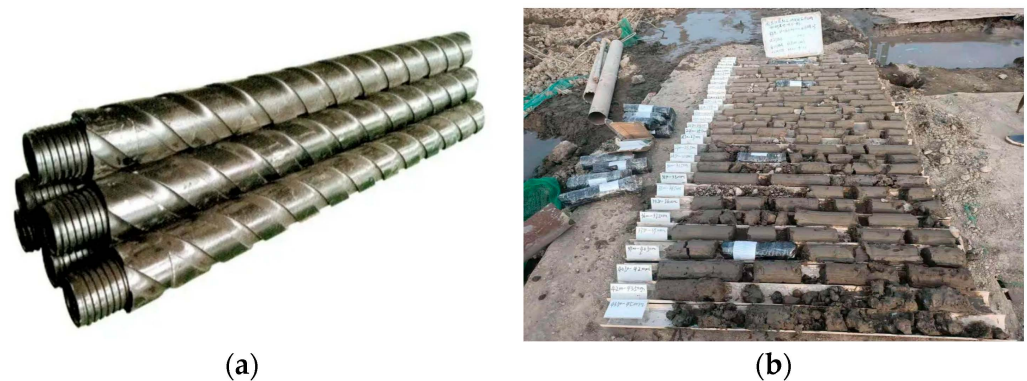
A total of 15 boreholes were drilled along the edge of the foundation pit for coring. Figure 8b shows the representative core samples obtained from the borehole with a depth of 45 m in the underground 3-floor basement area. It was found that after using the single-driving double-tube drilling tool, continuous core samples were obtained along the depth of waterproof curtain, and the coring quality in the pebble gravel layer and gravelly sand layer was significantly improved.

**Figure 8.** Core samples obtained by drilling for lab tests: (a) Drill pipe for coring. (b) Core samples of waterproof curtain.
