# Effectiveness of High-Performance Concrete Jacketing in Improving the Performance of RC Structures

**Keywords:** Kahramanmaraş; earthquake; RC; jacketing; high performance concrete

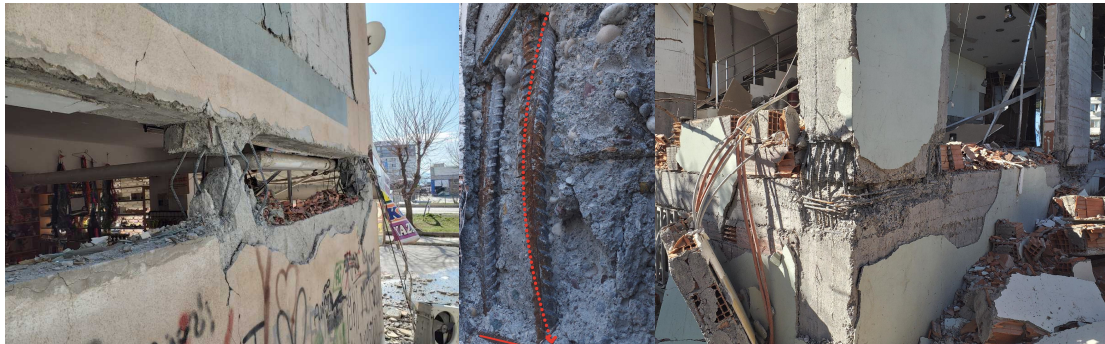
preventing buckling of longitudinal reinforcement. Adequate and appropriately spaced transverse reinforcement increases shear capacity in columns, allowing for ductile behaviour rather than brittle fracture. However, inadequate transverse reinforcement can lead to failure mechanisms leading to collapse, such as premature shear failure, concrete bursting, and buckling of longitudinal reinforcement. Such deficiencies, particularly under high seismic demands, significantly undermine the collapse safety of the structure and increase the risk of sudden strength loss and loss of life. Therefore, column transverse reinforcement detailing should be considered a vital design criterion for seismic safety of buildings. Examples of inadequate transverse reinforcement and damage caused by the Kahramanmaraş earthquakes are shown in Figure 1.

**Figure 1.** Examples of damage caused by inadequate transverse reinforcement.

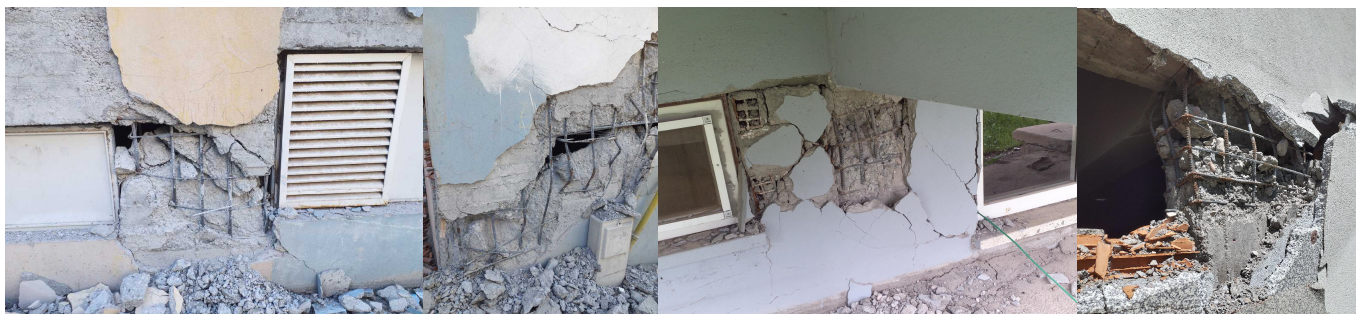
Concrete strength in columns is a fundamental parameter for the structural system to safely transfer vertical loads and exhibit ductile behaviour under earthquake effects. Concrete with adequate strength increases the rigidity and stability of the column through compressive strength and resistance to crack propagation. Transverse reinforcement provides a more effective confining effect, supporting ductility. However, using low-strength concrete can lead to critical problems such as premature collapse, uncontrolled crack expansion, and loss of bearing capacity. This can lead to sudden collapses, shear failures, and a weakening of the structure's overall stability, particularly in columns carrying high axial loads. Therefore, inadequate concrete strength in columns directly negatively impacts the structure's seismic performance, reducing collapse safety and significantly increasing the risk of loss of life. Examples of damage caused by the low-strength concrete in the Kahramanmaraş earthquake are shown in Figure 2.

**Figure 2.** Examples of damage by low-strength concrete.

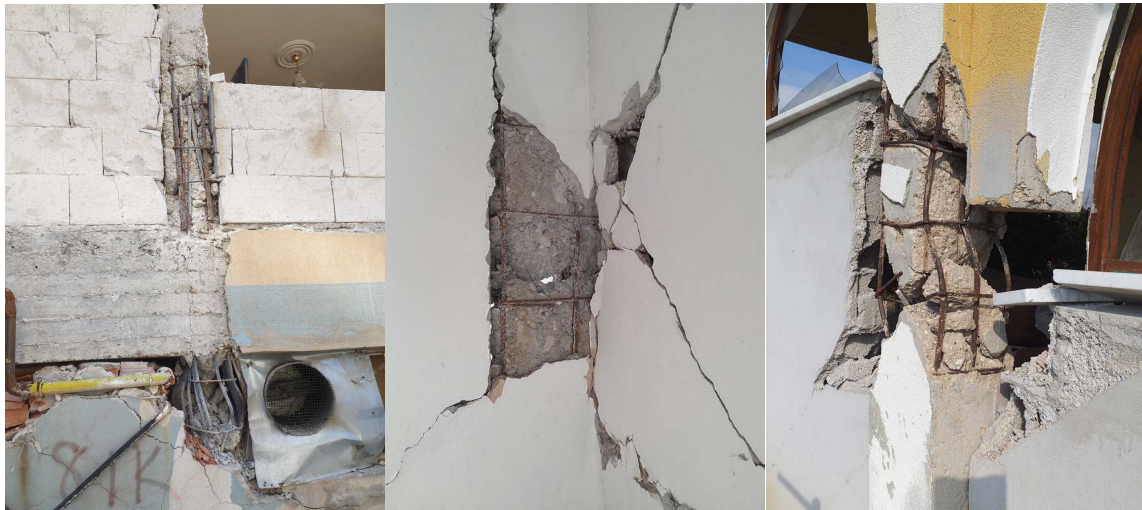
by preserving the reinforcement's thermal resistance under fire. Inadequate cover thickness accelerates reinforcement corrosion, weakens bonding, and increases crack formation, significantly reducing cross-sectional rigidity and load-bearing capacity. Such deterioration can lead to strength losses and ductility in columns, leading to the development of fracture mechanisms that can collapse under dynamic conditions such as earthquakes. Therefore, the adequacy of concrete cover thickness in columns should be considered an essential design criterion for long-term durability and structural safety. Examples of inadequate concrete cover thickness and resulting damage during the Kahramanmaraş earthquakes are shown in Figure 3.

**Figure 3.** Examples of damage caused by insufficient concrete cover.
