# Interior Detail as an Artefact, Reflecting Cultural Value and Architectural Style

Alexandrina Nenkova \* and Anastasiya Kasheva

University of Architecture, Civil Engineering and Geodesy Sofia, Architectural Faculty, Department Interior and Design for Architecture, 1164 Sofia, Bulgaria; kasheva\_far@uacg.bg

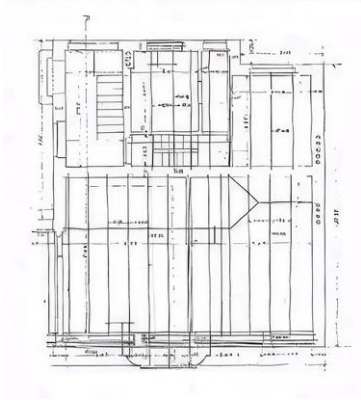
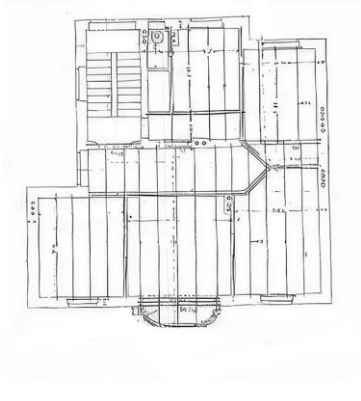
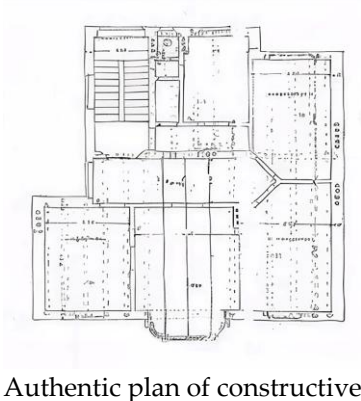
| Floor | Drawing | Section | Facade Image |
|---|---|---|---|
| | Authentic plan of constructive metal floor beams, approved in 1911 | Authentic section of the house, 1911 | Facade with original moulding raster and windows, facing Blvd Christo Botev (then Ferdinand), 1911 |

The 1911 archival drawings confirm that the building was constructed using metal floor beams as the primary structural system. The original façade drawing documents the moulding profile and window arrangement as originally approved, providing a reliable baseline against which the current state of the building—confirmed by the 2025 3D laser scanning—can be directly compared. The most complete survival of authentic interior details was identified at level +5.40, the principal floor.

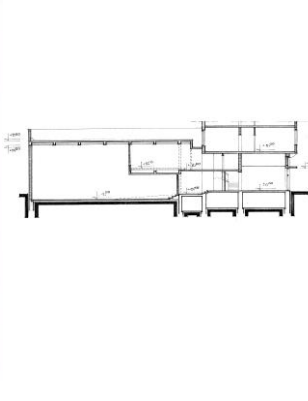
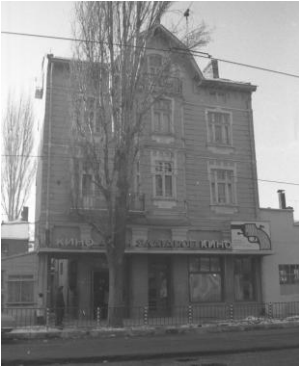
| Floor | Drawing | Section | Facade Image |
|---|---|---|---|
| | Authentic plan of constructive metal floor beams, approved in 1911 | Cross-section of reconstruction of level 0.00, approved 1997 | Picture from Public Municipality-archives of the structure during the 1970s |

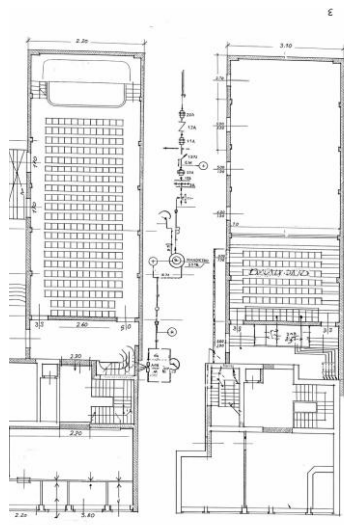
Authentic plan of scheme of  
electrical installation,  
approved in 1911

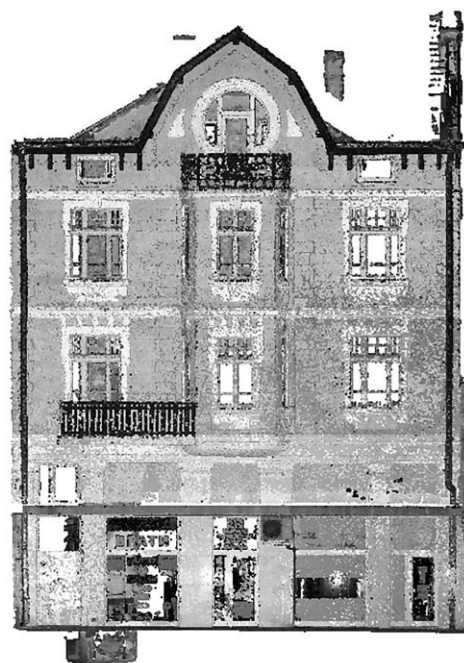
1a 3D laser scan of façade facing Blvd. “Christo Botev” and digital model, -2025

3D laser scanning of the building at Blvd ‘Christo Botev’ N85 was carried out in 2025 by an external specialist company using a Trimble SX12 Scanning Total Station. The building was selected for scanning for two reasons: first, the owner granted permission for the survey, which was not obtainable for the other two case study buildings; and second, the scanning was required as part of a parallel construction observation project for the structure. The Trimble SX12 is a robotic scanning total station capable of capturing 26,600 points per second, with a scanning range of up to 600 m and a field of view of  $360 \times 300$  degrees. It operates with an EDM accuracy of 1 mm + 1.5 ppm and uses a pulsed laser (1550 nm) with a green laser pointer (520 nm) for precise targeting. The scanning covered the principal façade of the building facing Blvd ‘Christo Botev’ and produced a point cloud characterised by high accuracy (2–10 mm) and high precision (3–15 mm spacing between points), with a low level of noise. Each point in the dataset contains real colour information, enabling an accurate and detailed digital record of the building’s current external condition. The key finding from the scanning data is the confirmation that the principal façade retains its original moulding profile and fenestration pattern, consistent with the 1911 approved drawings held in the municipal archive. No 3D scanning was carried out for Structures 2 and 3, as access permissions were not obtained; these buildings were documented exclusively through field survey, photographic recording, and archival research.

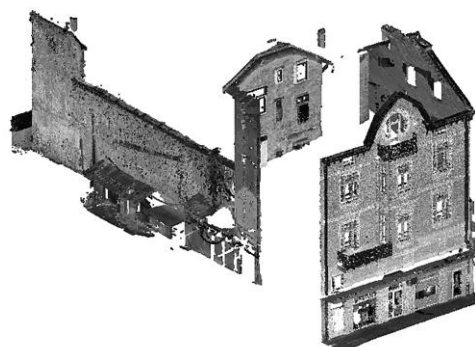
2a 3D laser scan of façade facing Blvd. “Christo Botev” and digital model, -2025

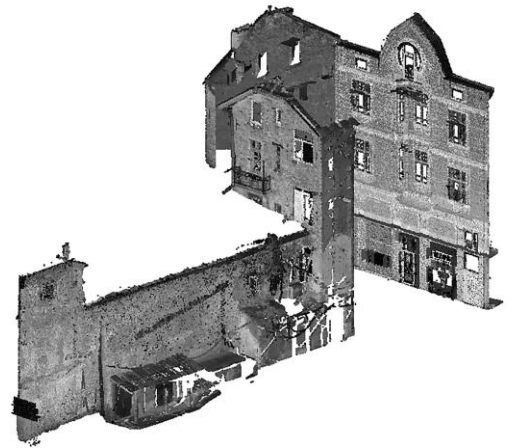
3a. 3D laser scan of façade facing Blvd. “Christo Botev” and digital model, -2025

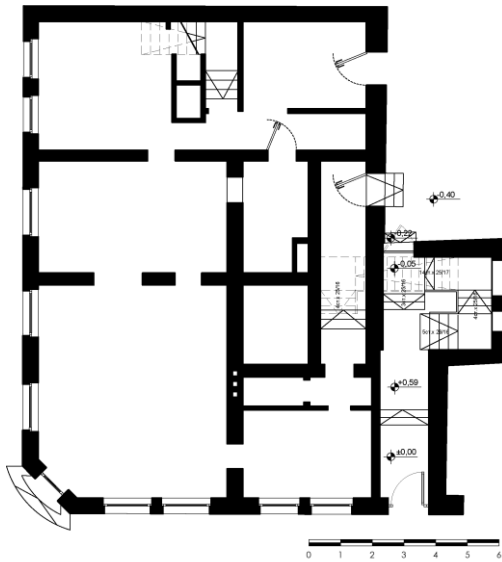
| Floor | Drawing <sup>‡</sup> | Section <sup>‡</sup> | Facade Image <sup>‡</sup> |
|---|---|---|---|
| | Restorative architectural survey plan level 0.00 | Restorative cross section | Archive photograph from- the 1980s<br><a href="https://nag.sofia.bg/">https://nag.sofia.bg/</a> (accessed on 26.01.2026) |

The absence of original architectural plans in the state archive reflects the extent of transformation the building has undergone. The restorative survey drawings presented in Table 2 were produced by the authors to reconstruct the original spatial configuration. They confirm that the ground floor commercial spaces were substantially altered—subdivided and extended vertically—during later interventions, while the upper floor levels retain a more legible relationship with the original building layout.

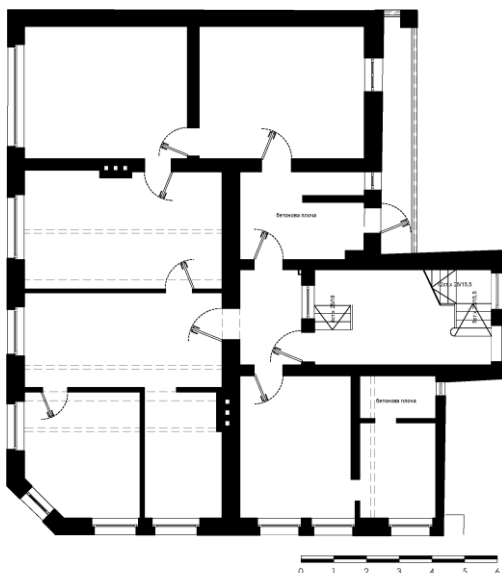
Restorative architectural survey plan level  
+4.58

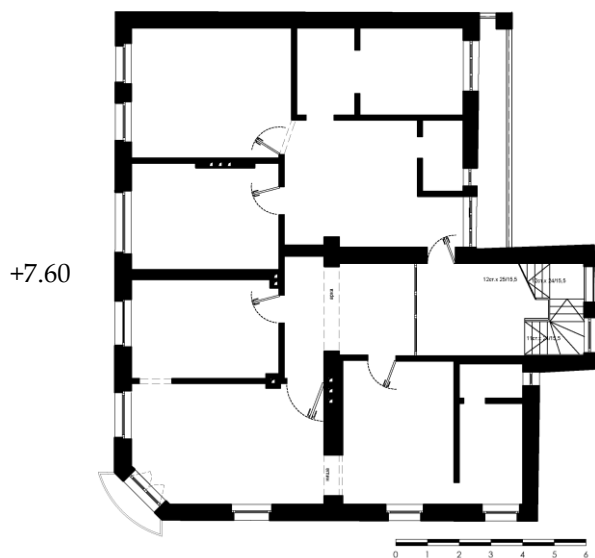
Restorative architectural survey plan level  
+7.60

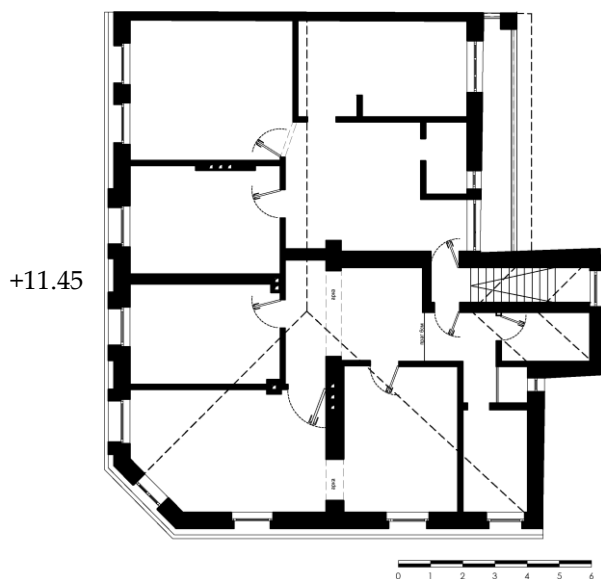
Restorative architectural survey plan level  
+11.45

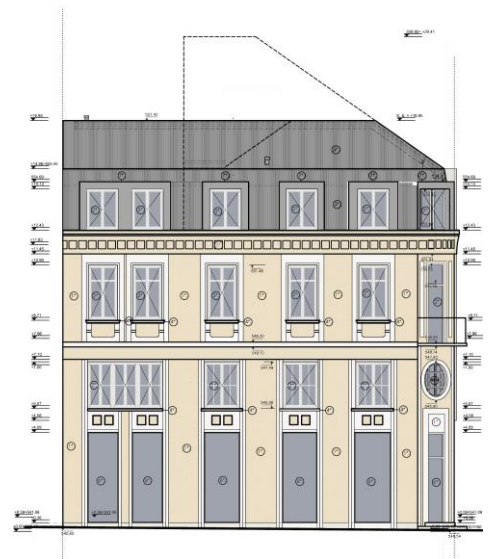
Elevation at the “Pirotka str.” —Project

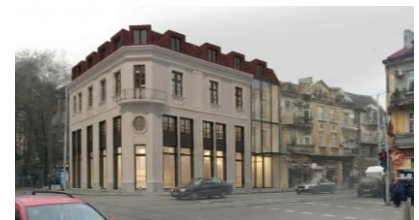
Adaptive visual project for structure  
N1

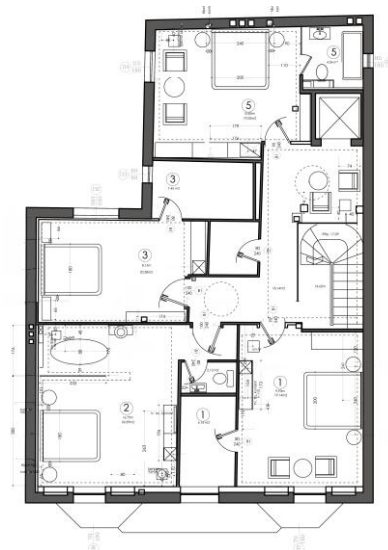
Adaptive architectural plan +6.50

The adaptive architectural plans presented in Table 3 document the building in its current state following conversion to a small hotel. The drawings confirm that the adaptation involved significant intervention at all floor levels. The archival photograph from the 1980s provides the primary visual evidence of the building’s pre-intervention condition and serves as the key reference point for assessing the degree of change the interior has undergone.

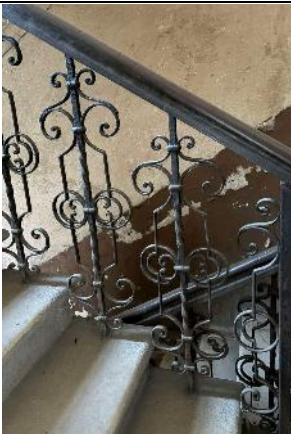
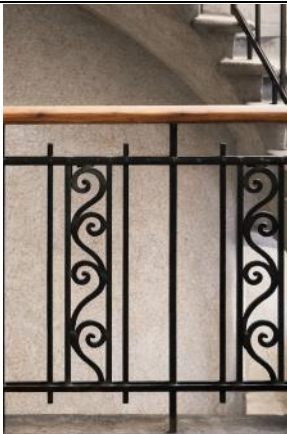
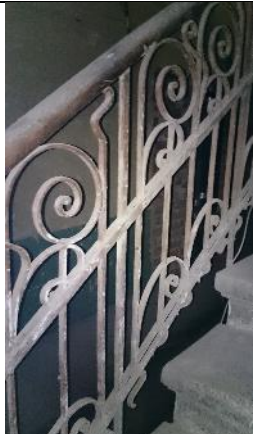
| Type of Construction on Detail | Pictures <sup>†</sup> of Structure 1<br>N85 Blvd. Christo Botev | Pictures <sup>†</sup> of Structure 2<br>N75 Blvd. Christo Botev | Pictures <sup>†</sup> of Structure 3<br>N36 Blvd. Stambolyisky |
|---|---|---|---|
| Stair rail—metal | | | |

All three buildings retain metal stair railings of wrought iron with cast decorative elements. Structure 1 presents the most complete and well-preserved example, with continuous ornamental scrollwork consistent with late Historicist production from the first decade of the twentieth century. Structure 2 retains partial original railings on the main stair, with later interventions visible on the upper flights. Structure 3 retains original railings on the primary stair only; the secondary stair has been replaced. In all three cases, the

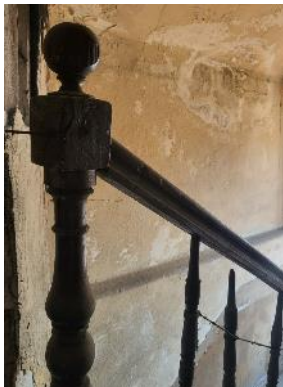
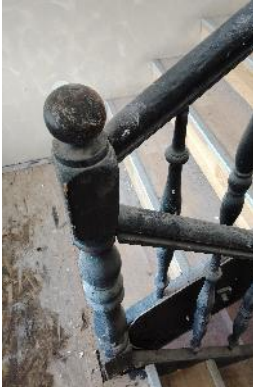
| Type of Construction on Detail | Pictures <sup>†</sup> of Structure 1<br>N85 Blvd. Christo Botev | Pictures <sup>†</sup> of Structure 2<br>N75 Blvd. Christo Botev | Pictures <sup>†</sup> of Structure 3<br>N36 Blvd. Stambolyisky |
|---|---|---|---|
| Stair rail—wooden | | Not available (wooden parts—damaged) | |

Granite treads were identified in all three buildings on the primary stair flights. In Structure 1 and Structure 3, the granite is original and retains its surface finish. In Structure 2, several treads have been replaced with a non-matching stone. Timber stair construction was found in the uppermost flights of all three buildings, consistent with the common practice of the period of using timber for secondary and service-level circulation.

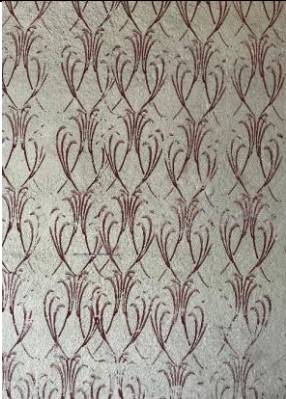
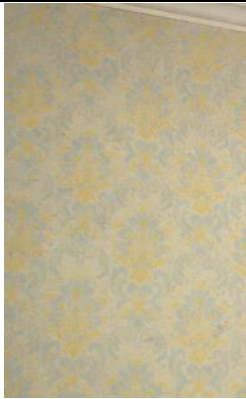
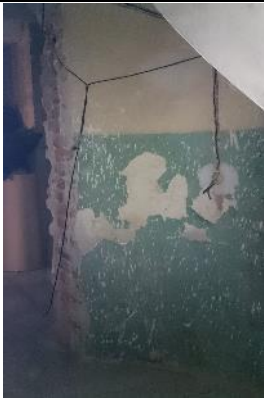
| Type of Surface De-<br>tail | Pictures <sup>+</sup> of Structure 1<br>N85 Blvd. Christo Botev | Pictures <sup>+</sup> of Structure 2<br>N75 Blvd. Christo Botev | Pictures <sup>+</sup> of Structure 3<br>N36 Blvd. Stambolyisky |
|---|---|---|---|
| Wall finishing <sup>1</sup> | | | |

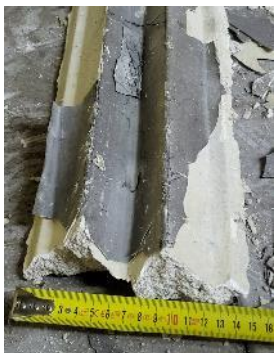
| Gypsum cornice | | Not available<br>(damaged) | Not available<br>(damaged) |

Ornamental plaster ceiling medallions and cornice enrichments were identified only in Structure 1. These are located at the principal floor level and are in a state of partial deterioration but remain legible. Structures 2 and 3 show no surviving ornamental plasterwork.

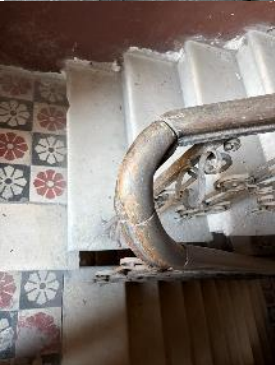
| Flooring patterns | | | |

Decorative ceramic floor tiles were identified in Structure 1 on the stair landings. The tile patterns—geometric and floral compositions in terracotta, cream, and red—correspond to production types documented in Italian and Central European catalogues of the 1900–1920 period. A comparable tile type has been identified in Milanese production of the same era. Structure 2 retains original timber flooring in one room at the upper level. Structure 3 has undergone complete floor replacement and retains no original flooring.

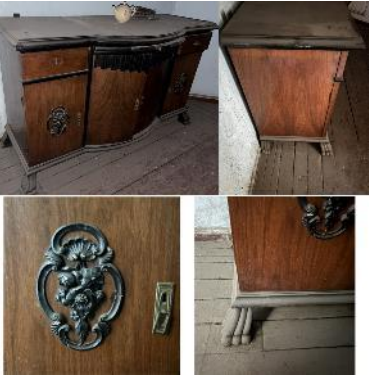
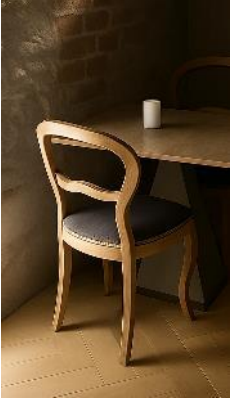
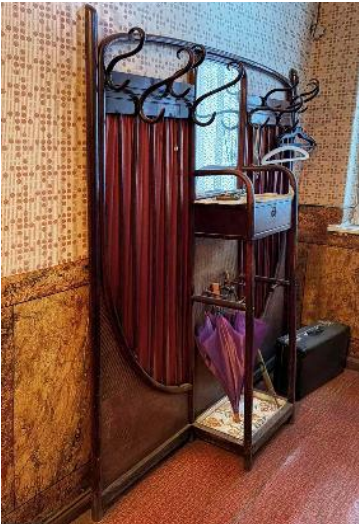
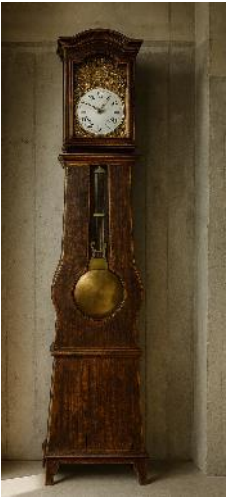
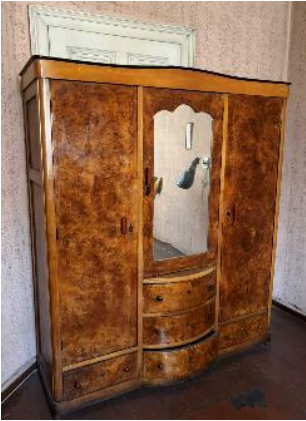
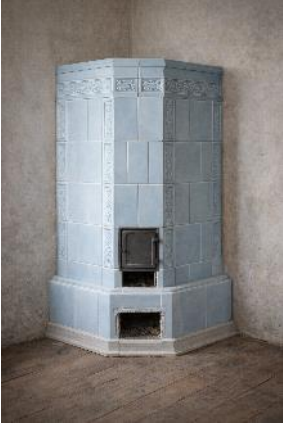
Table 6. Characteristic fitting and furniture interior details.

Table 6 documents the surviving fitted elements and furniture across the three buildings. The pattern of survival is consistent with that observed in Tables 4 and 5: Structure 1 retains the greatest number of authentic elements, including original heating appliances and furniture pieces, while Structures 2 and 3 show extensive replacement or loss. The ceramic tile stove identified in Structure 2 is the most significant surviving fitted element in that building and is discussed in detail in the comparative analysis that follows.

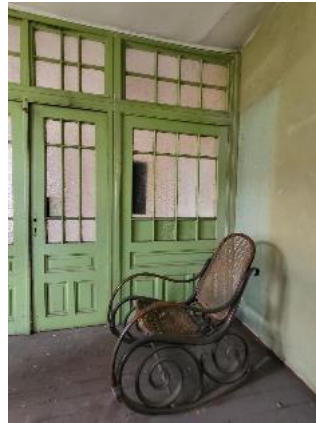
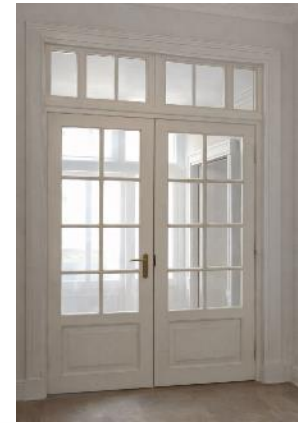
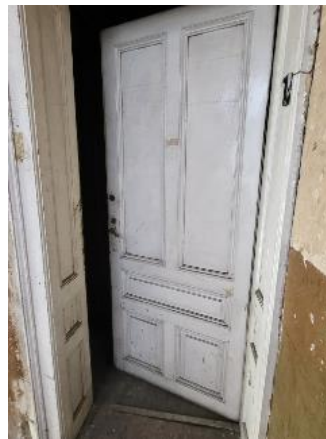
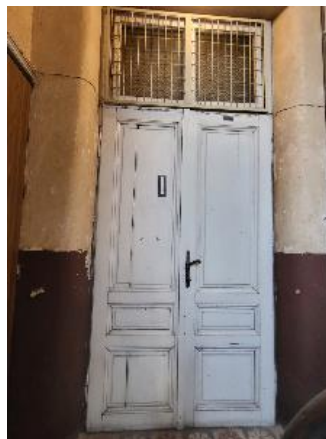
Table 7 shows that authentic door and window elements survive almost exclusively in Structure 1. The corner window retained in Structure 2 is the sole surviving original fenestration element in that building and represents a formal characteristic consistent with Secessionist influence. Structure 3 retains no original joinery of any kind. The pattern across all four tables confirms that Structure 1 is the most completely preserved of the three case study buildings, and that the degree of interior transformation correlates directly with the intensity of the adaptive reuse interventions each building has undergone.

frames. Structure 3 has undergone complete replacement of all windows and interior doors; no original joinery survives.

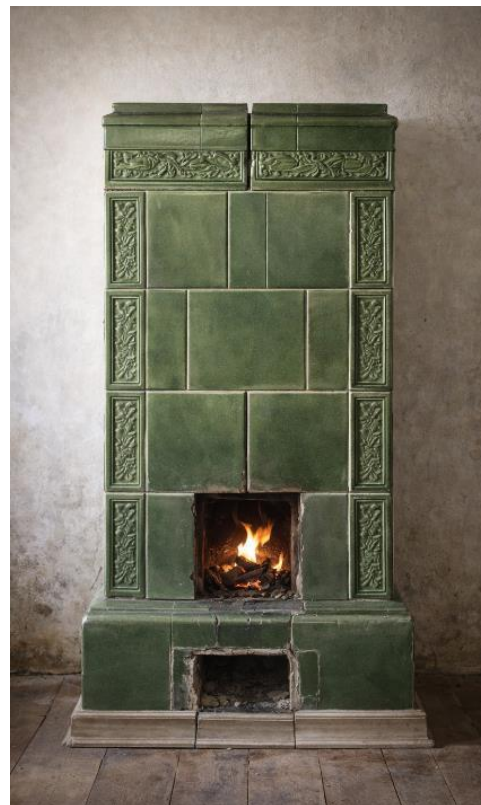
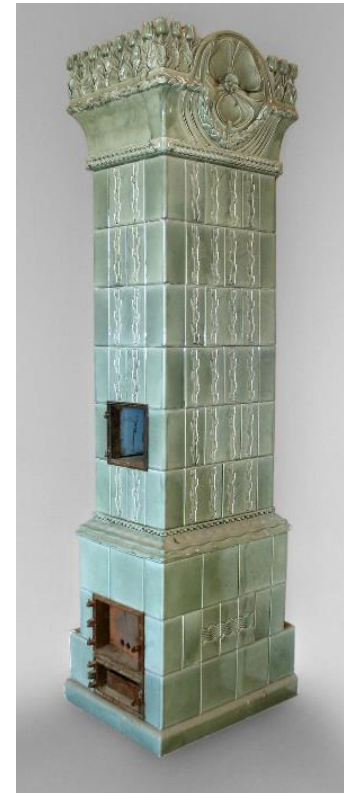
**Figure 4.** Images of objects in Sofia and an object from Meissen from 1902, with clear classicistic elements: (A) ceramic stove found inside Structure 2, at N75 Blvd. “Christo Botev”; (B) Kachelofen, 1902, Meissen Teichert, H 260 × B 77 × T 56 cm. (<https://www.invaluable.com/> (accessed on 13.01.2026)).

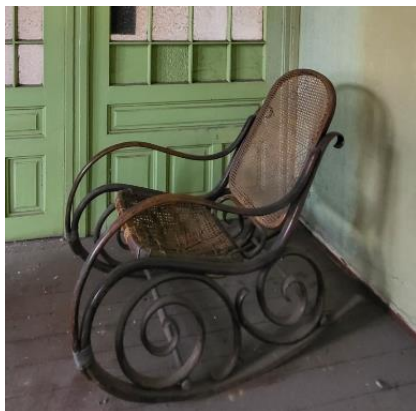
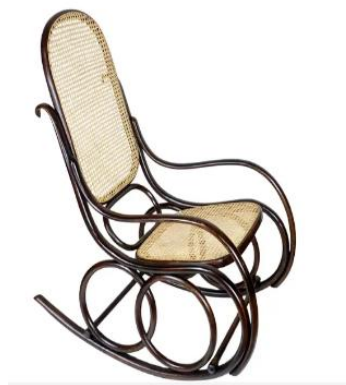
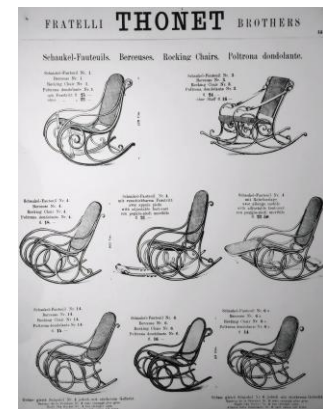
**Figure 5.** The rocking chair in the photograph is very similar but still different to Thonet's bentwood rocking chair: (A) rocking chair artefact from second floor of the structure; (B) Thonet rocking chair 10 By Jacob Josef Kohn (C) Sample page copy from Thonet katalog, from the site of museum-bop-pard.

The differences in the chair indicate that it is neither of the above ((B) or (C)). It has no marks of the producer, so this is a replica of a Thonet Brothers rocking chair. The details identified in Structure 1, displaying formal characteristics consistent with Thonet-style production; attribution to a specific maker or period cannot be confirmed from visual evidence alone.

A comparative analysis of the findings from Structure N1, the house at N85 Blvd. Christo Botev, regarding furniture, is illustrated in (Figure 5).

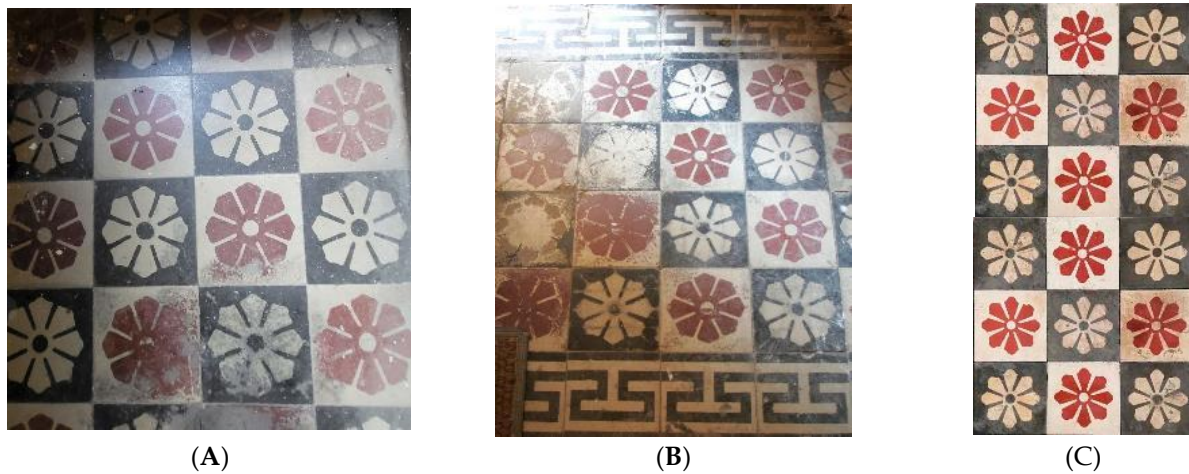
**Figure 6.** Evidence of shared decorative tile traditions across Central European and Italian production of the early twentieth century. (A) Ceramic floor tiles preserved on the stair landings of Structure 1 (Blvd 'Christo Botev' N85), documented during field survey. (B) Comparable tile pattern identified in a European heritage interior, illustrating the widespread use of identical decorative motifs across the region. (C) Decorative floor tiles from an early twentieth-century Italian producer, Milan, displaying the same geometric and floral compositions as those found in Structure 1. The Sofia artefact—measuring exactly 20 mm in total thickness, with a denser surface layer of approximately 5 mm—is fully consistent with the production standards of the Marche and Sicilian workshops of the period. The absence of a maker's mark is characteristic of the smaller regional ateliers whose output reached Bulgaria through the trade channels operating from Ancona, Trieste, and Budapest.

The visual correspondence between the three examples, illustrated in Figure 6, confirms that the tiles in Structure 1 are consistent with the wider Central European and Mediterranean production and trade networks that supplied Sofia's residential construction market during the late nineteenth and early twentieth centuries.
