# Looking Deeper into the Galaxy (Note 7)

**Abstract:** Li-ion cell designs, component integrity, and manufacturing processes all have critical influence on the safety of Li-ion batteries. Any internal defective features that induce a short circuit, can trigger a thermal runaway: a cascade of reactions, leading to a device fire. As consumer device manufacturers push aggressively for increased battery energy, instances of field failure are increasingly reported. Notably, Samsung made a press release in 2017 following a total product recall of their Galaxy Note 7 mobile phone, confirming speculation that the events were attributable to the battery and its mode of manufacture. Recent incidences of battery swelling on the new iPhone 8 have been reported in the media, and the techniques and lessons reported herein may have future relevance. Here we look deeper into the key components of one of these cells and confirm evidence of cracking of electrode material in tightly folded areas, combined with a delamination of surface coating on the separator, which itself is an unusually thin monolayer. We report microstructural information about the electrodes, battery welding attributes, and th

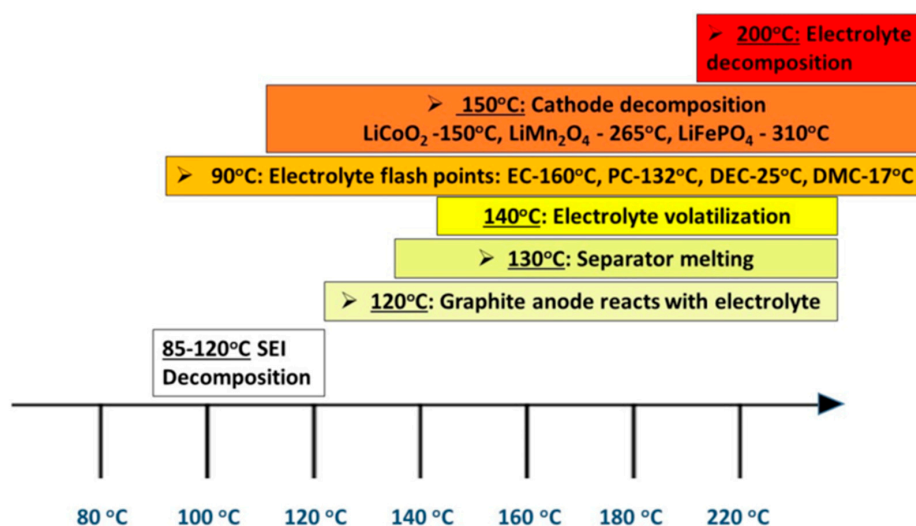
**Figure 1.** A summary of the thermal runaway cascade of reactions that take place inside a lithium-ion cell as a function of temperature.

Prior to commercial availability, a battery will undergo a formation cycle. This allows for the creation of a protective layer on the electrodes, generated from the decomposition of a small amount of electrolyte solution on the surface of the electrodes. This is termed the ‘solid electrolyte interphase’ (SEI). Following a short circuit event the localised temperature inside the cell begins to rise and at 100 °C the SEI film begins to decompose [11]. A series of exothermic reactions follow between SEI compounds and electrolyte solvents such as ethylene carbonate (EC) and diethyl carbonate (DEC). When this cascade of reactions proceeds uninterrupted, it causes a rapid elevation of the internal temperature whereby a series of reactions can generate large volumes of flammable hydrocarbon gases, which will vent to atmosphere—see Figure 1 [12–15].

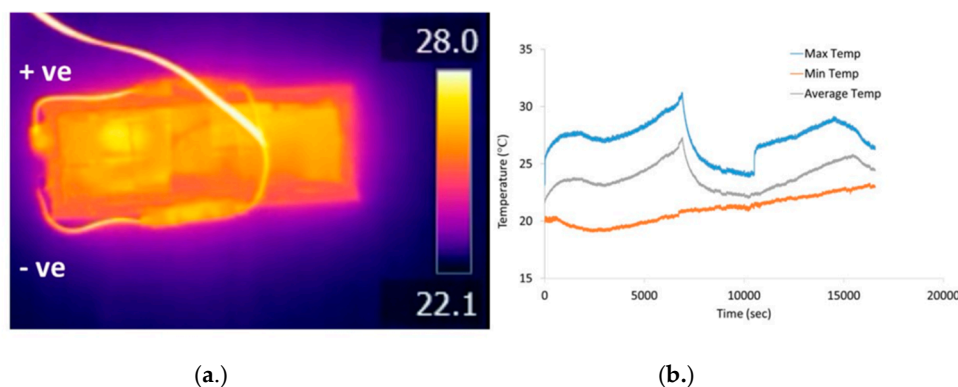
Figure 2a shows the temperature profile (maxima and minima) as a function of charging time with periodic thermal imaging. For the duration of the charging step, the temperature of the cell did not rise above 32 °C at a charging rate of C/2.

A noticeable temperature difference of up to 3 °C can be seen across the cell from top to bottom. The higher temperature side is where the positive terminal is sited and this is where current transport occurs with the cathodes. The current collectors for this electrode are made of aluminium, whereas the anode current collectors are made of copper. Cu and Al have differing thermal conductivities of 401 and 205 W/(m K) and electrical resistivities of  $1.72 \times 10^{-8}$  and  $2.65 \times 10^{-8} \Omega\text{-m}$  respectively, hence the anode has lower electrical resistance and the capacity to dissipate heat more quickly. Additionally, the Al current collector is 5  $\mu\text{m}$  thicker than the Cu current collector at the anode and can thus contribute to slowing down heat transfer.

**Figure 2.** (a.) Thermal imaging at 180 minutes charging and (b.) Operational temperature profile.

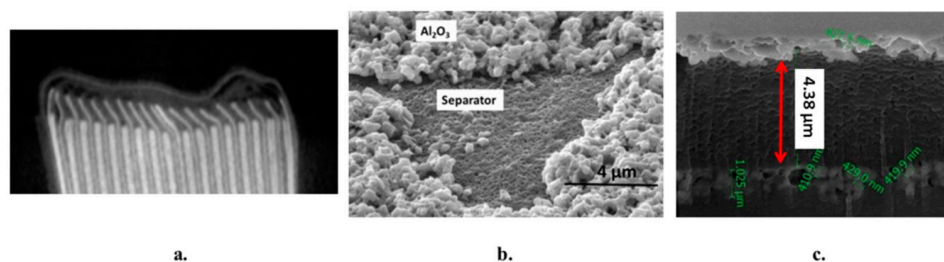
Consistent with device findings ascribed to cells that were produced at Manufacturer A, from the enlarged images in Figure 3a the feature that resemble a fallen row of dominoes the bottom section edge of the prismatic from unintended damage to the negative electrode windings. The corners are folded over and thought to be caused by a pouch design with insufficient internal space around certain regions of cell content. There is a clear deformation at the cell here, thought to derive from the manufacturing and assembly process.

The potential implications of this, taking into account typical expected dimensional manufacturing tolerances, are to increase the likelihood of an internal cell short circuit and subsequent thermal failure during normal operation.

**Figure 3.** (a.) X-ray CT scan of edge deformation in the phone battery electrodes; (b.) SEM image of ceramic-coated separator revealing a delaminated region; (c.) cross-sectional SEM image of the separator.

On disassembly of the cell and subsequent unravelling of the components, there were areas of separator that had small sections of electrode coating adhered to them. A thin  $\text{Al}_2\text{O}_3$  coating is evident on the polymer separator and had become delaminated in parts—as can be supported by the ceramic fragments found on the electrode surfaces in Figure 4. This was apparent during the disassembly of the pouch cell with electrode patches adherent to some areas near the edges of the separator, suggesting more mechanical stress exposure in these areas. From the SEM images below, the ceramic material phases are identified as being aluminium oxide from the adjacent EDS chemical maps. The electrode active materials were found to be graphite and lithium cobalt oxide for the anode and cathode respectively (as expected). The particle size range is very broad in the cathode allowing for increased packing density of the active material and thus higher capacity.

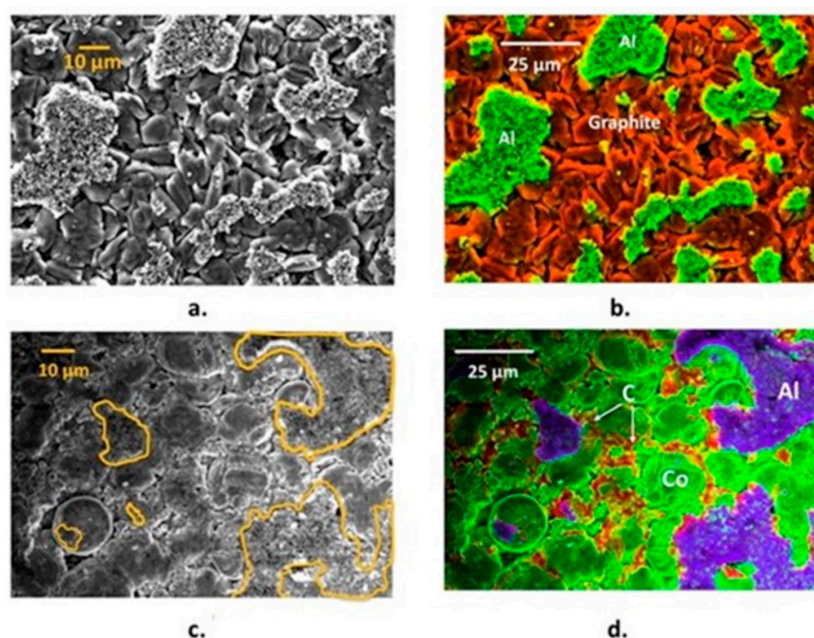
Upon forensic disassembly of the cell and subsequent unravelling of the electrodes there were visible areas of coating irregularities on both the electrodes and the separator—see Figure 3b. On the anode there is coating delamination on several edge regions, with cracking of the coating at the folded areas. This reflects greater pressure exerted on these regions and could indicate the potential for separator damage in these zones, leading to an internal short circuit. Additionally, any material detached from the electrode, if it were to enter the electrode stack, could increase local mechanical pressure on the separator.

Conversely, on the cathode electrode there were frequent deposits of a ceramic layer—this is investigated further. There have been no mentions of electrode manufacturing quality concerns or separator coating issues in the previous reports. SEM imaging was carried out on electrodes and pieces of separator material and is depicted in Figure 4, which shows surface analysis and cross-sectional characterisation. The anode was mainly composed of graphite and the cathode was based on lithium cobalt oxide (LiCoO<sub>2</sub>).

**Figure 4.** SEM-EDS images of (a.) LCO cathode; (b.) graphite anode; (c.) cathode showing carbon nanotubes; and (d.) cathode broad particle size distribution.

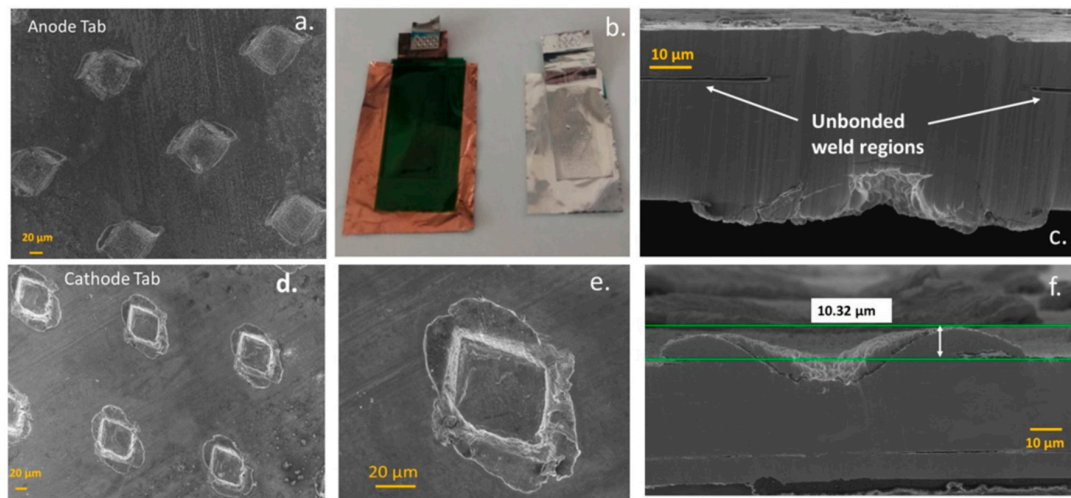
Figure 5 shows SEM images of the anode and cathode welded tab regions that transport current (charge) to the battery electrodes. This is typically used because conventional fusion welding processes (such as resistance spot welding and laser welding) are faced with challenges in joining multiple sheets of highly conductive, dissimilar materials over large areas [30]. The fusing together of cell current collectors and tabs achieved by ultrasonic welding uses high-frequency energy  $\geq 20$  kHz to generate oscillating shears at the interface between a sonotrode and metal sheets. This produces solid-state bonds between the sheets clamped under pressure in a period of time less than a second [31]. Thus, the solid-state mechanism of the ultrasonic process is better suited to generating weld joints with higher integrity.

The weld areas in the cathode tab section characterised in this study did not appear as sharp protrusions, however our sample size was limited and such failure, if present, would be expected only on a statistically small proportion of cells. We did however detect areas of unbonded weld regions and

one of the assessment criteria of weld quality is correlated to the joint characteristics. An ultrasonic metal weld with good weld quality should have dense and continuous interfacial bonds [30].

**Figure 5.** Images showing (a.) lower magnification SEM of welded tab; (b.) missing insulating polyimide tape on the cathode tabs; (c.) SEM cross-section of an anode tab weld; (d.) lower magnification SEM of the cathode welded tab; (e.) higher magnification cathode weld; (f.) SEM cross-section ion-milled cross-section of a cathode tab weld.

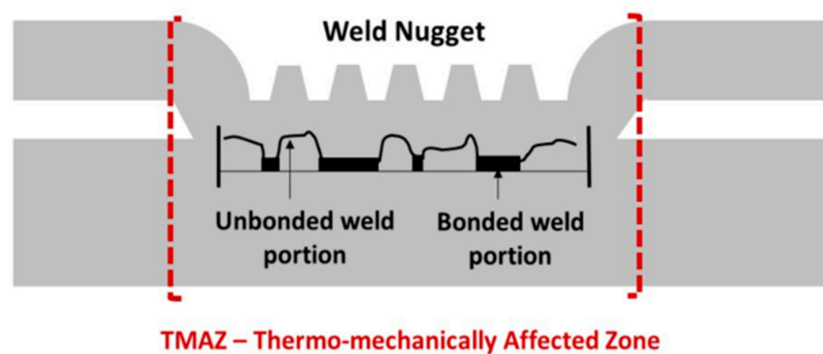
Evident within this type of welding is material flow, whereby excessive plastic deformation can thin and negatively affect the weld quality [30]. This can result in pieces of material from the thermomechanically affected zone (TMAZ), becoming detached and the weld bond being discontinuous. Cells from Manufacturer B were reported to have sharp protrusions in the welded tab region of the cathode, in the region of the thermomechanical affected zone—see Figure 6 for a description of key attributes in ultrasonic welds. UL and Exponent released independent reports of their testing on the Note 7 and reported internal cell faulting between the positive electrode tab welding defects and the anode copper foil directly opposite the defective welds—depicted in Figure 7 [32]. The figure shows sharp and relatively tall welding defect features and the report suggested a short circuit occurred between the weld defect features on the positive tab and the copper of the negative electrode, resulting in thermal runaway at high states of charge [32].

**Figure 6.** Schematic of some of the structural attributes of an ultrasonic weld.

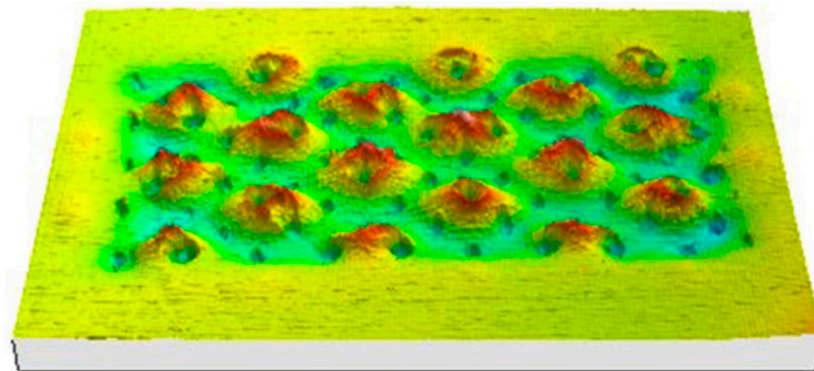
**Figure 7.** 3D reconstructed X-ray tomographic scan weld area defect features in the positive tab from Manufacturer B cells.
