## Article

# Prediction of Subsurface Fatigue Damage in Dental CAD/CAM Restorations: Intraoral Scanning vs. Optical Coherence Tomography

## Abstract

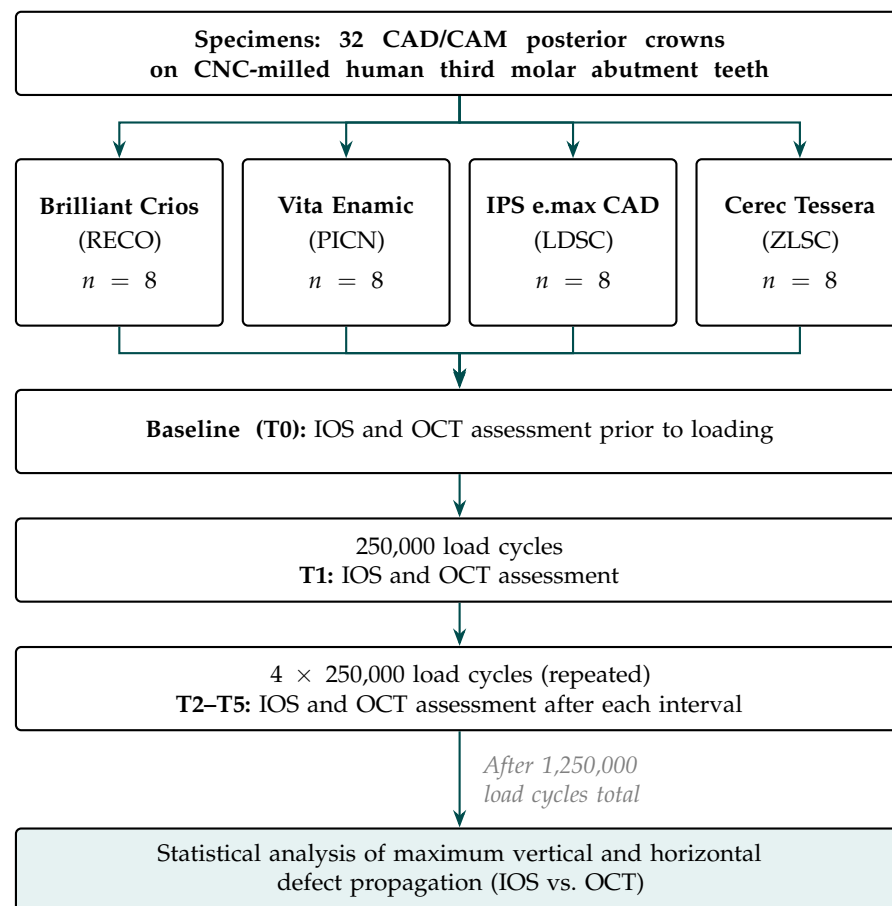
**Figure 1.** Schematic overview of the study protocol. CNC = computer numerical control; CAD/CAM = computer-aided design/computer-aided manufacturing; RECO = resin composite; PICN = polymer-infiltrated ceramic network; LDSC = lithium disilicate ceramic; ZLSC = zirconia-reinforced lithium silicate ceramic; IOS = intraoral scanning; OCT = optical coherence tomography.

IOS and OCT monitoring was performed at baseline (T0), and after 250,000 (T1), 500,000 (T2), 750,000 (T3), 1,000,000 (T4), and 1,250,000 (T5) load cycles (Figure 1), with each 250,000 cycles corresponding to approximately one year of intraoral function under average chewing conditions [35]. All assessments were conducted by a single calibrated examiner under clinical-close conditions in a dental phantom head with a model composed of human teeth; between simulation runs and imaging, specimens were kept continuously moist in distilled water. The same examiner performed the mechanical loading and all IOS and OCT acquisitions and analyses with knowledge of specimen material and timepoint; assessments were therefore not blinded, and blinding to timepoint was not feasible as progressive damage reveals the measurement sequence. Specimens that fractured prior to or at a given timepoint were assigned a maximum damage value of 100 % for both IOS- and OCT-derived metrics, with this value retained for all subsequent timepoints to represent complete restoration failure.

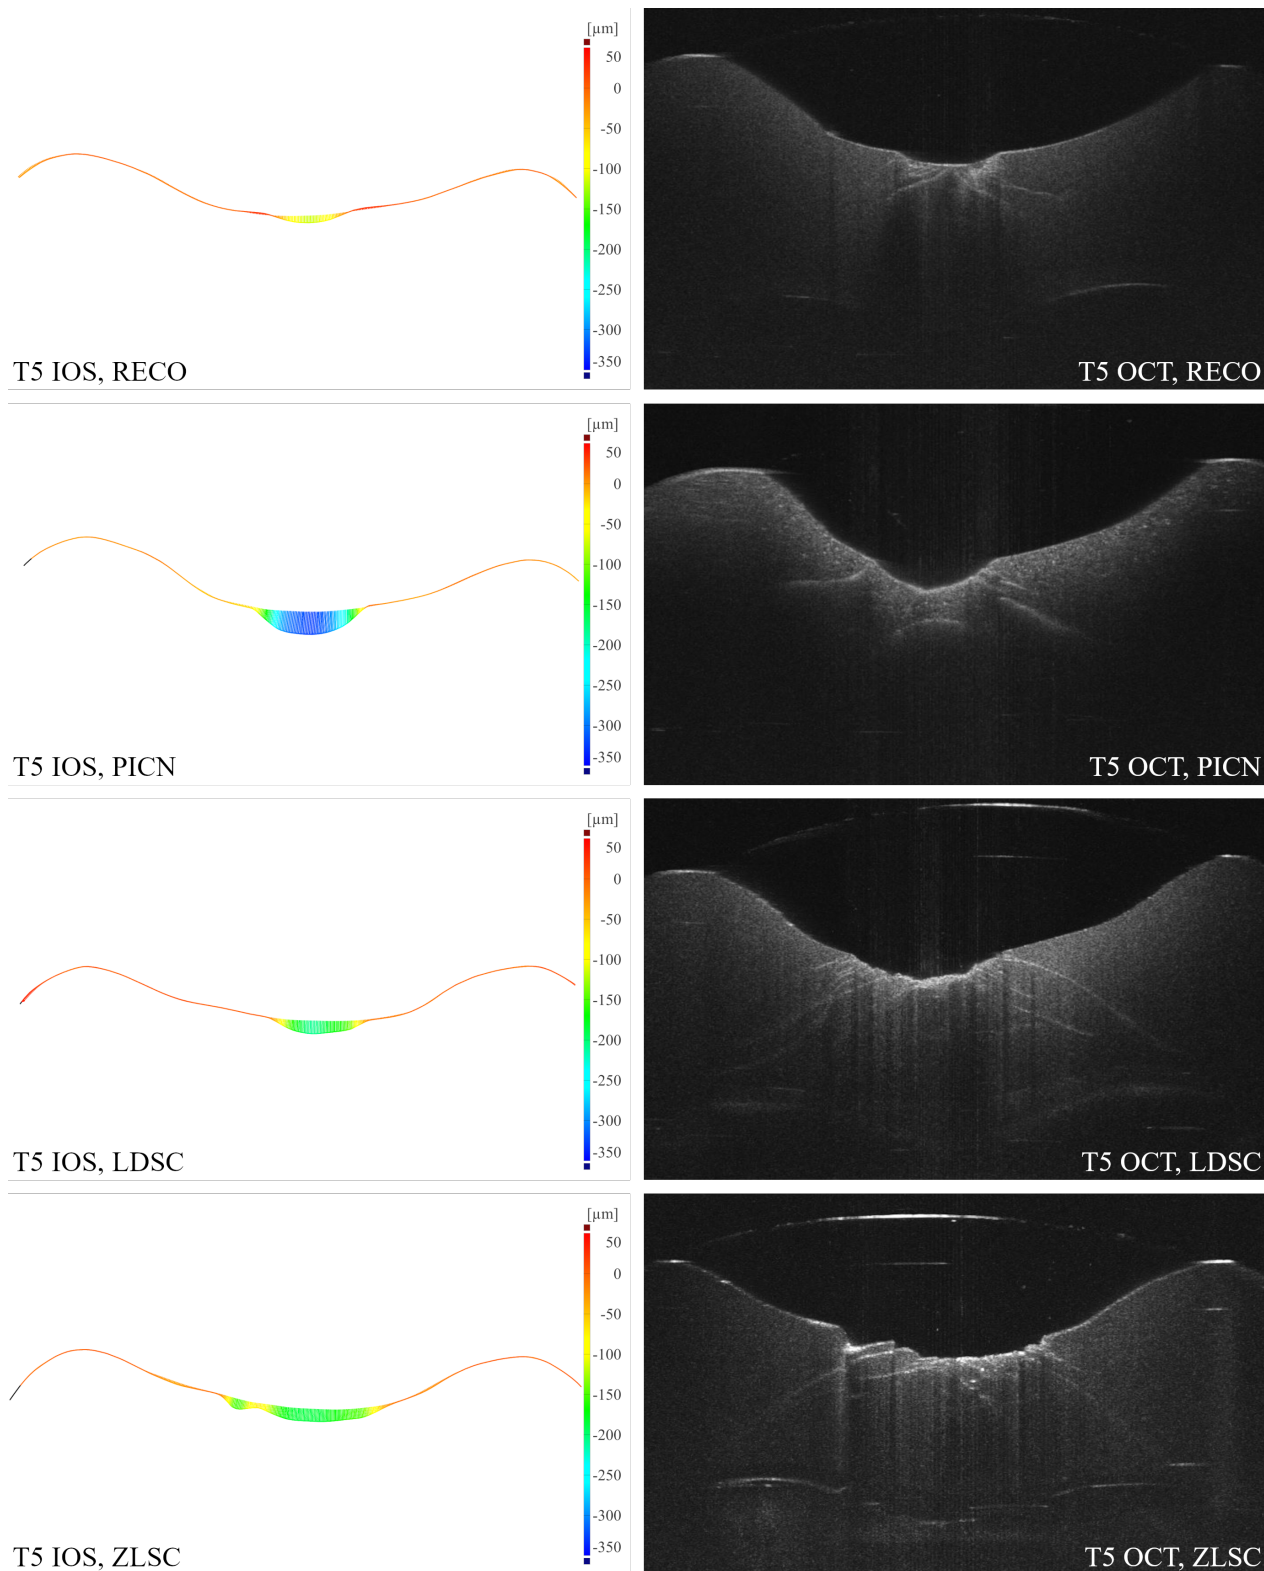
**Figure 2.** Comparison of surface wear and subsurface damage at T5 (after 1,250,000 load cycles) across all material classes; resin composite (RECO), polymer-infiltrated ceramic network (PICN), lithium disilicate ceramic (LDSC), and zirconia-reinforced lithium silicate ceramic (ZLSC). **Left:** Intraoral scanning (IOS) surface deviation maps referenced to T0. **Right:** Representative optical coherence tomography (OCT) cross-sections illustrating the qualitative extent and propagation of subsurface damage. Due to optical distortion caused by the water droplet used to reduce specular reflection and improve image contrast, the OCT images are intended for qualitative visualization only and do not provide reliable absolute spatial dimensions. RECO data previously reported in Kuhl et al. [1].

Despite the high failure rate in ZLSC, fatigue damage was detectable by both modalities from the earliest timepoint in all material classes. Both IOS and OCT revealed progressive damage over time across all four material classes, with OCT consistently indicating higher defect extents than IOS. Figure 2 shows a representative comparison of IOS-derived surface deviation maps and OCT-derived cross-sectional images at T5 for each material class. The images represent a longitudinal cross-section through the crown along the occlusal contact area; for each material class, the left image shows the IOS surface deviation map referenced to baseline (T0) and the right image shows the corresponding OCT cross-section. While both modalities capture progressive damage, their patterns differ fundamentally: IOS reflects external surface wear, whereas OCT reveals subsurface damage propagation, illustrating the systematic discrepancy between the two modalities across material classes.

A general mechanical principle relevant to all four material classes concerns the stress distribution under Hertzian contact loading: compressive stresses dominate directly beneath the antagonist, while tensile stresses develop at the contact periphery [17]. Since dental restorative materials fail preferentially under tension [12,14,17], and exhibit a marked tension-compression asymmetry [11], crack initiation occurs preferentially at the contact periphery, favoring horizontally oriented propagation. In more brittle silicate-based materials, this peripheral tensile initiation is additionally accompanied by rapid vertical full-thickness propagation, as visible in the OCT cross-sections of LDSC and ZLSC in Figure 2. This

damage morphology also explains why horizontal propagation was more closely mirrored by external surface changes than vertical propagation across all material classes. The OCT cross-sections (Figure 2) were dominated by cone cracks (outer, inner, and median) initiating at the periphery of the loaded contact, most pronounced at the crater rim in LDSC and ZLSC and more central in RECO and the PICN. Consistent with the purely axial loading, neither partial cone cracks nor radial or flexure cracks from the cementation side [12] were observed. Because the near-surface, horizontally oriented segment of a cone crack coincides with the region of occlusal material loss, its lateral extension is partially captured by IOS, whereas the vertical cone-crack penetration advances beneath an essentially intact surface—accounting for the closer IOS-OCT correspondence in the horizontal metric across all material classes.

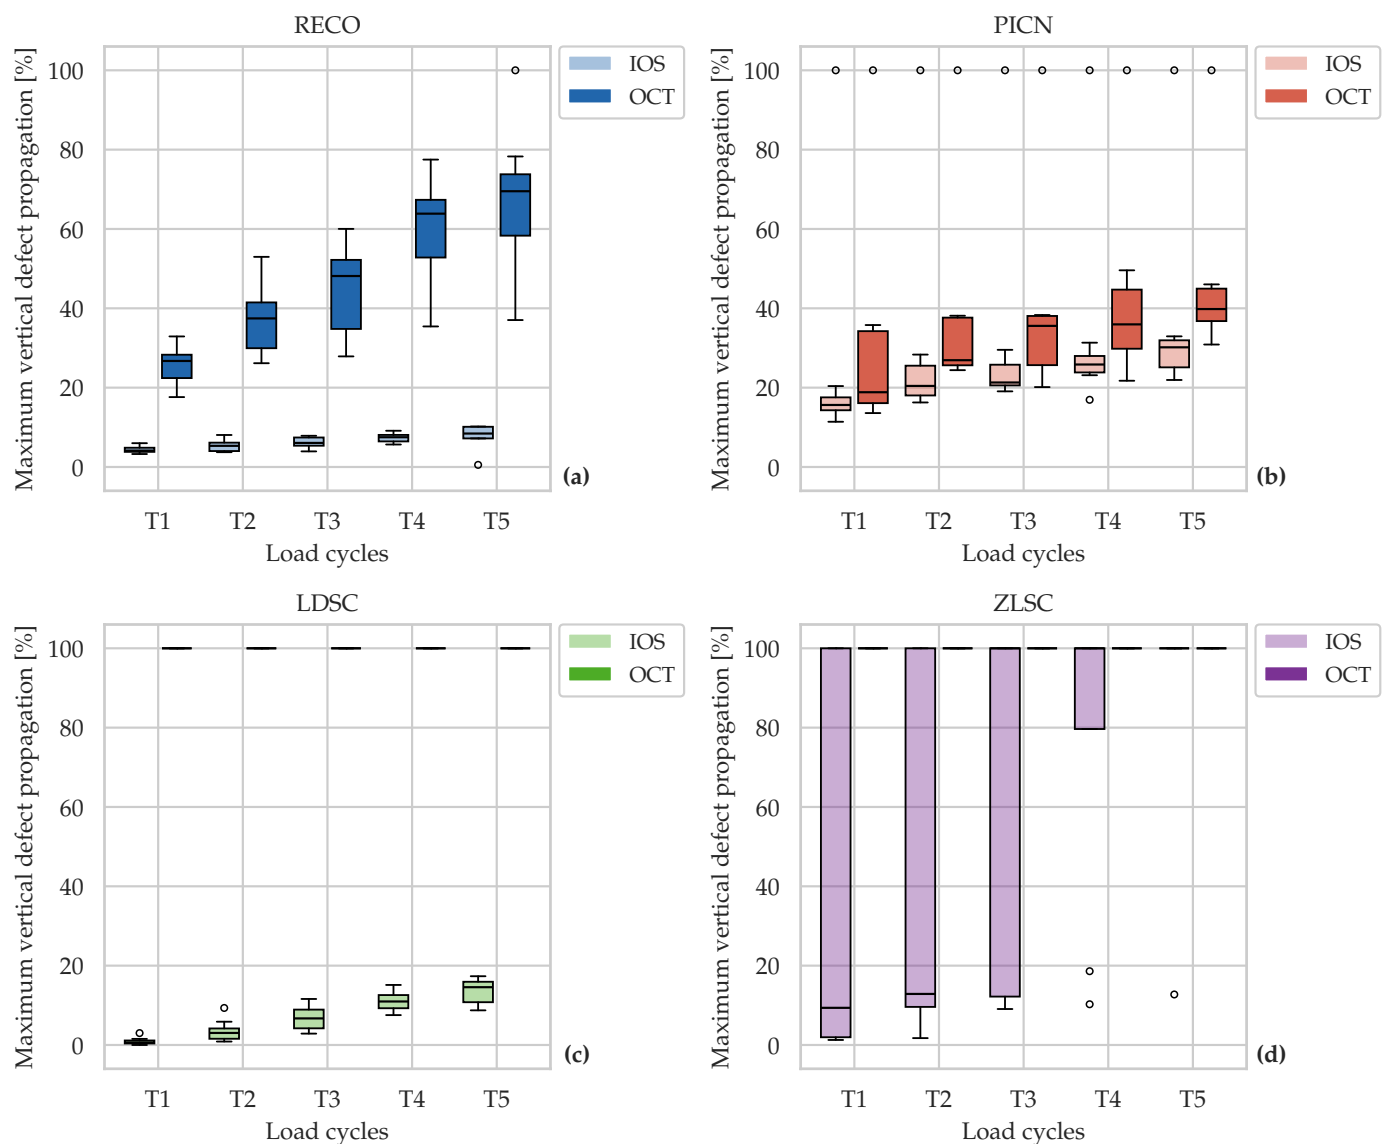
**Figure 3.** Maximum vertical defect propagation (%) by intraoral scanning (IOS, surface wear) and optical coherence tomography (OCT, subsurface damage) for four CAD/CAM crown materials: (a) resin composite (RECO, Brilliant Crios), (b) polymer-infiltrated ceramic network (PICN, Vita Enamic), (c) lithium disilicate ceramic (LDSC, IPS e.max CAD), and (d) zirconia-reinforced lithium silicate ceramic (ZLSC, Cerec Tessera). OCT values are normalized to local occlusal thickness and IOS values to a 1.5 mm reference. RECO data were previously reported in Kuhl et al. [1] and are included for cross-material comparison. Collapsed boxes (single horizontal line at 100%) indicate that all specimens within that group reached the maximum value, defined as either full-thickness cracking through the entire crown layer or catastrophic failure of the crown. Timepoints: after 250,000 (T1), 500,000 (T2), 750,000 (T3), 1,000,000 (T4), and 1,250,000 (T5) load cycles.

Figure 3 displays the maximum vertical defect propagation for all material classes across T1–T5. All four material classes showed progressive damage over time in both modalities, with OCT yielding systematically higher values than IOS throughout. For RECO and the PICN, both IOS and OCT revealed a monotonic increase in central tendency, consistent with gradual fatigue damage accumulation. For LDSC and ZLSC, OCT vertical measurements reached the maximum value of 100 % from T1 onward, indicating full-thickness vertical crack propagation from the earliest observation interval; as a result, the OCT boxplots for these materials collapse to a single horizontal line at 100 %, reflecting the absence of variance across specimens. IOS-derived surface wear remained substantially lower for LDSC across all timepoints. For ZLSC, the progressive specimen loss resulted in an increasing proportion of 100 % values in the IOS data as well as fractured specimens were assigned maximum damage values; this is reflected in the wide IQR and the upper extent of the IOS boxplots approaching 100 % at later timepoints. The dissociation between externally visible surface wear and subsurface crack depth was most pronounced in LDSC and ZLSC and reflects the capacity of OCT to detect subsurface damage that does not manifest proportionally at the surface. Detailed descriptive statistics are provided in Table A1.

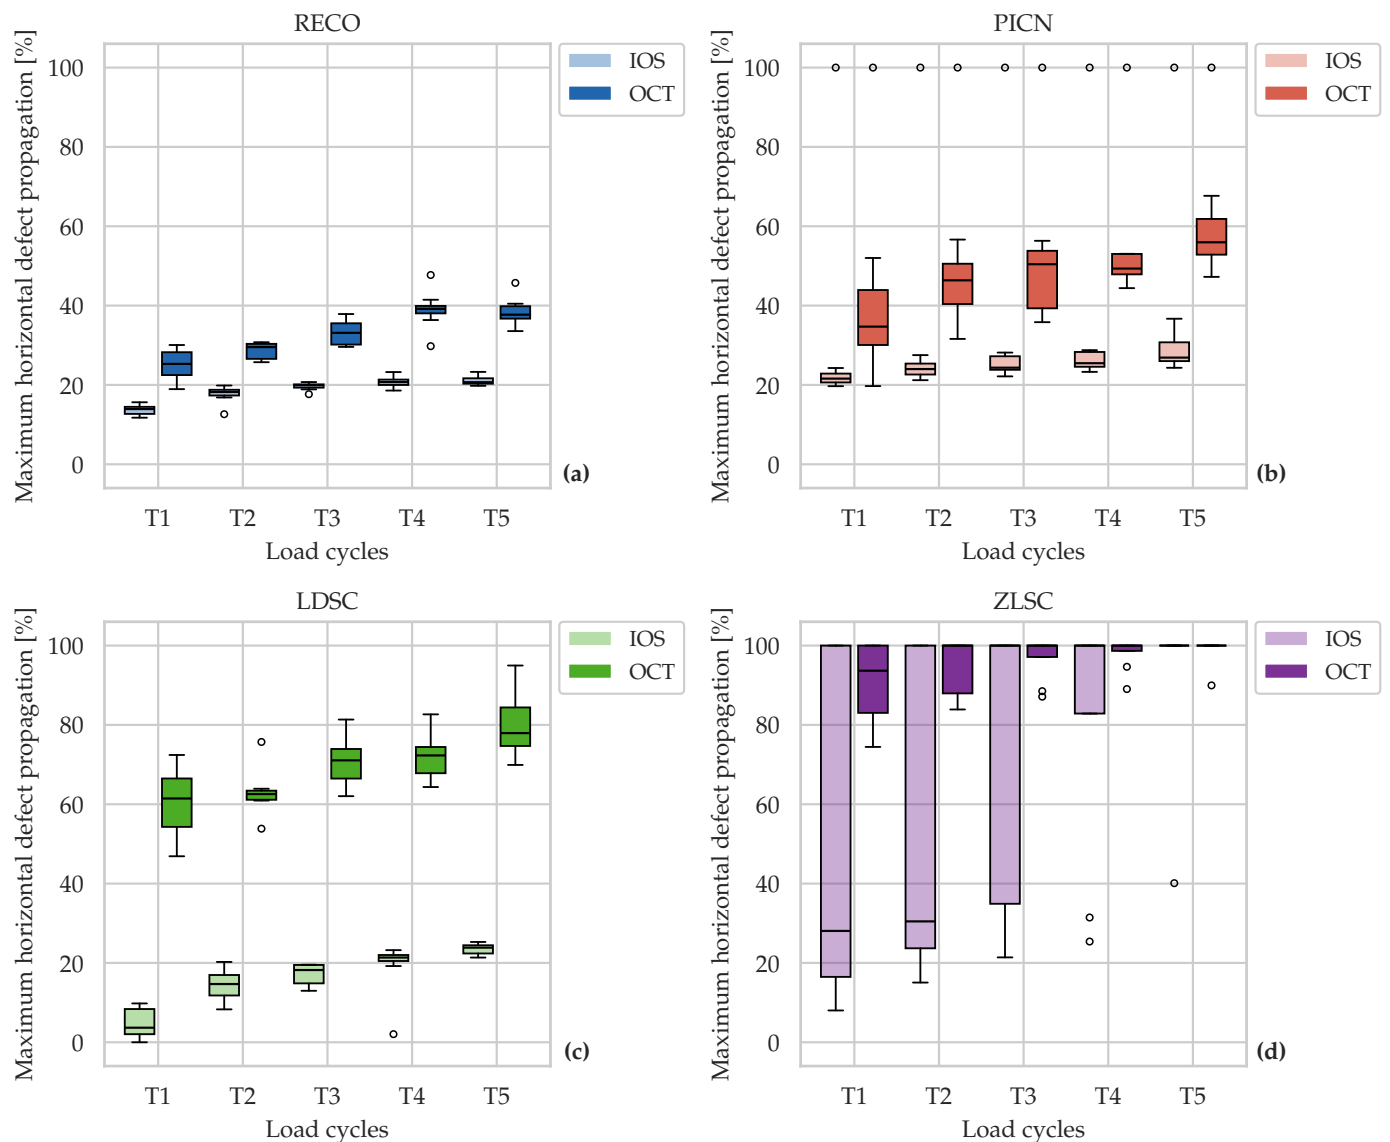
**Figure 4.** Maximum horizontal defect propagation (%) by intraoral scanning (IOS, surface wear) and optical coherence tomography (OCT, subsurface damage) for four CAD/CAM crown materials: (a) resin composite (RECO, Brilliant Crios), (b) polymer-infiltrated ceramic network (PICN, Vita Enamic), (c) lithium disilicate ceramic (LDSC, IPS e.max CAD), and (d) zirconia-reinforced lithium silicate ceramic (ZLSC, Cerec Tessera). OCT values are normalized to the cusp-tip distance; IOS values to a 7 mm reference. RECO data were previously reported in Kuhl et al. [1] and are included for cross-material comparison. Collapsed boxes (single horizontal line at 100 %) indicate that all specimens within that group reached the maximum value, defined as either full-thickness cracking through the entire crown layer or catastrophic failure of the crown. Timepoints: after 250,000 (T1), 500,000 (T2), 750,000 (T3), 1,000,000 (T4), and 1,250,000 (T5) load cycles.

Figure 4 displays the maximum horizontal defect propagation for all material classes across T1–T5. Consistent with the vertical metrics, OCT yielded higher values than IOS across all material classes and timepoints, and both modalities showed progressive increases over time. For the PICN and ZLSC, considerable variability was observed, particularly in the IOS data, driven in part by the 100 % values assigned to fractured specimens. For ZLSC, OCT horizontal values were already markedly elevated from T1, though without the complete ceiling effect seen in the vertical metric, as evidenced by the remaining variance in the OCT boxplots at early timepoints. Notably, between-method differences were smaller for the horizontal than for the vertical metric across all material classes, suggesting that horizontal crack propagation is more closely reflected by external surface changes than vertical crack depth. Detailed descriptive statistics are provided in Table A2.

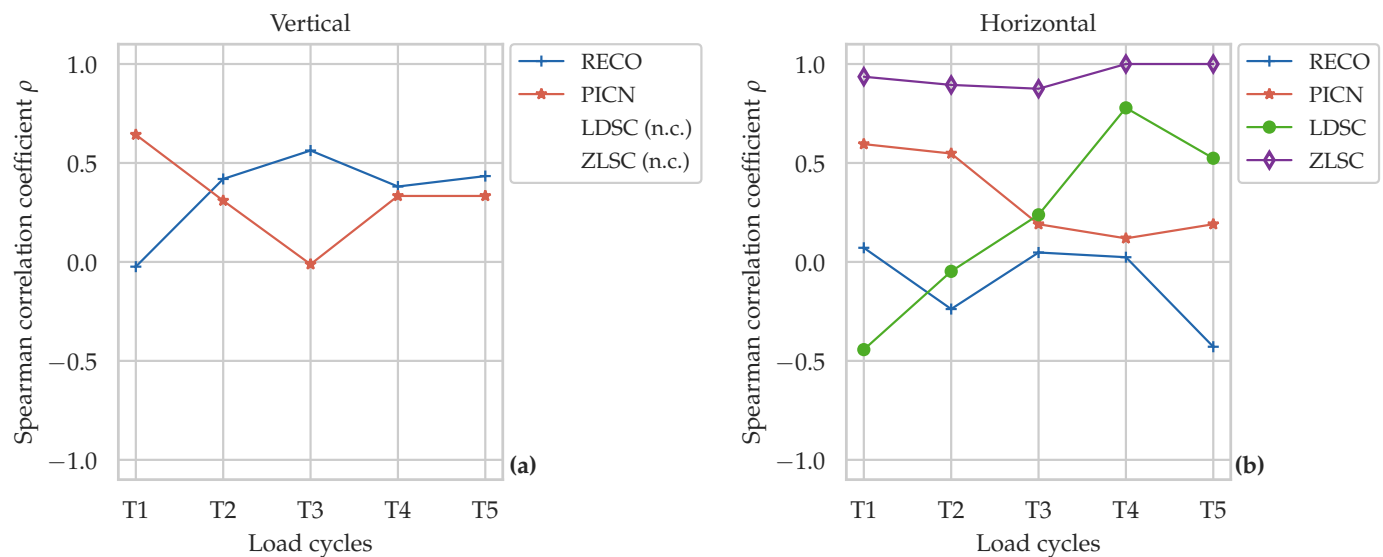
**Figure 5.** Spearman's rank correlation coefficient ( $\rho$ ) between IOS-derived surface wear and OCT-derived subsurface damage for vertical (a) and horizontal (b) metrics for four CAD/CAM crown materials: resin composite (RECO, Brilliant Crios), polymer-infiltrated ceramic network (PICN, Vita Enamic), lithium disilicate ceramic (LDSC, IPS e.max CAD), and zirconia-reinforced lithium silicate ceramic (ZLSC, Cerec Tessera). In panel (a),  $\rho$  could not be calculated for LDSC and ZLSC (n.c.) as OCT vertical values reached a ceiling of 100 % at all timepoints, reflecting predominantly vertical crack propagation in these materials. RECO data were previously reported in Kuhl et al. [1] and are included for cross-material comparison. Timepoints: after 250,000 (T1), 500,000 (T2), 750,000 (T3), 1,000,000 (T4), and 1,250,000 (T5) load cycles.

Spearman's rank correlation coefficients between IOS- and OCT-derived metrics are displayed in Figure 5 and reported in full in Tables A3 and A4.

Regarding the vertical metric,  $\rho$  could not be calculated for LDSC and ZLSC due to the OCT ceiling effect described above. Neither RECO nor the PICN showed statistically significant associations at any timepoint (all  $p > 0.05$ ). Across assessment timepoints, effect sizes following the conventions of Cohen [38] varied from small negative ( $|\rho| < 0.10$ ) to medium positive values ( $|\rho|$  up to 0.563 for RECO and 0.643 for the PICN), yet all tests remained non-significant, providing no evidence of a reliable association between vertical surface wear and subsurface crack depth for these materials. Consistent with the small sample size, the corresponding 95 % bootstrap confidence intervals were wide and included zero throughout (Table A3), underscoring the limited precision of these estimates.

Horizontal correlations showed a more differentiated picture across material classes. RECO and the PICN yielded no significant associations at any timepoint. In LDSC, a single significant correlation emerged at T4 ( $\rho = 0.778$ ,  $p = 0.023$ ), while all other timepoints remained non-significant; however, its 95 % confidence interval was wide and included zero (95 % CI:  $-0.190$  to  $1.000$ ), indicating that this isolated association is statistically fragile and should not be over-interpreted. ZLSC showed consistently strong and statistically significant correlations across all horizontal timepoints ( $\rho = 0.875$ – $1.000$ , all  $p \leq 0.004$ ).

However, these values must be interpreted with caution: the high  $\rho$  values at T4 and T5 in particular are likely driven by the progressive specimen loss in ZLSC, where the majority of fractured specimens were assigned 100 % for both IOS and OCT, producing near-identical ranks across modalities rather than reflecting a true biological association between surface wear and subsurface damage. This interpretation is reinforced by the confidence intervals, which collapsed to a zero-width interval at T4 and T5 (95 % CI: 1.000 to 1.000) as a direct consequence of the identical 100 % ranks assigned to fractured specimens, rather than reflecting a genuine association.
