Article

Assessment of Thermal Comfort and Air Quality in Office Rooms of a Historic Building: A Case Study in Springtime in Continental Climate

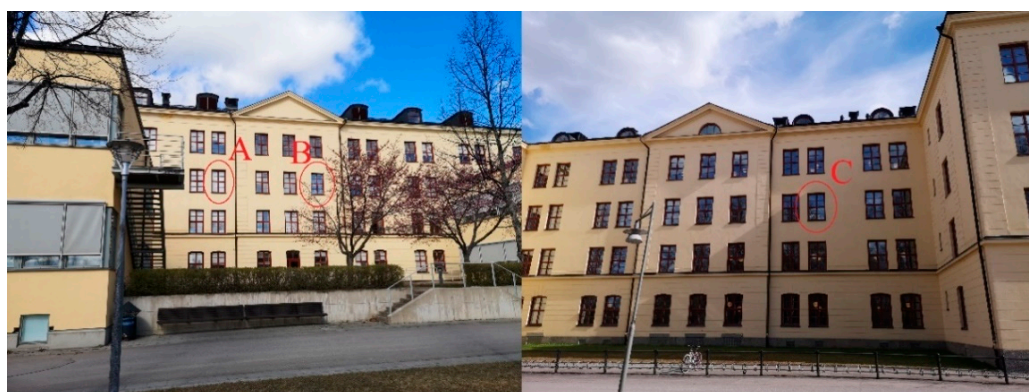
Figure 1. The windows to Rooms A and B face south, and the window to Room C faces north.

the building had a basement floor that was designated as floor one. Figure 1 shows a picture of the building and the office windows from the outside. The offices were designed for one person and had a computer installed in each room. They were equipped with a separate, height-adjustable desk set at 0.8 m. One of the rooms facing south (S), room A, had staff on weekdays while the other, room B, was empty most of the time. The room in the north position (N), room C, usually had staff only until lunchtime. In addition to having a computer in each room, rooms A and C both had two computer monitors, while room B only contained one.

The windows in all offices were double-glazed, which were subsequently supplemented with an extra layer of glass panes made by Grundels [31]. The total window area per office, which consisted of four individual windows placed together as one large window, was 3.1 m² with a total glass area of 1.7 m². Figure 3 shows the window layout. According to [31], the U-value of the windows was lowered to 1.3 W/m²·K after adding the extra glass pane, which previously was 2.9 W/m²·K. All offices were equipped with thin, almost transparent curtains on each side of the windows that extended all the way from the ceiling down to the floor, thus covering the elements that were placed under the windows. The detailed information about the curtains can be found in Table 2. The south-facing rooms also had blinds inside each of the four individual windows. There was no external shading. There were no trees outside the offices that cast shadows on the windows, and on the south side, there were no other buildings that cast shade. On the north side, room C(n) was shaded by a part of the building in the afternoon (to the left side), which meant that it received almost no direct sunlight; see Figure 1.

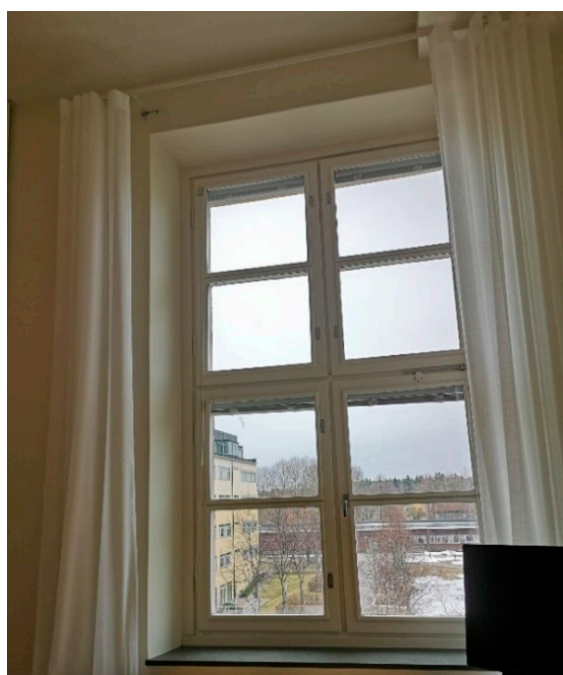
Figure 3. Room B(s) window.

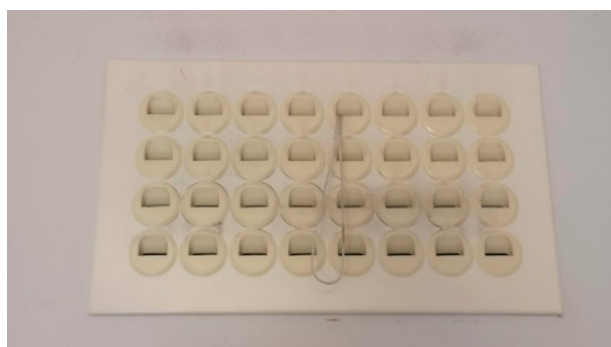
Figure 4. An air supply device with nozzles directed upwards towards the ceiling.

The ventilation was on from Monday to Friday between 05:00 and 18:00 and completely off at other times. The system was fan-controlled supply and exhaust air with heat recovery, i.e., FTX ventilation. The unit had a rotary heat exchanger and a heating and cooling coil. The ventilation was designed to supply 15 L/s to each office room. In the offices, there were exhaust and supply air devices for mixed ventilation, placed high up on the walls near the ceiling, as seen in Figure 2. The supply air nozzles in all rooms were directed upwards, towards the ceiling, as shown in Figure 4. The supply air temperature was configured depending on what the OT was; 20.0 °C when OT < −25.0 °C, 19.0 °C when OT between −25.0 °C–24.9 °C and 18.0 °C when OT ≥ 25.0 °C.

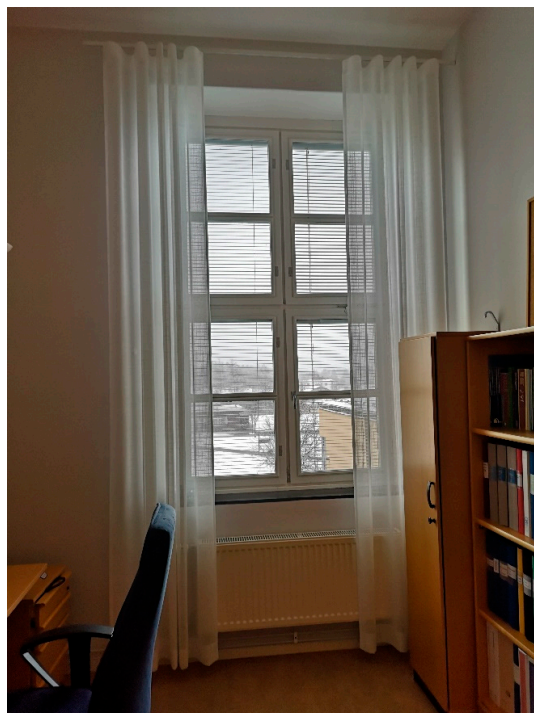
Figure 7. The window configuration in Room A.

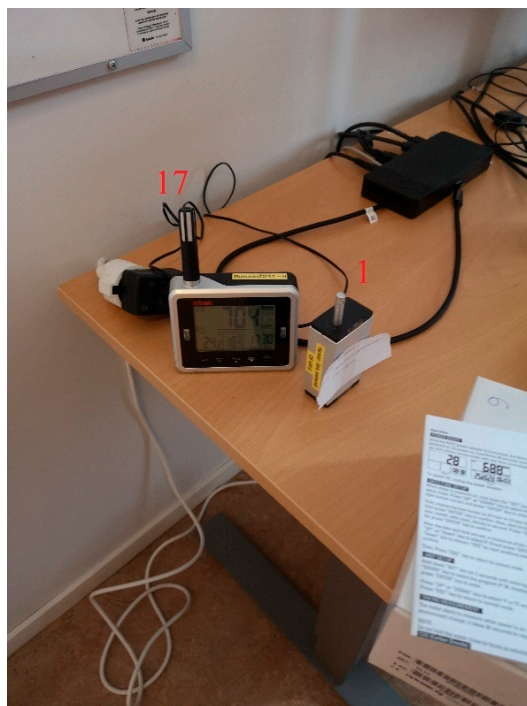
Figure 8. Placement of Loggers 1 and 17 in Room A.

In room A, the person could control the radiator and sunshade freely. Some type of sun protection was always used. The blinds were usually pulled down and angled horizontally, and the curtains were half drawn, as shown in Figure 7. On sunny days, however, the sunshades were used to a greater extent. In the room, logs 1 and 17 were placed

on the desk to the left of the two computer screens at a height of 0.8 m (see Figure 8). However, the interval on logger 17 had been forgotten to be specified and it was set to 10 sec previously.

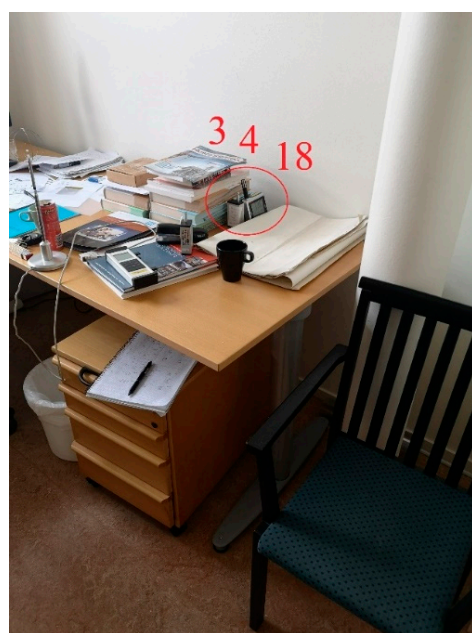
Figure 9. Placement of loggers 3, 4, and 18 in Room B.

In room B, the radiator thermostat was on the highest setting (max 3), and the staff usually worked from home. In room B, loggers 3 and 18 were set up on the desk at a height of 0.8 m, with the right side of the computer screen against the wall (see Figure 9). The

globe thermometer 2 was also set up on the desk in front of the window at a height of 1.08 m with an interval of five minutes. Two identical loggers were used here: 3 and 4. The difference between these was the measuring interval, which was set to 5 and 15 min respectively. In order to compare the globe thermometer in room B with the one in room C, globe thermometer 2 in this room was moved to the floor a few days after it was on the desk. It was placed at a height of between 0.7 m and 0.9 m from the window wall in front of the desk. See Figure 10 for the location of the globe thermometer before and after it was moved. The next day, the desk was lowered to 0.7 m, so that half of the globe thermometer ended up above the desk and therefore became more sunny. This meant that the log on the desktop was also lowered.

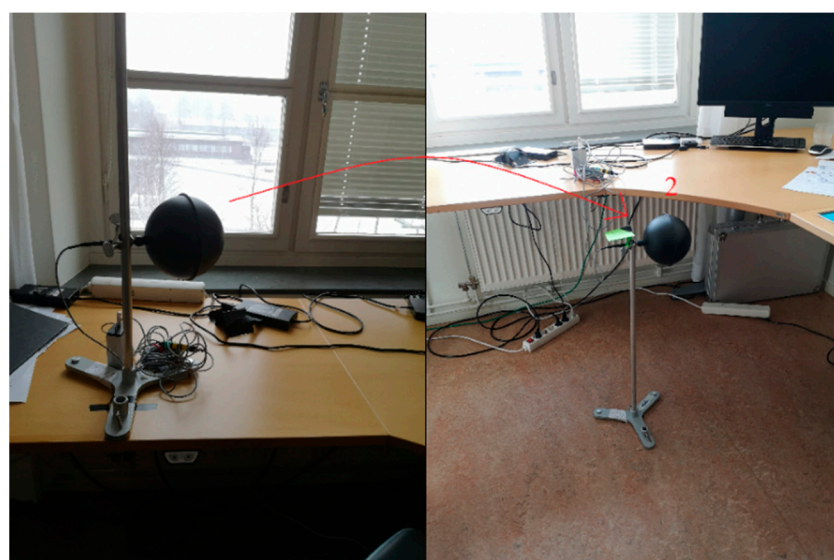
Figure 10. Placement of the globe thermometer in its first and second placements in Room B.

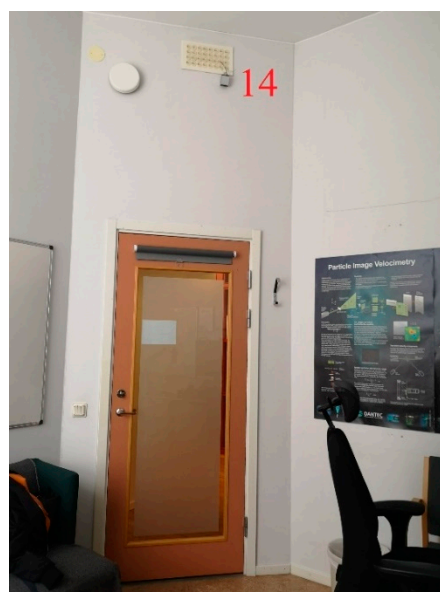
Figure 12. Placement of logger 14 (at the supply inlet) in Room C.

first and later moved to the desk behind the computer monitor at a height of 0.8 m to resemble the placement in the other rooms. See Figure 11 for the location of the loggers before and after they were moved. On day 5, logger 14 was placed in the supply air; see Figure 12. The globe thermometer 5 was placed on a stand directly in front of the window at a height of 0.7 m, 0.75 m in front of the radiator, which meant 0.9 m from the wall.

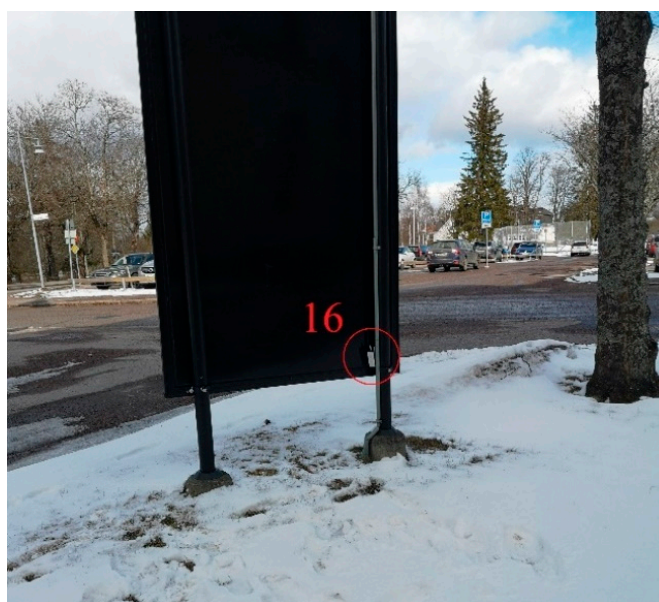
Figure 13. Placement of logger 16 behind a sign outside the university.

The loggers 15 and 16 were placed outdoors. The logger 15 was placed on a window-sill facing northwest on the 3rd floor, that is, the floor below the rooms where the measurements were performed. The logger was shaded all day except in the evenings. In addition, the logger 16 was placed on the back of a sign that was located north of the building (see Figure 13). The logger's location was exposed to sunlight for approximately four hours in the morning and two hours in the afternoon.

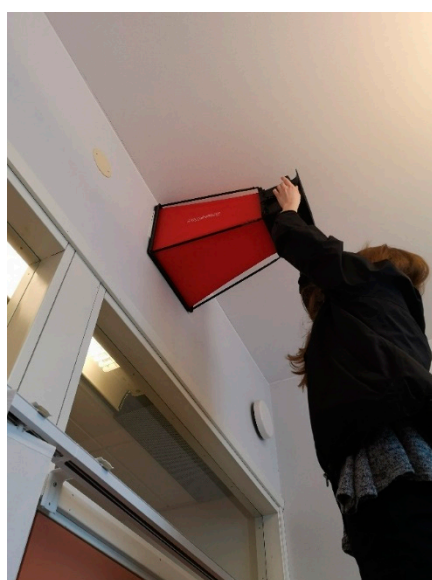
Figure 14. Show the airflow probe being used for measuring the ventilation flow rate of the supply device in room A.

A SwemaFlow airflow probe from Swema AB was used to measure the ventilation flows. This device can measure air flows between 1.5 and 125 L/s with a measurement uncertainty of $3\% \pm 0.5$ L/s. The measurements were carried out on one occasion in all three rooms on the supply air devices. Figure 14 shows the measurement of the supply air flow. The plug was placed over the device, and a reading of the flow was taken. During the measurements, the doors were closed.

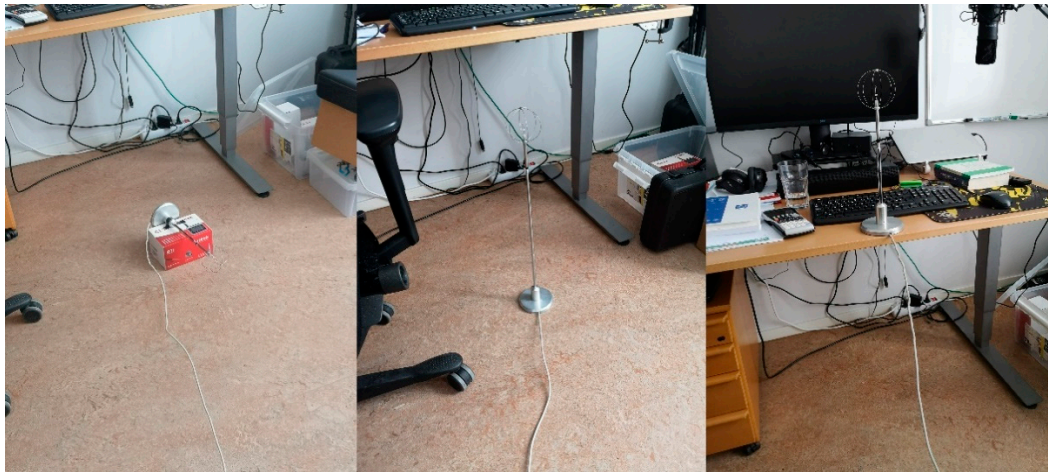
Figure 15. Air velocity measurements at 0.1, 0.6, and 1.1 m in Room C.

The air velocity measurements were done according to ISO 7726 at three different heights: 0.1 m, 0.6 m, and 1.1 m. Three measurements were made at each height in each room, and the measurement interval was set to 1 s. Each measurement period lasted for 30 s. Figure 15 shows the position of the air velocity measurements. The air measurements were taken for Room B(s) and Room C(n).

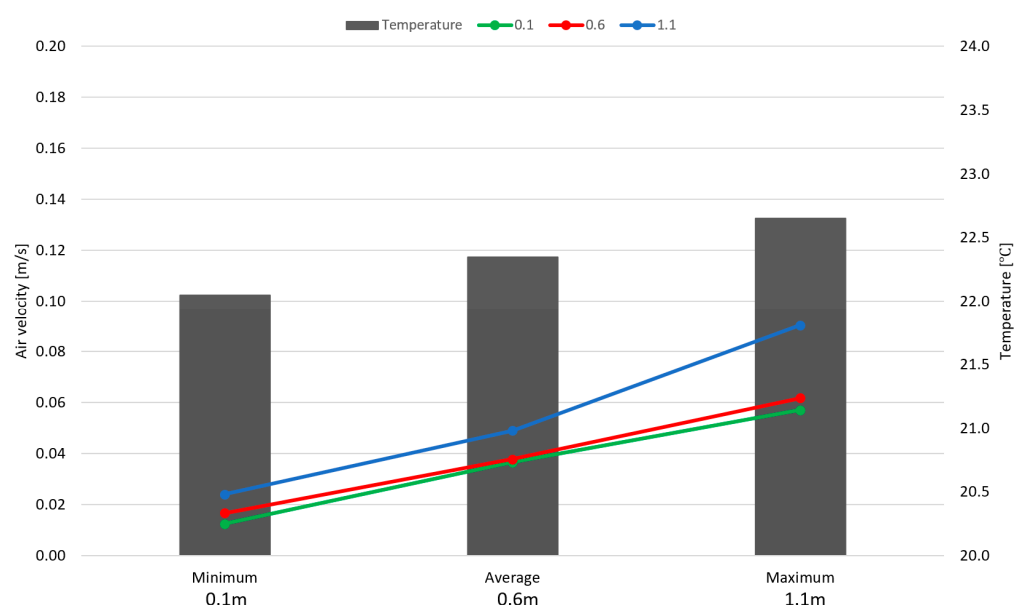
Figure 27. Results for room C facing north, showing the minimum, average, and maximum value for the air velocity measurements at three different heights and the mean temperature on the right axis for the different measuring heights.

According to the guidelines in Boverket’s building regulations in Sweden (BBR) [8], the air velocity in the occupied zone should not exceed 0.15 m/s during the heating season and 0.25 m/s during other times, including the cooling season, at a height of 0.1 m. The results show that the air velocities are well below these levels.

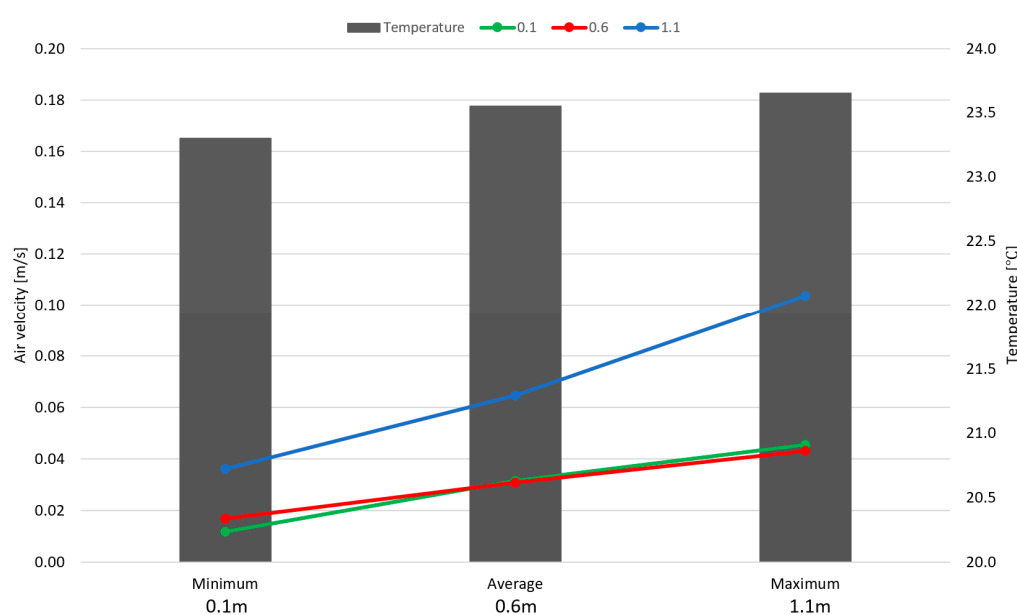
Figure 28. Results for room B facing south, showing the minimum, average, and maximum value for the air velocity measurements at three different heights, and the mean temperature on the right axis for the different measuring heights.
